RSH ENGINEERING, INC

FOUNDATION ANALYSIS

Subject: XYZ Anytown, TX

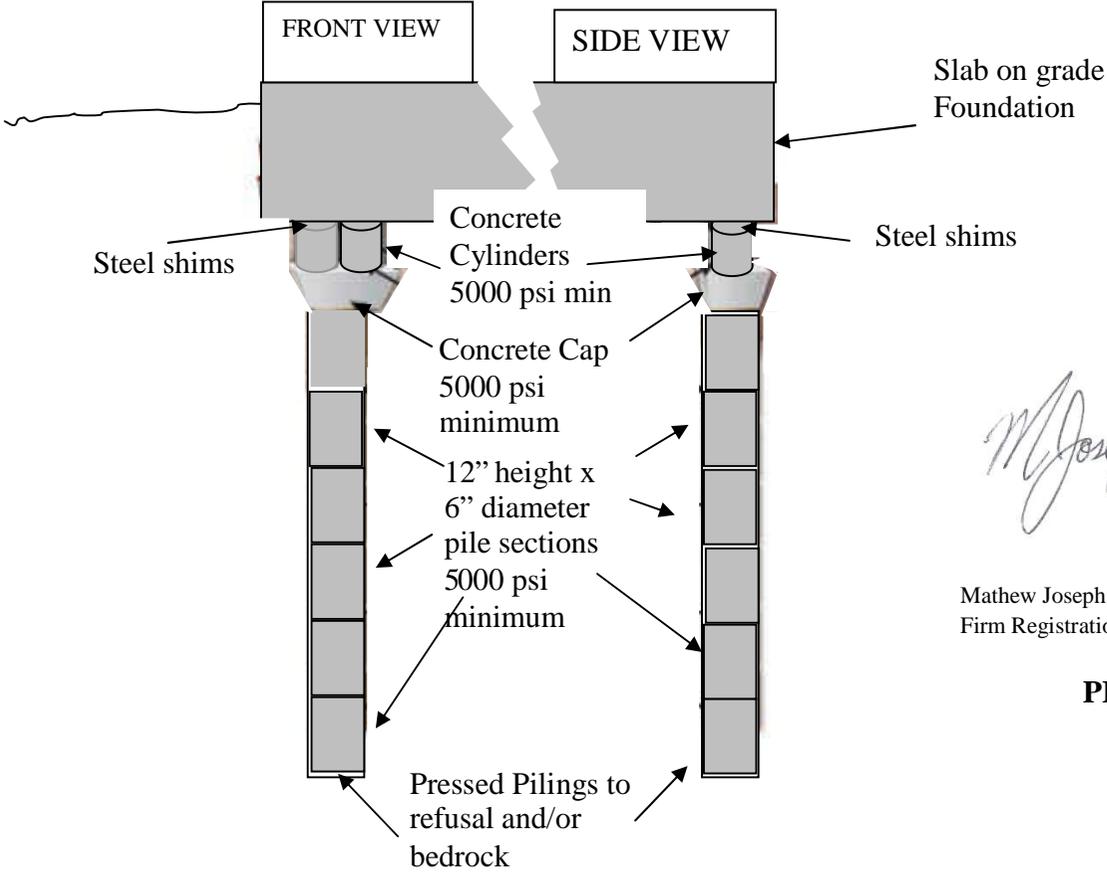
**FOUNDATION REPAIR PLAN-XYZ
Anytown, TX**

~ Existing cracks (not all shown)
NOTE: Use saw to cut concrete in square or rectangular cutouts where breakouts are required. Make sure all the cutouts are the same dimensions. Check with homeowner regarding the size of the cutouts and concrete finish out. Provide a clean, smooth finish out.

- Add Pressed Piers
- Jack up these areas and adjust/shim the existing Pressed Piers. See notes below regarding concrete breakouts. **RSH is not sure if existing piers are present. If piers are missing, add the piers at these locations.**

- ↔ Provide positive drainage
Slope of 1-inch of drop for the 1st five feet away from the foundation
- Provide minimum of 3 -feet downspout extenders to all gutter downspouts around the house.
