HEDDERMAN ENGINEERING, INC.

REF: CONDITION OF PROPERTY SURVEY - Roof Inspection.

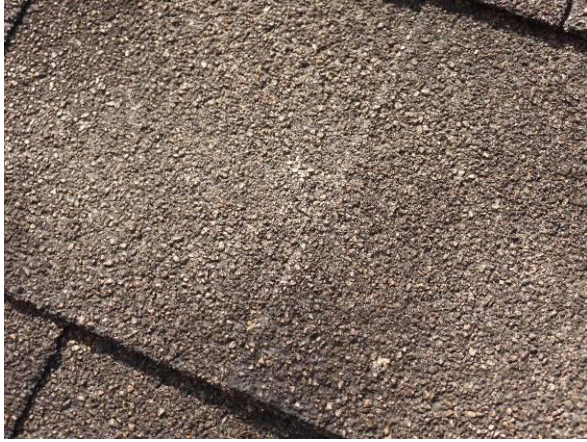
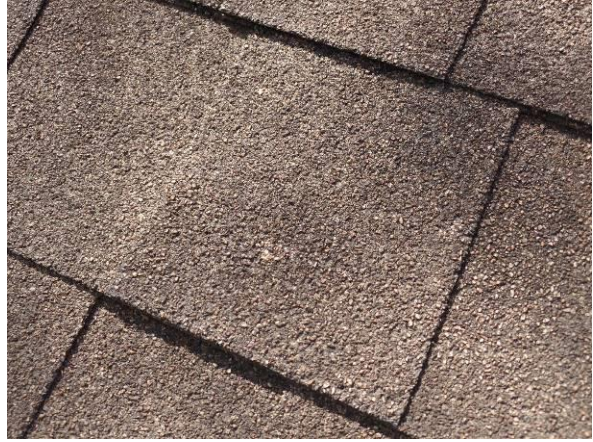
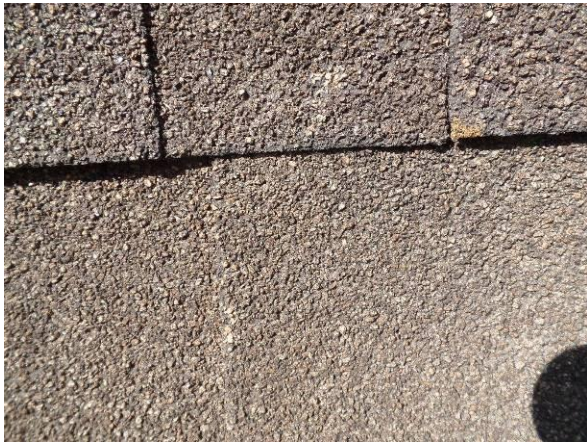
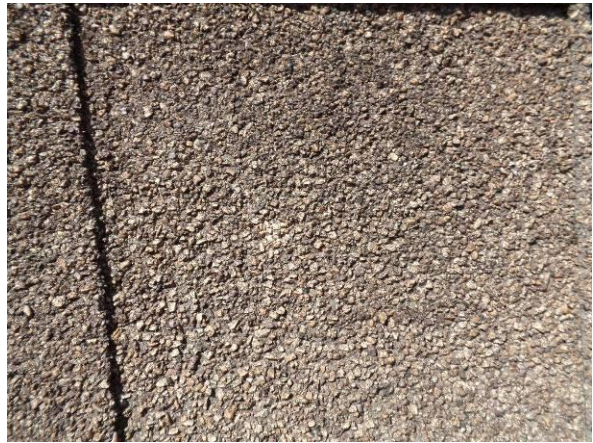
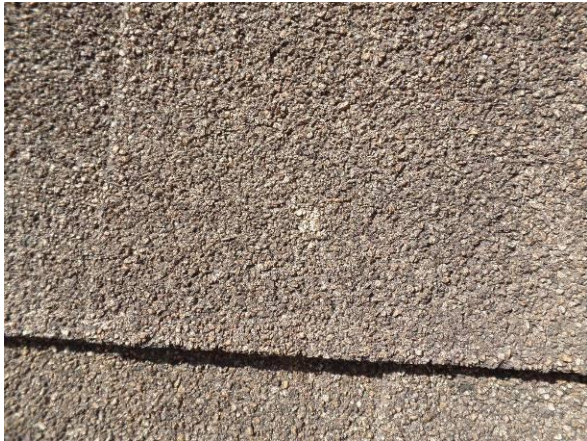
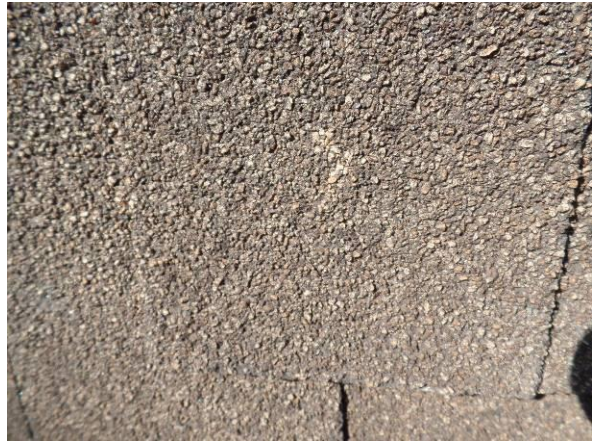
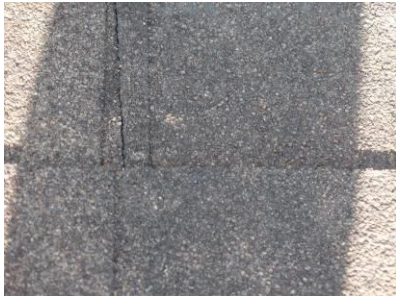
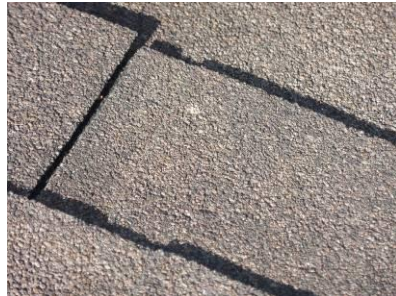
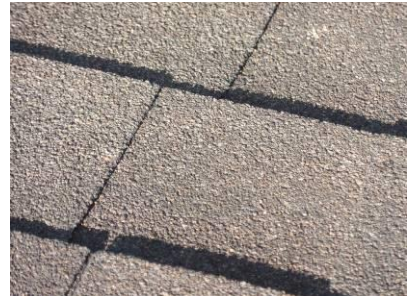
The composition roof has obviously been struck by hail, as evidenced by the numerous locations where the black discoloration on the surface of the shingles has been removed. Most of the damage from hail is principally an impact damage effect and takes place on the bottom side of the shingle, where the force of the hail strike causes microcracks in the base shingle material while loosening the aggregate where the hailstone strikes. These small cracks are not visible without plying and lifting the shingles to see the bottom side. Since this process can damage the shingles, we do not attempt to lift any shingles to see the bottom side.

It was very apparent when viewing the roof from its surface that the entire roof showed evidence of having been struck by hail.

This roof has clearly been struck and damaged by hail, and it is our opinion that the roofs on both the house and garage are in need of replacement, as well as the patio cover over the rear patio area.

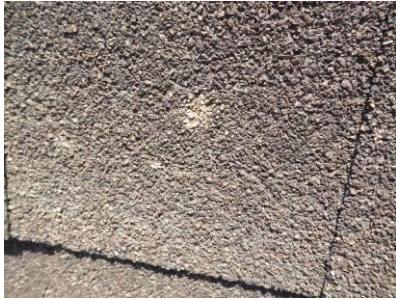
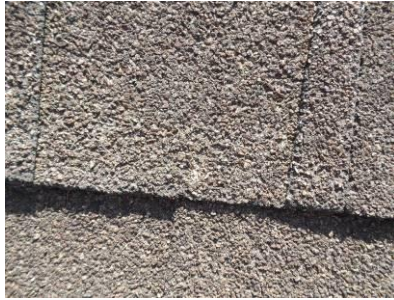
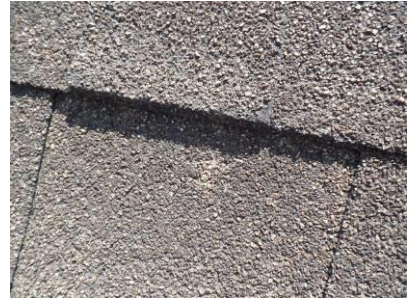
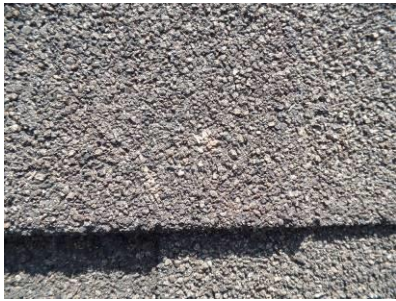
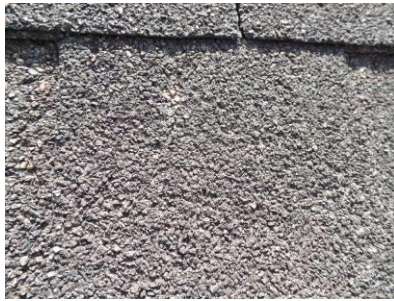
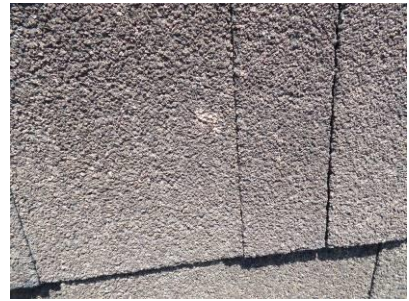
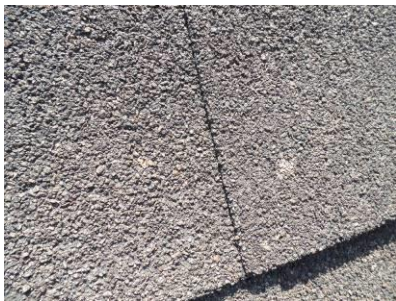
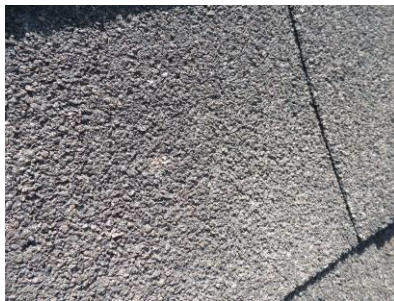
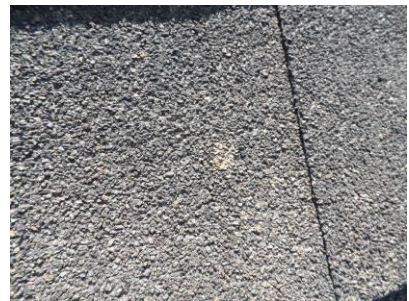
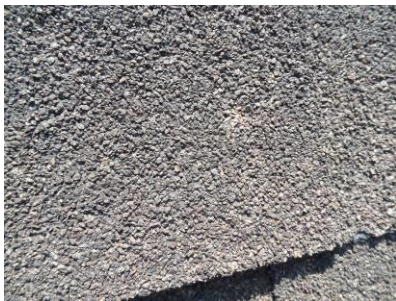
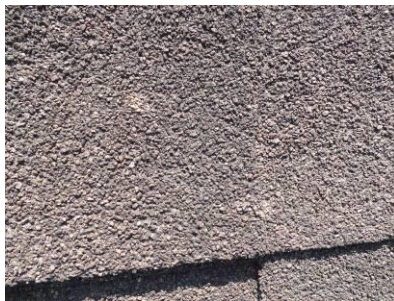
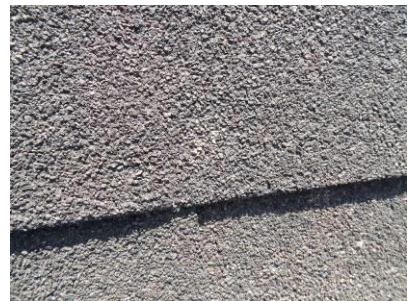
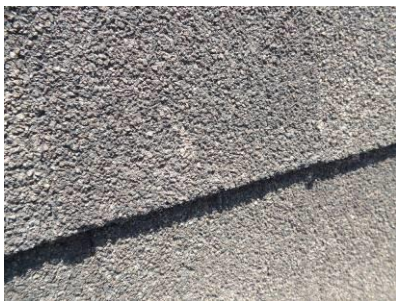
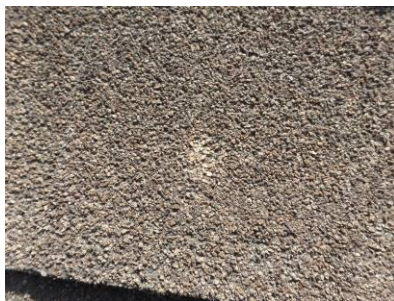
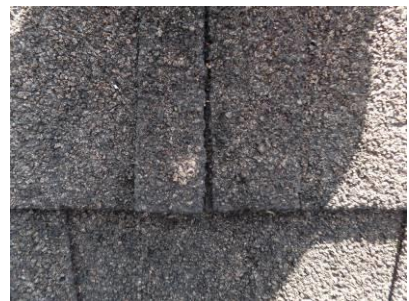
The roofs on the garage were also damaged by hail, as evidenced by the many strike points observed on the shingles and also on the modified bitumen low sloped surface at the rear of the garage.
