PROPERTY INSPECTION REPORT

Prepared For: **CLIENTS NAME**

Concerning: **PROPERTY ADDRESS**

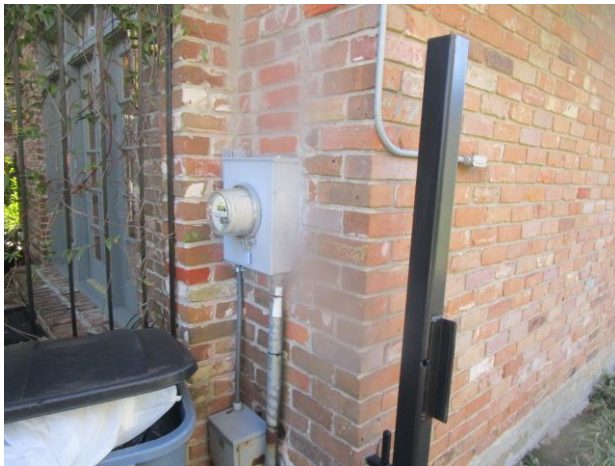
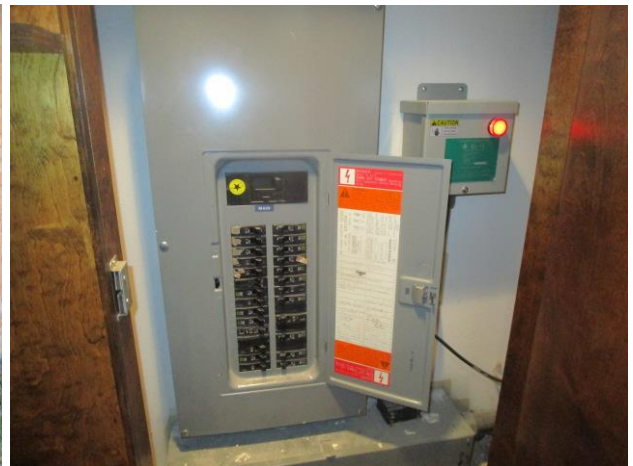
BREAKER PANELS

Manufacturer: Square-D**Rated Capacity:** 150 Amps**Main Breaker:** 150 -Amps**Location:** Family room gun closet

The ground rod was sticking out of the ground a few inches, and, since ground rods are typically 8 feet long and all 8 feet of the rod are required to be in the ground, it is recommended that the ground rod be pounded down flush with the top of the ground.

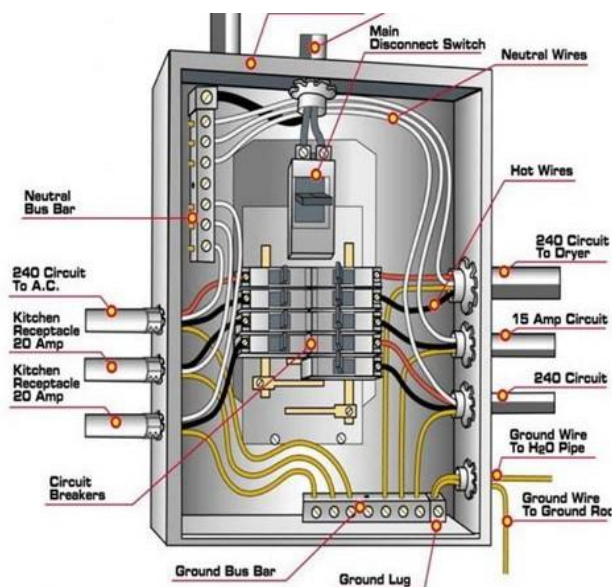
Breaker Panel Box

The legend in the breaker panel was not completely labeled to identify each circuit in the panel. It is recommended that an electrician be contacted to specifically identify each circuit.

The circuit breakers for both air conditioning condensing units were rated higher than the maximum size allowed by the manufacturer of the condensing units. The breakers should be replaced by the size listed on the manufacturers nameplates located on the condensing units.

One 20-ampere circuit breaker was observed that was rated higher than the wire that it was protecting. This condition can be a fire hazard, and the oversized breaker should be replaced with a breaker that is sized in accordance with the allowable ampacity of the wire.

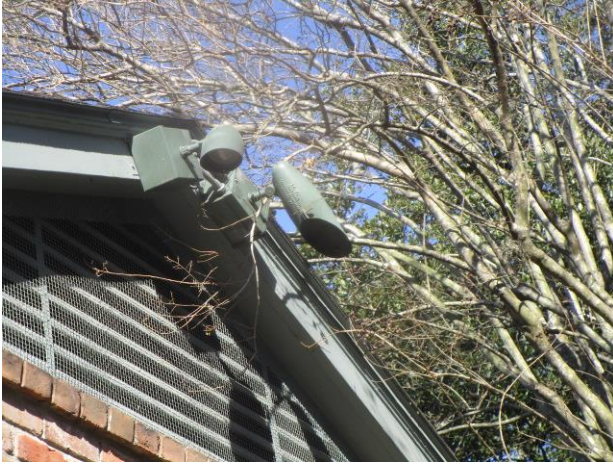
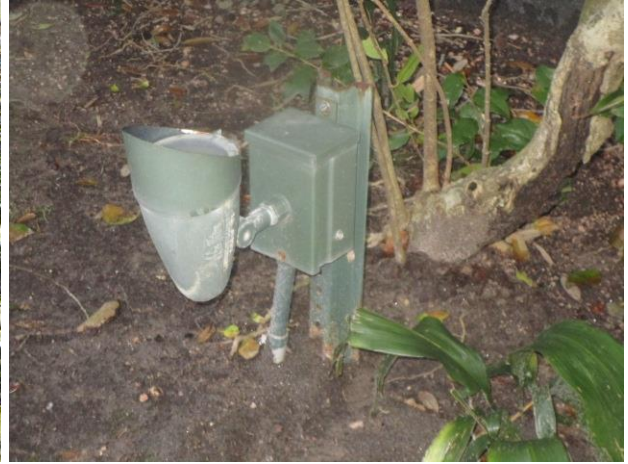
Visible Wiring

An open junction box(es) was observed.

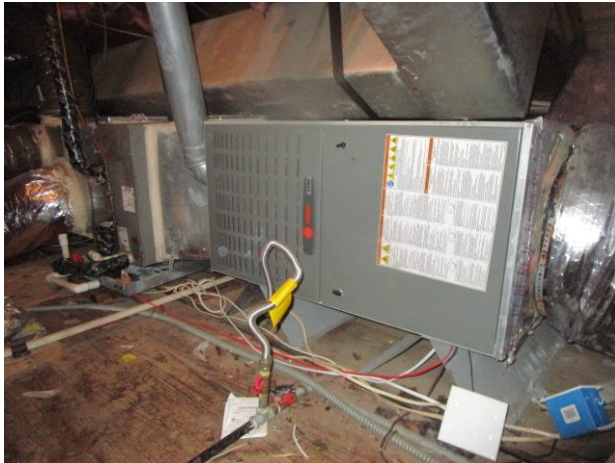
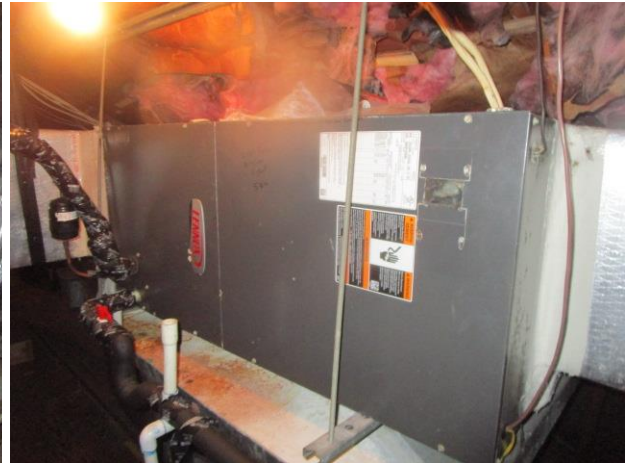
The heating for the house was provided by one gas-fired horizontal furnace and one electric furnace located in the attic. The equipment for the individual zones was as follows:

<u>Zone</u>	<u>Size</u>	<u>Manufact.</u>	<u>Date</u>	<u>Location</u>
Family Room	Electric	Lennox	2009	Attic
House	100,000-BTU	Trane	2012	Attic

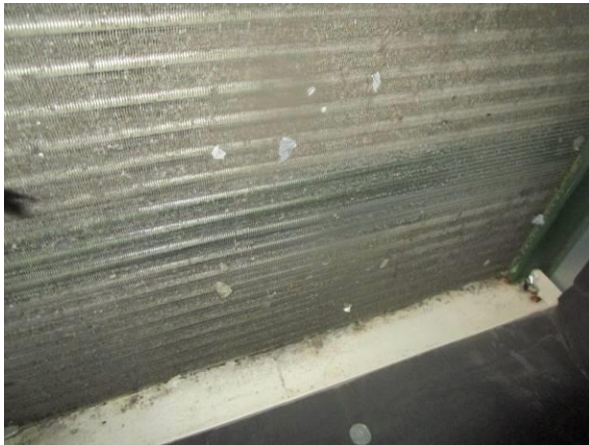
Location Include: 5-ton system

The evaporator coil for the 5-ton condensing unit was observed to be a 5-ton coil. Normally the coil should not be smaller than the condensing unit, as it can affect the condensing unit, and make it work harder. It is recommended that the system be checked by a service company, who should determine if the two components are compatible, or if the coil will need to be replaced.

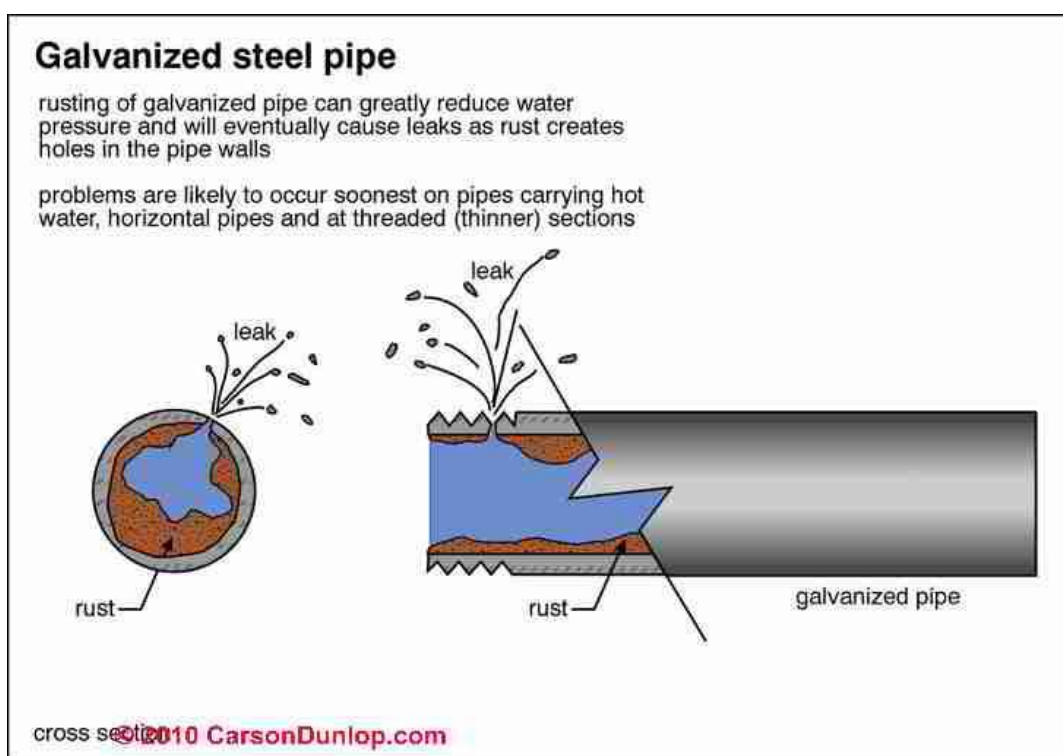
Some of the water piping inside the house was observed to be the original galvanized piping. Due to the age of the house, it is pointed out that the galvanized piping will deteriorate with time, and will corrode on the inside of the piping, thereby reducing the inside diameter of the pipe, and restricting the flow of the water through the pipe. In addition, the piping will corrode through to the outside wall of the pipe, and will eventually deteriorate to where the pipe will start leaking. It can be anticipated that the galvanized water piping throughout the house will need to be replaced or re-lined when it deteriorates to where it is restricting the flow of the water, and/or is corroded enough to start leaking. (Information)

The vacuum breaker devices were missing at one or more of the hose bibbs, and it is recommended that they be installed to prevent cross connections, which can allow contaminated water to enter the potable water supply.

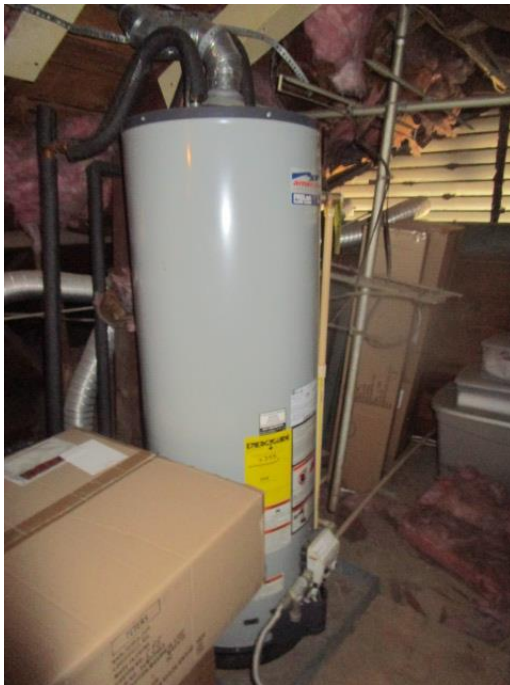
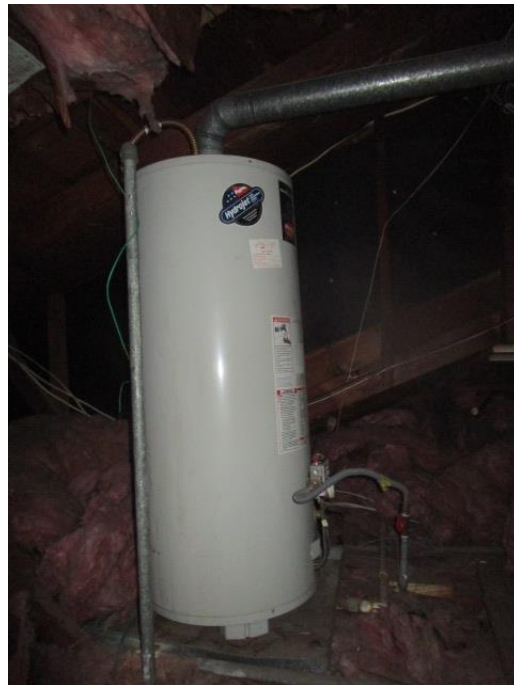
The hot water for the house was provided by two natural gas fired water heaters, one a 50-gallon unit manufactured by American in 2012 and located in the attic, and the other a 50-gallon unit manufactured by Bradford White in 2002 and located in attic. The water piping from the water heaters was observed to be galvanized steel.

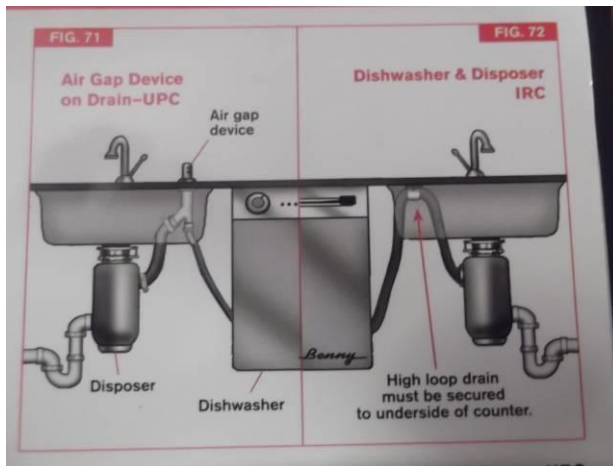
The electrical wiring for the disposal was not properly connected at the bottom of the unit.

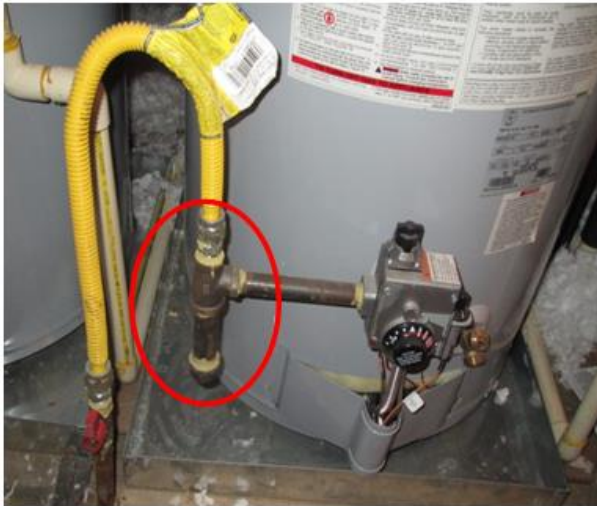
**HEI file photo showing sediment trap**

Moisture/Sediment traps were not installed at the gas supply lines for the gas fired equipment as currently required. A moisture/sediment trap is intended to catch moisture and debris in the gas supply lines before they can enter into the equipment. Obtain cost estimate for any needed repairs.
