HEDDERMAN ENGINEERING, INC.

REF: CONDITION OF PROPERTY SURVEY

ADDRESS OF HOUSE

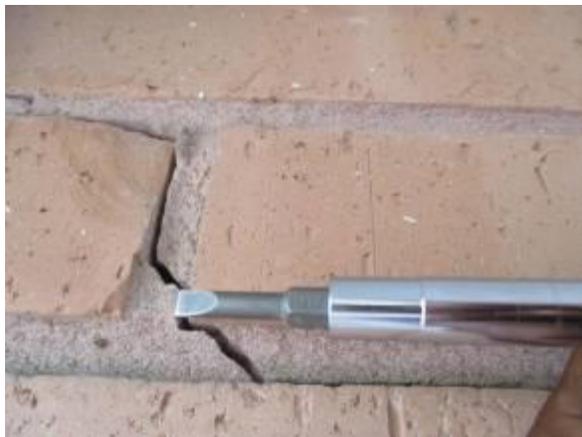
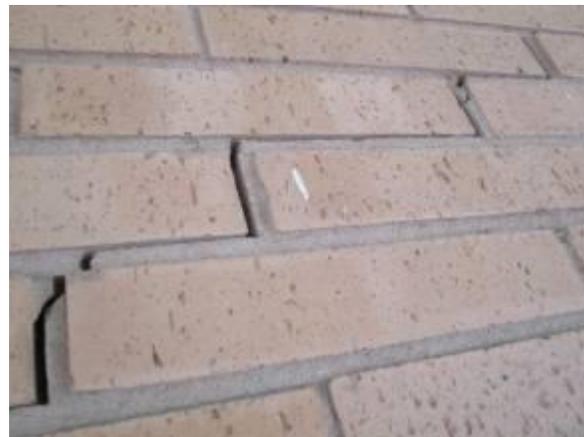
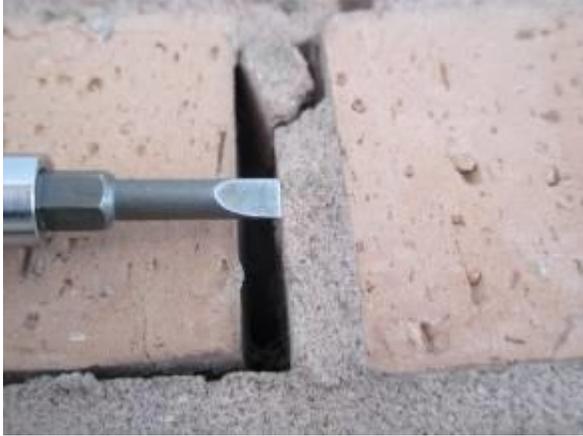
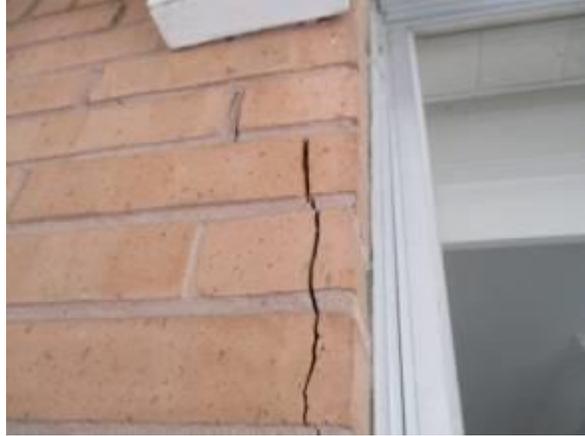
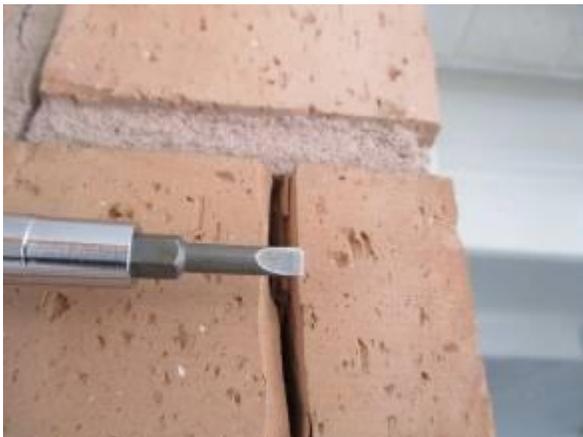
Veneer Cracks

Cracks and/or patches were observed throughout the exterior veneer.

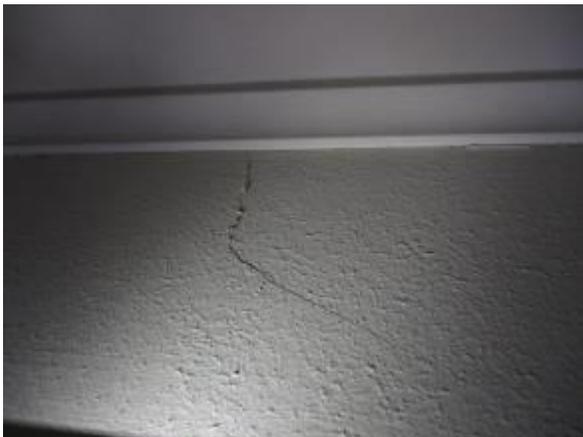
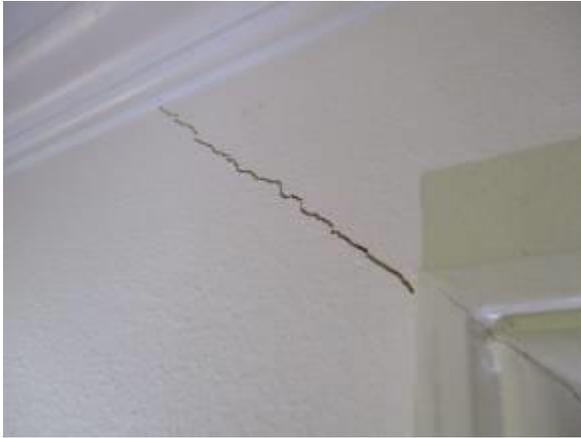
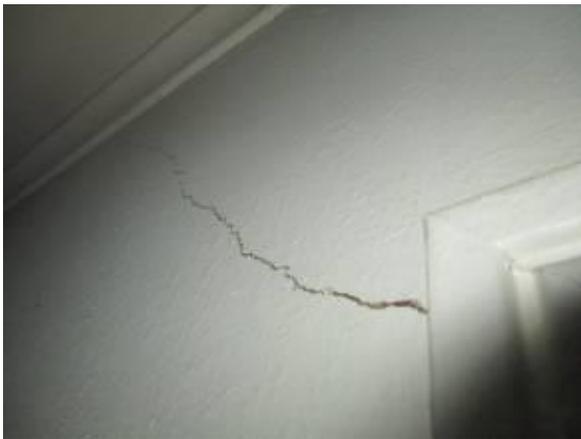
Sheetrock Cracks

Sheetrock cracks, patches, and/or compression ridges were observed throughout the house.

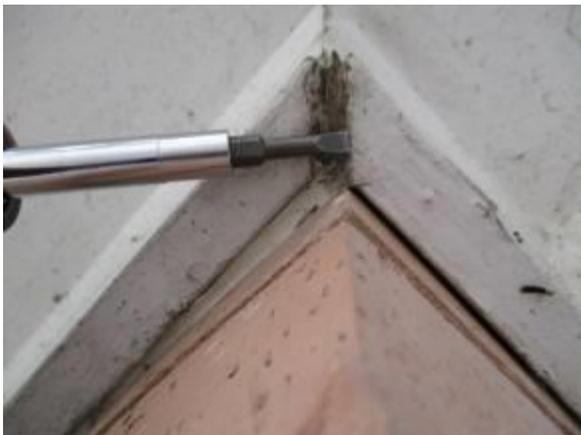
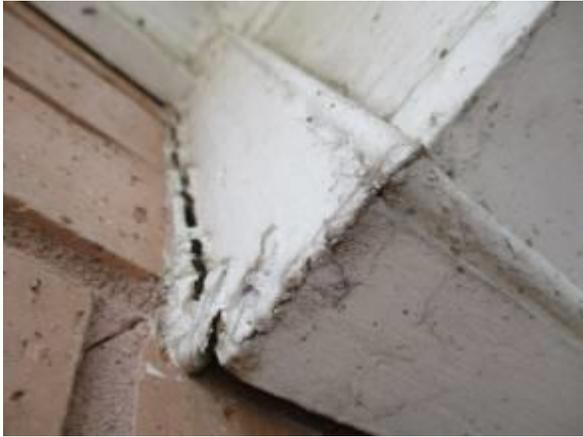
Some separations and differential movement of materials due to differential foundation movement were observed, including the following:

Separated frieze board molding

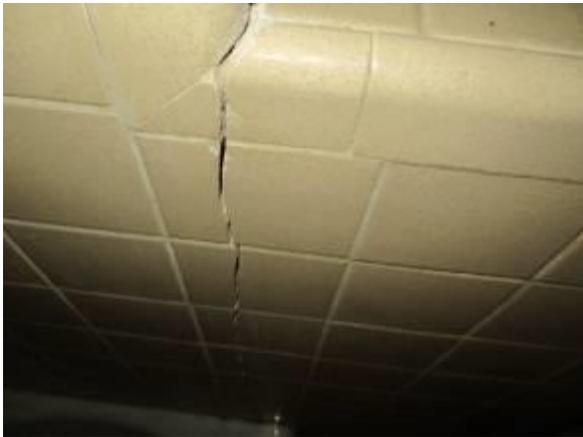
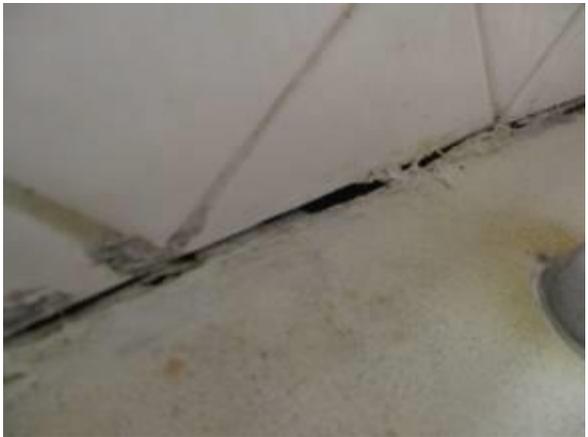
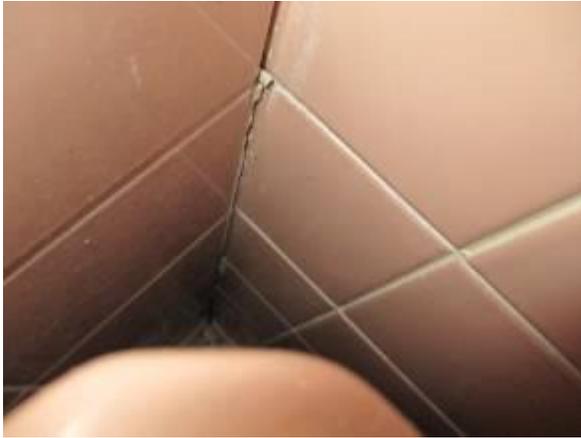
Separated wall tile

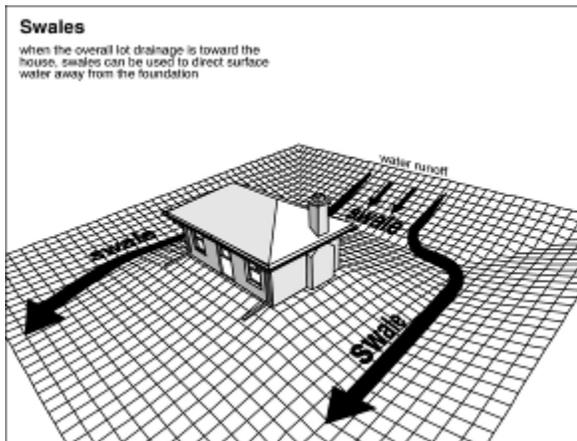
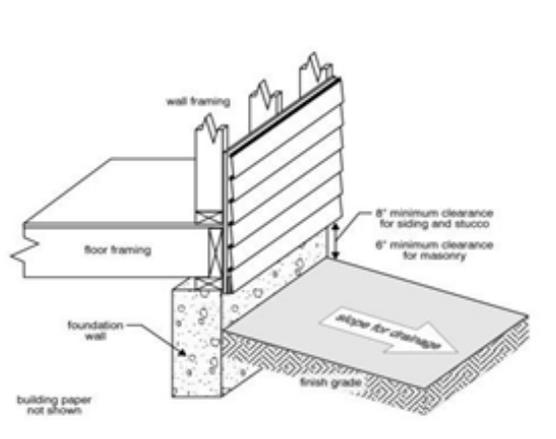
Poor Drainage

The grade was essentially flat, and it appears that water may pool at some areas after a rain. Further investigation with the homeowner is recommended to determine if water pools for a significant time after a rain. If so, an underground drainage system may need to be installed, and you should contact a company specializing in underground drainage system for a cost estimate.

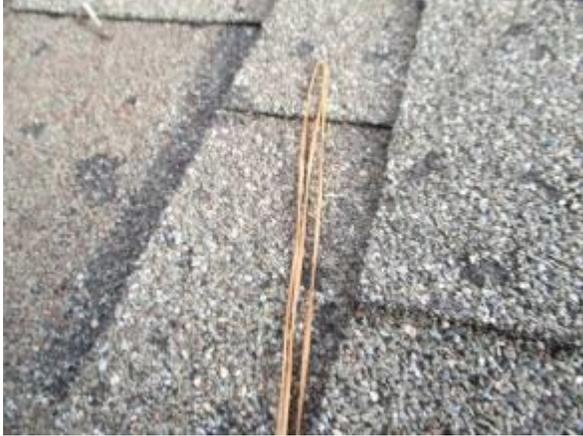
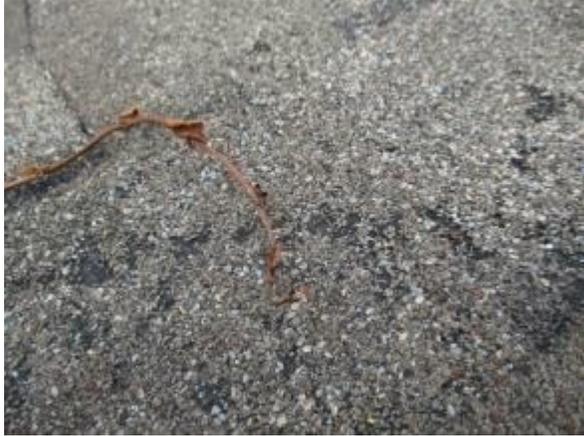
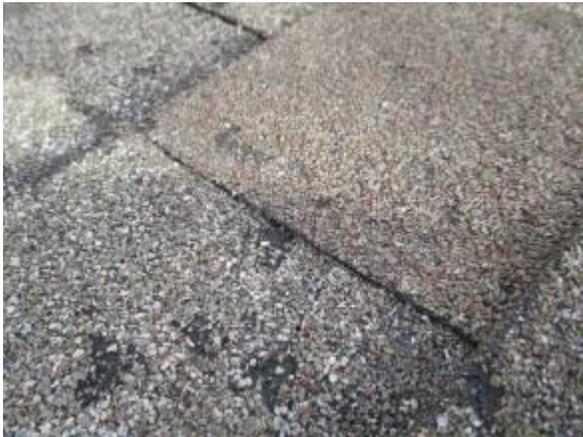
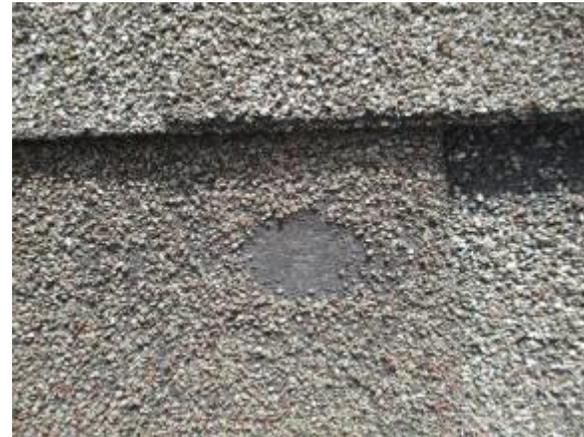
The composition roof surface was showing evidences of some deterioration, including shingles that were brittle, discolored, and starting to lose their aggregate. Several of the shingles at the west section of the roof were damaged by previous excessive ivy growth. It is recommended that the shingles at the west side of the property be replaced.

Ivy damaged shingles above the garage

Obtain Cost Estimate

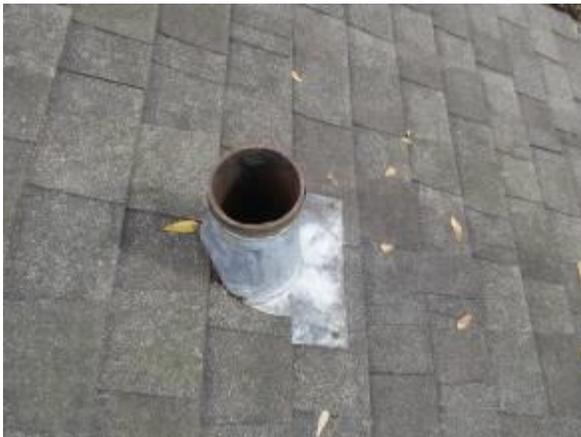
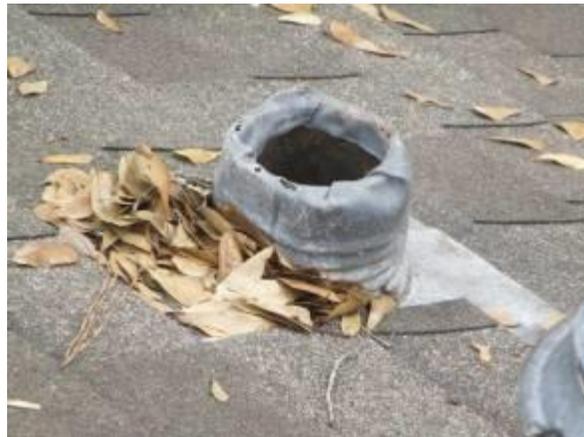
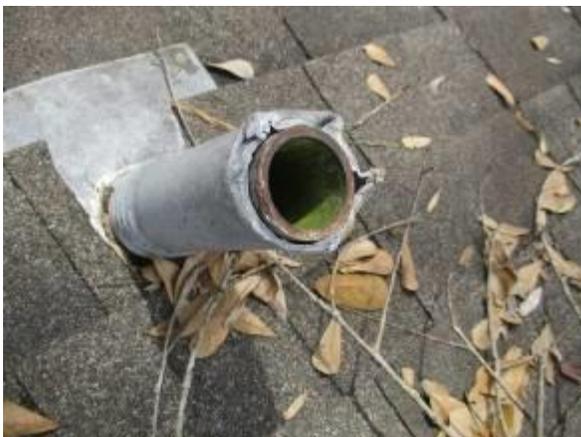
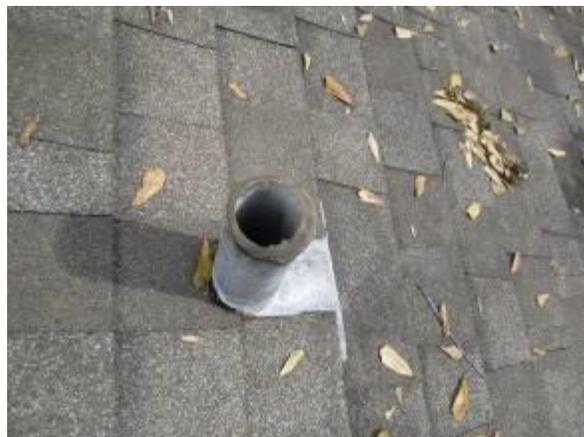
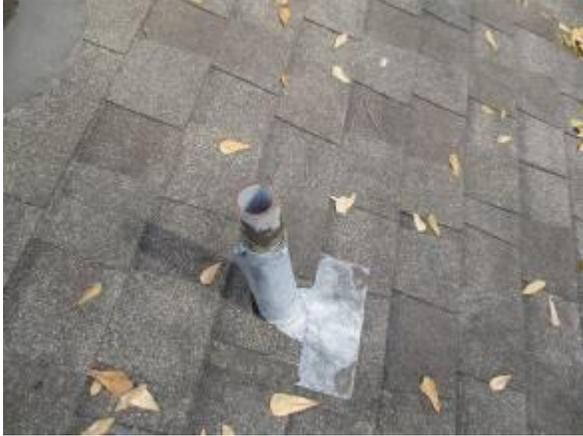
We observed one or more lead roof jacks at the roof penetrations that have been damaged, apparently by squirrels eating the lead jacks. The jacks can now allow water to enter the attic space as a roof leak, and the roof jacks need to be repaired as necessary to ensure that all the roof jacks are watertight.

One or more of the lead roof jacks at the roof penetrations were not properly folded into the top of the vent pipe since the vent pipes are longer than the roof jacks. Have a roofer make the repairs.

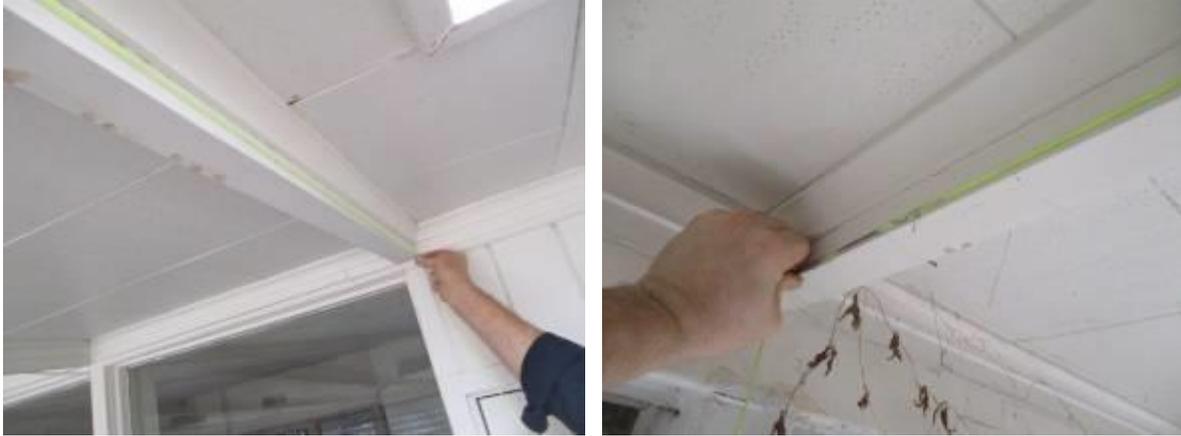
The ceiling framing had a more than normal amount of unlevelness. The allowable deflection in ceiling framing members is one inch deflection in a 30-foot horizontal distance ($L/\Delta = 360$ per the building code). Therefore, further investigation is recommended to determine the cause of the deflection, and the extent of any repairs that may be needed.

1" deflection in a 15' span is 2X the allowable deflection defined by the Houston Residential Code

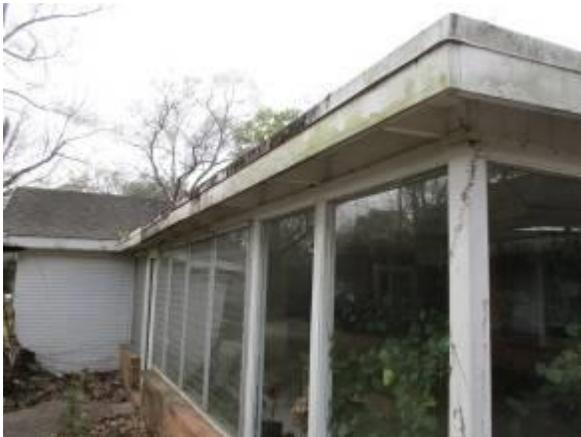
The source of the water penetration appears to be a lack of gutters which allows the water from the roof runoff to splash against the structure. It is recommended that gutters be installed to eliminate the source of the water, and that repairs be made to seal the door and threshold and correct any secondary damages.

Lack of gutters

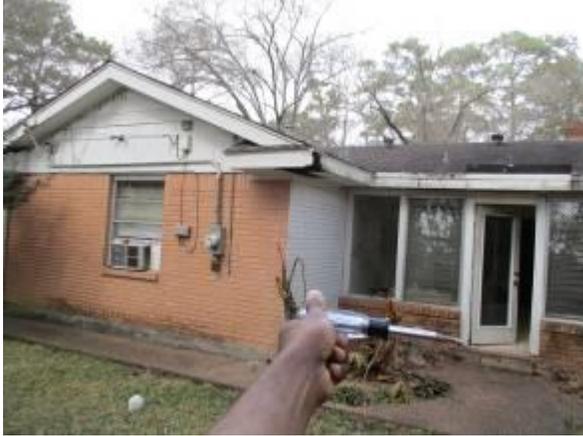
Rotted door trim

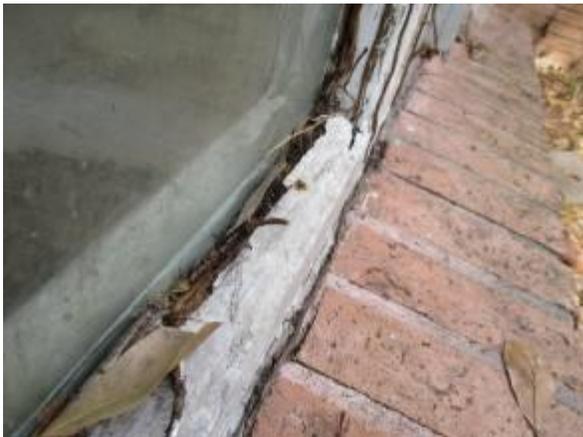
Wood rot/ivy growth

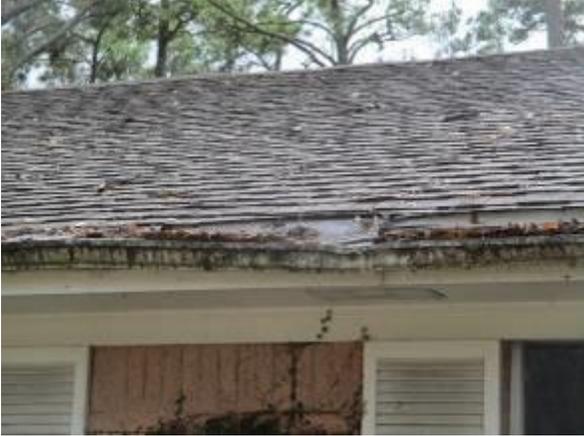
Damaged gutters/Cracked brick veneer

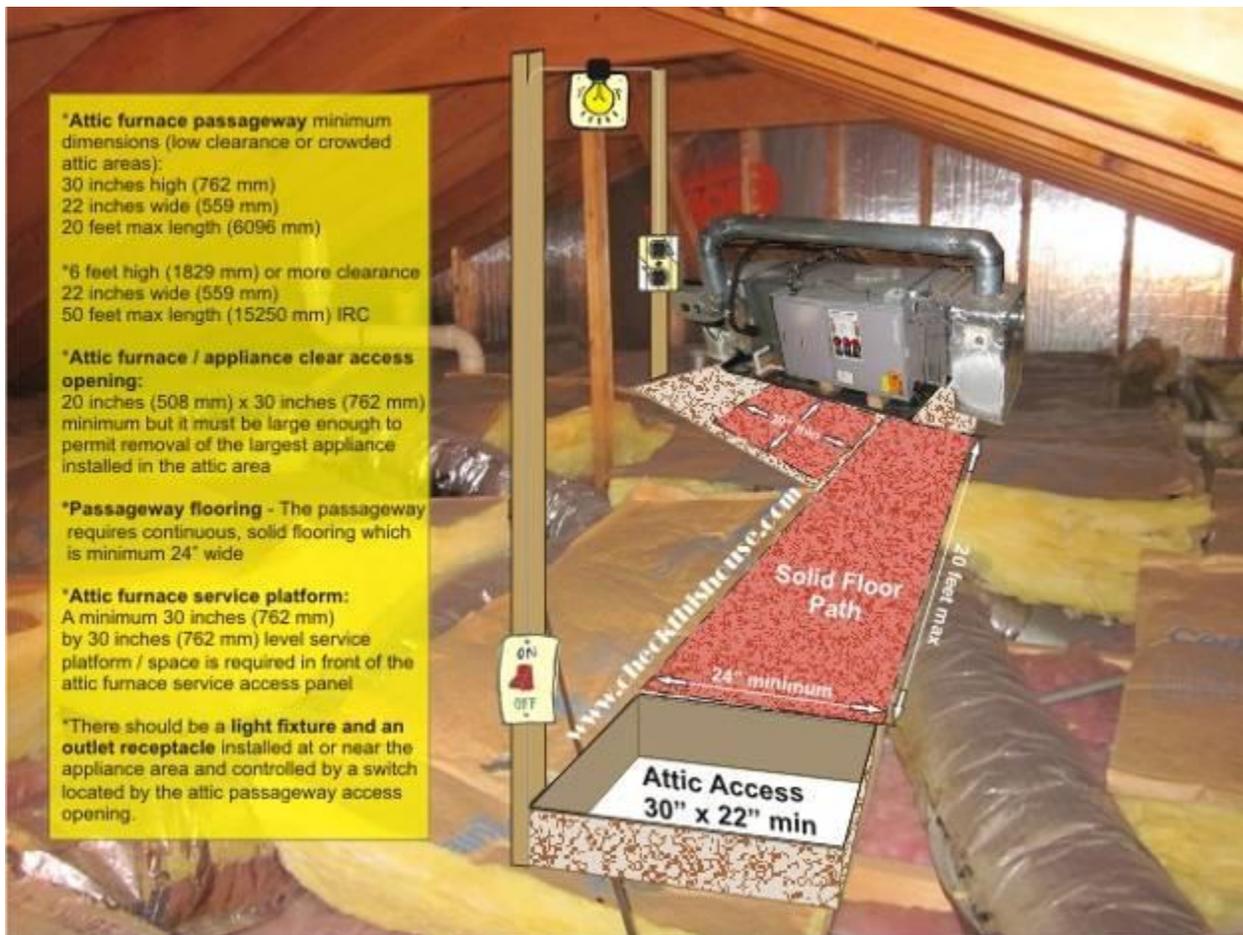
The attic did not have adequate service decking to all the equipment in the attic. The service decking should be a continuous deck that is a minimum of 24 inches wide, that extends from the attic access opening to all equipment in the attic. In addition, the decking should be free from any obstructions, such as gas lines, electrical wiring, ductwork, framing members, etc.

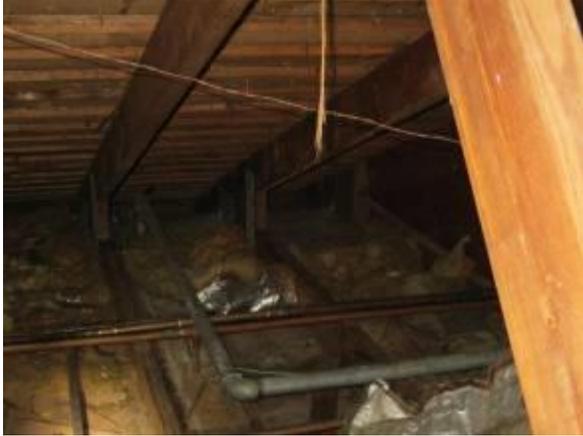
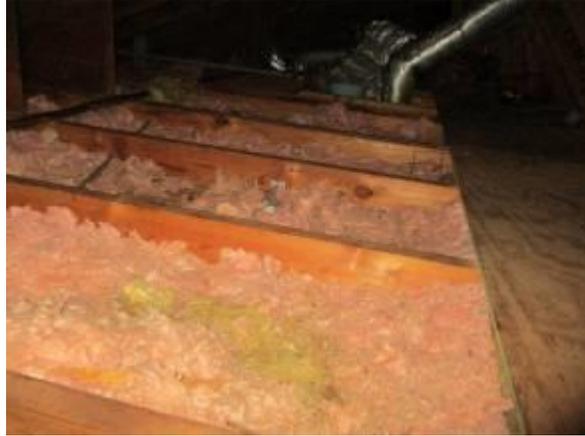
The insulation in the attic was missing at some of the vertical walls, and needs to be replaced.

The insulation in the attic was missing from between some of the joists.

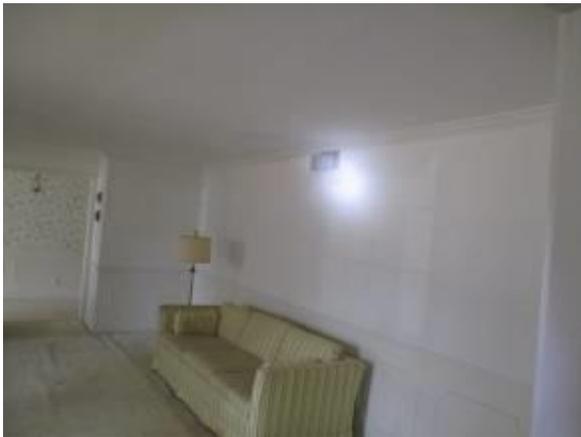
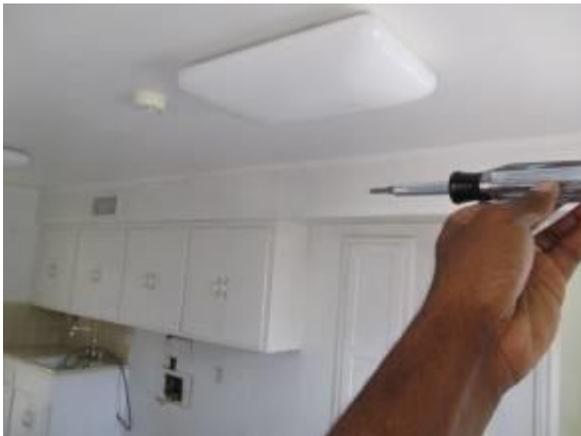
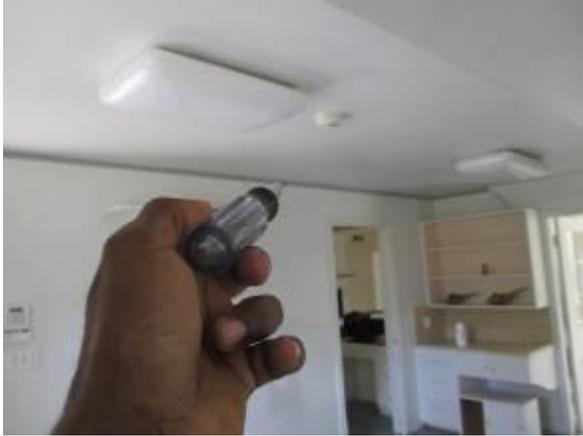
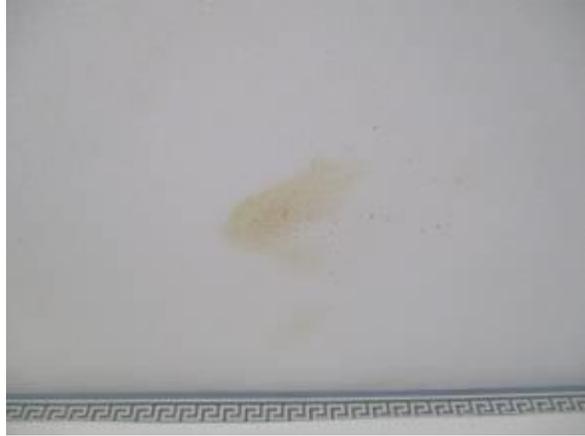
Mold/Mildew was observed at multiple locations in the house. It is recommended that a mold inspector be contacted to make an assessment of this condition and recommend any necessary repair.

Locations included: North bathroom, living room air register, utility room ceiling, utility room duct, master closet air register, guest quarters closet wall base

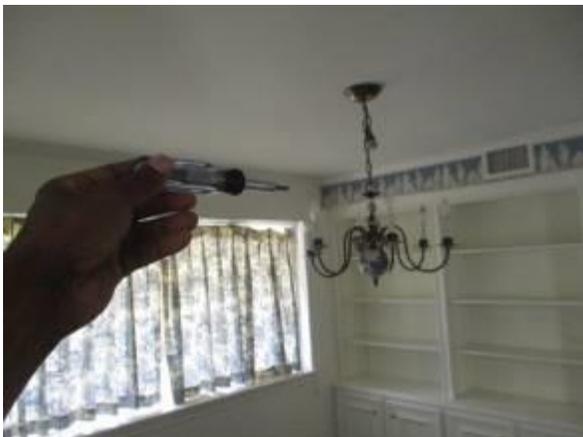
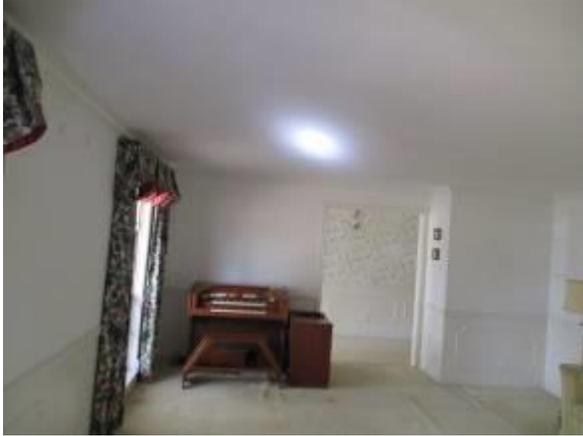
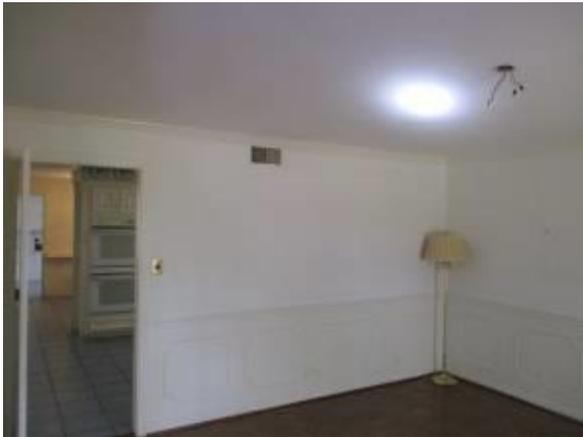
Water stains were observed at the dining room, living room, north bathroom, south bedroom and bathroom, and master suite ceilings. The source of the water stains could not be determined at the time of the inspection, but possible sources include roof leaks, plumbing leaks in the bathrooms located above the stained areas, or possibly some other source. Have a service company determine the source of the water stains, and provide a cost estimate for any necessary repairs.

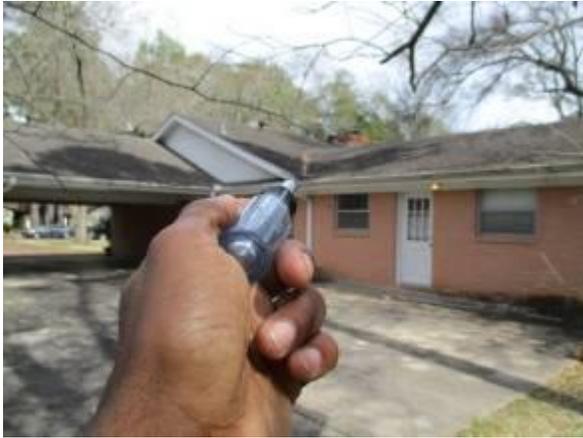
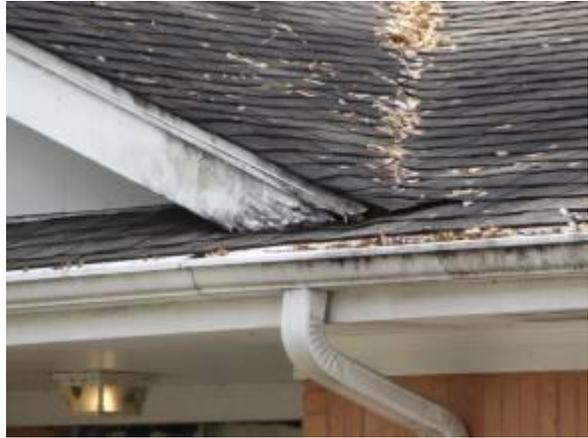
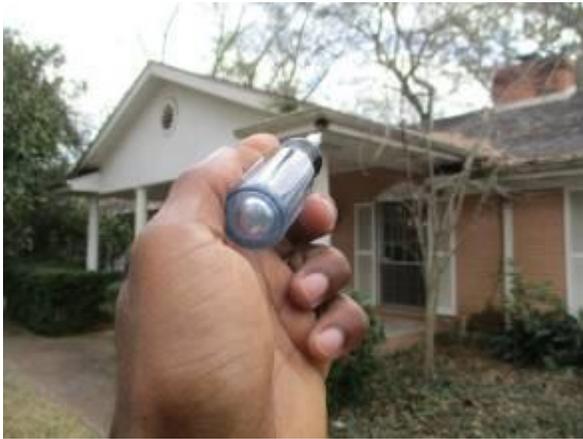
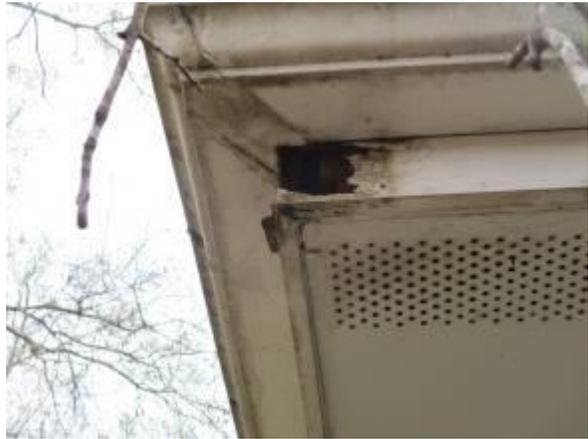
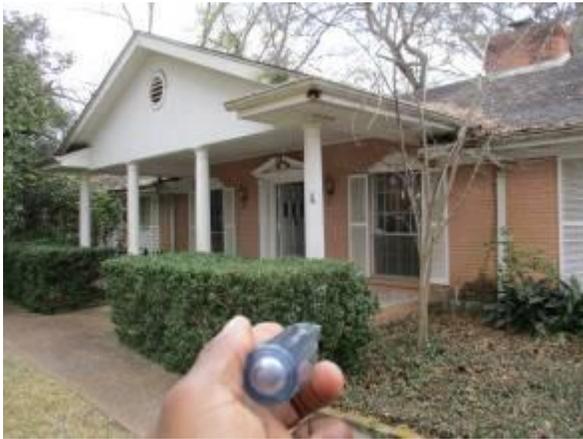
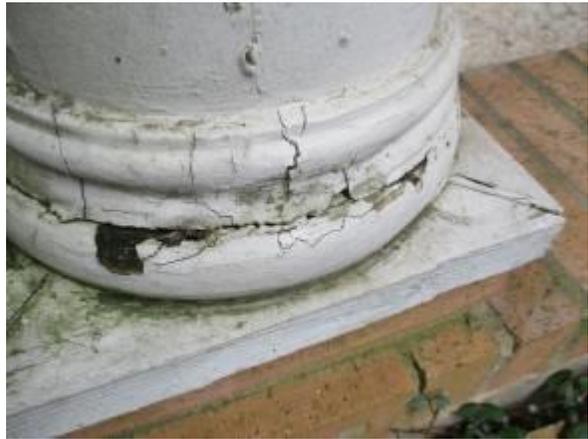
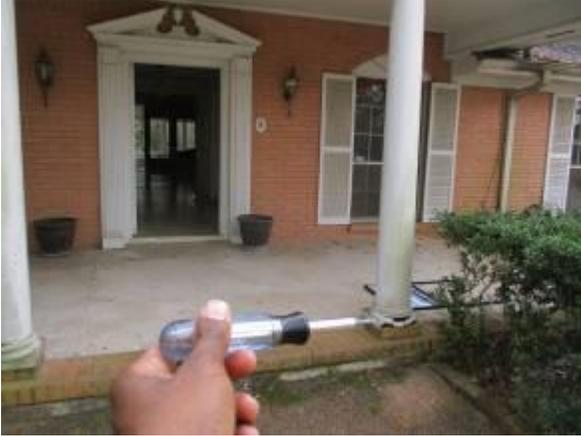
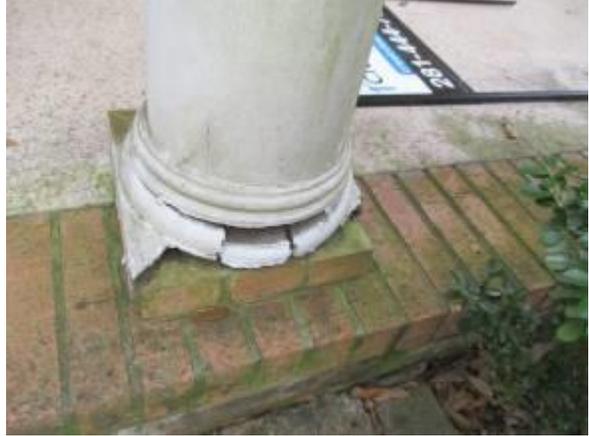
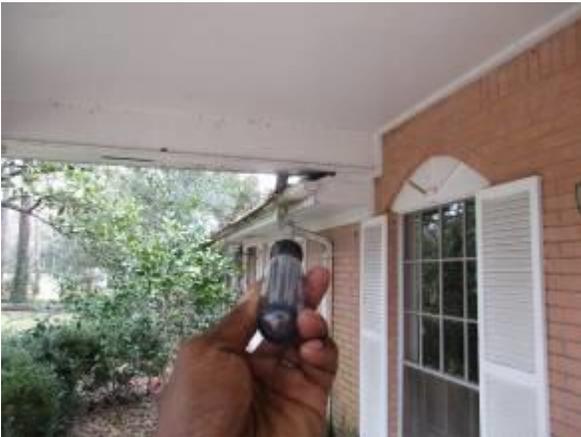
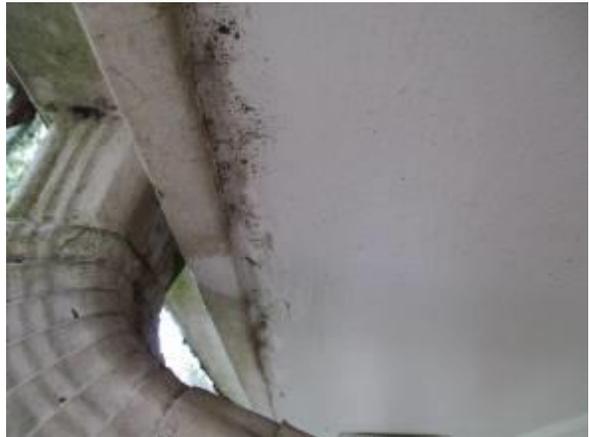
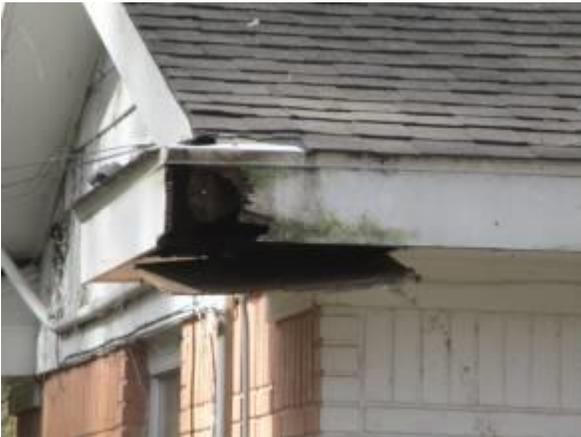
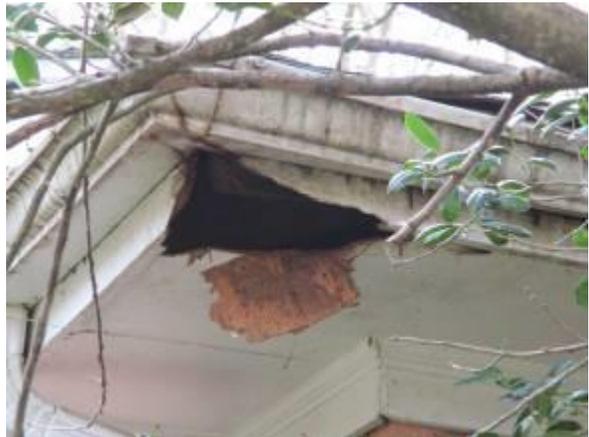
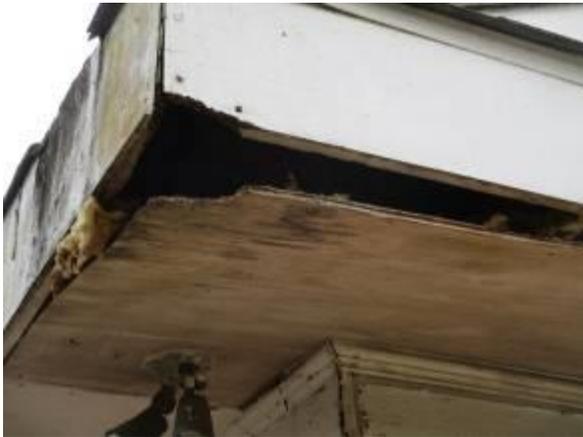
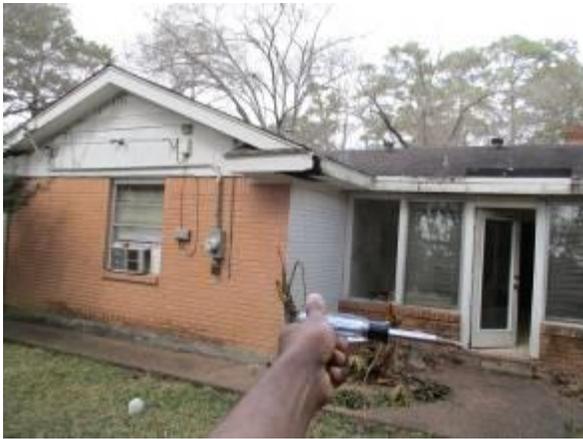
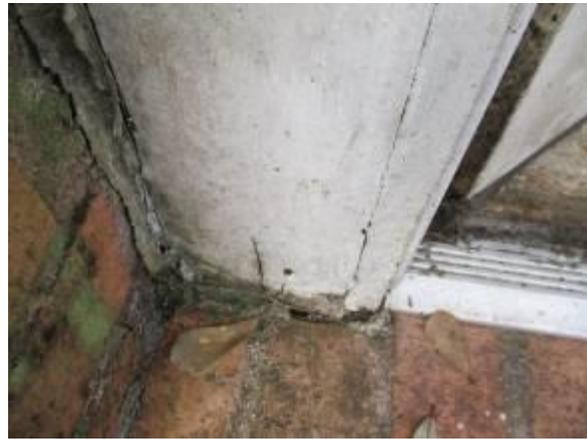
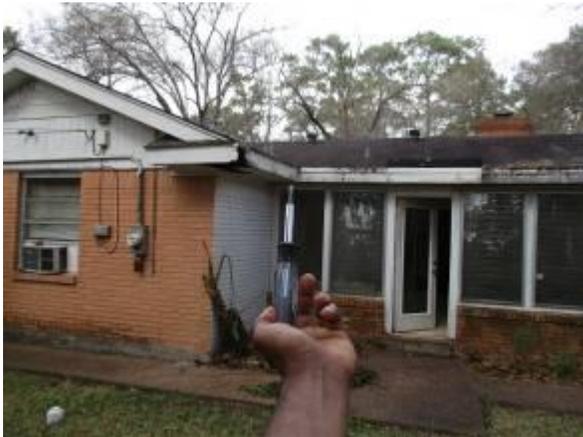
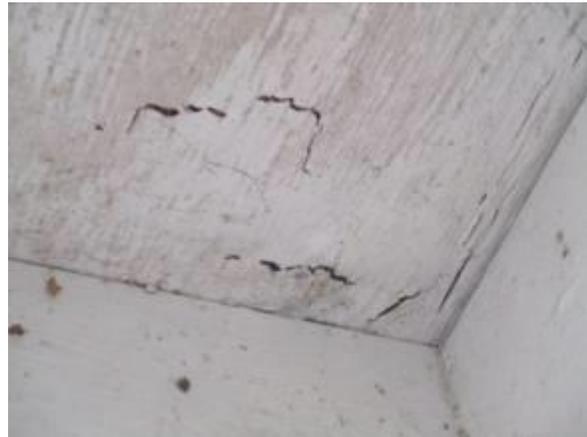
Wood Rot

Wood rot was observed and it is recommended that the damaged wood be replaced. It is pointed out that additional damage could be present under the rotted material that will not be visible until the outer rotted materials are removed. Have a service company determine the entire scope of wood rot throughout the house, and provide a cost estimate to replace all rotted wood.

Obtain Cost Estimate

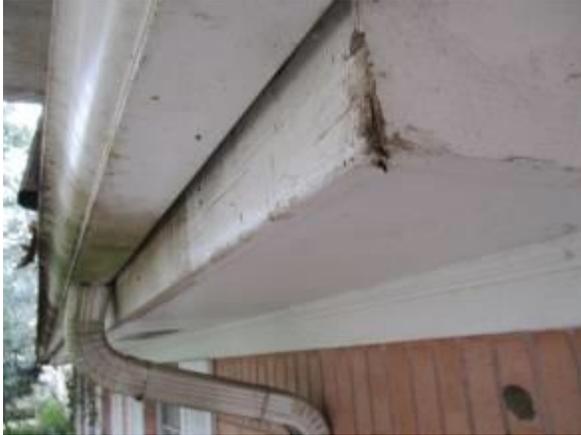
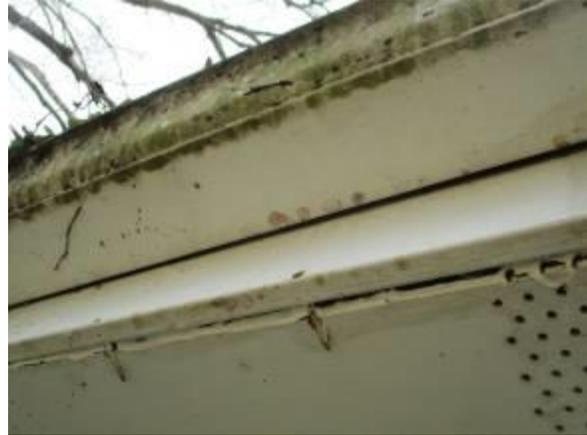
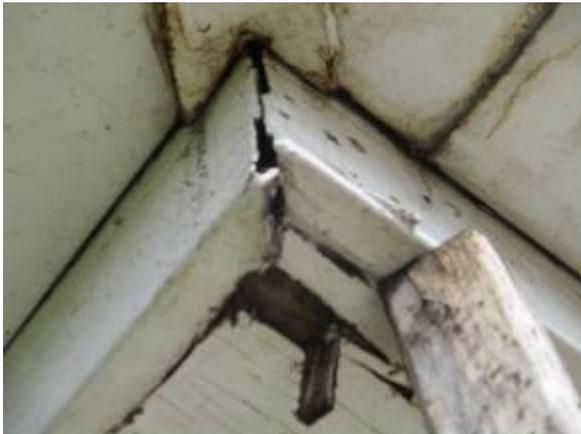
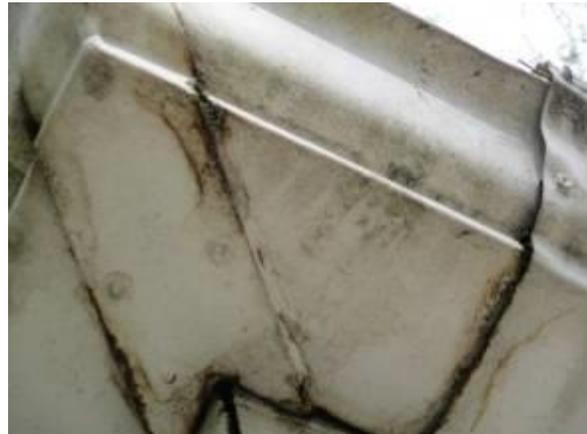
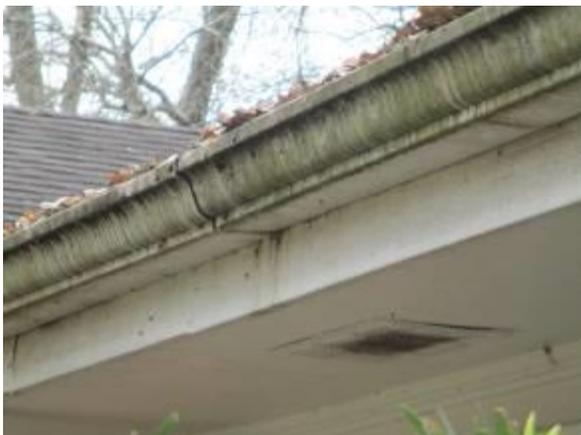
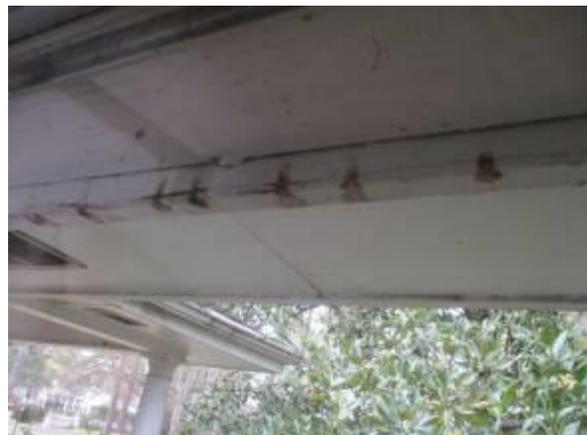
The gutters were in generally poor condition. The gutters and downspouts are essentially at the end of their normal, useful life and should be replaced.

Obtain Cost Estimate

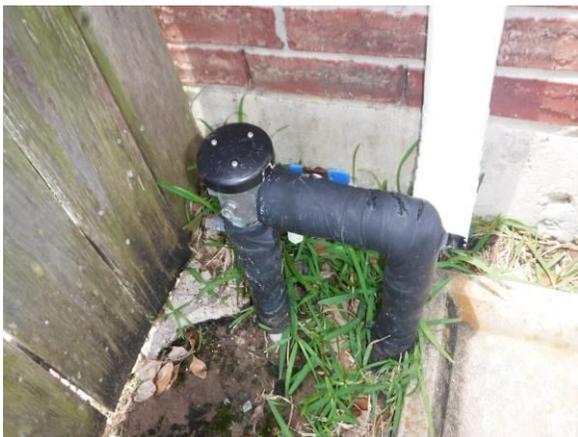
Heads were spraying the house, and need to be adjusted on zones 3, 4, and 5.

Obtain Cost Estimate

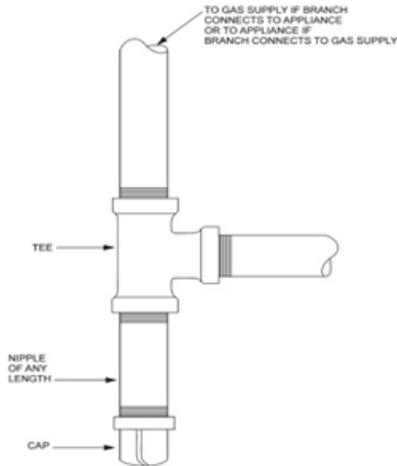
One or more gas supply line(s) was not equipped with a sediment trap on the gas line as shown in the clip art below. Have a plumber make the needed repairs.

Clip art showing a sediment trap in gas line

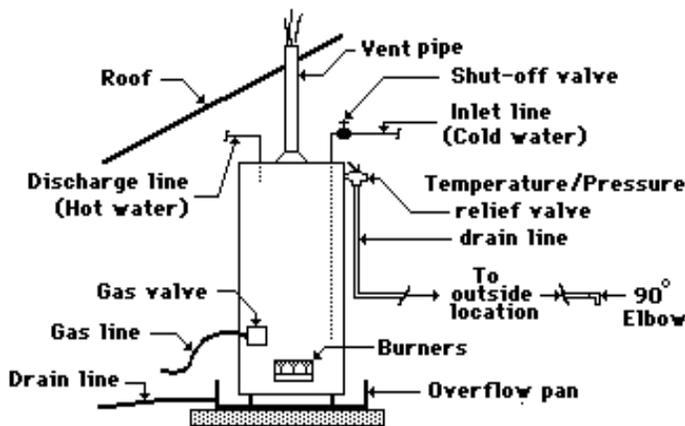
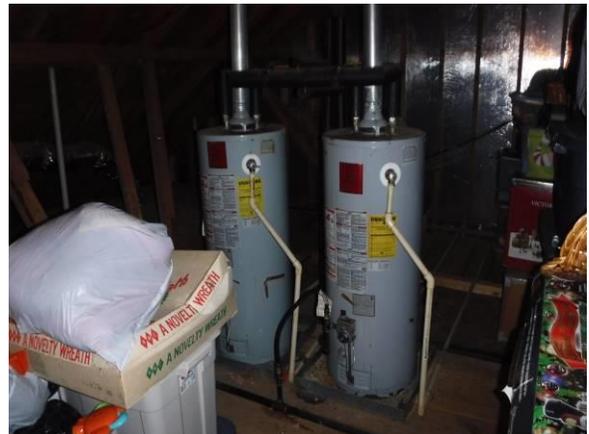
Gas Water Heater

The water heaters were functional at the time of the inspection. However, due to the age and/or condition of the equipment, it is the opinion of the inspector that they have only a limited amount of life remaining. Normal life expectancy of a water heater in the Houston area is approximately 7 to 10 years.

The tanks were observed to be gurgling while they were heating, indicating a build-up of scale and other deposits inside the water heaters. The water heaters were still functional at the time of the inspection, and we do not recommended that they be replaced at this time. However, it can be anticipated that the condition will continue to worsen until the water heaters are replaced.

The piping at the top of both water heaters was severely corroded at the fittings, and is in need of repair.

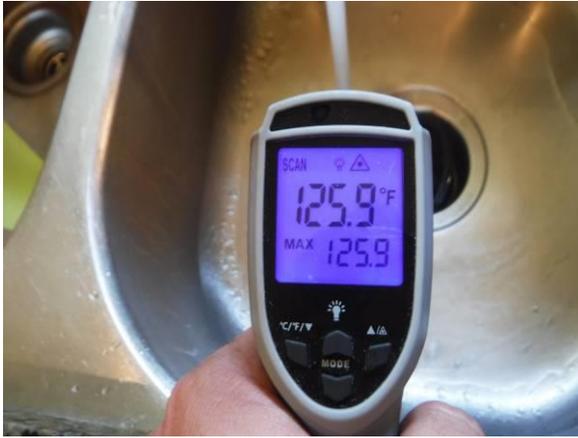
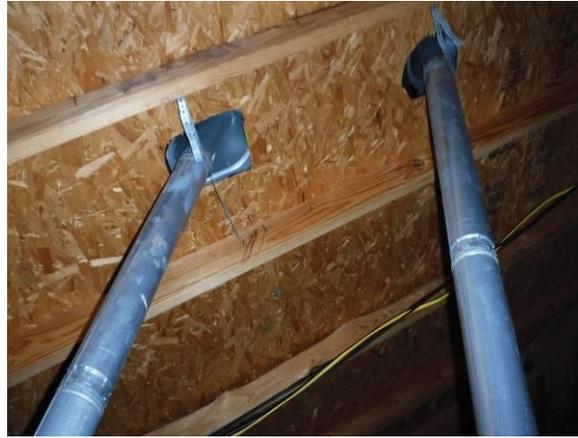
The temperature of the hot water was measured to be 126 degrees at the kitchen sink at the time of the inspection. Normally, 120-125 degrees is the recommended maximum temperature of hot water to prevent accidental scalding. See the chart below for more information about hot water burns, as taken from the International Residential Code, 2012.

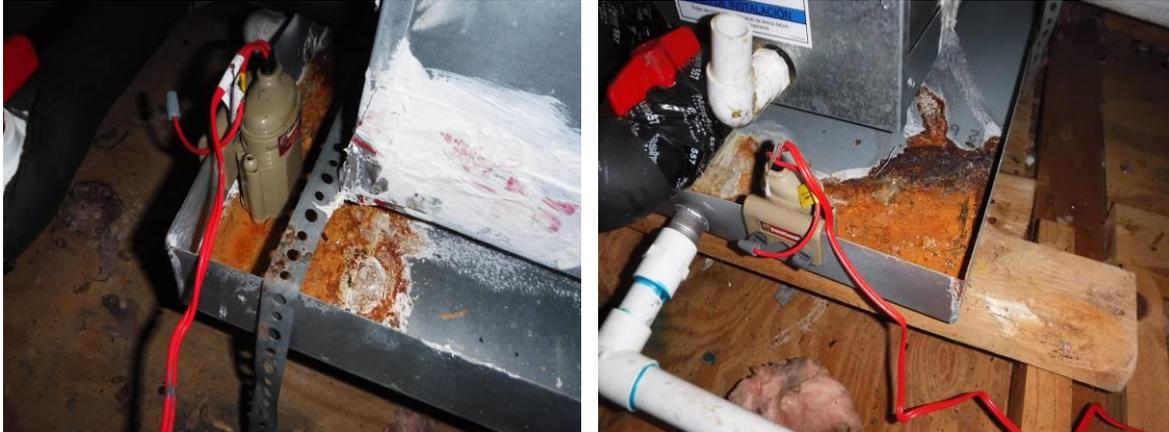
Overflow Pans – Rust

The overflow pans under the evaporator coils had rust in the pans, apparently from

water overflowing the condensate drain lines into the overflow pans. No water was in the pans at the time of the inspection, but, since we only ran the units for a few minutes, it is recommended that the drain lines be checked by an air conditioning service company.

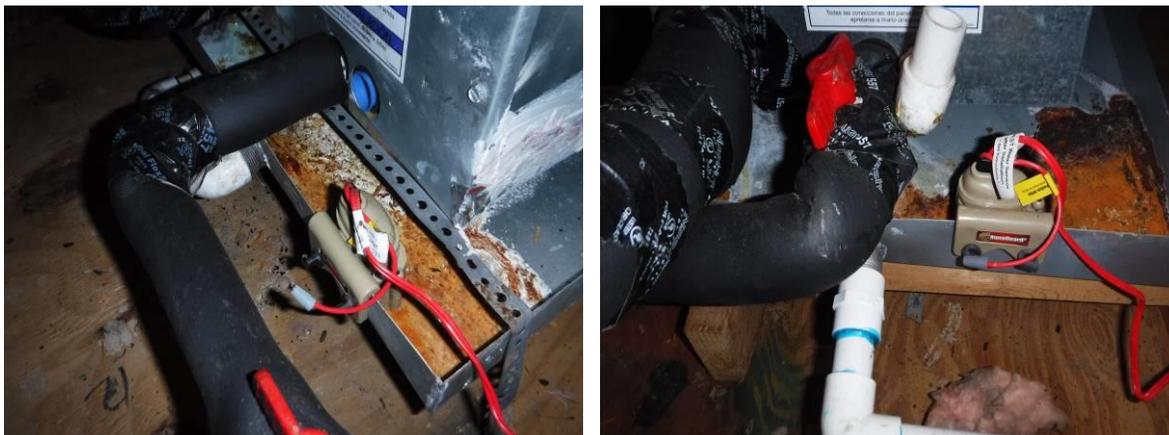
Overflow Pans – Float Switch

The overflow pans under the evaporator coils were equipped with float switches which should shut off the air conditioning units if the pans fill with water.

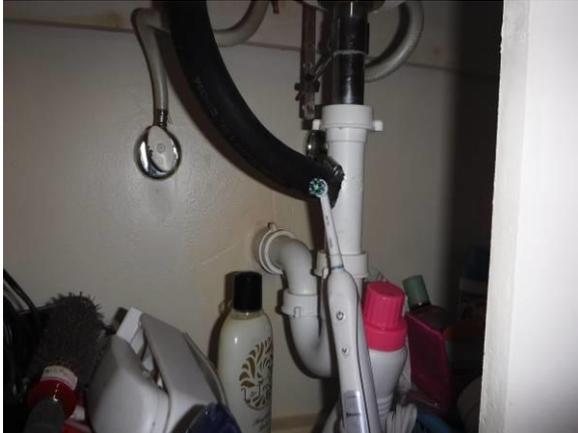
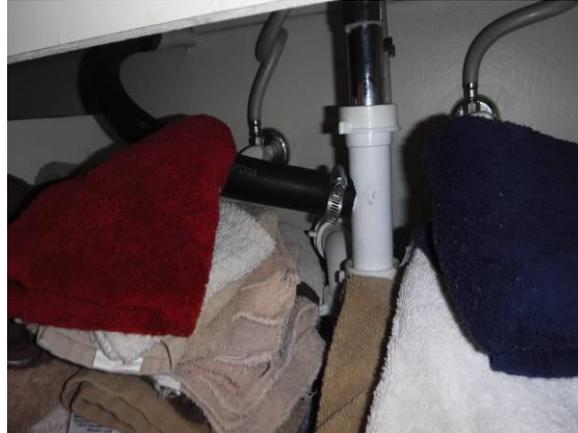
Primary Condensate Drain Line(s)

The primary condensate drain lines were observed to empty into the P-traps under the sinks at the master bathroom and the second floor hall bath. This is correct, and no repairs are needed. However, for your information, it is pointed out that it is not uncommon to hear the sound of dripping water at the sinks, which is related to the

proper function of the drain lines, and not to a leak at the sink, or in the wall.

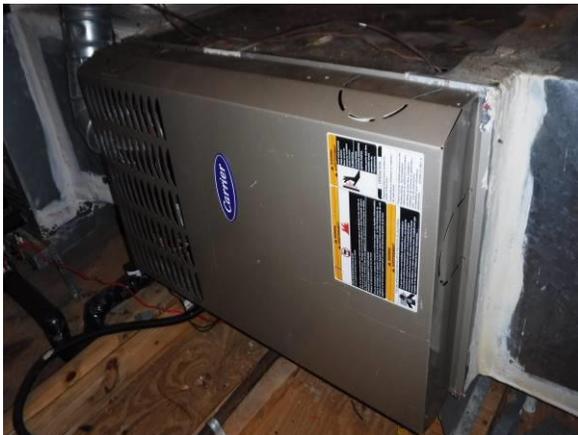
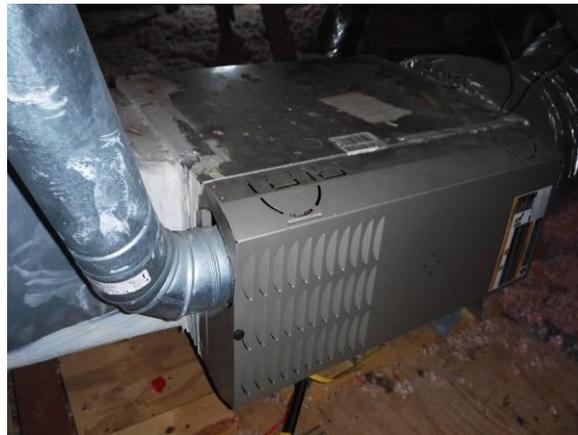
The furnaces were operationally checked at the time of the inspection, and no repairs were indicated to the operation of the furnaces. The furnaces responded to the thermostats, and the burners came on, and were heating.

Due to the age and/or condition of the equipment, it is the opinion of the inspector that the units have only a limited amount of remaining life. Therefore, it is recommended

that a service company be contacted to dismantle the furnaces, and view the heat exchangers for cracks.

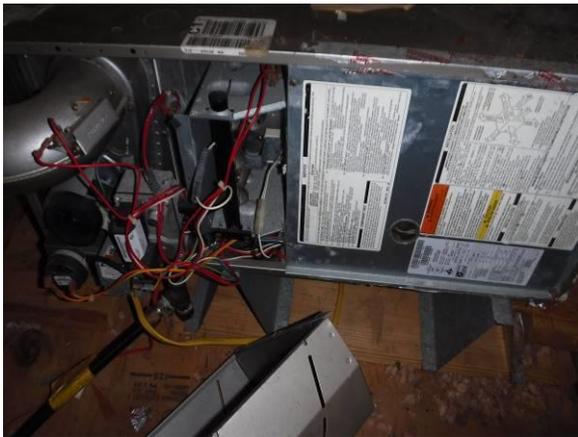
Furnace Burner Compartments

The furnaces are constructed such that the units must be dismantled in order to view the entire heat exchangers. The units were not dismantled, and the heat exchangers were not able to be viewed for evidences of a crack. If further investigations are desired, then it is recommended that a service company be contacted to dismantle the units. Due to the age and/or condition of the furnaces, it is recommended that a service company be contacted to dismantle the furnaces, and view the heat exchangers for cracks. The service company should provide a written statement on the condition of the equipment.
