HEDDERMAN ENGINEERING, INC.

REF: CONDITION OF PROPERTY SURVEY

ADDRESS OF HOUSE

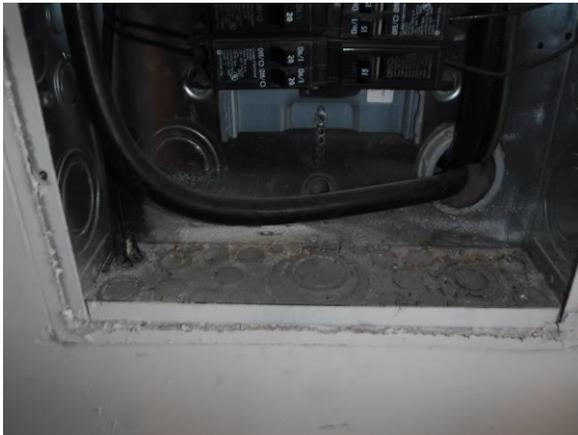
Foreign matter was observed in the panel box, which can be a safety hazard, and it is recommended that the panel be cleaned

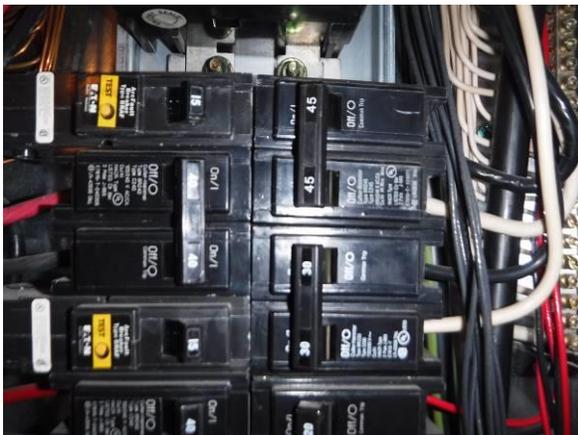
We observed one or more white wires that were used as a “hot” wire, and were connected to a circuit breaker. Typically, the white wires are the grounded conductors, and if they are used as a “hot” conductor, they must be permanently marked or wrapped with black or red tape to identify them as a “hot” ungrounded conductor.

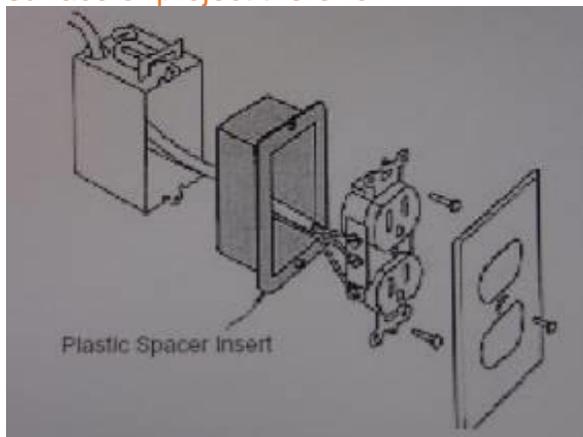
We observed outlets located in baseboard molding and countertop backsplashes that were not protected by extender boxes. This is considered to be a fire hazard, and it is recommended that the extender boxes be installed.
