HEDDERMAN ENGINEERING, INC.

REF: CONDITION OF PROPERTY SURVEY

ADDRESS

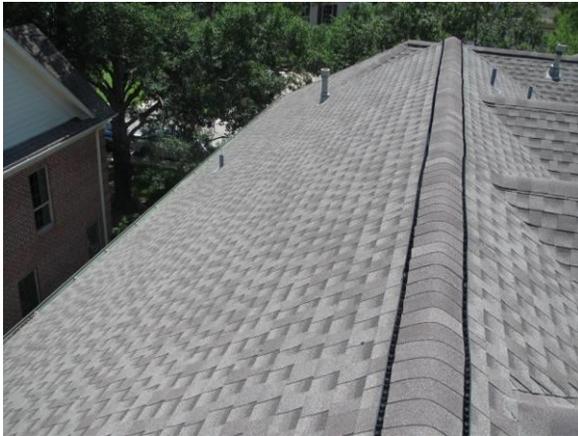
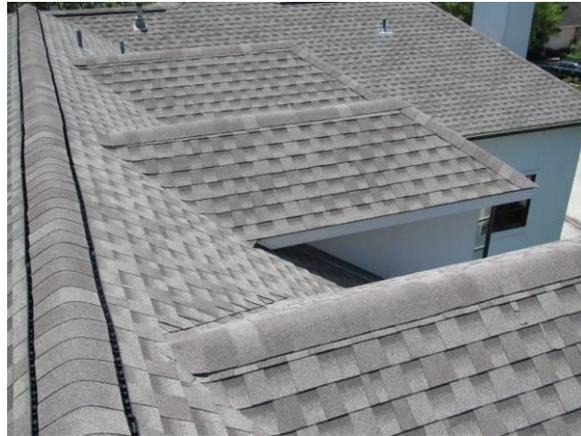
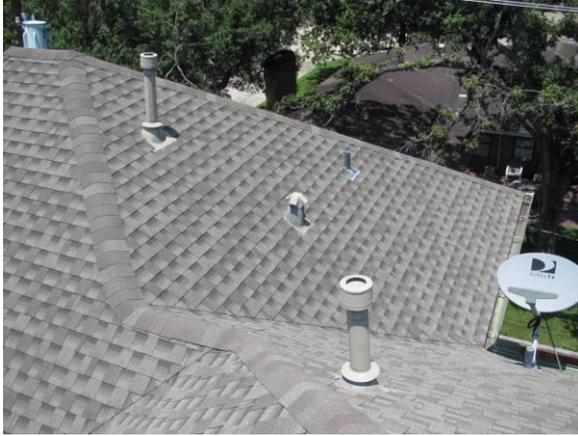
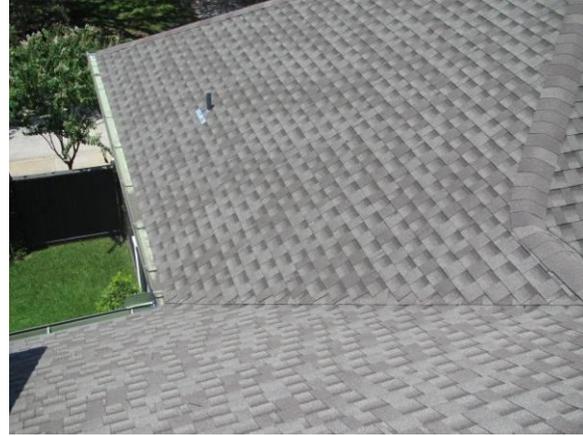
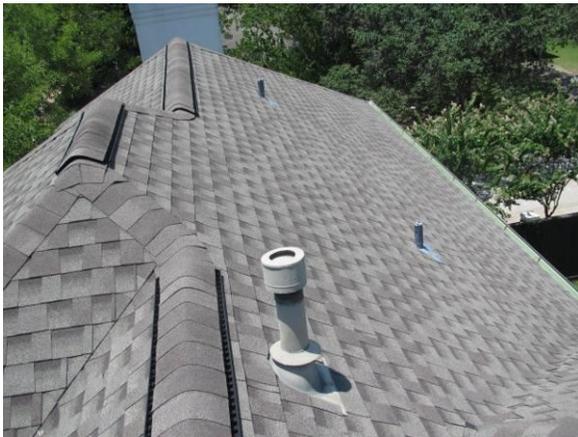
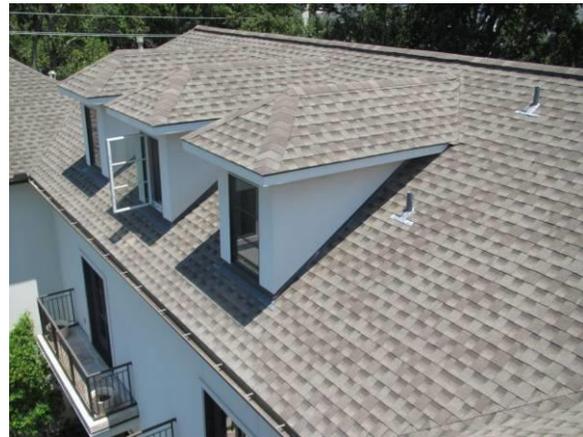
The roof surface was constructed of composition shingles. The life expectancy of a composition shingle roof has been observed to vary from 10 to 20 years, with most requiring replacement at about 15-18 years. We estimate that the age of the roof is approximately AGE..

After observing the interior of the structure, evidences of roof leaks were not visible. The absence of evidences of roof leaks does not guarantee that roof leaks were not present; rather, that no evidences of leaking were visible at the time of the inspection.

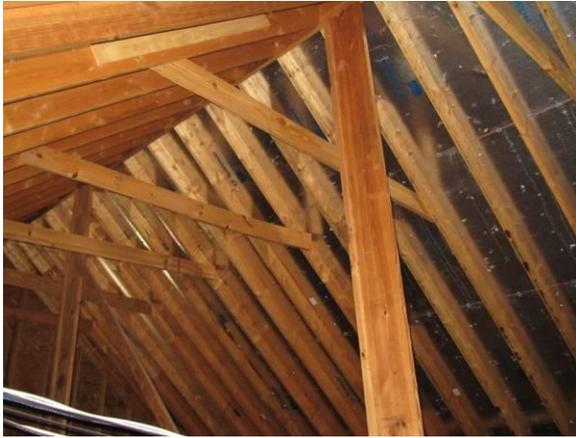
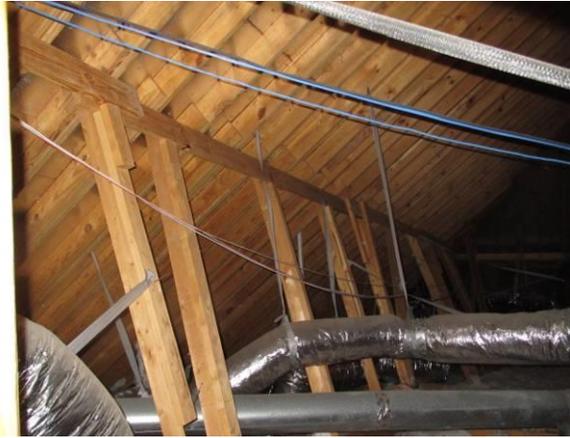
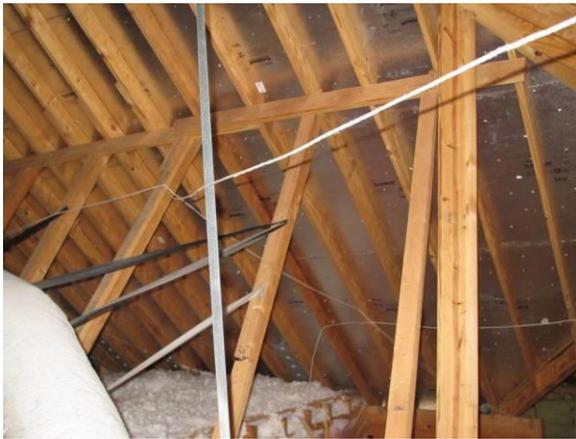
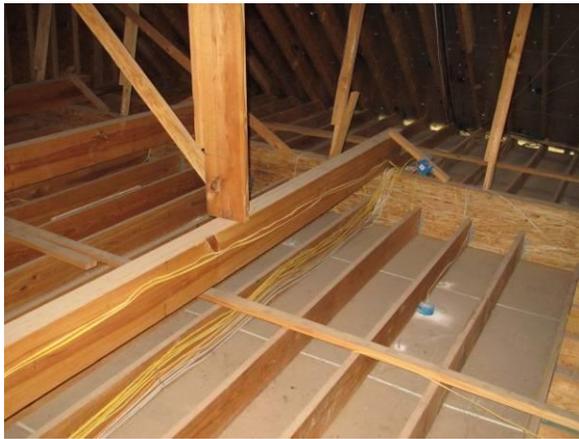
The house was observed to be a two story wood frame structure that includes standard major framing components, including wall studs, ceiling joists, floor joists, and roof rafters with purlins and strut supports.

No deficiencies were observed in the primary load carrying members of the structural framing that were accessible and viewed at the time of the inspection, including the roof framing, load bearing walls, ceilings, and floors. No significant deflections were observed in the roof framing as we were able to look up the plane of the roof from the different sides of the house. No unusual sloping of the upstairs floor framing was noted, beyond the normal amount of framing deflections for an upstairs floor.
