Inspection Report

30047 West Barrier Reef Blvd
Lewes DE 19958

Tip Top Property Inspections, LLC

Date: 5/11/2019	Time: 03:30 PM	Report ID: 20190511-30047-West-Barrier-Reef-Blvd
Property: 30047 West Barrier Reef Blvd Lewes DE 19958	Customer: Mr. Robert Kuehnl	Real Estate Professional: Mike Kuehnl TEST Brokers

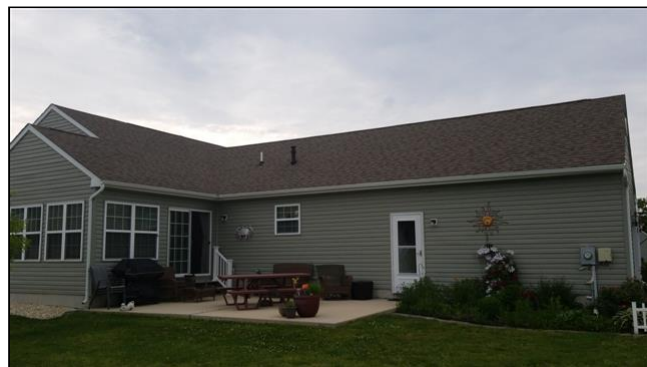
1.0 Item 2(Picture)

Roof is approximately 7 years old and appears to be in good condition.

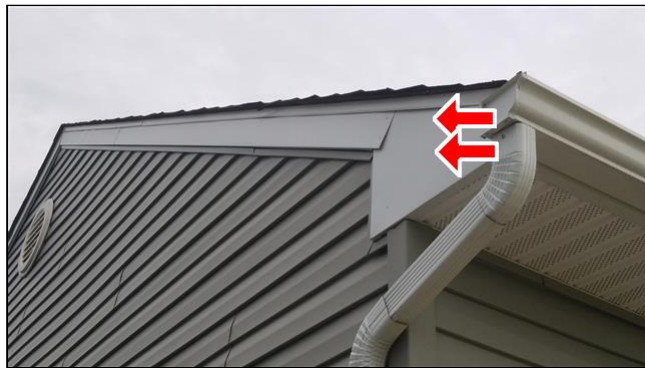
3.4 Item 2(Picture)

3.4 The fascia trim loose at the time of the inspection should be re-fastened by a qualified contractor.

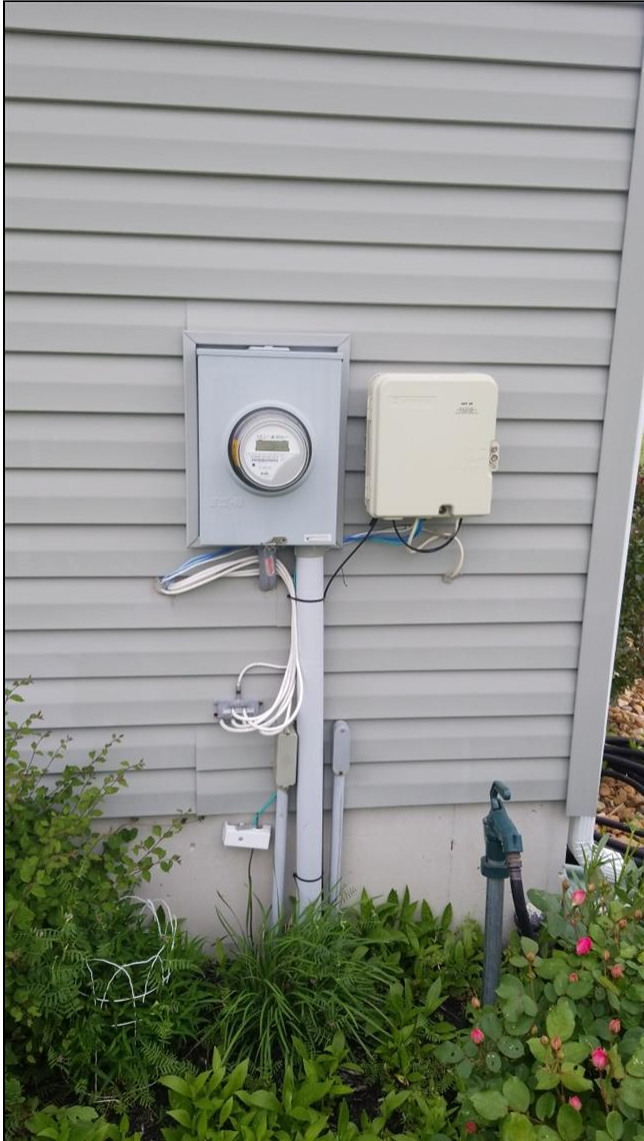
6.4 Item 1(Picture)

6.4 At the time of the inspection, the Inspector observed no deficiencies in the condition of the electric meter. Electric meters are installed by utility companies to measure home electrical consumption.

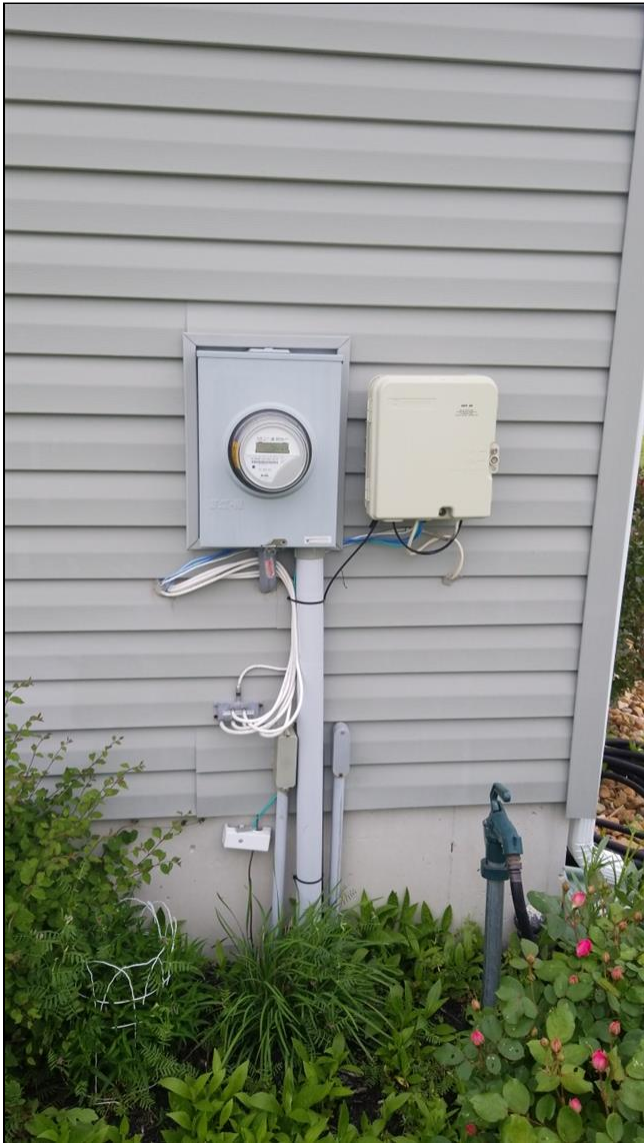
6.5 Item 1(Picture)

6.5 Because the service entrance conductors were hidden behind service panel components the inspector was unable to view markings in order to determine the service conductor amperage rating. Confirmation of correct service entrance conductors sizing will require the services of a qualified electrical contractor.

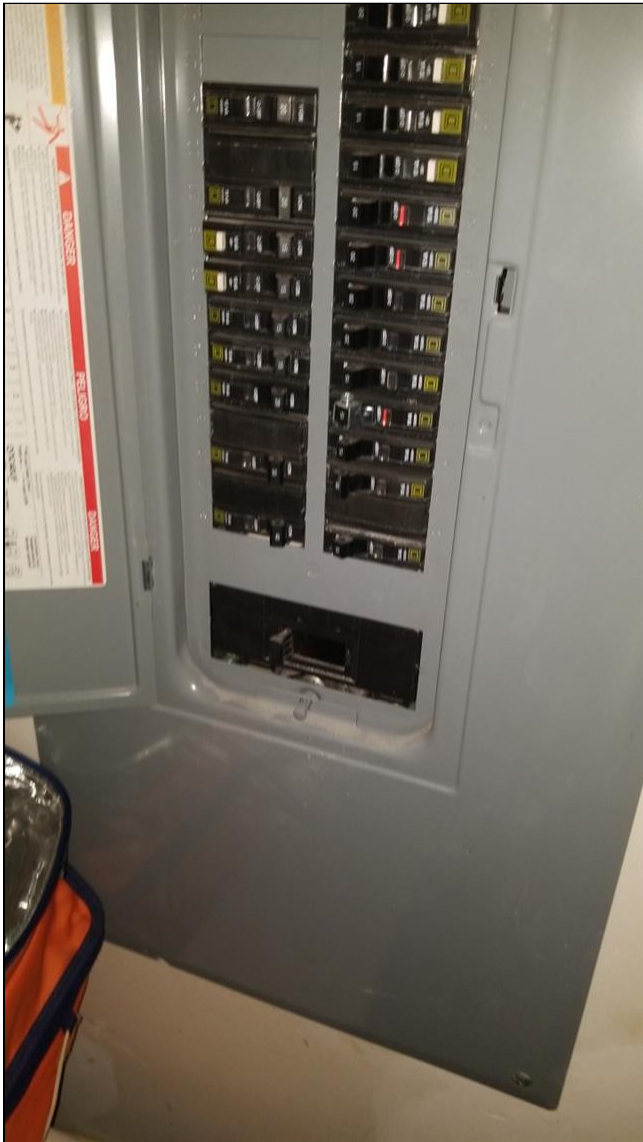
6.6 Item 1(Picture)

6.6 The service panel brand was Square D

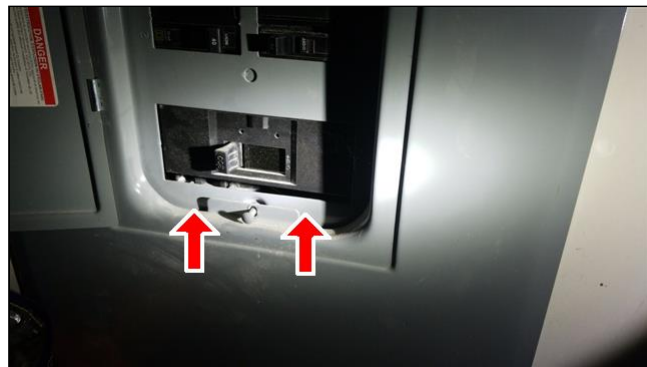
6.7 Item 2(Picture)

6.7 The inspector was unable to remove the dead front cover and electrical components inside the service panel were not inspected. The Inspector recommends that before the expiration of your Inspection Objection Deadline you have this condition corrected and the service panel contents inspected by a qualified electrical contractor.

Space between main disconnect and dead front cover which is a safety issue. Recommend a licensed electrician make necessary repairs.

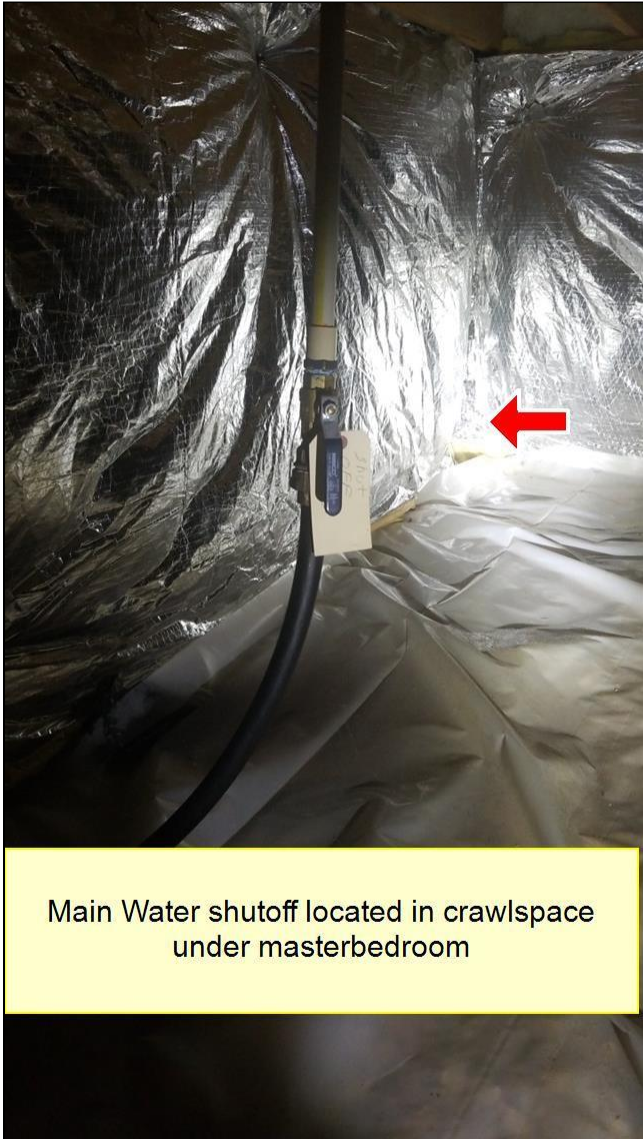
9.2 Item 1(Picture)

9.2 (1) At the time of the inspection, the Inspector observed no deficiencies in the condition of the main water supply shut-off valve. It was not operated but was visually inspected.

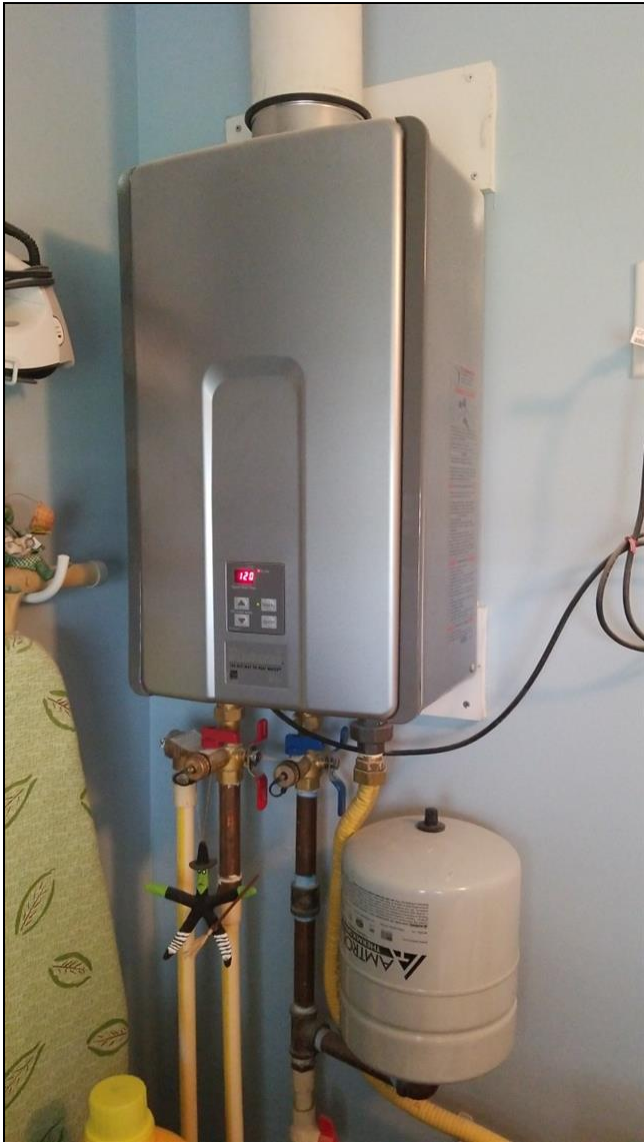
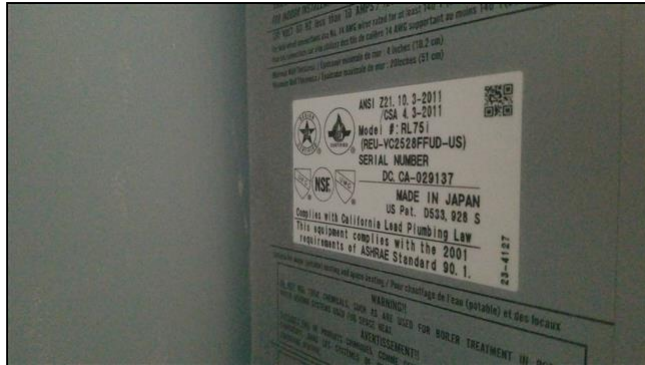
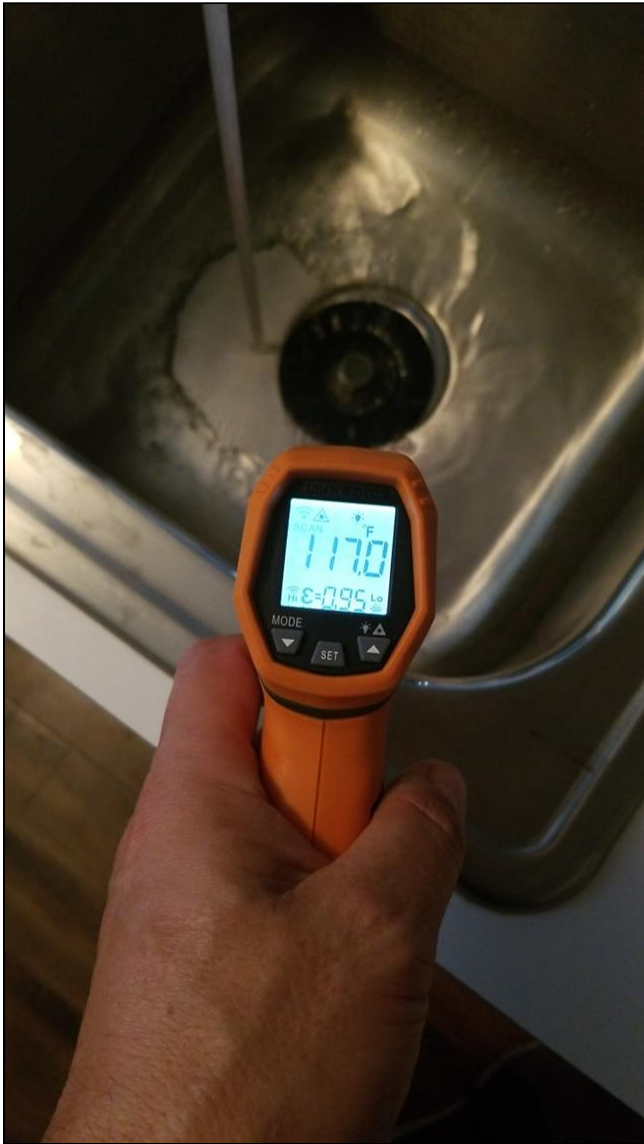
This water heater serial number was DC - CA-029137

Water temperature measured at 117F degrees.

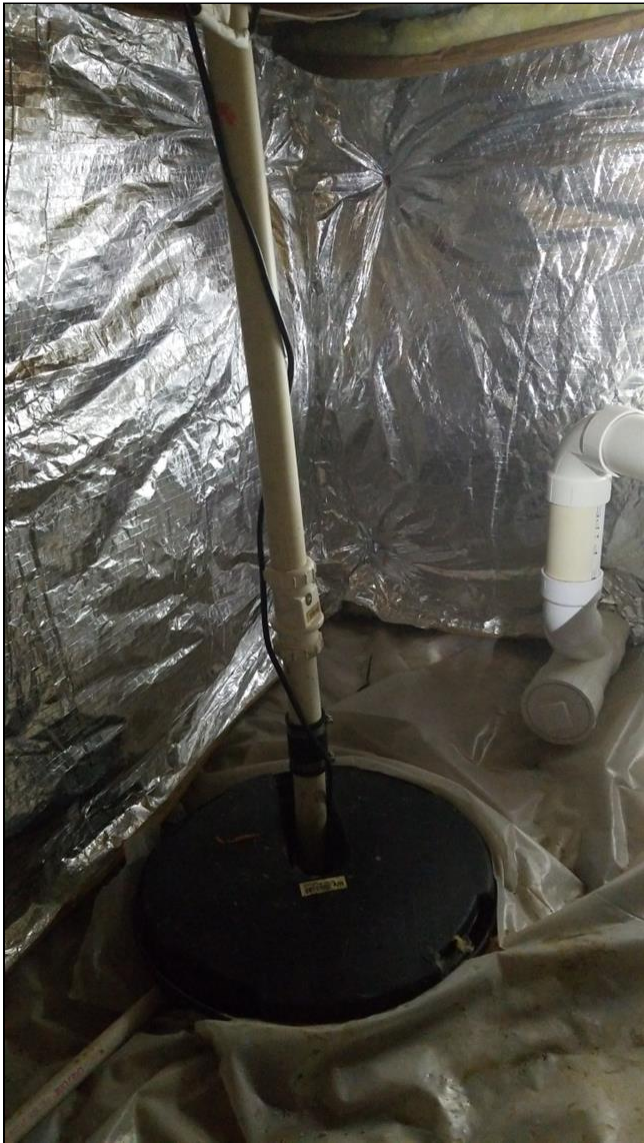
9.5 Item 2(Picture)

(2) The crawlspace contained a sump pump. A sump pump is a water pump installed in a pit in the lower level of the home. This system protects the home from water intrusion by discharging rising groundwater or seepage from surface runoff to the exterior of the home or to a waste pipe or storm drain. Sump pumps require periodic maintenance to ensure that they work when they're needed. The Inspector recommends having it serviced immediately and asking the service provider for advice on the best maintenance schedule.

At the time of the inspection, the Inspector observed no deficiencies in the condition or operation of the sump pump.

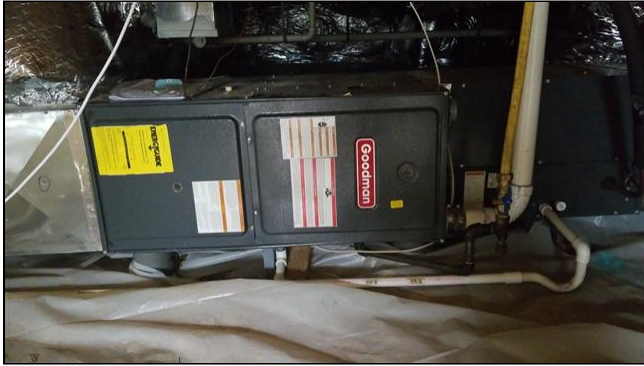
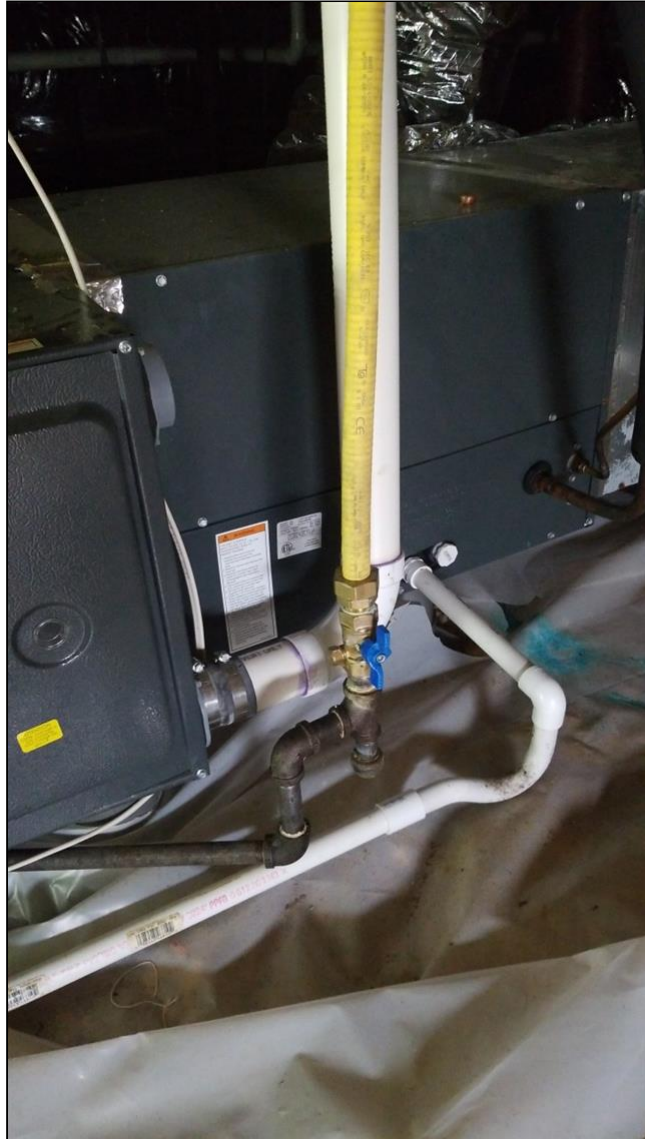
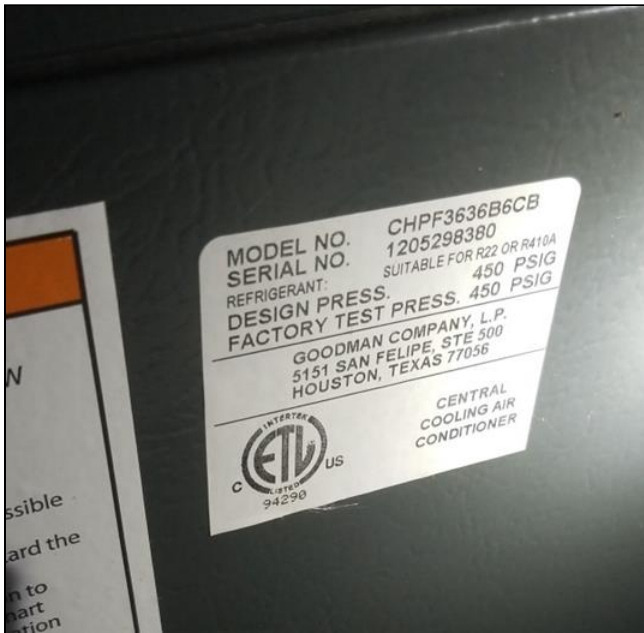
The year of furnace manufacture appeared to be May 2012.

This furnace was gas-fired, high-efficiency, forced-air.

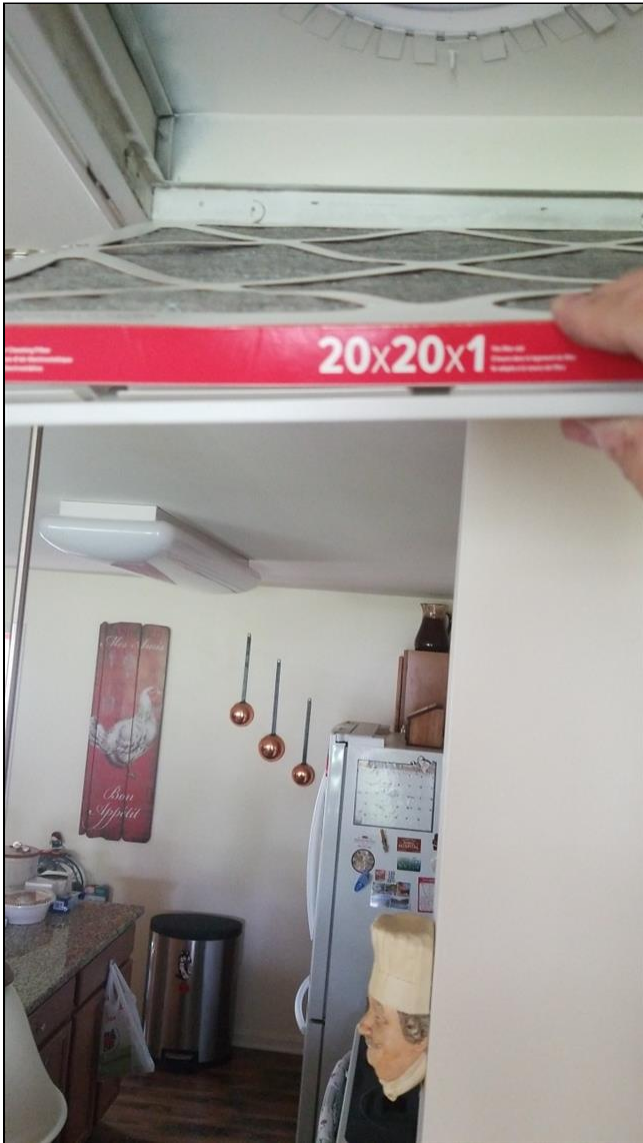
10.4 Item 1(Picture)

10.4 There are 3 separate filters in this system Two are 12x12x1 located in Masterbedroom ceiling and sunroom, the third is a 20x20x1 located in the kitchen ceiling. All filters were clean at the time of the inspection.

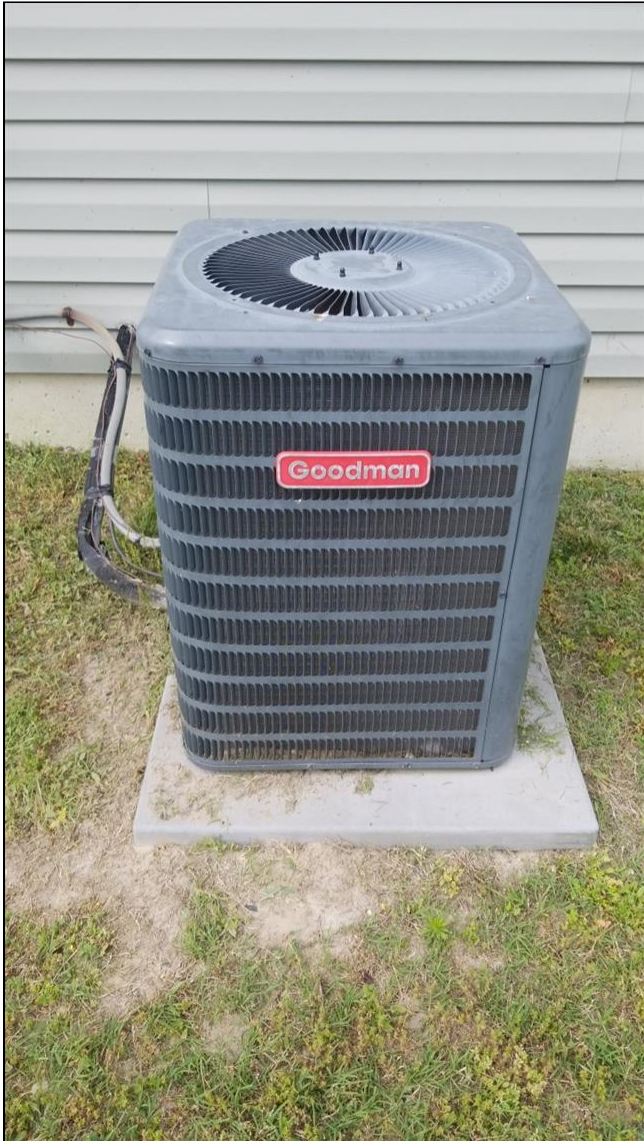
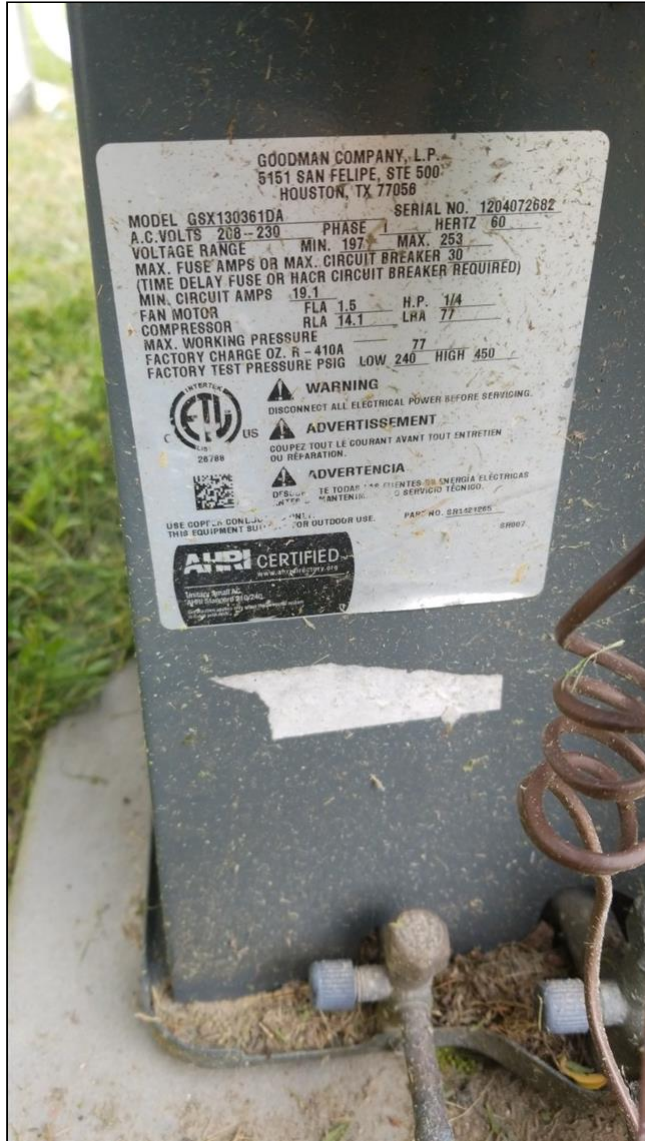
The air-conditioner date of manufacture appeared to be 2012.

The system was NOT tested due to outside temperature at the time of the inspection.

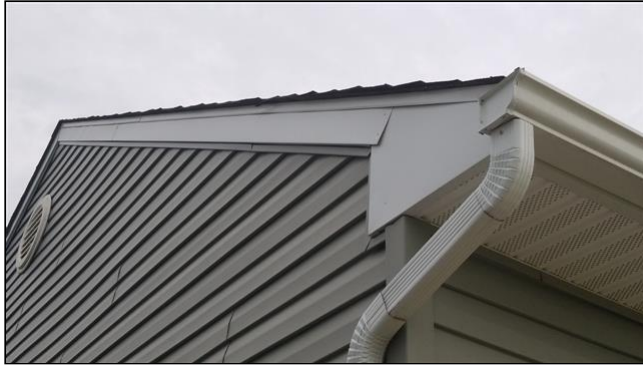
1.2 Item 3(Picture)

1.2 (1) Nail heads not properly covered in ridge vent and flashing resulting in corrosion. Recommend having a roofing contractor properly seal these to prevent future damage.

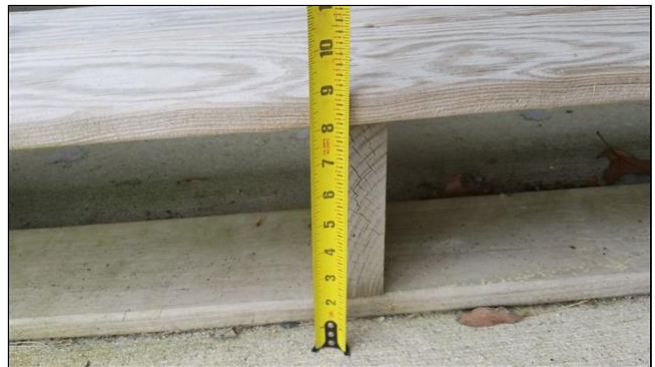
3.6 Item 2(Picture)

3.6 A risers are too high for exterior stairs leading into the sunroom. Risers shouldn't be more than 7 ¾ inches high. Correction and further evaluation is recommended.

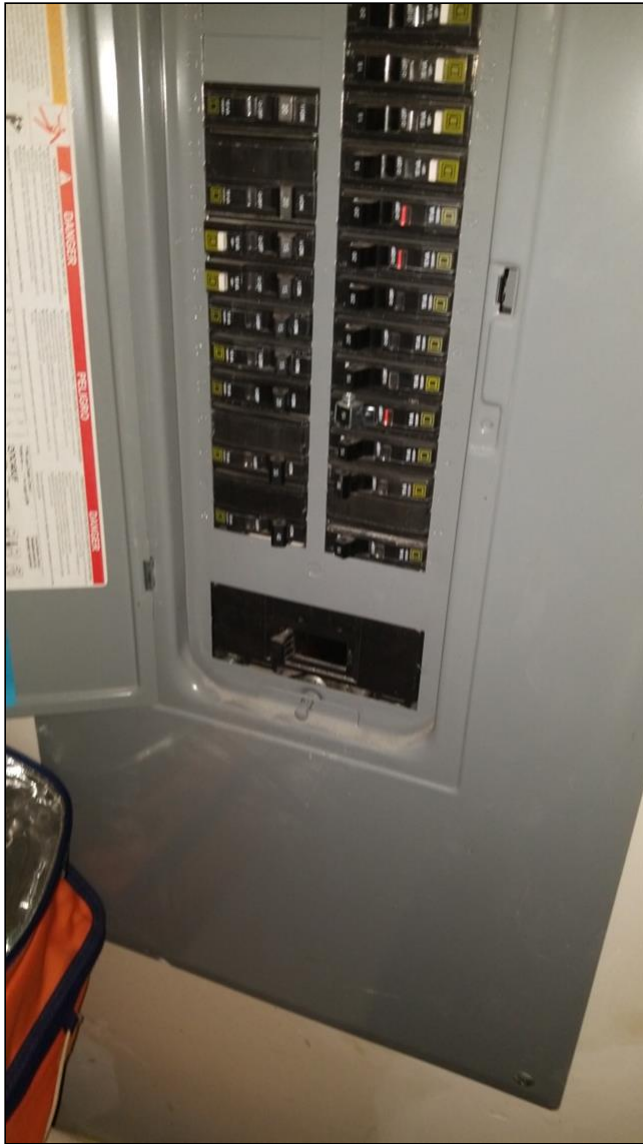
6.6 Item 1(Picture)

The service panel brand was Square D

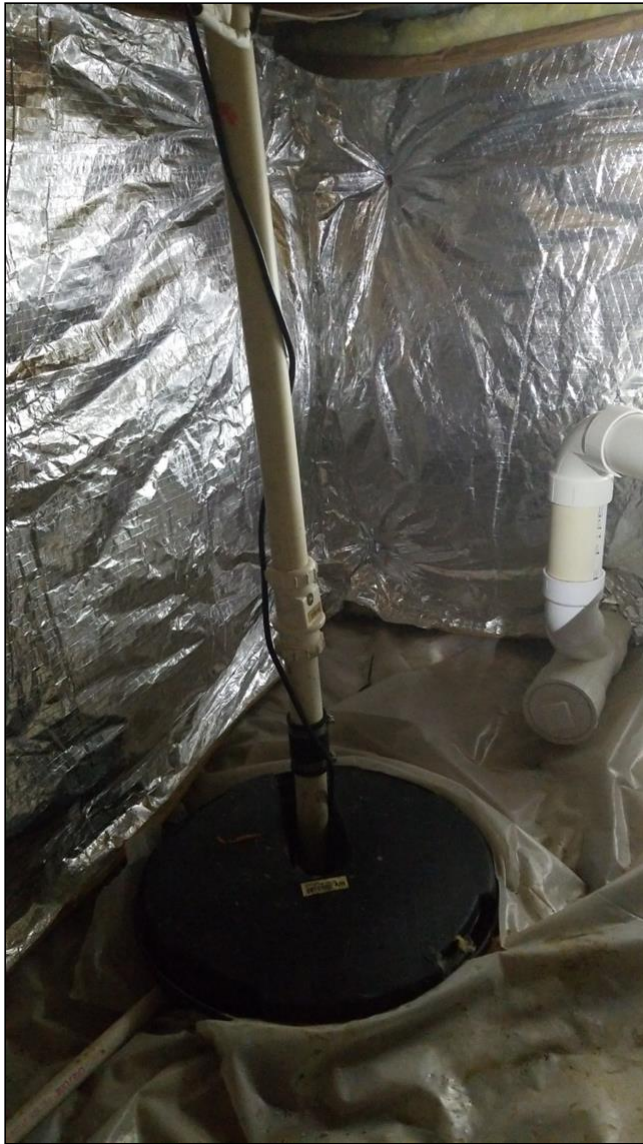
9.5 Item 2(Picture)

(2) The crawlspace contained a sump pump. A sump pump is a water pump installed in a pit in the lower level of the home. This system protects the home from water intrusion by discharging rising groundwater or seepage from surface runoff to the exterior of the home or to a waste pipe or storm drain. Sump pumps require periodic maintenance to ensure that they work when they're needed. The Inspector recommends having it serviced immediately and asking the service provider for advice on the best maintenance schedule.

At the time of the inspection, the Inspector observed no deficiencies in the condition or operation of the sump pump.

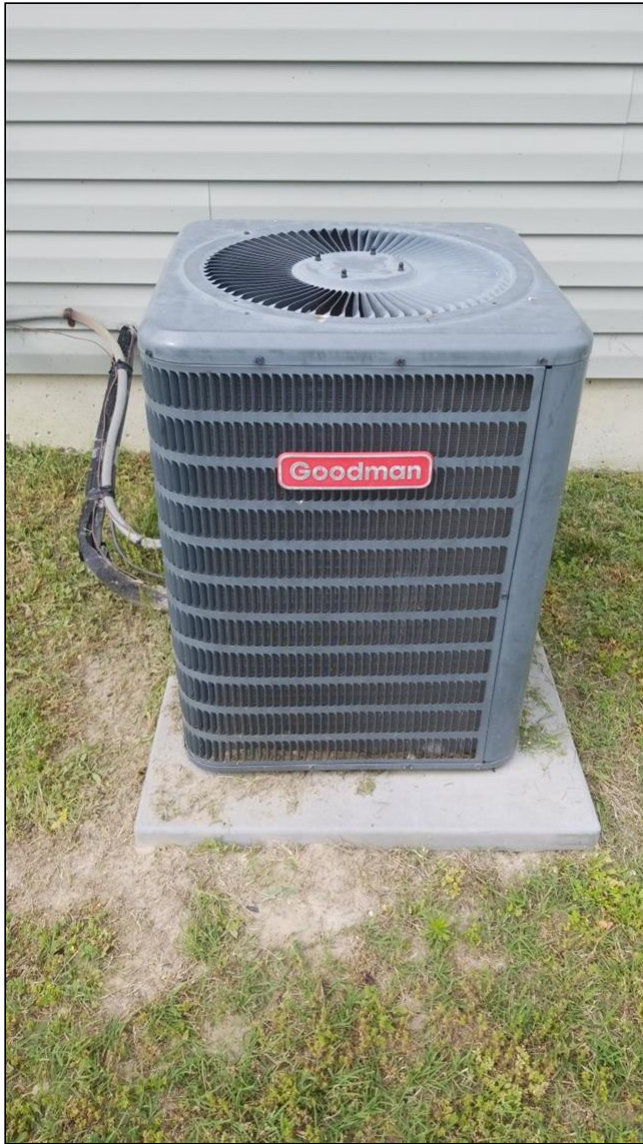
11.0 Item 1(Picture)

(1) At the time of the inspection, the Inspector observed few deficiencies in the condition of the air-conditioning system. Notable exceptions will be mentioned in this report.

The air-conditioner date of manufacture appeared to be 2012.

The system was NOT tested due to outside temperature at the time of the inspection.

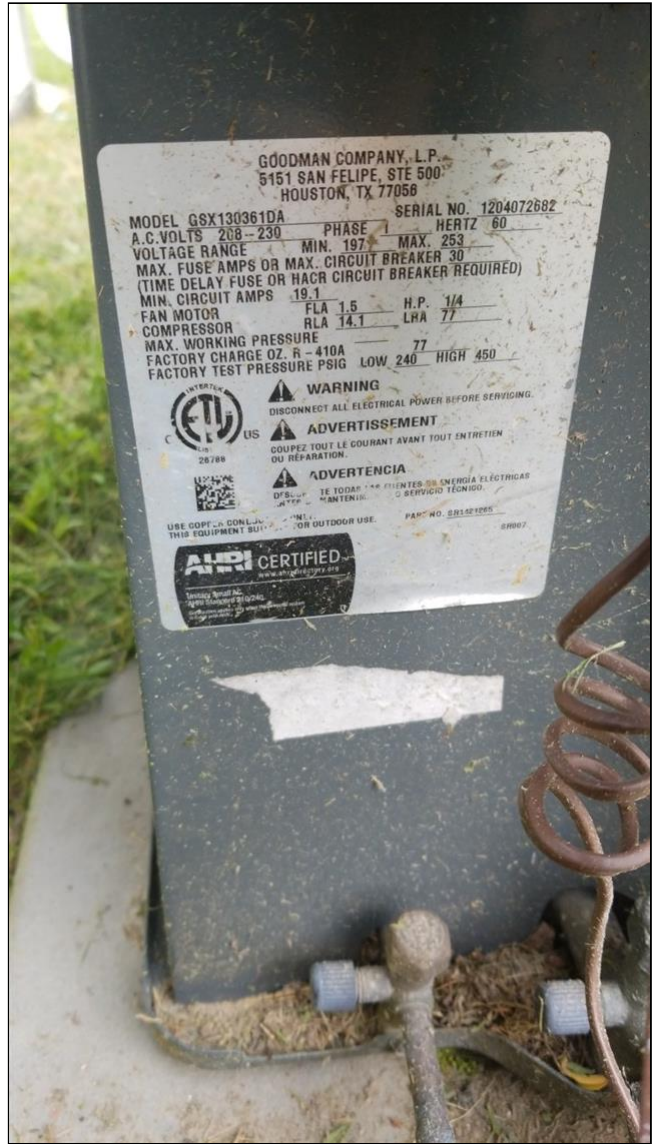
11.0 Item 2(Picture)

(2) Phone condensate line should be replaced.
