BELLANCA AIRCRAFT CORP.

SERVICE LETTER NO. 39 MARCH 8, 1967

SUBJECT: PILOT RUDDER PEDAL REPLACEMENT

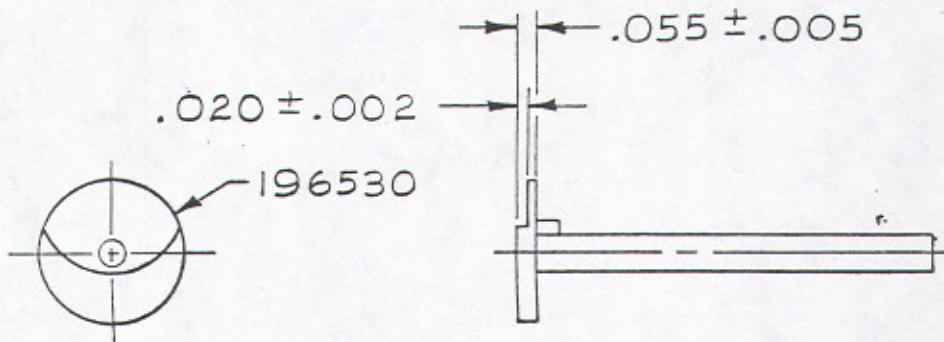
FIG. 2

It has been brought to our attention that some of the Bellanca models 14-19-3A and 17-30 have excessive corrections in the static system. The step on the static vent button should be .020 inches high (see figure 2). These vents are located on either side of the aft fuselage. Static vents are available from the factory with the correct dimensions or the present vents can be modified according to figure 2. Vents may be modified on the airplane by filing or grinding the step. Care must be taken to assure no chips enter the static system and that the step is kept flat. If possible, the vents should be removed to be modified. This can be accomplished by working thru the opening under the baggage floor.

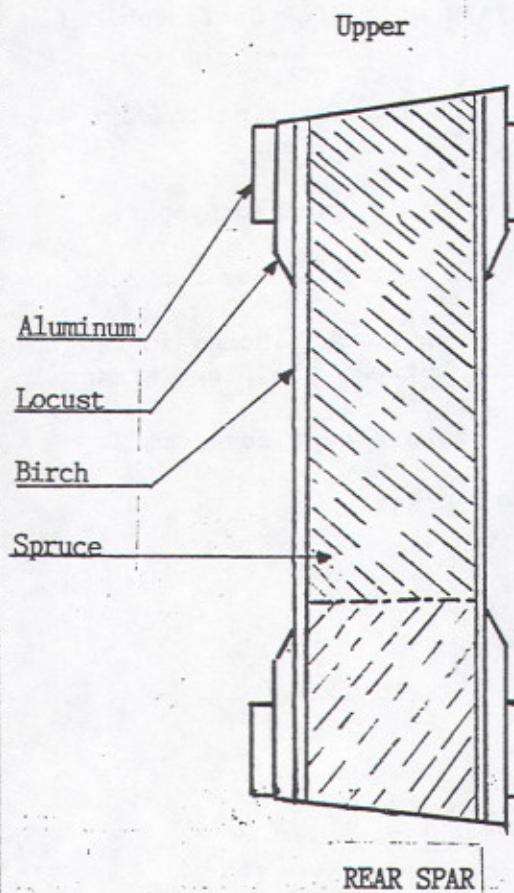
PICTORIAL PRESENTATION OF DAMAGE ALLOWANCE

Therefore, the front spar must be 100% effective for all 10 bolts. No cracks may be allowed in the front spar. The rear spar, however, may have cracks in the spruce only if they do not extend (outboard - ed) beyond the second bolt and do not penetrate the compression plates.

\\\\ = Cracks allowed in spruce only

//// = Cracks allowed in spruce only and cracks must not extend beyond the second bolt.

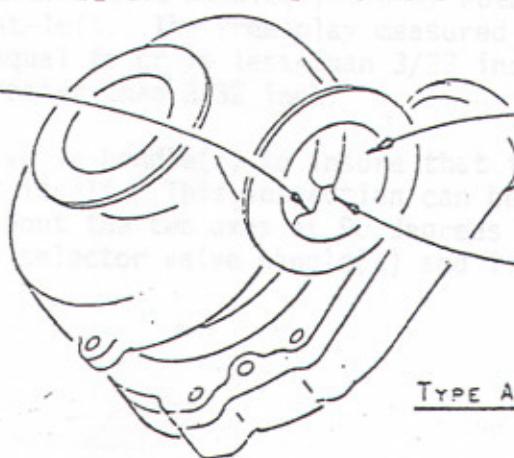
CAUTION

DO NOT MISINTERPRET THE PARTING LINE OF THE CASTING IN THIS AREA TO BE A CRACK.

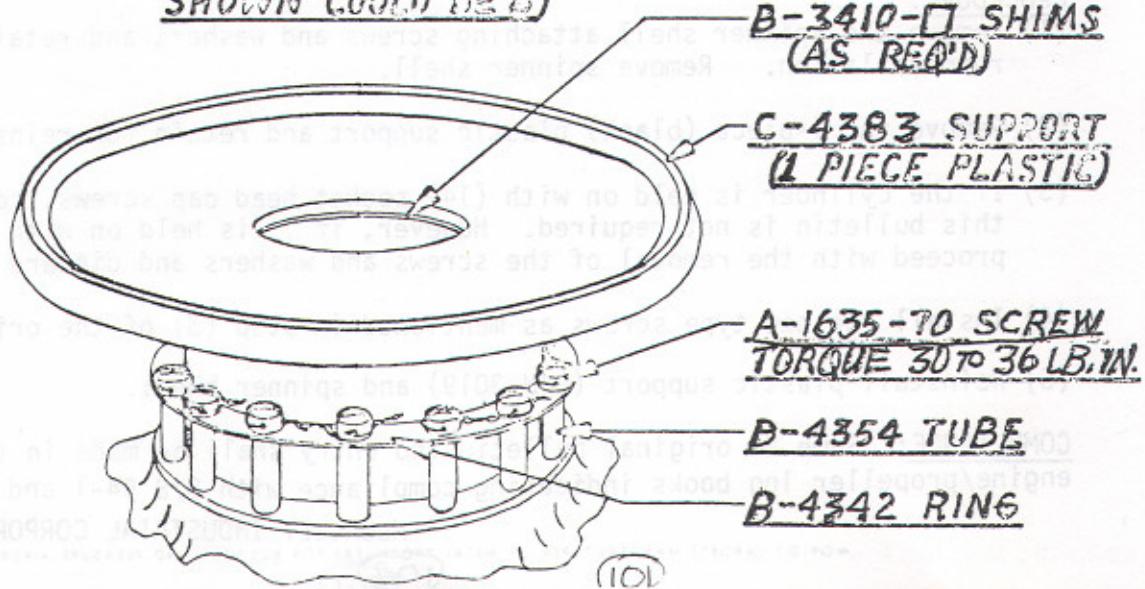
**FIGURE 2.**

NEW METHOD
(14 CYLINDER SCREWS
SHOWN COULD BE 8)

3. Install the new type screws, tubes and ring as shown in Fig. 2. Tighten screws with torque wrench to 30-35 pound-inches torque and lockwire with .032 corrosion resistant wire.

NOTE: Fig. 2 shows a typical (14) screw type installation.
On models that have provisions for only 8 screws,
install in similar manner and discard excess screws
and tubes.

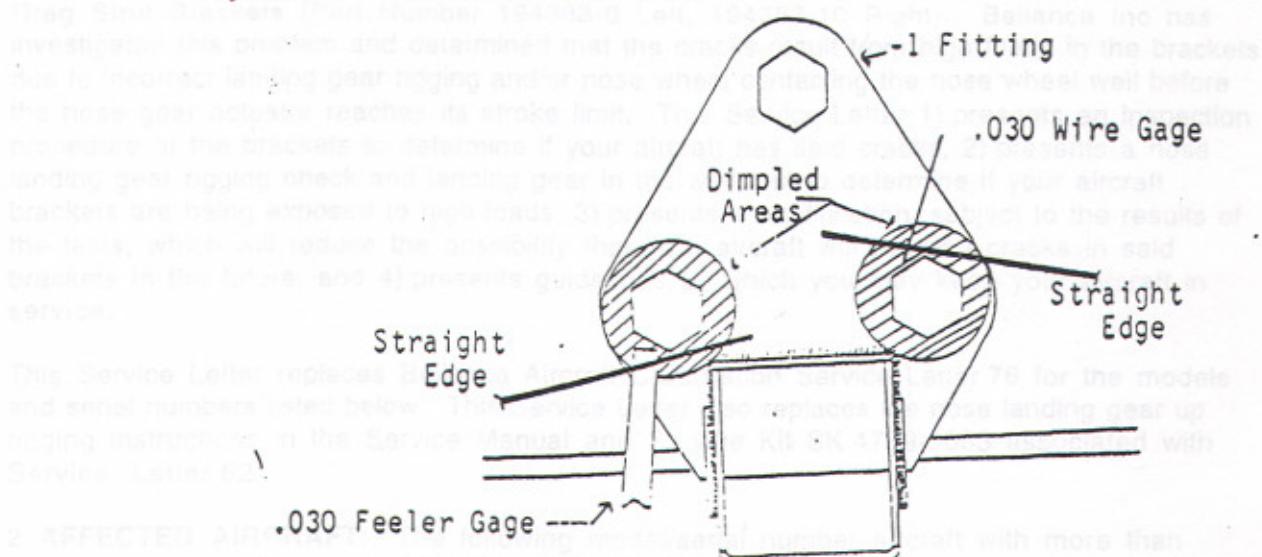
Figure 2: EXAMPLES OF MEASURING DEPTH OF DIMPLED AREAS

Lay a straight-edge alongside the lower aft attachment bolts as shown on Figure 2. Use an 0.030 inch gauge to look for evidence of local deformation (dimpling) in the -1 Fitting. If any deformation greater than 0.030 is found, replace the assembly with a new fitting assembly P/N 194153-30 or P/N 194153-40, as applicable, prior to further flight.

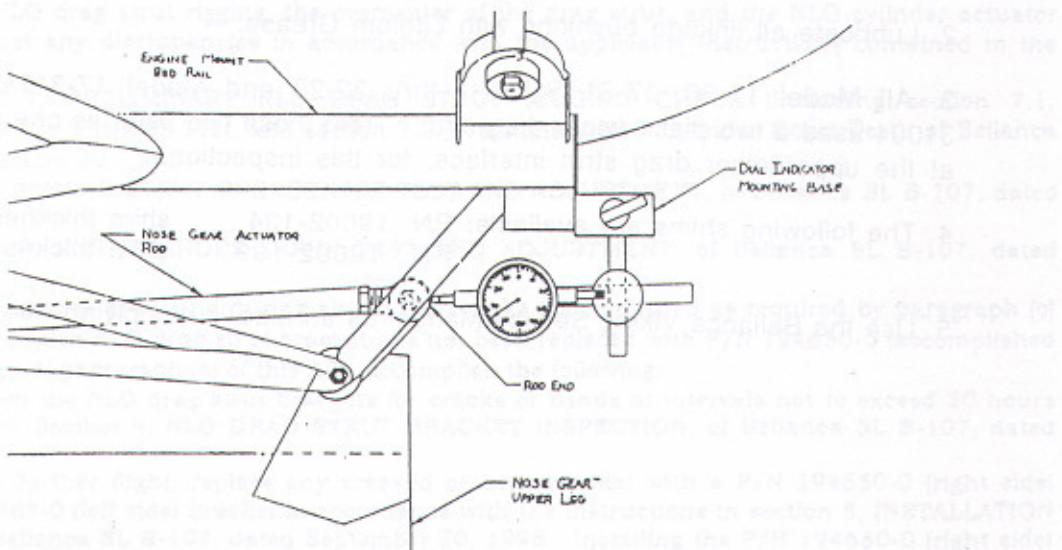
Figure 2: Dial Indicator Set-up (Model 17-30A Shown)

Slowly retract the landing gear until the nose wheel just touches the wheel well using the following procedure: 1) place landing gear switch in the up position, 2) locate an observer at the nose gear, 3) turn master switch on until nose wheel moves to approximately 12 inches from contacting the nose wheel well, 4) jog the master switch until the wheel is within inches of touching the well, 5) manually move the nose wheel and/or the main gear (pull main gear down to move nose wheel up) until the nose wheel just touches the well. It should be possible to turn the wheel with one hand noting some friction between the wheel and the well. Warning - do not allow the pump to move the nose wheel to contact the well and develop up pressure; failure to do so may cause excessive loads and damage the drag strut brackets. Install a dial indicator to measure motion between the nose gear cylinder and cylinder rod as illustrated in figure 2.

Deflate the nose gear tire by removing the valve core. Turn the master switch on and allow the electrohydraulic power pack to move the landing gear to the full up position. Note the nose gear cylinder rod motion. Place the landing gear switch in the down position and allow the landing gear to move to the down and locked position; check for three green lights. Turn the master switch off. Install nose wheel valve core and inflate the nose wheel tire to 35 psi.
