Under The Roof Home Inspection

Sample Property Inspection Report

Sample Report
Sample Report, TX 00000
Inspection prepared for: Sample Report
Date of Inspection: 0/00/0000 Time: 9:00am
Age of Home: Built 0000 Size: 0000 Total
Weather: Cloudy/Rainy

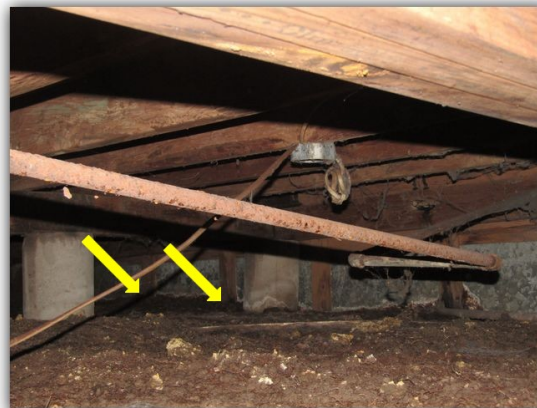
Wood to soil contact observed in crawlspace

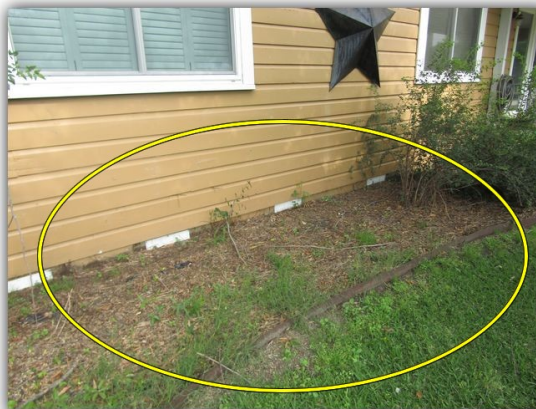
Appears grading on east side of home is flat or slopes toward home. Appears water may pool near home and enter crawlspace

- Possible poor drainage in crawlspace. Appears water may enter crawlspace and pool in multiple locations in crawlspace. Appears water may flow from east to west in crawlspace.
- Appears grading on east side of home is flat or slopes toward home. Appears water may pool near home and enter crawlspace
- Recommend splash block under exterior faucet on east side of home
- Recommend gutters on home

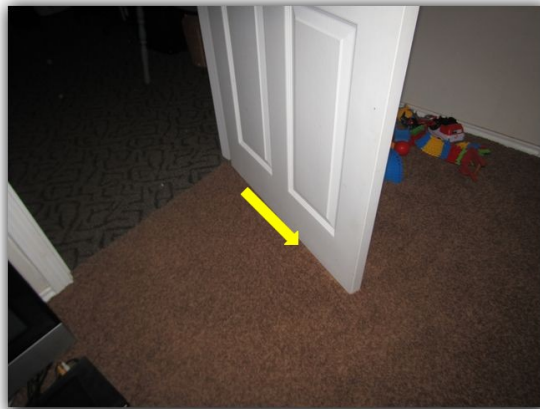
Appears door to office rubs against carpet and floor

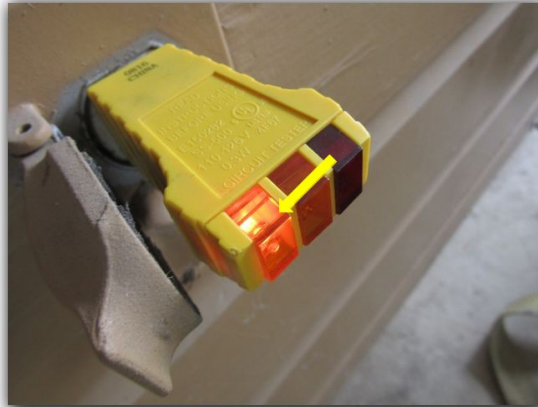
Carport receptacle is on an open neutral

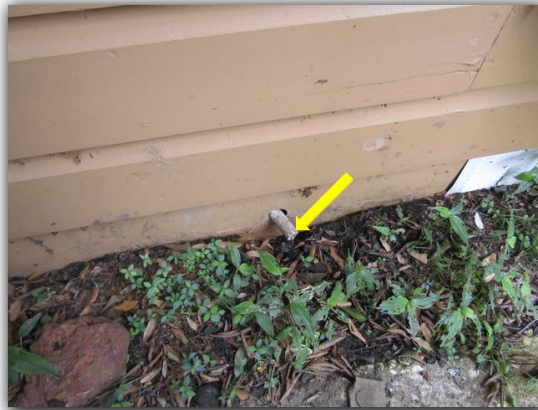
A/C drain line terminates to exterior.

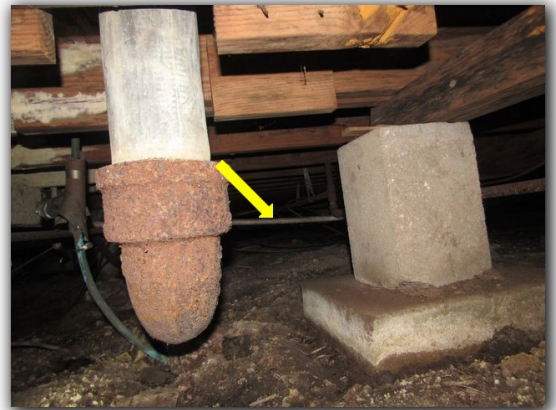
Appears A/C drain line is tilts back towards A/C unit in crawlspace and not towards termination

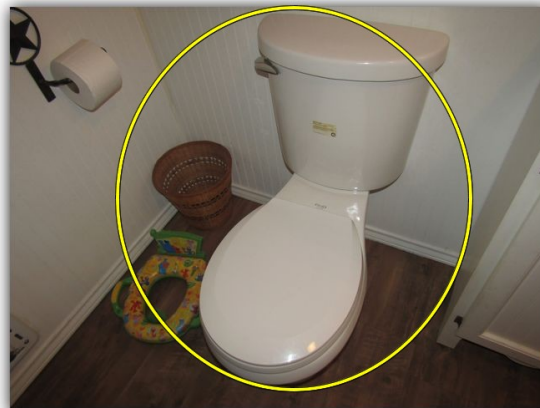
Hall bathroom toilet loose at base

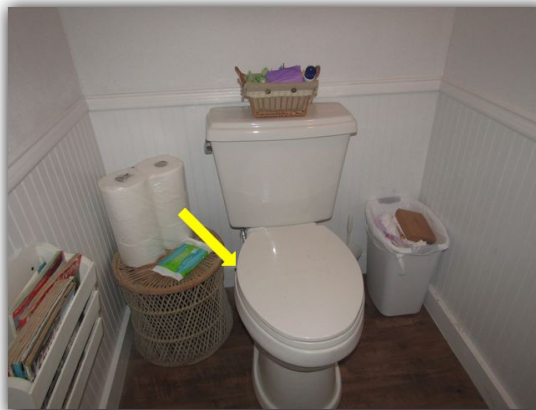
Supply valve for master toilet was turned off at time of inspection.

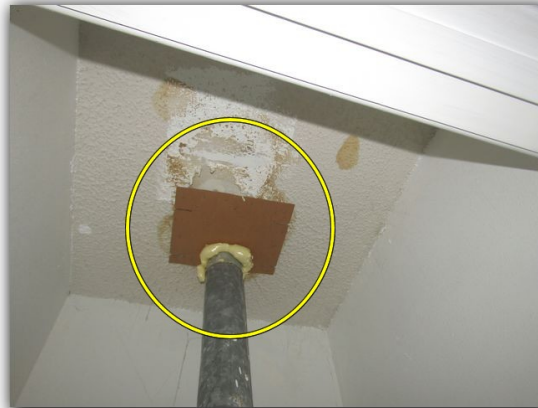
Recommend heat shield at kitchen water heater

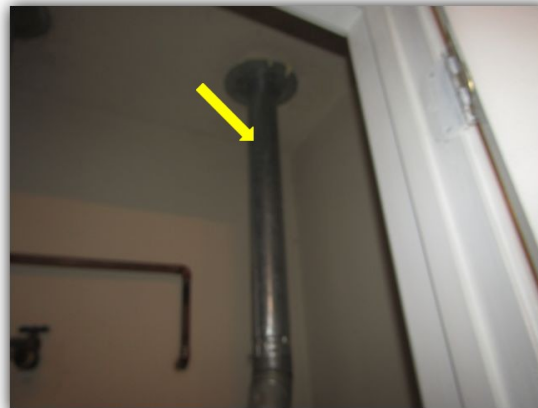
Appears to be a flue no longer in use in hall bathroom water heater closet

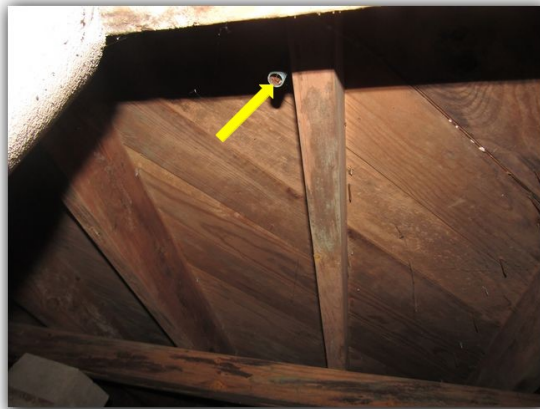
Drain line for hall bathroom water heater temperature pressure relief valve terminates in crawlspace.

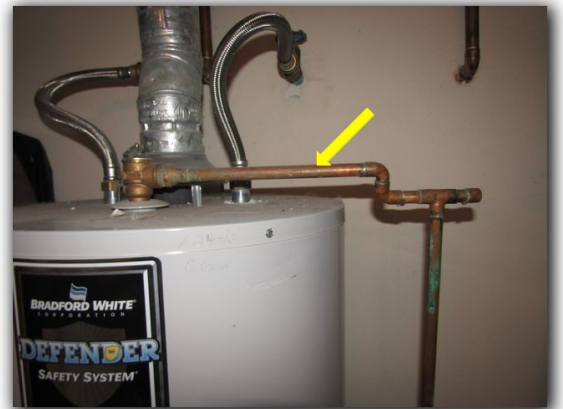
TPR drain line for hall bathroom water heater appears to be too small

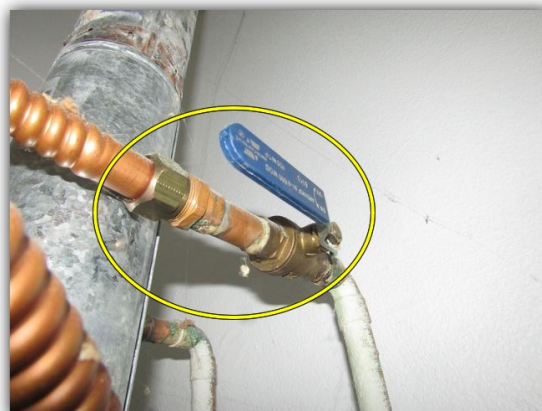
Possible corrosion observed at cold water supply valve for kitchen water heater

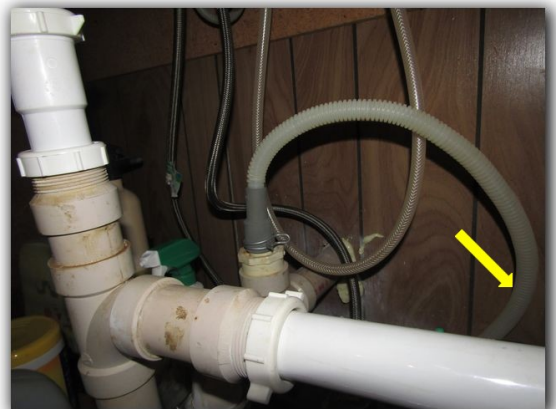
Dishwasher Drain line should be elevated or an anti-syphon device be installed to prevent backups from contaminating the dishwasher

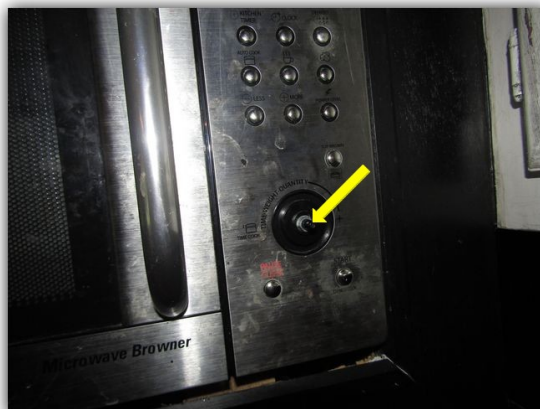
Appears microwave is missing knob
