The Energy Kite

Selected Results from the Design, Development and Testing of
Makani's Airborne Wind Turbines

Part III, Technical Artifacts

Selected Decks From RPX Lessons Learned Reviews

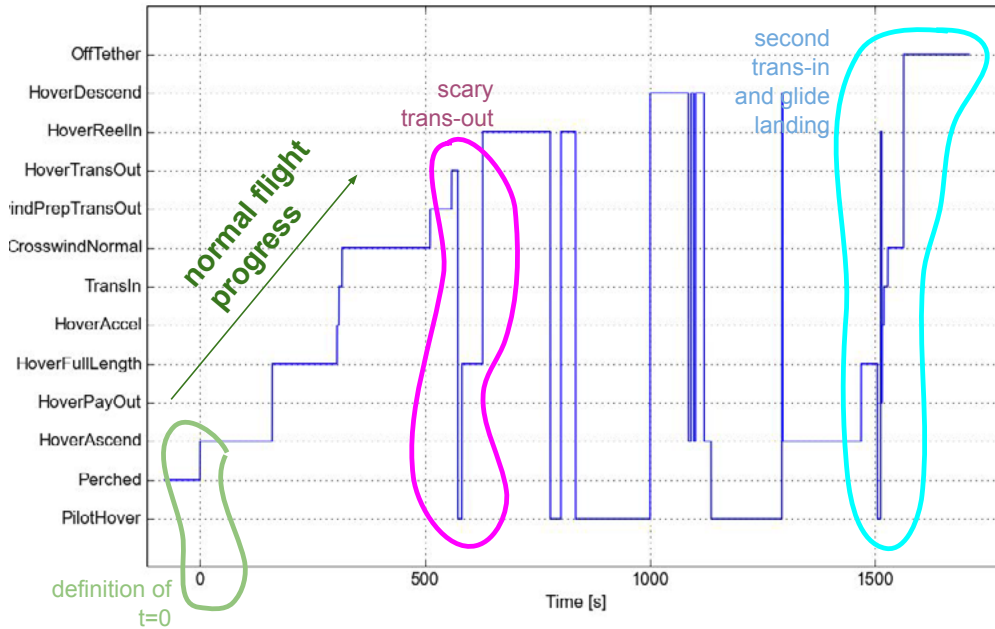
Flight Mode Summary

The initial flight mode progression to crosswind was as planned.

Trans-out was scary. The descent nearly hit the ground.

Elected to trans-in again and do a tether release and glide landing.

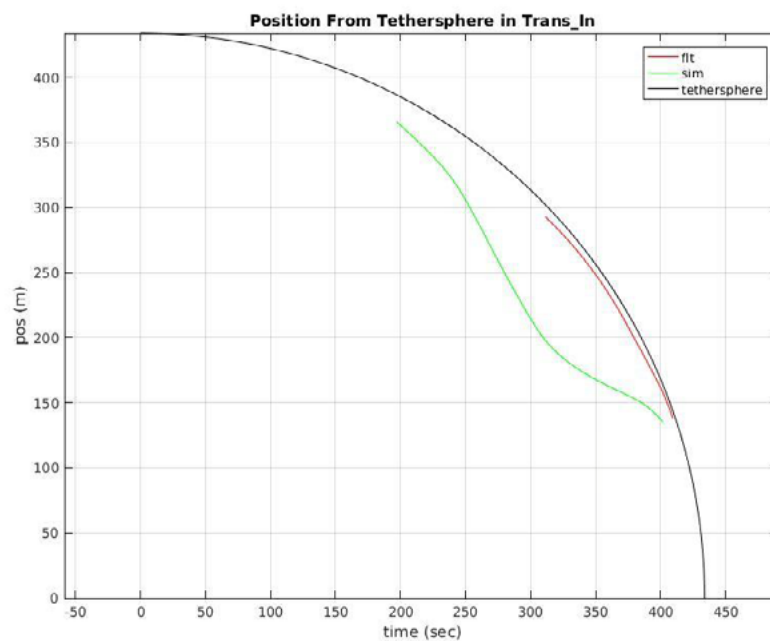
Trans-In

The kite started trans-in much closer to the tethersphere than the sim.

The kite remained much closer to the tethersphere during trans-in than the sim.

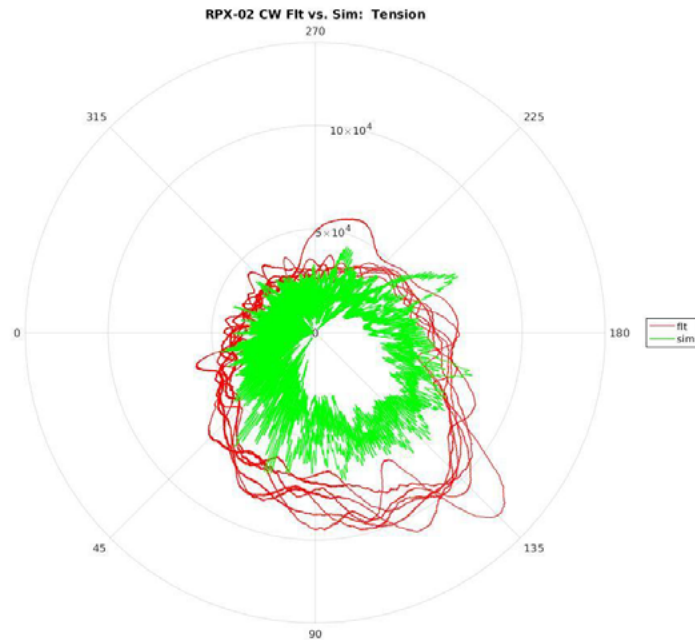
Crosswind Tension

The flight test tether tension is systematically a factor of 2 or greater in the flight test than the sim in the downstroke (near the 5 o'clock position).

The cause is not yet known.

Possible reasons are:

1. Higher lift than predicted
2. More tether dynamics than predicted
3. Error in the load cell measurements

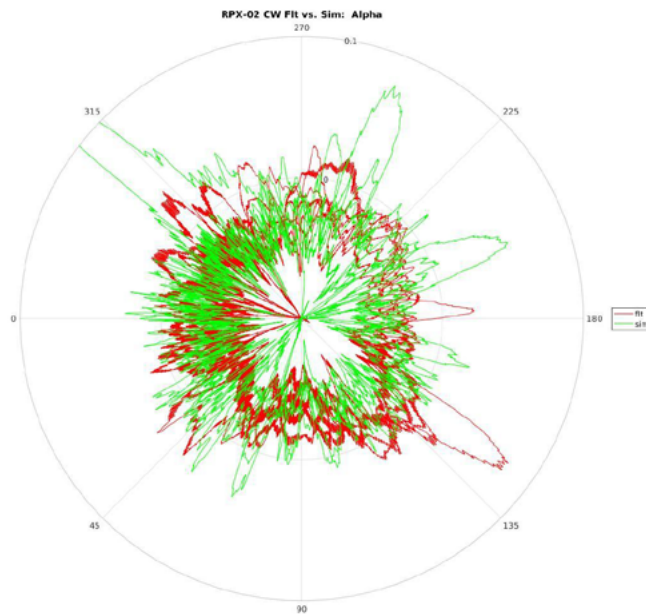
Crosswind Angle of Attack

The angle of attack in the flight test and sim match quite well, in general. There is one large spike in alpha at the 4:30 position that correlates to the large measured tension spike in the tension plot.

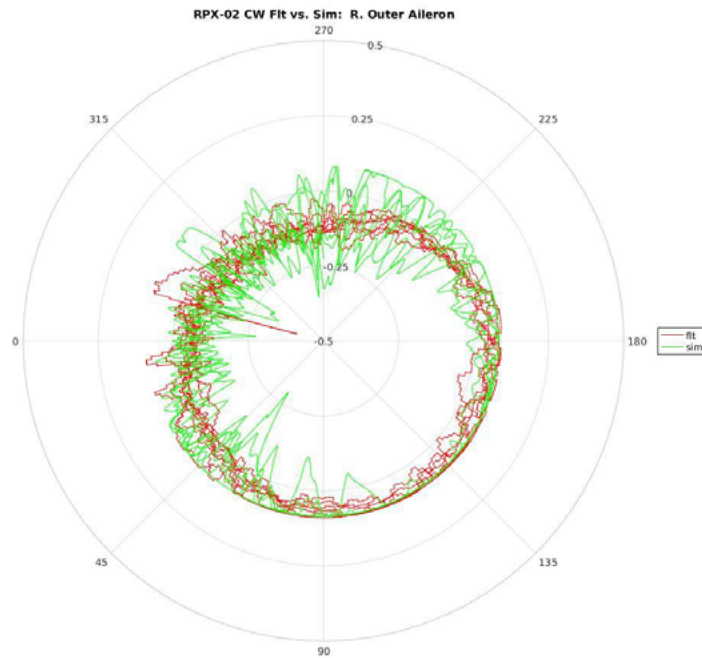
Crosswind A8 (Right Outer Aileron)

The flight right outer aileron is not saturating quite as much on the downstroke as in the simulation.

This suggests that the roll gains could be increased slightly to decrease the turn radius.

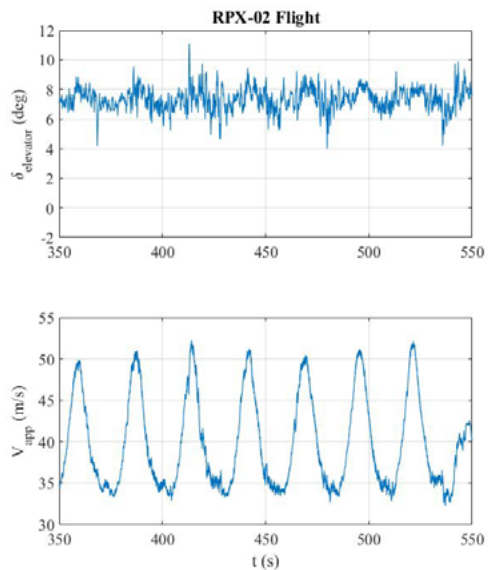
Crosswind Tail Loads

- The elevator force discrepancy appears to be associated with an offset in the elevator trim angle.

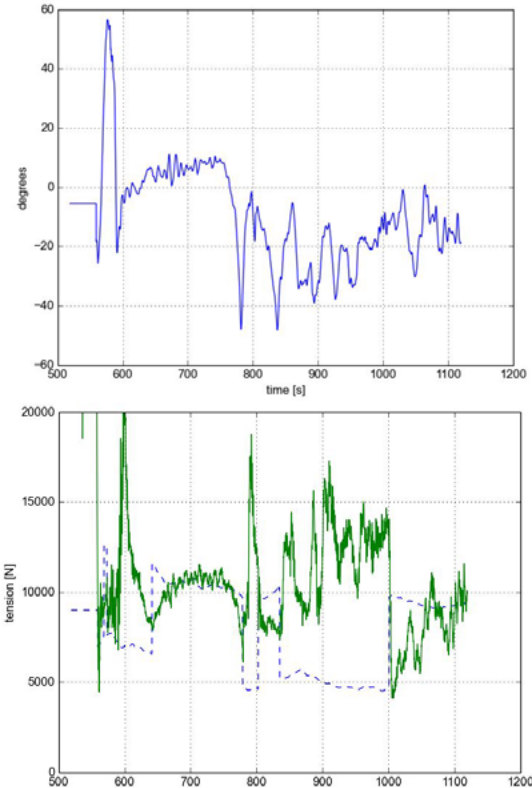
Hover Tension and Roll

- After trans-out, there were many instances of roll excursion due to inadequate tension.
- Switched to PilotHover to command immediate pitch-back.
- Loadcell bias was a contributing factor.
- Near-crash after trans-out.

- Resolve loadcell bias problem.
- Revisit horizontal tension setpoint.
- Consider pitch feed-forward.
- Consider supplemental active roll control.

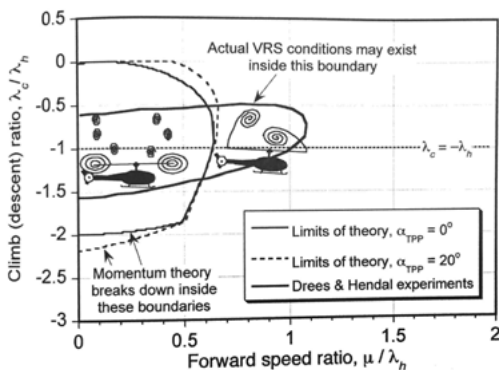
Trans-Out Vortex Ring State

- After mode switch from CrosswindPrepTransOut to HoverTransOut, there was a residual descent velocity: ~4 m/s. Not a big problem yet...
- On mode switch from HoverTransOut to PilotHover, the net thrust abruptly dropped. Descent velocity increased and the rotors entered Vortex Ring State for ~20 seconds

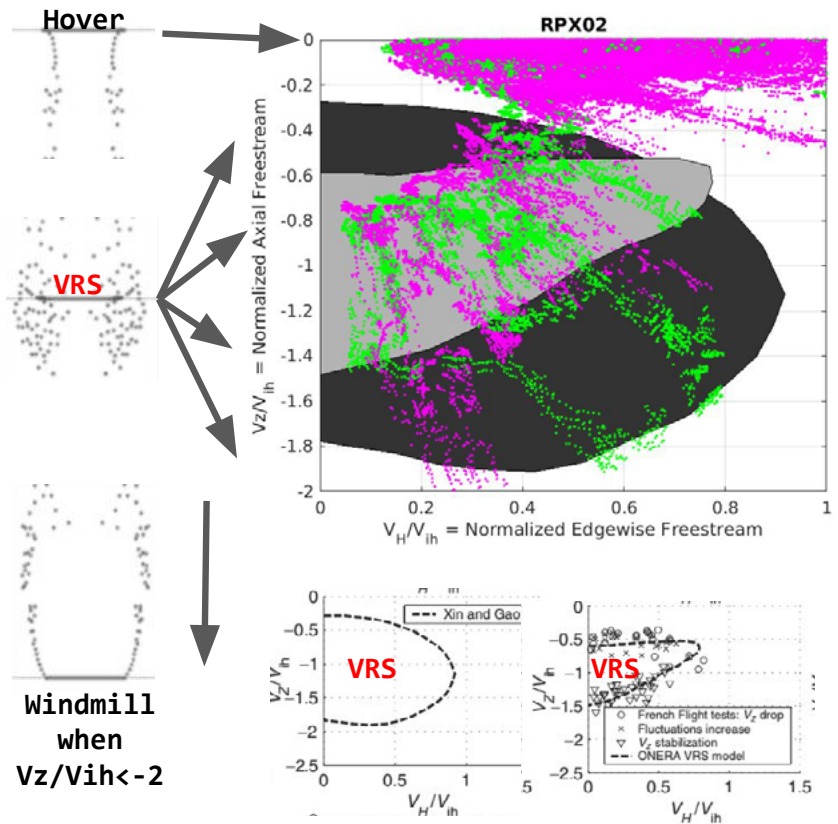
Trans-Out Vortex Ring State

- Recovery from VRS *begun* on switch to HoverFindDownwind, likely well before any ground effect began to help.
 - Anything that changes the wake geometry helps
- Plot at right shows RPX02 rotors on top of VRS boundary definitions from the literature
 - Magenta = HoverTransOut
 - Green = PilotHover
- All VRS indicators are present
 - Relative wind @ Rotors is exactly inside VRS boundary
 - “Suck In” effect (**hard to stop once it starts**)
 - Highly unsteady aero loads

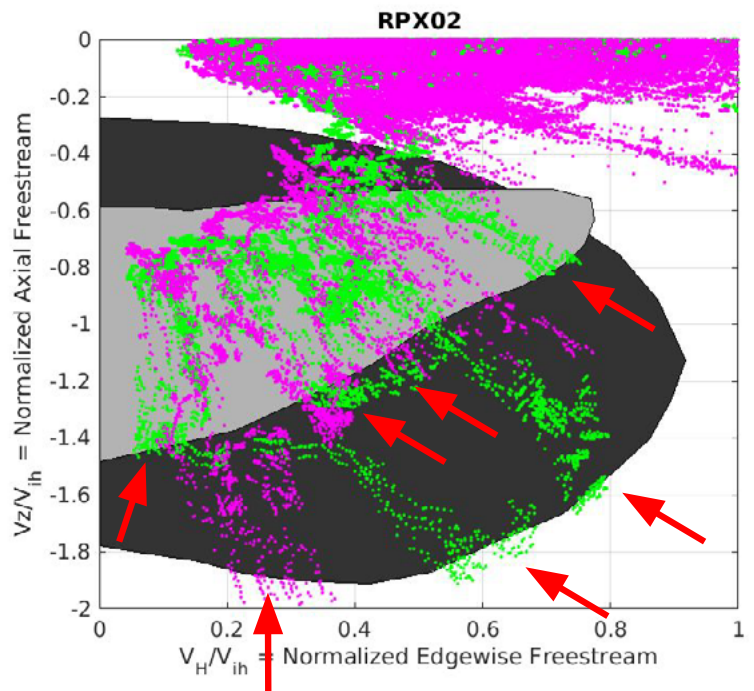
Trans-Out Vortex Ring State

- Flight in VRS is unsteady, often described as “negative thrust damping”
- This effect tends to suck vehicles deeper into VRS upon entry
- Vehicles which enter VRS often traverse to the opposite side of the VRS boundary before recovering
 - **If we touch -6 m/s or so in a Hover mode, we will likely enter VRS and accelerate toward the ground**
- Data from RPX02 shows rotors recovering AT the VRS boundary published in literature
- Using edgewise speed to exit VRS is known to be effective. Fly laterally out of it if possible.

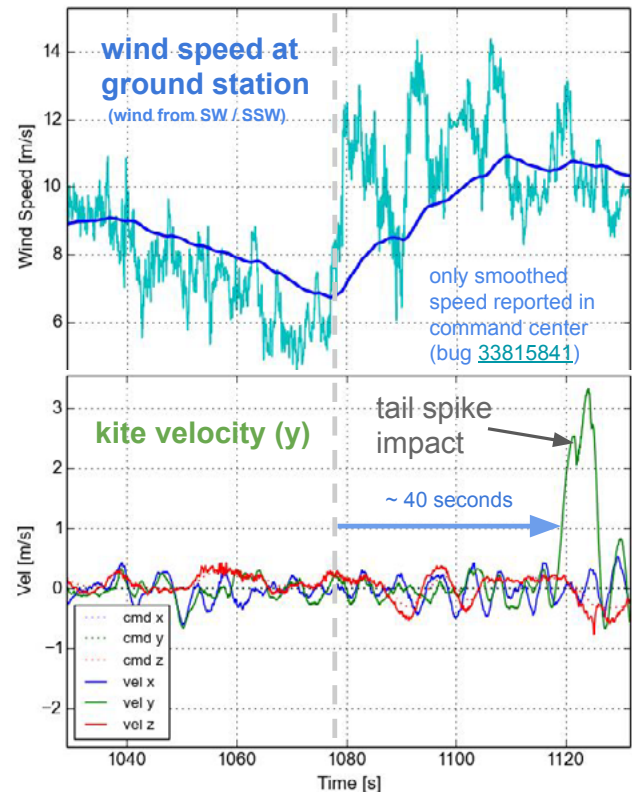
Loss of Tail Spike

While attempting to land on the perch, a sudden position excursion to starboard knocked off the tail spike.

This was due to a strong gust of wind. We felt the gust at the command center and intended to wait it out, but did not wait long enough.

t = 1067	"Big gust, big gust"	Tobin
1077	"Big gust"	Tobin
1082	"We might wait out this gust."	Johnny
1103	"I think I'm going to let it go, it looks fine."	Johnny
1119	Ascend! (Excursion starts)	Johnny
1122	Tail spike impact, "Tail spike's gone."

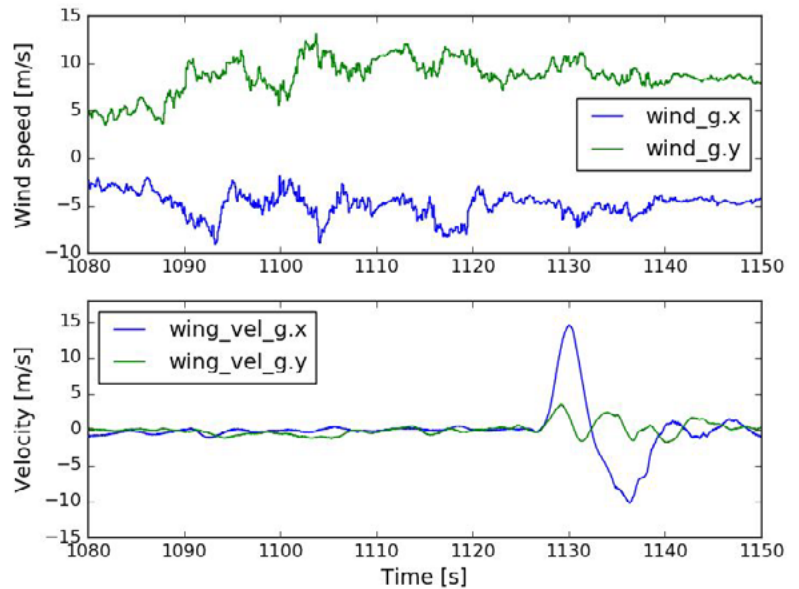
"Tail spike gust"

- Similar interval between gust and excursion (~40 s)
- Similar magnitude of y-velocity excursion (~3 m/s)
- Inconsistency: Large x-velocity excursion, which is opposite to wind direction. TODO: Why?

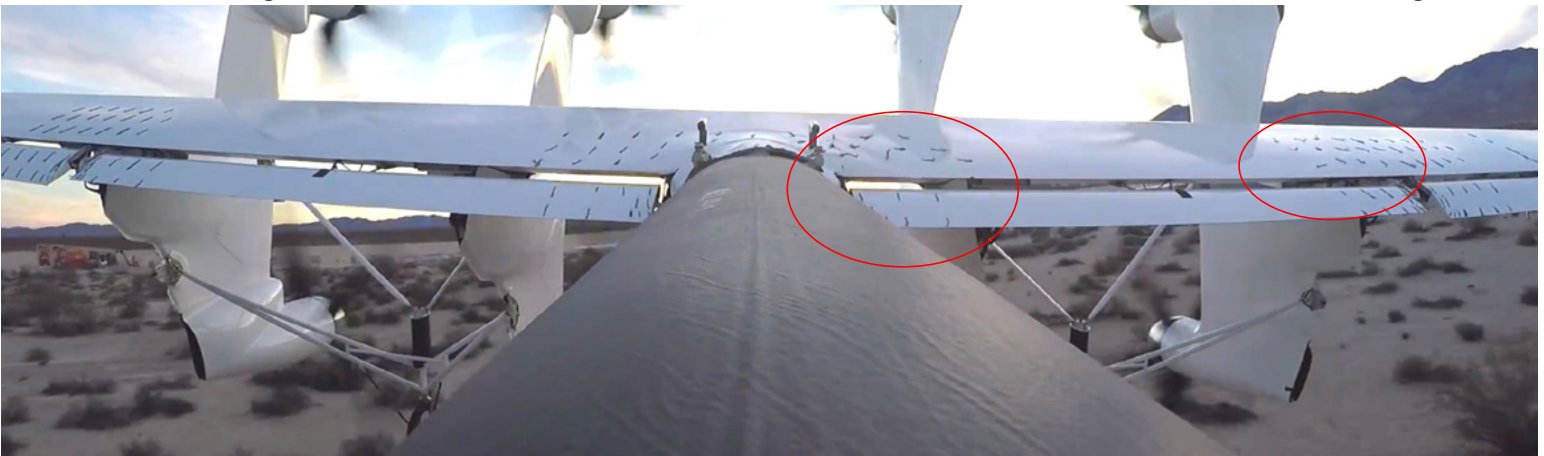
RPX-02 Glide Landing Tuft Videos

- Asymmetric Stall right before touchdown
 - TODO: What alpha and speed did that happen?
 - Does that match predicted stall speed/alpha?
- Worth noting that the starboard side of center is often the first to stall in CFD as well. Under investigation

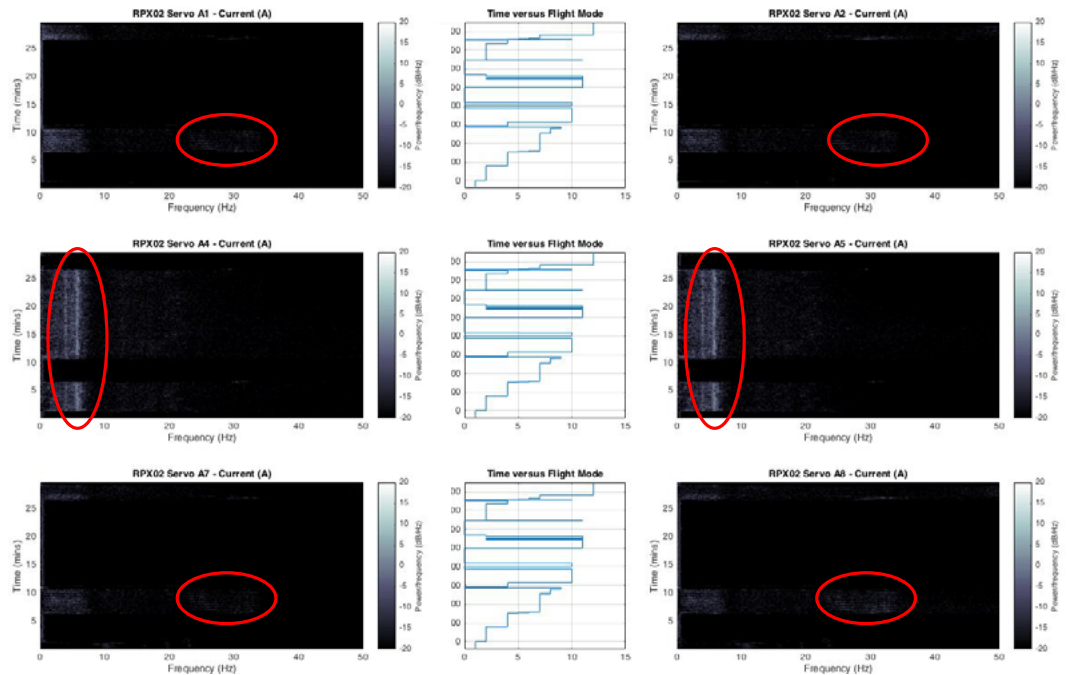
- A1, A2, A7 and A8 show noise in x-wind and off tether (signal oscillates between ~25 and ~35 Hz)
- A4 and A5 show noise in all hover modes (also have pronounced peaks at ~4 and ~6 Hz)

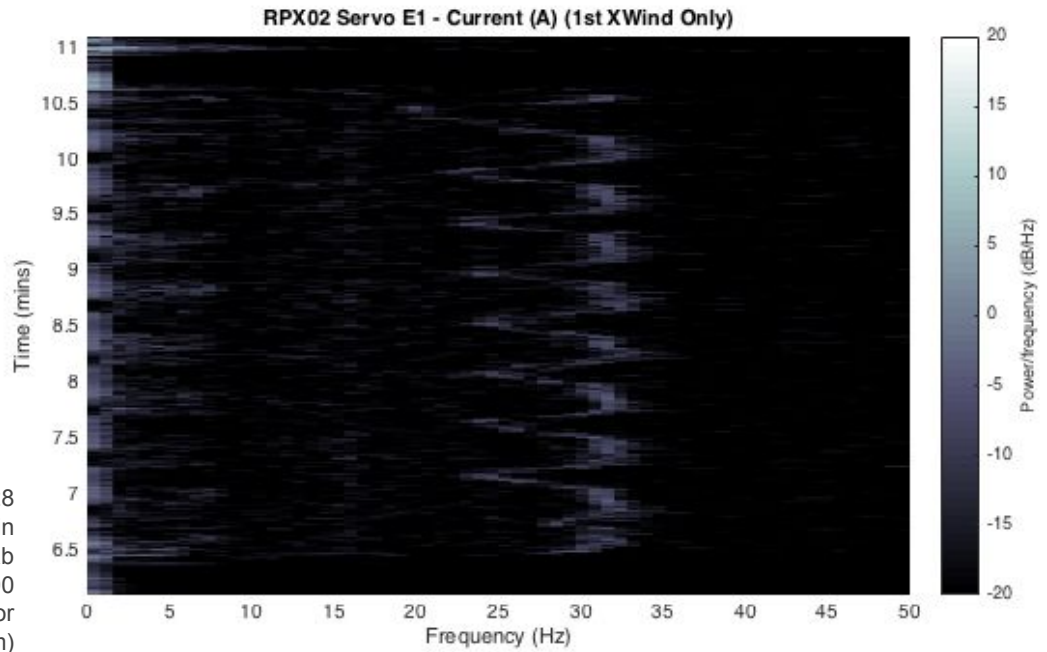
RPX-02 Servo Current Crosswind

- Typical high frequency content present in following servos in crosswind flight
 - Flaps - A1, A2, A7, A8
 - Elevator - E1 (shown), E2
 - Rudder - R1, R2

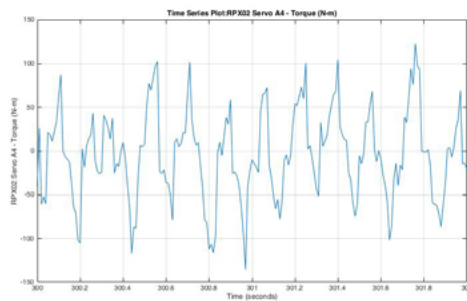
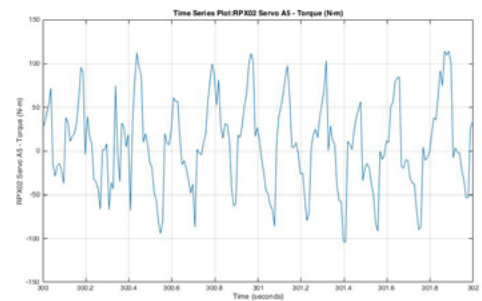
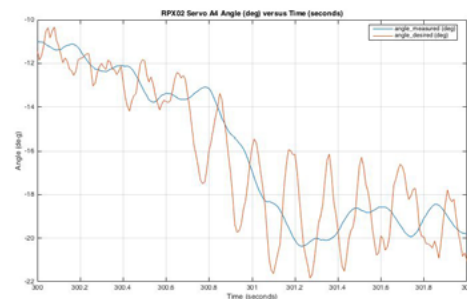
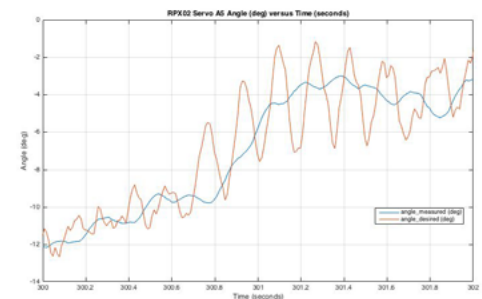
RPX-02 Servo Current Ailerons

- A4 and A5 hover noise
- (typical behavior)

- Are there plans to tweak servo controller to reduce this behavior?

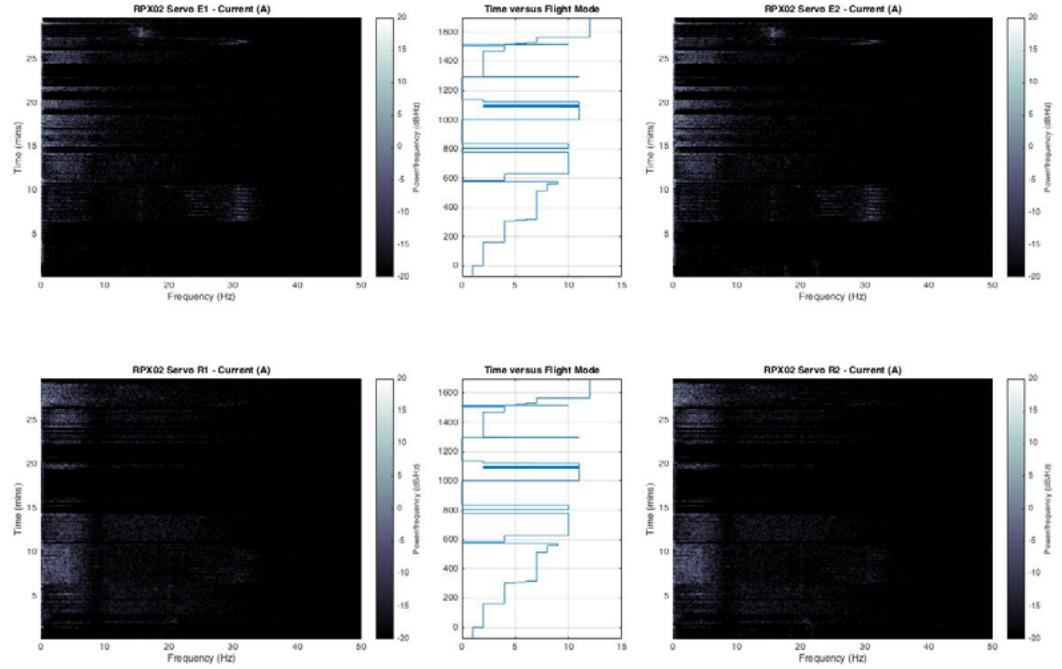
RPX-02 Servo Current Elevator & Rudder

- Elevator and Rudder show broadband noise in some flight modes and not others

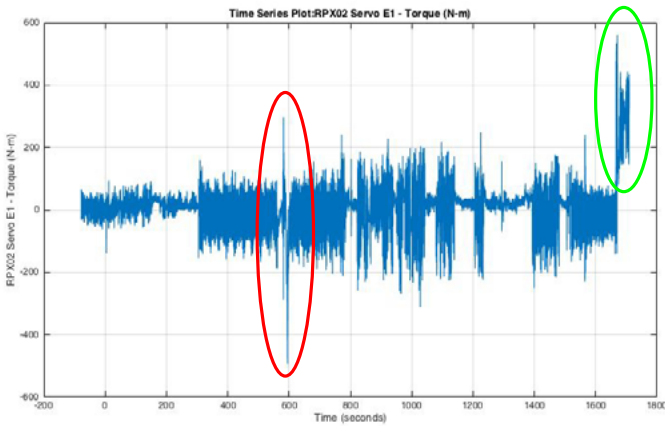
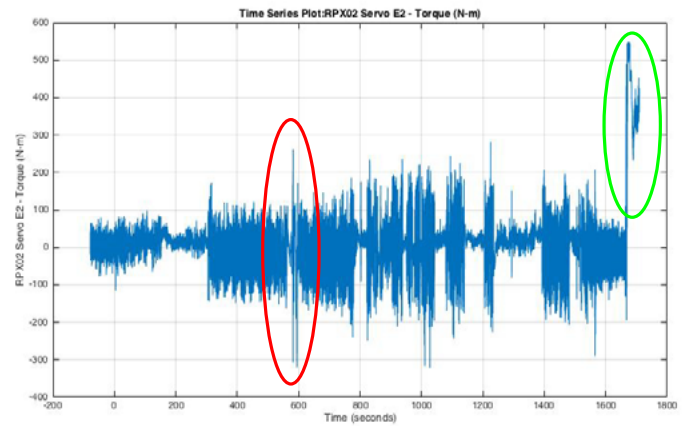
RPX-02 Servo Torques Elevator

- Elevator servo torque spike during **trans-out**
- Elevator dragging on the **ground**

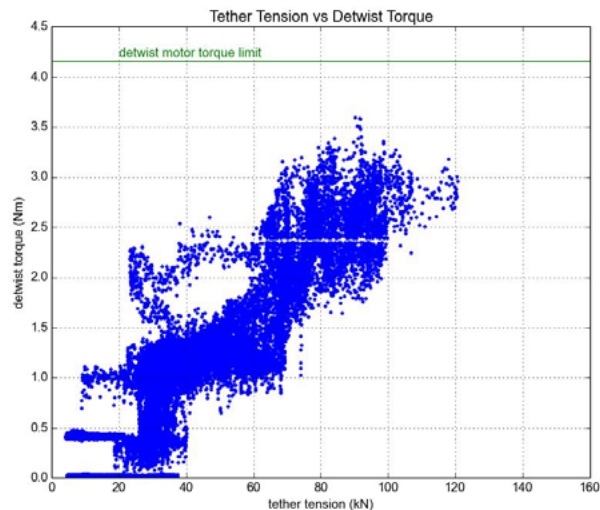
Detwist Torque

- High-load testing of detwist was skipped prior to RPX
- The torque required to rotate the detwist appears correlated with tether force
- At rated crosswind tensions the torque may exceed the gearbox limit of 4.16Nm
- Mechanical solutions are being considered

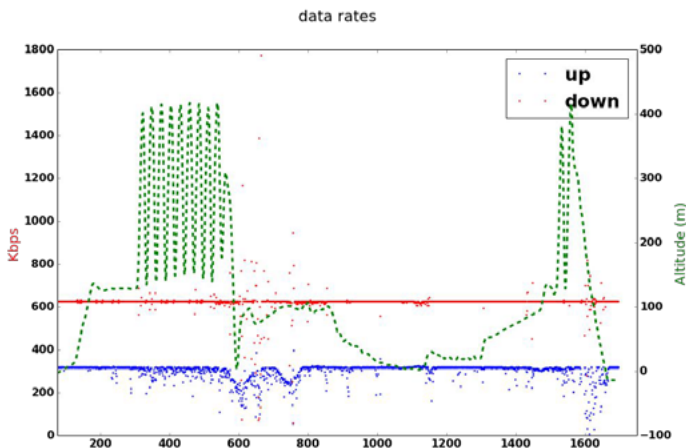
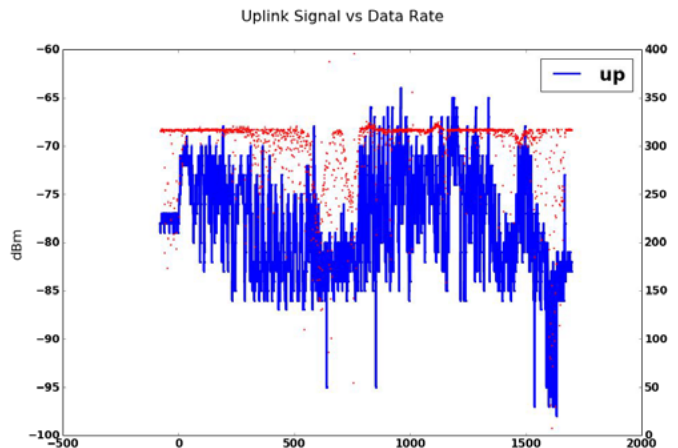
Joystick Radio - Packet Drops

- Correlated with RSSI drop.
- Asymmetry (up vs. down) may be due to antenna diversity being RX only.
- Worse near at the end of the glide than last flight
 - May have been difficult to control landing on only JS link.
 - No danger of triggering scuttle.

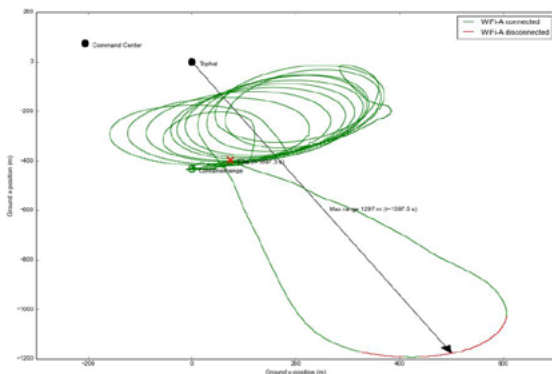
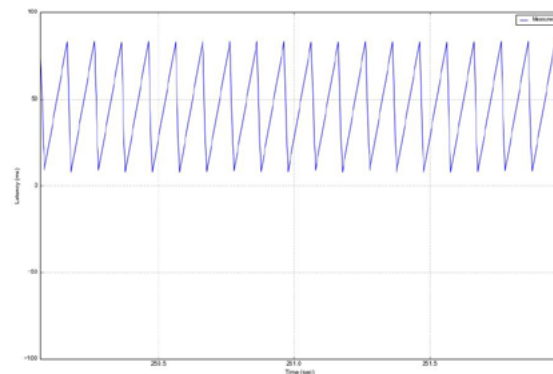
Wideband-A (Proxim) performance

- Proxim exhibits similar behavior as RPX-01:
 - Latency measurements vary between 2.5 ms to 90+ ms on downlink, and exhibit a periodic behavior (ControlTelemetry?) – this was solved in the birdcage post flight and due to the WORP sync feature
 - Lost comms for 13 seconds during glide landing (at similar distance as RPX-01)
- To do: Disable WORP sync on the Proxim radios at CL and limit SU units to 1

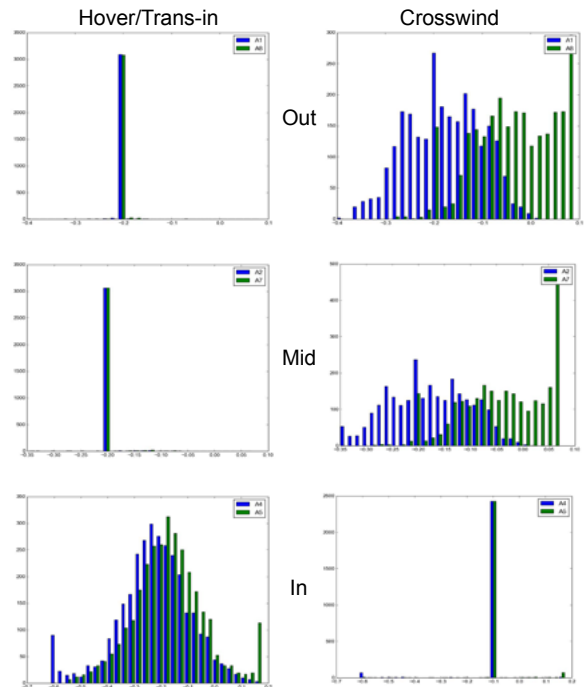
Ailerons

- Starboard out and midboard ailerons saturate in crosswind—may need more range in positive deflection.
- Inboard ailerons used over full range in hover, some saturation. Mostly unused in crosswind.

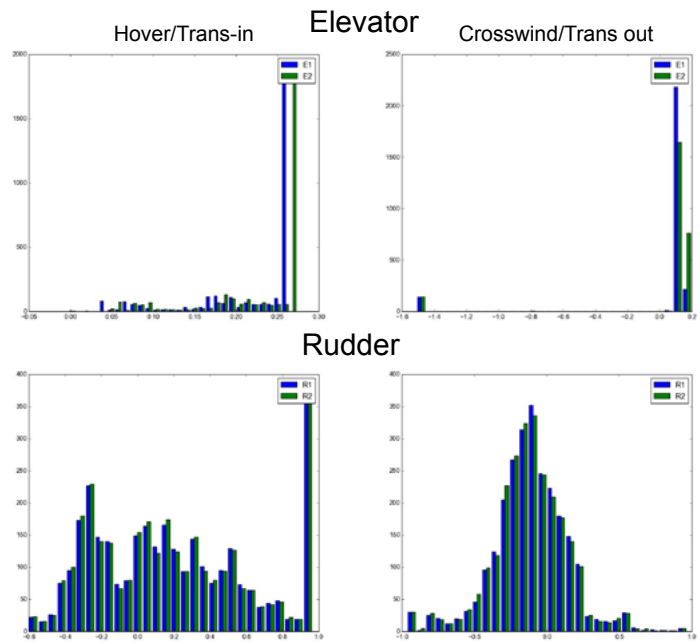
Flap Angular Positions

- Rudder saturates often with full positive (port) deflection in hover, likely due to crosswind takeoff configuration, usage is well distributed in crosswind.
- Elevator used over extremely limited range until trans out (then extensively slewing during recovery/pilot hover)

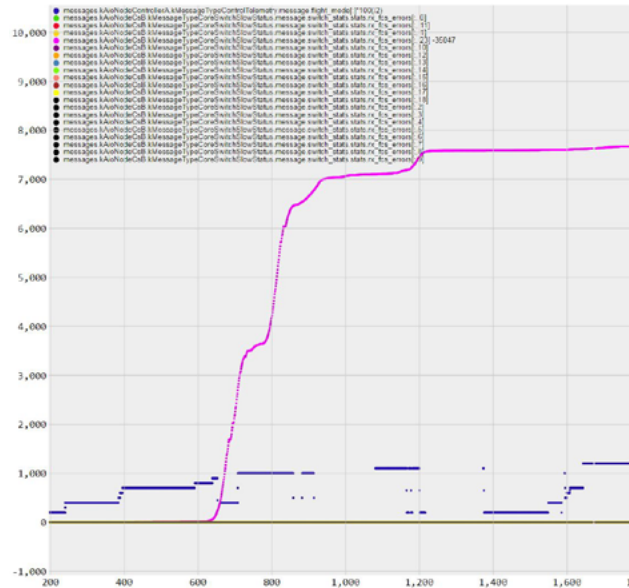
- No Frame Checksum errors in RX packets on the network *except* for port 23 on CSB, the JS radio.
- No dropped TX packets due to congestion

Frame Check Sum errors: only the JS radio accumulated errors

To Do: verify proper link setup between JS radio and CSB <http://b/33413959>

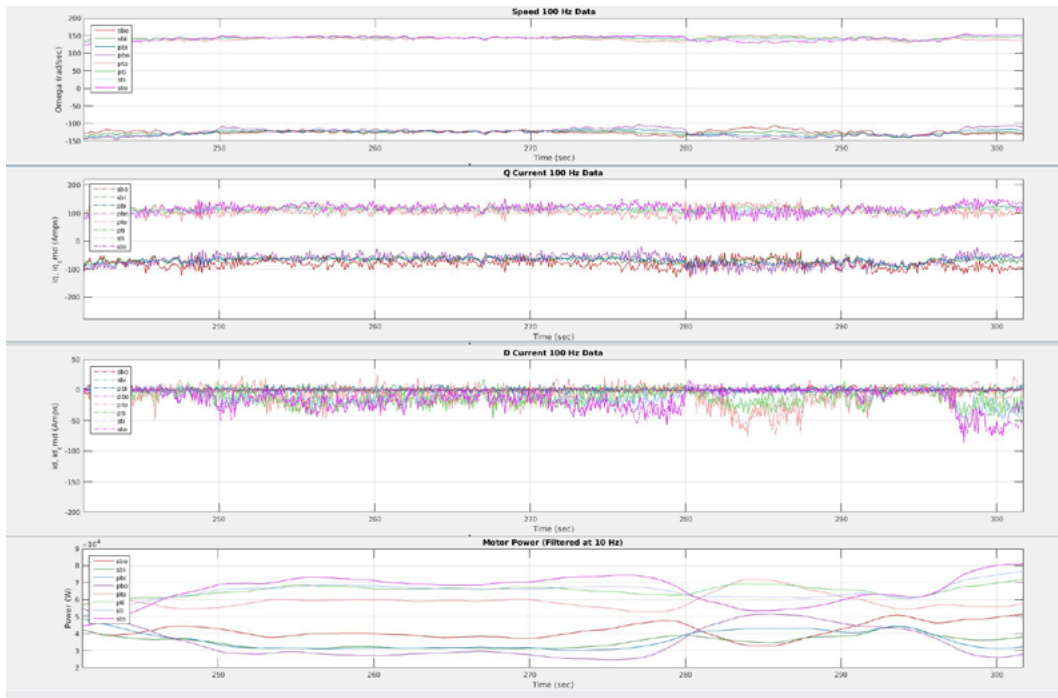
Hover detail

Still fighting against pitch-back moment

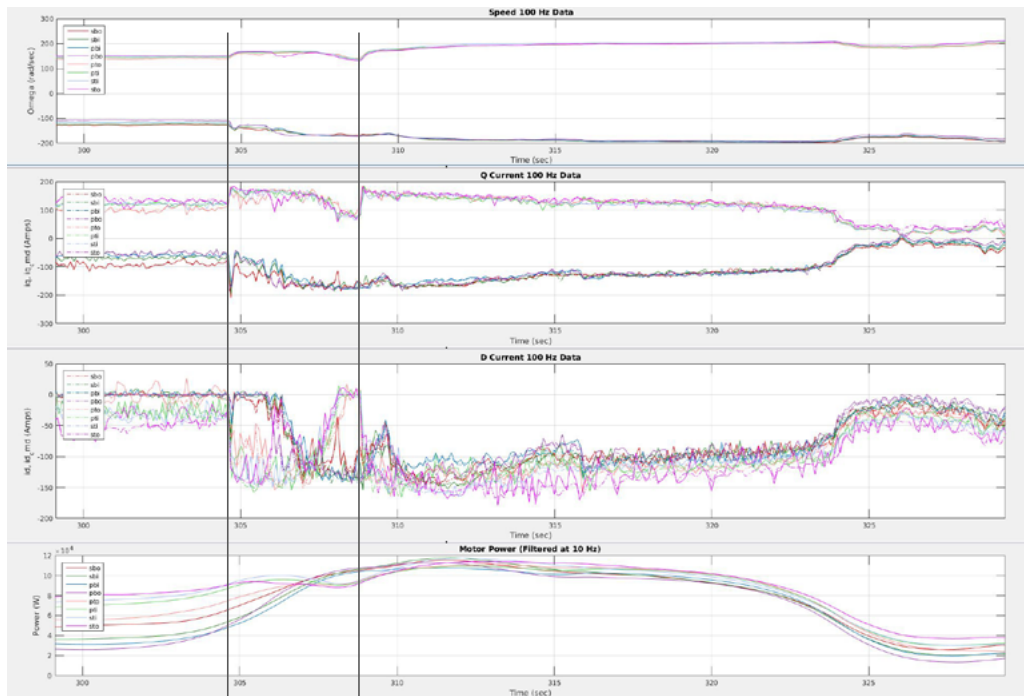
Trans-In Detail

All motors operating at or near controller current limit as flow attaches

At present limits of ground power

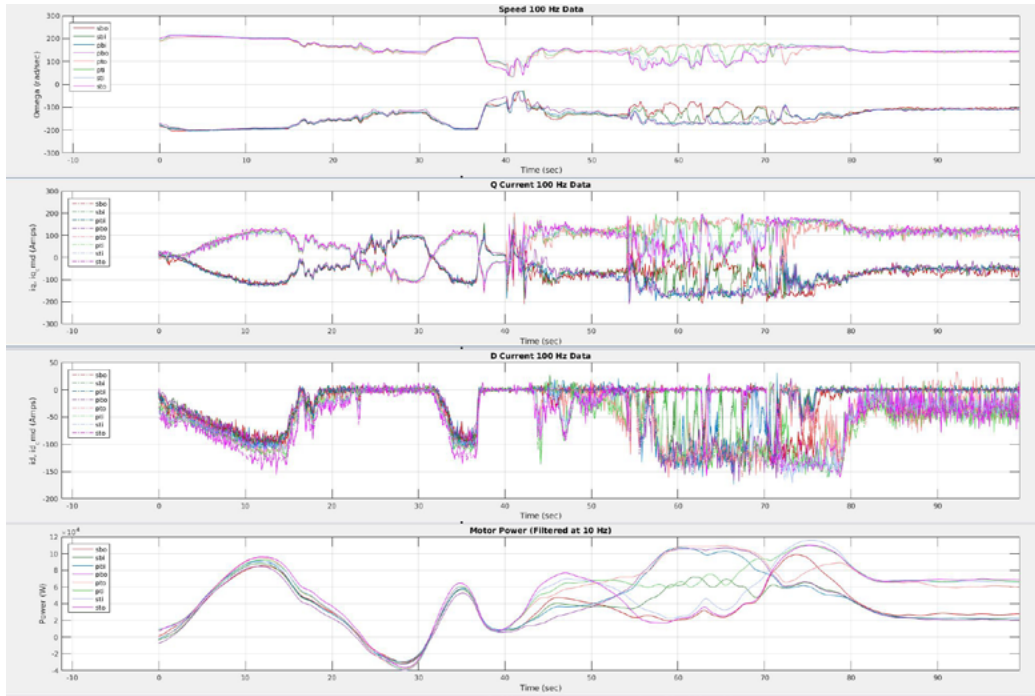
Trans-out detail

Rapid command fluctuations; can probably be improved

Battle between thrust and attitude during stationkeeping after trans-out

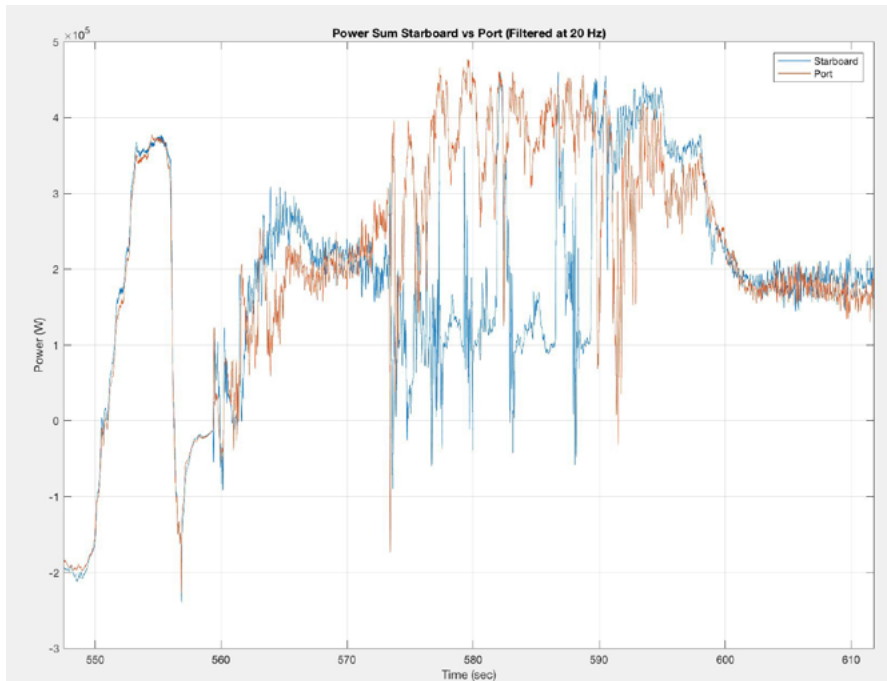
Port vs Starboard Power Diff during the Trans out fall

Large lateral difference in speed commands

Functional problem in hover tension controller at extreme roll angles

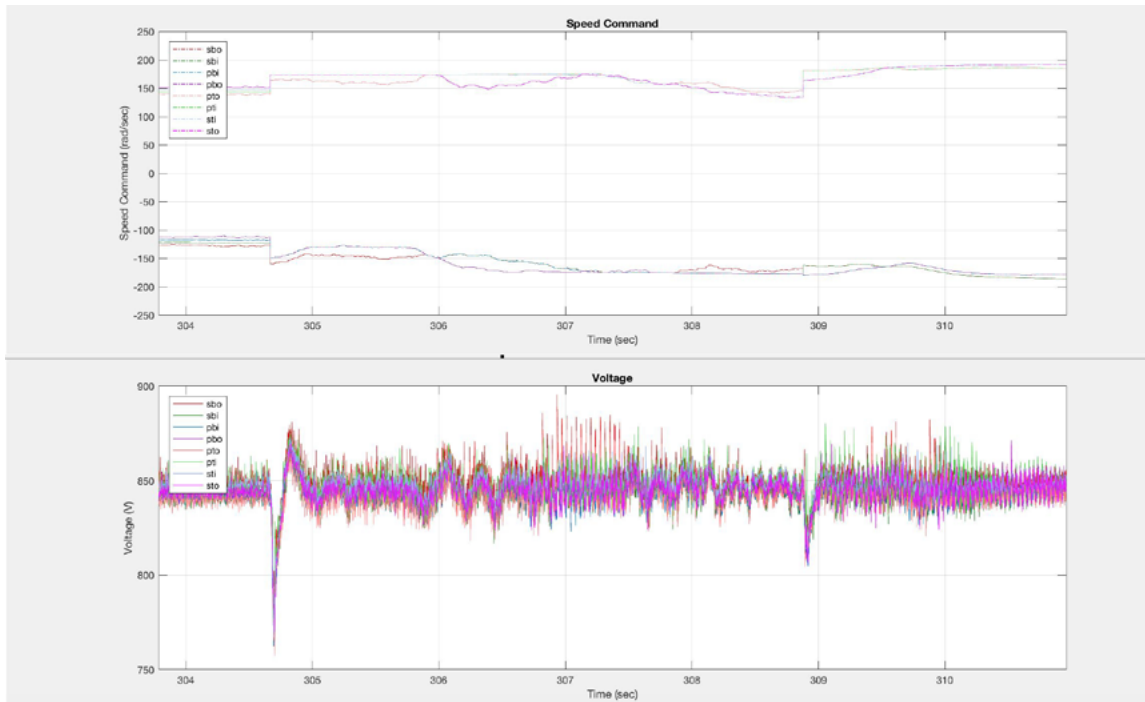
Command Discontinuities with mode-switches

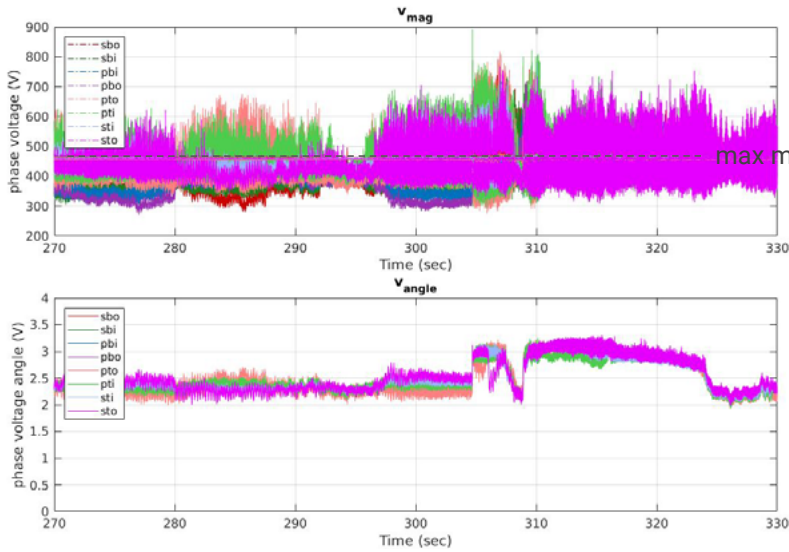
- Implementation notes:
 - Difference between pre-saturated and post-saturated terminal voltage is integrated to rotate i_d - i_q command.
 - Separate PI loops are used to control i_d and i_q in all operating conditions.
- Consistent 0.25 to 0.4 rad swing in voltage angle through all modes.
- Huge swings in pre-saturated phase voltage mag. when flux weakening
 - Consequence of poor current control.
 - Causes command to rapidly move back into the region of achievable (i_d , i_q).

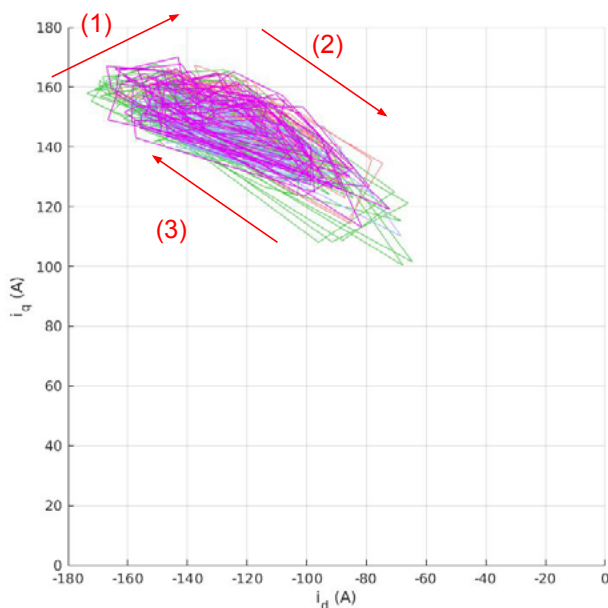
- Plot to the left taken over 0.2s of trans-in.
 - (1) Angle error causes true voltage angle to decrease $\rightarrow v_q$ increases $\rightarrow i_q$ increases and becomes unsustainable.
 - (2) i_q and i_d collapse while the FW command angle increases.
 - (3) Command becomes realizable (and probably over corrects due to integrator and reversing angle error), resulting in rapid recovery.
- Working theory for poor control:
 - When not flux weakening, (fast) i_d and i_q PI loops are able to reject dq-frame angle errors and control phase current well.
 - When flux weakening, extra phase lag is introduced from FW angle integrator and behavior deteriorates as described.
- Known issue, but surprisingly bad during flight.

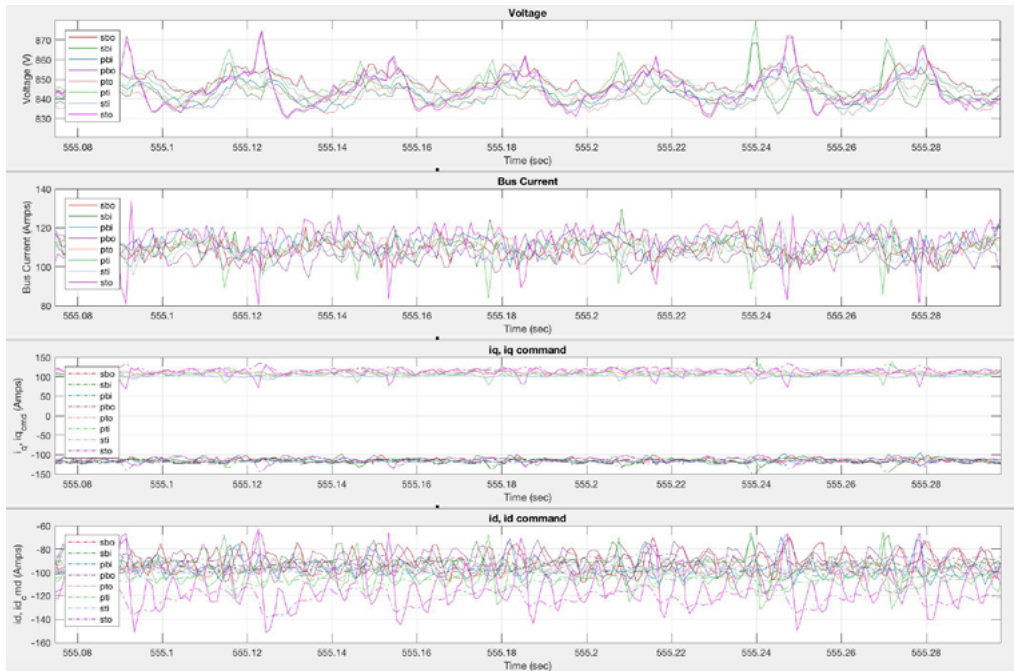
Stacking (All motors in flux weakening)

More bus voltage variation

Sync'd in pairs

At mechanical frequency

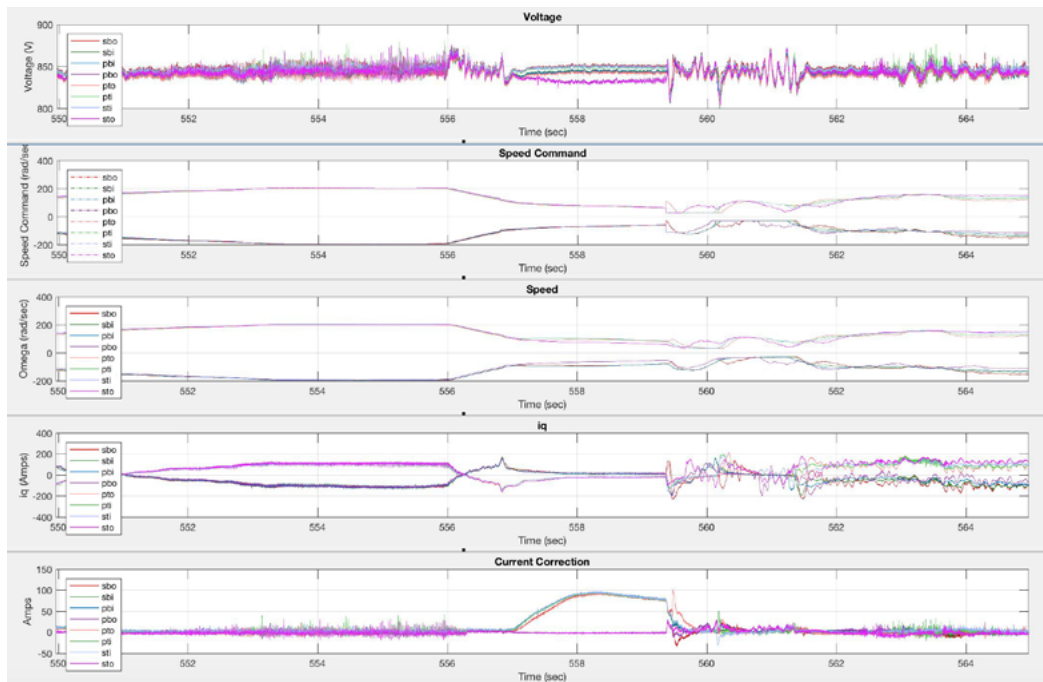
Largest Stacking Correction - Trans Out

SBO and PBO end up at lower speed while stacking controller has to bump up other speeds to keep power balanced.

Bit of a mystery why that command needed such a strong correction.

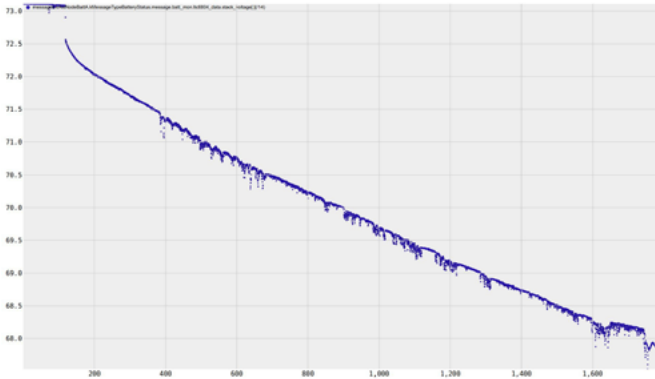
For this flight, we flew with big box only (no small box connected to the bus -- no redundancy) because both small boxes at CL were over-discharged (new board rev to be added before next crosswind flight will eliminate the cause of this issue).

Big box discharged from 73V down to 68V over course of test (still mid-charge).

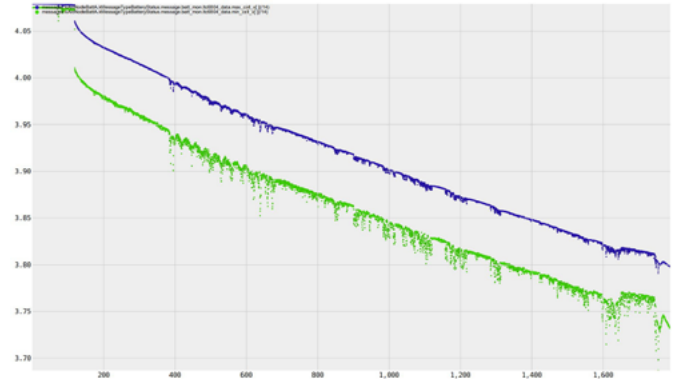
Min and max cell voltages over time.

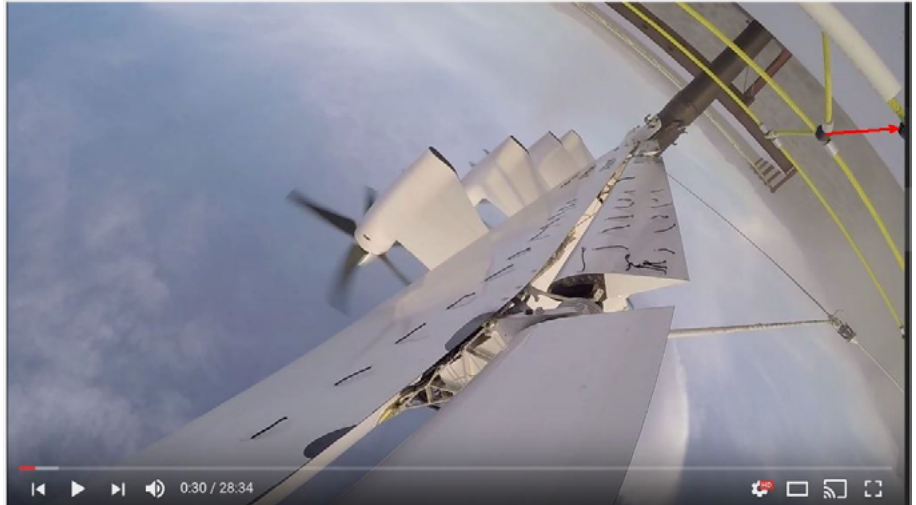
Port net damage during launch

- Rapid radial motion caused high energy impact into rear cable of net, breaking connector on inboard end of cable

Action pending full inspection of nets:

- Best case
 - Fittings are sacrificial and replaceable
- Worst case
 - Cables are damaged and stronger replacements must be sourced

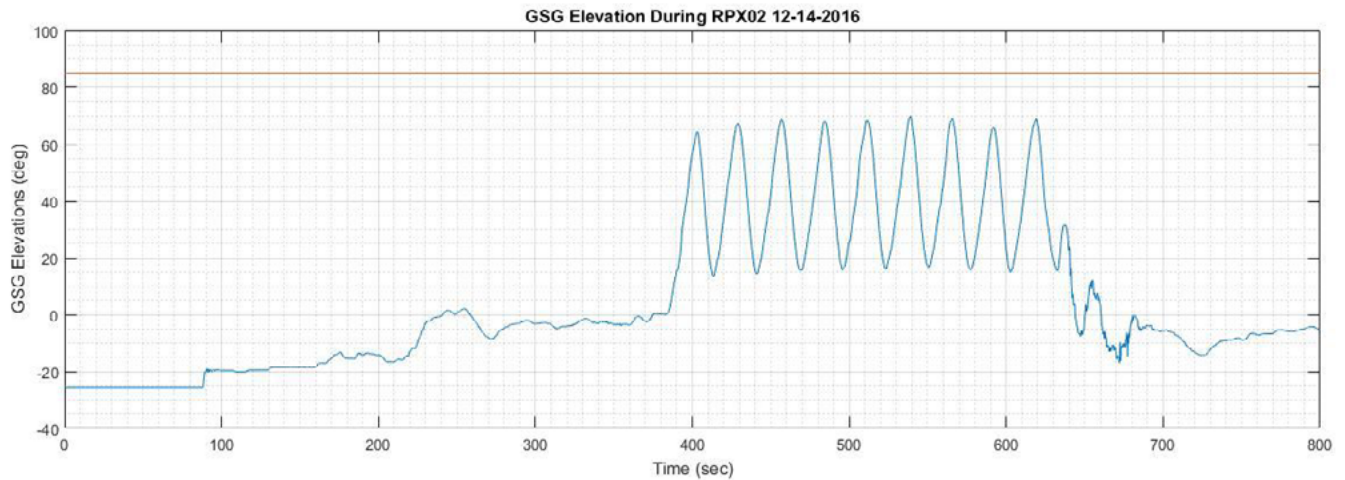
- Hard limit at 85° due to physical limitation of the Elevation Head range of motion
- Maximum angle achieved approximately 70°
- Motion in line with expectations - no concerns

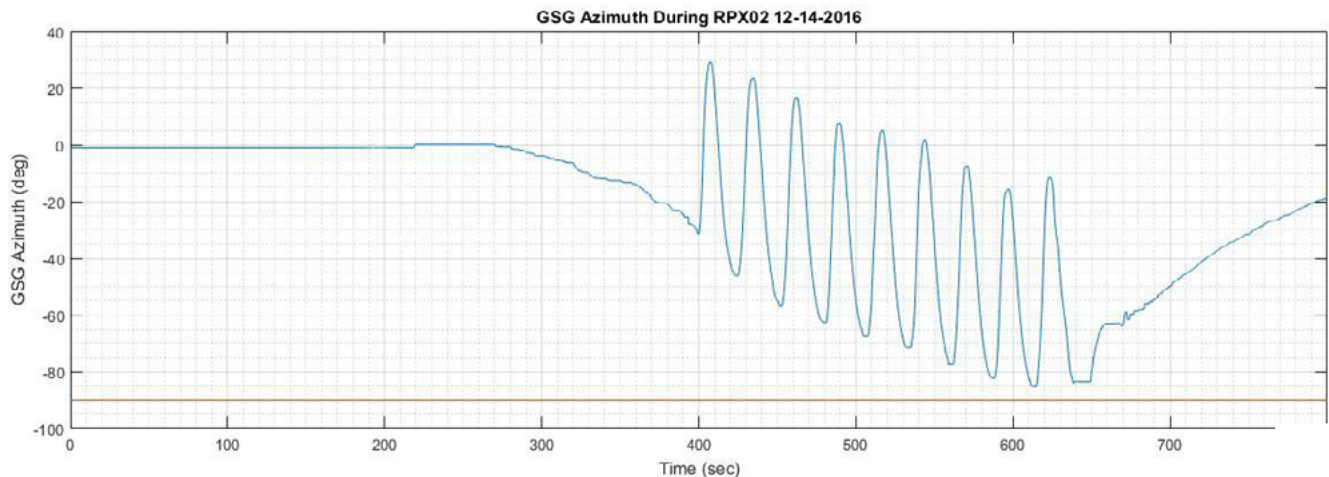
Azimuth

- Hard limit at -90° due to interference with the wind mast and cable tray
- Maximum azimuth motion was within 5° on its last loop, bug 34176608 initiated to prevent exceeding this and to investigate potential to open this window further - see video from last loop in "20161214 RPX-02 - Groundside Gimbal & Tether Attachment" on [YouTube playlist](#)
