The Energy Kite

Selected Results from the Design, Development and Testing of
Makani's Airborne Wind Turbines

Part III, Technical Artifacts

Selected Decks From RPX Lessons Learned Reviews

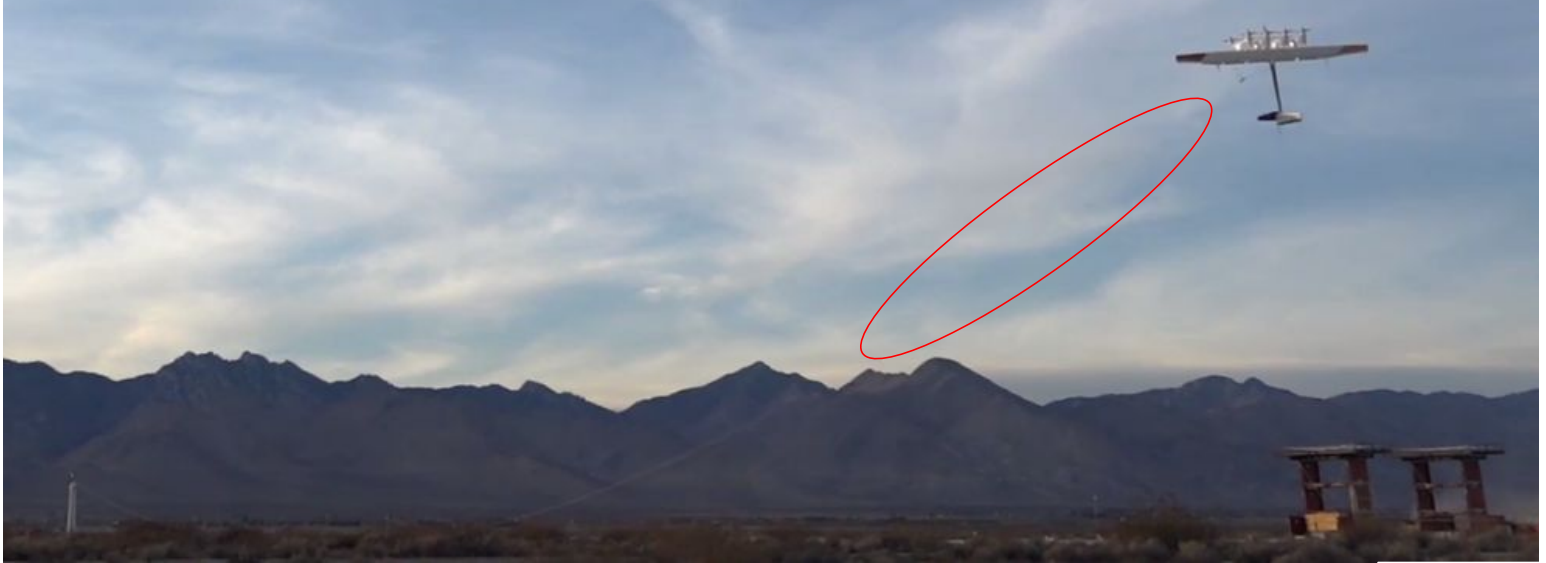
Twist and Torque induced by tension

- We would normally expect about peak torque of ~ 13 Nm in the SW3 tether at 30 C and 140 kN, but with 20 RH twists it should be ~ 21 Nm.
- \rightarrow almost double the torque

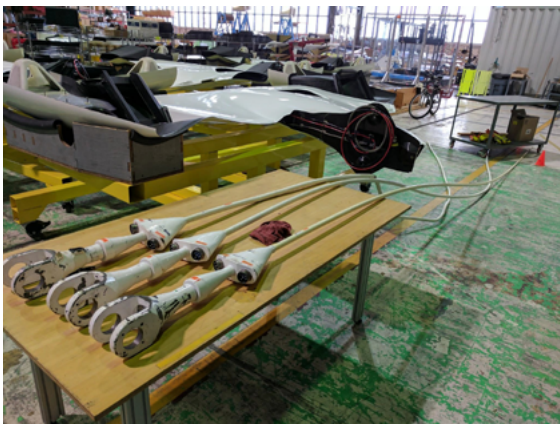
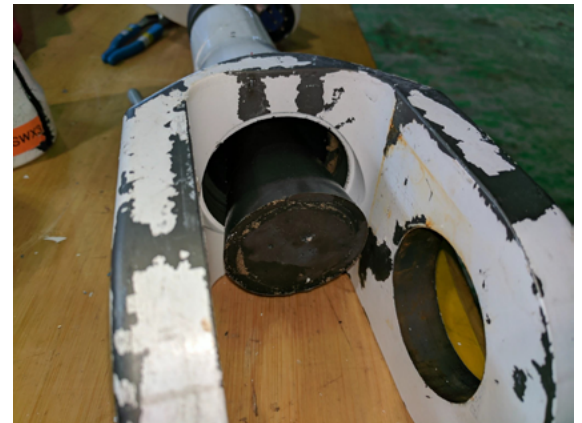
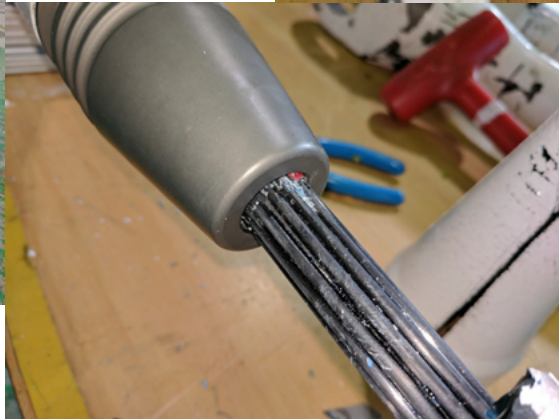
Tether SW3-02 post flight inspection

- Post RPX-02 Inspection document
- At GS termination, nothing unusual/worrying

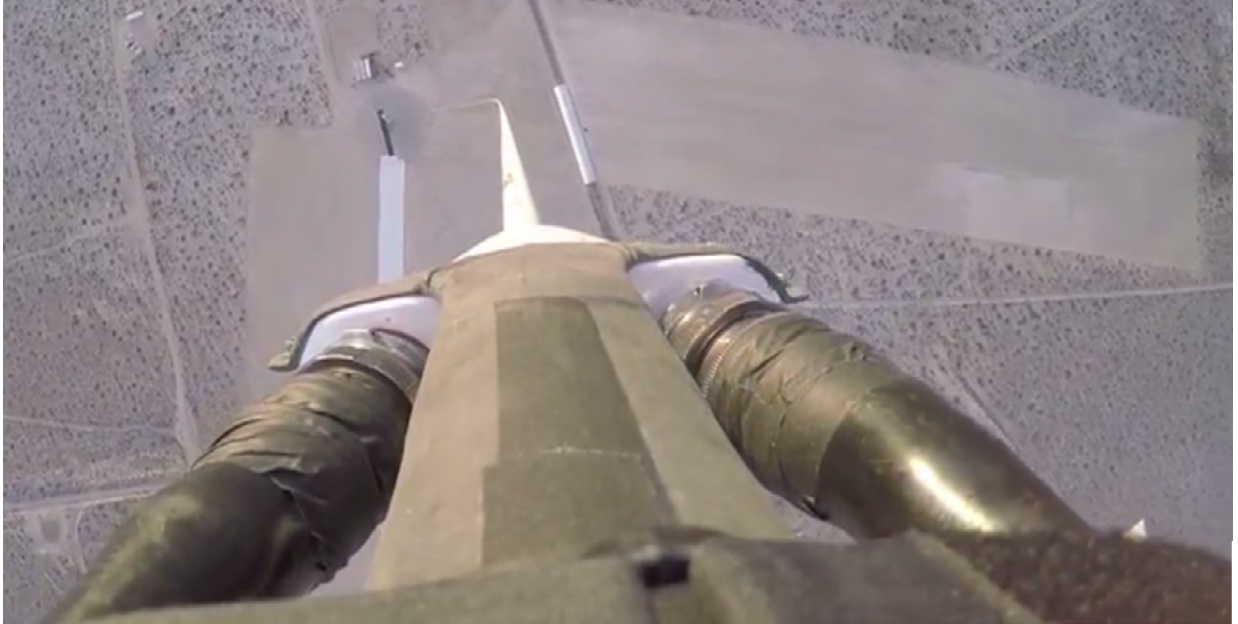
Tether strumming

- *No video or audio evidence of strumming in crosswind (yet)*

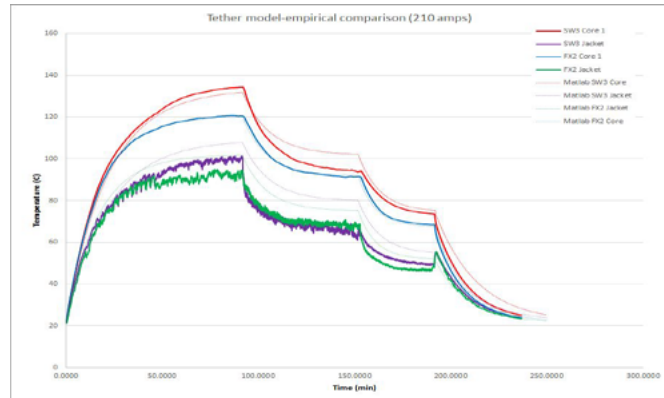
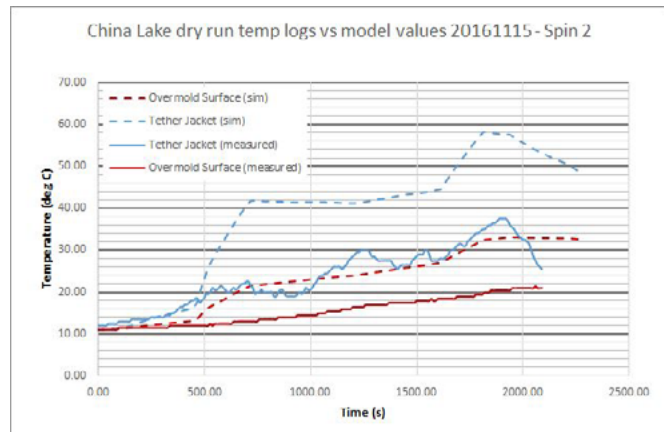
Thermal Model Comparison

Comparing the thermal model to bench test values shows reasonable fidelity (top).

Dry run data from China Lake shows large discrepancies (bottom), reasons currently unknown (possibly thermocouple placement). Fortunately the discrepancy is conservative

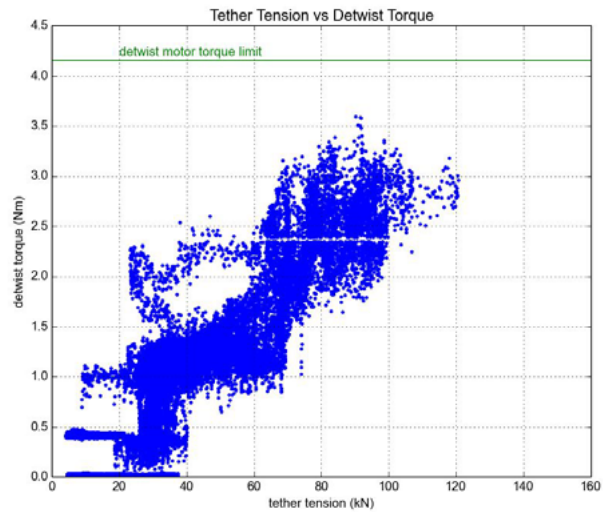
Detwist Torque

- High-load testing of detwist was skipped prior to RPX
- The torque required to rotate the detwist appears correlated with tether force
- At rated crosswind tensions the torque may exceed the gearbox limit of 4.16 Nm
- Mechanical solutions are being considered

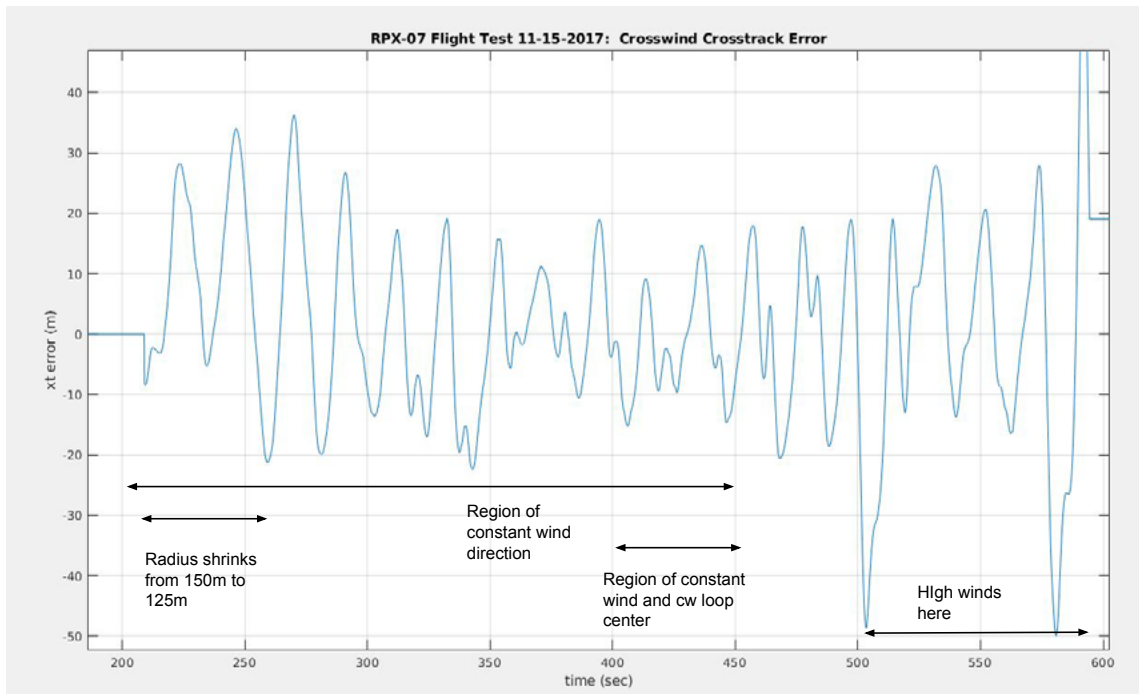
RPX-07 Crosswind Crosstrack Error

- Errors are outside the commanded radius on the downstroke
- Error are generally inside the commanded radius on the upstroke
- Some of this error is due to aileron saturation
- Some error is due to incorrect tether roll feedforward command (off-nominal operations)

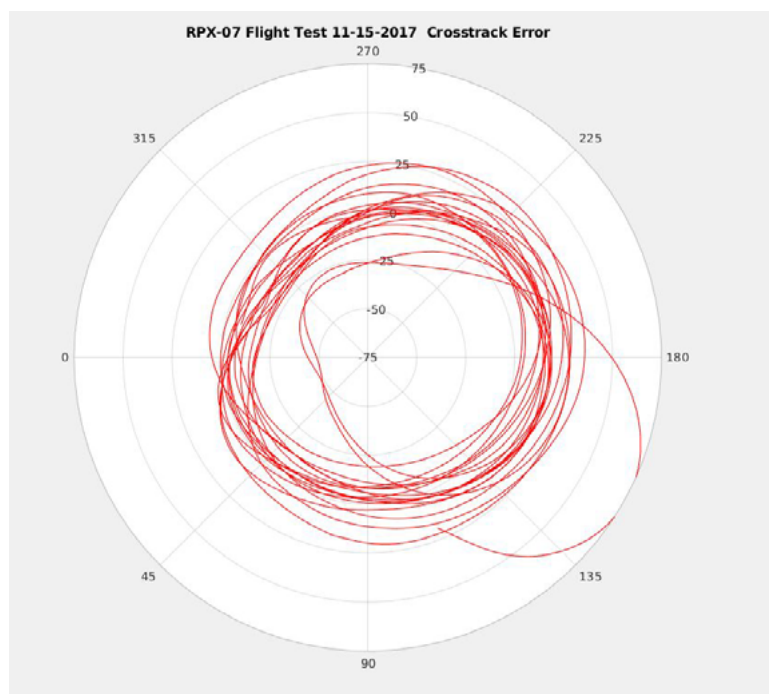
RPX-07 Crosswind Crosstrack Error

- The tether roll angles fairly well followed the commands until the wind increased at about 450 sec.
- The tether roll error was very large (20 deg) in the high wind regions.

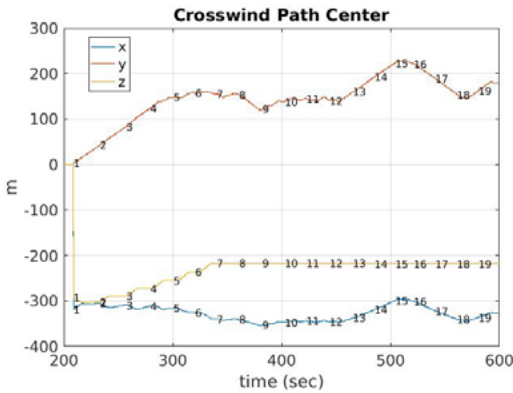
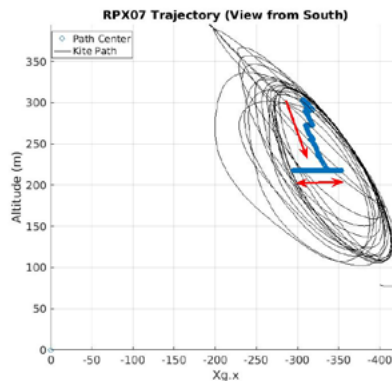
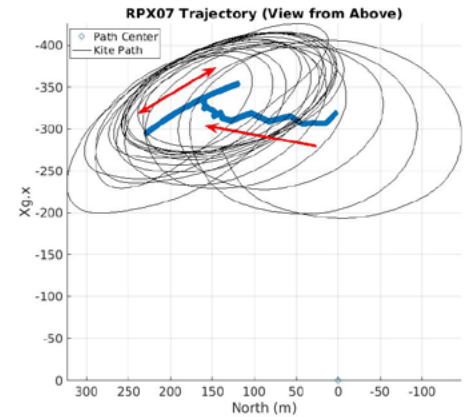
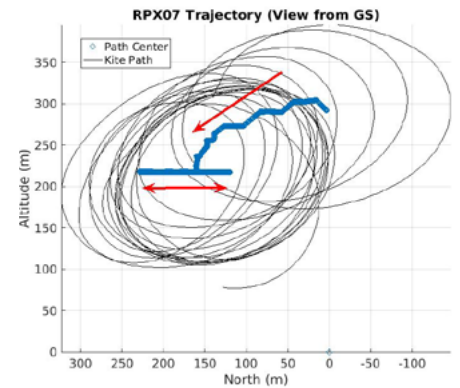
RPX-07 Crosswind Path Center Slewing

- Crosswind circle plots tell a deceptive story.
- The crosswind plane moves in order to track the wind.
- Max travel per loop: about 40 m laterally, 25 m vertically

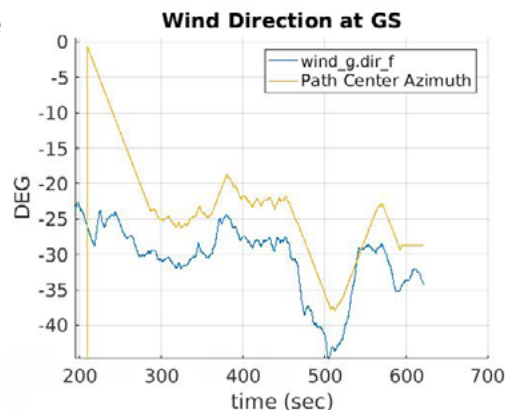
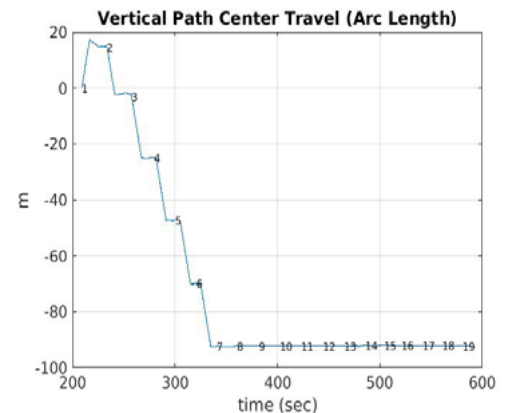
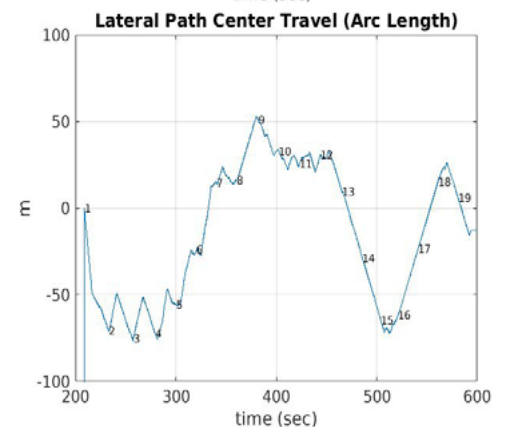
RPX-07 Crosswind Path Center Slewing

- Vertical position moves at the beginning of each loop, then plateaus. After loop 7 it is constant.
- Lateral position moves for every loop except 10, 11, 12.
- The azimuth of the path center tracks the azimuth of the wind
 - This is by design
 - Consider slowing the max slew rate
- Our "worst" loops are those where the path center changes direction (15, 18 especially)

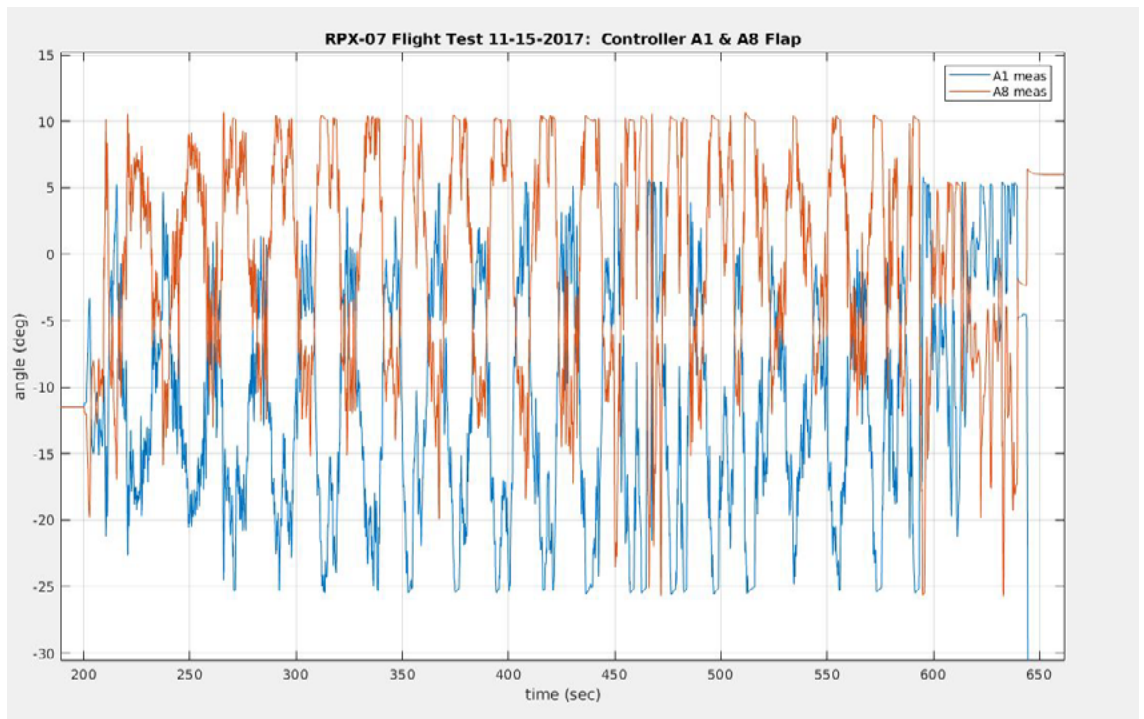
RPX-07 Crosswind Ailerons

- The right outer aileron saturated on most loops.

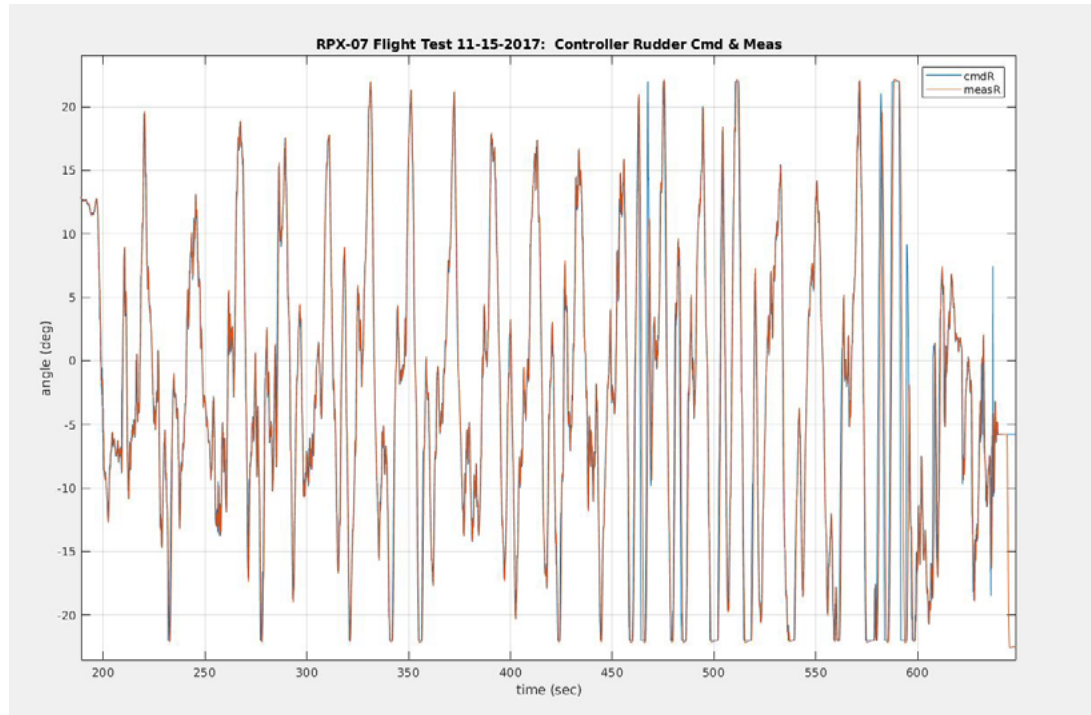
RPX-07 Crosswind Rudder

- The rudder began saturating when the wind increased around 450 sec.

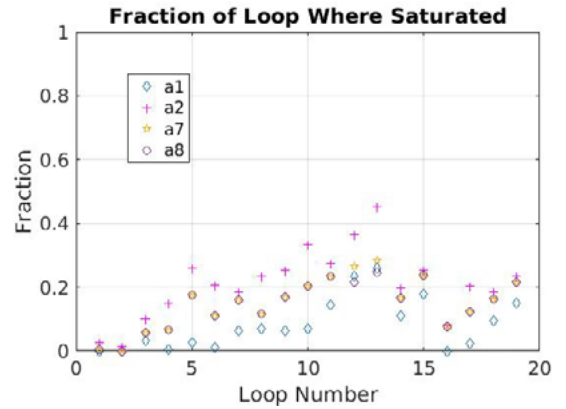
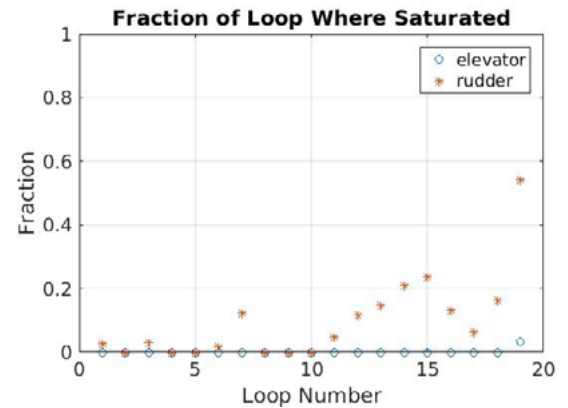
RPX-07 Crosswind Actuator Saturations

- The kite regularly saturates its ailerons (high and low)
- Rudder saturations are more frequent later in the flight at higher wind
 - Motor steering is helping the rudder
 - It would otherwise be worse
- Elevator only saturates on Loop 19 just before we release

a1	7.8%
a2	20.7%
a7	14.4%
a8	13.9%
elevator	0.1%
rudder	8.5%

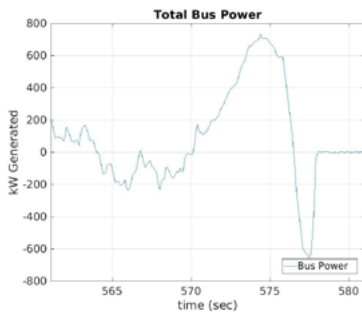
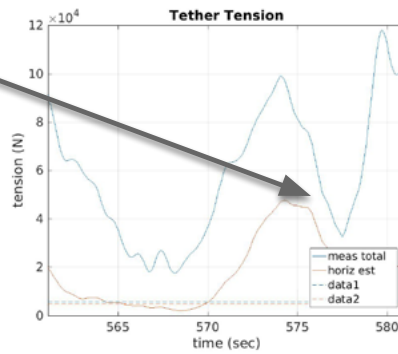
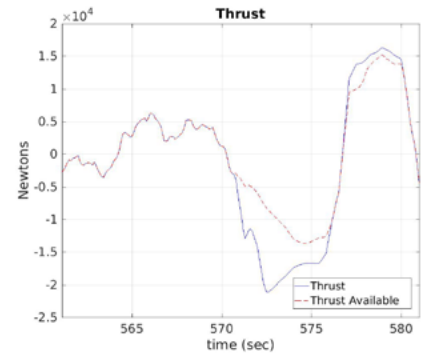
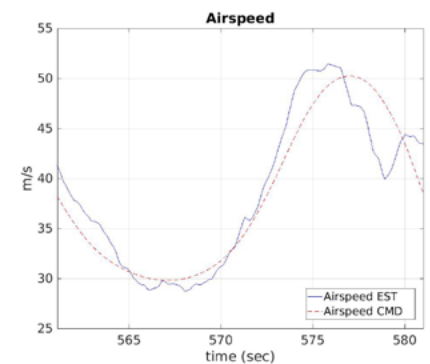
RPX-07 Crosswind What Happened on Loop 18

- We made the ground power station angry because
- We requested huge swings in thrust because
- Our airspeed error swung from + to - to + quickly because
- We flew a poor loop during which we saw
 - Big sideslip followed by
 - Drop in alpha
 - Drop in tether tension

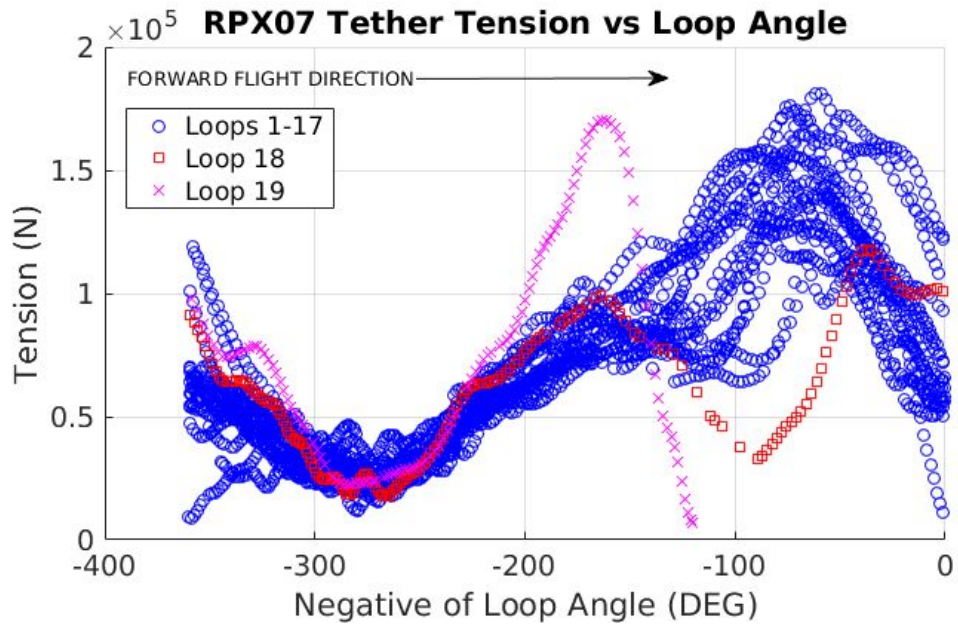
RPX-07 Crosswind What Happened on Loop 18

- The tension event on loop 18 was “unique” in that it was the worst example of something that only sometimes happens
- These low tensions on the downstroke have large tether pitch angle changes associated

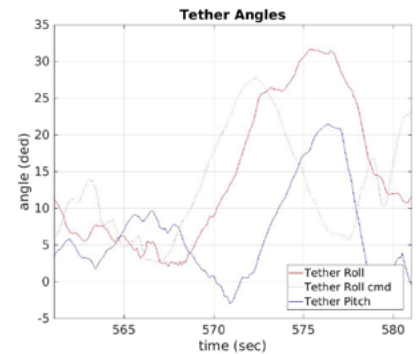
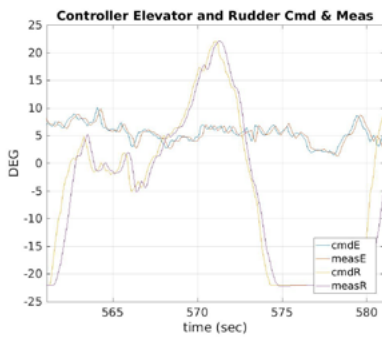
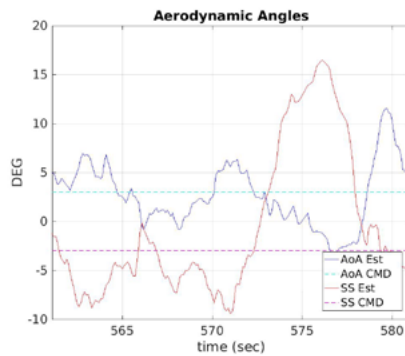
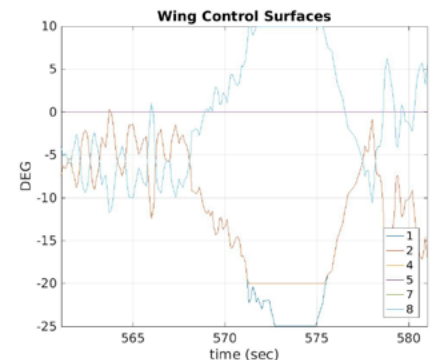
RPX-07 Crosswind What Happened on Loop 18

- Really bad aileron saturations on this loop
- Leads to large tether_roll errors
- We also saturated the rudder very badly
- Leads to large beta (during which alpha drops)
- Followed by large alpha (this is a theme)

Path center slew changed direction during this loop (max rate on both sides of the change)

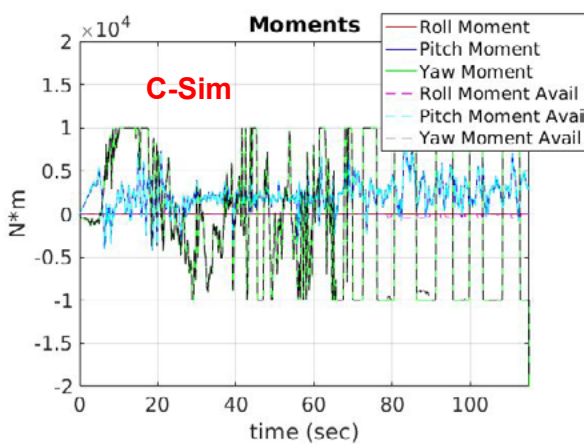
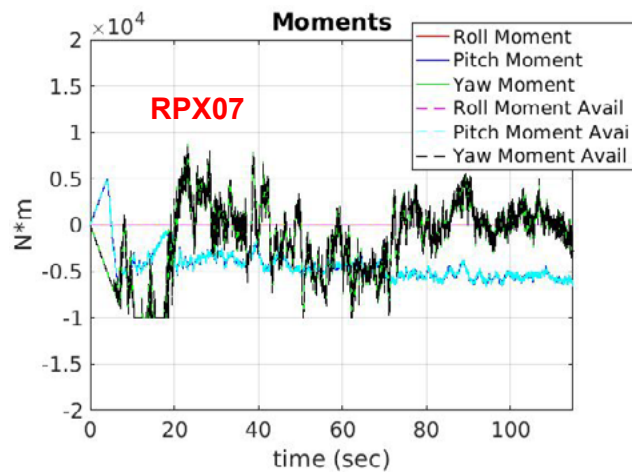
RPX-07 Hover Ascend

- Sim has rotor yaw moment saturations leading to limit cycle oscillations
- Not seen during flight test
- Incorrect prediction of total aerodynamic moments on the kite in hover
 - Notice the wrong sign on the pitching moment

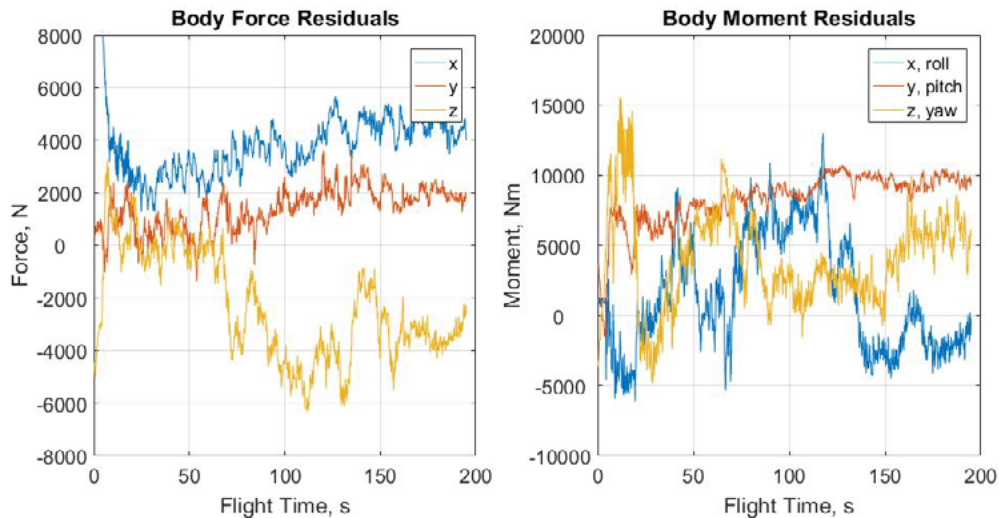
RPX-07 Hover Ascend & Hover Full Length

- Residuals = what we think the models (or measurements) are missing
- We have unaccounted for:
 - Pitch-back moment (+y)
 - Upwards X force (-weight, +rotor thrust, -tether tension)
 - Backwards Z force (+kite drag, -tether tension)

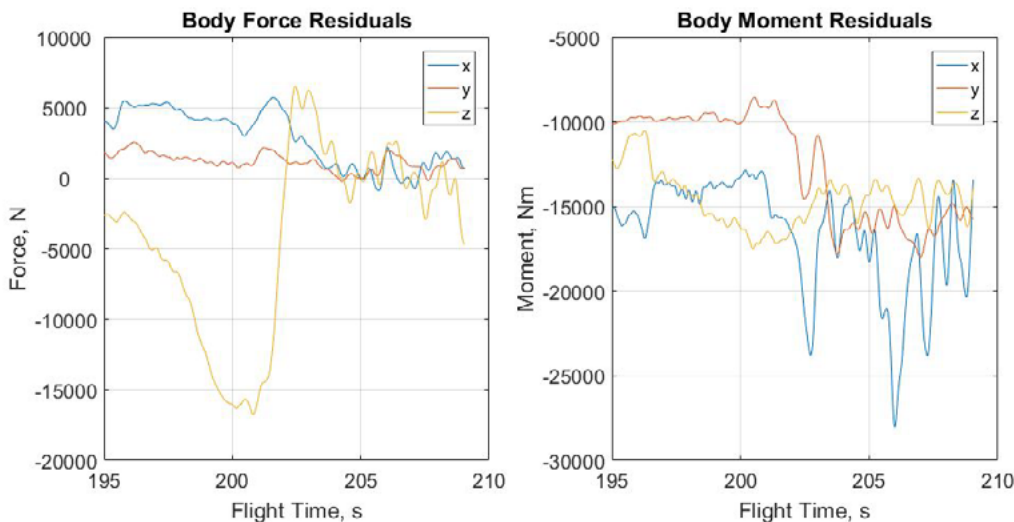
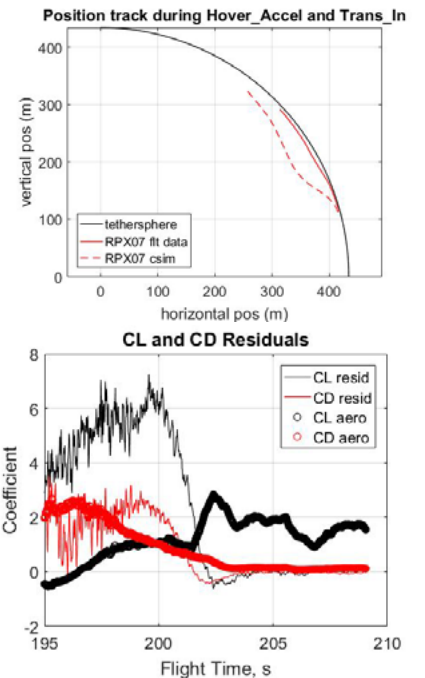
RPX-07 Hover Accel & Trans In

- At start of Hover Accel, same residuals as at the end of hover
- Then, large -Z force residual develops (missing a large force pinning us to the sphere)
 - This cannot come from excess rotor thrust, due to geometry
 - Airspeed estimate at the peak is approx 12 m/s
- At the peak, aero models predict $CL = 1$
 - Missing lift force is equivalent to an extra +6 CL

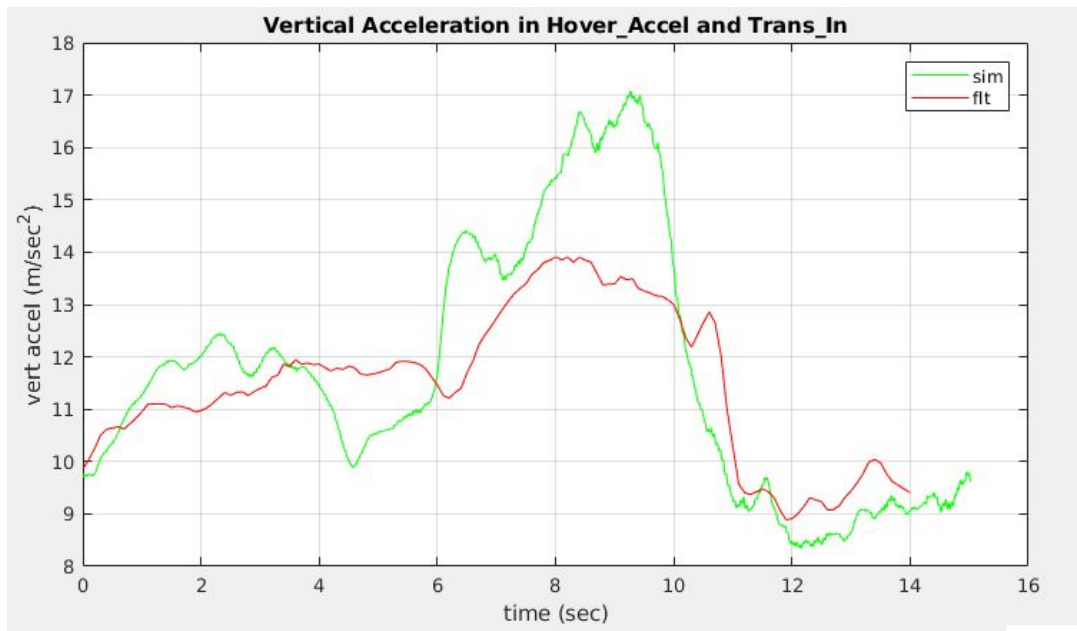
RPX-07 Hover Accel Vertical Acceleration

The vertical accel is greater in the sim than in flight.

The opposite was true in rpx-02.

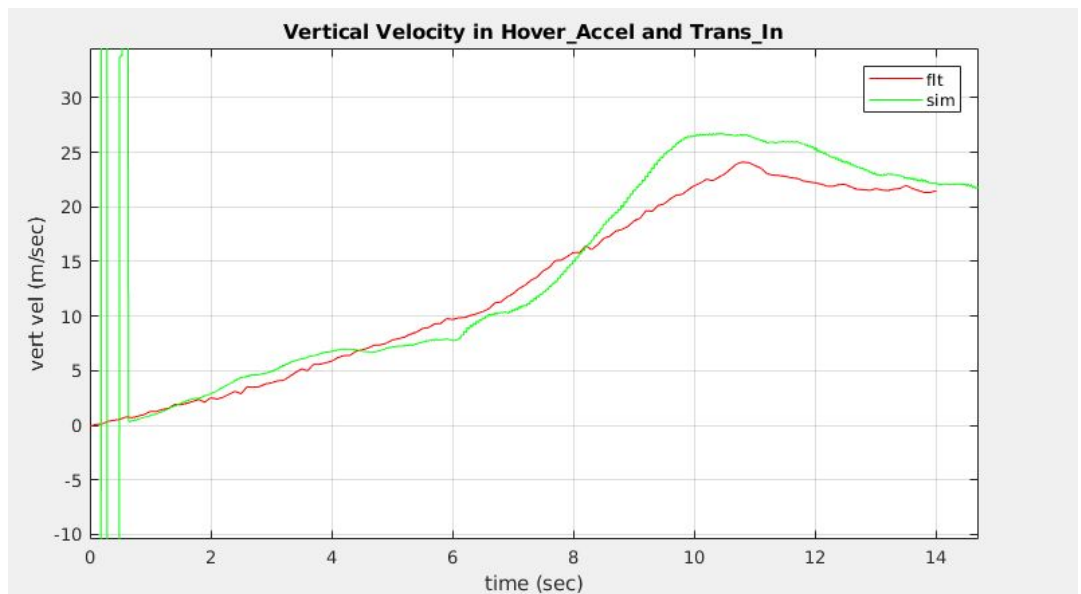
RPX-07 Hover Accel Mode: Vertical Velocity

The vertical accel is greater in the sim than in flight.

The opposite was true in rpx-02.

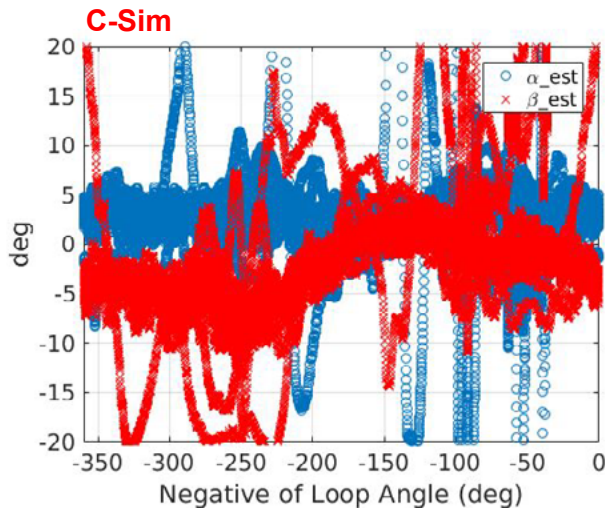
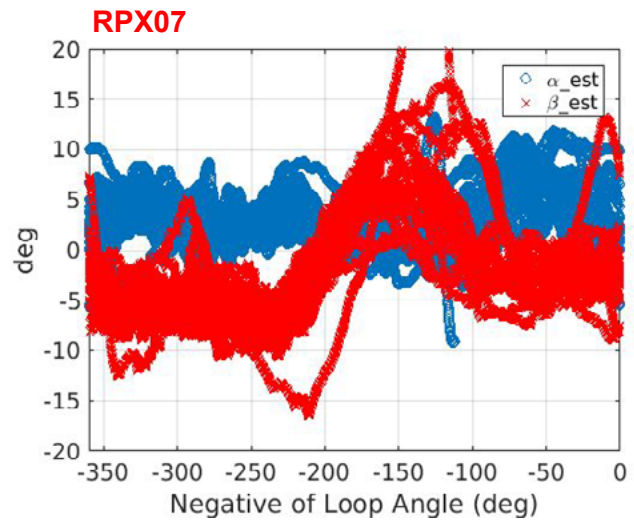
RPX-07 Crosswind Aerodynamic Angles vs Loop Angle

- The general trend of beta excursions around the loop is predicted
- Sim underpredicts the size of the once per loop swing from - to +

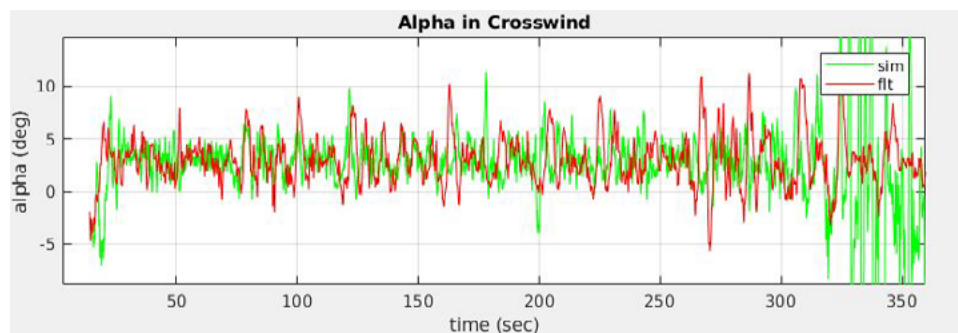
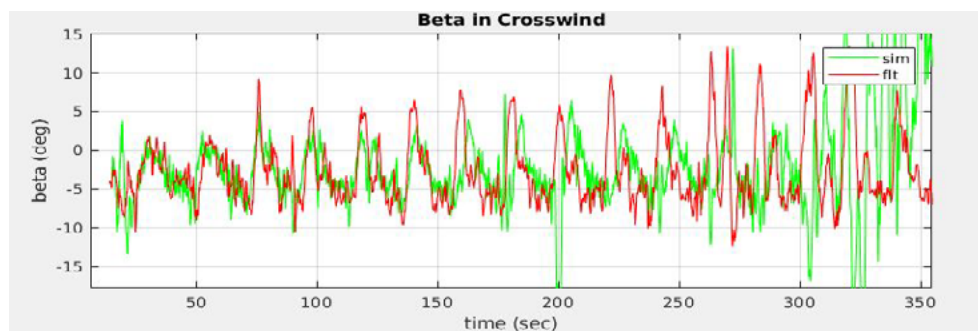
RPX-07 Crosswind Aerodynamic Angles vs Time

The alpha and beta excursions are between sim and flight are similar, but the flight values are generally larger.

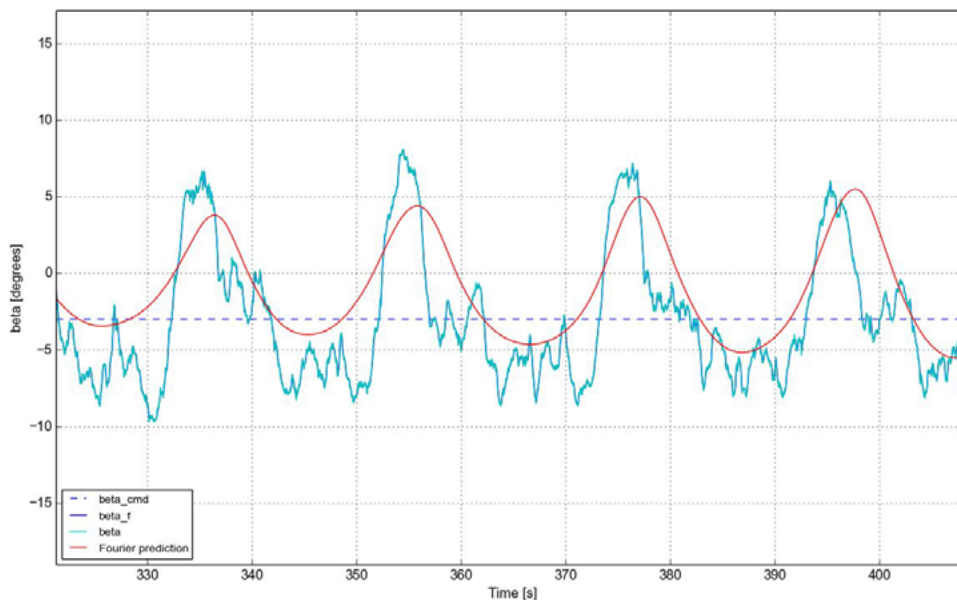
RPX-07 Crosswind Aerodynamic Angles Beta

But the fit doesn't look so great in the flight data.

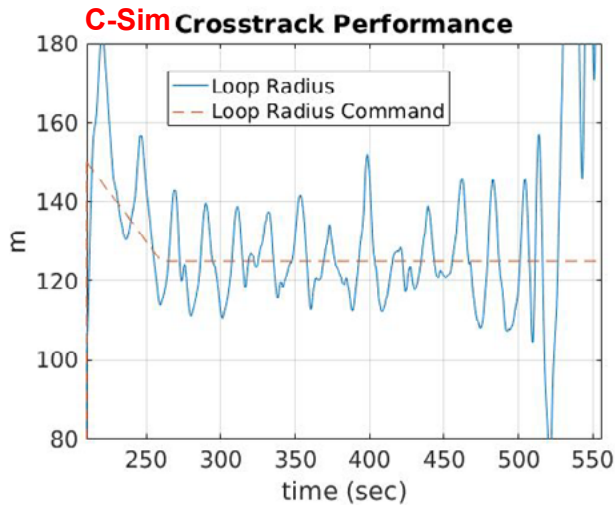
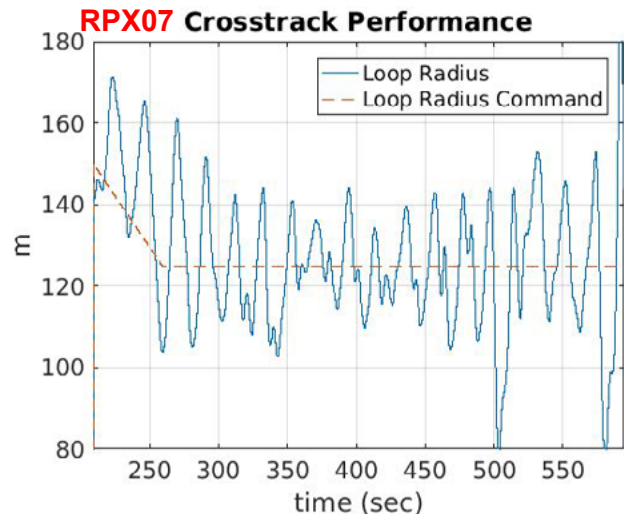
RPX-07 Crosswind Crosstrack Performance

- Crosstrack performance is slightly worse in flight than in sim
- Note that the C-sim crashes and so has a shorter x axis for this flight mode

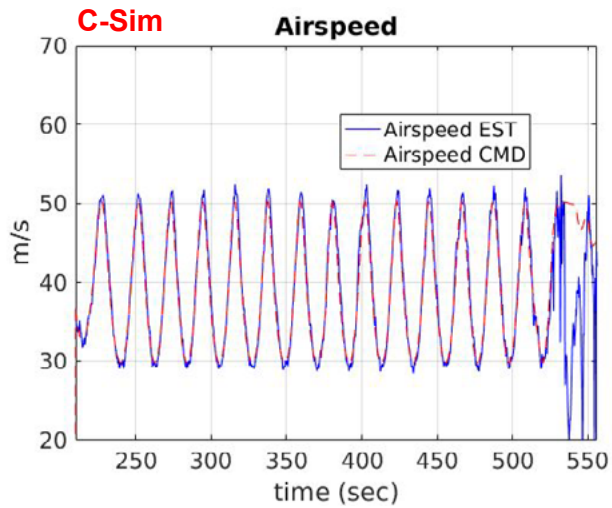
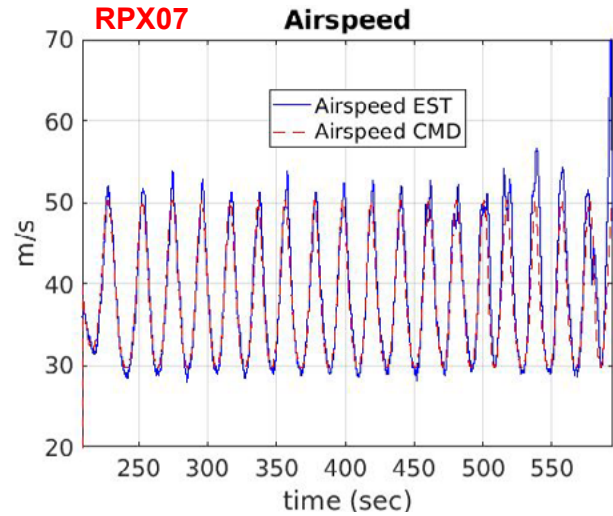
RPX-07 Crosswind Airspeed Performance

- Airspeed performance is slightly worse in flight than in sim

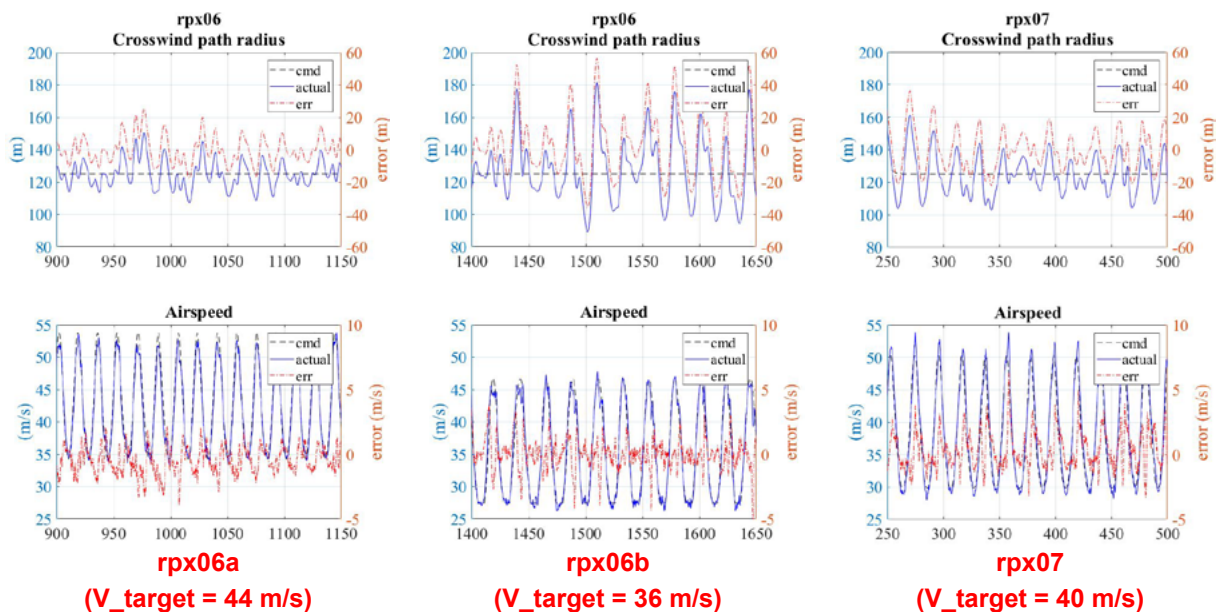
Path and Airspeed Control

- After the transient from the first two loops, the x-track error in rpx07 was similar to rpx06a: +/- 20 m.
- The airspeed error in rpx07 was significantly larger than any of the two rpx06 cases.
- See next slide for zoom and details

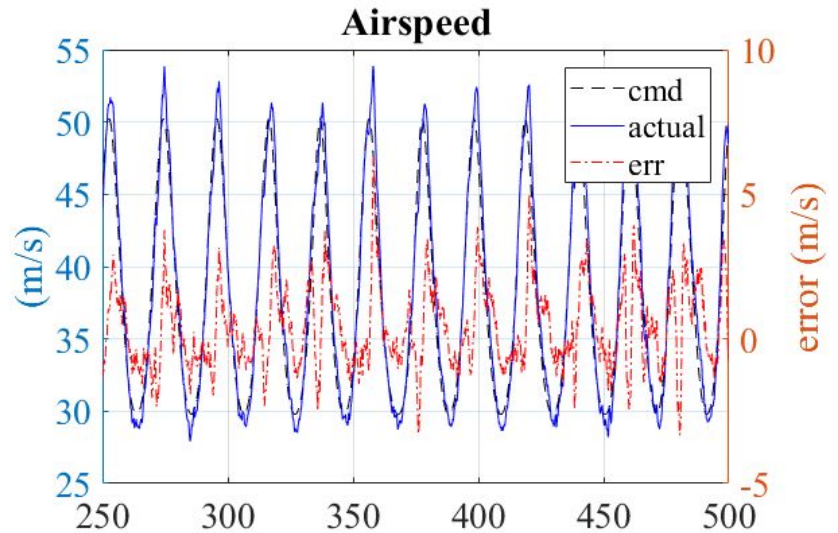
Path and Airspeed Control

- The airspeed error during RPX07 was +/- 3 m/s with a few peaks at +5 m/s.
- The max airspeed error occurred close to the bottom of the loop.

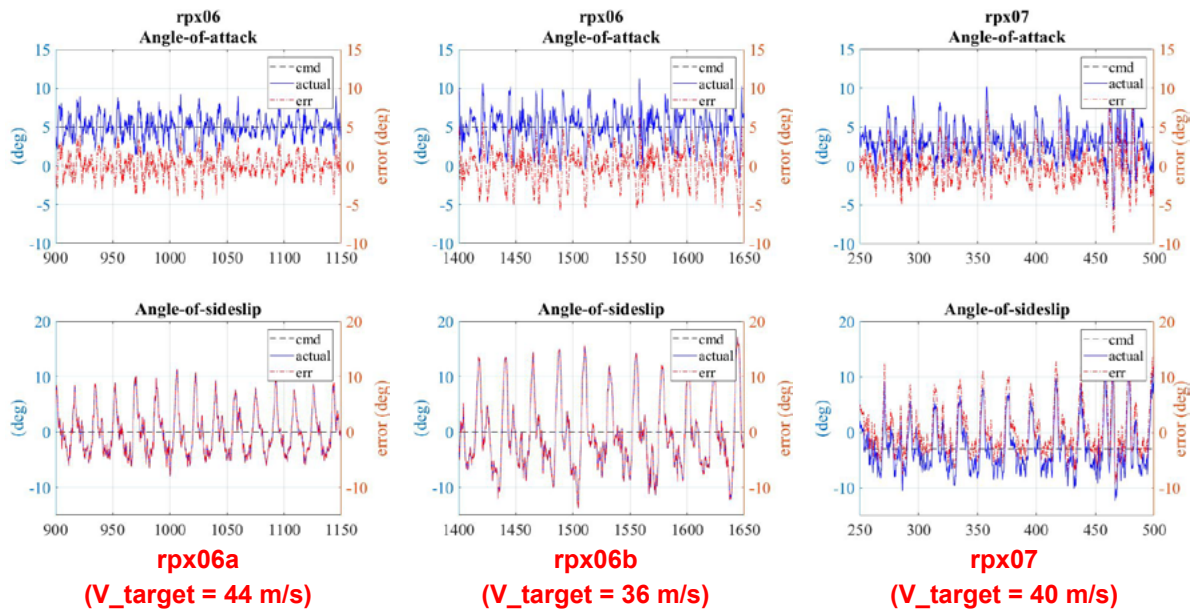
Aero Angles Control

- The **sideslip excursions** during RPX07 were similar to RPX06a (-5 / +10 deg.) and less than during RPX06b.
- The **angle-of-attack excursions** during RPX07 were worse than RPX06a and on a par with RPX06b.
- The higher angle-of-attack excursions at lower airspeeds suggests that the excursions are not due to a lack of passive stability (stability decreases with airspeed)

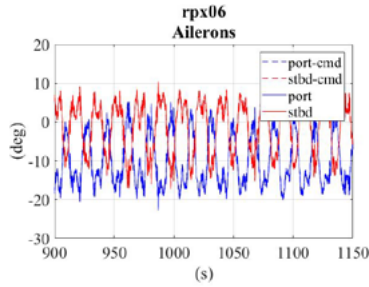
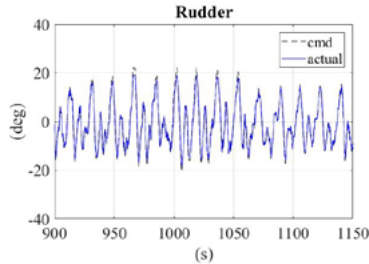
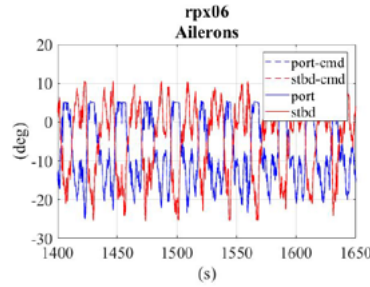
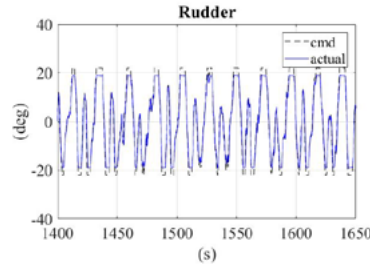
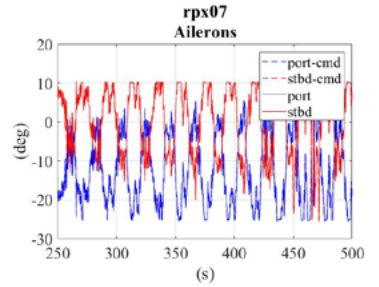
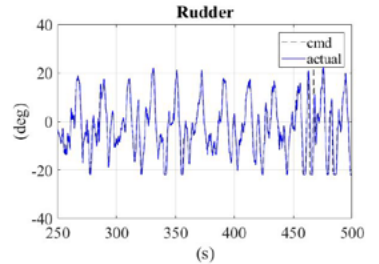
Ailerons and Rudder Control

- The rudder was saturated in a similar way between RPX06a and RPX07. The rudder saturated a lot more during rpx06b.
- The ailerons saturated a lot more during RPX07 than RPX06 a or b.

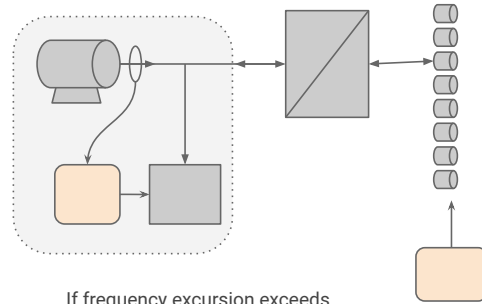
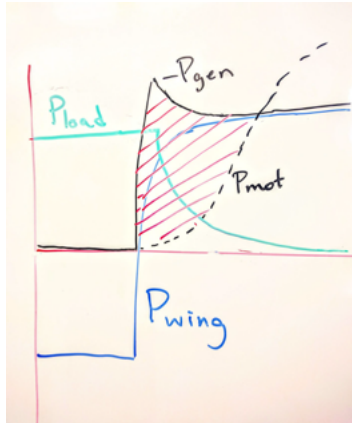
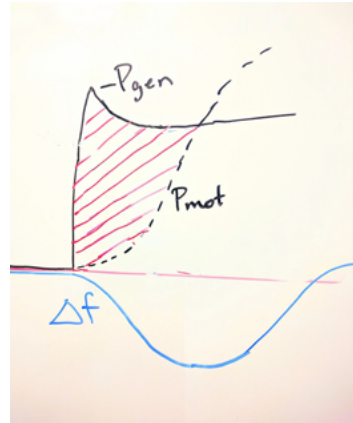
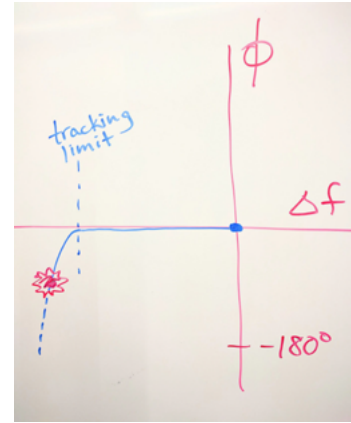
What Took Out the Ground Power?

$P_{gen} + P_{lb} + P_{wing} = 0$
 $\tau_{load} \sim 1 \text{ sec}$
 $\tau_{gen} \sim 2 \text{ sec}$
 $J_{gen} \sim 100 \text{ kg}\cdot\text{m}^2 \text{ (guess)}$
 $\Delta E \sim 270 \text{ kJ}$
 Time to tracking limit $\sim 0.36 \text{ sec}$

Fast control inputs and slow throttle response cause ENERGY DEFICIT

Energy deficit causes FREQUENCY EXCURSION

If frequency excursion exceeds tracking limit, PHASE DRIFT ensues

Phase excursion causes virtual short circuit, if severe enough

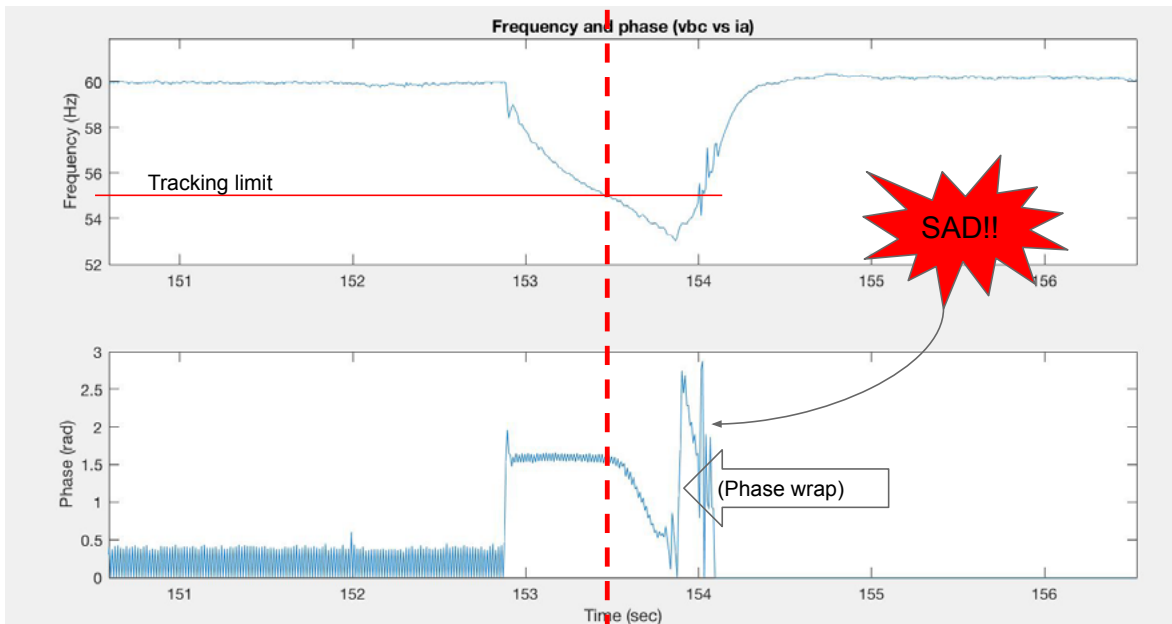
What Took Out the Ground Power?

Try to reproduce the problem at the E-lot:

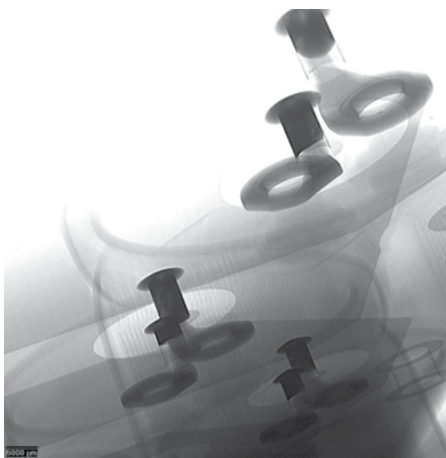
BEFORE

- Solder fill problems
 - Thick board
 - Poorly specified QC
 - Poor design entraps air under capacitors
- Reworked design
 - Air vents
 - Better QC reporting
- Success!!

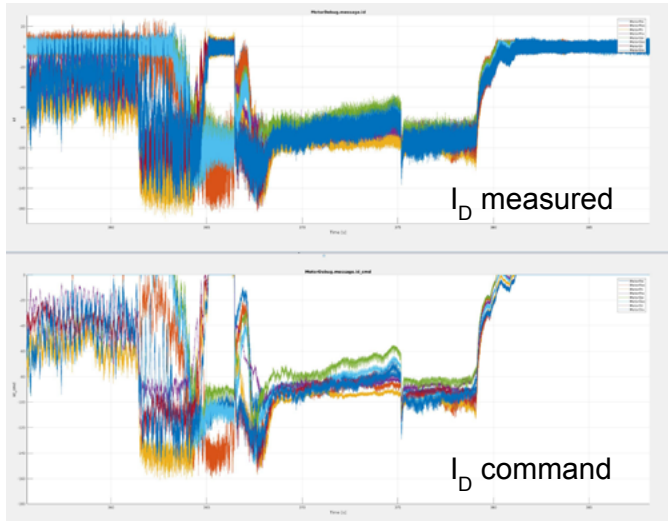
RPX06 Trans-in I_D

- 5x mechanical noise due to angle sensor error.

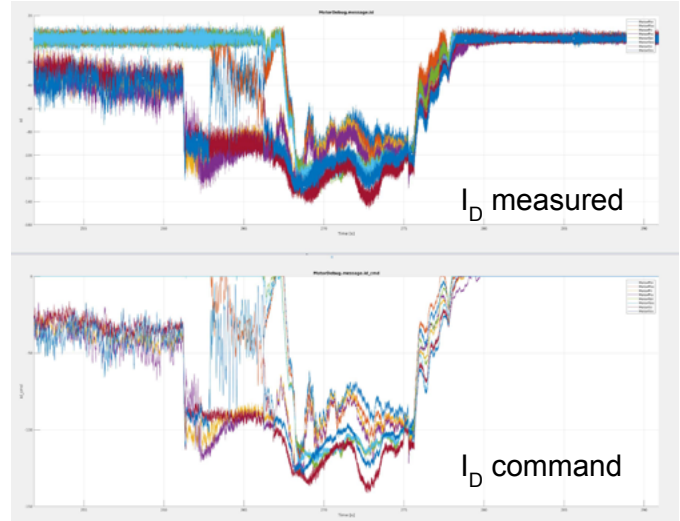
RPX07 Trans-in I_D

- Better current regulation despite running at half the switching frequency of Gins.
- Angle sensor error compensation code is working as expected.
