The Energy Kite

Selected Results from the Design, Development and Testing of
Makani's Airborne Wind Turbines

Part III, Technical Artifacts

Selected Decks From RPX Lessons Learned Reviews

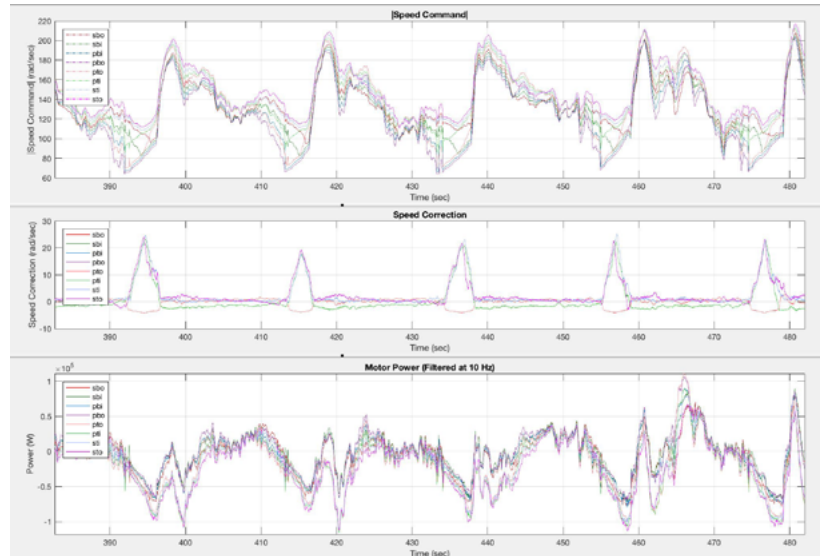
Stacking Control Performance

- Stacking controller is significantly backing off $\frac{3}{4}$ of motor pairs during period of generation.
- Backing off occurs during power extracting phase of the loop.
- Up against advance ratio limit
- Always SBO-PTO pair with PTO against the advance ratio limit
- PBI and PBO both hit the advance ratio limit first with no consequence.

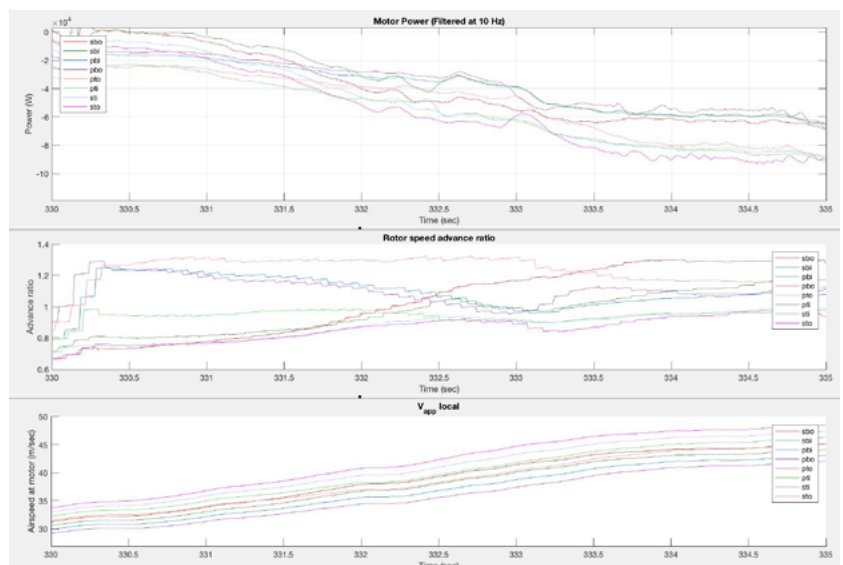
Stacking Control Performance (Power and Advance Ratio)

- At 333.5, despite having higher advance ratio and higher calculated apparent wind we see SBO flatten out its generation performance relative to PTO.
- Meanwhile, PTO improves its generation performance as the advance ratio increases (though v_{app} is also increasing).
- During period when they had similar v_{app} , PTO generated 25% more power with advance ratio < 1.2 compared to 1.3 for SBO.
- Based on prop models 1.3 is near peak power. Here it looks like we're slightly stalled.

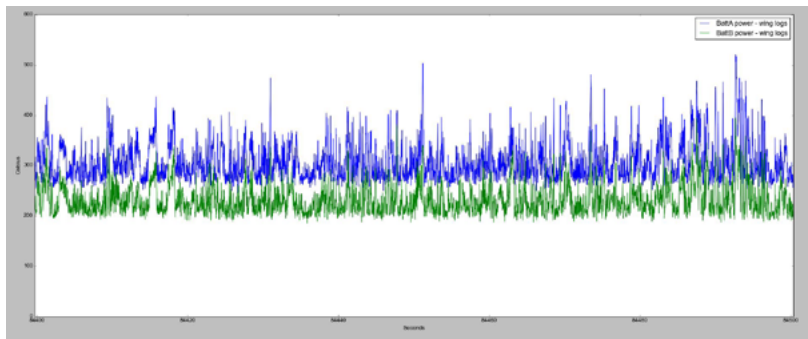
← RPX07

Similar power usage from last rpx, but somewhat higher spikes (probably servos in higher wind).

Note with MVLV and batt box, if we lose batt box, LV bus will brown out for any power spikes in excess of the MVLV's continuous power capability.

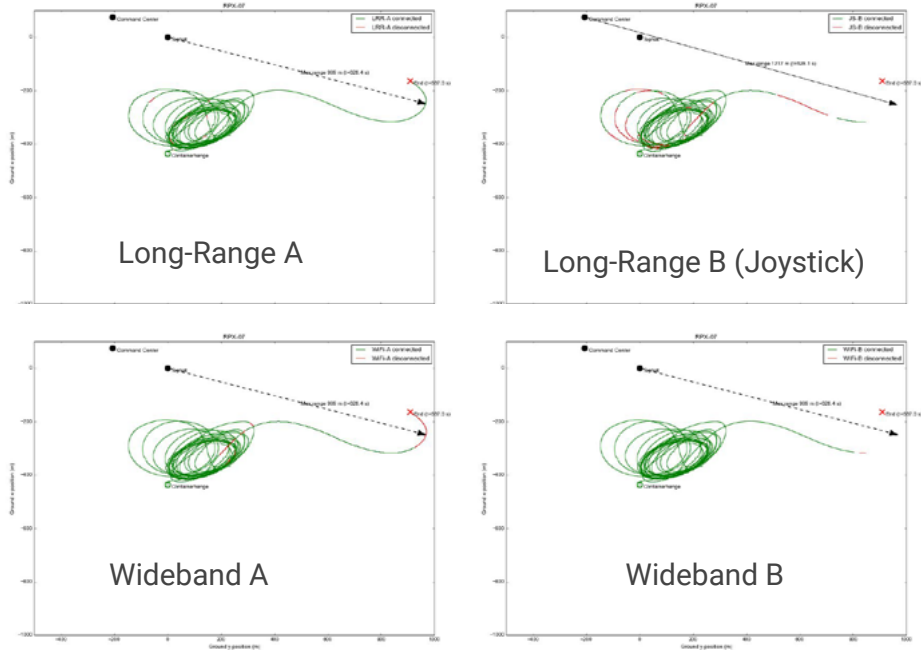
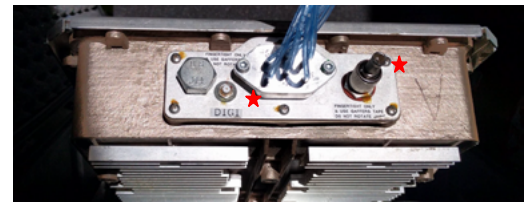
RPX-07 Kite/Ground Radio Link Performance

- LRR-A allowed us to land
- Wideband B allowed us to collect continuous command center telemetry for the on-tether operation.
- Long Range Radio and GSP antenna cables severed during landing.

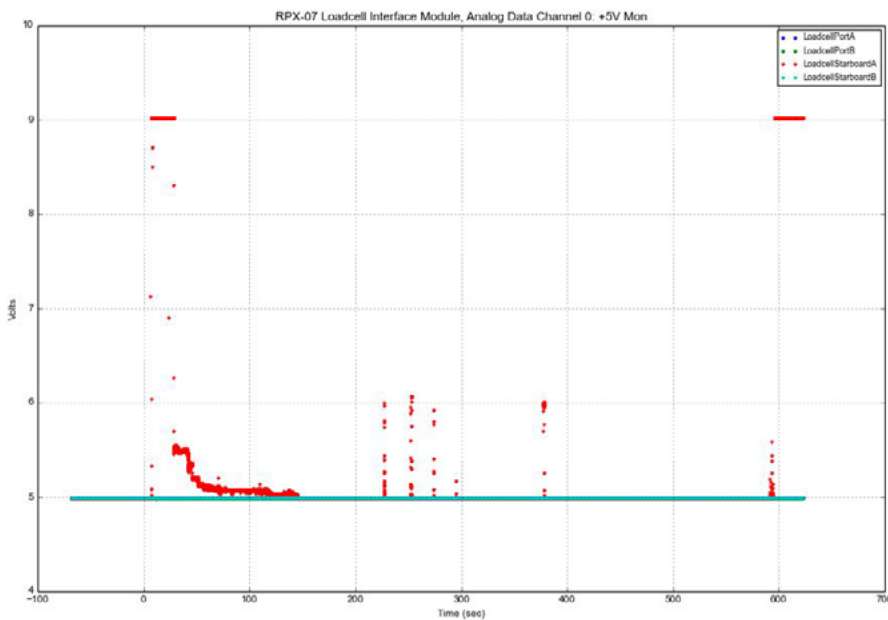
Starboard A Load Cell Interface Error: +5V Monitor

- Bug 69789643
Starboard A Load Cell 5 V reference warnings on RPX-07
- Hardware fault, to be investigated (hardware to arrive today).

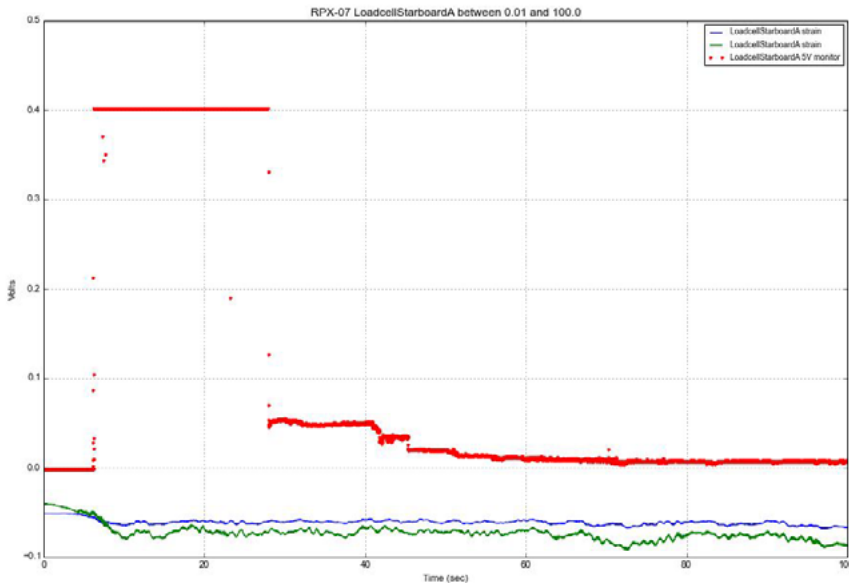
Starboard A Loadcell Interface Error: Strain Measurements

The 5V Reference is used by the A/D converter for the load cell strain measurement.

The measurement appears unaffected.

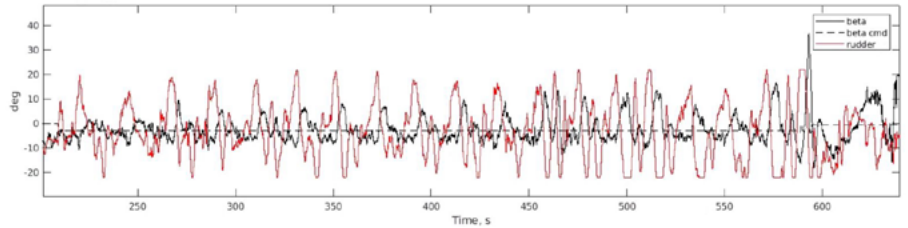
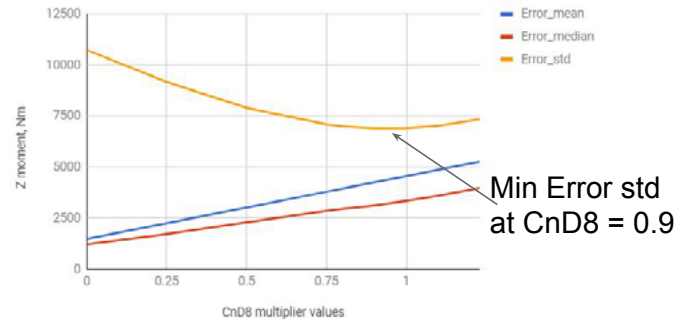
Rudder

- Constantly hitting the limits (even with the rotors help)
- Using Dynamic Replay:
 - Min standard deviation is around $0.9 * CnD8$
 - Might indicate the control derivatives are too high/not accurate in database

Yaw moment error stats with changing CND8 multiplier

Address the rudder database fidelity and sizing for RPX-08

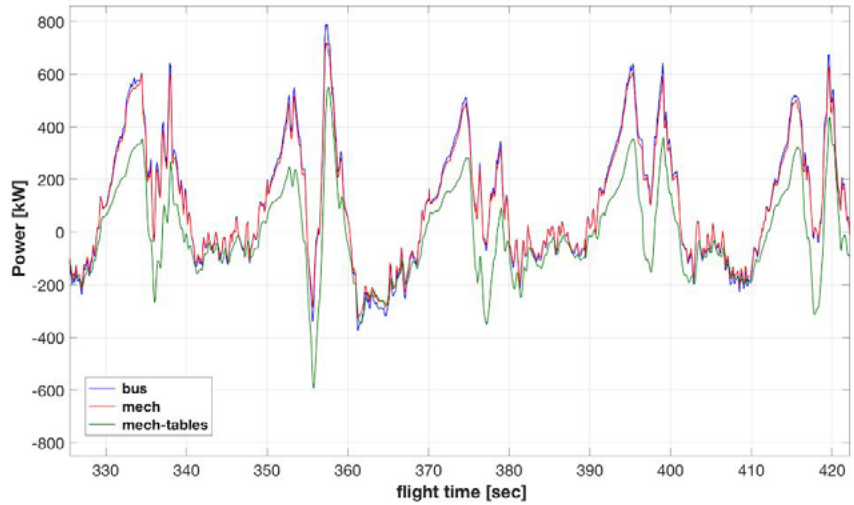
Rotors

- Large error between expected rotor aero model and measured power/torque
- Suspects:
 - Rotor table itself
 - Wing interference model

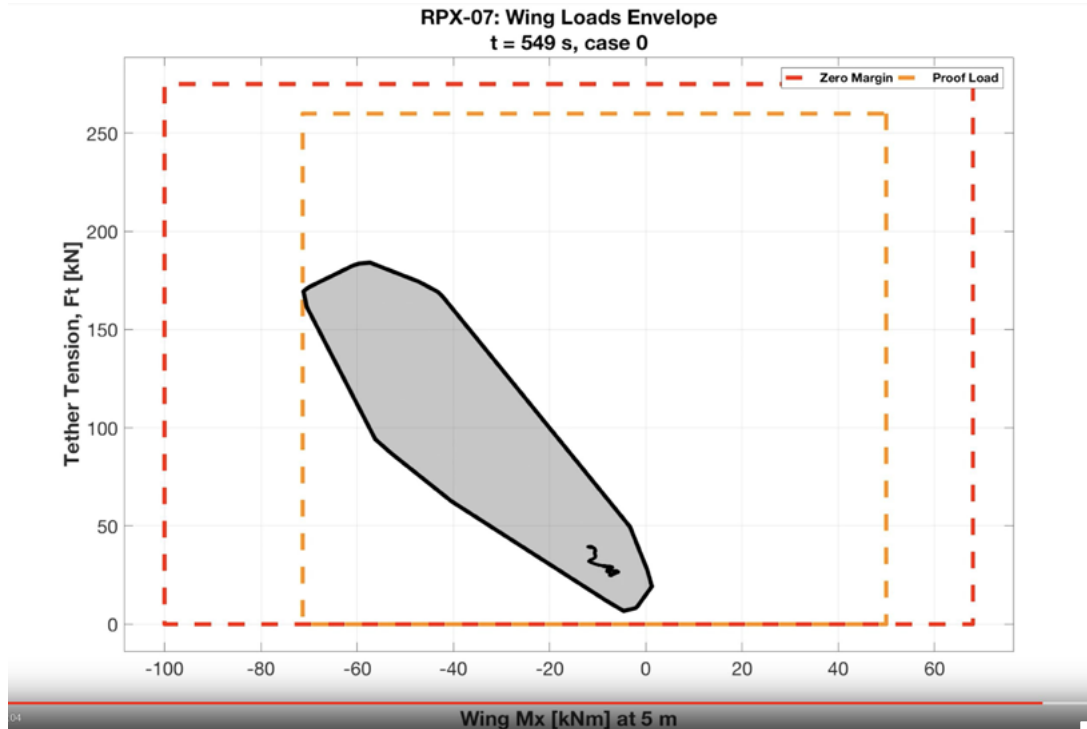
Wing Loads

Loads were fine up until the last loop

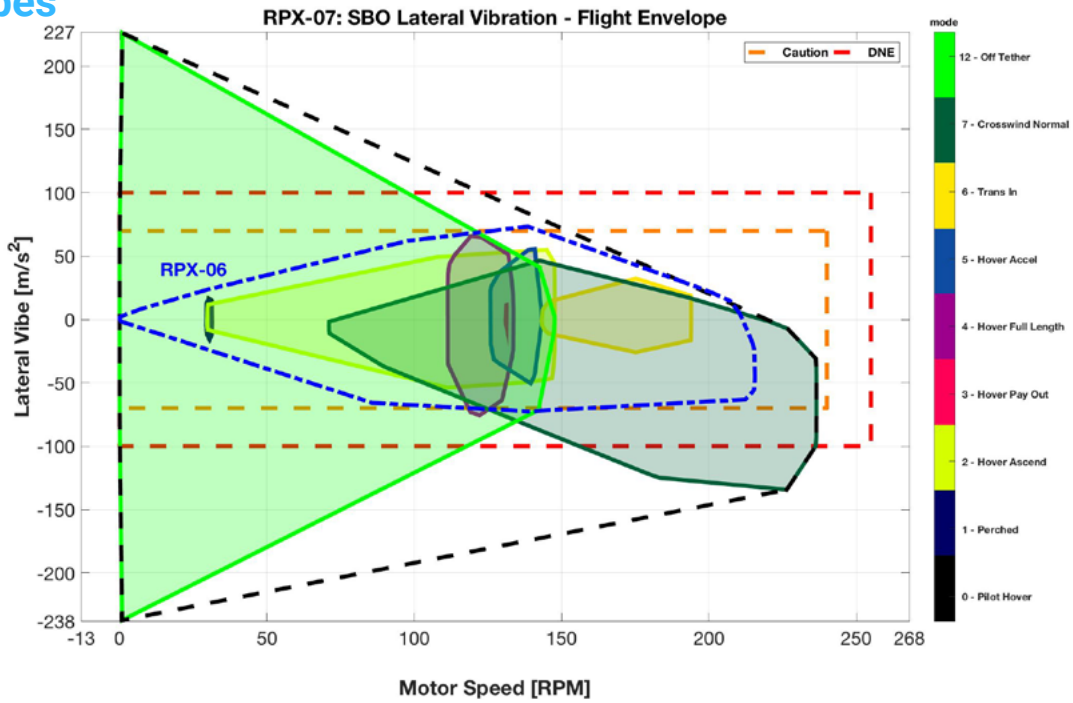
Pylon Vibes

LL: Vibes okay until end of flight.

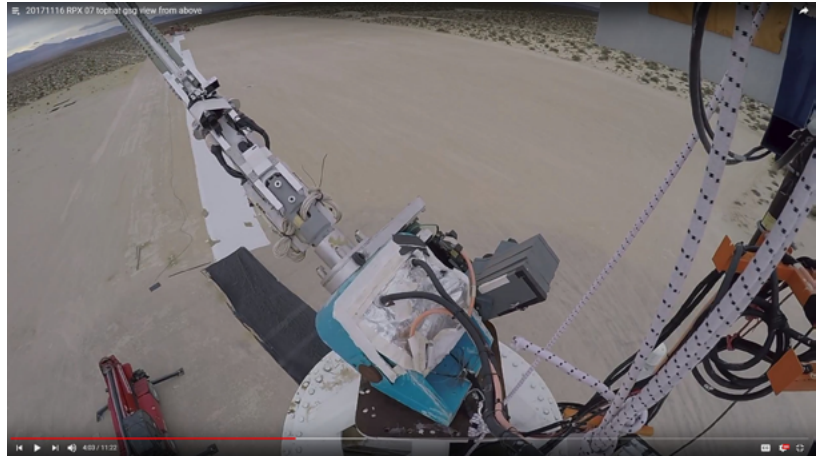
GSG jolt

- Bug 36788267
- Still shown here shows slight jolt. Still taken from [YouTube playlist](#) video "20171116 RPX-07 - View of Groundside Gimbal, Tether Attachment, and Detwist"
- no jumps in encoders
- Azi stiction during crosswind is better (smaller jumps)
- Plan to leave as-is

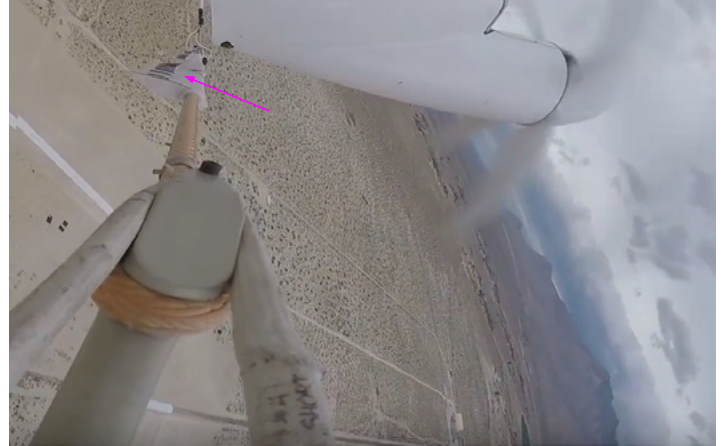
Summary - rotating sections

- Fairly successful—lots of video for observations but a few questions to address next flight
- Had some ‘bridle shake’ at airspeed over 40 m/s ([YouTube playlist](#) video “20171116 RPX-07 - Seventh Unconstrained Flight of Makani M600”)
- Underdamped heave vibration
- Lost middle fairing just before release
- Suspecting shedding from stalled fairing that was misaligned
- No instability observed on tether fairings
- Repeat test with a new design that has better bushings and exclude the section directly behind pylon 4, move GS slamstick to bridle to check frequency content of vibration.

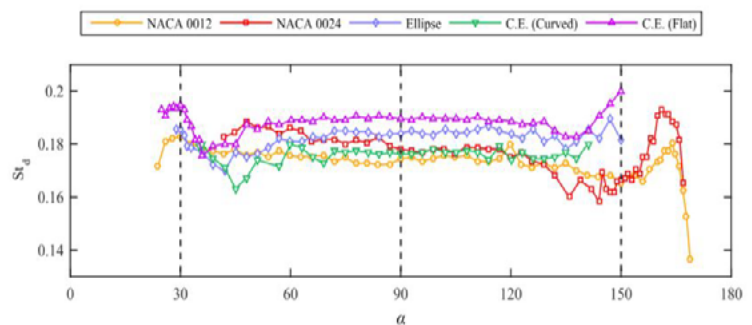
Fig. 15. Magnitude and frequency of unsteady airloads acting on four airfoils through 180° at $Re = 6.6 \times 10^5$.

Comparing 86 hz to the 17-20 hz content observed in the load cell data it seems unlikely that the stalled airfoil was causing the instability because this frequency is 4x of what was measured.

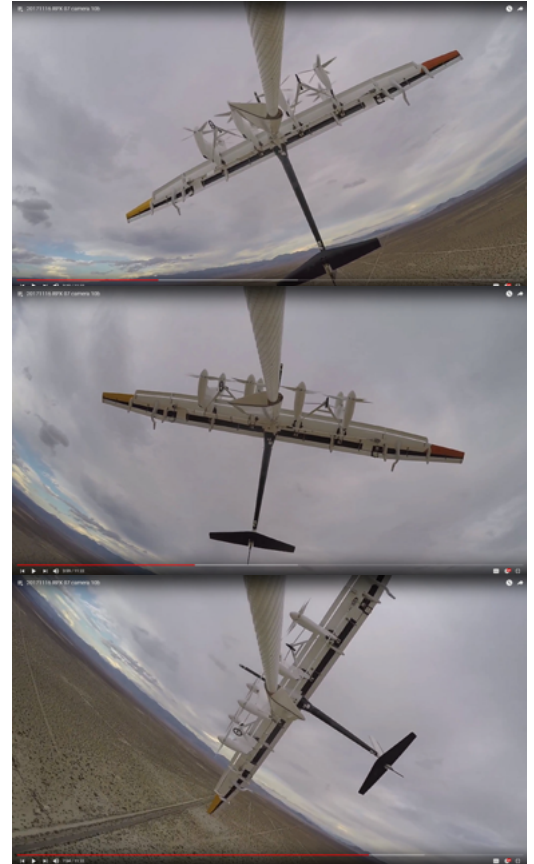
Summary - fixed section

- Initial misalignment, but this may have been enough to twist the tether
 - Although the camera itself probably played a role
- Slowly crept into alignment; also seemed stable

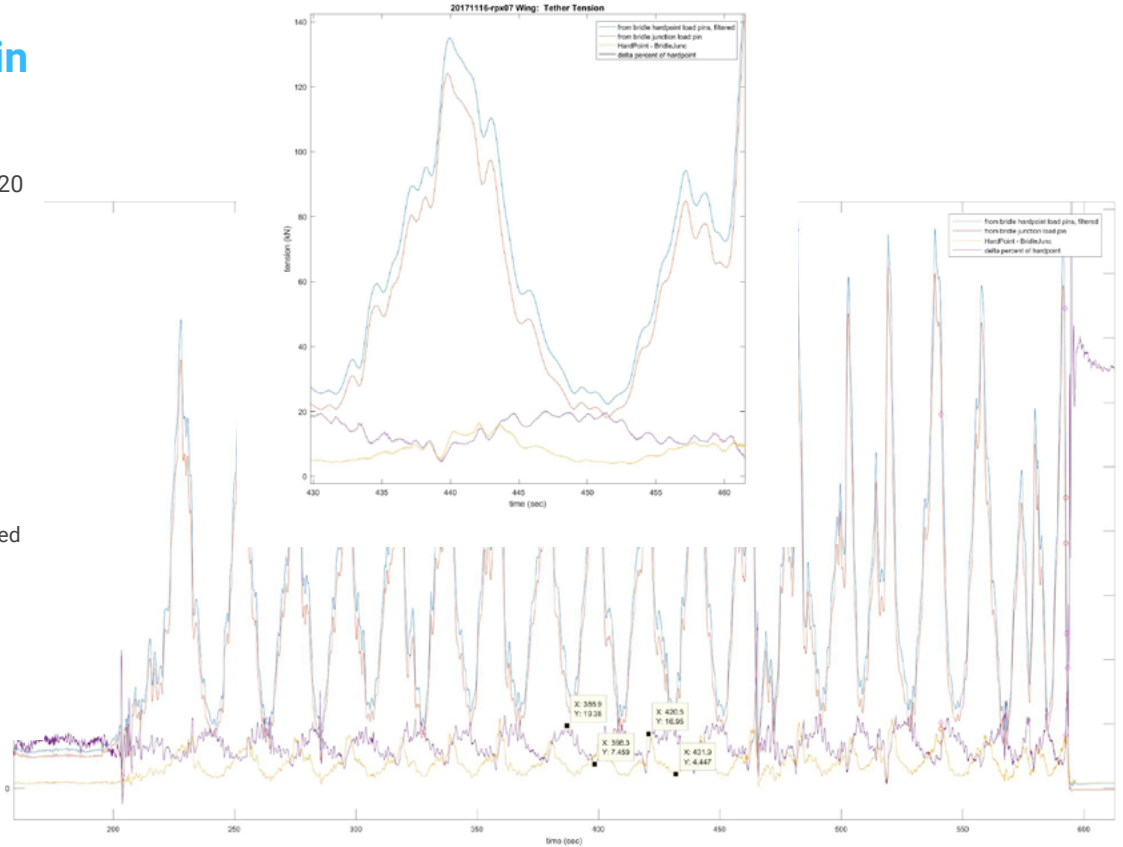
BridleJunc Load Pin

- BridleJunc reads lower than HardPoints
- 4-17 kN delta → ~10% (max 20 but only at low tension)
 - → about the same as our CI deltas...
- Only updates @ 10Hz
- → should try to recalc aero coeffs w/ this load
- Bug 69812220
- We expected delta might be opposite
- Minor notes
 - BridleJunc slightly filtered (lags behind unfiltered tether tension)
 - Bridle junction load pin configuration

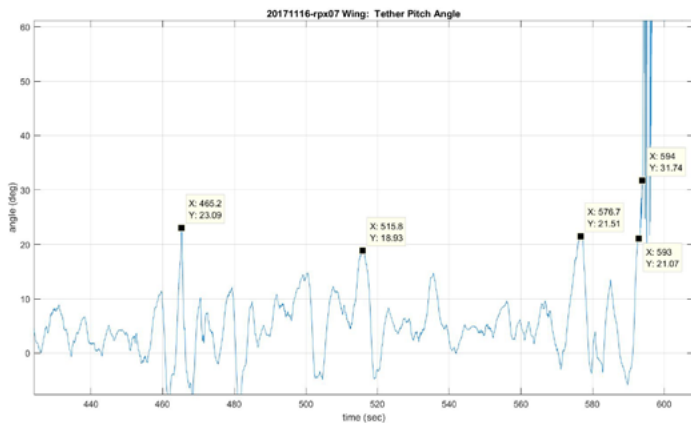
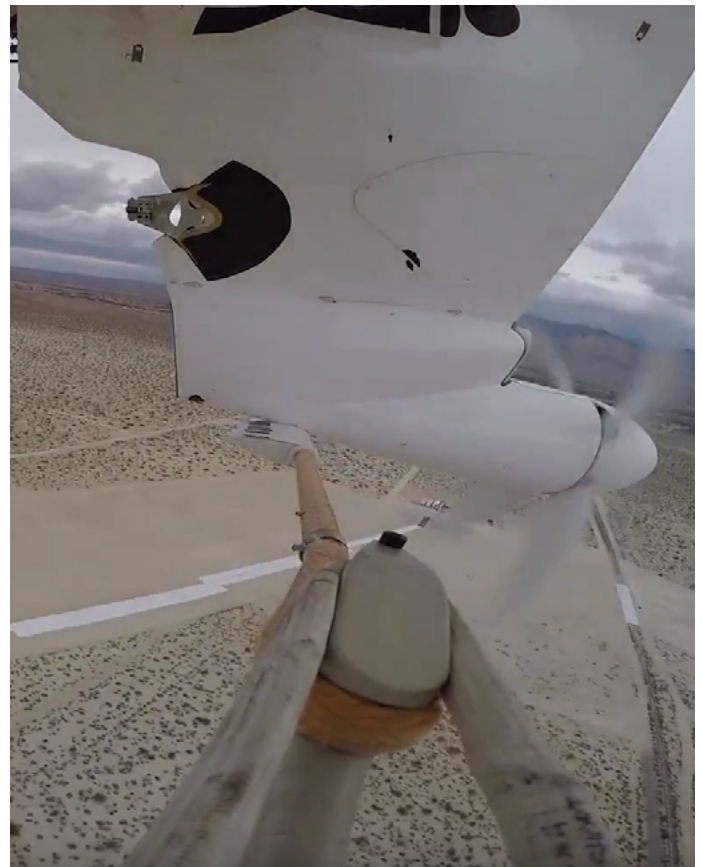
Tether Pitch

- Contact between bridle fairings and pylon **4 times**, Bug 69978773
 - Left marks/cracked nacelle, but seems no structural pylon damage
 - Contacted the 2nd fairing
 - Expected contact (w/o fairing) @ 17.7 deg
 - Achieved contact at just under ~19 deg as measured
 - Noticed extreme jump to ~90deg on final contact before release. Could this have future impact on controls? → file bug

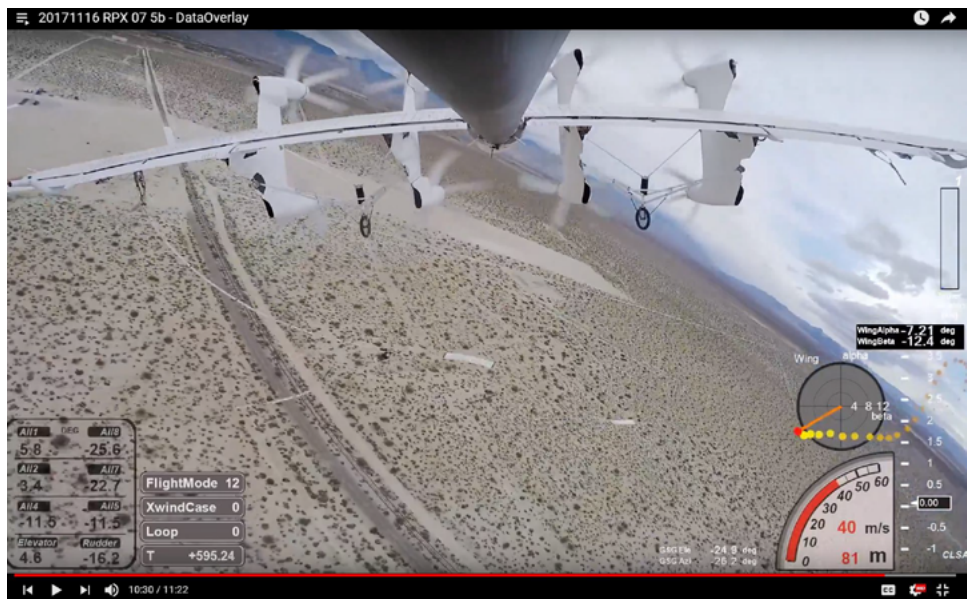
- Worked! Including signal sever
- We released at <1 kN of tension and high roll (tether weight on stbd bridle), so the MV connectors didn't pull out for ~1s

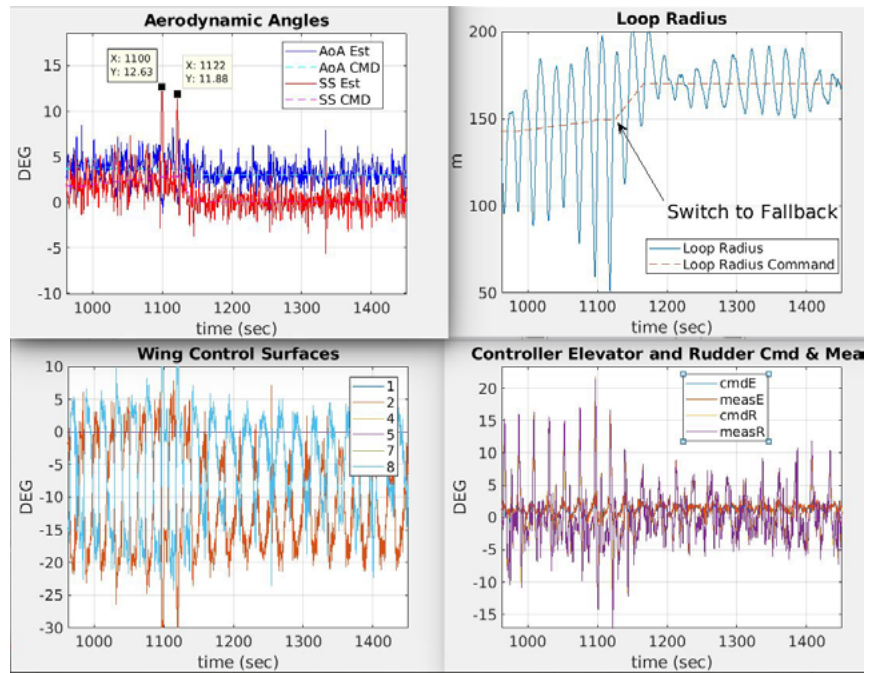
Example of Poor Flight Quality Prior to Fallback Switch

- Sideslip excursions beyond 10 degrees!
- Saturated ailerons!
- Path errors near 100 m!
- Huge rudder use!

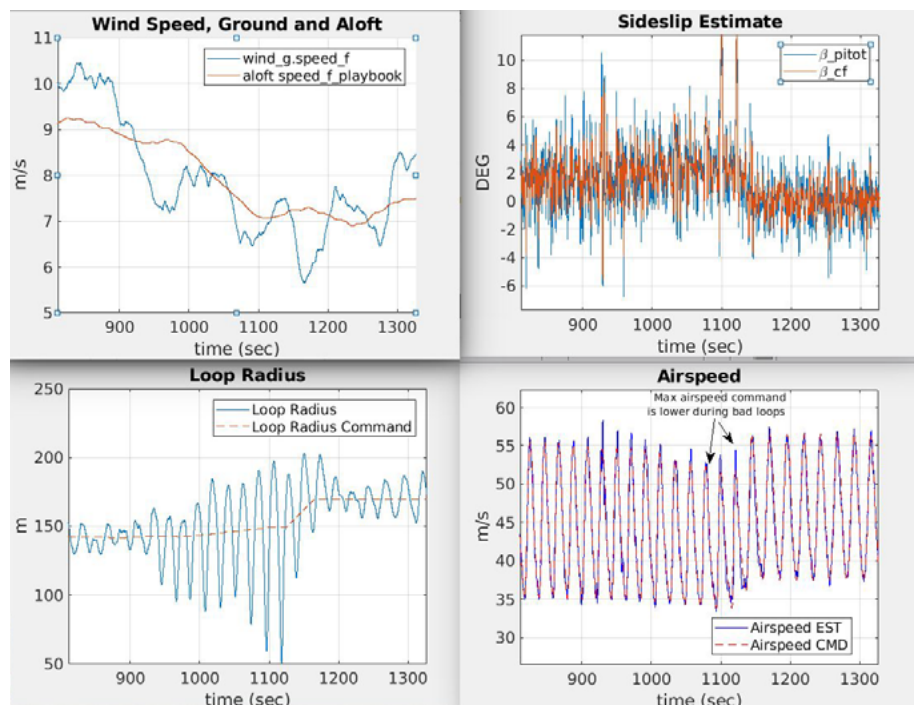
Flying Slower Doesn't Help Us Fly Well

Worst loops were also the loops with the lowest max airspeed command.

This decrease in max airspeed command seems to come with the decreasing wind aloft speed estimate used in playbook.

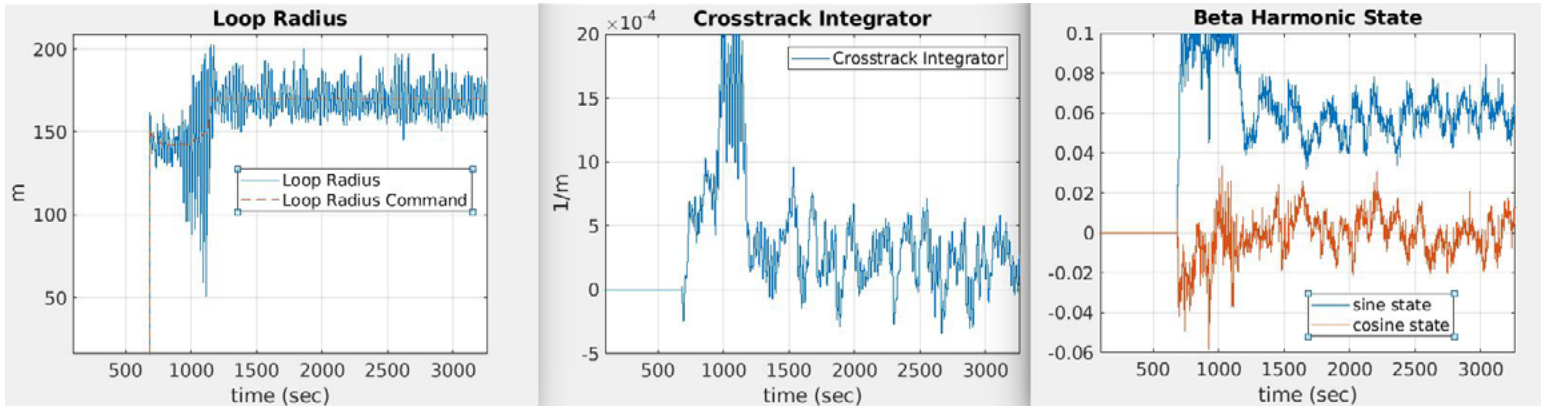
Our Crosswind Controls “Patches” Saturated

Both the Harmonic Gain for Sideslip and the Crosstrack Integrator saturated during our poor flight quality at the start of the flight.

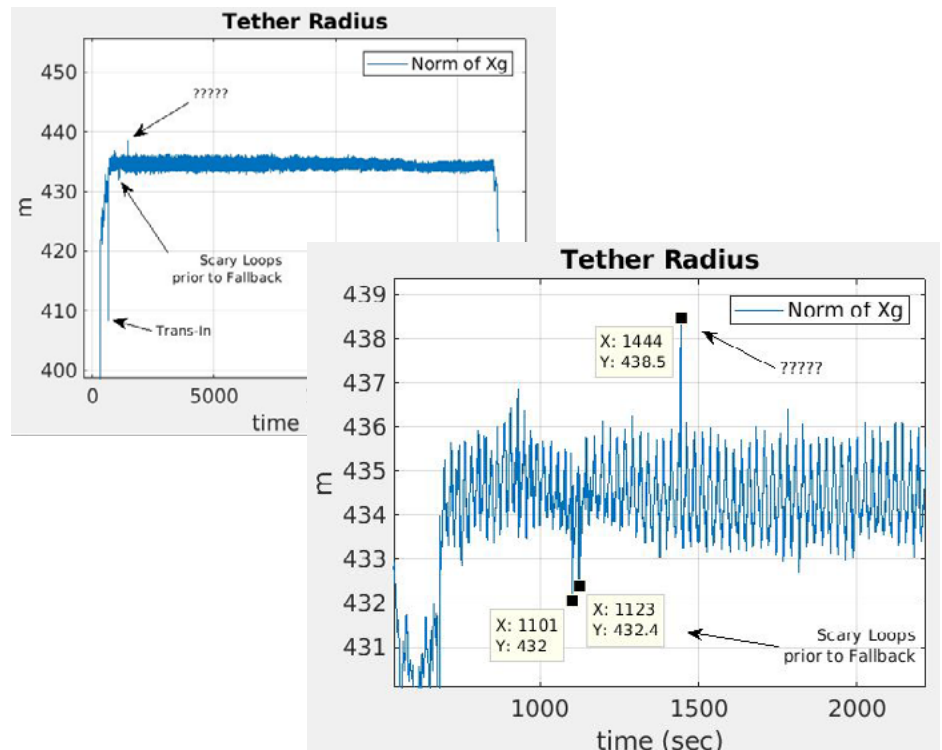
Tether Sphere Deviation

- Worst sphere deviation is about 2.4 m below the Crosswind mean.
- (RPX09 crash was nearly 8 m below)
- No idea what the strange increase in radial position is about. ???
 - UPDATE! Solved. GPS trouble

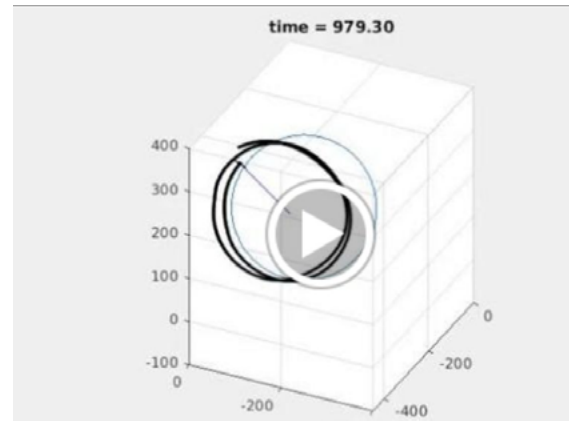
Crosswind Is Harder to Fly During Positive Azimuth Slews

- Bottom of the loop requires the most turning effort (fighting gravity)
- Paths that slew negative effectively increase the radius in this part of the loop (easier)
- Paths that slew positive decrease the radius in this part of the loop (harder)
- Our worst CW06 loops are during positive azimuth slews

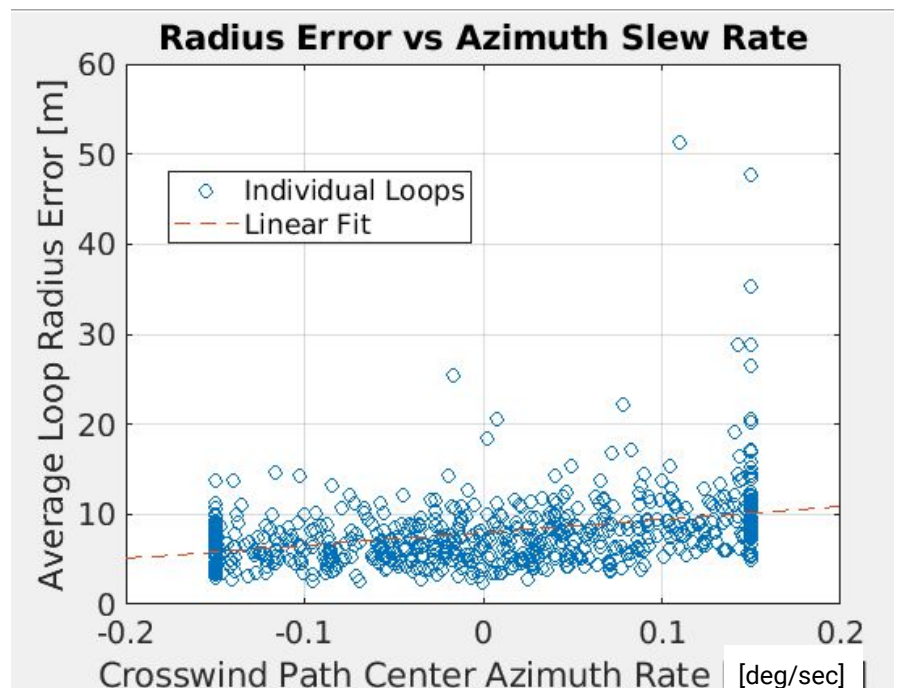
Radius Errors vs Crosswind Path Azimuth Rate

Our worst loops are during positive slews.

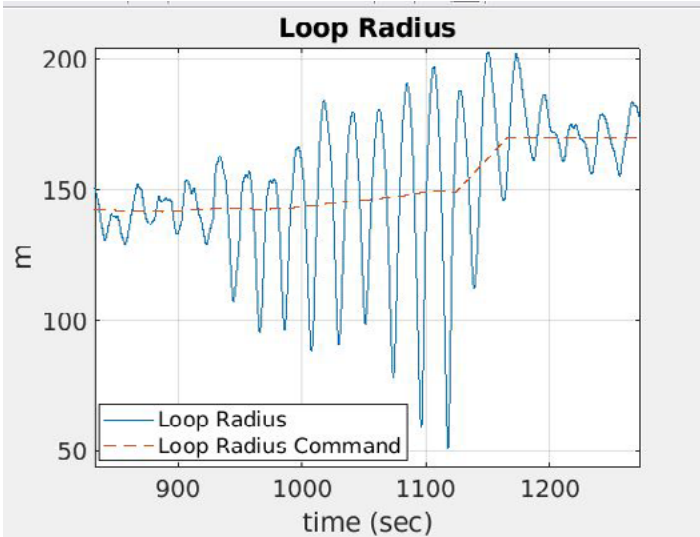
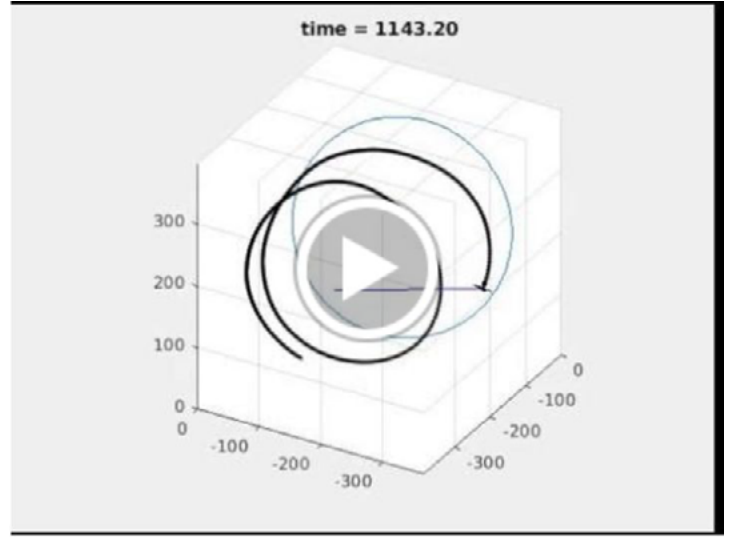
Transitioning Into and Out of Bad Flying Quality

This much-faster-than-realtime animation [internal reference] shows the kite entering poor flight quality as the path slews right then recovering on the switch to Fallback

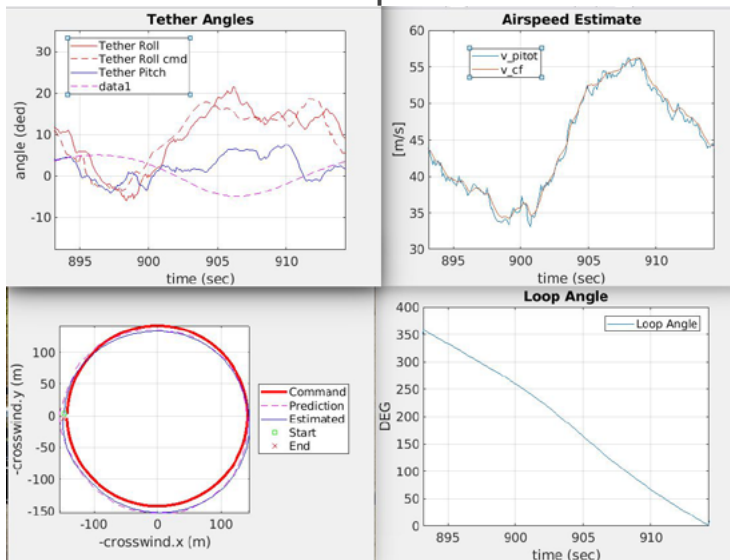
Loop 10

- Things which are scheduled on loop angle:
 - Airspeed CMD
 - Alpha CMD
 - Tether Roll Feedforward CMD
 - Detwist
- Loop angle is calculated based on kite position relative to the *commanded* circle center
 - Changed from velocity-based calculation after RPX05 due to worries about discontinuities in GPS velocity estimates (“rabbit hops”)
- When the kite cuts across the circle, the loop angle gets distorted and so do these commands
 - Velocity-based angle may be what we want in these cases!

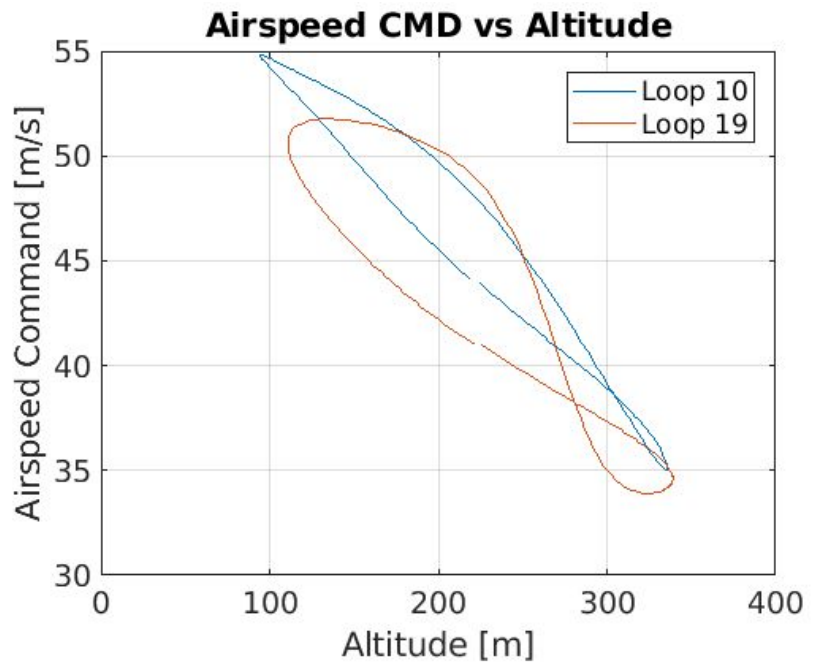
Airspeed Command vs Altitude is getting Badly Distorted

- The airspeed command vs altitude is much more important than airspeed vs loop angle

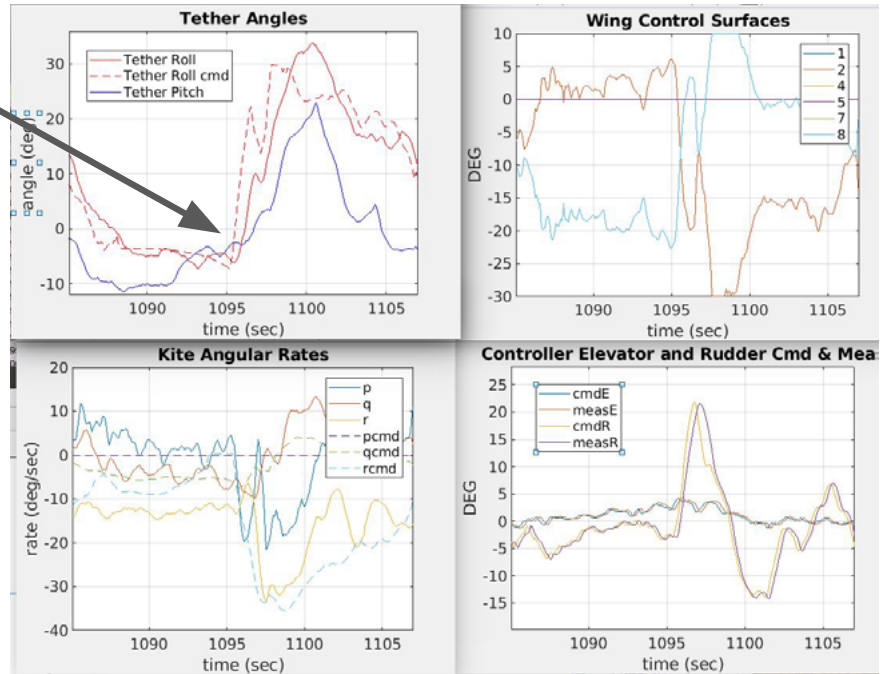
Poor Flight Quality: Loop 19 (Ridiculous Roll Rates)

- Tether roll command has an extremely sharp corner
 - Big roll rates are hard for our inner loops
 - CNp term in particular
- Finding a way to calm the tether roll command time history will help improve flight quality

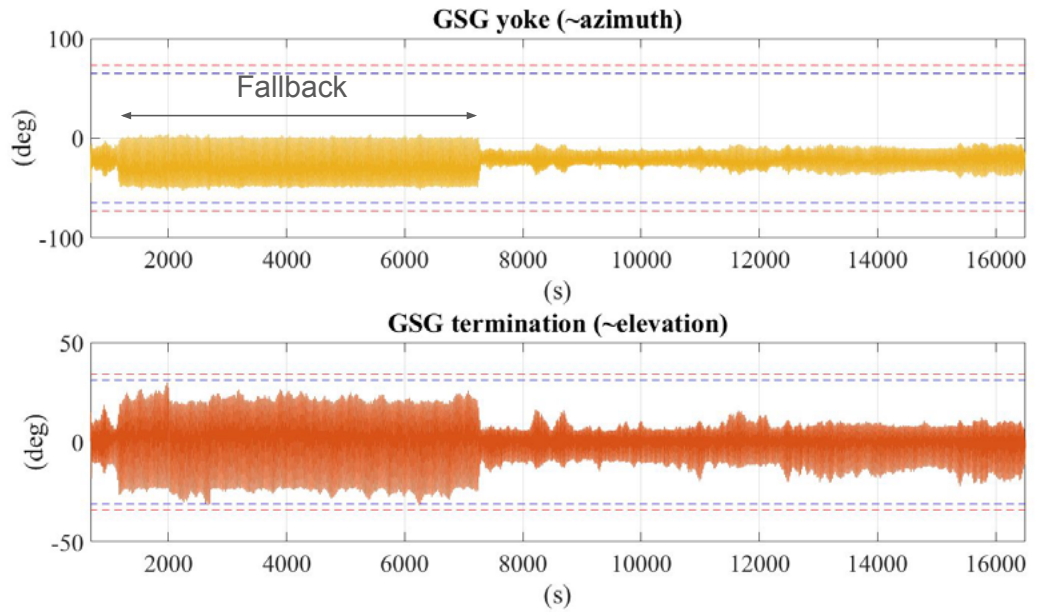
GSG Angles in Crosswind

- The GSG termination warning limit was exceeded a couple of times while flying on fallback.
- Recall fallback parameters:
 - Path radius target: 170 m
 - Loop center elevation: 50 deg (0.87 rad)
 - Azimuth offset from downwind: 5.7 deg (0.1 rad)
- Can we increase our GSG termination angle margins by modifying the fallback outer-loop parameters? (bug 130882010)

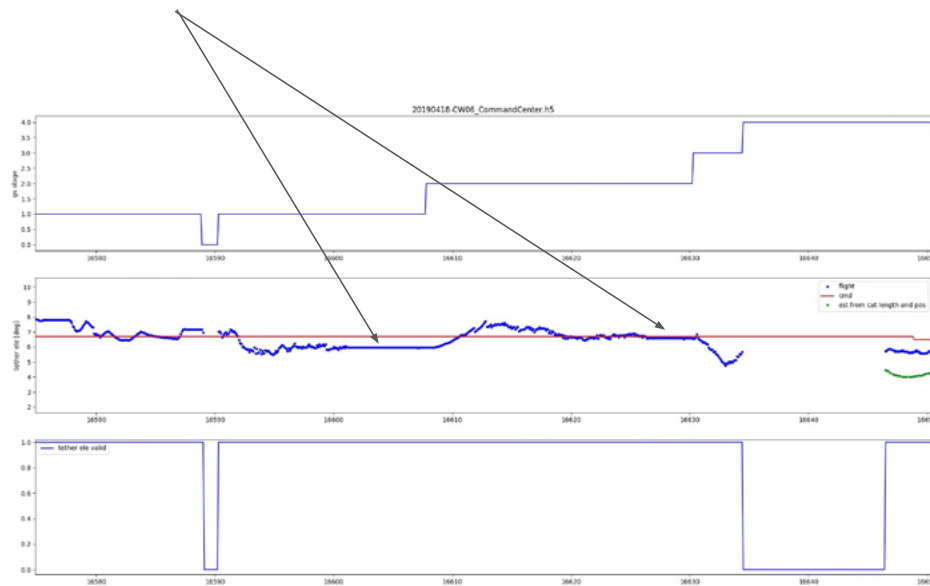
Tether Elevation During CW06 TransformDown

Suspiciously flat... tether_ground_angles.elevation_valid claims to be True

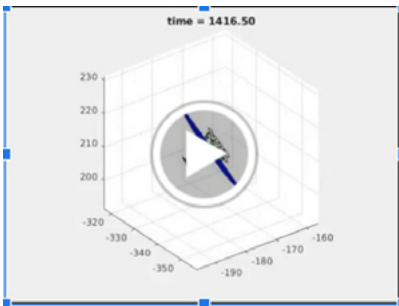
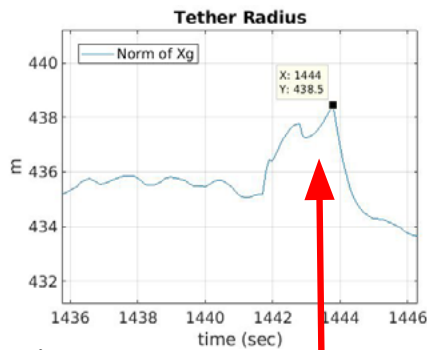
What That Strange Increase in Radial Position Is About

There was a big disagreement among GPS solutions during loop 33

Not real.

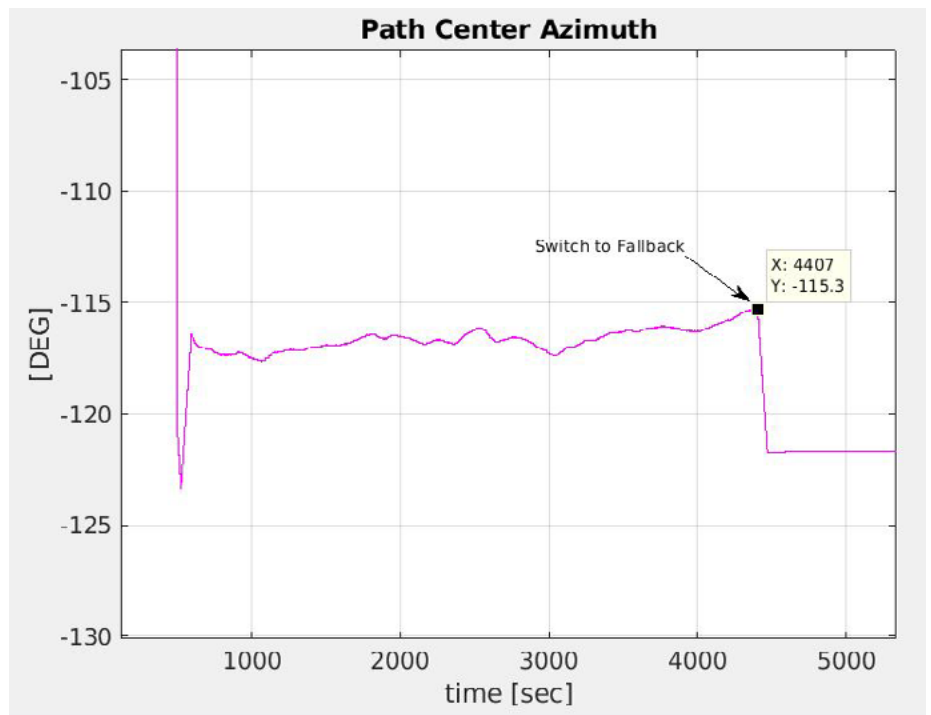
Path Center Azimuth Barely Moved

- Biggest movements were TransIn and the switch to Fallback
- Path center slewing is not the reason for poor flight quality in CW07

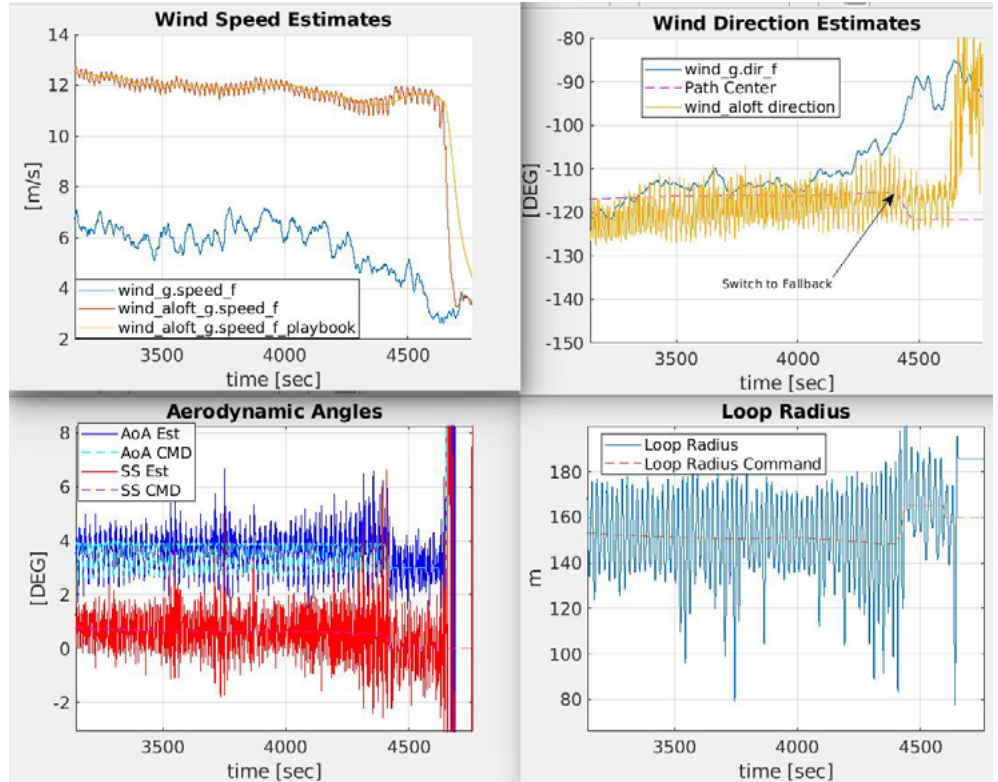
Flight Quality

- Better and worse throughout the flight
- Errors in Alpha, Beta, Loop Radius make it clear when the kite is struggling
- This was not as bad as CW06

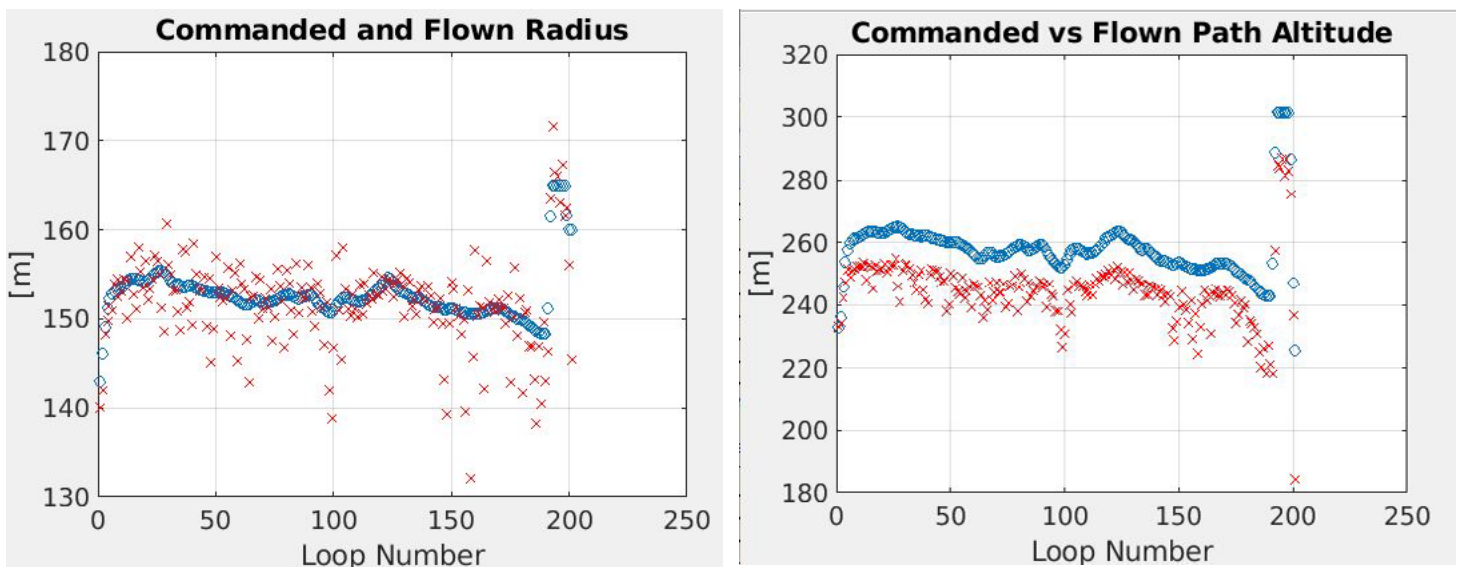
Path Tracking Performance

- Loops are generally lower than commanded
- Loops often have smaller radius than commanded

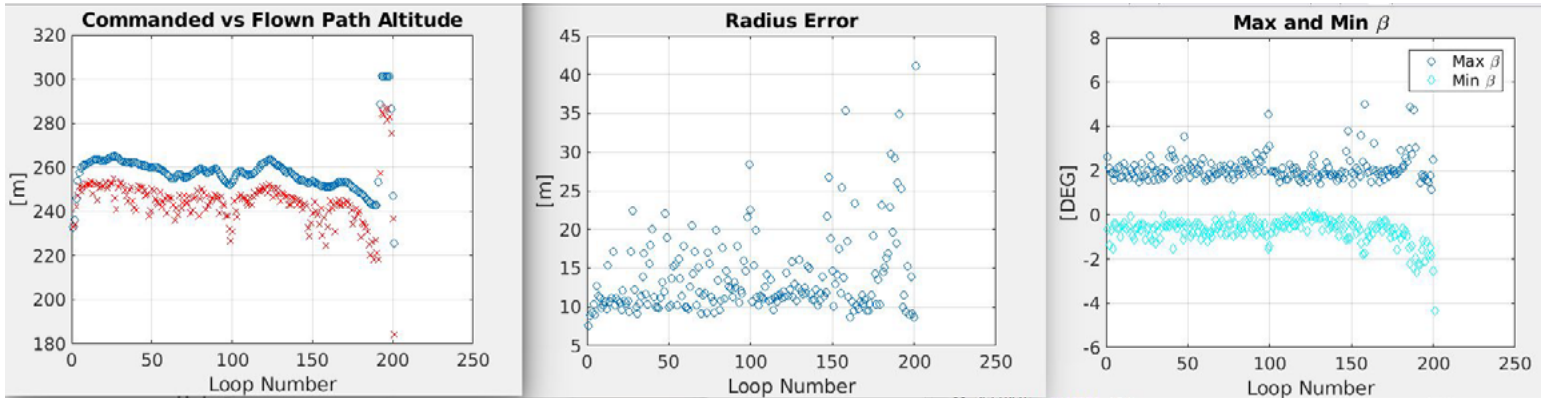
Poor Path Following Leads to Bad Flight Quality

- Bad aero angle tracking correlates with poor path tracking.
- We have poor flight quality because of large path tracking errors

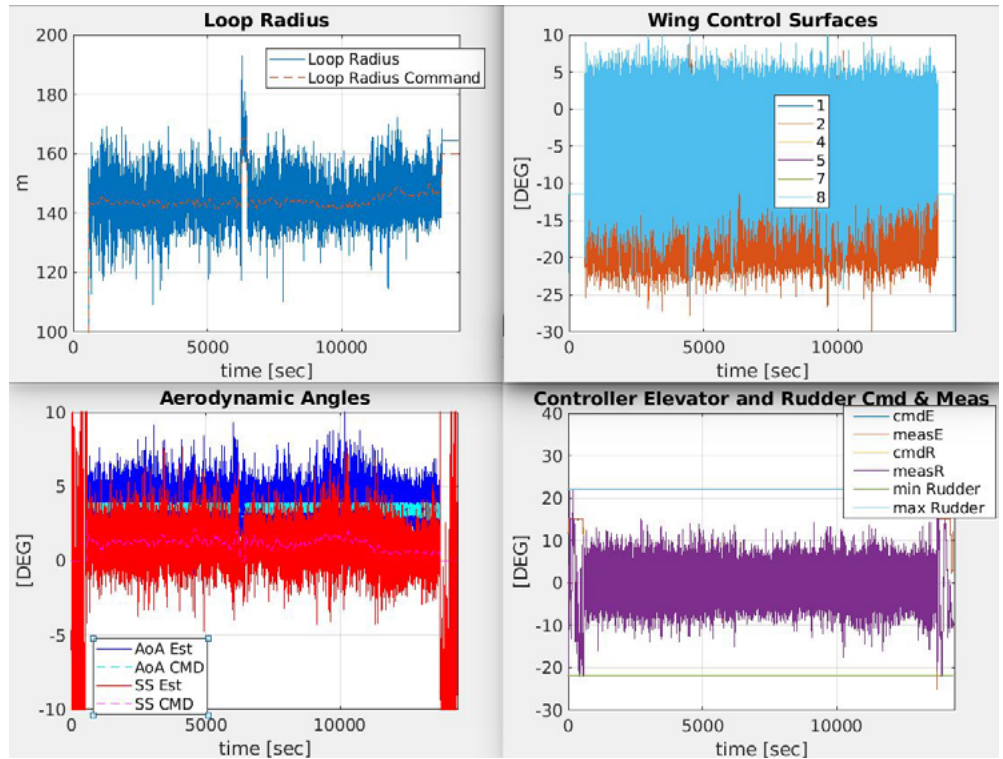
Flight Quality

- No extremely scary loops like CW06
- Mostly had aileron margin throughout
 - A few isolated saturation events
- Rudder did not saturate in crosswind
- Aero angles mostly okay
 - A few bad excursions
 - Beta always between -5 and +8 deg
 - Alpha always between -2.8 and +10.5 deg
