The Energy Kite

Selected Results from the Design, Development and Testing of
Makani's Airborne Wind Turbines

Part III, Technical Artifacts

Selected Decks From RPX Lessons Learned Reviews

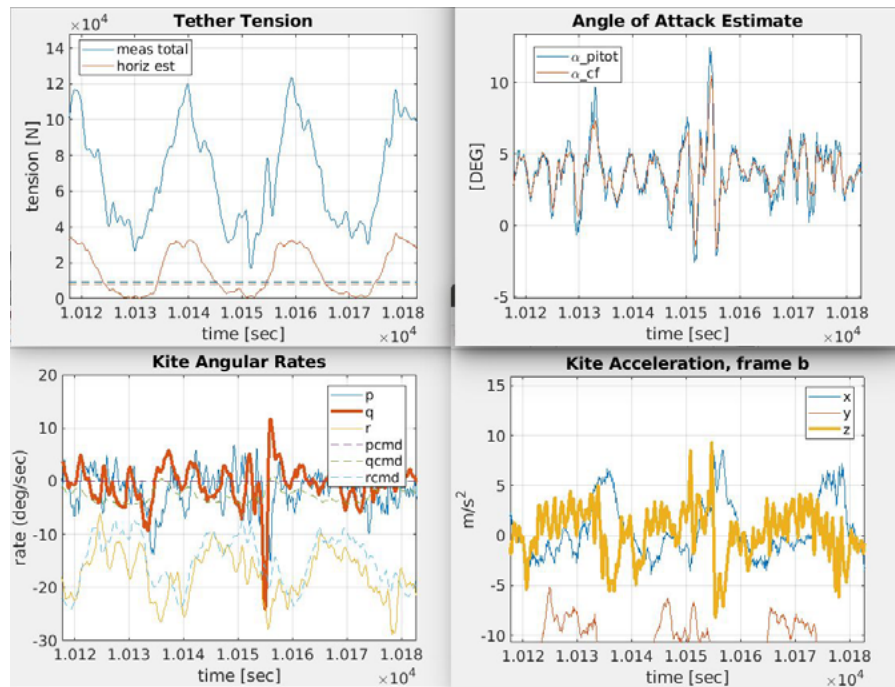
Alpha Excursion Beyond +10 Degrees in Loop 465

- This is our worst alpha excursion of CW08
- The event stands out due to
 - alpha
 - tension
 - kite pitch rate
 - kite heave acceleration
- Time scale shown here is approximately 3 loops
- Event is approximately 2:50:30 in the videos from CW08 day—see specifically “20190501 CW-08 - Onboard View of Makani M600 During Night Flight” on [YouTube playlist](#)

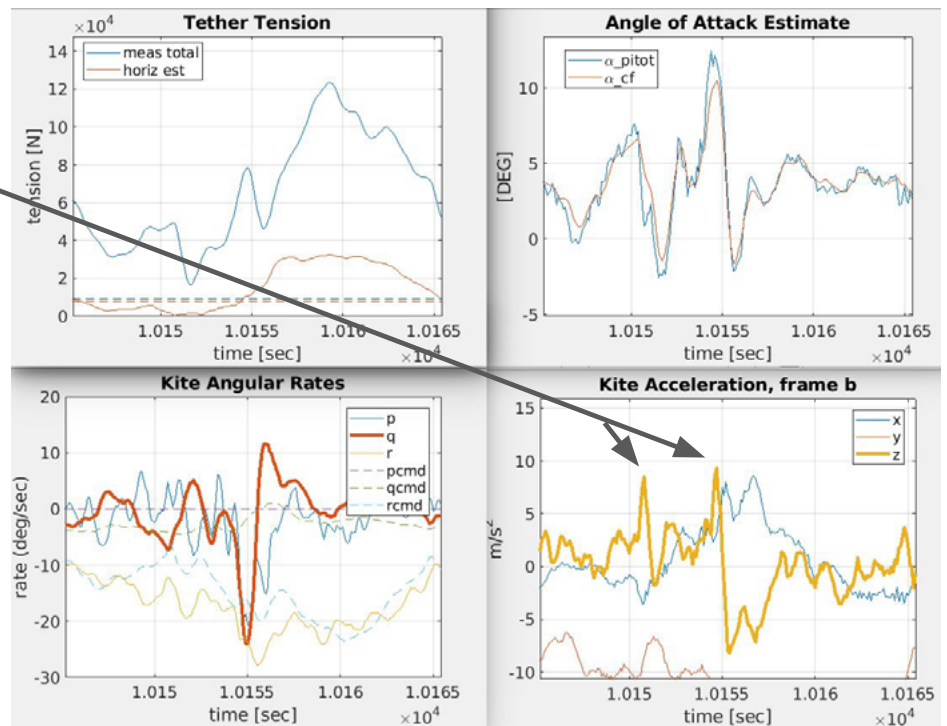
Loop 465 in Detail

- Sharp excursions toward positive z acceleration may indicate a sudden loss of lift
- Stall confirmed with video "20190501 CW-08 - Onboard View of Makani M600 During Night Flight" on [YouTube playlist](#)
- The large negative pitch rate is due to the stall

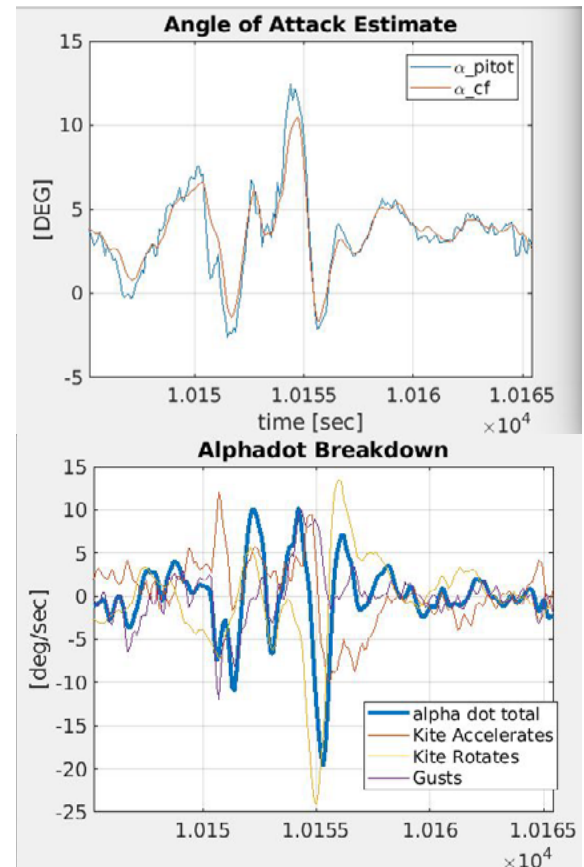
Reasons for Alpha Changes in Loop 465

It is possible to break down the contributions [see internal ref] to the time derivative of alpha (and beta). They come from three sources:

- The kite accelerates (accelerometers)
- The kite rotates (gyros)
- The wind itself changes (everything else)

In Loop 465 (and in general), kite accelerations and gusts are much faster than kite rotations from a $d/dt(\alpha)$ perspective. Gust causes the alpha excursions and stalls the wing a bit.

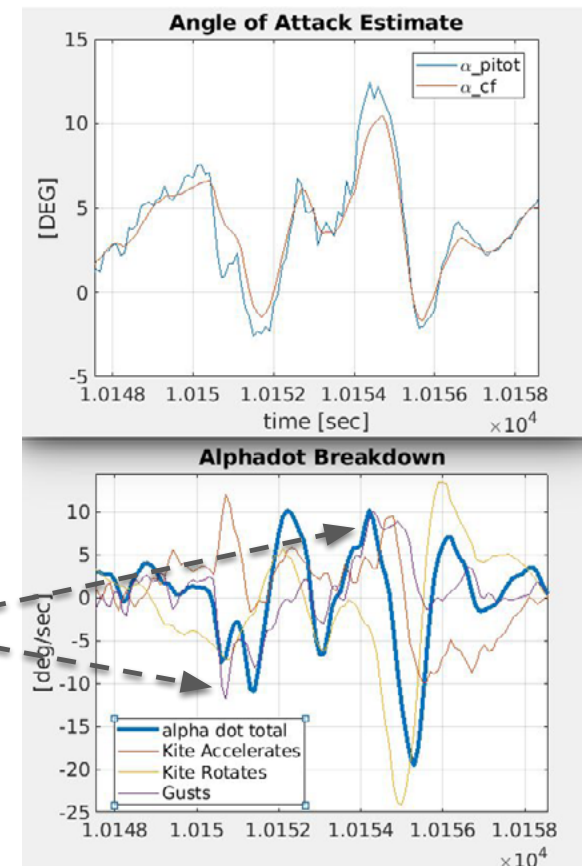
A Closer Look at $d/dt(\alpha)$ in Loop 465

- "Gusts" are every part of $d/dt(\alpha)$ which cannot be explained by measured kite motion
- The measured kite acceleration is > 0 for the time leading up to the large alpha excursion
 - For well-regulated constant alpha, the acceleration and rotation contributions cancel
- "Gusts" seem responsible for much of the high frequency content in $d/dt(\alpha)$

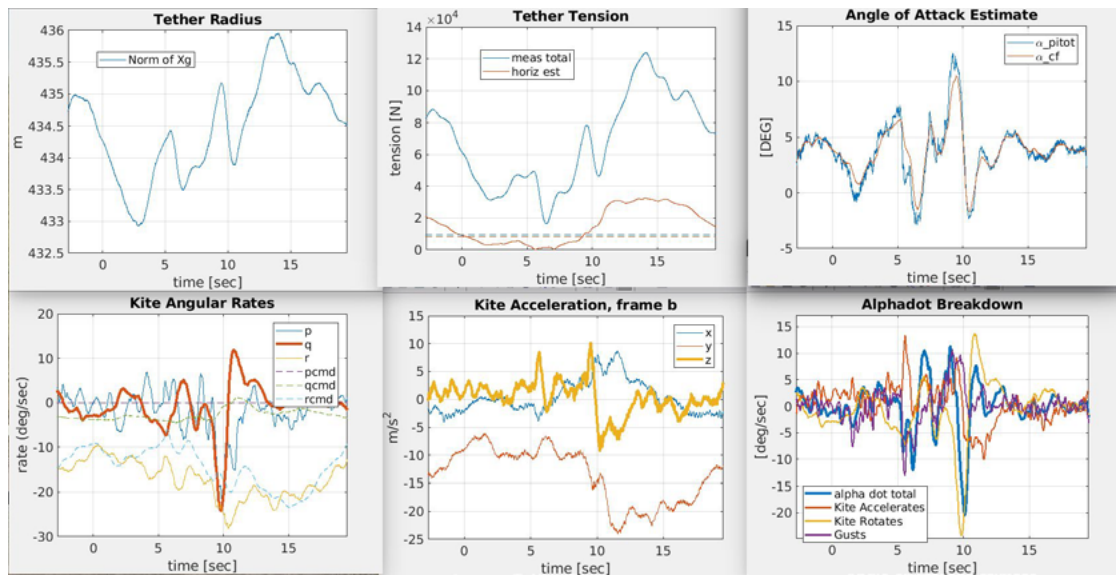
Overview of “The Event” in Loop 465

- Sharp gusts hit the wing at the start of the downstroke
- The gusts changed angle of attack primarily
- Much of the wing stalled when angle of attack went beyond +10 degrees
- Captured on video “20190501 CW-08 - Onboard View of Makani M600 During Night Flight” near 2:50:30 on [YouTube playlist](#)

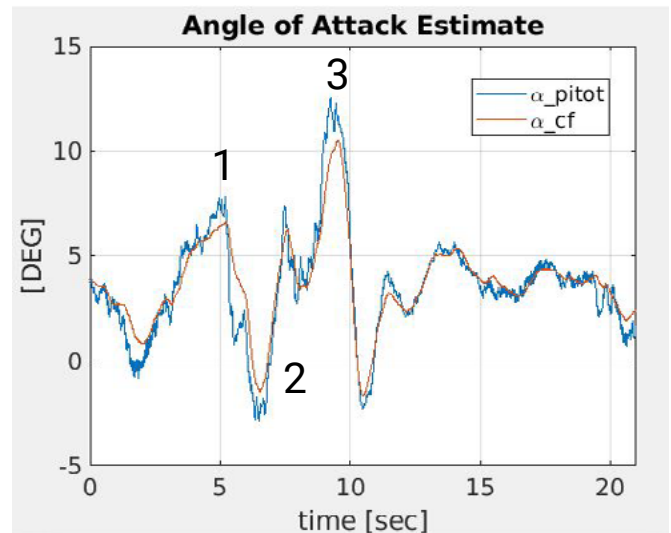
Order of Events in Loop 465

1. A gust swiftly reduces the kite’s angle of attack
 - a. The kite loses lift and accelerates “downward”
 - b. Tension drops
 - c. Kite moves 1 m toward the center of the sphere
 - d. Elevator responds to the alpha error
2. Positive kite pitch rate develops in response to the elevator motion
 - a. Angle of attack reaches a minimum of -1 deg and then starts recovering

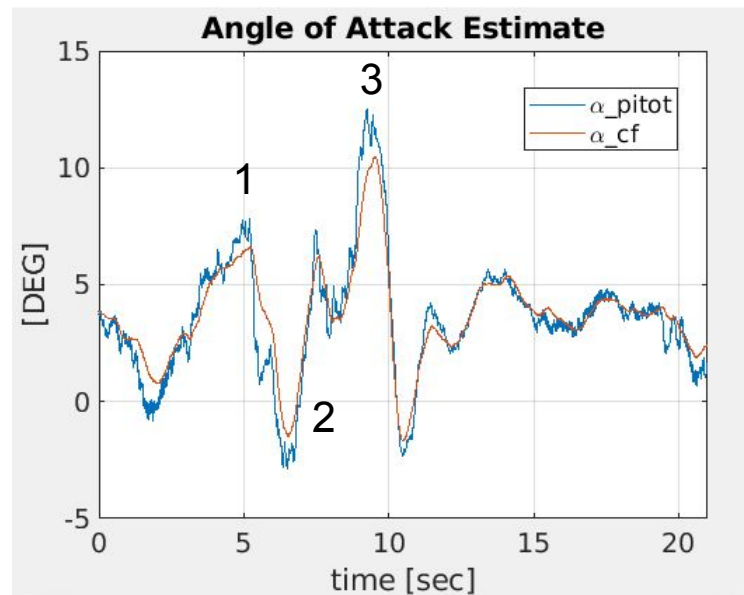
Order of Events in Loop 465

3. The opposite side of the gust arrives, sending angle of attack to over + 10 deg. The wing stalls.

- a. -20 deg/sec pitch rate, -20 deg/sec roll rate
- b. Big heave acceleration (loss of lift)
- c. Tension drops
- d. Kite moves 1 m toward the center of the sphere

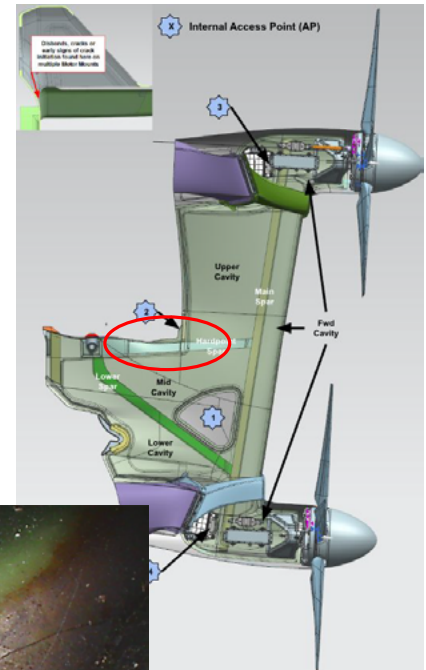
- Bug 132559403
- RH skin <-> hardpoint spar bond repaired after jazz hands - this crack did not grow
- Possible new cracks on LH skin <-> hardpoint spar bond (still collecting info)

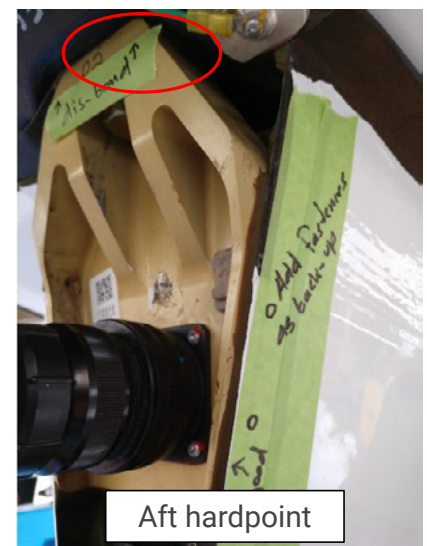
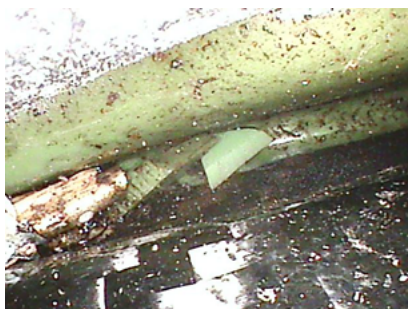
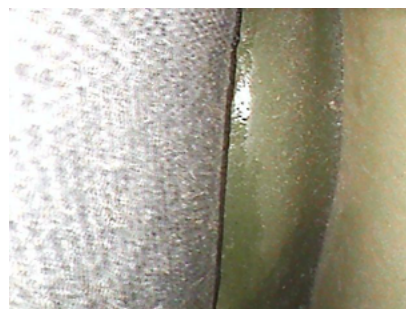
Pylon 2 - Aft Hardpoint Bond, Lower Nacelle

- Bug 132560583
- Also previously repaired from jazz hands incident
- Aft hardpoint upper bond separated
 - Partial separation from jazz hands, wasn't possible to repair: that's OK, joint is clamped by big bolt and is not a primary shear load path.
- Lower nacelle bond: still collecting more info about this

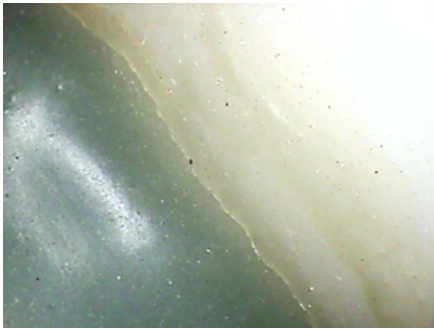
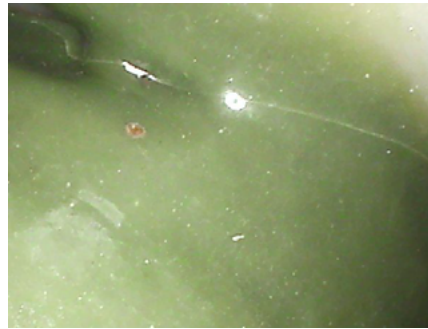
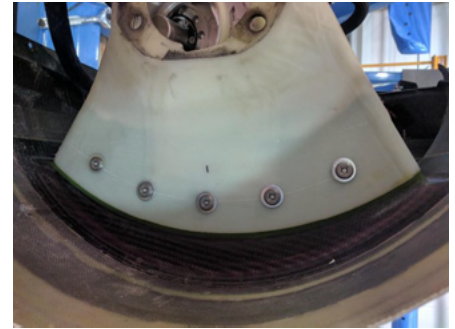
Pylon 2+3 - Motor Mount Bonds

- Bug 132559087
- This first appeared on SN2, fix was 5x fasteners through bond: applied to all pylons, regardless of cracks
- Plan: mark crack extent, inspect each flight unless short+benign.

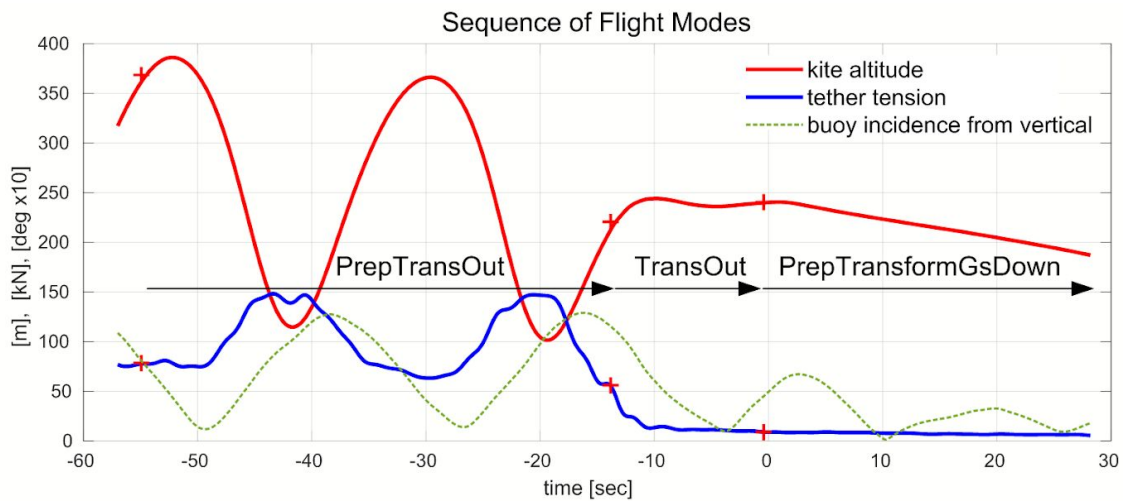
Fig. 1: Sequence of flight modes leading up to the loss of kite.

The kite lost attitude control during the maneuver to get in position where the ground station can transform into the reel-in configuration. This flight mode is "PrepTransformGsDown." The sequence of flight modes leading up to this mode is shown below. The last crosswind flight mode before transitioning to hover is flight mode "PrepTransOut." There, the kite flies large loops, tether tensions are high. The buoy rocks in sync with the tether tension. The path planner lowers the loop center to target a favorable transout height. The kite then transitions to hover mode in flight mode "TransOut." The tether tension decays rapidly as the kite comes to a stable hover at a constant altitude. The buoy motion decays, but still persists. In "PrepTransformGsDown," the kite lowers its altitude while traversing to get into position for the ground station transformation. For FCW-01 this was the last automated flight mode before the pilot assumed control of the flight.

The system operated, mostly nominally, until PrepTransformGsDown; many of the plots in this analysis zero the timescale when the system enters that last flight mode.

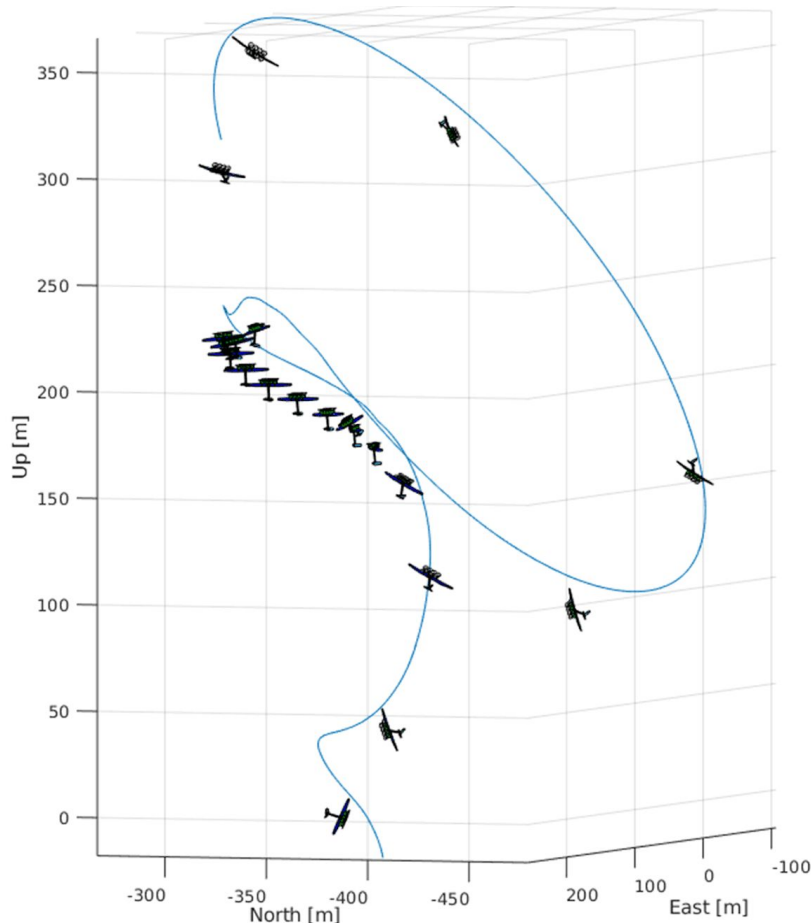
Fig. 2: The kite's trajectory before the loss of the kite.

In FCW-01, the autonomous flight controller lost control of the kite's roll attitude, then the kite's yaw attitude, and consequently lost the kite to the Atlantic Ocean. The kite had just transitioned from crosswind flight to hover mode. It was preparing for the tether reel-in operation. In this "PrepTransformGsDown" flight mode, the kite hovers to a position to hold the tether in place so the Ground Station can transform from "the anchoring the tether for crosswind" configuration to the "reeling" configuration. To reach this position, the kite lowers its altitude while simultaneously translating sideways. After 22 seconds, the kite begins to overcome the bridle moment and roll away from the tether. About 28 seconds into PrepTransformGsDown mode, the pilot took over control but could not successfully stabilize the kite. Fig. 2 shows the trajectory of the final moments of the flight. A video of the end of the flight can be seen in the video "FCW-01 end of flight," available on the X Development YouTube channel, in the Makani playlist.

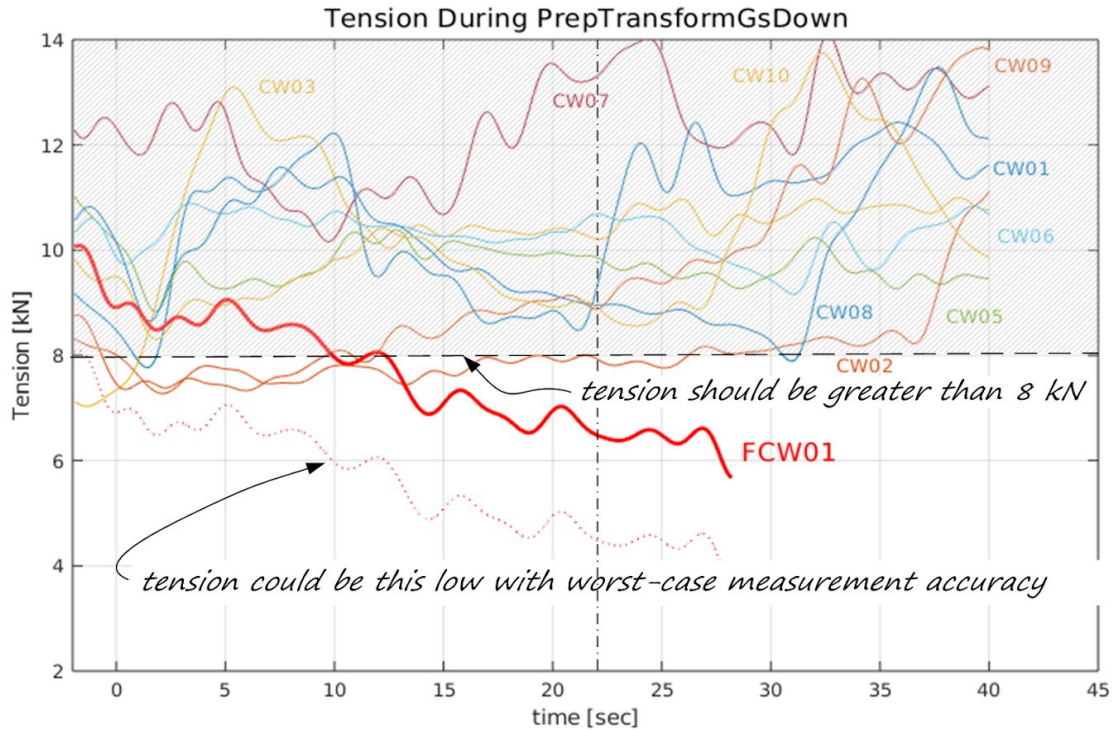
Fig. 4: Total tether tension, low-pass filtered, during PrepTransformGsDown.

FCW-01 lost tether tension steadily after transitioning from crosswind flight into hover. Tether tension became too low for the bridle to stabilize roll. The kite overcame the restoring bridle roll moment and eventually crashed. Fig. 4 below graphs tension vs. time for FCW-01 with kite YM600-05, compared to previous successful crosswind flights at Parker Ranch with kite YM600-04. (For clarity the data is low-pass filtered with a zero-phase non-causal filter with a 0.1Hz cutoff). Some flights start at lower tension than FCW-01. These flights eventually exceed the requisite minimum tension of 8 kN, while

FCW-01 steadily loses tension. The tension measurement based on load cells is somewhat inaccurate, it can be up to 2 kN off. The line on the bottom of the graph shows the measured tension of FCW-01 with the worst-case offset of 2 kN. Fig. 5 shows the horizontal tension component.

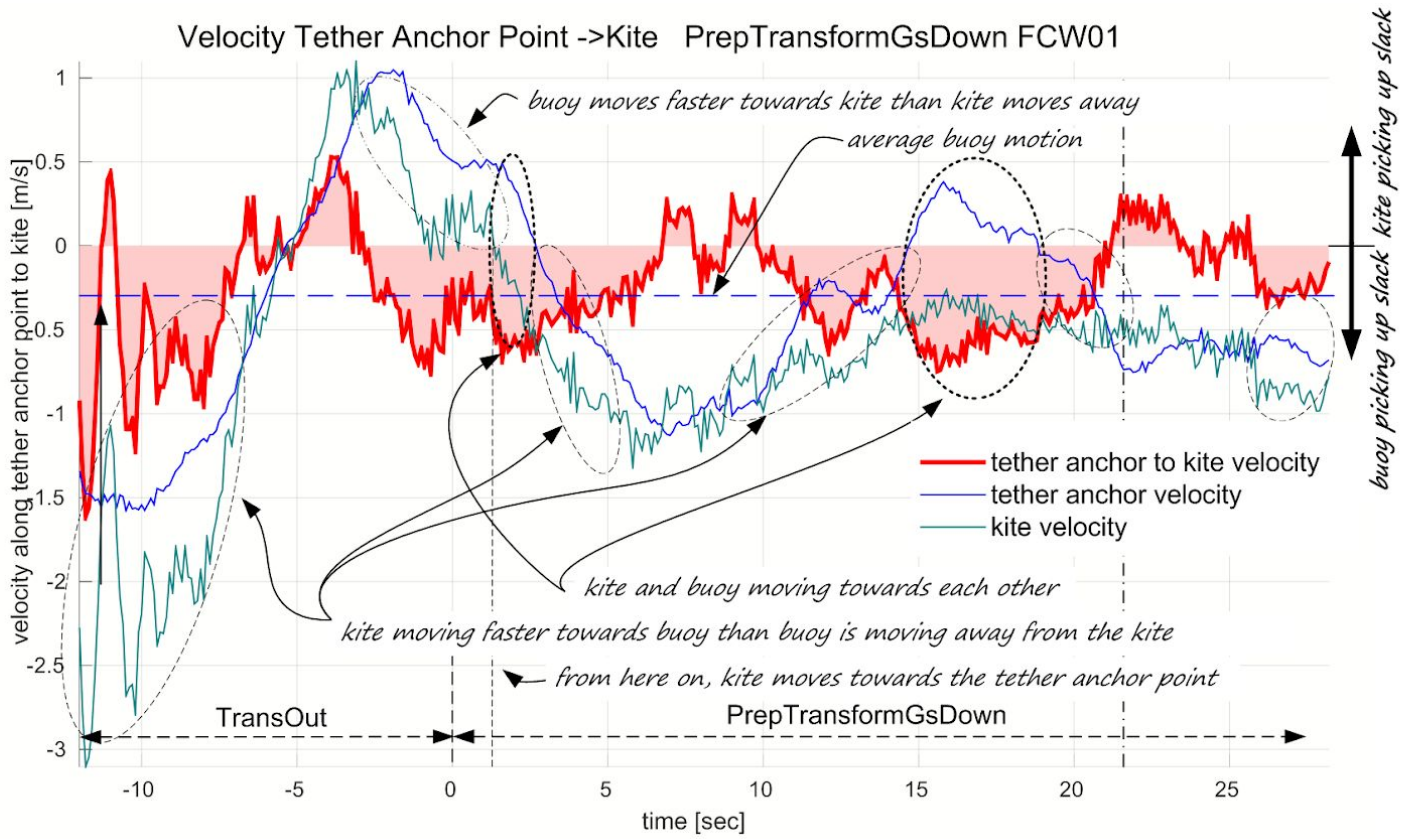
Fig. 8: Velocity components along the direction of the tether anchor to the kite. The shaded area indicates the distance is shortening, thus lowering tension.

Fig. 8 below shows plots of the velocity components of kite and buoy along the direction from anchor point to kite, i.e. the components that contribute to the change in tether radius. These components are in the range of 1 meter/second, with a net difference around 0.5 meter/second. This compares to the kite descending at 2 meters/second while translating around 4 meters/second (see plots). The buoy motion, that was in sync with the kite’s crosswind loops, is now decaying and rocking with a period of about 17 seconds. At the same time, the mooring lines are slowly retracting the buoy at an average rate of 0.3 meters/sec now that the crosswind tension has subsided. Due to its rocking motion, the buoy does at times slacken the tether. In the plot, zero velocity indicates constant tautness, positive kite velocities correspond to the kite moving away from the buoy, negative anchor velocities correspond to the anchor point moving away from the kite. If the kite velocity is more negative than the anchor point velocity, the kite is closing in on the buoy and tension will drop. If the anchor point velocity is more positive than the kite velocity, the buoy is closing in on the kite and tension will drop. On the average, kite and buoy are moving towards one another.

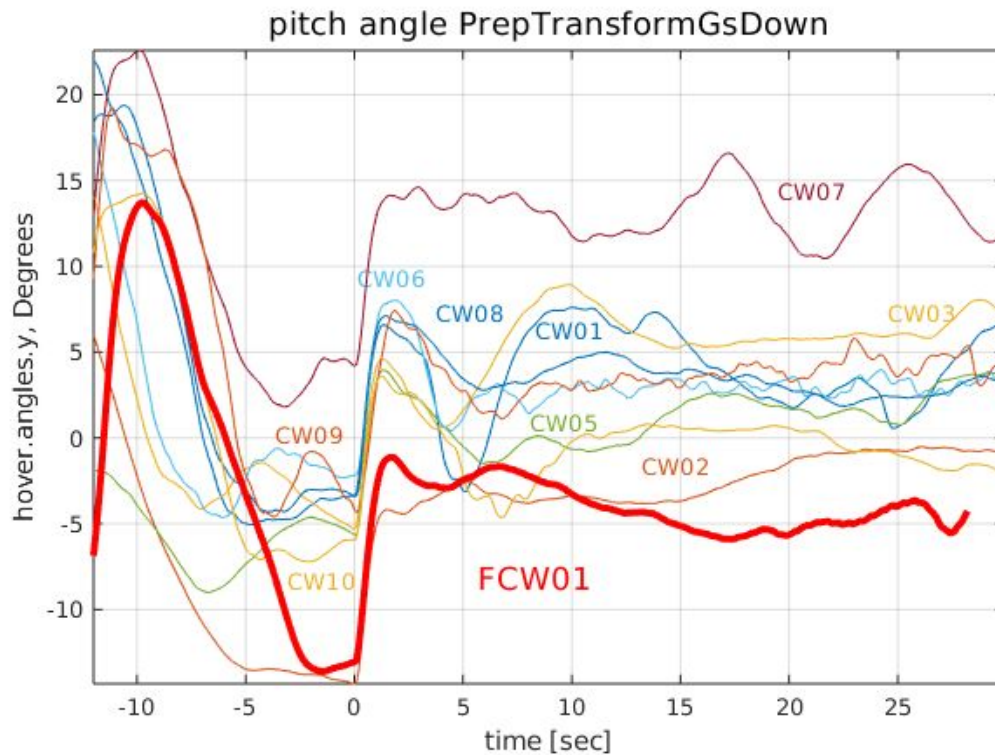
The plots below show the pitch angle for FCW-01 and previous on-shore flights at Parker Ranch. The step change at time 0 is the result of a change in pitch integrator limit from -20° to -7° at the transition into the PrepTransformGsDown flight mode. Other than CW-02, all flights started at a more positive pitch angle. CW-02 had, however, the benefit of a lower TransOut height. The more favorable bridle geometry resulted in a more stable operating regime for the PrepTransformGsDown operation in CW-02, roll and yaw stability were maintained throughout (see [Tether pitch contours from catenary equations](#)).

Fig. 9: Pitch angle during TransOut and PrepTransformGsDown.

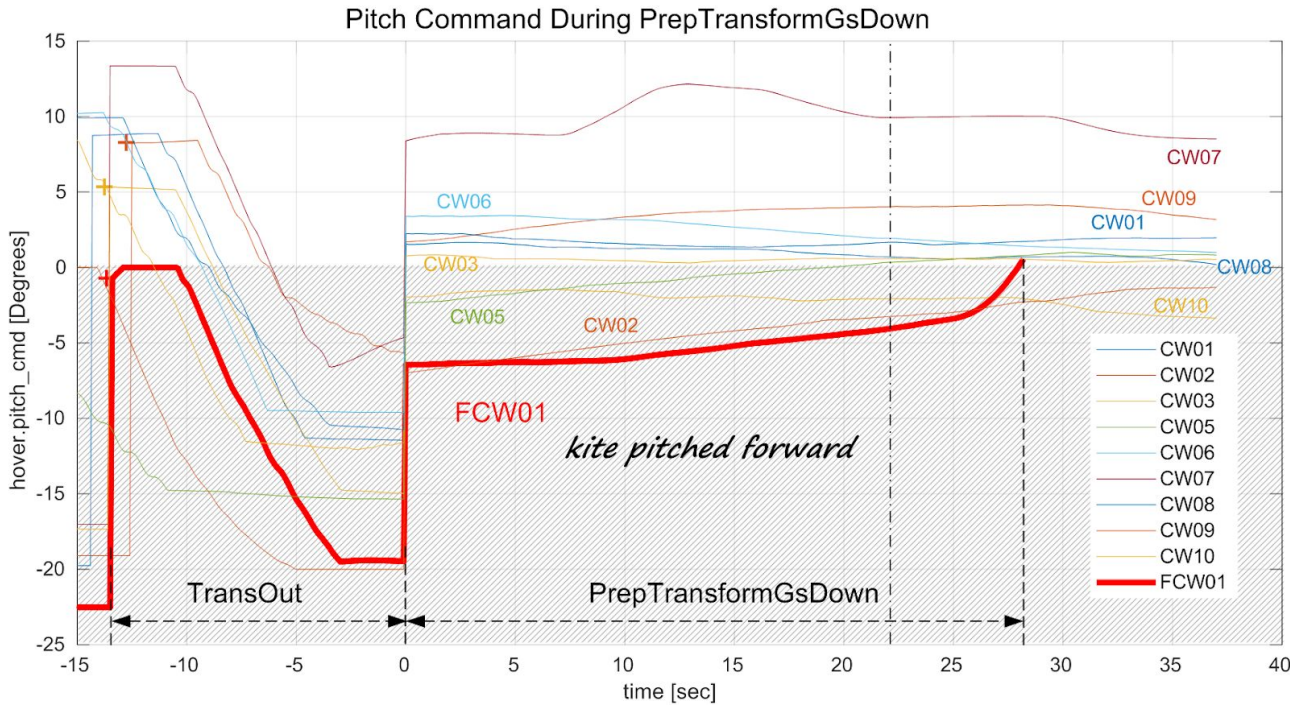
Kite remains pitched forward despite low tension during PrepTransform Down

Even though tension is steadily decreasing, the pitch command produced by the tension controller remains negative during PrepTransformDown.

Fig. 10: The pitch commanded by the tension controller.

Maximize tension regulation bandwidth within allowable stability margins to counteract tension disturbances caused by unpredictable kite and tether motion.

This corrective action should address the regulation problem described in [Kite remains pitched forward despite low tension during PrepTransform Down](#). One difficulty associated with increasing regulation bandwidth is that the C-Sim does not capture the tether dynamics that predict the stability of the tension controller. In test flight HH-1 a sustained oscillation of the tether elevation loop was observed that is not predicted by the C-Sim. A better model of the system needs to be created to design and test feedback controllers against. A plan to experimentally identify the dynamics (Hover System ID Test Plan) is under development. Once a model has been derived from flight test data, it should be possible to design a feedback regulator and test it against the identified model.

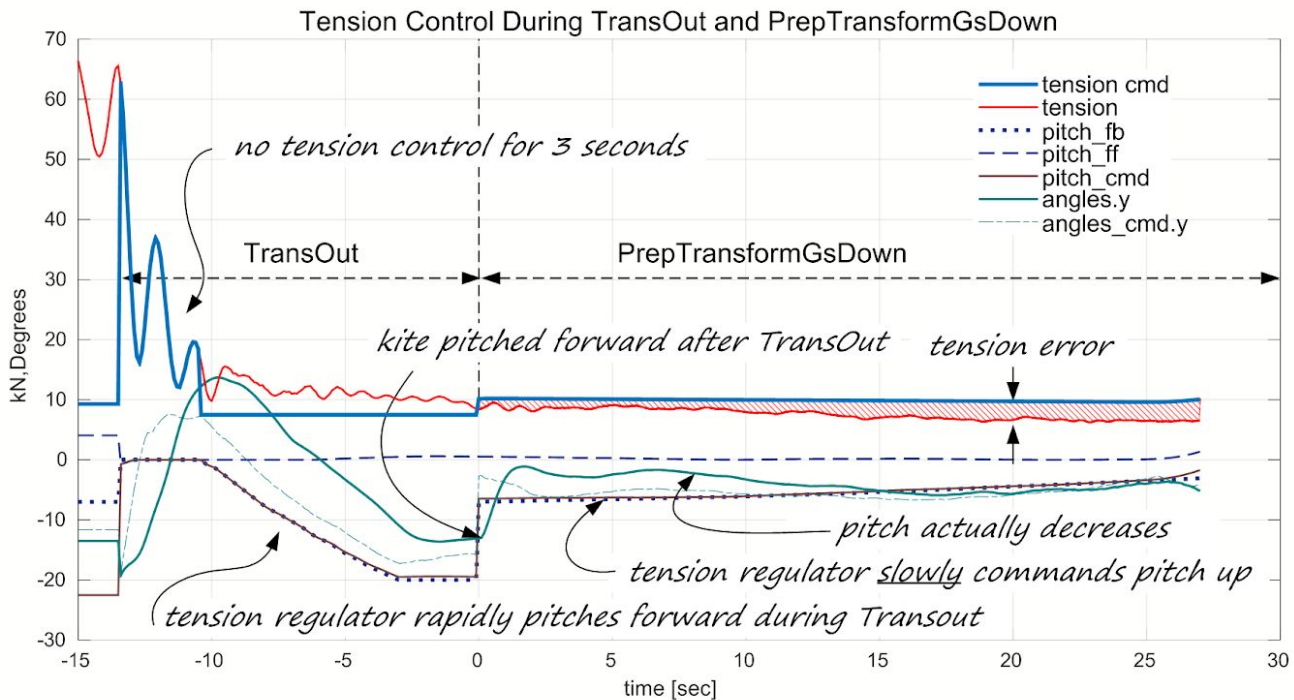
The operation of the tension controller leading up to the crash of FCW-01 is shown in the figure below. Three seconds after entering the TransOut mode, the controller aggressively pitches the kite forward at a rate limit, since the rapidly decaying tether tension is higher than the setpoint and the integrator gain is high. The flight mode moves from TransOut to PrepTransformGsDown when the Kite has finished the TransOut flare and hovering at nominally zero velocity. At that flight mode transition, the tension reference is increased, regulation gains are lowered and the forward pitch limit on the integrator is adjusted from -20° to -7° . The tension regulator now slowly acts to pitch back the kite to increase tension, about 2.5° in 22 seconds. At maximum thrust of 28 kN, this change in pitch is good for about 1.2 kN in horizontal tension. However, the pitch, also commanded by the hover position controller with radial velocity damping, actually decreases the pitch angle. Tension continues to drop.

Fig. 12: Tension control during TransOut and PrepTrasformGsDown.

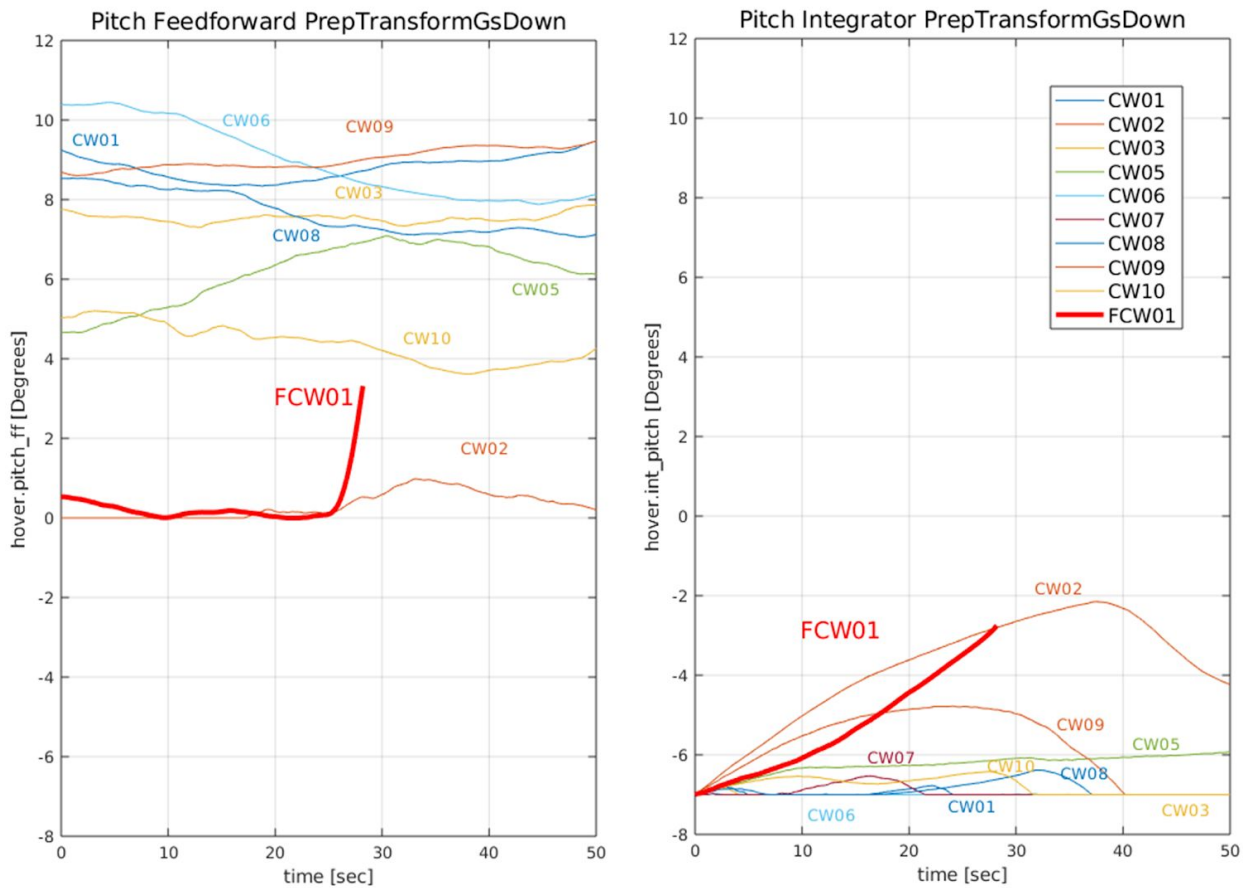
The pitch feed-forward is combined with pitch integrator feedback to form the pitch command shown in Fig. 10. The feed-forward pitch command attempts to command the correct pitch angle to achieve the desired horizontal tether tension, taking into account the aerodynamic force on the wing and the tether, the mass of the kite and tether. Many past flights achieved commanded (or higher) tensions in the PrepTransformGsDown mode based on the feed-forward commands. The feed-forward compensated for the pitch feedback commanding a strong forward pitch after TransOut. The pitch integrator, usually starting at the pitch forward limit of -7° , typically ramps up slowly. The fastest rate seen on past flights is CW-02, which started at a similar initial pitch as FCW-01, is about 3 degrees in 16 seconds. Compare that to CW-10 (appendix G). The (excessive) feed-forward in CW-10 puts the pitch at the requisite pitch angle to maintain tension immediately.

Flights CW-01, CW-05, CW-06, CW-08 and CW-10 were at the commanded tether tension at the 15 second mark in these figures.

Fig. 13: Pitch feed-forward and pitch feedback components of the pitch command.

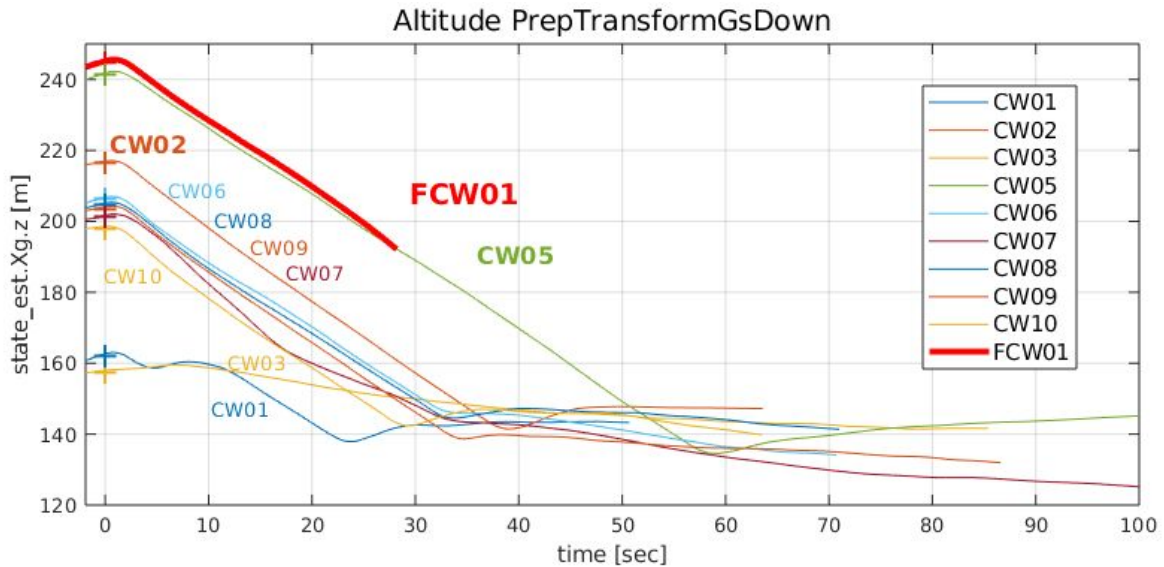
Flight FCW-01 transitioned from crosswind to hover at a comparatively high altitude of 245 meters (applying a 20 meter correction motivated in the next section). Flight CW-05 had a similar TransOut height but maintained tension and remained in control. A more detailed analysis is in [Appendix E: FCW-01 comparison with CW-05](#).

Fig. 14: TransOut Altitudes during PrepTransformGsDown (20m correction applied to FCW-01).

The series of changes that address lowering the TransOut altitude are described in ECR 480. These incorporate changes that cause the kite to transition from crosswind to hover at lower altitudes and at slower speeds. The control strategy during the TransOut flight mode has changed: rather than attempting to control tether tension in the transient phase from crosswind to hover, the hover controller commands a constant pitch.

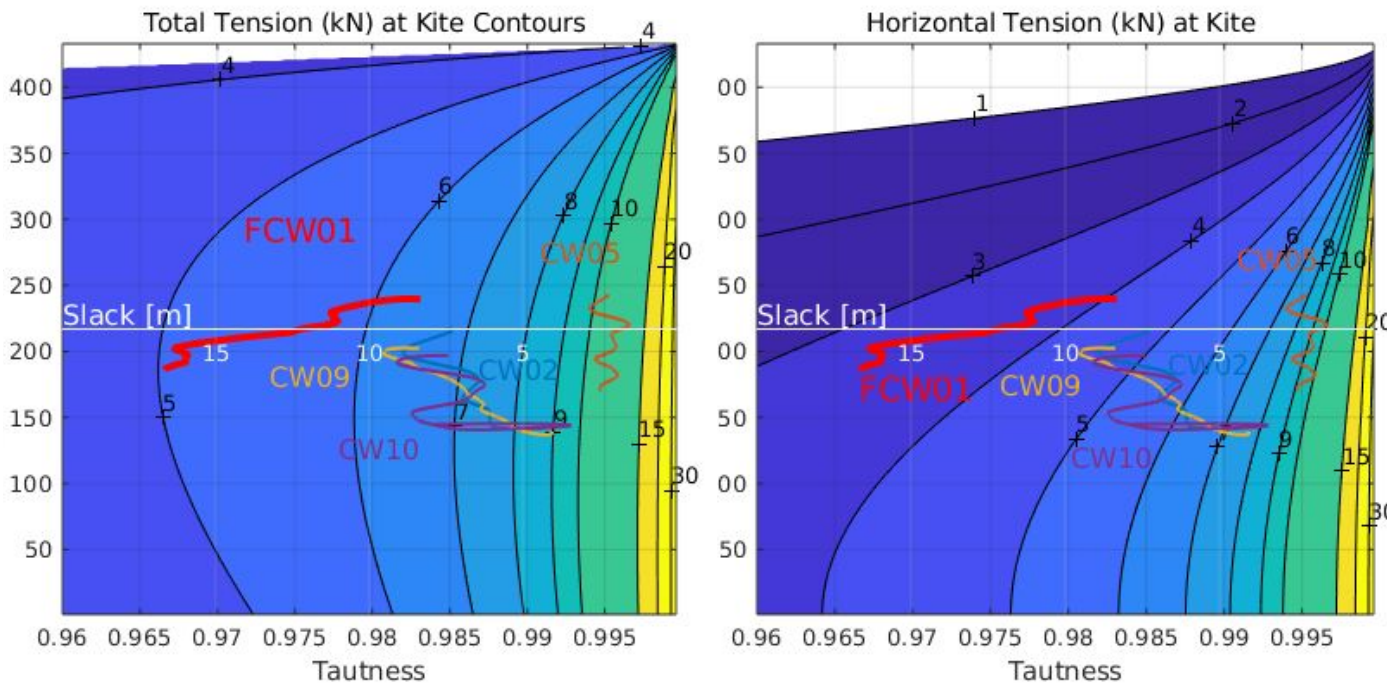
A contour plot of the total tether tension at the kite for a tether of 433 meters with a linear mass density of 0.917 kg/m is shown in Fig. 16 below. Tether tautness is defined as the total effective tether length (including the bridle) divided by the tether radius (the distance between anchor point on the ground and the effective attachment point on the kite, Fig. 6). A transout height of 240 meters requires a tautness of 0.9906 (~4.1 meter slack) for 8 kN tension. A tautness of 0.9805 (~8.4 meter slack) yields 6 kN. This 2kN change in tension corresponds to a change in tether radius of about 4.3 meters. Recall that during FCW-01 the kite closed in on the tether ground anchor point at around 0.5 m/sec for 10 seconds at a time (Fig. 8) and the radius decreased by 7 meters (Fig. 7).

The horizontal tether tension component provides the actual roll stabilization when the kite is hovering in the nominal upright position. It becomes substantially more difficult to generate the horizontal tension at high altitudes since the kite has to carry more of the tether and the tether has to be stretched tauter to achieve a given horizontal tension. The horizontal tension contour plot in Fig.15 below shows the tautness required to maintain horizontal tension at altitude. The contours show at 240 meters a tautness of 0.992 (slack of 3.46 meters) gives a horizontal tension component of 6 kN. At 150 meters, a tautness of 0.987 (slack of 5.6 meters) gives the same tension.

Fig. 15: Tether tension contours from catenary equations.

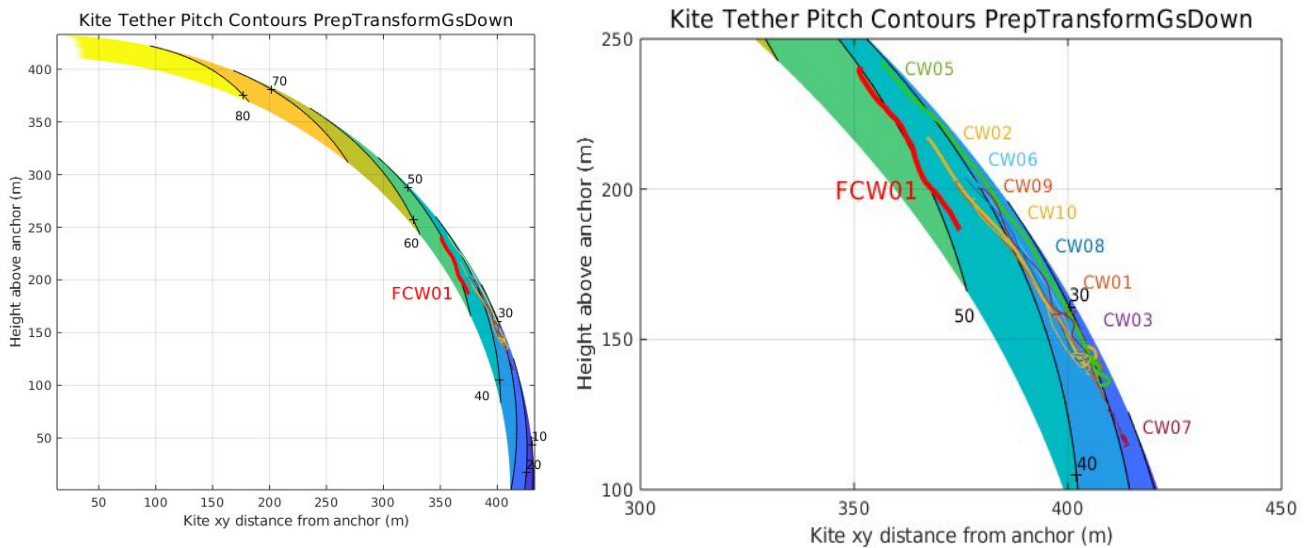
It is harder to generate horizontal tension at higher altitudes as the bridle geometry becomes less favorable for producing stabilizing roll moments. At 0°, all the tension is in the horizontal direction and works to counter roll. At more inclined angles, the horizontal tension is reduced and tether tension increasingly couples into yaw moment. A tether pitch angle of -45° or better is considered the safe operating region of the kite.

Fig. 16: Tether pitch contours from catenary equations.

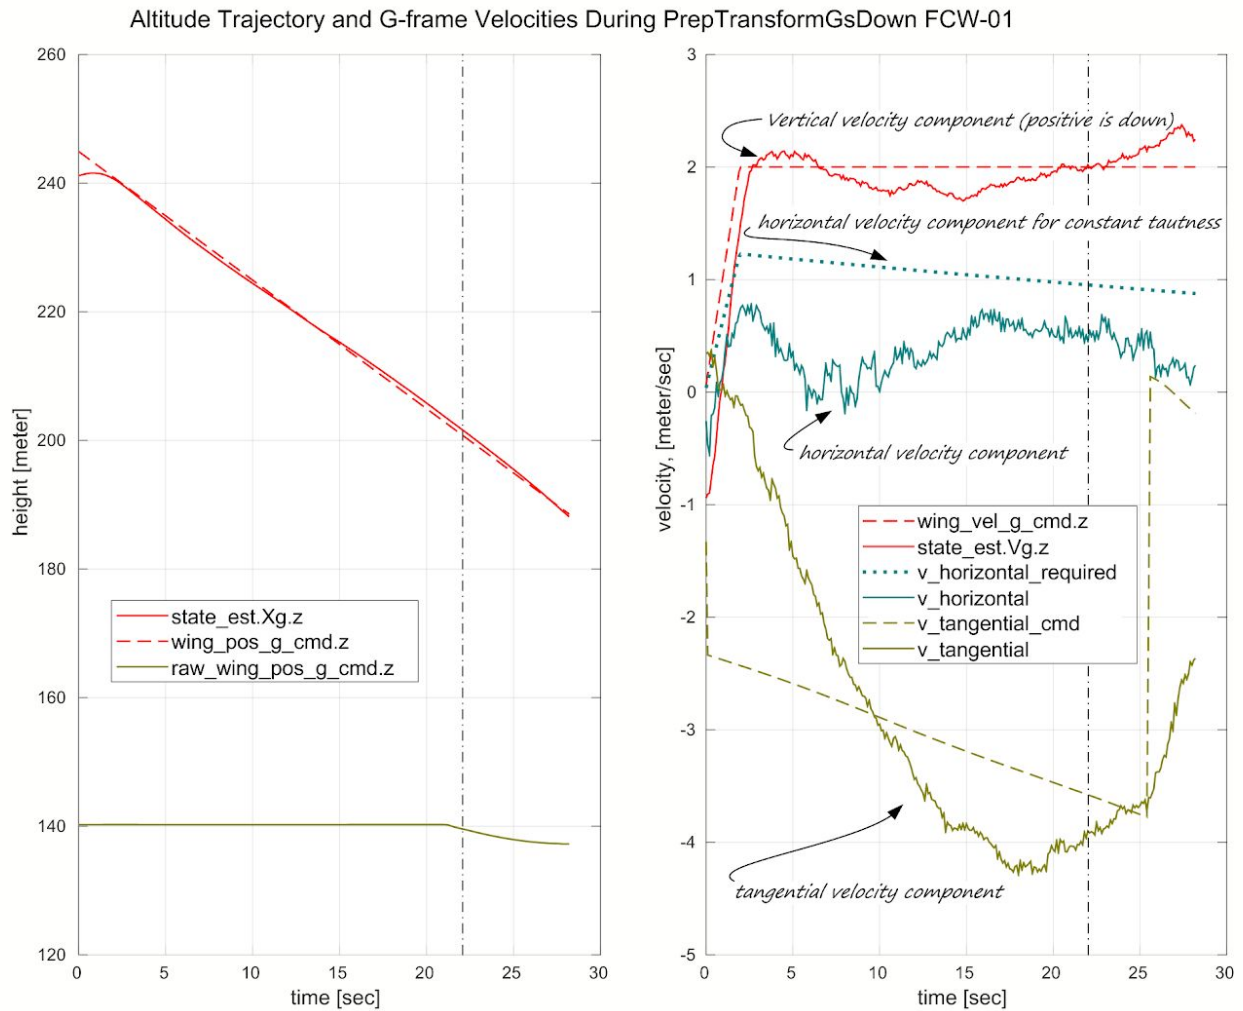
FCW-01 descends at 2 meters/sec. The figure below compares the horizontal velocity component required (assuming a fixed anchor point) to maintain tautness to the actual velocity achieved. In the 22

seconds the radial velocity is about 0.5 m/sec less than it should be to maintain the initial tautness at the beginning of PrepTransformGsDown.

Fig. 18: The radial velocity component required to maintain tautness and actual radial velocity.

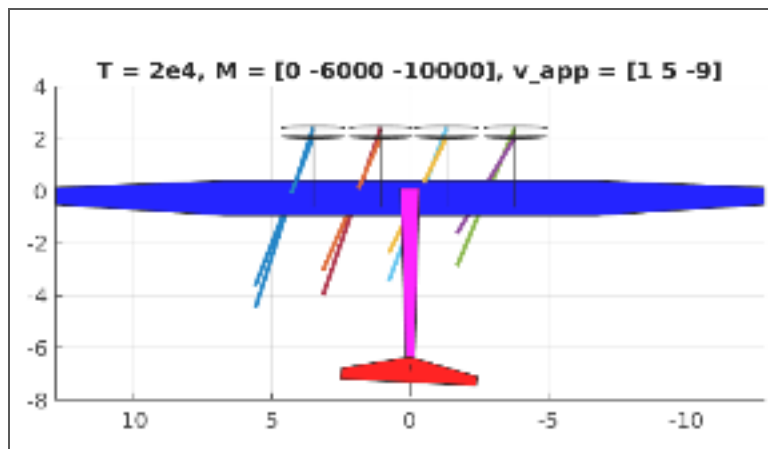
The rotor wake is blown towards the starboard wing as the kite traverses to the position for the ground station transform. This creates an asymmetric lift and induces a roll moment (see Fig. 19).

Fig. 19: Sideslip induces roll moment due to asymmetric lift from rotor wake.

The exact formulation for a model for this induced roll moment is still under investigation. Some observations and simulations can be found in Rotor Wake Directions In M600 Hover. It is hypothesized that the roll moment arises due to asymmetric blown lift on the wing. The asymmetry is hypothesized to be caused by both Rotor Yawing Moment and by Kite Sideslip. The related bug is: <http://b/139670231> Why did the kite develop a negative roll rate in FCW01 PrepTransformDown?

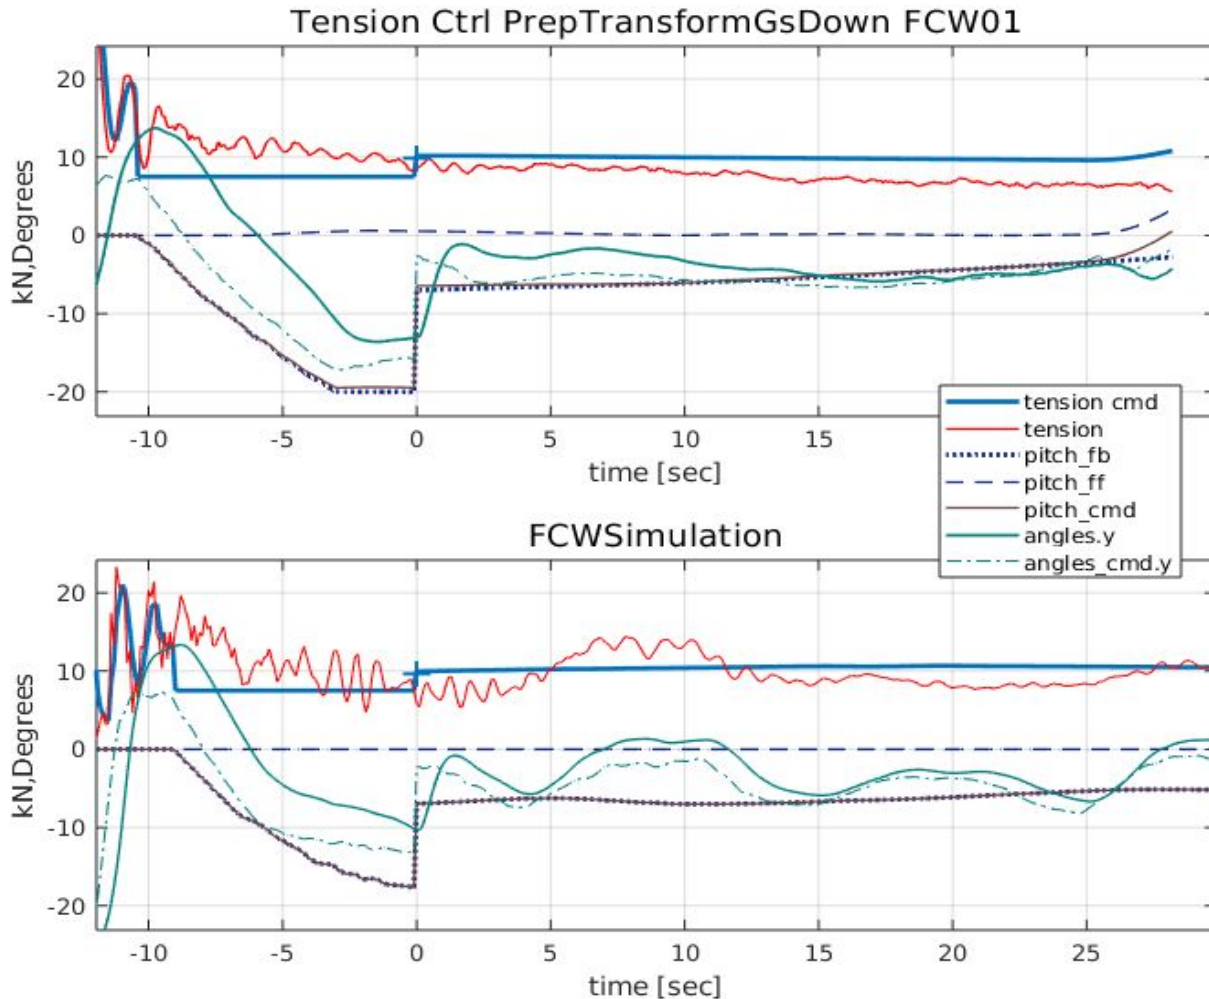
The C-Sim did not predict the tensions accurately in the TransOut and PrepTransformGsDown flight modes. Below is a plot comparing tension control for the flight and a C-Sim simulation. Tension is fluctuating, but not trending lower.

Fig. 20: The C-Sim predicts adequate tension during PrepGsTransformDown.

CA7 Corrective Action: Improve fidelity of Buoy-Kite interaction in the C-Sim
 The parameters in the C-Sim (for damping, spring constants) should be adjusted based on the observed values in FCW-01 to better predict the kite-buoy interaction.

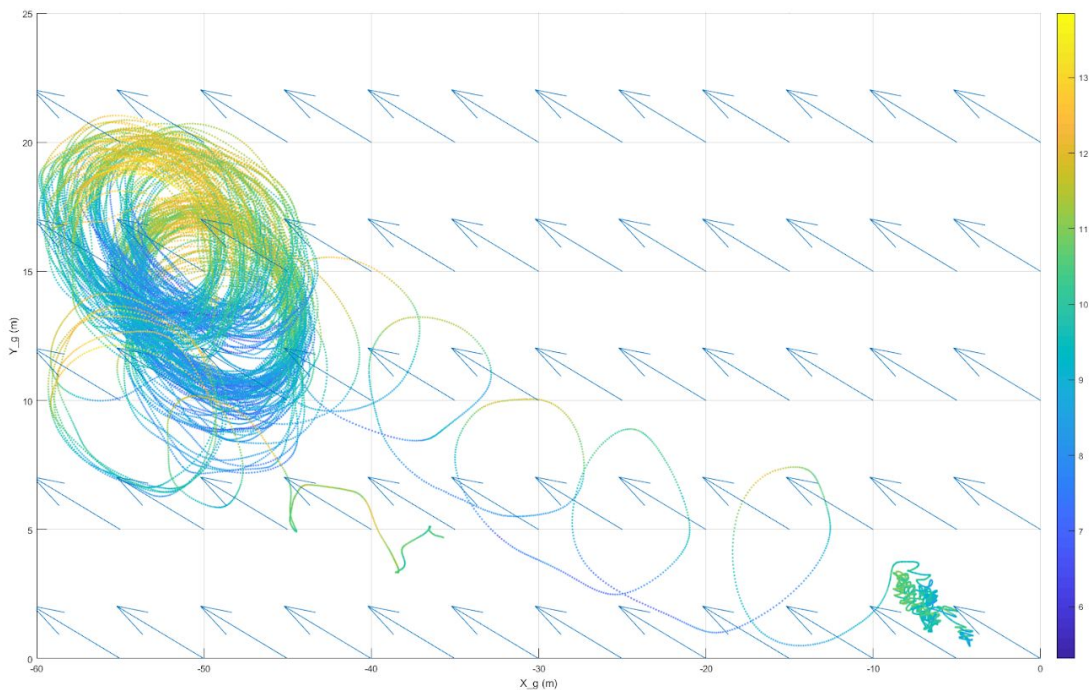
Fig. 24 shows the amplitude of raw GS wind speed measured along the GS trajectory during FCW-01. The blue arrows are representing the average wind direction during the flight. This figure confirms that the GS drifts down wind during the flight. Also, it can be seen that the measured wind speed gets its minimum value when the GS is drift in the downwind direction. This supports the assertion that the wind data used by the controller is valid and did not contribute to the loss of kite.

Fig. 24: Raw wind speed measurement along GS trajectory.
