The Energy Kite

Selected Results from the Design, Development and Testing of
Makani's Airborne Wind Turbines

Part III, Technical Artifacts

Selected Decks From RPX Lessons Learned Reviews

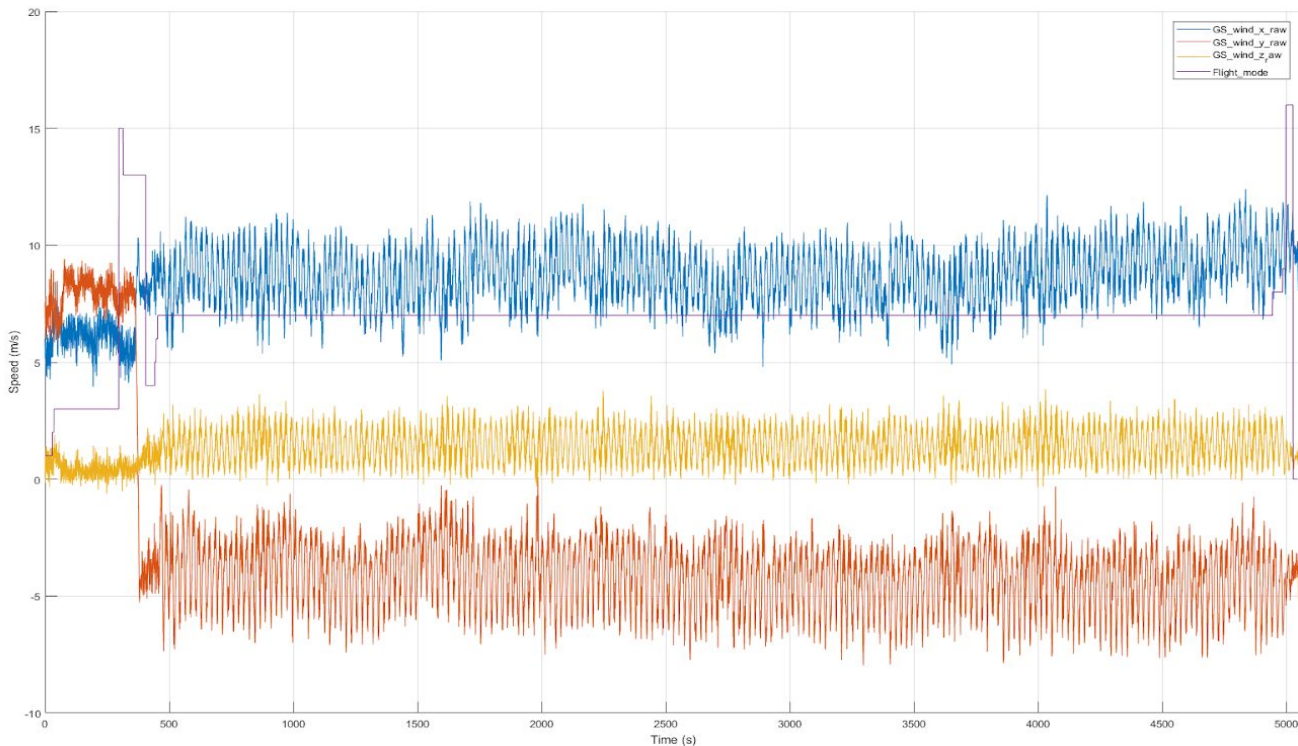
Fig. 25: Raw wind speed measurements during the flight.

1. There is a step change in both x and y velocity measurement at around 400sec. This was caused by the rotation of the ground station when the kite paid out.
2. There are ringing features when the kite was in crosswind flight mode (`flight_mode = 7`). This is caused by circular motion of the buoy.
3. After trans-out (at around 5000 sec), the raw wind data returned to those values close to those prior to trans-in (around 440 sec). This suggests the wind speed and direction doesn't change too much during the FCW-01.

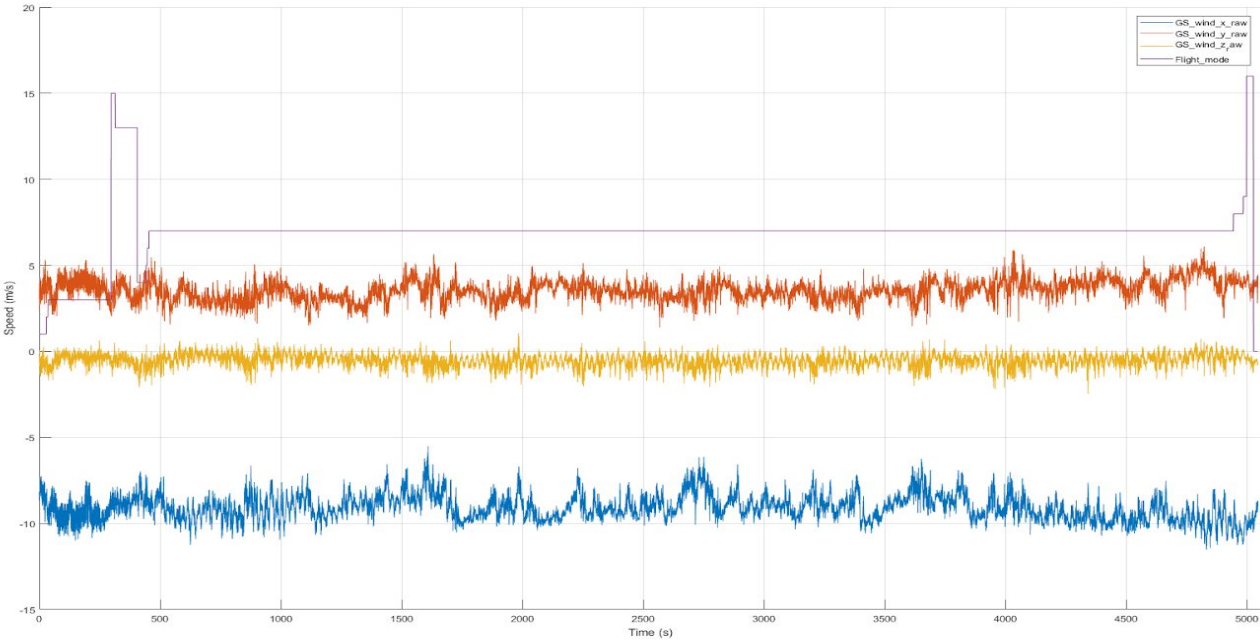
The raw data from the wind sensor were fed to the controller which transformed the data into the ground frame. Fig. 26 shows filtered wind data in the ground reference frame. The step change due to ground station rotation and ringing feature during crosswind can't be found in this plot. It implies that the ground station motion was removed from the raw data.

Fig. 26: Wind speed measurements corrected for platform motion.

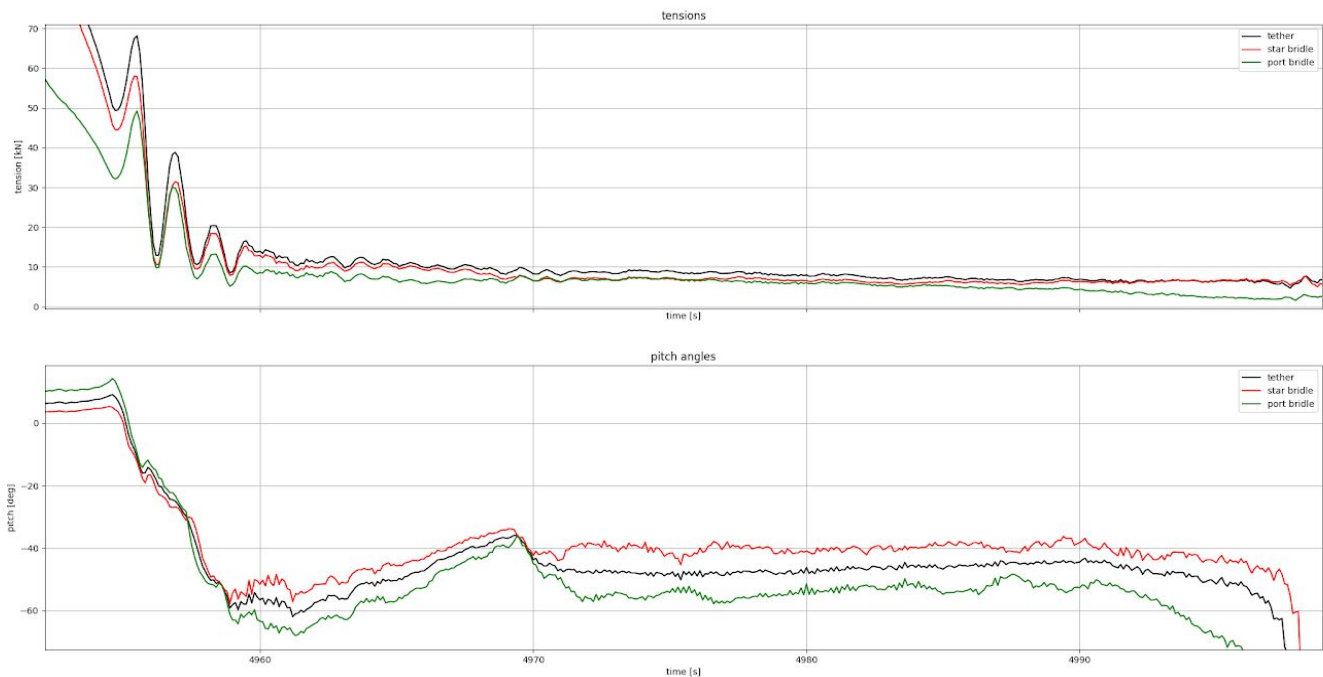
The load cell measurements are also used to calculate tether pitch angles. The pitch angles on the bridles agree to within 10 degrees.

Fig. 27: Load cell measurements and pitch angle computations. The PrepTransformGsDown flight mode begins at time 4969

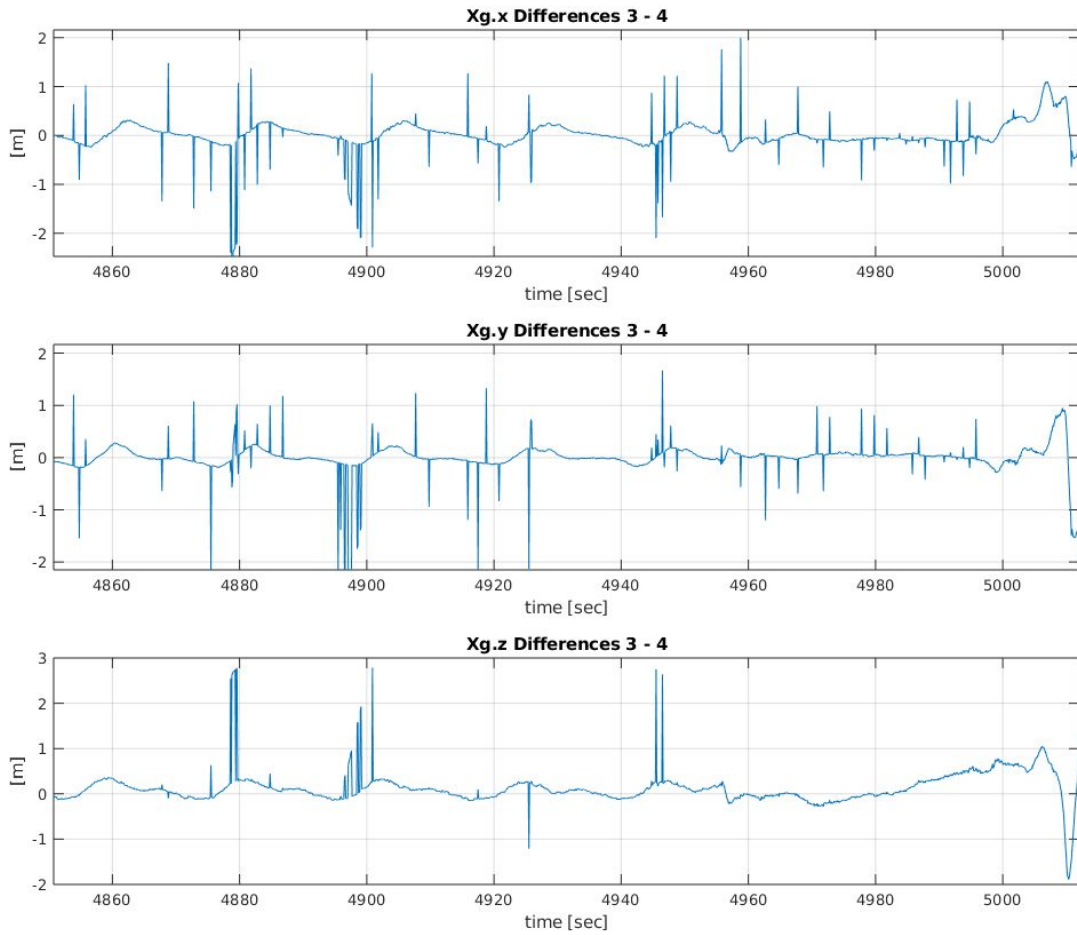
The GPS measurements differ by several meters during the flight.

Fig. 28: GPS Errors towards the end of the flight

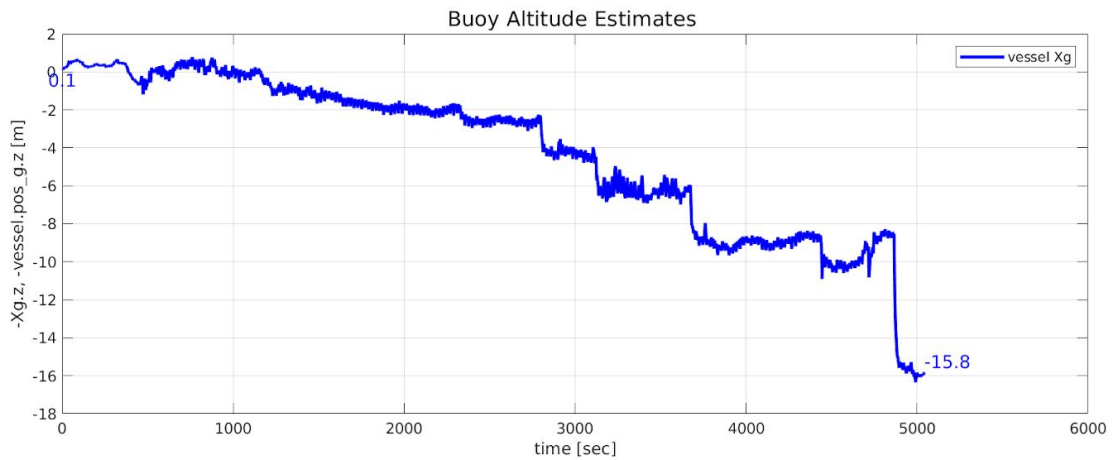
Fig. 29: The buoy altitude estimate drifts below sea level.

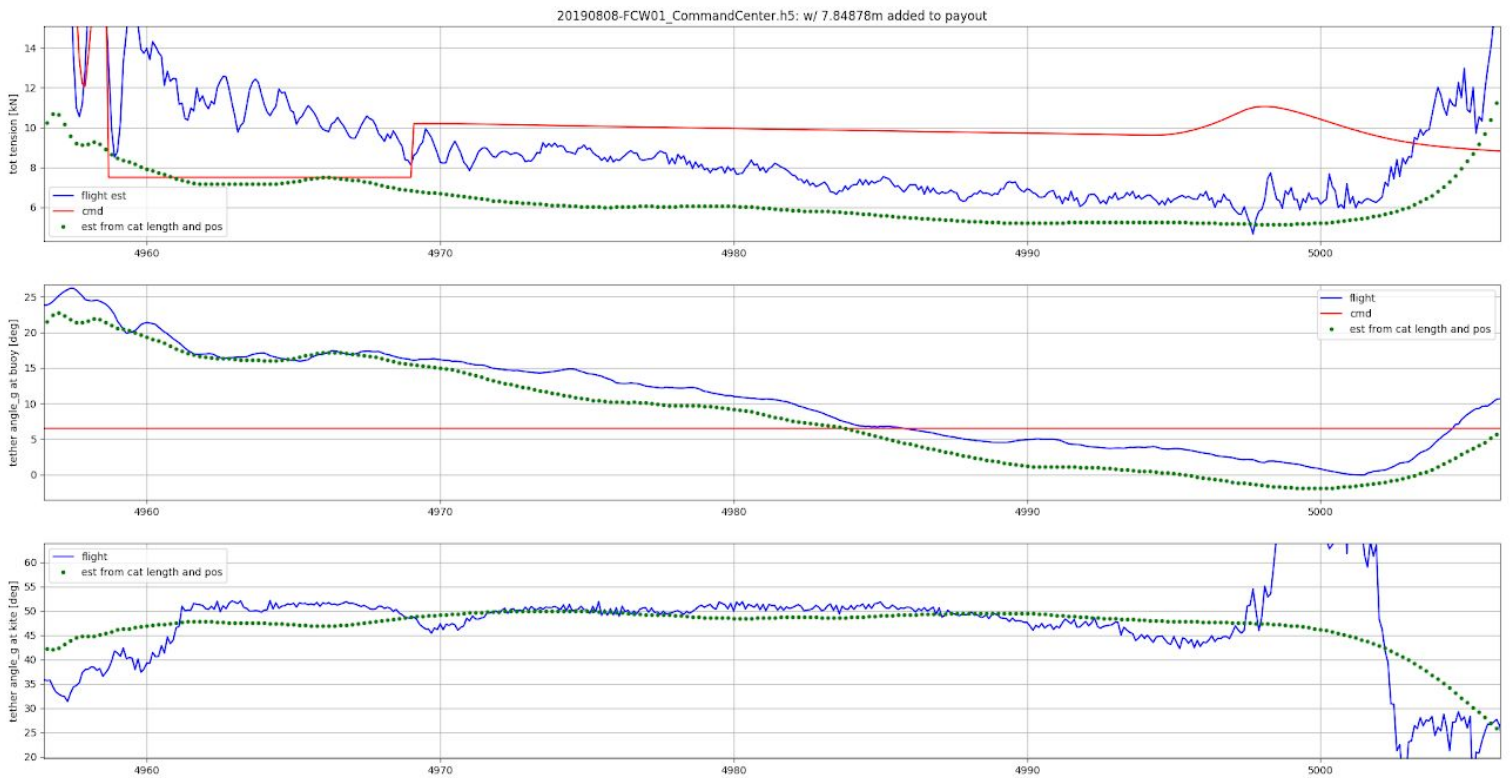
The 23 seconds starting from 4967 to 4990, the tension drop computed is from 7.5kN to 5.1kN. The computed tension is lower than the estimated tension used on the kite to control tension, but the trend is similar.

Fig. 30: Tension predicted by catenary equations.

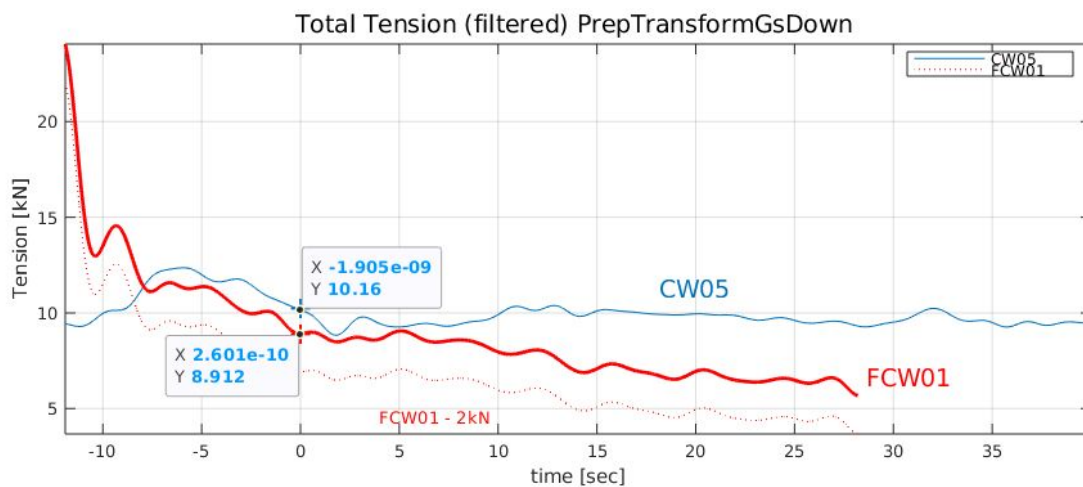
The tension for CW-05 was sustained around 10 kN and the hover remained controlled.

Fig. 32: FCW-01 and CW-05 tension comparison.

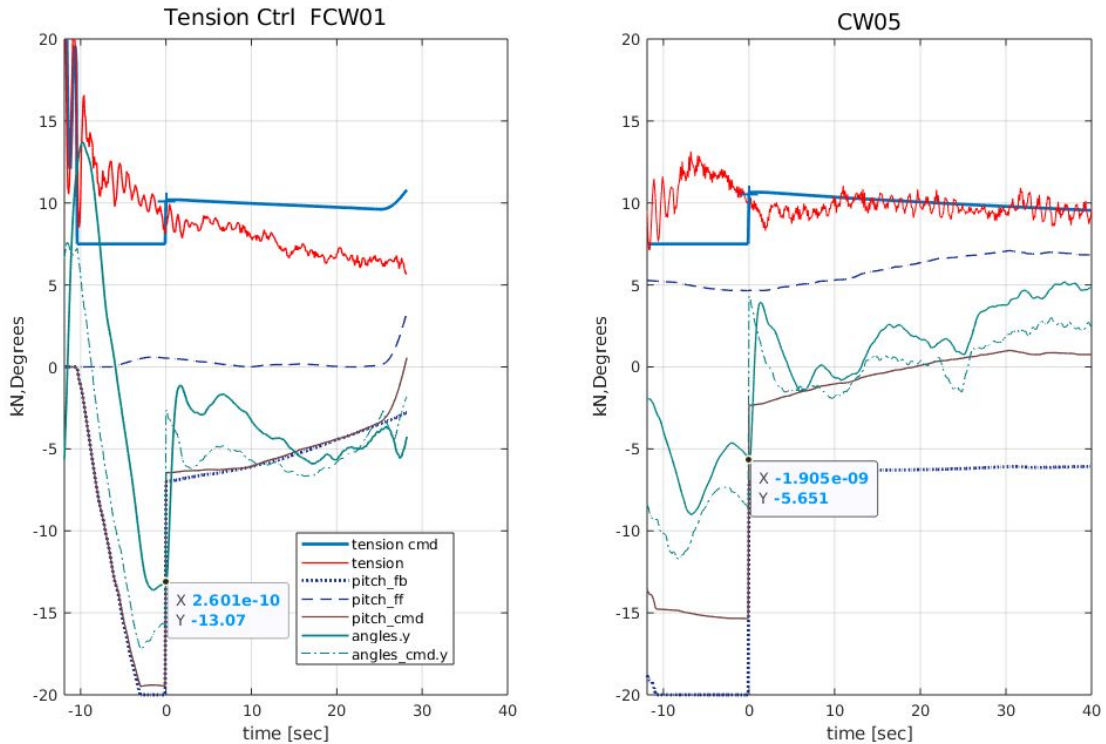
CW-05 began PrepTransformGsDown with the kite pitched forward by 7.3°. The tension feed-forward in CW-05 applied a pitch back command through TransOut and PrepTransformGsDown, but not in FCW-01. The tension feedback was similar (and not effective) in both flights, but the combination of feed-forward and feedback resulted in good tension control for CW-05. Notable is also that the TransOut for CW-05 did not have the characteristic pitch jog.

Fig. 33: FCW-01 and CW-05 tension control comparison.

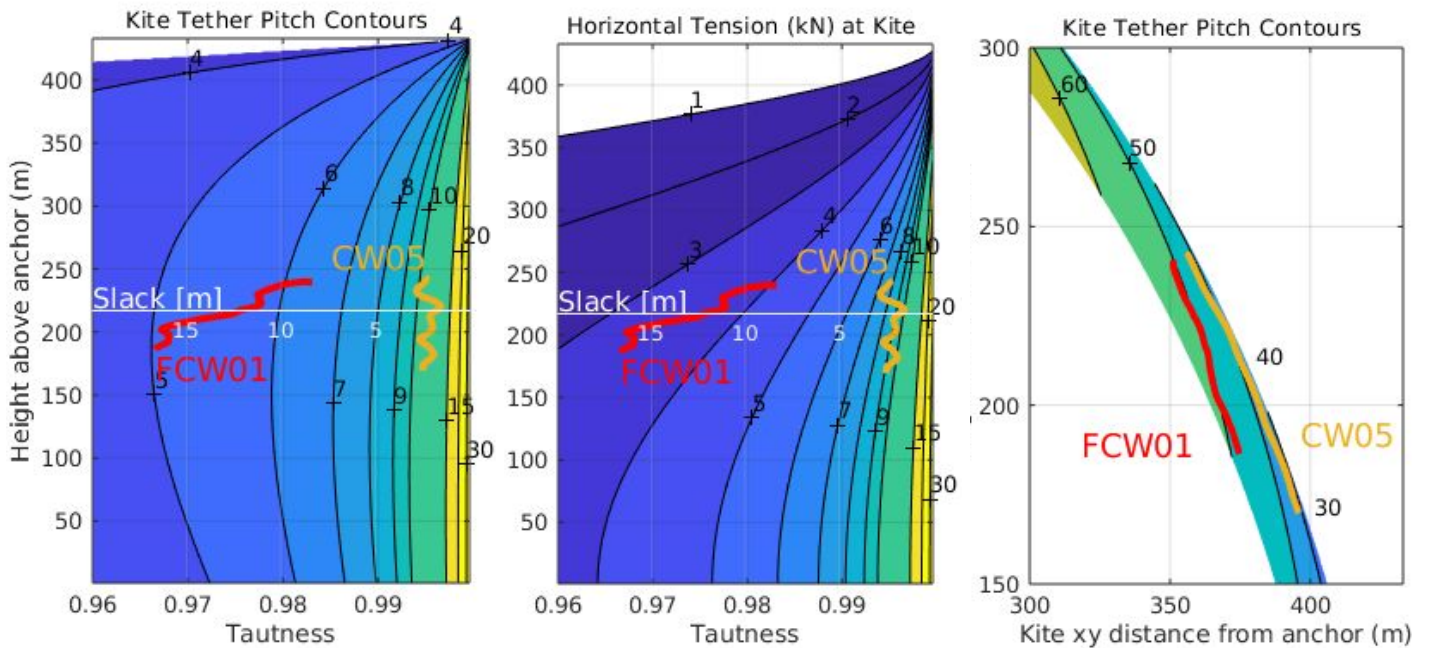
The trajectory of both flights over the catenary equation contour plots indicate a lower tension for FCW-01 at the start of PrepTransformGsDown (~6.5 kN) than the load cell measurements give (8.9 kN). The tether lengths are the same, but the load cells are different.

Fig. 34: FCW-01 and CW-05 tension contour plot comparison.

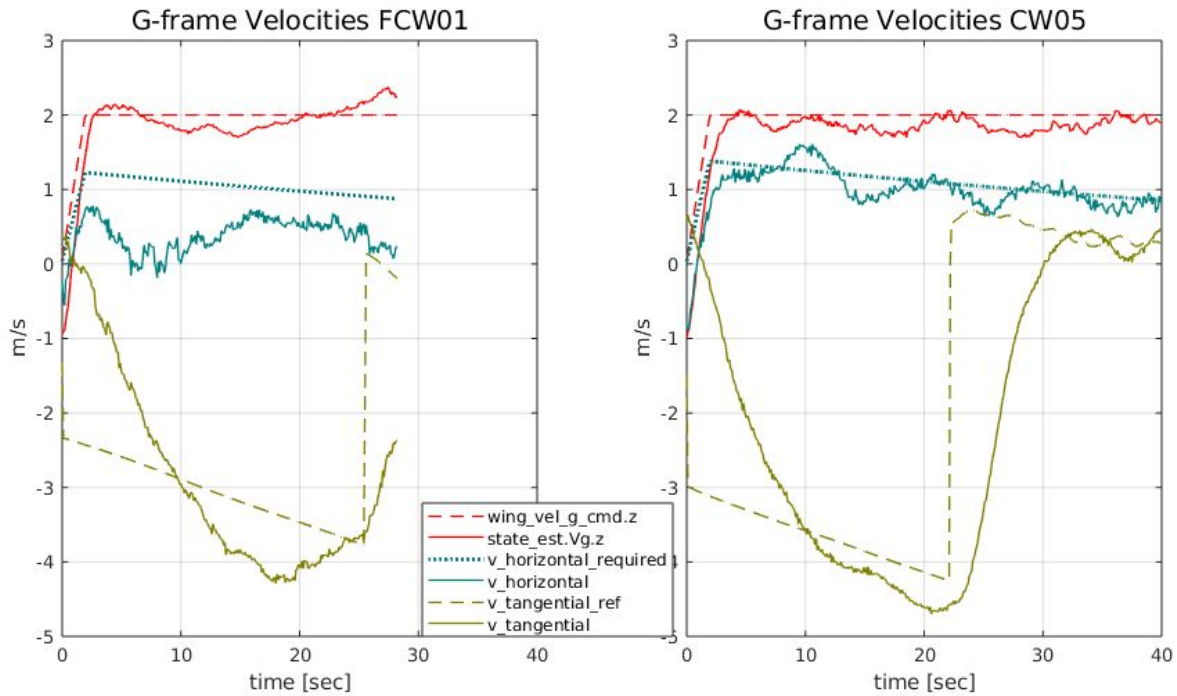
The kite velocities during the descent/translate motion are shown below. CW-05 maintained the horizontal velocity component to keep the tether taut.

Fig. 35: FCW-01 and CW-05 g-frame hover velocity comparison.

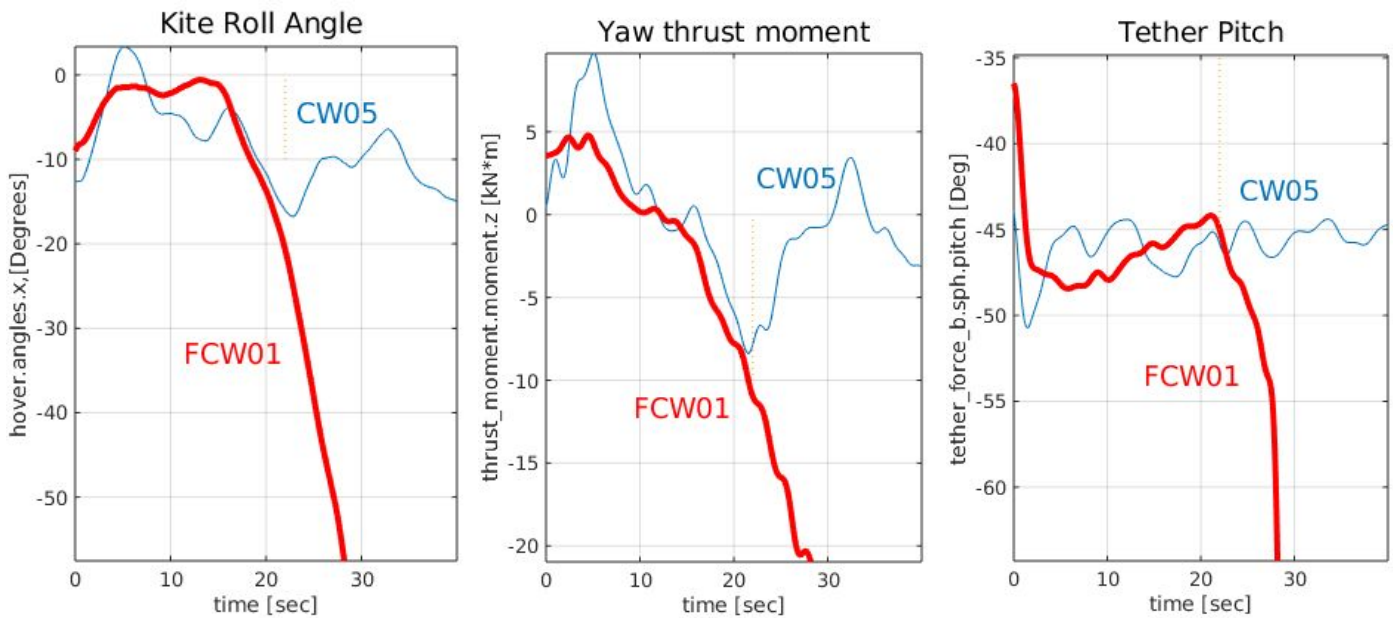
The plots below show that the increased tension allowed the kite to maintain its attitude with similar bridle geometry and yaw thrust moments.

Fig. 36: FCW-01 and CW-05 roll, yaw thrust and tether pitch comparison.
