I01MI007 **CENTERFORCE TECH. LINE (928) 771-8422**

## CHEVROLET, PONTIAC, OLDSMOBILE & BUICK V-8 ENGINES WITH MECHANICAL CLUTCH LINKAGE

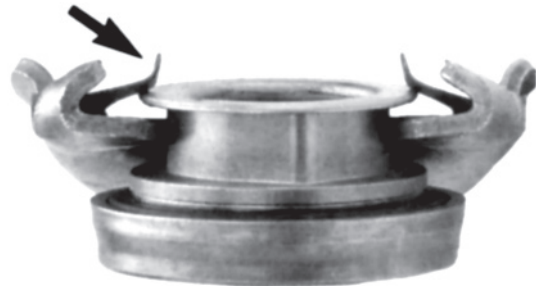
## INCORRECT

THE FORK SPRING CLIPS MUST BE INSTALLED BETWEEN THE THROWOUT BEARING COLLAR FLANGES. IF THE CLIPS ARE INSTALLED ABOVE THE TOP FLANGE AS SHOWN BELOW, PROPER ADJUSTMENT CANNOT BE MADE.
