# FACILITY CONDITION ASSESSMENT

## **DLR Group**

Mission Middle School  
939 East Mission Avenue  
Escondido, California 92025

164076.23R000-014.017

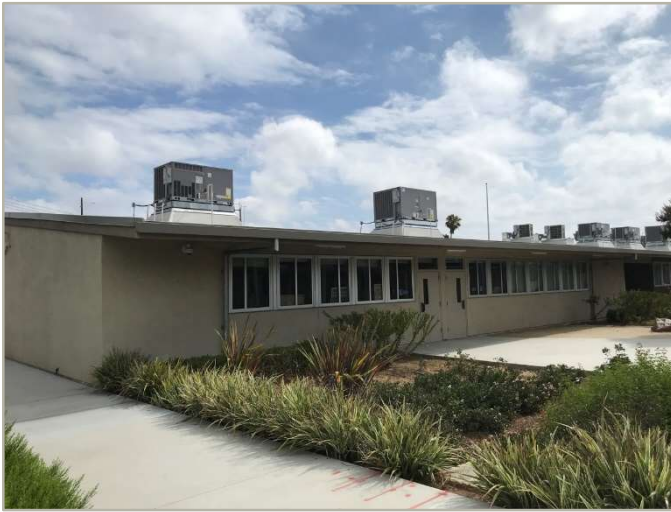
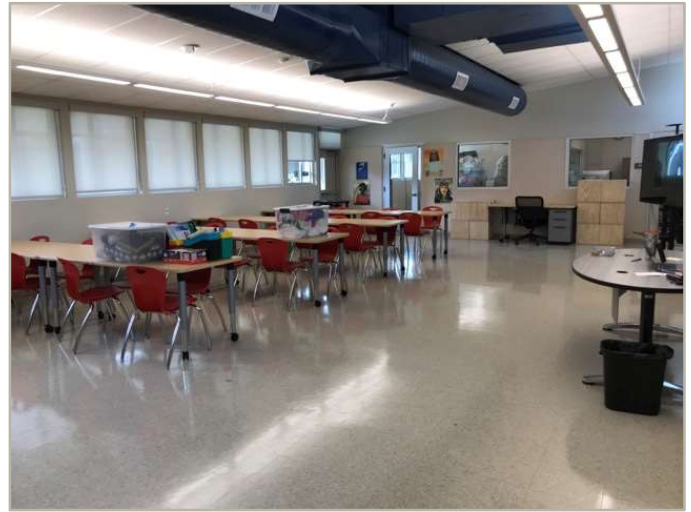
## 2. Building 01-06

<b>Address</b>	939 East Mission Avenue, Escondido, California 92025	
<b>Constructed/Renovated</b>	2020	
<b>Building Size</b>	9,500 SF	
<b>Number of Stories</b>	One above grade	
<i>System</i>	<i>Description</i>	<i>Condition</i>
<b>Structure</b>	Conventional wood frame structure over concrete slab and footing foundation	Good
<b>Façade</b>	Primary Wall Finish: Stucco Windows: Aluminum	Good
<b>Roof</b>	Primary: Flat construction with modified bituminous finish	Fair
<b>Interiors</b>	Walls: Painted gypsum board, vinyl, ceramic tile and Unfinished Floors: VCT and Unfinished Ceilings: ACT	Good
<b>Elevators</b>	None	--
<b>Plumbing</b>	Distribution: Copper supply and PVC waste and venting Hot Water: None Fixtures: sinks in some classroom	Good
<b>HVAC</b>	Non-Central System: Packaged units Supplemental components: Ductless split-systems, Split-system heat pumps and exhaust fans	Good
<b>Fire Suppression</b>	Fire extinguishers only	Good

<b>Electrical</b>	Source & Distribution: Main switchboard and panels with copper wiring Interior Lighting: LED, and linear fluorescent Emergency Power: None	Good
<b>Fire Alarm</b>	Alarm system with smoke detectors, alarms, strobes, pull stations, and exit signs	Good
<b>Equipment/Special</b>	None	--
<b>Accessibility</b>	Presently it does not appear an accessibility study is needed for this building. See Appendix D.	
<b>Additional Studies</b>	No additional studies are recommended for this building/site at this time.	
<b>Key Issues and Findings</b>	No key findings at this time	
<b>Key Spaces Not Observed</b>	All key areas of the property were accessible and observed.

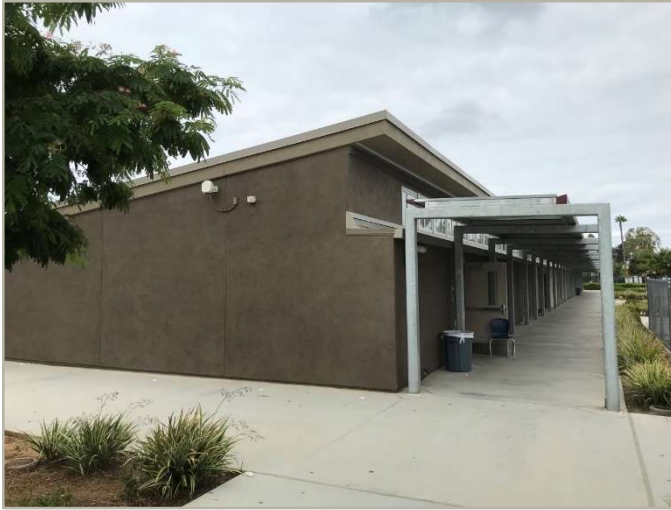
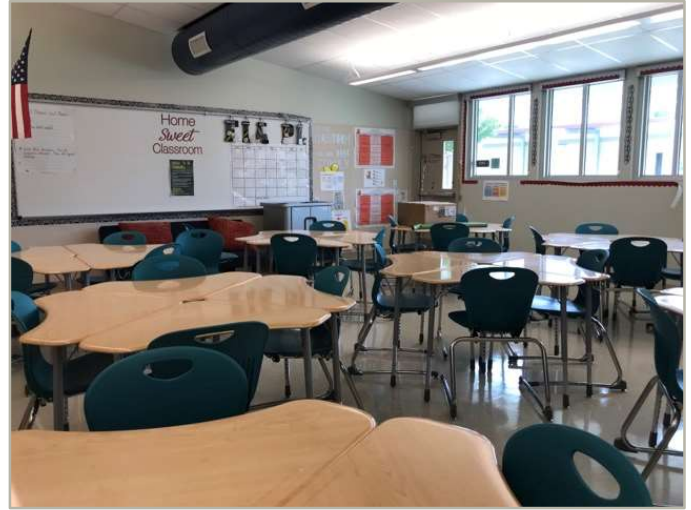
### 3. Building 11-16

Address	939 East Mission Avenue, Escondido, California 92025	
Constructed/Renovated	2020	
Building Size	9,500 SF	
Number of Stories	One above grade	
System	Description	Condition
Structure	Conventional wood frame structure over concrete slab and footing foundation	Good
Façade	Primary Wall Finish: Stucco Windows: Aluminum	Good
Roof	Primary: Flat construction with modified bituminous finish	Fair
Interiors	Walls: Painted gypsum board, vinyl, ceramic tile and Unfinished Floors: VCT, ceramic tile, and unfinished concrete Ceilings: Painted gypsum board and ACT	Good
Elevators	None	--
Plumbing	Distribution: Copper supply and PVC waste and venting Hot Water: None Fixtures: Toilets, urinals, and sinks in all restrooms	Good
HVAC	Non-Central System: Packaged units Supplemental components: Split-system heat pumps and exhaust fans	Good
Fire Suppression	Fire extinguishers only	Good

<b>Electrical</b>	Source & Distribution: Main panel with copper wiring Interior Lighting: LED, and linear fluorescent Emergency Power: None	Good
<b>Fire Alarm</b>	Alarm panel with smoke detectors, alarms, strobes, pull stations, and exit signs	Good
<b>Equipment/Special</b>	None	--
<b>Accessibility</b>	Presently it does not appear an accessibility study is needed for this building. See Appendix D.	
<b>Additional Studies</b>	No additional studies are recommended for this building/site at this time.	
<b>Key Issues and Findings</b>	No key findings at this time	
<b>Key Spaces Not Observed</b>	All key areas of the property were accessible and observed.

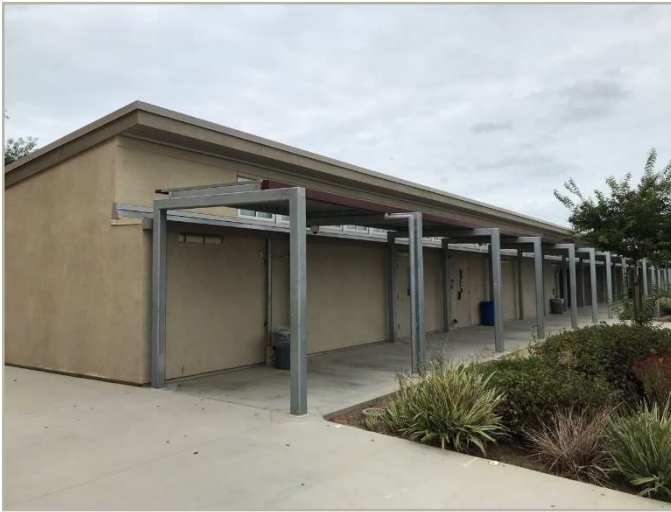
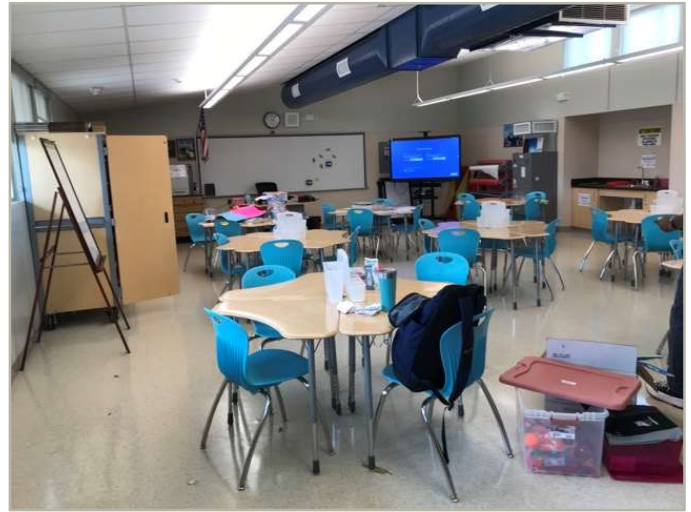
## 4. Building 21-26

<b>Address</b>	939 East Mission Avenue, Escondido, California 92025	
<b>Constructed/Renovated</b>	2020	
<b>Building Size</b>	9,500 SF	
<b>Number of Stories</b>	One above grade	
<i>System</i>	<i>Description</i>	<i>Condition</i>
<b>Structure</b>	Conventional wood frame structure over concrete slab and footing foundation	Good
<b>Façade</b>	Primary Wall Finish: Stucco Windows: Aluminum	Good
<b>Roof</b>	Primary: Flat construction with modified bituminous finish	Fair
<b>Interiors</b>	Walls: Painted gypsum board, vinyl, ceramic tile and Unfinished Floors: VCT, ceramic tile and unfinished concrete Ceilings: Painted gypsum board and ACT	Good
<b>Elevators</b>	None	--
<b>Plumbing</b>	Distribution: Copper supply and PVC waste and venting Hot Water: None Fixtures: Toilets, and sinks in all restrooms	Good
<b>HVAC</b>	Non-Central System: Packaged units Supplemental components: Ductless split-systems and exhaust fans	Good

<b>Electrical</b>	Source & Distribution: Main panel with copper wiring Interior Lighting: LED, and linear fluorescent Emergency Power: None	Good
<b>Fire Alarm</b>	Alarm system with smoke detectors, alarms, strobes, pull stations, and exit signs	Good
<b>Equipment/Special</b>	None	--
<b>Accessibility</b>	Presently it does not appear an accessibility study is needed for this building. See Appendix D.	
<b>Additional Studies</b>	No additional studies are recommended for this building/site at this time.	
<b>Key Issues and Findings</b>	No key findings at this time	
<b>Key Spaces Not Observed</b>	All key areas of the property were accessible and observed.

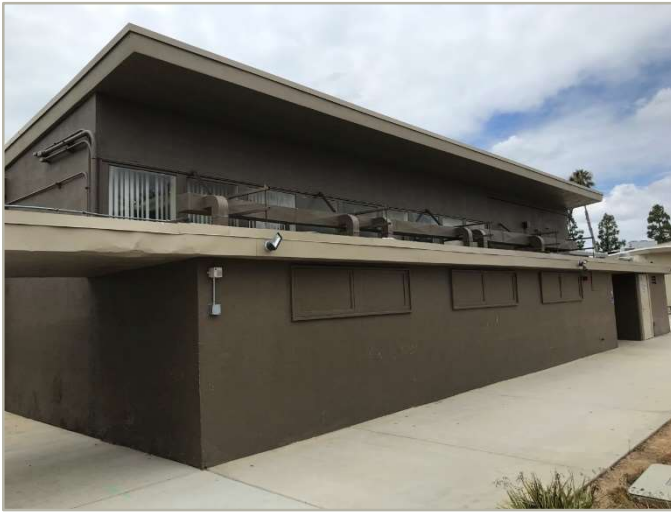
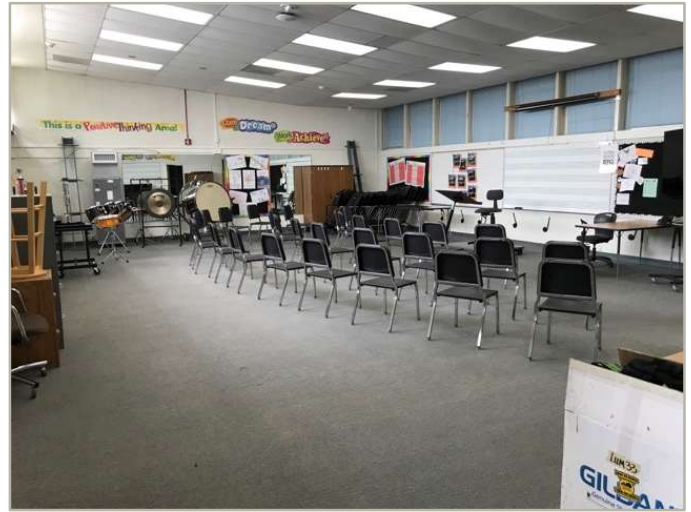
## 5. Building 31

<b>Address</b>	939 East Mission Avenue, Escondido, California 92025	
<b>Constructed/Renovated</b>	1954 / as needed	
<b>Building Size</b>	2,200 SF	
<b>Number of Stories</b>	One above grade	
<i>System</i>	<i>Description</i>	<i>Condition</i>
<b>Structure</b>	Conventional wood frame structure over concrete slab and footing foundation	Good
<b>Façade</b>	Primary Wall Finish: Stucco Windows: Steel	Fair
<b>Roof</b>	Primary: Flat construction with modified bituminous finish Secondary: Flat construction with built-up finish	Fair
<b>Interiors</b>	Walls: Painted gypsum board and Unfinished Floors: Carpet and unfinished concrete Ceilings: ACT and Unfinished/exposed	Fair
<b>Elevators</b>	None	--
<b>Plumbing</b>	Distribution: None Hot Water: None Fixtures: None	--
<b>HVAC</b>	Non-Central System: Packaged units Supplemental components: Exhaust fan	Good
<b>Fire Suppression</b>	Fire extinguishers only	Good

<b>Electrical</b>	Source & Distribution: Main panel with copper Interior Lighting: Linear fluorescent Emergency Power: None	Good
<b>Fire Alarm</b>	Alarm system with smoke detectors, alarms, strobes, pull stations and exit signs	Fair
<b>Equipment/Special</b>	None	--
<b>Accessibility</b>	Presently it does not appear an accessibility study is needed for this building. See Appendix D.	
<b>Additional Studies</b>	No additional studies are recommended for this building/site at this time.	
<b>Key Issues and Findings</b>	Exterior service door is in poor condition	
<b>Key Spaces Not Observed</b>	All key areas of the property were accessible and observed.

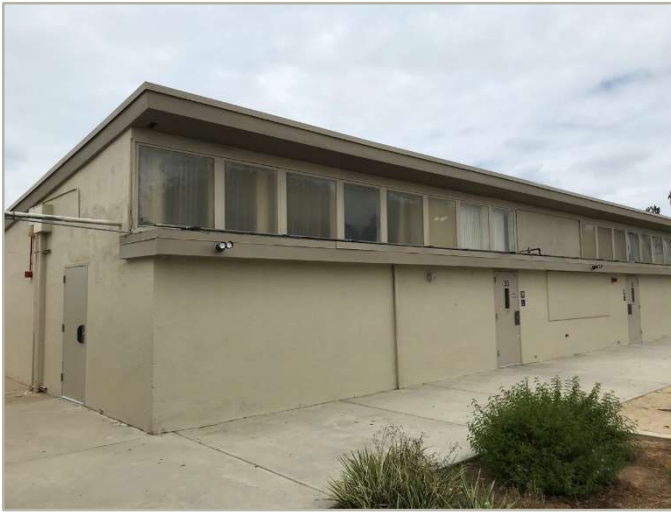
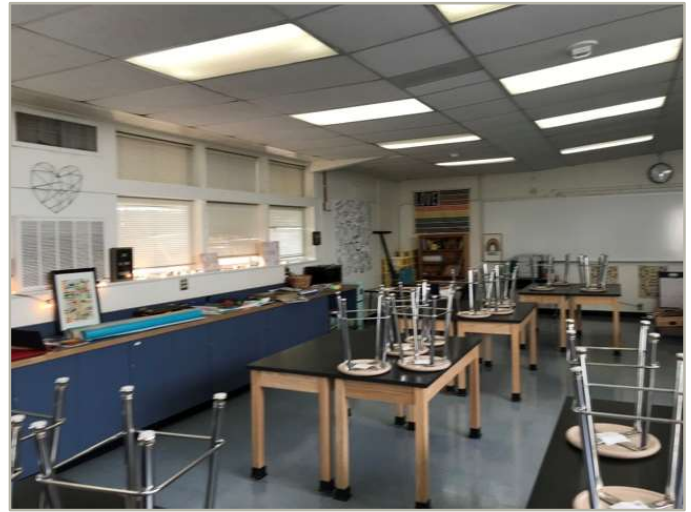
## 6. Building 32-33

<b>Address</b>	939 East Mission Avenue, Escondido, California 92025	
<b>Constructed/Renovated</b>	1954/as needed	
<b>Building Size</b>	2,280 SF	
<b>Number of Stories</b>	One above grade	
<i>System</i>	<i>Description</i>	<i>Condition</i>
<b>Structure</b>	Conventional wood frame structure over concrete slab and footing foundation	Good
<b>Façade</b>	Primary Wall Finish: Stucco Windows: Wood	Poor
<b>Roof</b>	Primary: Flat construction with modified bituminous finish	Fair
<b>Interiors</b>	Walls: Painted gypsum board Floors: Carpet, and VCT Ceilings: ACT	Fair
<b>Elevators</b>	None	--
<b>Plumbing</b>	Distribution: Copper supply and PVC waste and venting Hot Water: None Fixtures: Sinks in classroom	Fair
<b>HVAC</b>	Non-Central System: Heat pumps Supplemental components: Exhaust fans	Fair
<b>Fire Suppression</b>	Fire extinguishers only	Good

<b>Electrical</b>	Source & Distribution: Main panel with copper wiring Interior Lighting: Linear fluorescent Emergency Power: None	Fair
<b>Fire Alarm</b>	Alarm system with smoke detectors, alarms, strobes, pull stations and exit signs	Fair
<b>Equipment/Special</b>	None	--
<b>Accessibility</b>	Presently it does not appear an accessibility study is needed for this building. See Appendix D.	
<b>Additional Studies</b>	No additional studies are recommended for this building/site at this time.	
<b>Key Issues and Findings</b>	Exterior windows are warped and rotting	
<b>Key Spaces Not Observed</b>	All key areas of the property were accessible and observed.

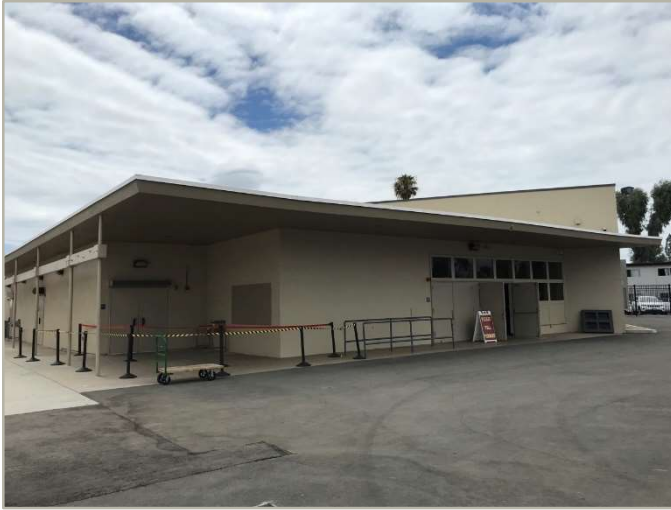
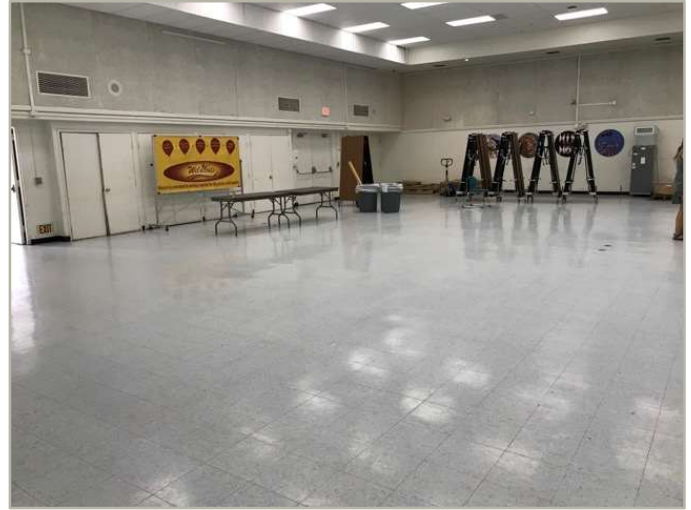
## 7. MPR

<b>Address</b>	939 East Mission Avenue, Escondido, California 92025	
<b>Constructed/Renovated</b>	1958/as needed	
<b>Building Size</b>	12,400 SF	
<b>Number of Stories</b>	One above grade	
<i>System</i>	<i>Description</i>	<i>Condition</i>
<b>Structure</b>	Conventional wood frame structure over concrete slab and footing foundation	Good
<b>Façade</b>	Primary Wall Finish: Stucco Windows: Wood	Fair
<b>Roof</b>	Primary: Flat construction with modified bituminous finish	Fair
<b>Interiors</b>	Walls: Painted gypsum board, vinyl, ceramic tile, FRP and Unfinished Floors: VCT, ceramic tile, rubber tiles and unfinished concrete Ceilings: Painted gypsum board, ACT and Unfinished/exposed	Fair
<b>Elevators</b>	None	--
<b>Plumbing</b>	Distribution: Copper supply and PVC waste and venting Hot Water: Gas water heater with integral tank Fixtures: Toilets, urinals, and sinks in all restrooms	Fair
<b>HVAC</b>	Non-Central System: Packaged units Supplemental components: Split-system heat pumps, Make-up air unit, Heat pump and exhaust fans	Fair

<b>Electrical</b>	Source & Distribution: panel with copper wiring Interior Lighting: Linear fluorescent and incandescent Emergency Power: None	Fair
<b>Fire Alarm</b>	Alarm system with smoke detectors, alarms, strobes, pull stations, and exit signs	Fair
<b>Equipment/Special</b>	Commercial kitchen equipment	Fair
<b>Accessibility</b>	Presently it does not appear an accessibility study is needed for this building. See Appendix D.	
<b>Additional Studies</b>	No additional studies are recommended for this building/site at this time.	
<b>Key Issues and Findings</b>	No key findings at this time	
<b>Key Spaces Not Observed</b>	All key areas of the property were accessible and observed.

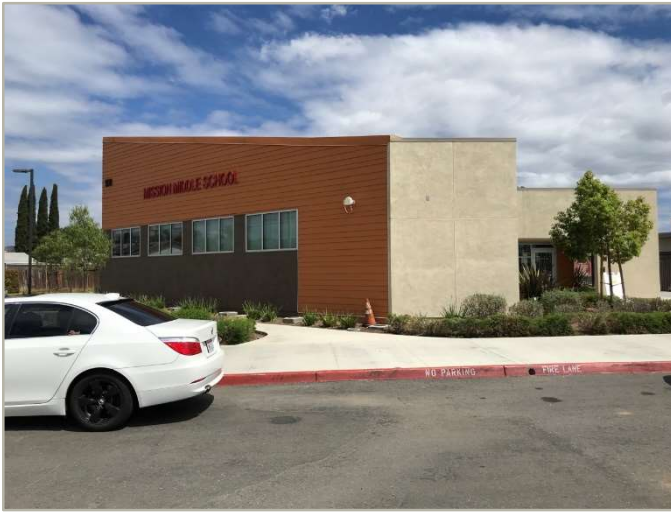
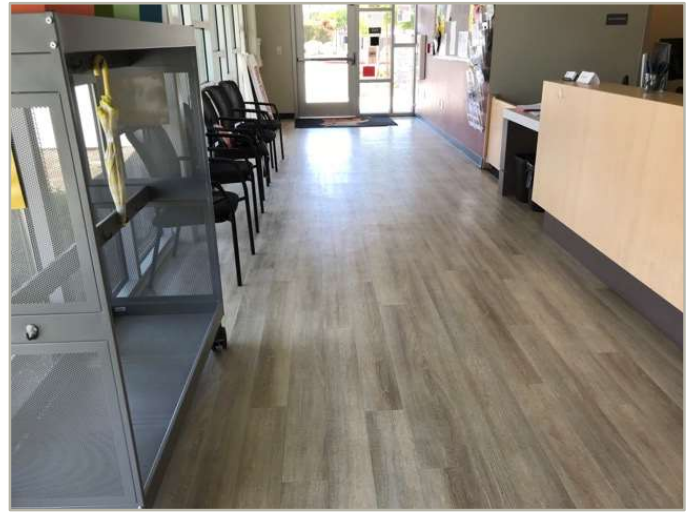
## 8. Office Building

<b>Address</b>	939 East Mission Avenue, Escondido, California 92025	
<b>Constructed/Renovated</b>	2020	
<b>Building Size</b>	6,800 SF	
<b>Number of Stories</b>	One above grade	
<i>System</i>	<i>Description</i>	<i>Condition</i>
<b>Structure</b>	Conventional wood frame structure over concrete slab and footing foundation	Good
<b>Façade</b>	Primary Wall Finish: Stucco Secondary Wall Finish: Wood siding Windows: Aluminum	Good
<b>Roof</b>	Primary: Flat construction with modified bituminous finish Secondary: Shed construction with metal finish	Good
<b>Interiors</b>	Walls: Painted gypsum board, vinyl, ceramic tile and Unfinished Floors: Carpet, VCT, ceramic tile and unfinished concrete Ceilings: Painted gypsum board, ACT and Unfinished/exposed	Good
<b>Elevators</b>	None	--
<b>Plumbing</b>	Distribution: Copper supply and PVC waste and venting Hot Water: Gas water heater with integral tank Fixtures: Toilets, and sinks in all restrooms	Good

<b>Electrical</b>	Source & Distribution: Main panel with copper wiring Interior Lighting: LED, and linear fluorescent Emergency Power: None	Good
<b>Fire Alarm</b>	Alarm system with smoke detectors, alarms, strobes, pull stations, and exit signs	Good
<b>Equipment/Special</b>	None	--
<b>Accessibility</b>	Presently it does not appear an accessibility study is needed for this building. See Appendix D.	
<b>Additional Studies</b>	No additional studies are recommended for this building/site at this time.	
<b>Key Issues and Findings</b>	No key findings at this time	
<b>Key Spaces Not Observed</b>	All key areas of the property were accessible and observed.

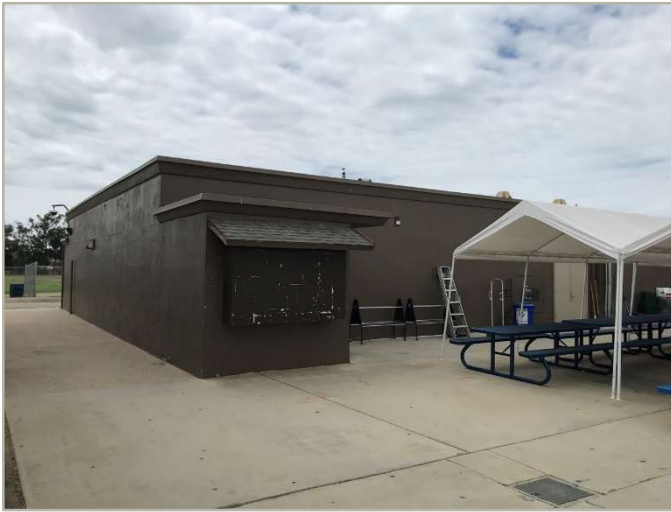
## 9. Physical Education Building 37-38

<b>Address</b>	939 East Mission Avenue, Escondido, California 92025	
<b>Constructed/Renovated</b>	1958/as needed	
<b>Building Size</b>	3,348 SF	
<b>Number of Stories</b>	One above grade	
<i>System</i>	<i>Description</i>	<i>Condition</i>
<b>Structure</b>	Conventional wood frame structure over concrete slab and footing foundation	Good
<b>Façade</b>	Primary Wall Finish: Stucco Windows: None	Fair
<b>Roof</b>	Primary: Flat construction with built-up finish	Fair
<b>Interiors</b>	Walls: Painted gypsum board, ceramic tile and Unfinished Floors: VCT, ceramic tile, and unfinished concrete Ceilings: Painted gypsum board and Unfinished/exposed	Fair
<b>Elevators</b>	None	--
<b>Plumbing</b>	Distribution: Copper supply and PVC waste and venting Hot Water: Gas water heater with integral tank Fixtures: Toilets, urinals, showers and sinks in all restrooms	Fair
<b>HVAC</b>	No heating or cooling system Supplemental components: Exhaust fans	Fair

<b>Electrical</b>	Source & Distribution: Main panel with copper Interior Lighting: Linear fluorescent, and incandescent Emergency Power: None	Fair
<b>Fire Alarm</b>	Alarm system with smoke detectors, alarms, strobes, pull stations and exit signs	Fair
<b>Equipment/Special</b>	None	--
<b>Accessibility</b>	Presently it does not appear an accessibility study is needed for this building. See Appendix D.	
<b>Additional Studies</b>	No additional studies are recommended for this building/site at this time.	
<b>Key Issues and Findings</b>	Exterior paint is failing	
<b>Key Spaces Not Observed</b>	All key areas of the property were accessible and observed.

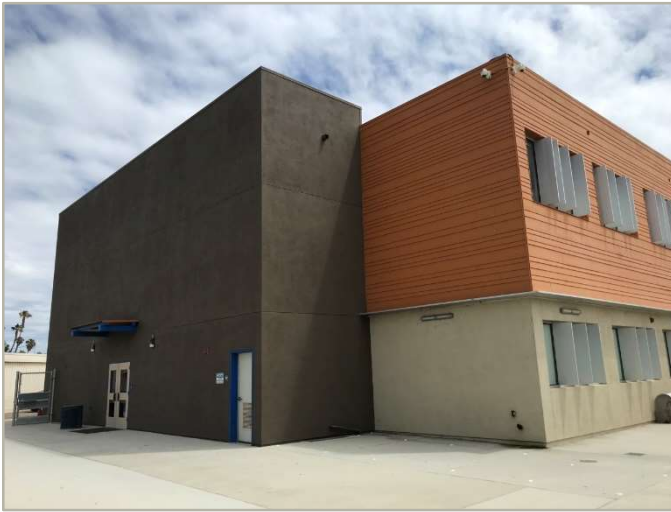
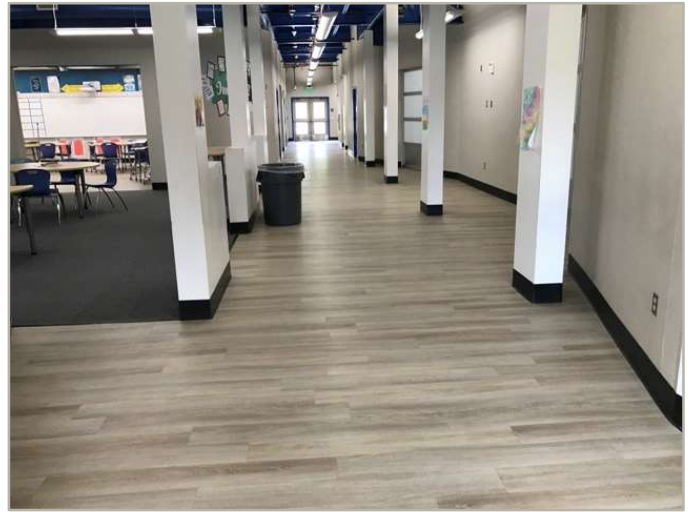
## 10. Two-Story Building

<b>Address</b>	939 East Mission Avenue, Escondido, California 92025	
<b>Constructed/Renovated</b>	2017	
<b>Building Size</b>	16,844 SF	
<b>Number of Stories</b>	Two above grade	
<i>System</i>	<i>Description</i>	<i>Condition</i>
<b>Structure</b>	Steel frame with concrete-topped metal decks over concrete pad column footings	Good
<b>Façade</b>	Primary Wall Finish: Cement board siding Secondary Wall Finish: Stucco Windows: Aluminum	Good
<b>Roof</b>	Primary: Flat construction with single-ply TPO/PVC membrane	Good
<b>Interiors</b>	Walls: Vinyl, ceramic tile and Unfinished Floors: Carpet, VCT, ceramic tile, and unfinished concrete Ceilings: Painted gypsum board, ACT and Unfinished/exposed	Good
<b>Elevators</b>	Passenger: One hydraulic car serving all two floors	Fair
<b>Plumbing</b>	Distribution: Copper supply and PVC waste and venting Hot Water: Gas water heater with integral tank Fixtures: Toilets, urinals, and sinks in all restrooms	Good

<b>Electrical</b>	Source & Distribution: Main panel with copper wiring Interior Lighting: LED, and linear fluorescent Emergency Power: None	Good
<b>Fire Alarm</b>	Alarm system with smoke detectors, alarms, strobes, pull stations, and exit signs	Good
<b>Equipment/Special</b>	None	--
<b>Accessibility</b>	Presently it does not appear an accessibility study is needed for this building. See Appendix D.	
<b>Additional Studies</b>	No additional studies are recommended for this building/site at this time.	
<b>Key Issues and Findings</b>	None observed at the time of assessment.	
<b>Key Spaces Not Observed</b>	All key areas of the property were accessible and observed.

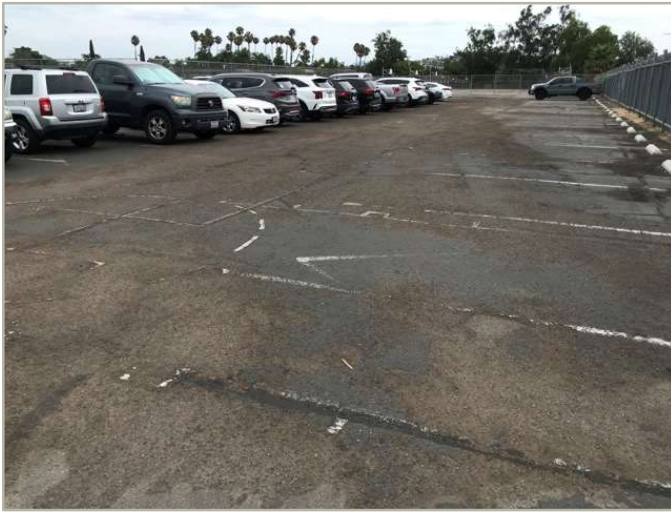
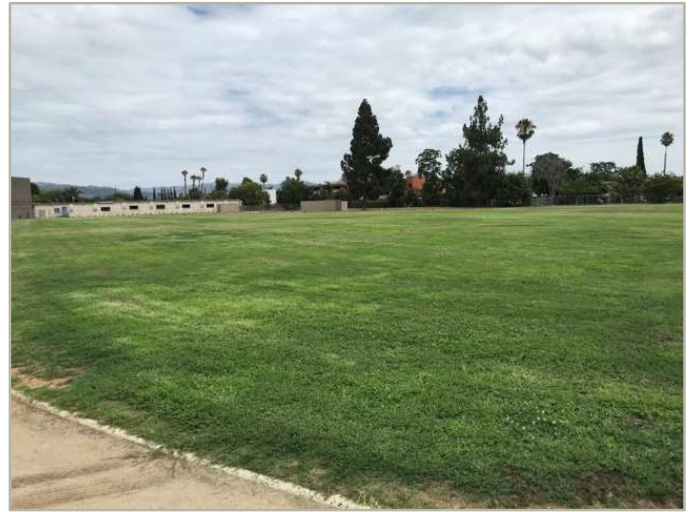
## 11. Site Summary

Site Information		
System	Description	Condition
<b>Pavement/Flatwork</b>	Asphalt lots with limited areas of concrete aprons and pavement and adjacent concrete sidewalks, curbs, ramps, and stairs	Fair
<b>Site Development</b>	Property entrance signage; chain link and wrought iron fencing; CMU wall dumpster enclosures Sports fields and courts with fencing, and site lights	Fair
<b>Landscaping and Topography</b>	Significant landscaping features including lawns, trees, bushes, and planters Irrigation present No retaining walls Low to moderate site slopes throughout	Fair
<b>Utilities</b>	Municipal water and sewer Local utility-provided electric and natural gas	Good
<b>Site Lighting</b>	Pole-mounted: LED Building-mounted: LED and incandescent	Fair
<b>Ancillary Structures</b>	Modular buildings	Fair
<b>Accessibility</b>	Presently it does not appear an accessibility study is needed for this building. See Appendix D.

<b>Additional Studies</b>	The east roadway adjacent to the office building and the area south of the basketball court gets flooded during heavy rains. A professional engineer must be retained to analyze the existing condition, provide recommendations and, if necessary, estimate the scope and cost of any required repairs. The cost of this study is included in the cost tables. Due to the ambiguity of the required repair scope at the time of this assessment, the cost for any possible subsequent repairs is not included.

Severe alligator cracking and potholes at parking lots and roadways, parking lots seal and stripe, eroded landscaping areas, and inadequate lot drainage issues

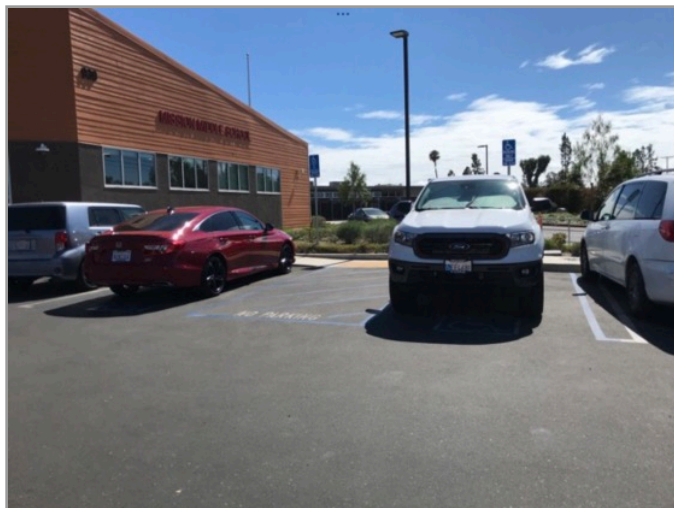
OVERVIEW OF ACCESSIBLE PARKING AREA

Question		Yes	No	NA	Comments
1	Does the required number of standard ADA designated spaces appear to be provided ?	✗			
2	Does the required number of van-accessible designated spaces appear to be provided ?		✗		
3	Are accessible spaces on the shortest accessible route to an accessible building entrance ?	✗			
4	Does parking signage include the International Symbol of Accessibility ?	✗			
5	Does each accessible space have an adjacent access aisle ?	✗			
6	Do parking spaces and access aisles appear to be relatively level and without obstruction ?	✗

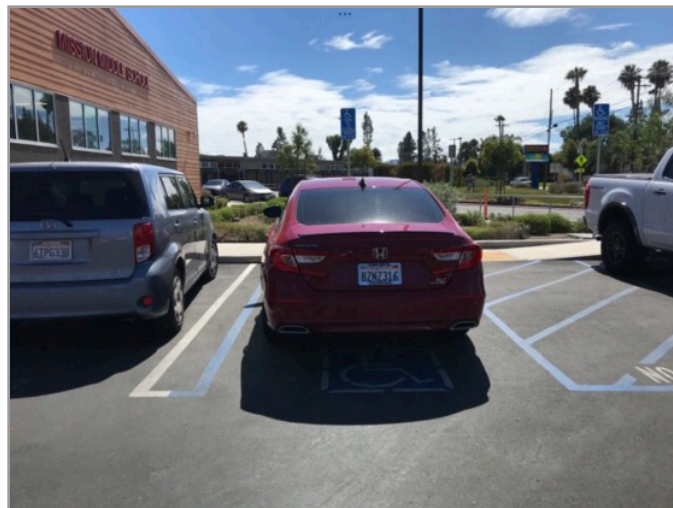
CLOSE-UP OF STALL

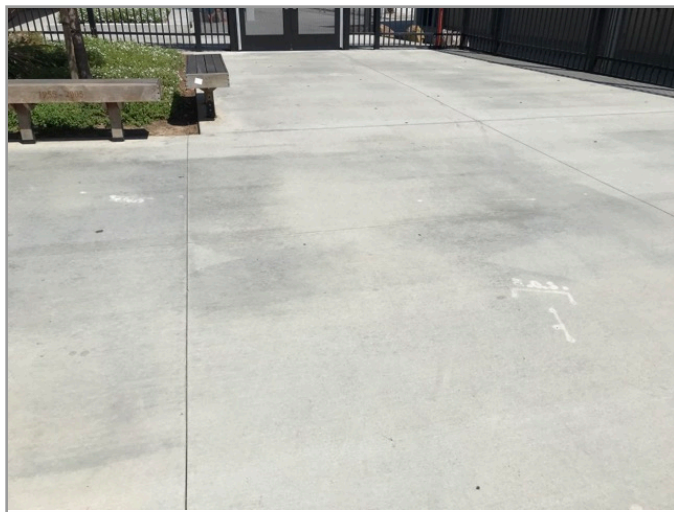
ACCESSIBLE PATH

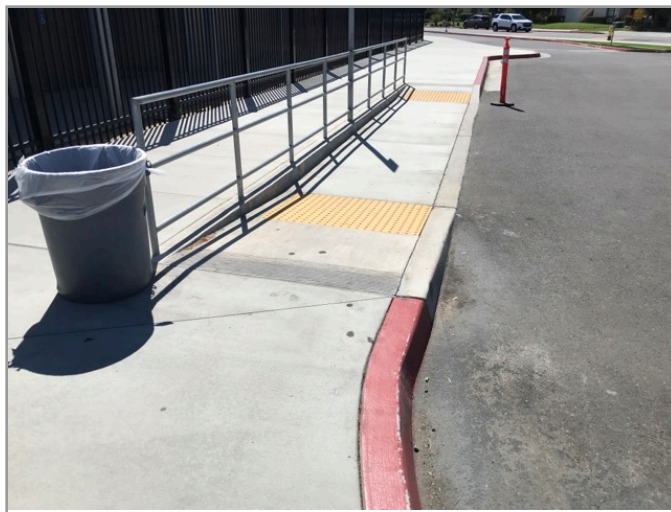
CURB CUT

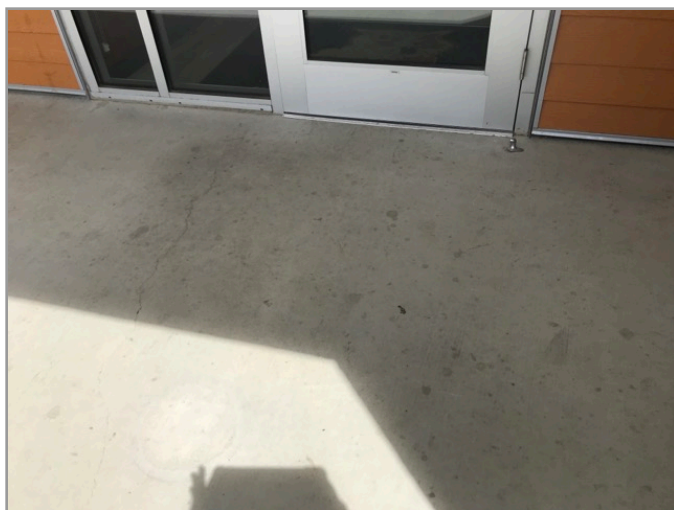
MAIN ENTRANCE

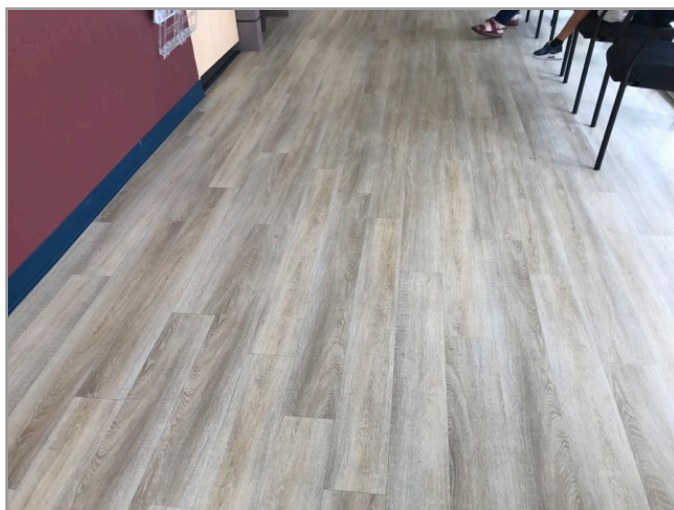
ACCESSIBLE INTERIOR PATH

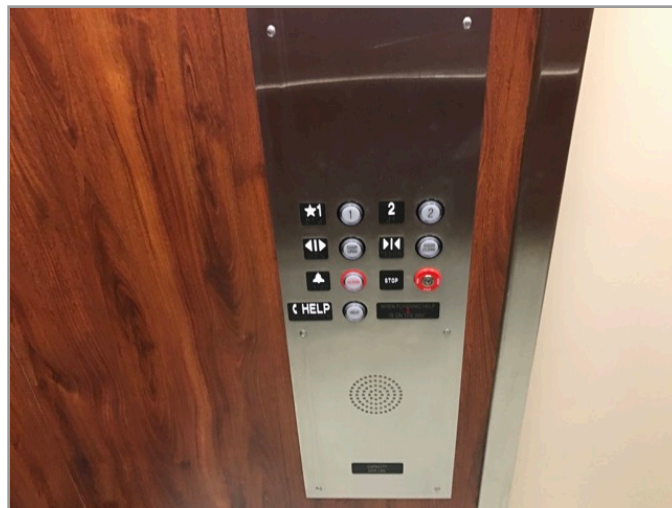
IN-CAB CONTROLS

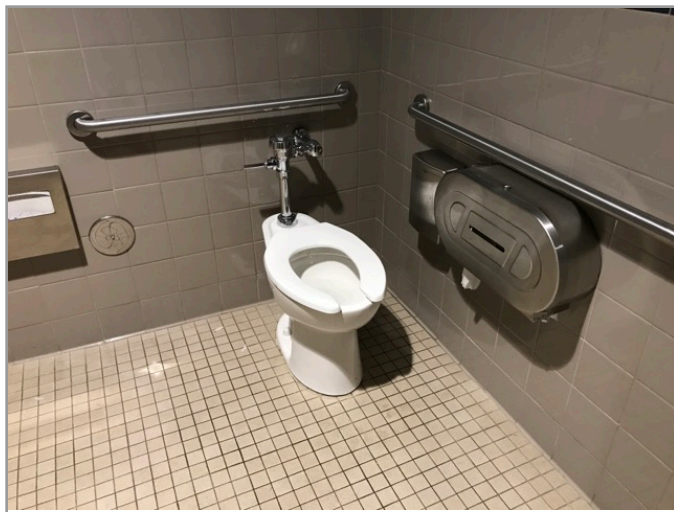
TOILET STALL OVERVIEW

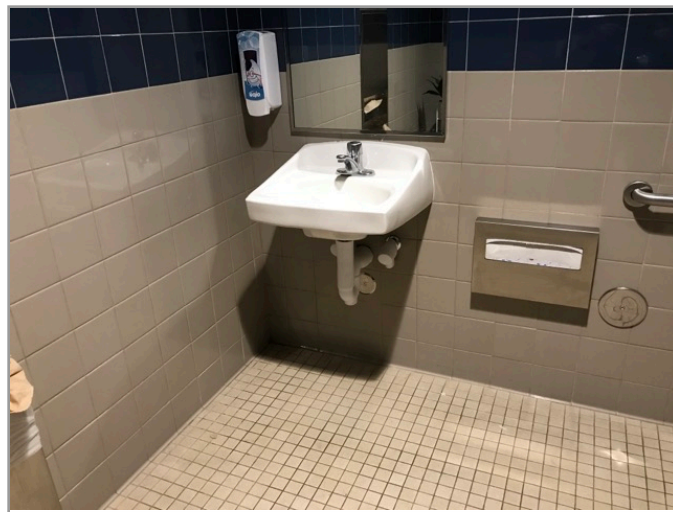
SINK, FAUCET HANDLES AND ACCESSORIES

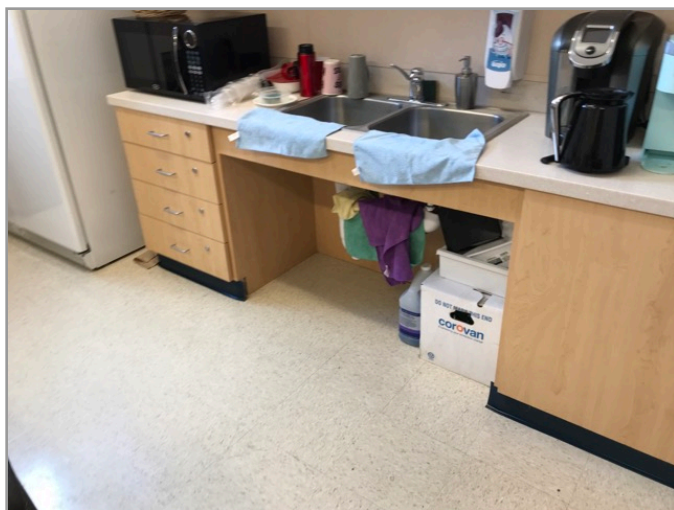
SINK CLEARANCE

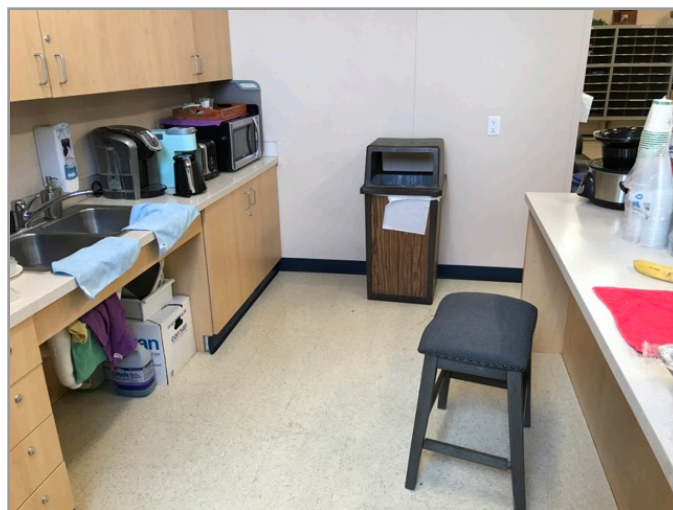
KITCHEN OVERVIEW

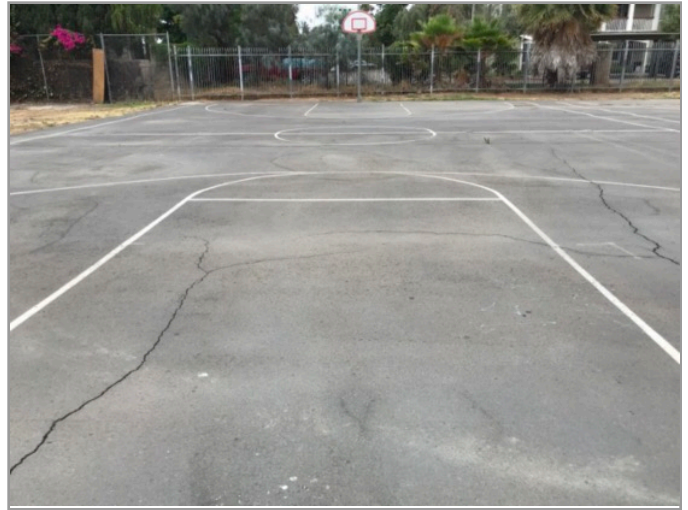
PLAYGROUND SURFACE
