ROTOKAURI NORTH SHA

PRELIMINARY GEOTECHNICAL REPORT

PROJECT NO: HD631
GREEN SEED CONSULTANTS
LIMITED
REFERENCE: PCR
27 JULY 2018

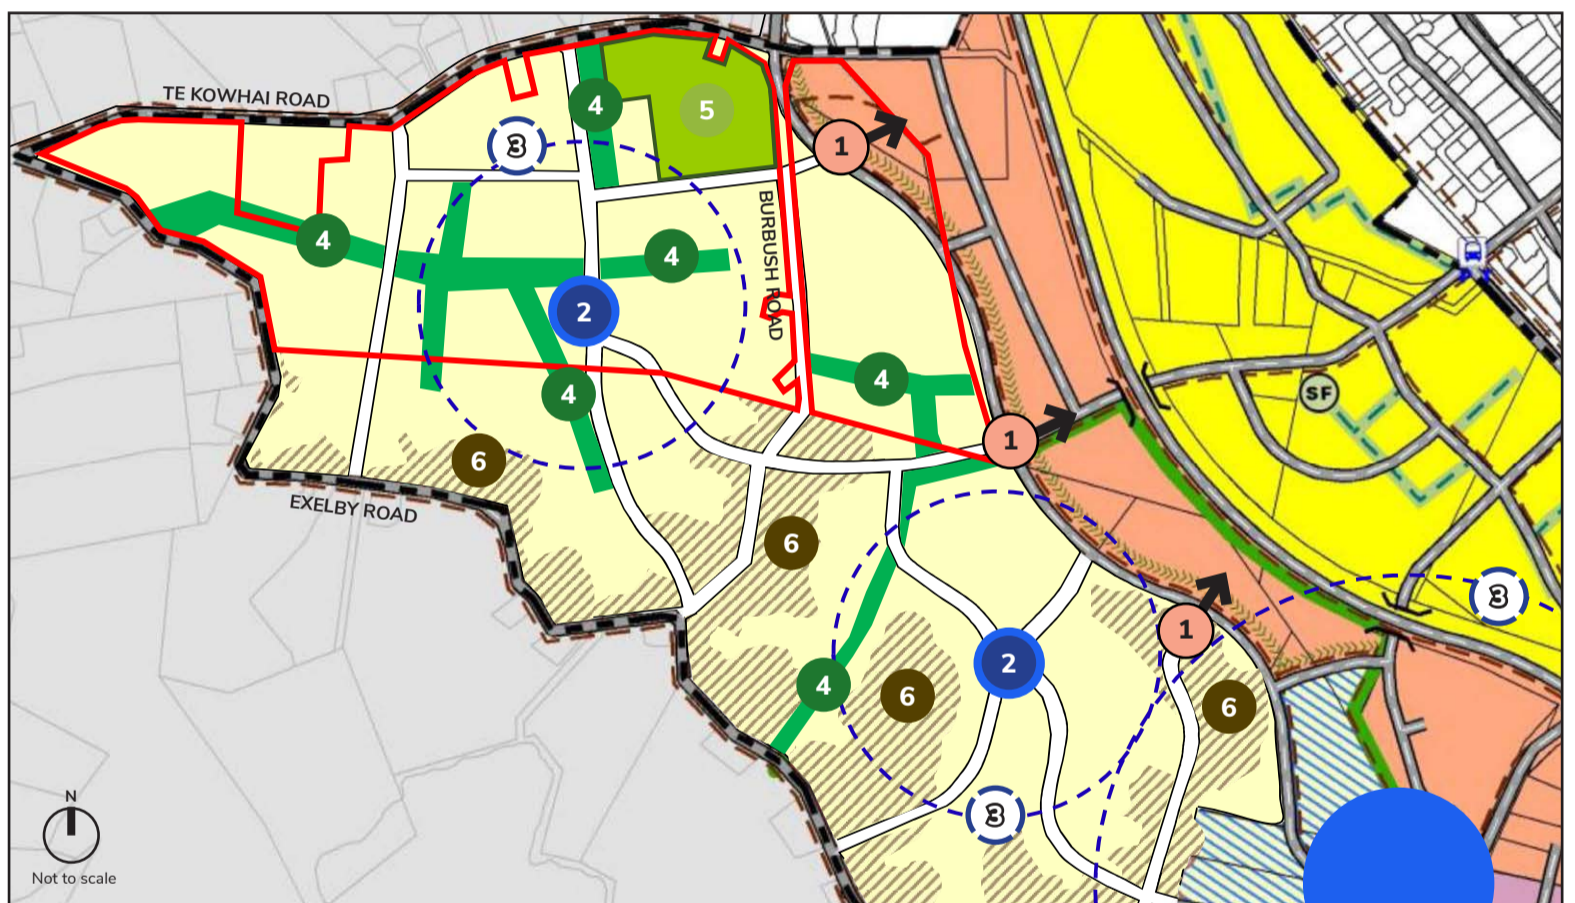
Figure 1: Key structuring elements of Rotokauri North SHA concept

- Site area
- 1 Optimise connections to east (jobs) as well south.
- 2 Ensure each small centres is focused on its local community.
- 3 Maximise residential catchment around a small centre, and integrate movement network around the centre.
- 4 Provide for necessary stormwater conveyance and storage.
- 5 Provide district-level open space so as to maximise exposure and accessibility to all. Size will be determined by Council acquisition agreement.
- 6 Ensure sensitive slopes can be appreciated as landscape features.

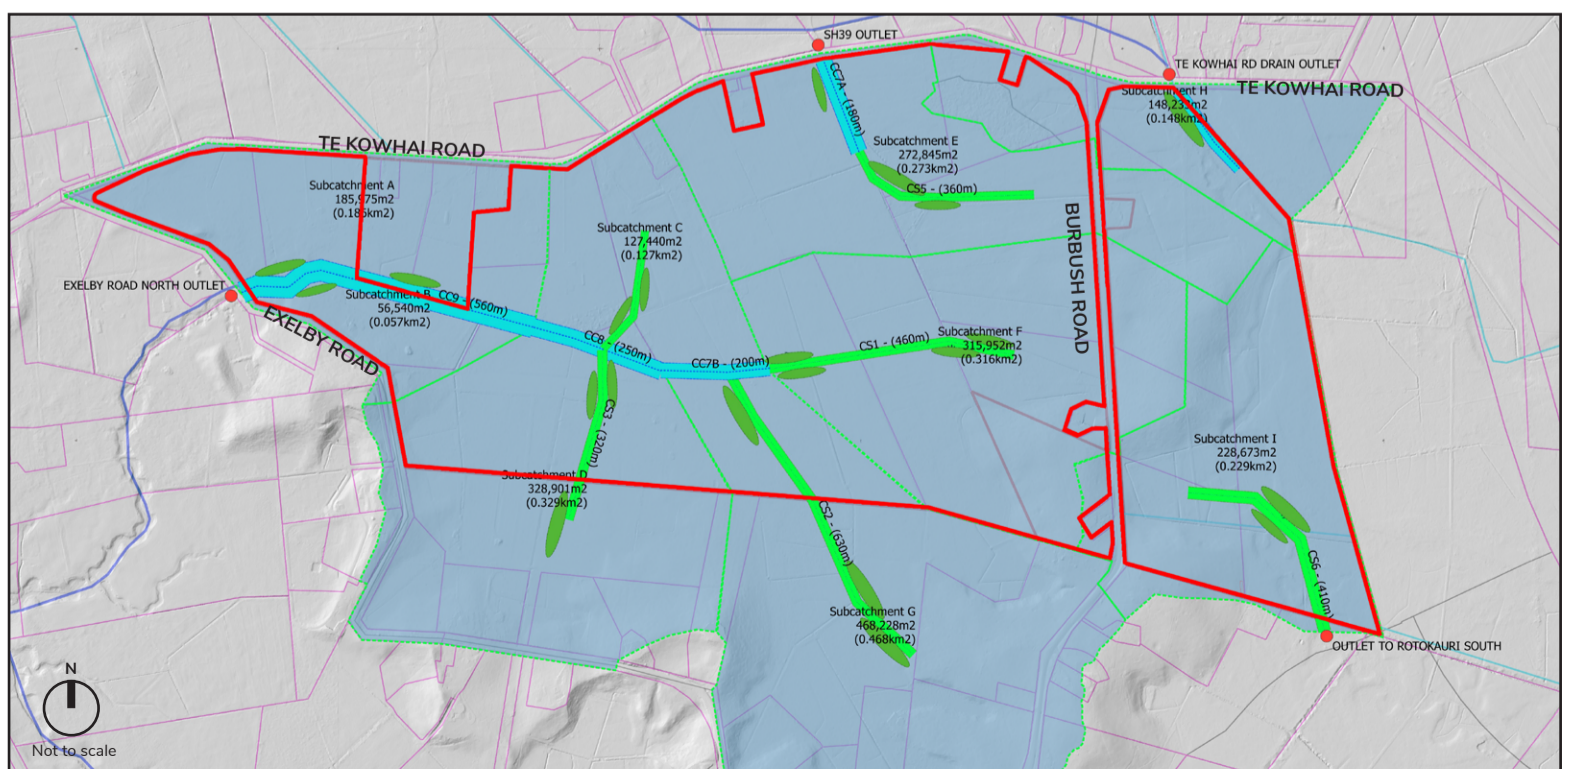
Figure 3: Rotokauri North SHA options for stormwater

- Site area
- Floodway basin (conveyance and flood storage)
- Swale (conveyance only)
- Treatment wetlands
- Discharge locations

As mentioned above, the formation of the stormwater swales at the site may create a liquefaction induced lateral spreading hazard at the site. Reducing the slope grade of the swales may reduce this hazard or slope stabilisation methods may be required. Further assessment of the lateral spreading risk will be required.

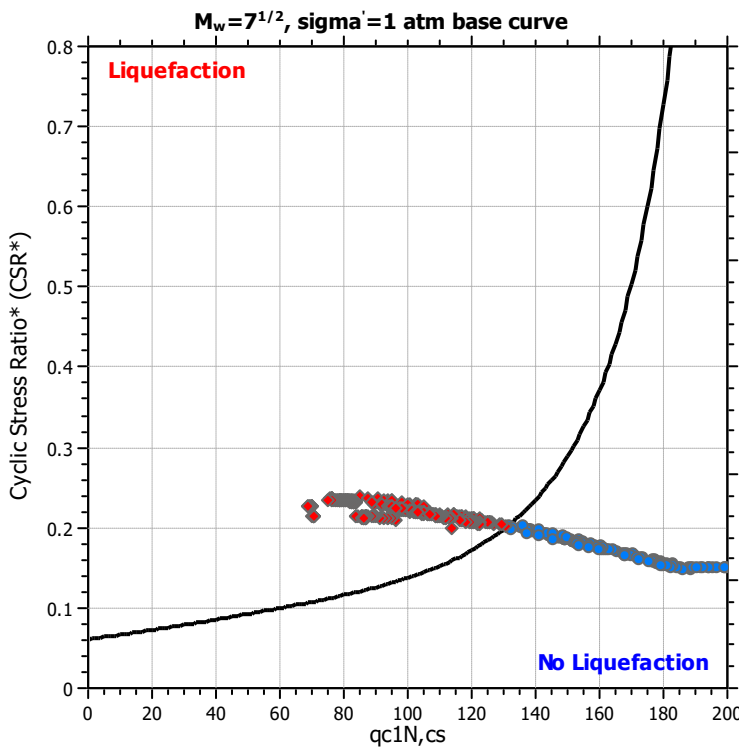
Analysis method:	B&I (2014)	G.W.T. (in-situ):	0.10 m	Use fill:	No	Clay like behavior applied:	Sand & Clay
Fines correction method:	B&I (2014)	G.W.T. (earthq.):	0.10 m	Fill height:	N/A	Limit depth applied:	Yes
Points to test:	Based on Ic value	Average results interval:	3	Fill weight:	N/A	Limit depth:	15.00 m
Earthquake magnitude M_w :	5.90	Ic cut-off value:	2.60	Trans. detect. applied:	Yes	MSF method:	Method
Peak ground acceleration:	0.22	Unit weight calculation:	Based on SBT	K_σ applied:	Yes

A liquefaction assessment has been undertaken using data from the CPT testing. The assessment has been undertaken in accordance with the 2016 MBIE and NZGS⁵ guidelines in order to estimate the liquefaction hazard across the site. This study would qualify as a Level C, 'detailed area-wide assessment' in accordance with the 2017 EQC and MBIE planning guidelines⁶. Outputs from the liquefaction analysis are included in Appendix D.

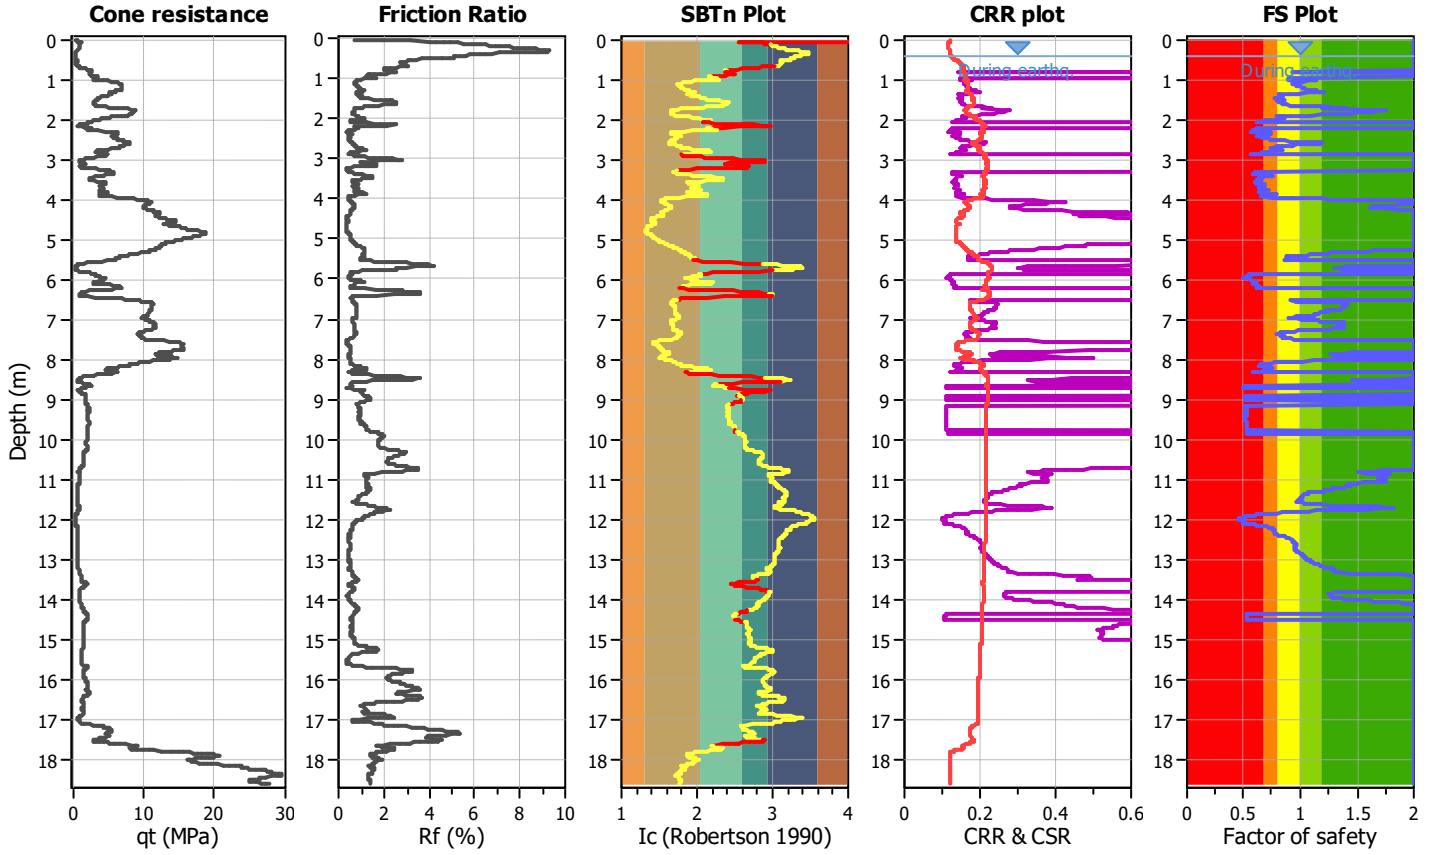
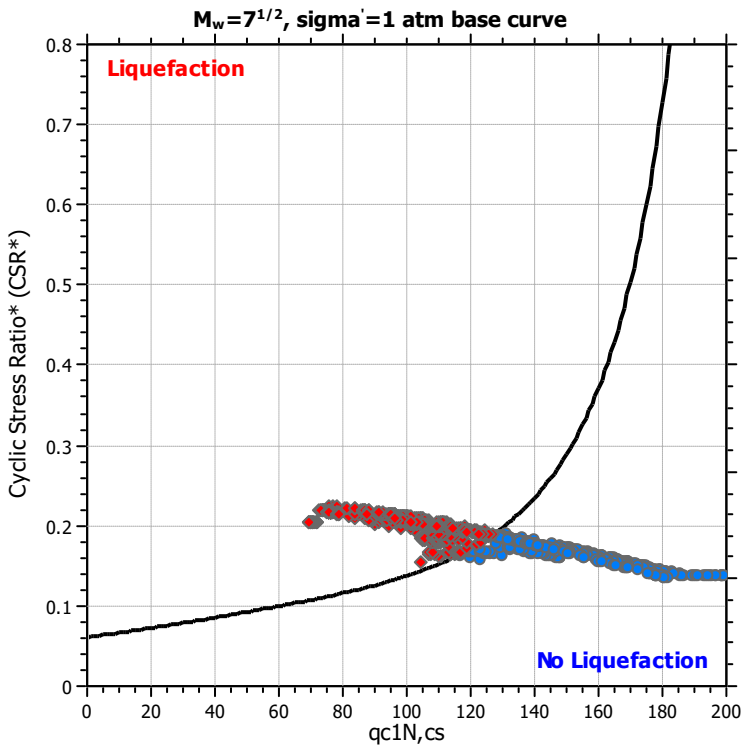
Analysis method:	B&I (2014)	G.W.T. (in-situ):	0.40 m	Use fill:	No	Clay like behavior applied:	Sand & Clay
Fines correction method:	B&I (2014)	G.W.T. (earthq.):	0.40 m	Fill height:	N/A	Limit depth applied:	Yes
Points to test:	Based on Ic value	Average results interval:	3	Fill weight:	N/A	Limit depth:	15.00 m
Earthquake magnitude M_w :	5.90	Ic cut-off value:	2.60	Trans. detect. applied:	Yes	MSF method:	Method
Peak ground acceleration:	0.22	Unit weight calculation:	Based on SBT	K_g applied:	Yes

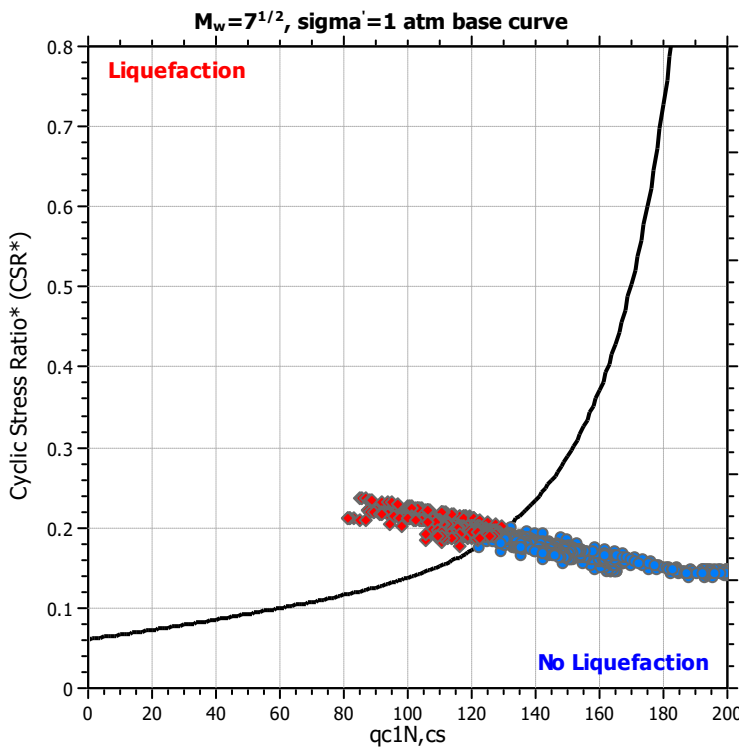
Analysis method:	B&I (2014)	G.W.T. (in-situ):	0.30 m	Use fill:	No	Clay like behavior applied:	Sand & Clay
Fines correction method:	B&I (2014)	G.W.T. (earthq.):	0.30 m	Fill height:	N/A	Limit depth applied:	Yes
Points to test:	Based on Ic value	Average results interval:	3	Fill weight:	N/A	Limit depth:	15.00 m
Earthquake magnitude M_w :	5.90	Ic cut-off value:	2.60	Trans. detect. applied:	Yes	MSF method:	Method
Peak ground acceleration:	0.22	Unit weight calculation:	Based on SBT	K_σ applied:	Yes

Zone A₁: Cyclic liquefaction likely depending on size and duration of cyclic loading
 Zone A₂: Cyclic liquefaction and strength loss likely depending on loading and ground geometry
 Zone B: Liquefaction and post-earthquake strength loss unlikely, check cyclic softening
 Zone C: Cyclic liquefaction and strength loss possible depending on soil plasticity, brittleness/sensitivity, strain to peak undrained strength and ground geometry

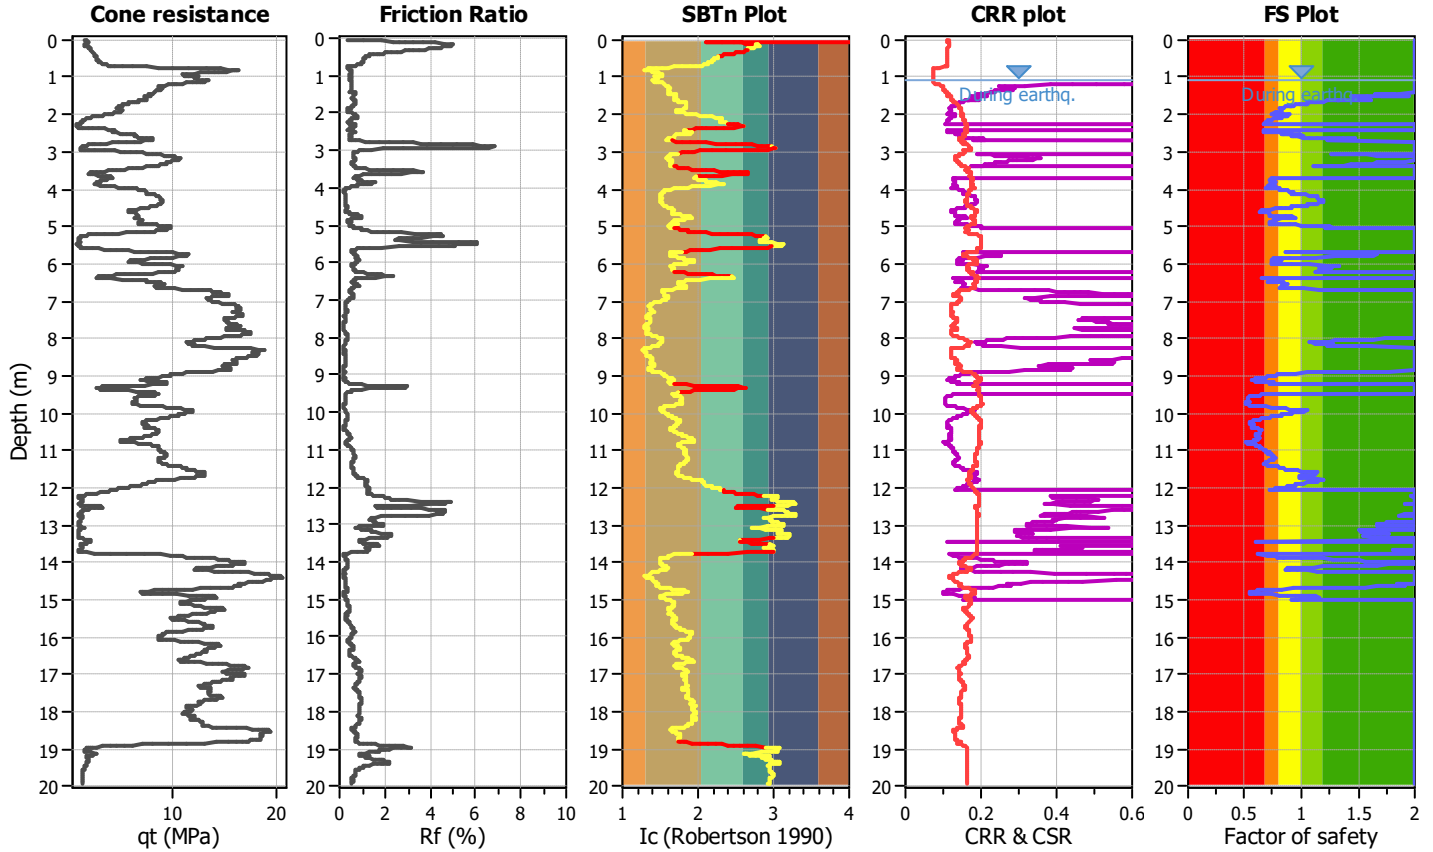
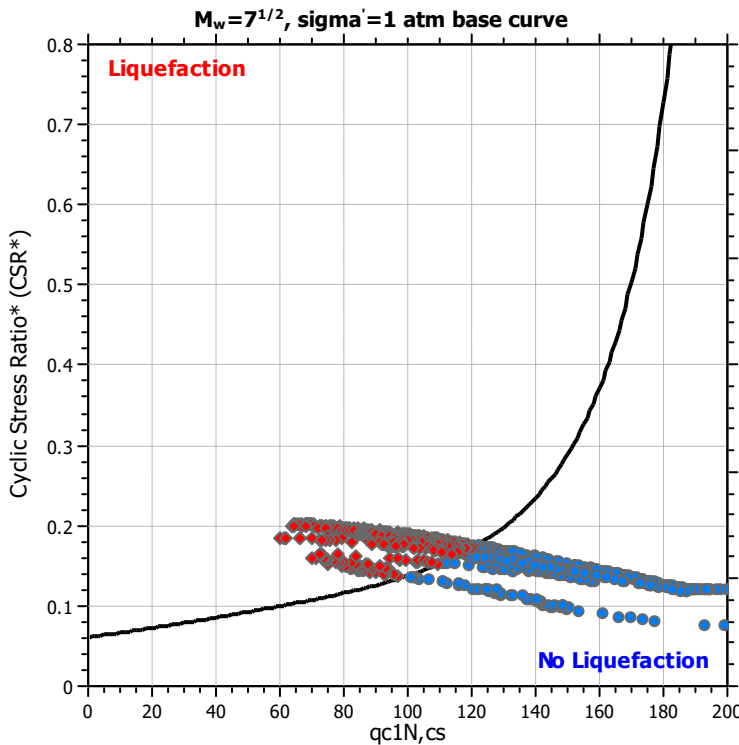
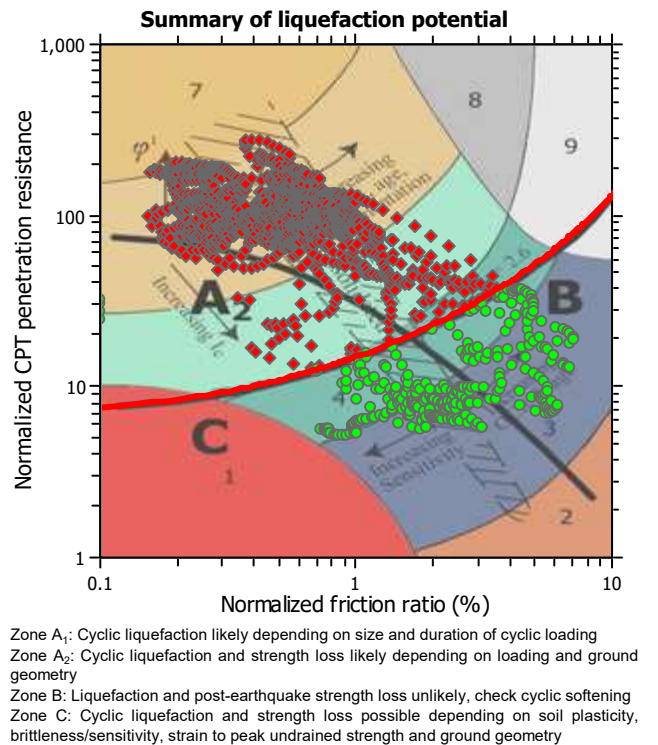
Analysis method:	B&I (2014)	G.W.T. (in-situ):	1.10 m	Use fill:	No	Clay like behavior applied:	Sand & Clay
Fines correction method:	B&I (2014)	G.W.T. (earthq.):	1.10 m	Fill height:	N/A	Limit depth applied:	Yes
Points to test:	Based on Ic value	Average results interval:	3	Fill weight:	N/A	Limit depth:	15.00 m
Earthquake magnitude M_w :	5.90	Ic cut-off value:	2.60	Trans. detect. applied:	Yes	MSF method:	Method
Peak ground acceleration:	0.22	Unit weight calculation:	Based on SBT	K_σ applied:	Yes

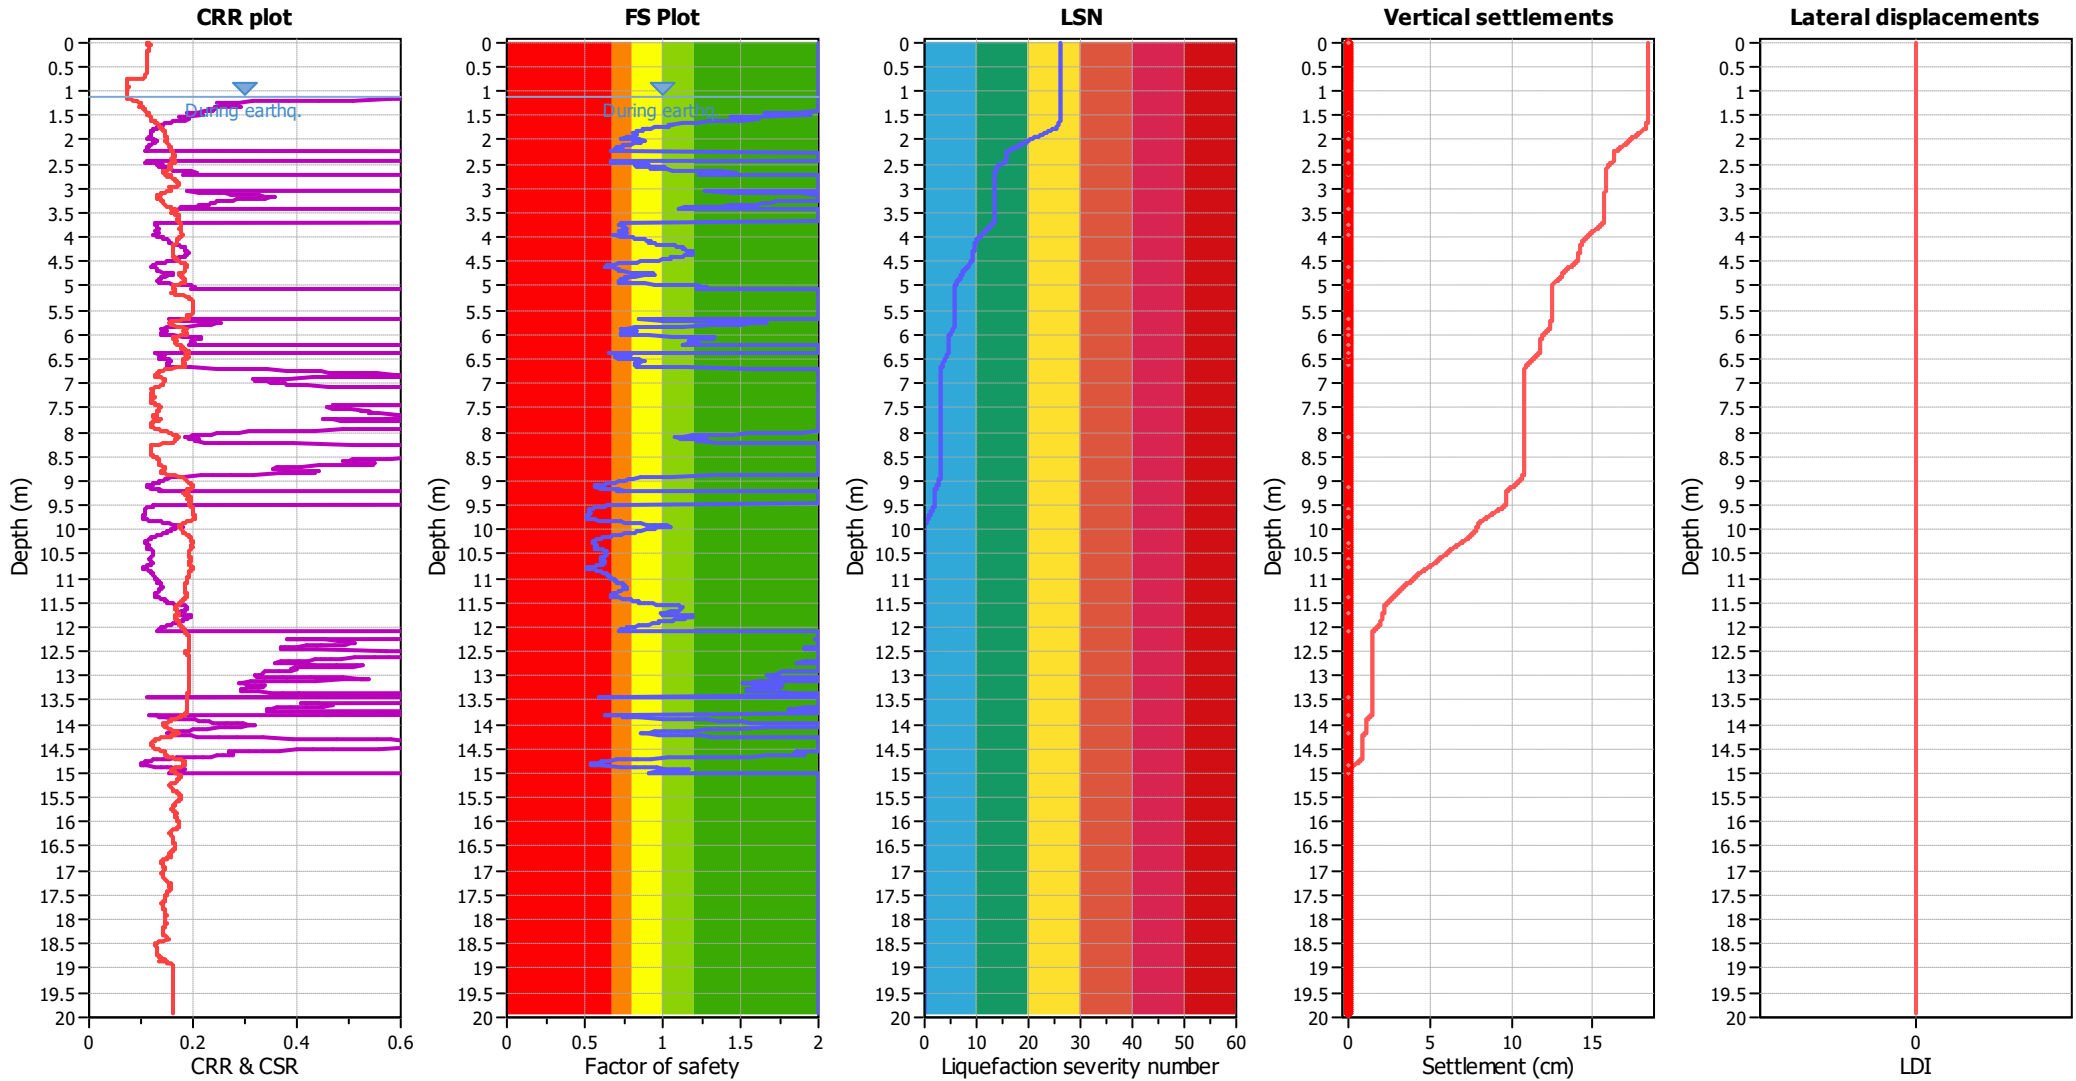
Liquefaction analysis overall plots

Analysis method:	B&I (2014)	Depth to GWT (erthq.):	1.10 m	Fill weight:	N/A
Fines correction method:	B&I (2014)	Average results interval:	3	Transition detect. applied:	Yes
Points to test:	Based on Ic value	Ic cut-off value:	2.60	K_{σ} applied:	Yes
Earthquake magnitude M_w :	5.90	Unit weight calculation:	Based on SBT	Clay like behavior applied:	Sand & Clay
Peak ground acceleration:	0.22	Use fill:	No	Limit depth applied:	Yes
Depth to water table (insitu):	1.10 m	Fill height:	N/A	Limit depth:	15.00 m

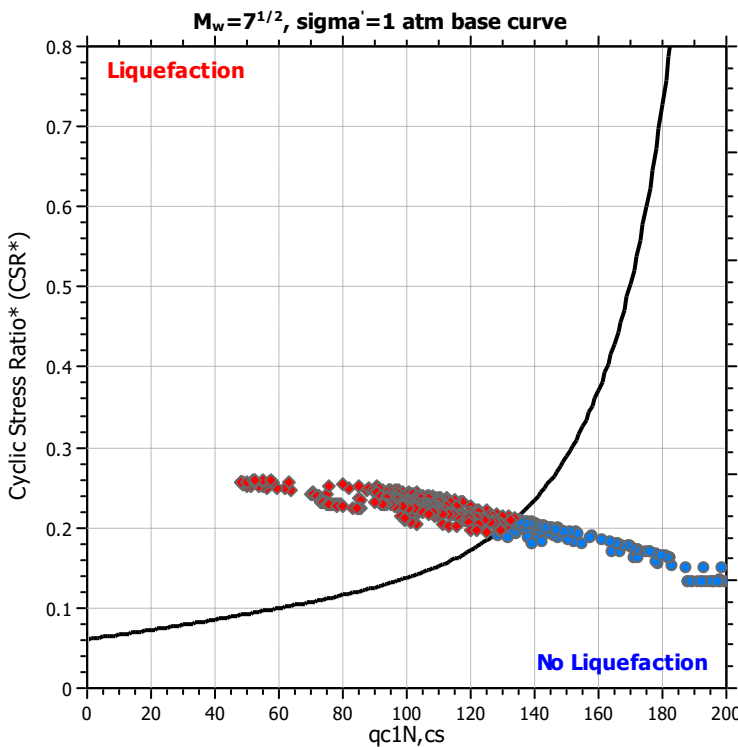
Analysis method:	B&I (2014)	G.W.T. (in-situ):	0.10 m	Use fill:	No	Clay like behavior applied:	Sand & Clay
Fines correction method:	B&I (2014)	G.W.T. (earthq.):	0.10 m	Fill height:	N/A	Limit depth applied:	Yes
Points to test:	Based on Ic value	Average results interval:	3	Fill weight:	N/A	Limit depth:	15.00 m
Earthquake magnitude M_w :	5.90	Ic cut-off value:	2.60	Trans. detect. applied:	Yes	MSF method:	Method
Peak ground acceleration:	0.22	Unit weight calculation:	Based on SBT	K_σ applied:	Yes

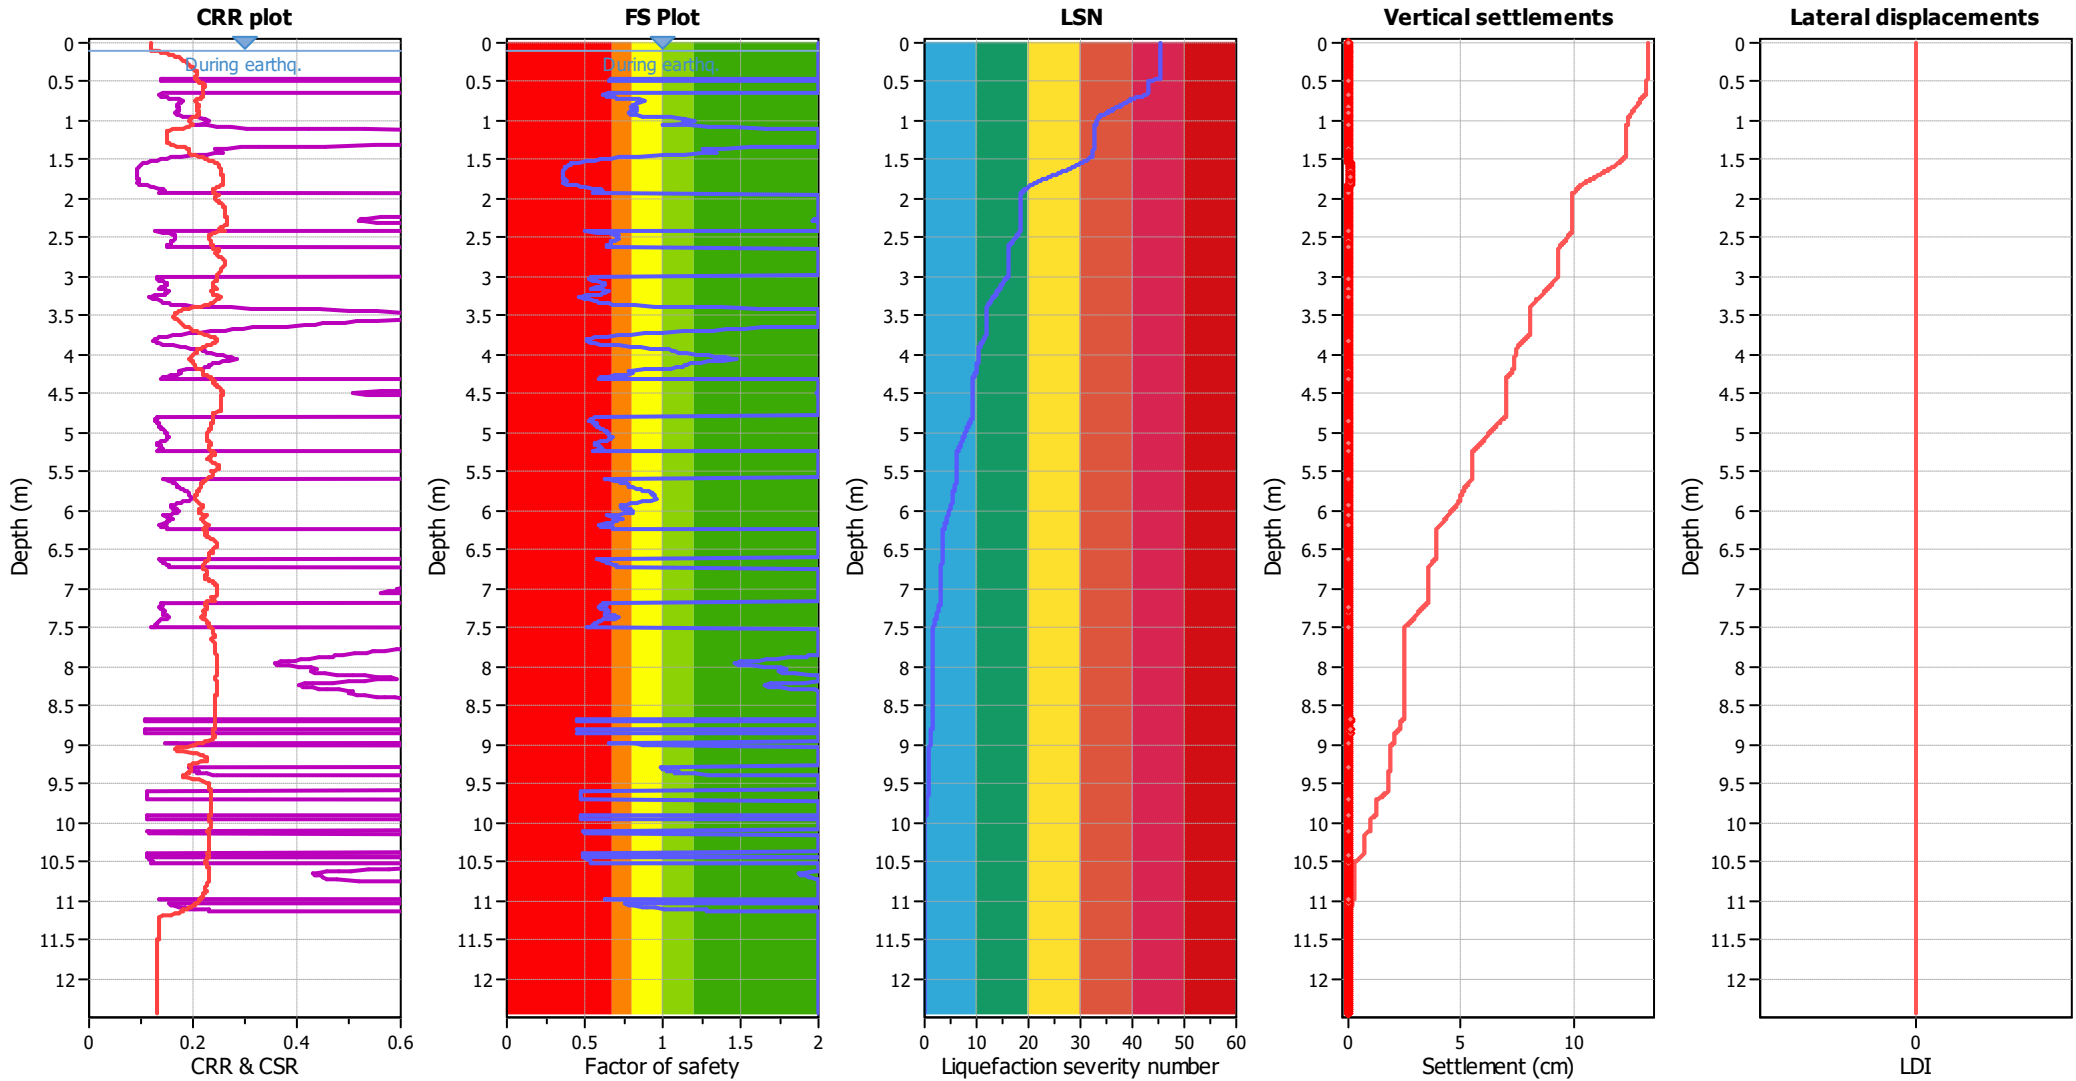
Liquefaction analysis overall plots

Analysis method: B&I (2014)
 Fines correction method: B&I (2014)
 Points to test: Based on Ic value
 Earthquake magnitude M_w : 5.90
 Peak ground acceleration: 0.22
 Depth to water table (insitu): 0.10 m

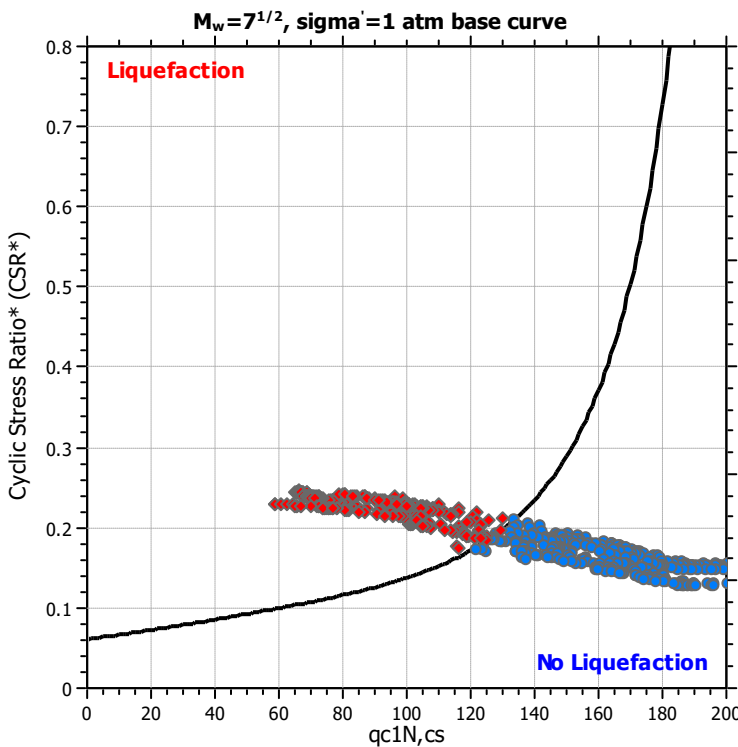
Analysis method:	B&I (2014)	G.W.T. (in-situ):	0.20 m	Use fill:	No	Clay like behavior applied:	Sand & Clay
Fines correction method:	B&I (2014)	G.W.T. (earthq.):	0.20 m	Fill height:	N/A	Limit depth applied:	Yes
Points to test:	Based on Ic value	Average results interval:	3	Fill weight:	N/A	Limit depth:	15.00 m
Earthquake magnitude M_w :	5.90	Ic cut-off value:	2.60	Trans. detect. applied:	Yes	MSF method:	Method
Peak ground acceleration:	0.22	Unit weight calculation:	Based on SBT	K_σ applied:	Yes

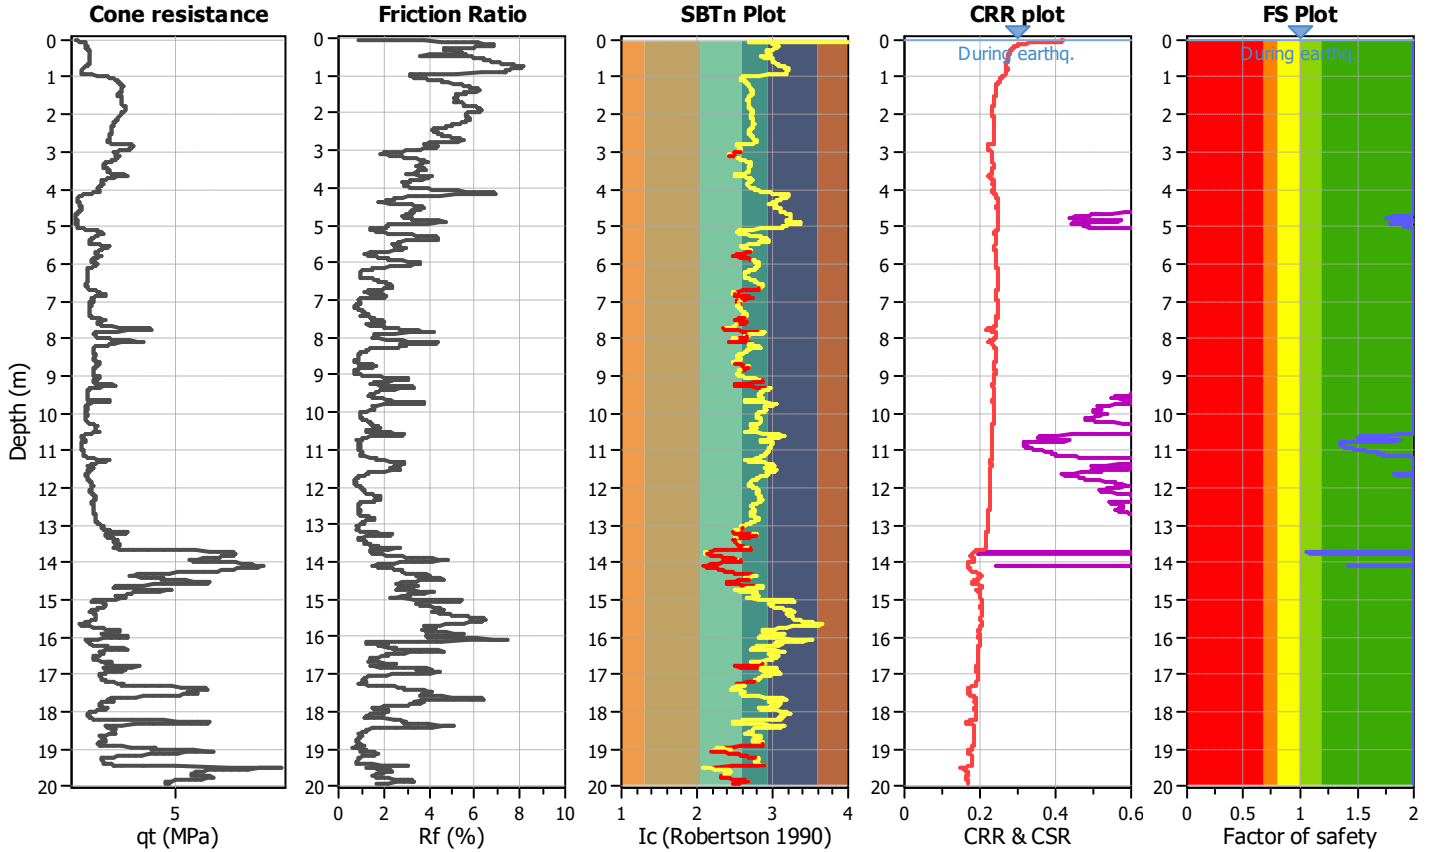
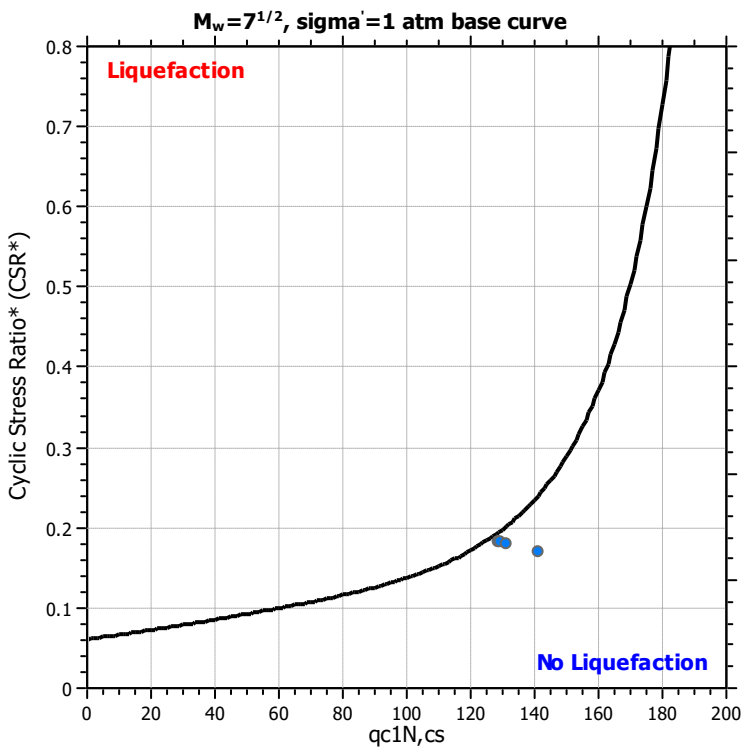
Input parameters and analysis data

Analysis method:	B&I (2014)	G.W.T. (in-situ):	0.00 m	Use fill:	No	Clay like behavior applied:	Sand & Clay
Fines correction method:	B&I (2014)	G.W.T. (earthq.):	0.00 m	Fill height:	N/A	Limit depth applied:	Yes
Points to test:	Based on Ic value	Average results interval:	3	Fill weight:	N/A	Limit depth:	15.00 m
Earthquake magnitude M_w :	5.90	Ic cut-off value:	2.20	Trans. detect. applied:	Yes	MSF method:	Method
Peak ground acceleration:	0.22	Unit weight calculation:	Based on SBT	K_g applied:	Yes

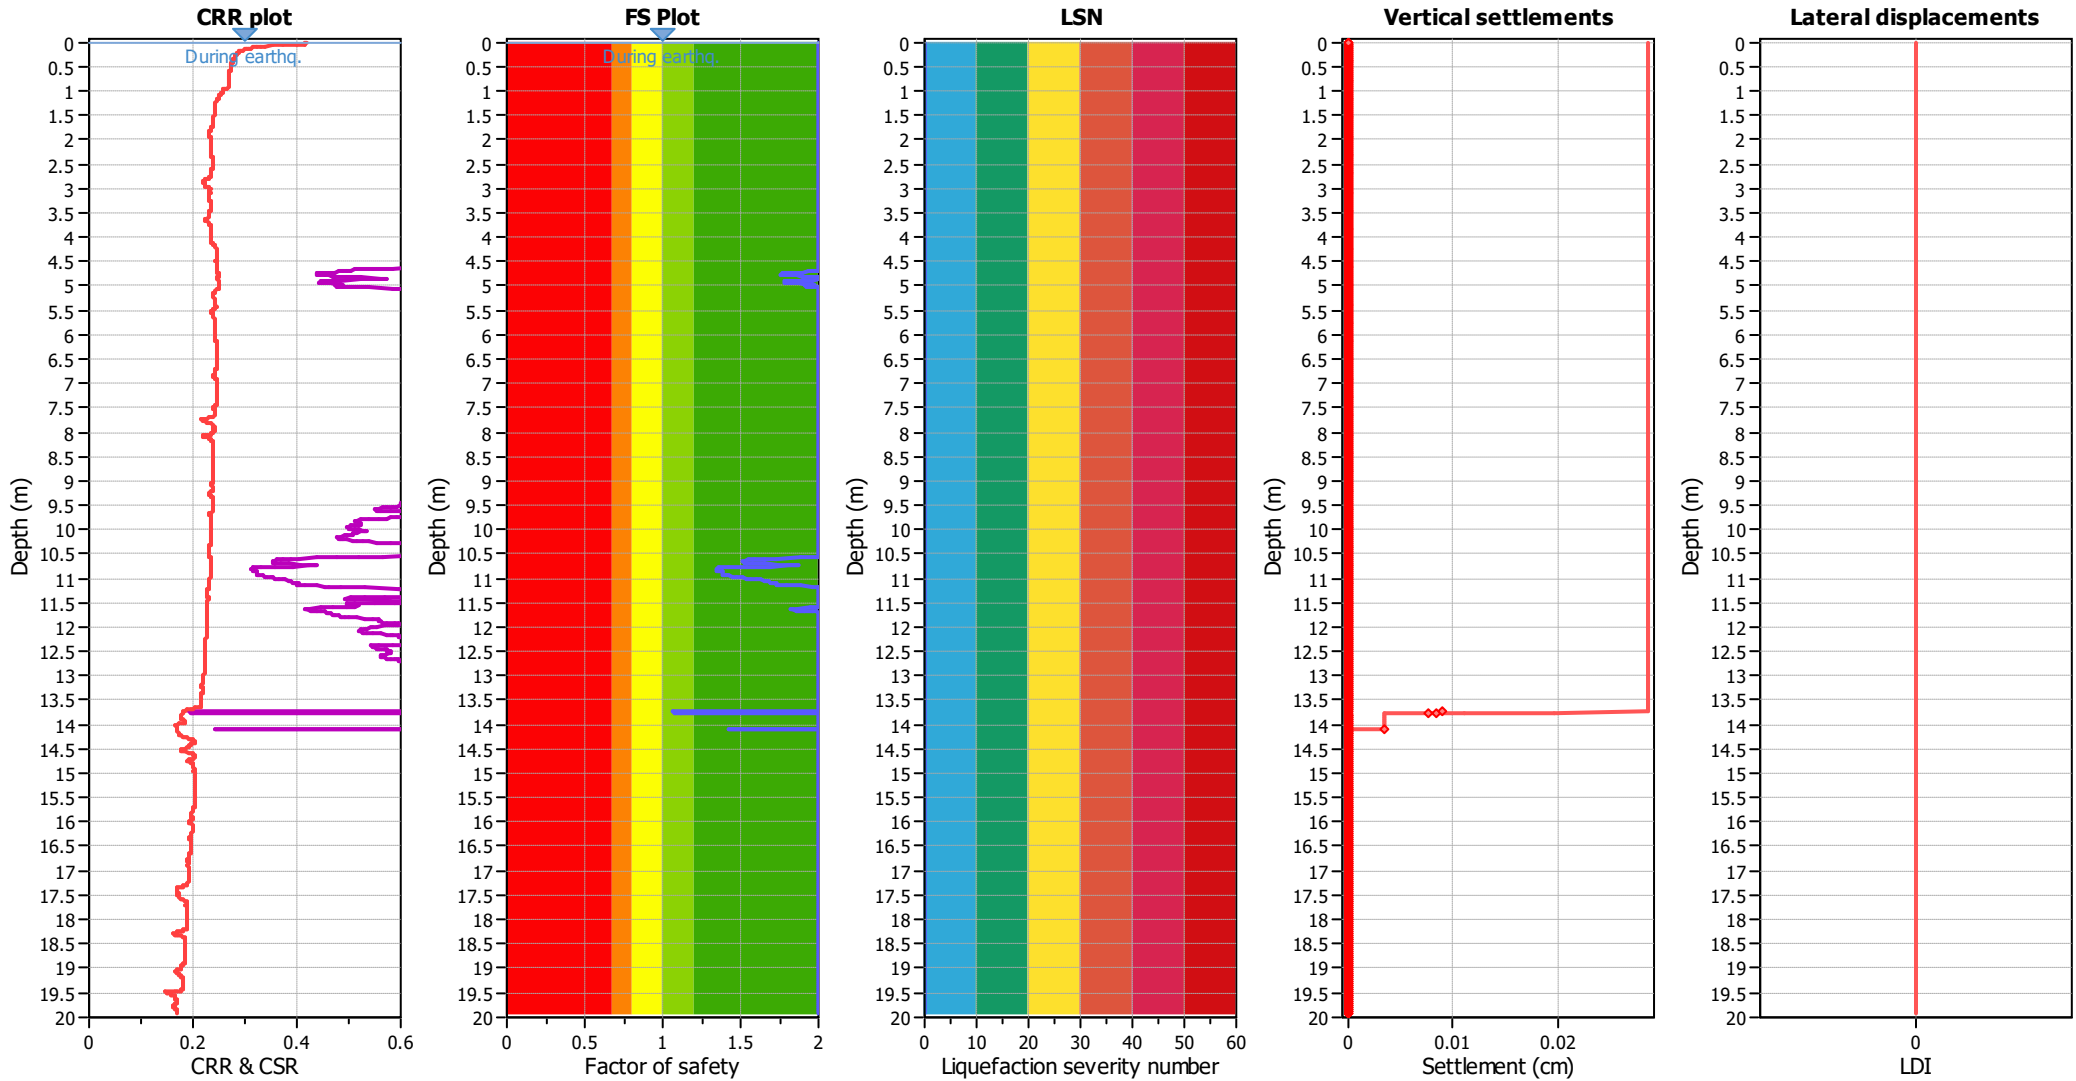
Liquefaction analysis overall plots

Input parameters and analysis data

Analysis method:	B&I (2014)	Depth to GWT (erthq.):	0.00 m	Fill weight:	N/A
Fines correction method:	B&I (2014)	Average results interval:	3	Transition detect. applied:	Yes
Points to test:	Based on Ic value	Ic cut-off value:	2.20	K_f applied:	Yes
Earthquake magnitude M_w :	5.90	Unit weight calculation:	Based on SBT	Clay like behavior applied:	Sand & Clay
Peak ground acceleration:	0.22	Use fill:	No	Limit depth applied:	Yes
Depth to water table (insitu):	0.00 m	Fill height:	N/A	Limit depth:	15.00 m

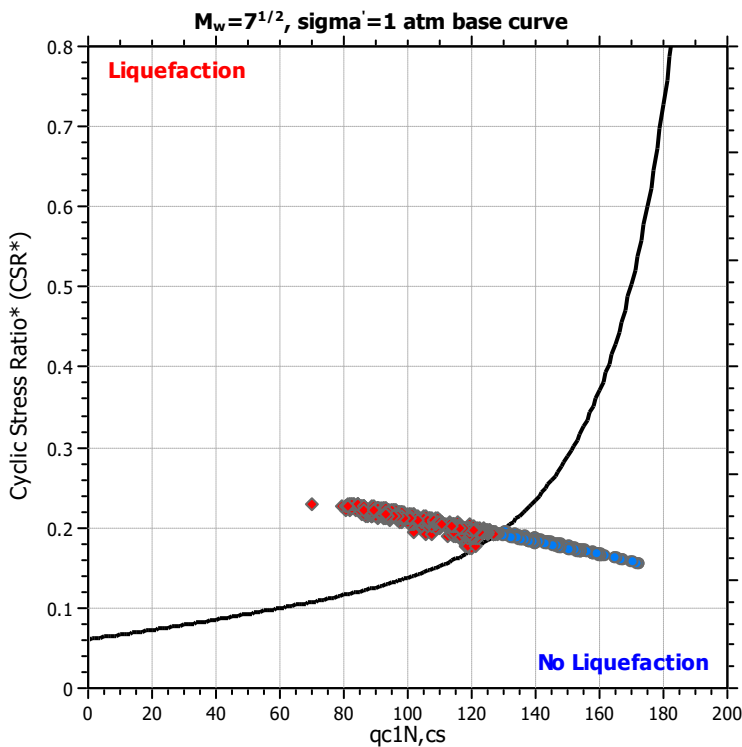
Input parameters and analysis data

Analysis method:	B&I (2014)	G.W.T. (in-situ):	0.30 m	Use fill:	No	Clay like behavior applied:	Sand & Clay
Fines correction method:	B&I (2014)	G.W.T. (earthq.):	0.30 m	Fill height:	N/A	Limit depth applied:	Yes
Points to test:	Based on Ic value	Average results interval:	3	Fill weight:	N/A	Limit depth:	15.00 m
Earthquake magnitude M_w :	5.90	Ic cut-off value:	2.60	Trans. detect. applied:	Yes	MSF method:	Method
Peak ground acceleration:	0.22	Unit weight calculation:	Based on SBT	K_σ applied:	Yes

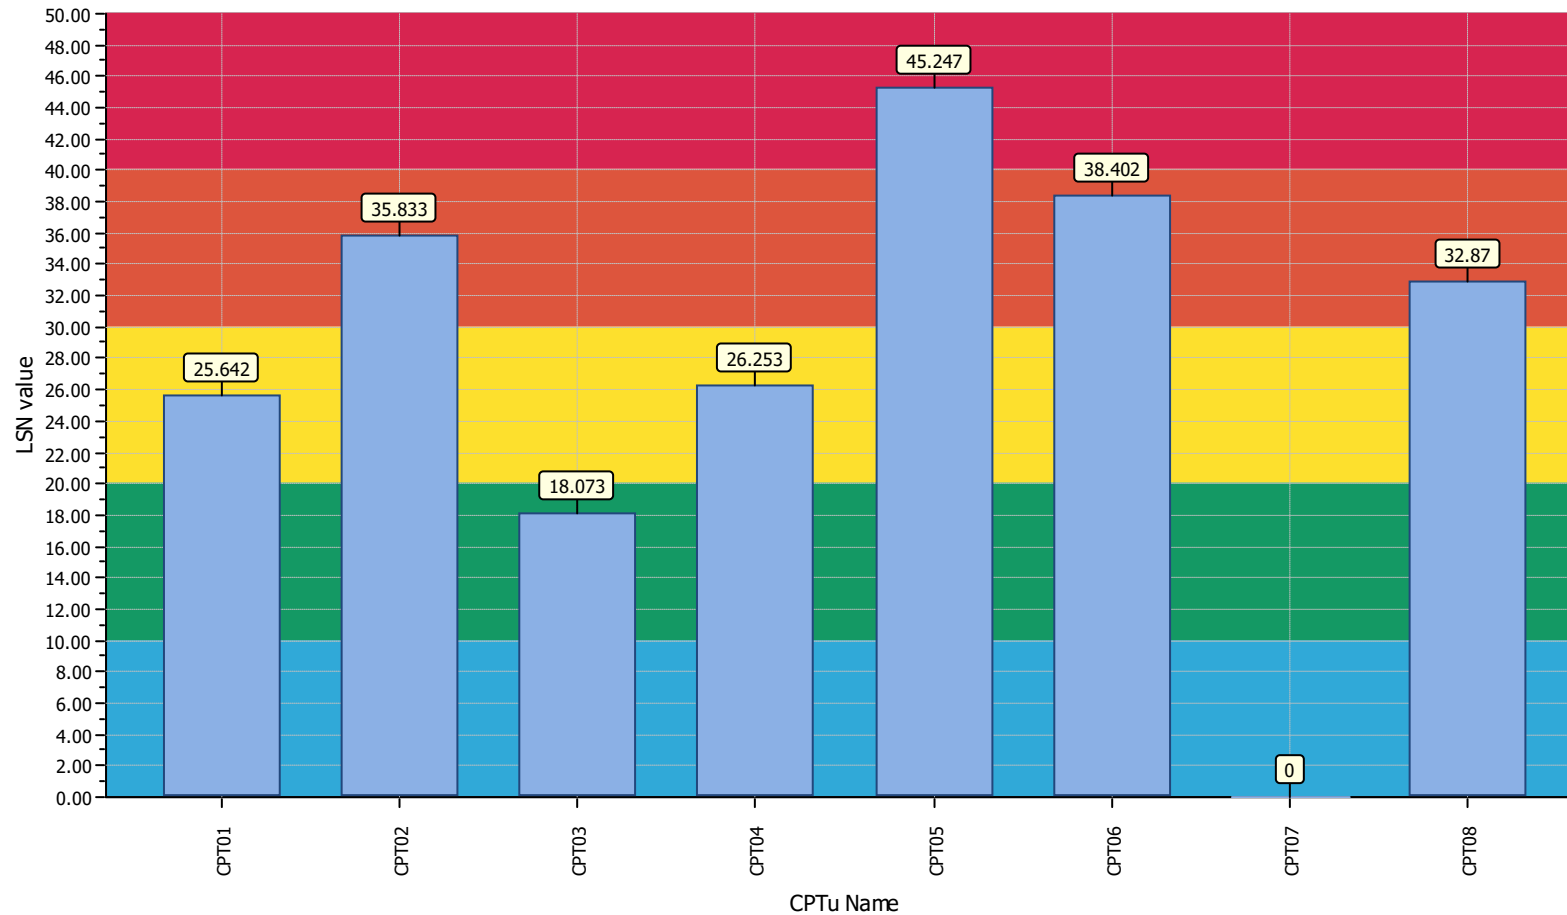
Overall Liquefaction Severity Number report

LSN color scheme

- Severe damage
- Major expression of liquefaction
- Moderate to severe exp. of liquefaction
- Moderate expression of liquefaction
- Minor expression of liquefaction
- Little to no expression of liquefaction
