ROTOKAURI NORTH SHA

PRELIMINARY GEOTECHNICAL REPORT

PROJECT NO: HD631
GREEN SEED CONSULTANTS
LIMITED
REFERENCE: PCR
27 JULY 2018

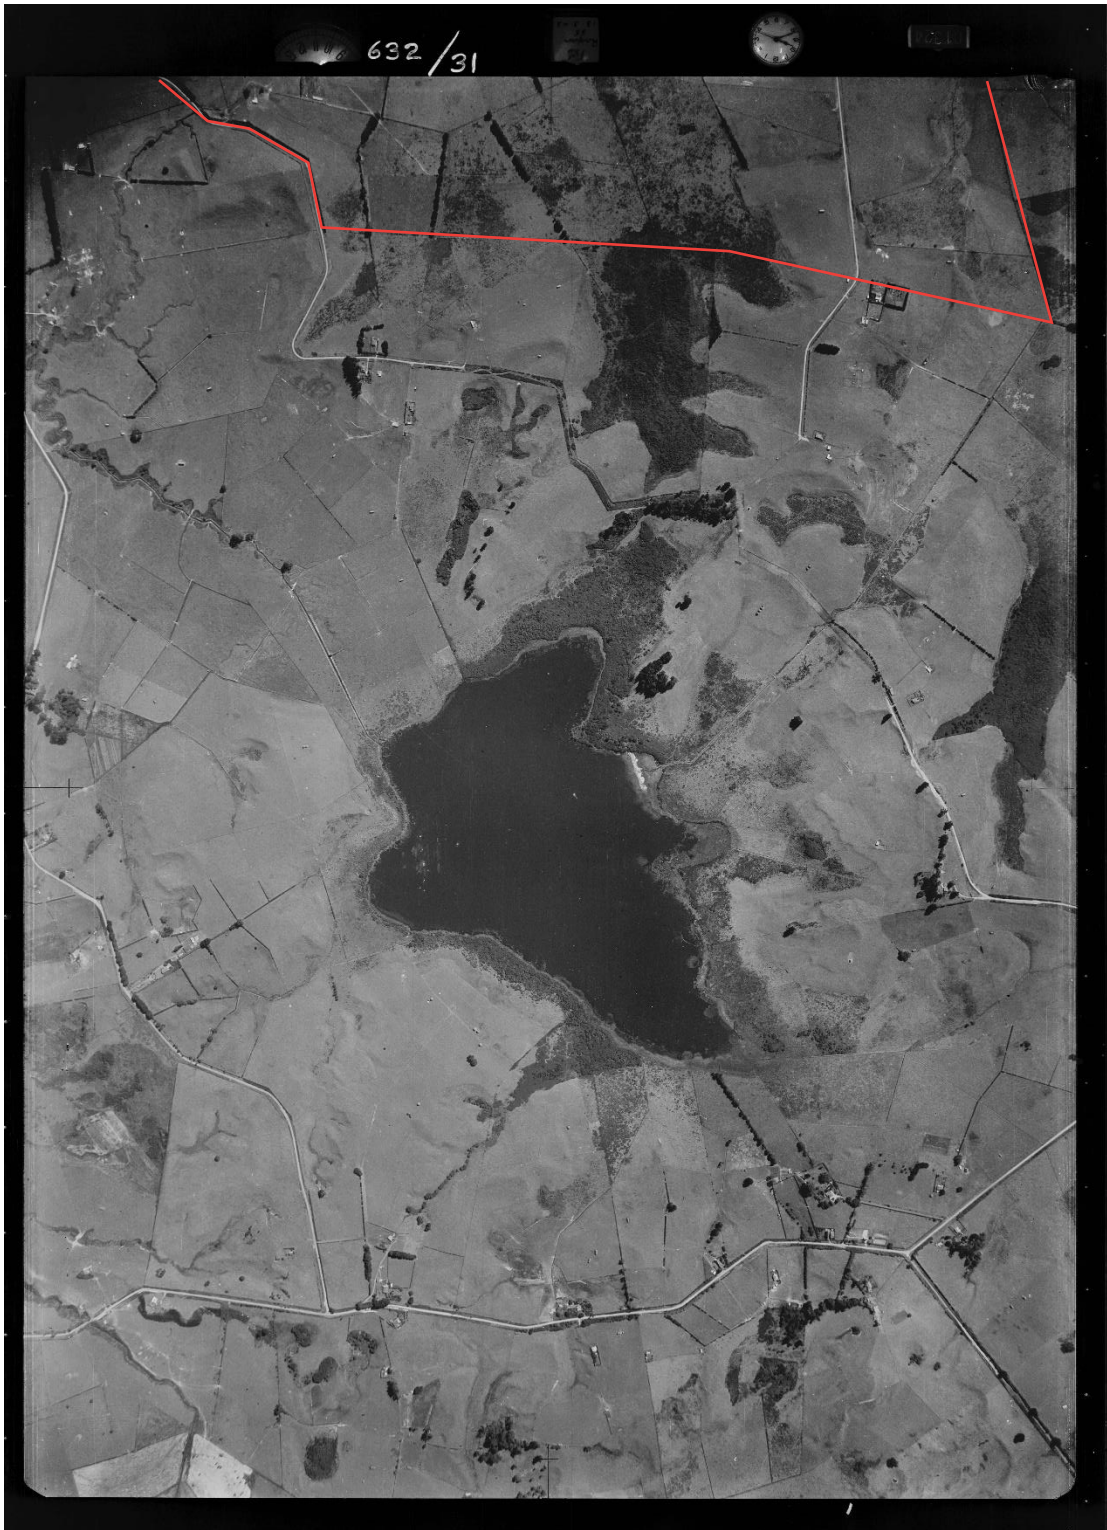
Figure 1. Aerial imagery from 1943. Site boundary in red.

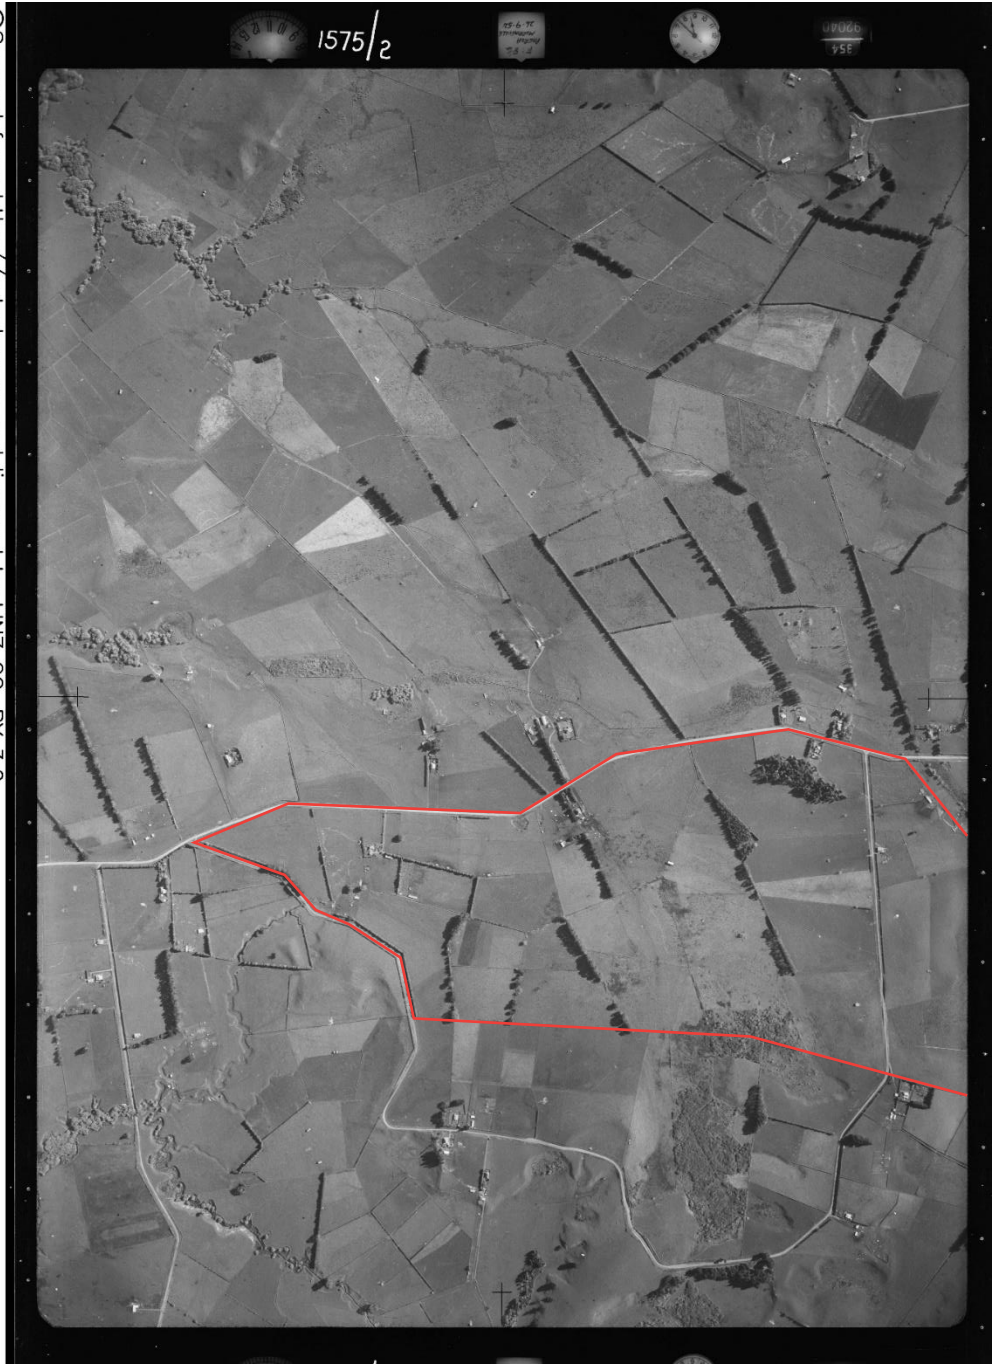
Figure 2. Historical imagery from 1952. Site boundary in red.

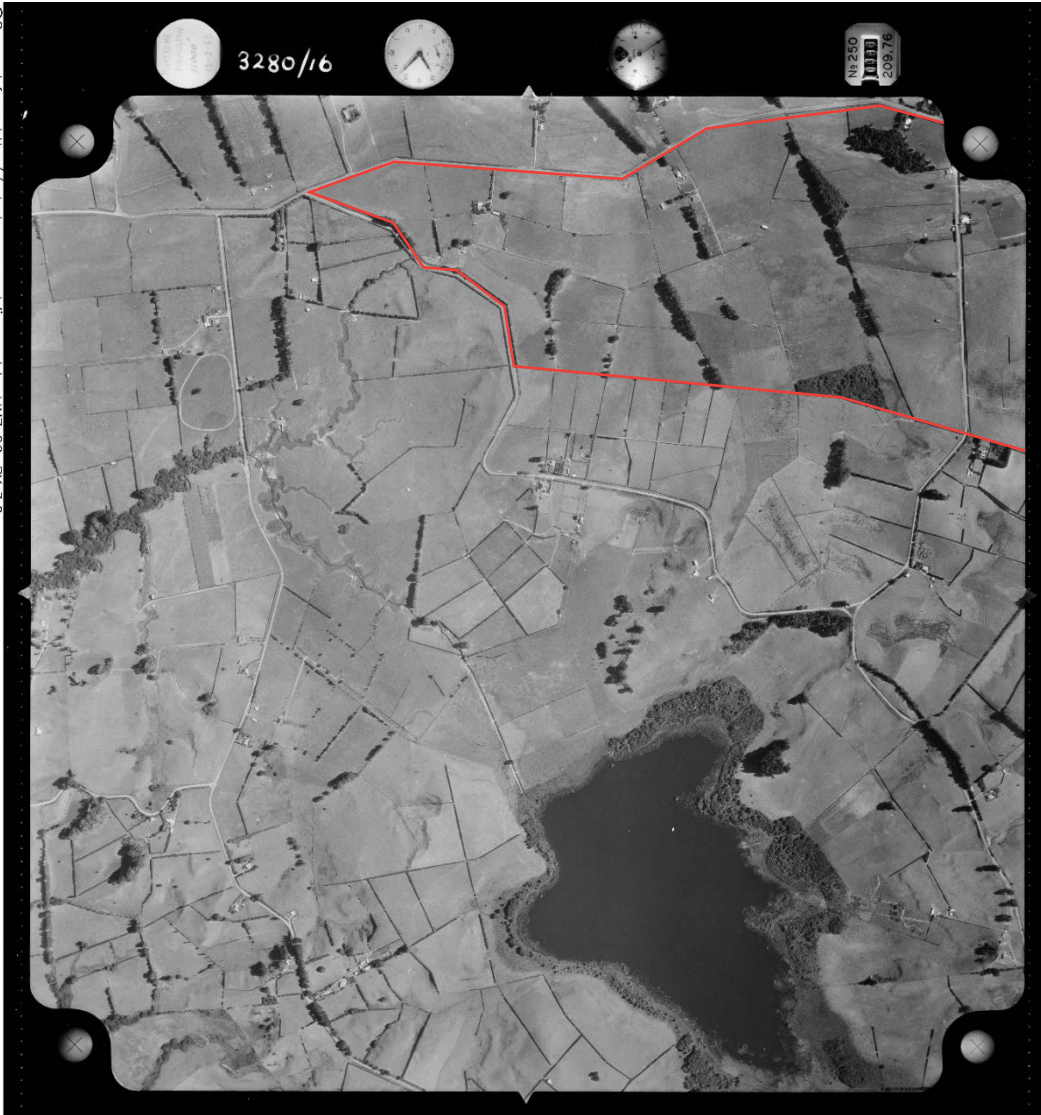
Figure 3. Historical Imagery from 1963. Site boundary in red.

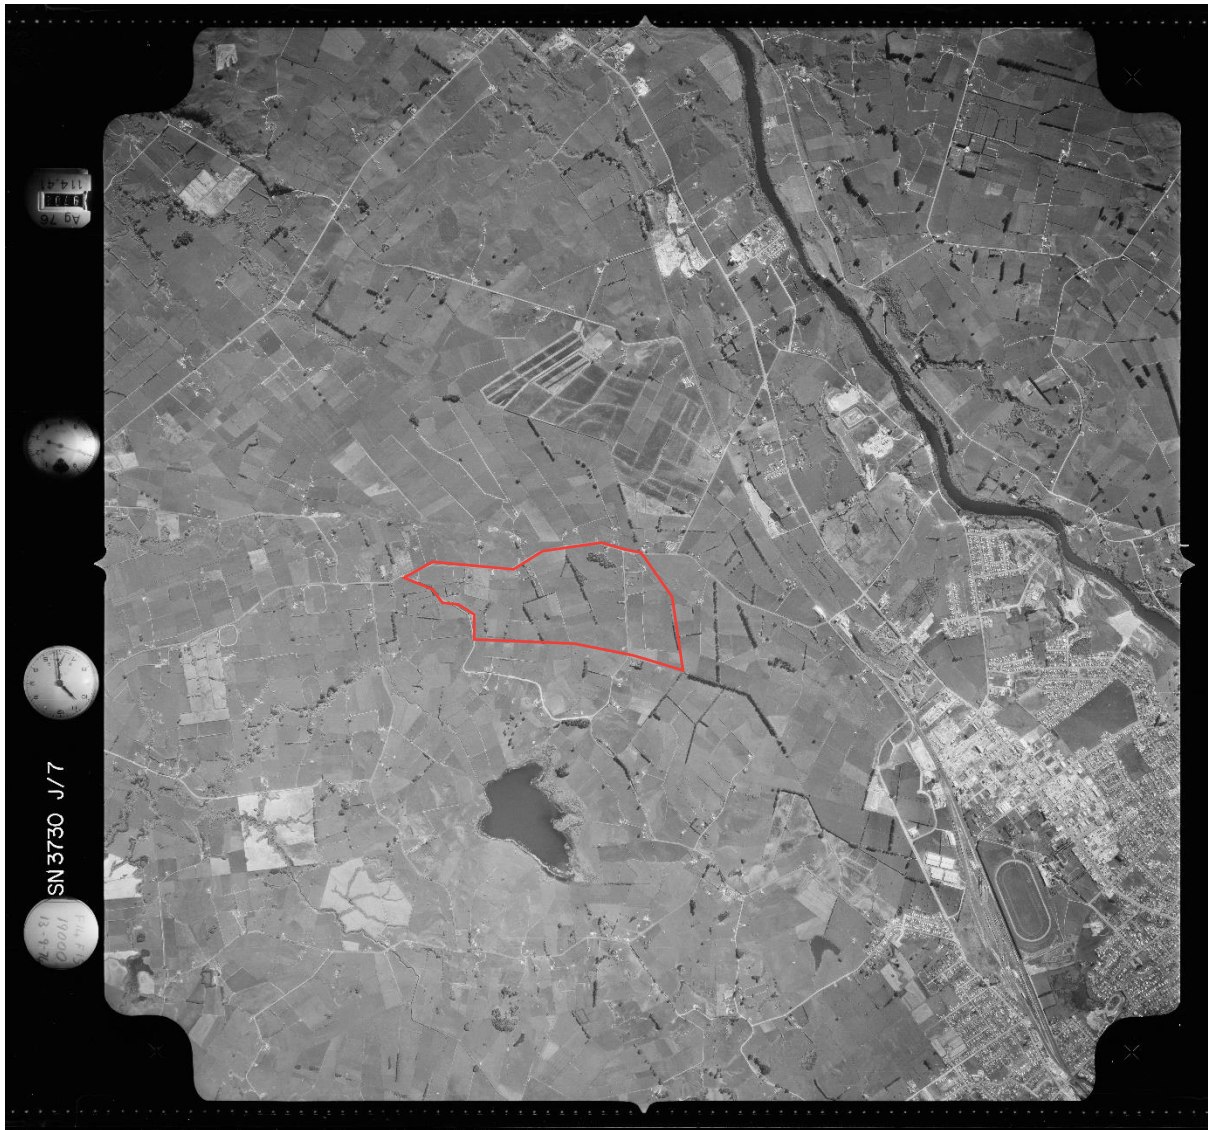
Figure 4. Historical Imagery from 1974. Site boundary in red.
