**MOISTURE TESTING GUIDE
FOR WOOD FRAME CONSTRUCTION
CLAD WITH EXTERIOR INSULATION AND FINISH SYSTEMS
(EIFS)
Version 3.01**

EIFS Review Committee

New Hanover County Inspection Department
414 Chestnut Street - Room 201
Wilmington, North Carolina 28401

August 4, 1998

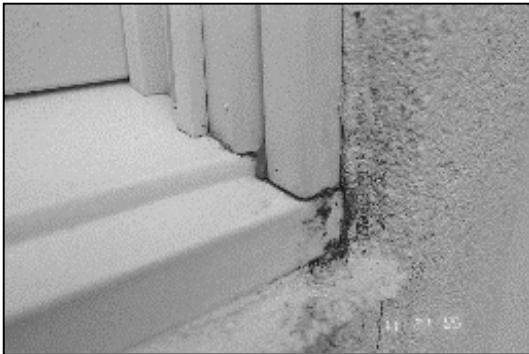
Window frame leaks at the corner of sill and jamb connections are "typical" of some windows.

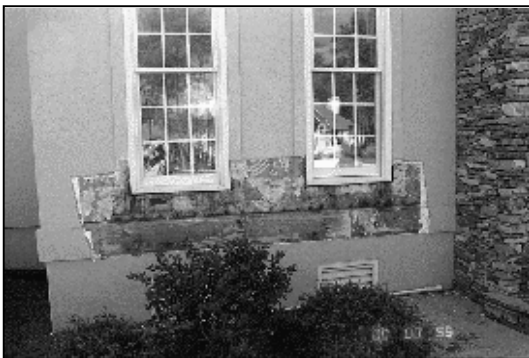
Small opening in window construction allowed a large quantity of water to enter a wall resulting in rot.

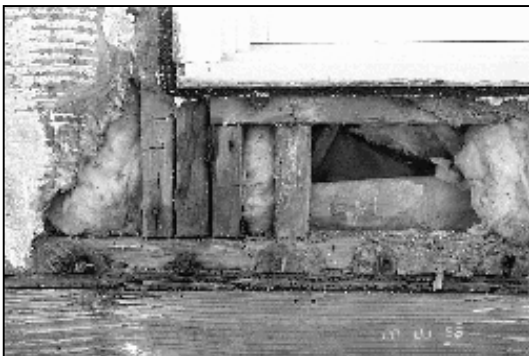
Extent of decay in studs can be assessed with an awl.

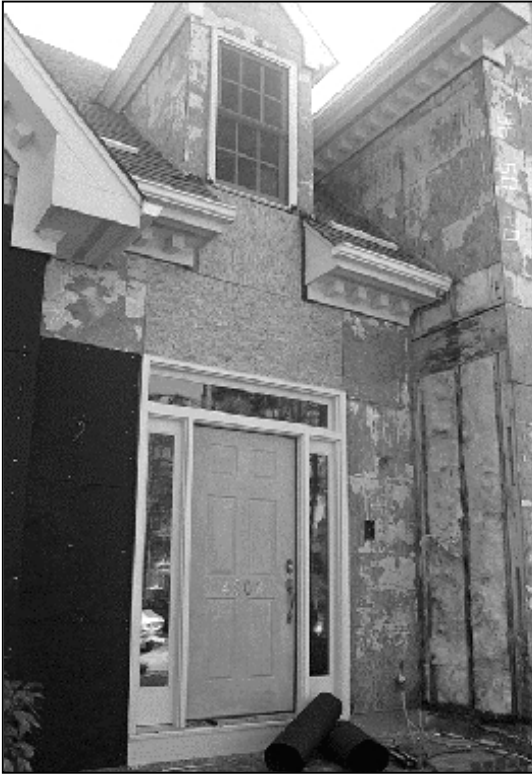
Decay discovered in a wall and floor band below a rake (kick out) flashing area.

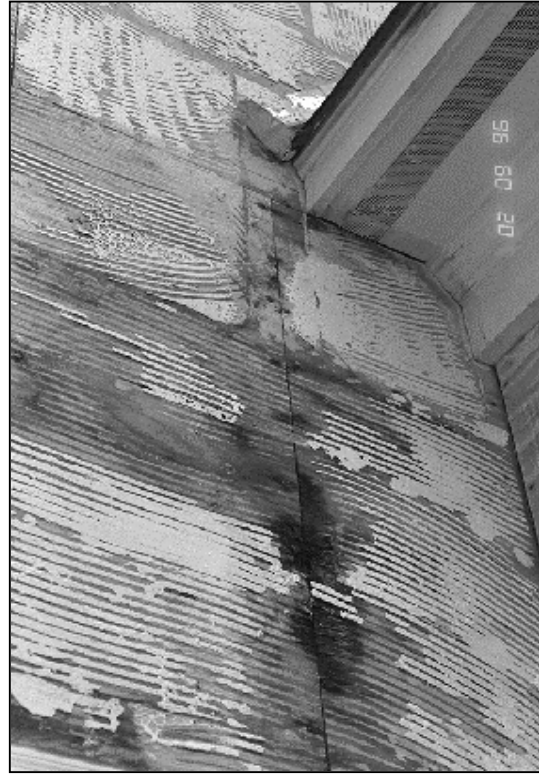
Pattern of water damage below a rake (kick out) flashing.

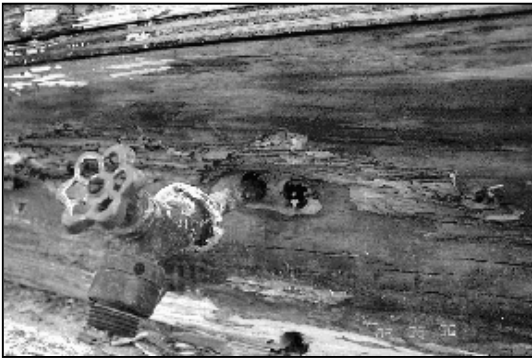
Decay of a 2x10 band from a hose bib penetration.

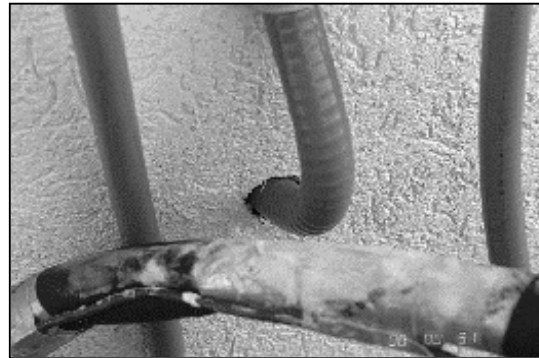
Electrical conduit penetrates without sealant.

NOTE The white substance on the substrate is the adhesive that once held the insulation board in place. You can clearly see some horizontal trowel marks in the adhesive. These marks can channel water away from the point of entry. In the photo at the top right, you can see that the vertical joint in the substrate directly below the kick-out flashing channeled the water straight down. The result of water being guided from one point to another is referred to as "Water Migration."

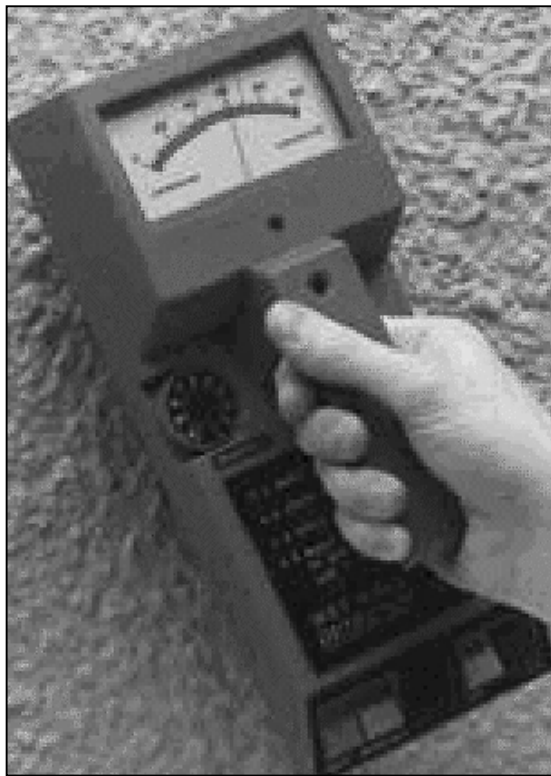
Figure 2
Moisture Scanner

Moisture scanners are non-invasive devices that are simply placed against the exterior surface of the EIFS and passed over the wall area being tested while remaining in contact with the surface. Scanners are used for detecting excessive moisture present under relatively large wall areas. The surface must be dry to obtain accurate measurements. Changes in substrate material or lamina thickness can also affect the scanner's accuracy, as will metal such as flashing, metal lath or metal studs. Moisture in the lamina or insulation board will also be detected by the scanner. Much practice and repeated use is necessary to gain competency interpreting scanner readings. For these reasons, a deep-wall-probe type moisture meter is necessary to confirm and quantify high "relative" scanner readings.

Tramex "Wet Wall Detector"
(photo courtesy of Tramex LTD)

- **Moisture Scanner:** Used to locate general areas of high moisture in walls, provides relative indication of moisture and is not designed to quantify moisture percentages. A commercially available device is manufactured by Tramex. It frequently gives false positive indications of moisture being present and depending on the wall detail, it can also give false negative indications of no elevated moisture when moisture is present, especially to the untrained or inexperienced inspector. Follow-up any high moisture indications by a scanner with a probe meter to get an accurate moisture level and to get a physical feel for the condition of the substrate. Is it soft or firm

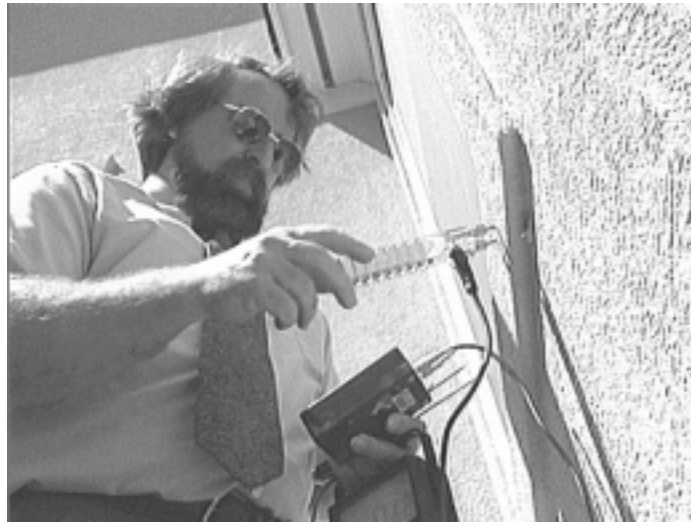
Figure 3
Moisture Meter and Probe

Moisture meters are equipped with probes that contain two electrodes that are pushed through the exterior surface of the EIFS to measure the moisture content of the interior portions of a wall. To insure that interior portions of the wall are reached, use a probe with (minimum) 3-inch long electrodes. Apply firm pressure when in contact with the substrate and taking a reading. Electrodes can be purchased with an electrically insulated covering such that only the tips are exposed. Insulating the probes minimizes false readings that may occur due to the presence of moisture on the outside of, or within the EIFS. To maximize the reliability of the moisture readings, be sure to follow the manufacturer's recommendations for changing the battery and calibrating the meter.

- **Moisture Probe Meter:** Used to probe substrates and framing members for indications of extremely soft or rotted materials as well as obtain accurate moisture content measurements. These meters use hand held deep wall probes, typically up to five inches long that have insulated electrodes. The probes are electrically conductive at the tip for measuring resistance of the material into which the tips are embedded. The meter displays moisture as a percentage by weight for wood and gypsum. The probe also gives an indication of the structural integrity of the substrate, whether it is soft or firm.
