# Aquatic Plant Management Plan for Lower Spring Lake 2023 - 2028

Jefferson County
Land and Water Conservation Department

This plan was approved by the Lower Spring Lake Protection and Rehabilitation District at their meeting on March 25th, 2023.

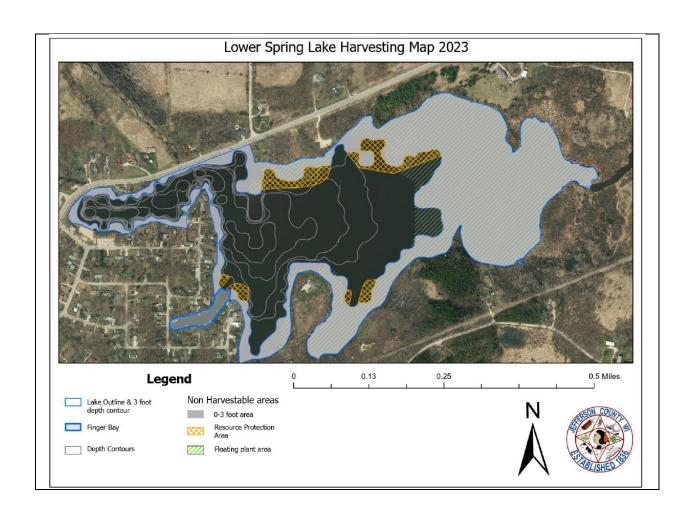
# Appendix G – Proposed Harvesting Map for Lower Spring Lake for Future DNR Permit Applications
