Edgemere Subdivision: Planned Unit Development Narrative Updated Per P&Z Comments

### **Edgemere Subdivision**

# EDGEMERE SUBDIVISION

# PRELIMINARY PLAT FOR EDGEMERE SUBDIVISION

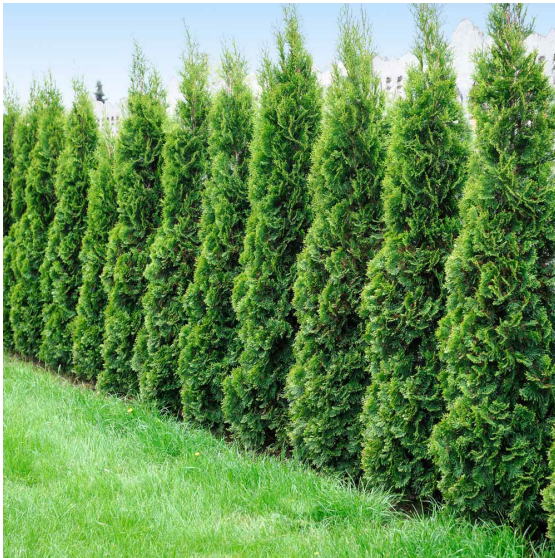
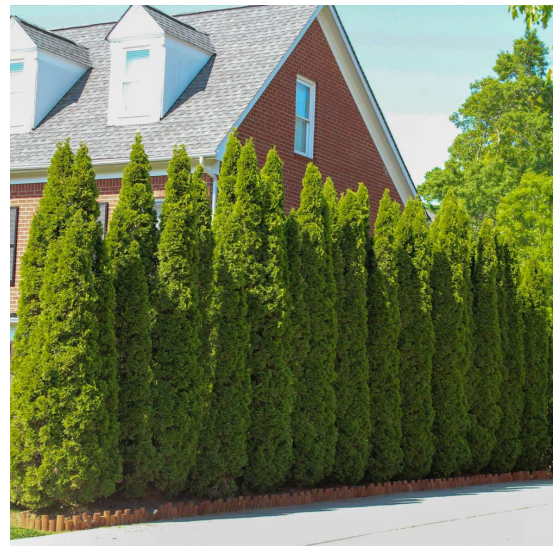
Degroot's Spire Thuja Arborvitae Tree

The revised plan includes an increase in perimeter landscaping consistent with Garden City Code requirements. The development now provides a six foot (6') wide vegetative buffer at maturity along the perimeter. The landscape plan details Degroot's Spire Thuja Arborvitae Trees (seen below) as proposed landscaping buffer plants. These landscaping trees provide a privacy between the existing home units.

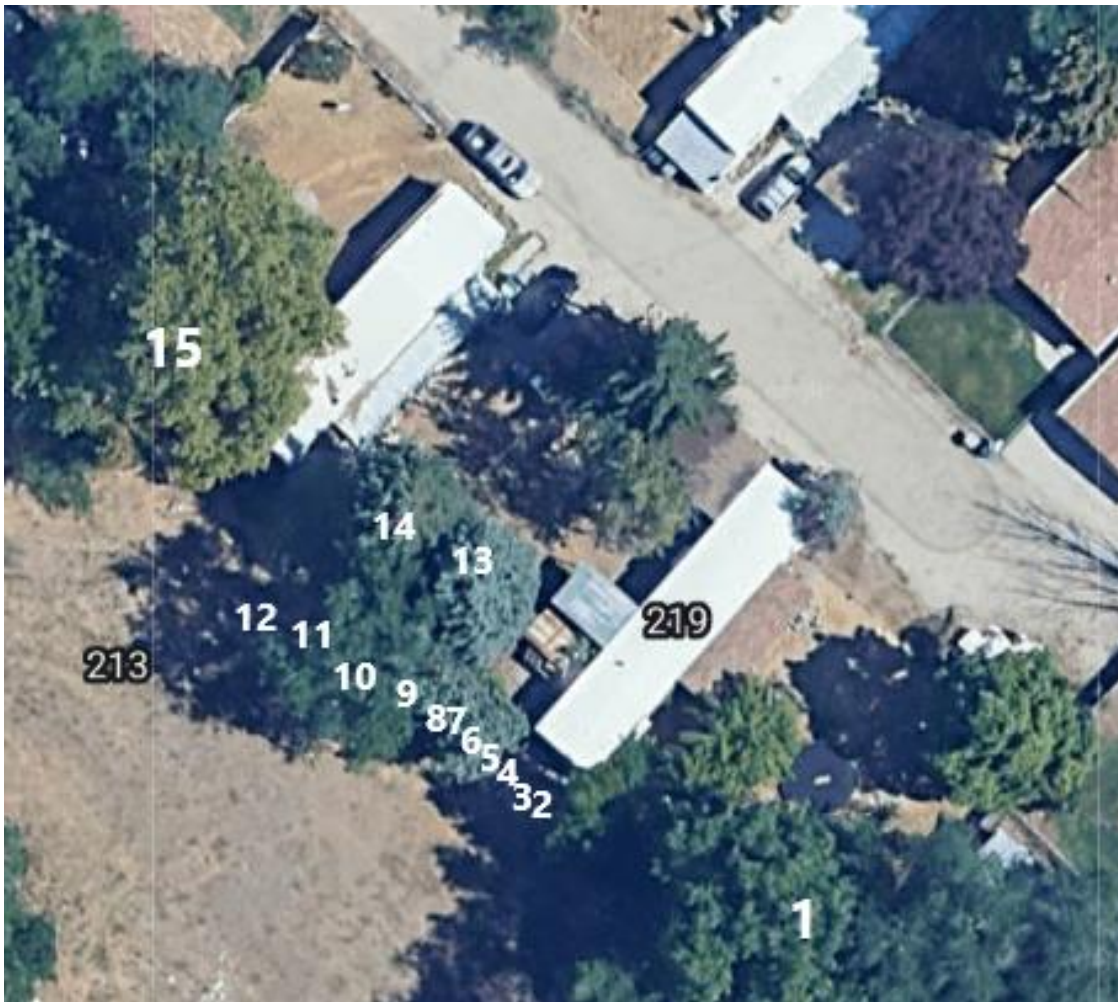
Figure 1. Subject property and trees with identifying tree numbers.

We collected data on 15 trees (Figure 1).

Tree #1 is a 27" DBH Walnut, English (*Juglans regia*) in fair condition.

Trees #2 through #12 range between 6" to 10" DBH Juniper (*Juniperus* sp.) in poor condition.

Tree #13 is an 18" DBH Spruce, Colorado (*Picea pungens*) in good condition.

Tree #14 is a 15" DBH Spruce, Colorado (*Picea pungens*) in good condition.

Tree# 15 is a 15" DBH Maple, Norway (*Acer platanoides*), in fair condition.

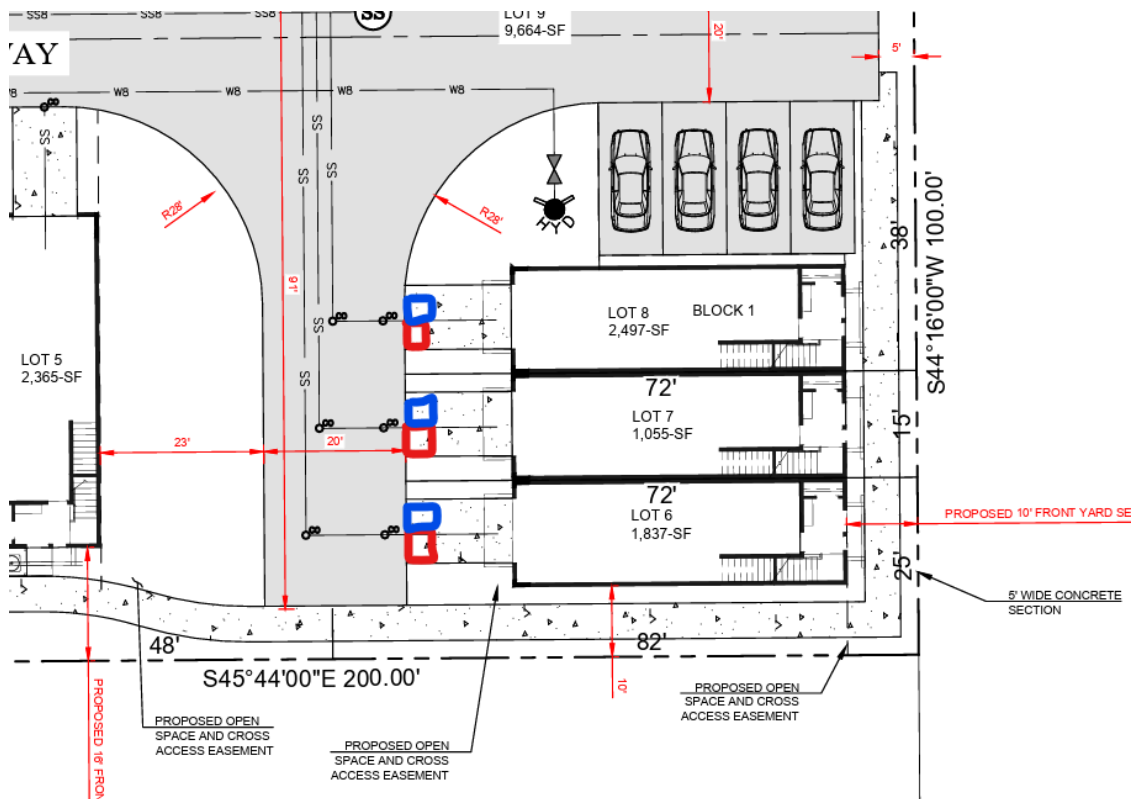
Okay, good to know! Just to clarify (a city council member had this specific question); Any concerns with lots 6 - 8 now that they are turned 90 degrees? The blue and red squares are where we had previously shown the trash carts at the end of the driveway but the concern raised at city council was "how would the truck pick up these carts if the arm is on the right/passenger side of the truck and the carts are on the left." (assuming that the truck was to drive directly into the turnaround area). Any concerns with this?
