# **Project Plan**

# Clean Water State Revolving Fund (CWSRF)

Ontonagon, Michigan

May 2023 Project 2300109

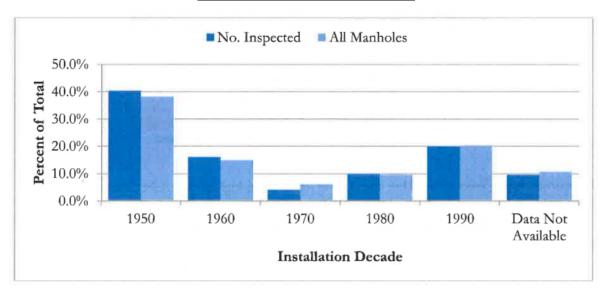
#### **Manhole Installation by Decade**

Majority of manholes (>50%) were installed in the 1950's and 1960's (see graph below). During the assessment, 416 out of the total 476 manholes were inspected. Of the 416 manholes, approximately 90% are in good to moderate condition. The remaining 10% have major structural or O&M issues with them. Out of the 416 manholes inspected, 193 have active inflow and infiltration. A Manhole Assessment is available in Table A-1 in Appendix G.

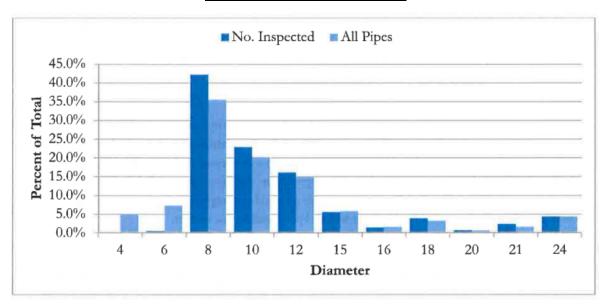
#### **Pipe Installation by Diameter**

The sanitary sewer gravity main is comprised of vitrified clay pipe (VCP), asbestos cement pipe, reinforced plastic (truss) pipe, and polyvinyl chloride (PVC) pipe. Diameters of gravity main vary between 4" and 24", the most of which being 8" and 10". The majority (>60%) of the gravity main was installed in the 1950's and 1960's. The graphs below breakdown the percentage of pipe by diameter, age, and material. Inflow and infiltration, pipe damage, and

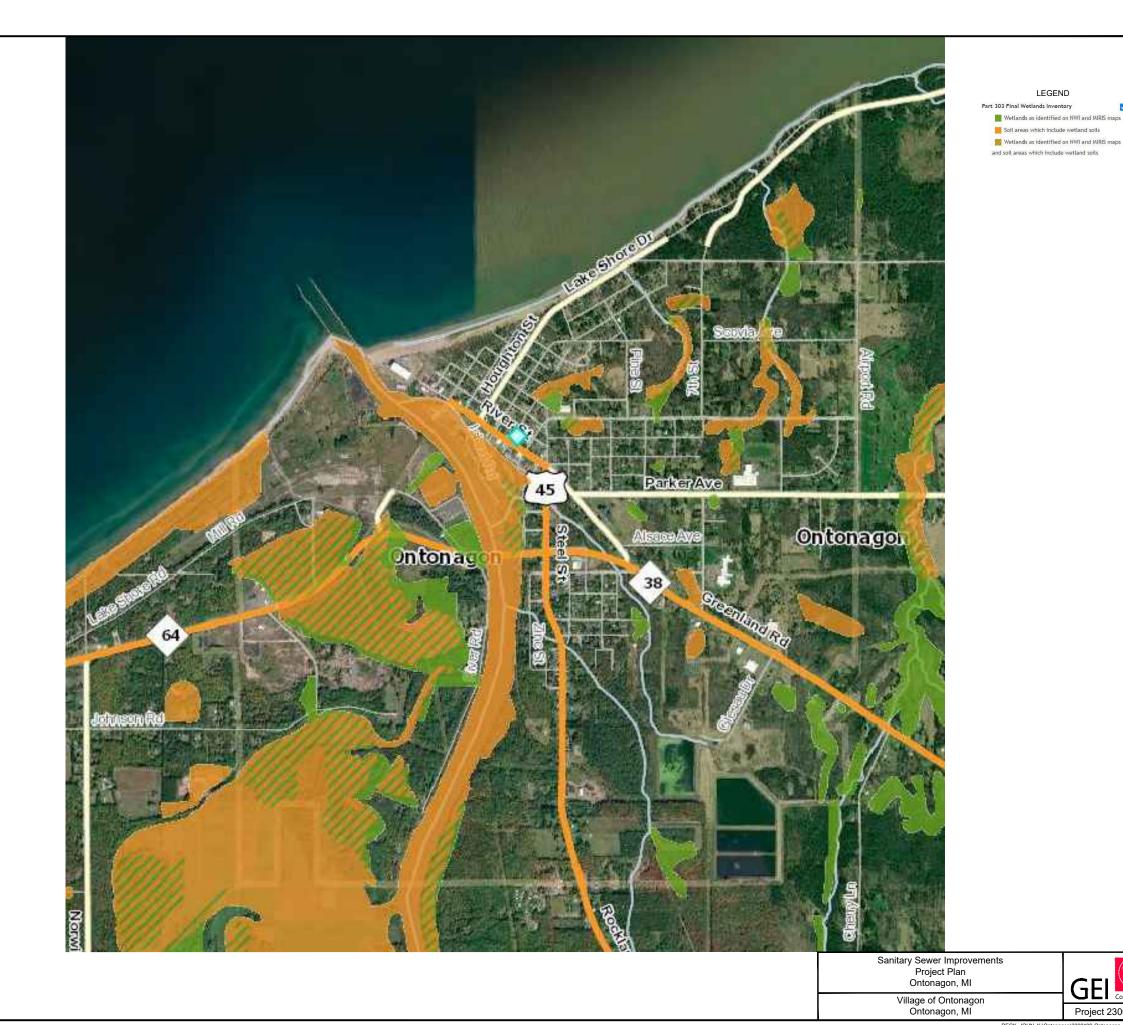
WETLANDS MAP

Wetlands are identified within the project area, the majority of which are on the Rose Island portion of the project. Soils with wetland characteristics are also identified within the study area. A wetlands map is included in Figure 5 of Appendix A.

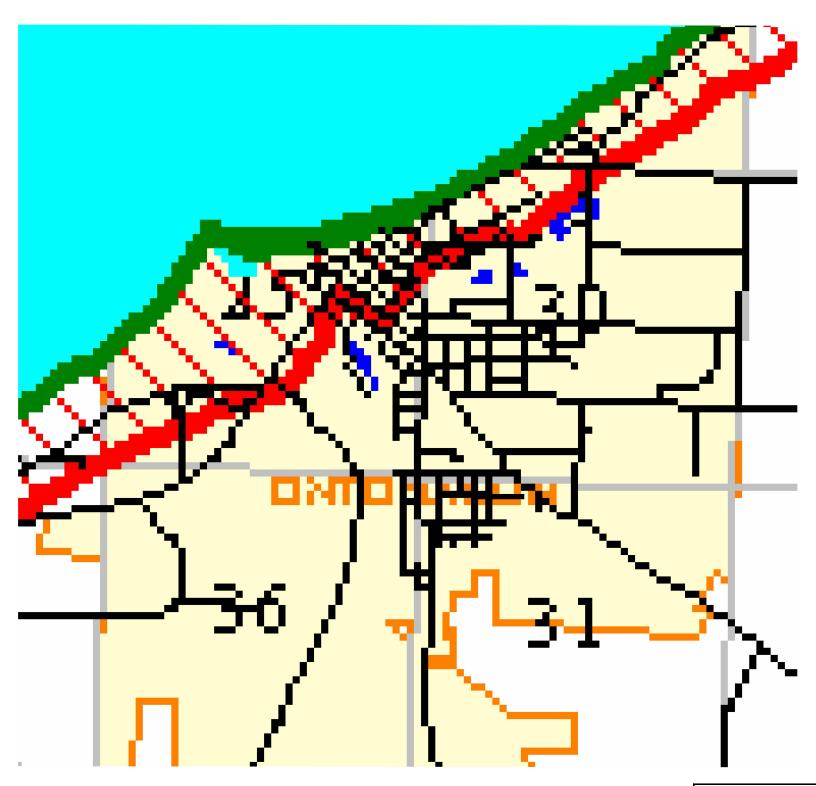
COASTAL ZONE MAP

The study area is within the Coastal Zone of Lake Superior. Please see coastal zone map in Figure 6 of Appendix A for more details.

The heavy red line is the *Coastal Zone Management Boundary*The red hatched area is the *Coastal Zone Management Area*

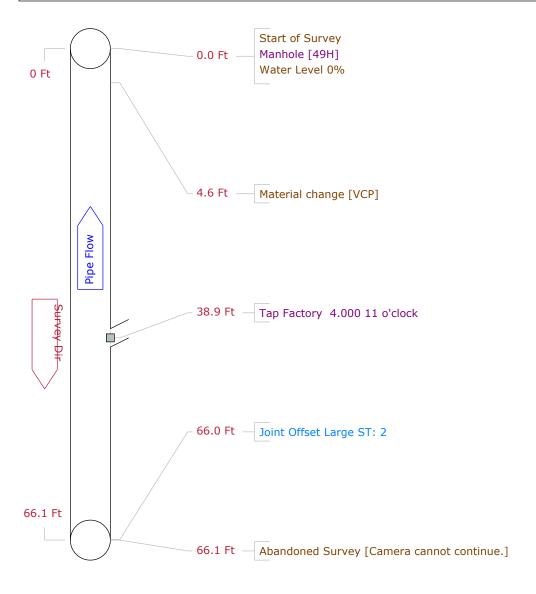
Pipe Graphic Report of PSR	27H	Χ	for	Village of Ontonagon

<u> </u>						
Setup 90 Surveyo	r GJK	Certificate #	U-114-6019861	System Ow	ner Village	of Ontonagon
Drainage	Survey Custom	er Village of C	Ontonagon			
P/O #	Date 2017/09/26	Time 17:44	Street N. 4th	า		
City Ontonagon	Further lo	cation details	offset joint			
<b>Up</b> 27H	Rim	to invert	Grade to	invert	Rim to	grade Ft
Down 49H	Rim	to invert	Grade to	invert	Rim to	grade Ft
Use Sanitary	Direction	Upstream	Flow control	Not Controlled	Medi	a No
Shape Circular	Height 1	0 Width	ins Pred	lean J	Date Clea	aned 2017/09/26
Material Vitrified Clay Pi	pe <b>J</b> o	oint length	Ft Total leng	jth Ft	Length S	Surveyed 66.10 Ft
Lining		Year laid	Year rehabilit	ated	Weather	Dry
Purpose Capital Impro	ovement Program Assessmer	nt C	Cat			
Additional info A			,	Structural	O & M	Constructional
Location Easement/R	Right of Way			Miscellaneous	Hydraulic	
Project Ontonagon Sa	initary Sewer System		_	Work	Order	
Northing		Easting	J	Elev	ation

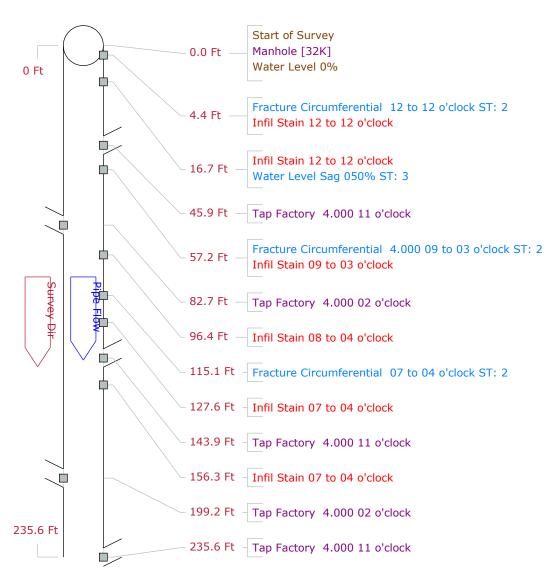
Pipe Graphic Report of PSR	32K	Χ	for	Village of Ontonagon

Setup 49 Surveyor GJK	Certificate #	U-815-07000963 <b>System O</b>	wner Village of Ontonago	on
Drainage Surve	ey Customer Village of O	ntonagon		
P/O # Date 2017/0	09/20 <b>Time</b> 11:00	Street Peeble Beach		
City Ontonagon	Further location details			
<b>Up</b> 32K	Rim to invert	Grade to invert	Rim to grade	Ft
Down 31K	Rim to invert	Grade to invert	Rim to grade	Ft
Use Sanitary	Direction Downstream	Flow control	Media No	
Shape Circular	Height 8 Width	ins Preclean J	Date Cleaned 2017	/09/18
Material Asbestos Cement	Joint length	Ft Total length Ft	Length Surveyed	351.90 <b>Ft</b>
Lining	Year laid	Year rehabilitated	Weather Dry	
Purpose Capital Improvement Program	Assessment C	at		
Additional info A		Structural	O & M Constru	ctional
Location Easement/Right of Way		Miscellaneous	Hydraulic	
Project Ontonagon Sanitary Sewer Syst	tem	Worl	k Order	
Northing	Easting	Ele	vation	
Coordinate System		GPS Accura	су

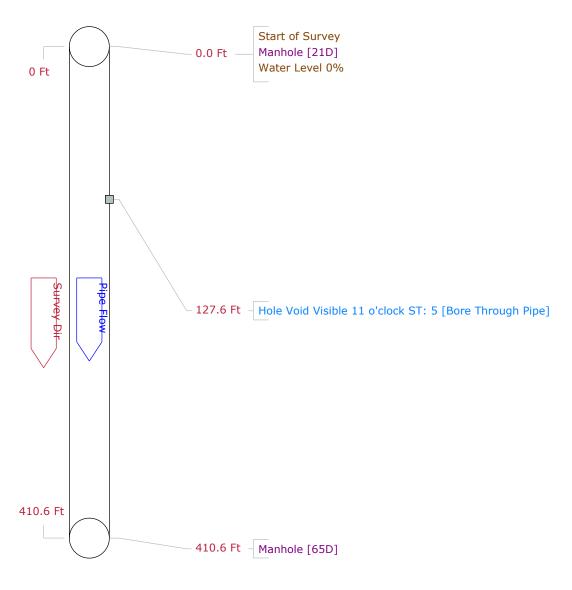
Pipe Graphic Report of PSR 21D	Χ	for	Village of Ontonagon
--	--------------------------------	---	-----	----------------------

Setup 44 Surveyor GJK	Certificate #	U-815-07000963 <b>System Ov</b>	vner Village of Ontonago	n
Drainage	urvey Customer Village of C	Ontonagon		
P/O # Date 20	17/09/20 <b>Time</b> 8:15	Street Mercury		
City Ontonagon	Further location details	Lagoon outfall		
<b>Up</b> 21D	Rim to invert	Grade to invert	Rim to grade	Ft
Down 65D	Rim to invert	Grade to invert	Rim to grade	Ft
Use Sanitary	Direction Downstream	Flow control	Media No	
Shape Circular	Height 24 Width	ins Preclean N	<b>Date Cleaned</b>	
Material Polyvinyl Chloride	Joint length	Ft Total length Ft	Length Surveyed	410.60 <b>Ft</b>
Lining	Year laid	Year rehabilitated	Weather Dry	
Purpose Capital Improvement Prog	ram Assessment C	Cat		
Additional info A		Structural	O & M Constru	ctional
Location Easement/Right of Way		Miscellaneous	Hydraulic	
Project Ontonagon Sanitary Sewer	System	Work	Order	
Northing	Easting	g Elev	/ation	
Coordinate System		GPS Accura	су

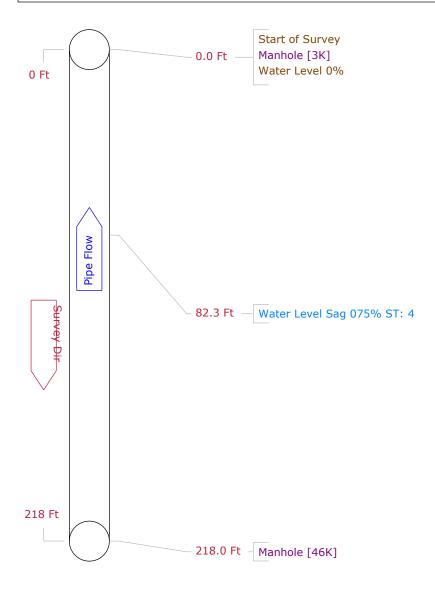
Tipe Graping Report of Fore Total Amage of Ontologe	Pipe Graphic Report of PSR	46K	Χ	for	Village of Ontonagon
---	----------------------------	-----	---	-----	----------------------

Setup	77 Surveyor	GJK	Cei	rtificate #	U-815	-07000963	System C	Owner Villa	ge of Ontona	gon
Drainage		Surve	ey Customer	Village of C	Ontonag	on				
P/O #		<b>Date</b> 2017/0	-	ime 18:45		treet Penns	sylvania Ave			
City	Ontonagon		Further locat	ion details	S					
<b>Up</b> 46	<		Rim to i	nvert		Grade to i	nvert	Rim	to grade	Ft
Down 3K			Rim to i	nvert		Grade to i	nvert	Rim	to grade	Ft
Use Sanit	ary	1	Direction Ups	stream	Flo	w control N	Not Controlled	M M	edia No	
Shape Cir	cular		Height 8	Width	ins	Preci	lean J	Date (	Cleaned 201	7/09/18
Material	Reinforced Plastic	c Pipe (Truss	Join	t length	Ft	Total lengt	th Ft	Leng	th Surveyed	218.00 <b>Ft</b>
Lining			Ye	ar laid	Ye	ar rehabilita	ated	Weath	<b>er</b> Dry	
Purpose	Capital Improve	ement Program	Assessment	(	Cat					
Additional	info A					S	Structural	O & M	Constr	uctional
Location	Easement/Rig	ht of Way				N	/liscellaneous	Hydraulic		
Project	Ontonagon Sani	tary Sewer Syst	em				Wo	rk Order

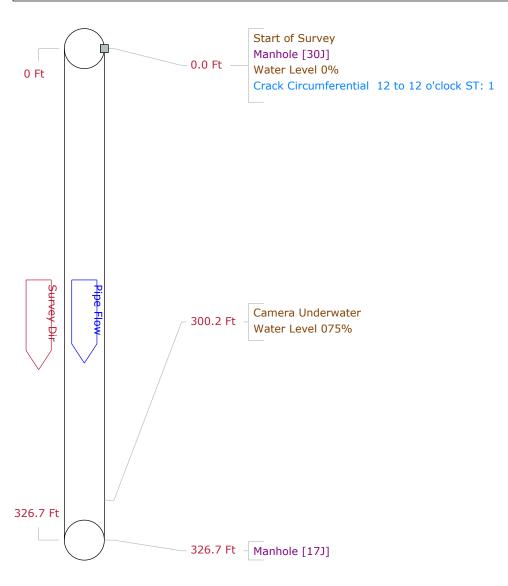
Pipe Graphic Report of PSR	30J	X	for	Village of Ontonagon
--	----------------------------	-----	---	-----	----------------------

· · · · · · · · · · · · · · · · · · ·				
Setup 80 Surveyor GJH	Certificate #	U-815-07000963 System Ow	vner Village of Ontonago	n
Drainage	Survey Customer Village of C	Ontonagon		
P/O # Da	<b>ate</b> 2017/09/25 <b>Time</b> 15:37	Street Fifth		
City Ontonagon	Further location details	5		
<b>Up</b> 30J	Rim to invert	Grade to invert	Rim to grade	Ft
Down 17J	Rim to invert	Grade to invert	Rim to grade	Ft
Use Sanitary	<b>Direction</b> Downstream	Flow control Not Controlled	Media No	
Shape Circular	Height 10 Width	ins Preclean J	Date Cleaned 2017	09/25
Material Asbestos Cement	Joint length	Ft Total length Ft	Length Surveyed	326.70 <b>Ft</b>
Lining	Year laid	Year rehabilitated	Weather Dry	
Purpose Capital Improvemen	nt Program Assessment C	Cat		
Additional info A		Structural	O & M Constru	ctional
Location Easement/Right of	Way	Miscellaneous	Hydraulic	
Project Ontonagon Sanitary S	Sewer System	Work	Order	
Northing	Easting	g Elev	ation

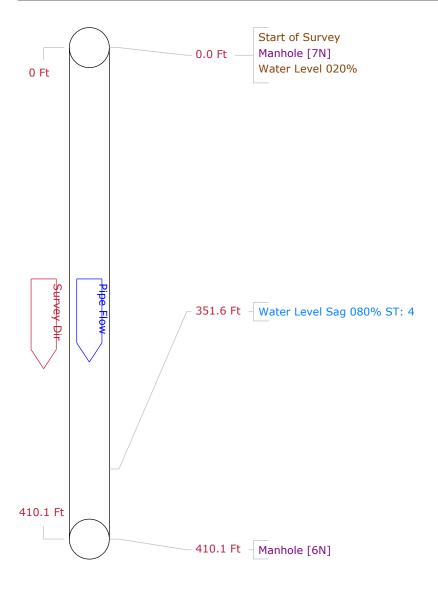
Pipe Graphic Report of PSR 7N	С	for	Village of Ontonagon
-------------------------------	---	-----	----------------------

• •		,	,	0	
Setup 103 Surveyor GJK	Certificate #	U-815-07000963 <b>Sy</b>	stem Owner	Village of Ontonagon	
Drainage	Survey Customer Village of	Ontonagon			
P/O # Date :	2017/09/28 <b>Time</b> 13:3	9 Street M64			
<b>City</b> Ontonagon	Further location detai	ls			
Up 7N	Rim to invert	Grade to inver	t	Rim to grade	Ft
Down 6N	Rim to invert	Grade to inver	t	Rim to grade	Ft
Use Sanitary	<b>Direction</b> Downstream	Flow control		Media No	
Shape Circular	Height 8 Width	ins Preclean	J [	Date Cleaned 2017/0	9/28
Material Polyvinyl Chloride	Joint length	Ft Total length	Ft	Length Surveyed 4	10.10 <b>Ft</b>
Lining	Year laid	Year rehabilitated	V	<b>Veather</b> Dry	
Purpose Capital Improvement Pro	ogram Assessment	Cat			
Additional info A		Structi	ıral O &	M Construct	ional
<b>Location</b> Easement/Right of Way	1	Miscel	laneous Hyd	draulic	
Project Ontonagon Sanitary Sewe	er System		Work Orde	er	
Northing	Eastir	ng	Elevation	า

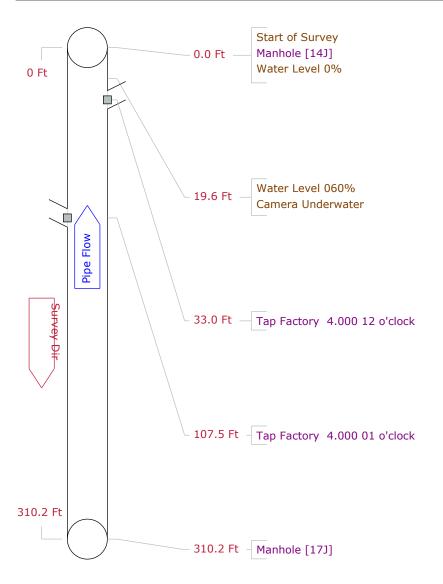
Pipe Graphic Report of PSR 17J	Χ	for	Village of Ontonagon
i ipo olapino itopolitori olt. Ilo	, ,		rmage or orneriager

Setup	- 8	3 Surveyo	· GJK		Certificate #	U-114-6	:019861	System Ov	vner Village	of Ontonag	on
•		o ourveyor		0				System Sv	viiei viilage	or Ornoriag	OII
Draina	ge			Survey Custo	mer Village of	Ontonagor	1				
P/O #			Date 2	2017/09/26	<b>Time</b> 13:45	5 <b>St</b> ı	reet Fifth				
City	C	ntonagon		Further	location detai	ls					
Up	17J			Rim	n to invert	(	Grade to i	nvert	Rim to	grade	Ft
Down	14J			Rim	n to invert	(	Grade to i	nvert	Rim to	grade	Ft
Use S	Sanita	ry		Direction	<b>u</b> Upstream	Flow	control N	lot Controlled	Med	ia No	
Shape	Circ	ular		Height	10 Width	ins	Preci	ean J	Date Cle	aned 2017	//09/25
Materia	al A	sbestos Ceme	nt	,	Joint length	Ft 7	Γotal lengt	h Ft	Length	Surveyed	310.20 <b>Ft</b>
Lining					Year laid	Year	rehabilita	ated	Weather	Dry	
Purpos	se	Capital Impro	vement Pro	gram Assessm	ent	Cat					
Additio	onal	<b>nfo</b> Cl	EAN				S	tructural	O & M	Constru	uctional
Location	on	Easement/R	ight of Way				N	liscellaneous	Hydraulic

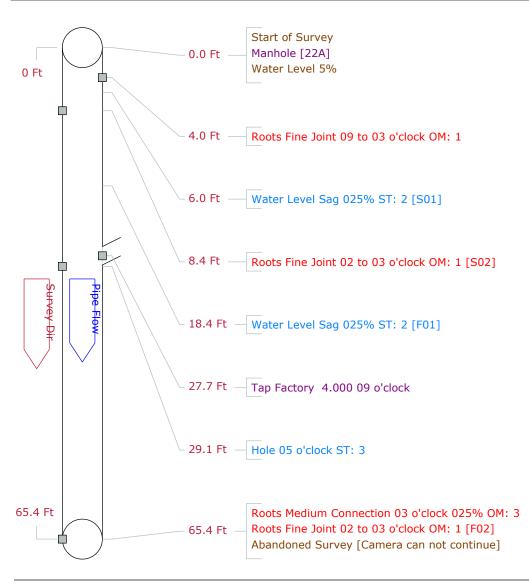
Pipe Gra	phic Report of	PSR 2	22A	Χ	1	or	Village of Ont	onagon		
Setup	160 Surveyor	LDJ	(	Certificate #	U-514-06	023286	System Ow	ner Village	of Ontonagor	1
Drainage		;	Survey Custom	er Village of C	Ontonagon					
P/O #		Date 2	2017/10/11	Time 14:24	Stre	et Chip	oewa			
City	Ontonagon		Further loc	cation details	3					
Up 2	2A		Rim t	o invert	G	rade to	invert	Rim to	grade	Ft
Down 2	1A		Rim to	o invert	G	rade to	invert	Rim to grade		Ft
Use Sanitary			Direction [	Downstream	Flow control Not Controlled			Media No		
Shape C	Circular		Height 8	Width	'idth ins Preclean J			<b>Date Cleaned</b> 2017/10/11		
Material	Vitrified Clay Pipe		Jo	Joint length Ft Total length F			jth Ft	Length Surveyed 65.40 Ft		
Lining			•	Year laid Year rehabi			tated	Weather	Dry	
Purpose	Capital Improve	ment Pro	gram Assessmen		Cat					
Additiona	al info						Structural	O & M	Construc	tional
Location	Light Highway						Miscellaneous	Hydraulic

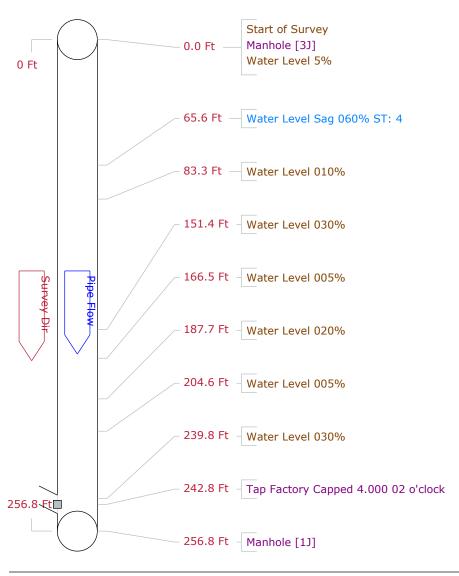
6-t CC 6	0	II 544 00000000	Nillana of Ontana	
Setup 66 Surveyor LDJ	Certificate #	U-514-06023286 <b>System C</b>	Owner Village of Ontonagor	1
Drainage Surv	ey Customer Village of O	Intonagon		
<b>P/O #</b> Date 2017/0	09/26 <b>Time</b> 13:17	Street Michigan Ave.		
City Ontonagon	Further location details	<b>;</b>		
Up 3J	Rim to invert	Grade to invert	Rim to grade	Ft
<b>Down</b> 1J	Rim to invert	Grade to invert	Rim to grade	Ft
Use Sanitary	Direction Downstream	Flow control Not Controlled	Media No	
Shape Circular	Height 10 Width	ins Preclean J	Date Cleaned 2017/0	9/26
Material Asbestos Cement	Joint length	Ft Total length Ft	Length Surveyed 2	56.80 <b>Ft</b>
Lining	Year laid	Year rehabilitated	Weather Light Rain	
Purpose Capital Improvement Program	Assessment C	at		
Additional info		Structural	O & M Construc	tional
<b>Location</b> Light Highway		Miscellaneous	Hydraulic	
Project Ontonagon Sanitary Sewer		Wo	rk Order

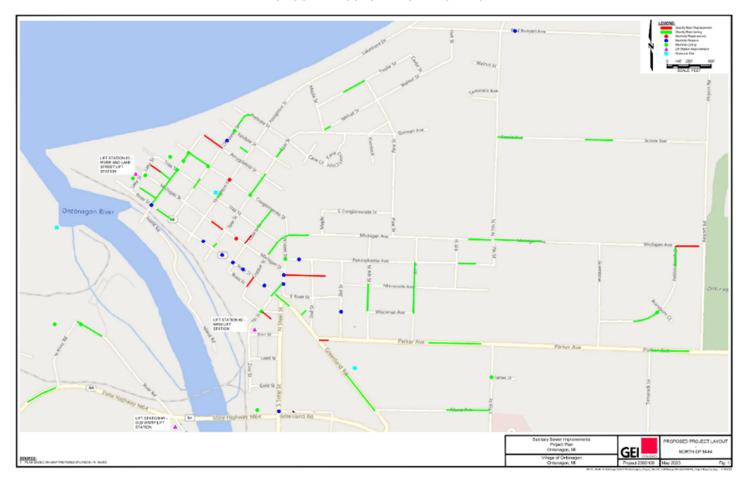
### PROPOSED PROJECT – NORTH OF M-64

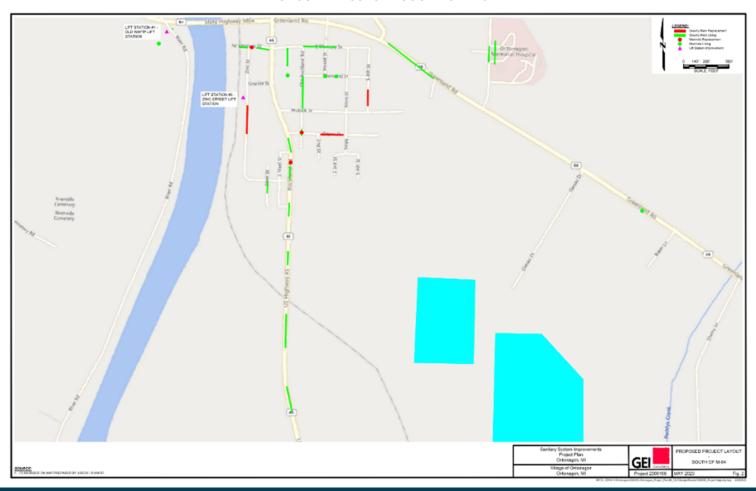
### PROPOSED PROJECT – SOUTH OF M-64

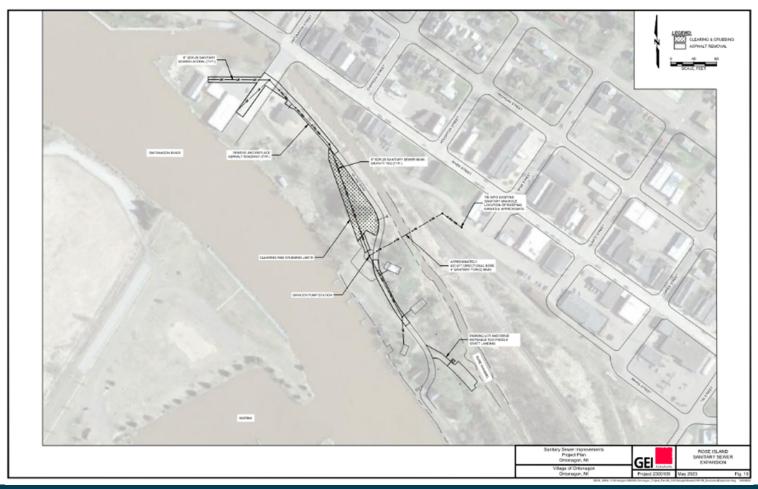
### PROPOSED PROJECT – ROSE ISLAND
