Intuvo 9000 GC

Firmware Bulletin

Revision A.02.2.2.4

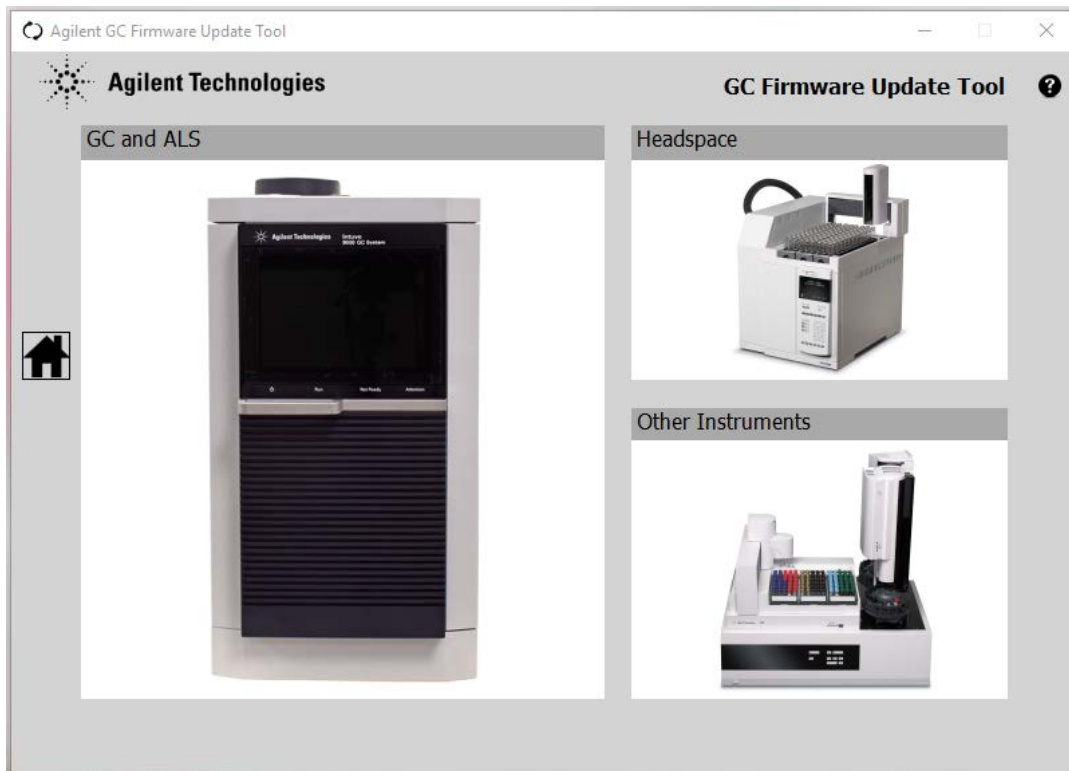
After the program has been loaded and executed the following screen appears.

This enables the user to select which instrument type needs to have its firmware downloaded. In this case we select the GC and ALS.

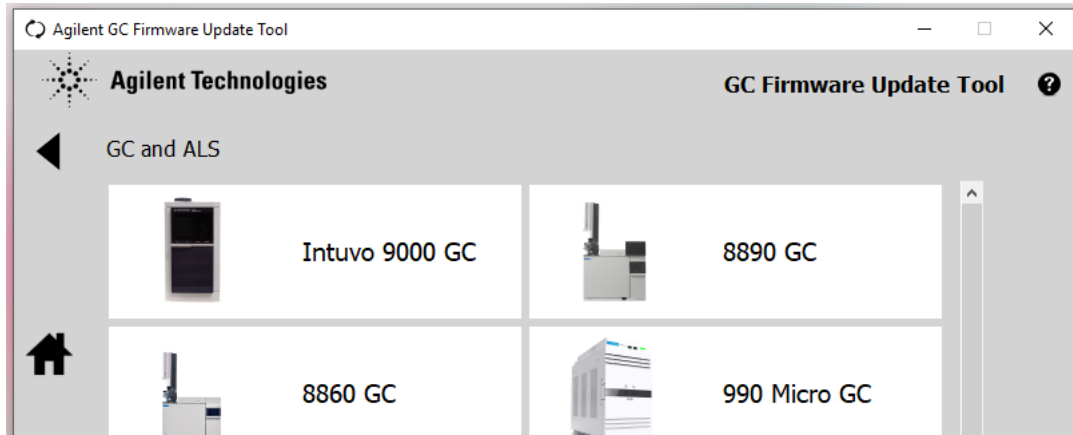
The Intuvo 9000 GC is chosen from the Product menu.

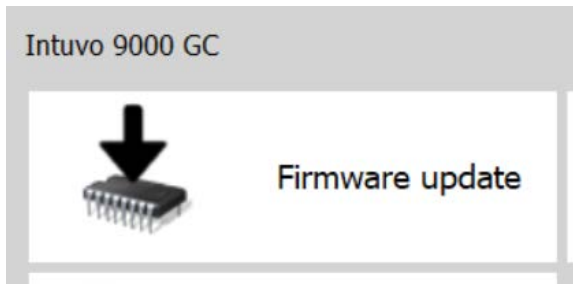
The next screen allows us to either modify firmware or PID values for the EPC modules.

Firmware update is selected.

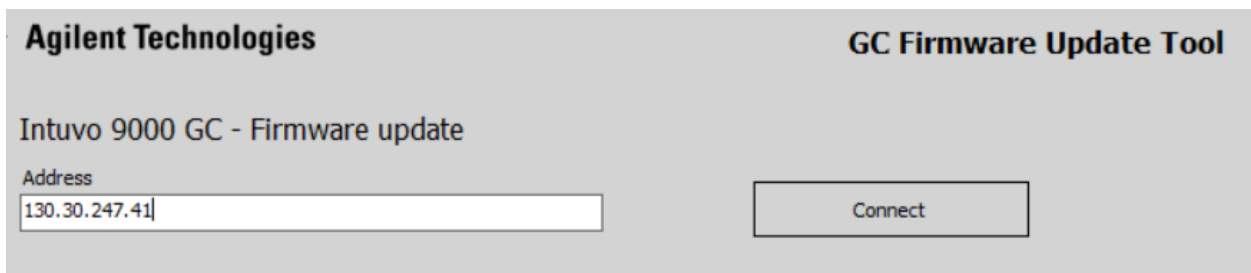
After choosing to update firmware, you must then enter the IP address of the Intuvo that you wish to connect to and then press Connect.

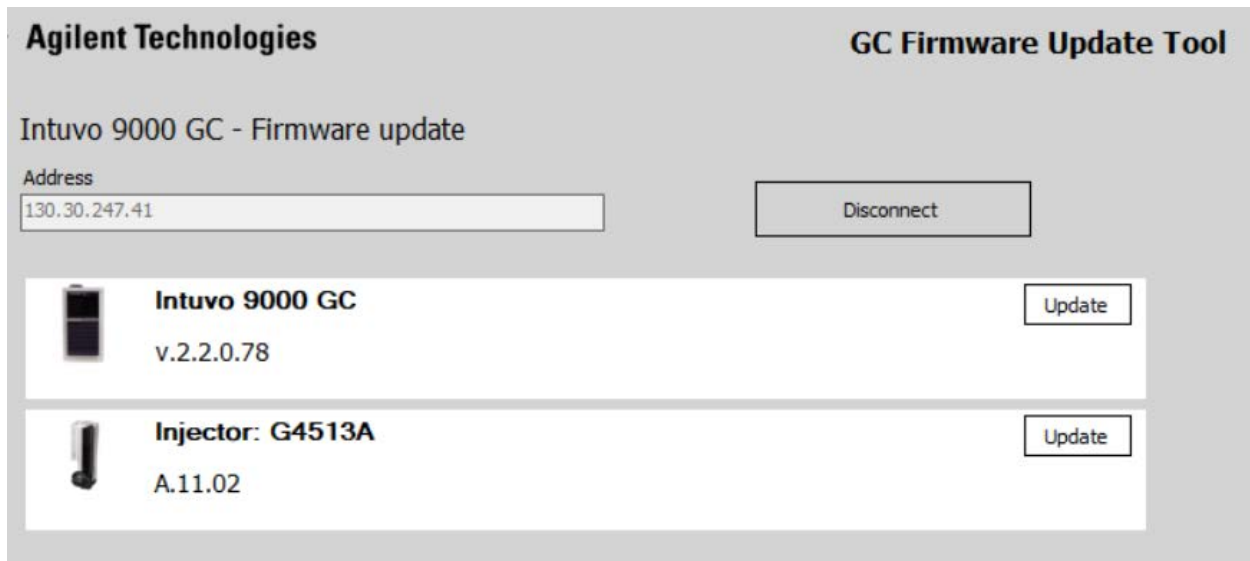
Information such as current installed firmware will then be displayed.

Press Update.

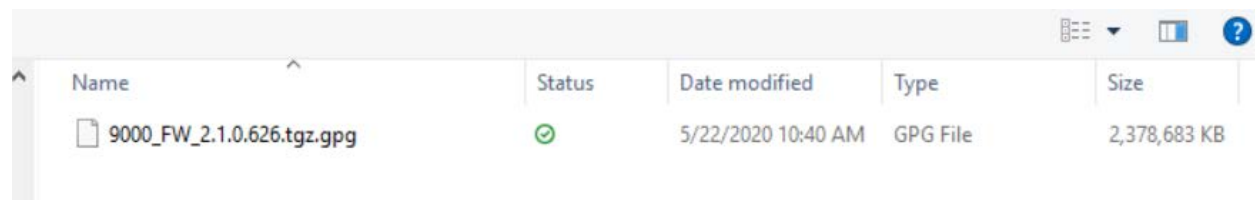
A Windows Explorer directory will then appear and you must select the firmware revision that needs to be downloaded.

If the required firmware version is not displayed then you can "browse" your harddrive to find it.

The firmware file has the structure 9000_FW_X.X.X.tgz.gpg
