# FACILITY CONDITION ASSESSMENT

## **DLR Group**

William Orr Elementary  
12130 South Jersey Avenue  
Norwalk, California 90650

October 19, 2022

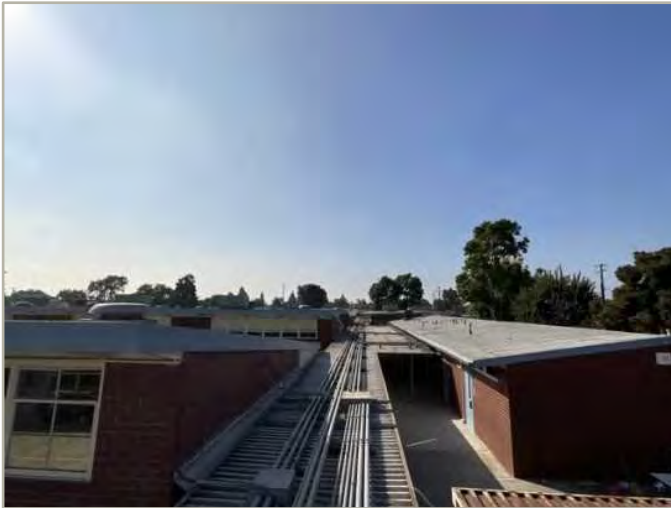
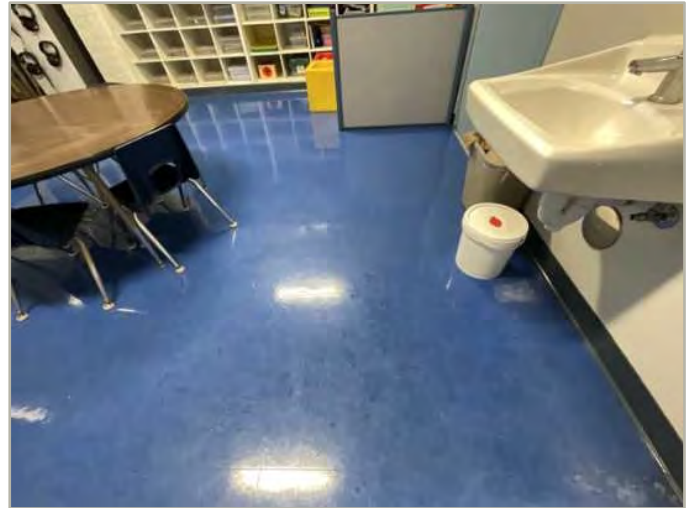
## 2. Building 100

Constructed/Renovated	1955	
Building/Group Size	3000 SF	
Number of Stories	One above grade	
System	Description	Condition
Structure	Masonry bearing walls with metal roof deck supported by open-web steel joists and concrete wall footing foundation system over concrete slab foundation	Fair
Façade	Primary Wall Finish: Brick Windows: Aluminum	Fair
Roof	Primary: low slopped with modified bitumen roofing	Fair
Interiors	Walls: Painted drywall and Ceramic tile Floors: Carpet and ceramic tile Ceilings: ACT	Fair
Elevators	None	--
Plumbing	Distribution: Copper and PVC waste and venting Fixtures: Toilets and sinks in all restrooms	Fair
HVAC	Non-Central System: Packaged units	Fair
Fire Suppression	Fire extinguishers	Good
Electrical	Source and Distribution: Main distribution panel Interior Lighting: Fluorescent	Fair
Fire Alarm	Alarm panel with smoke detectors, alarms, strobes, pull stations, back-up emergency lights, and exit signs	Fair

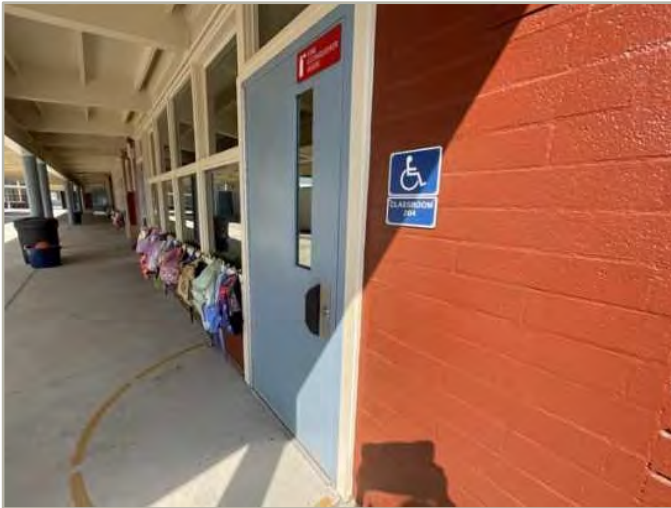
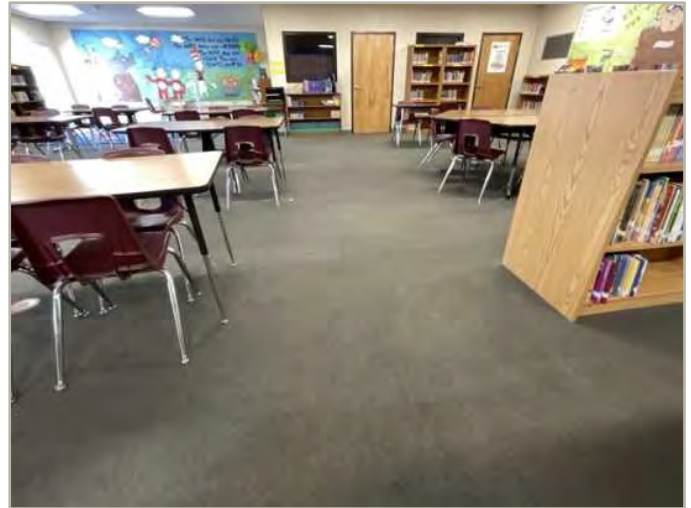
### 3. Building 200

<b>Constructed/Renovated</b>	1955	
<b>Building/Group Size</b>	4500 SF	
<b>Number of Stories</b>	One above grade	
<i>System</i>	<i>Description</i>	<i>Condition</i>
<b>Structure</b>	Masonry bearing walls with metal roof deck supported by open-web steel joists and concrete wall footing foundation system over concrete slab foundation	Fair
<b>Façade</b>	Primary Wall Finish: Brick Windows: Aluminum	Fair
<b>Roof</b>	Primary: low slopped with modified bitumen roofing	Fair
<b>Interiors</b>	Walls: Painted drywall Floors: Carpet Ceilings: ACT	Fair
<b>Elevators</b>	None	--
<b>Plumbing</b>	Distribution: Copper and PVC waste and venting Fixtures: sinks in all classrooms	Fair
<b>HVAC</b>	Non-Central System: Packaged units	Fair
<b>Fire Suppression</b>	Fire extinguishers only	Good
<b>Electrical</b>	Source and Distribution: Main distribution panel Interior Lighting: Fluorescents	Fair
<b>Fire Alarm</b>	Alarm panel with smoke detectors, alarms, strobes, pull stations, back-up emergency lights, and exit signs	Fair

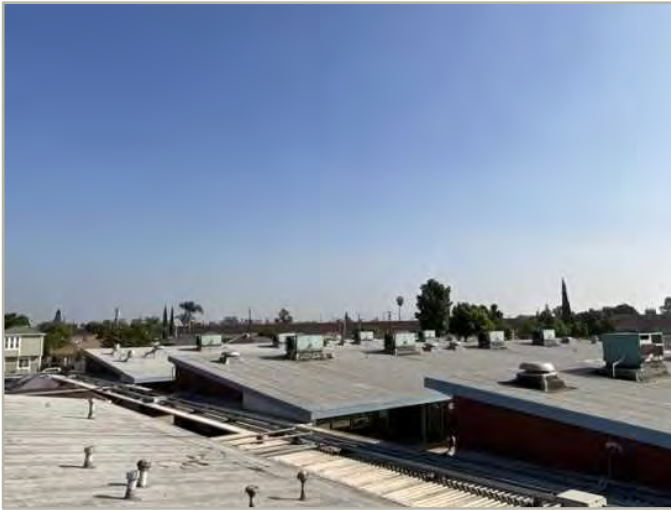
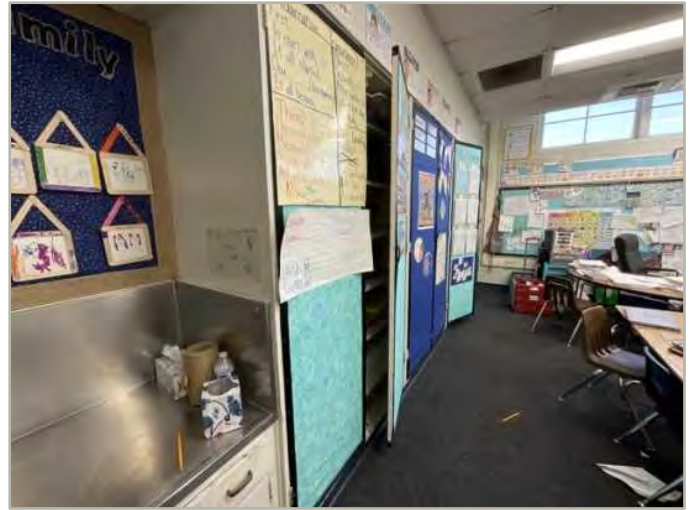
## 4. Building 300

Constructed/Renovated	1955	
Building/Group Size	5000 SF	
Number of Stories	One above grade	
System	Description	Condition
Structure	Masonry bearing walls with metal roof deck supported by open-web steel joists and concrete wall footing foundation system over concrete slab foundation	Fair
Façade	Primary Wall Finish: Brick Windows: Aluminum	Fair
Roof	Primary: Low slopped with modified bitumen	Fair
Interiors	Walls: Painted drywall and ceramic tile Floors: Carpet and ceramic tile Ceilings: ACT	Fair
Elevators	None	--
Plumbing	Distribution: Copper and PVC waste and venting Fixtures: Toilets and sinks in all restrooms	Fair
HVAC	Non-Central System: Packaged units	Fair
Fire Suppression	Fire extinguishers	Good
Electrical	Source and Distribution: Main switchboard Interior Lighting: fluorescent	Fair
Fire Alarm	Alarm panel with smoke detectors, alarms, strobes, pull stations, back-up emergency lights, and exit signs	Fair

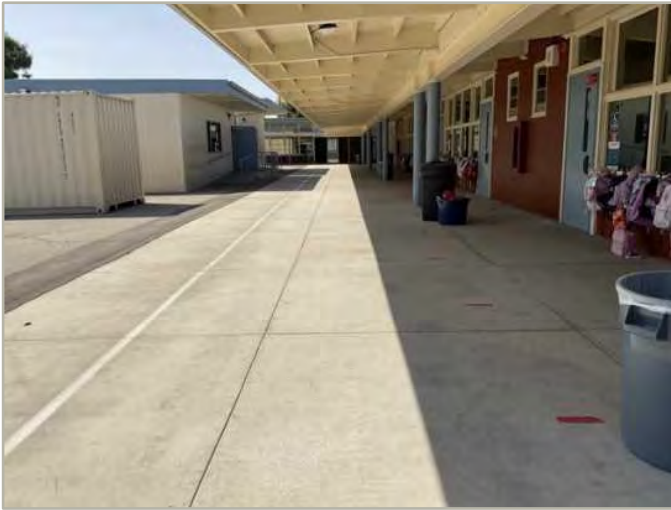
## 7. Building 800

Constructed/Renovated	1955	
Building/Group Size	5000 SF	
Number of Stories	One above grade	
System	Description	Condition
Structure	Masonry bearing walls with metal roof deck supported by open-web steel joists and concrete wall footing foundation system over concrete slab foundation	Fair
Façade	Primary Wall Finish: Brick Windows: Aluminum	Fair
Roof	Primary: Low slopped with modified bitumen	Fair
Interiors	Walls: Painted drywall and ceramic tile Floors: Carpet and ceramic tile Ceilings: ACT	Fair
Elevators	None	--
Plumbing	Distribution: Copper and PVC waste and venting Fixtures: Toilets, urinals, and sinks in all restrooms	--
HVAC	Non-Central System: Packaged units	Fair
Fire Suppression	Fire extinguishers	Good
Electrical	Source and Distribution: Main distribution panel Interior Lighting: Fluorescent	Fair
Fire Alarm	Alarm panel with smoke detectors, alarms, strobes, pull stations, back-up emergency lights, and exit signs	Fair

<b>Equipment/Special</b>	None	--
<b>Accessibility</b>	Presently it does not appear an accessibility study is needed for this building. See Appendix D.	
<b>Key Issues and Findings</b>	ACT ceiling has lots of damage from roof leaks

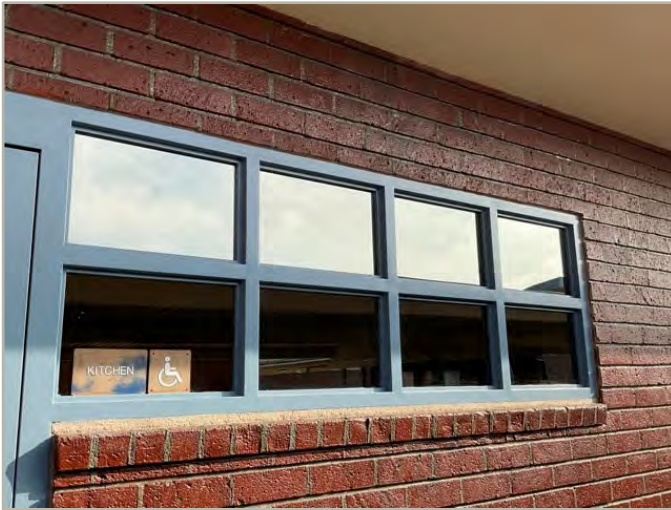
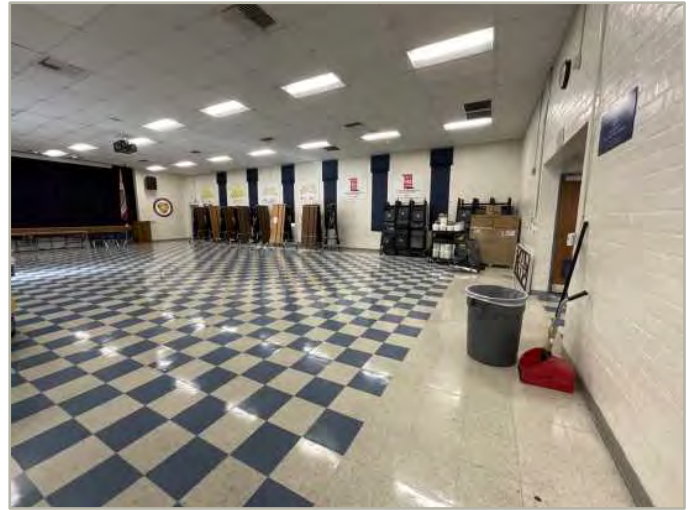
## 8. Building MPR

Constructed/Renovated	1955	
Building/Group Size	5300 SF	
Number of Stories	One above grade	
System	Description	Condition
Structure	Masonry bearing walls with metal roof deck supported by open-web steel joists and concrete wall footing foundation system over concrete slab foundation	Fair
Façade	Primary Wall Finish: Brick Windows: Aluminum	Fair
Roof	Primary: Low slopped with modified bitumen	Fair
Interiors	Walls: Painted drywall and ceramic tile Floors: Carpet, ceramic tile and epoxy flooring Ceilings: Painted drywall	Fair
Elevators	None	--
Plumbing	Distribution: Copper and PVC waste and venting Hot Water: Gas water heaters with integral tanks Fixtures: Toilets and sinks in all restrooms	Fair
HVAC	Non-Central System: Packaged units, evaporative cooler	Fair
Fire Suppression	Fire extinguishers	Good
Electrical	Source and Distribution: Main switchboard and electrical panel Interior Lighting: Fluorescent	Fair

<b>Equipment/Special</b>	None	--
<b>Accessibility</b>	Presently it does not appear an accessibility study is needed for this building. See Appendix D.	
<b>Key Issues and Findings</b>	One food warmer is not working

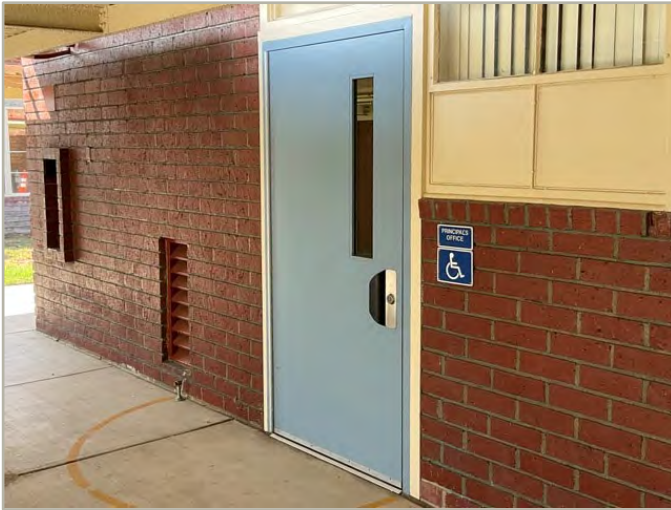
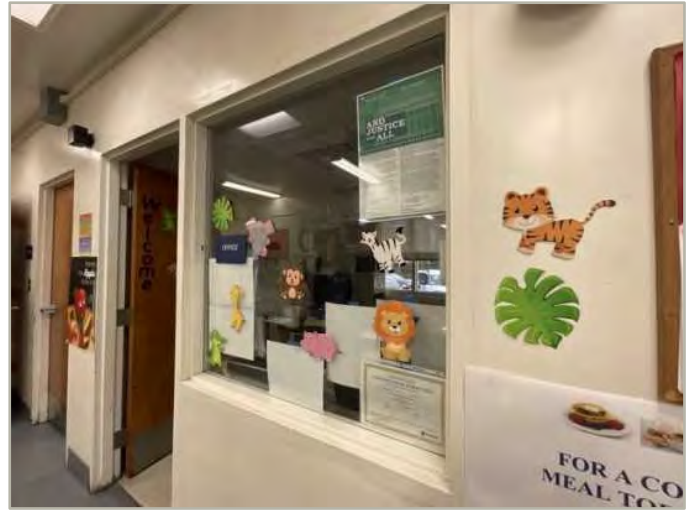
## 9. Office Building

Constructed/Renovated	1955
Building/Group Size	3700 SF
Number of Stories	One above grade
System	DescriptionCondition
Structure	Masonry bearing walls with metal roof deck supported by open-web steel joists and concrete wall footing foundation system over concrete slab foundationFair
Façade	Primary Wall Finish: Brick Windows: AluminumFair
Roof	Primary: Low slopped with modified bitumenFair
Interiors	Walls: Painted drywall and ceramic tile Floors: Carpet and VCT and ceramic tile Ceilings: ACTFair
Elevators	None--
Plumbing	Distribution: Copper and PVC waste and venting Hot Water: Gas water heaters with integral tanks Fixtures: Toilets, urinals, and sinks in all restroomsFair
HVAC	Non-Central System: Packaged unitsFair
Fire Suppression	Fire extinguishersGood
Electrical	Source and Distribution: Main distribution panel Interior Lighting: FluorescentFair
Fire Alarm	Alarm panel with smoke detectors, alarms, strobes, pull stations, back-up emergency lights, and exit signsFair

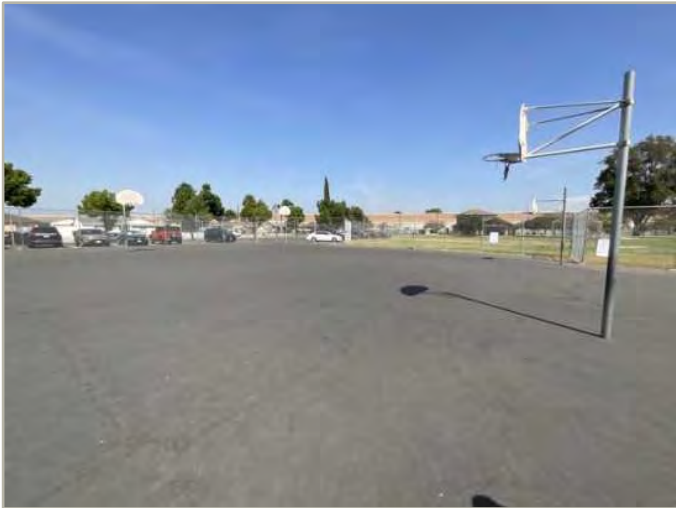
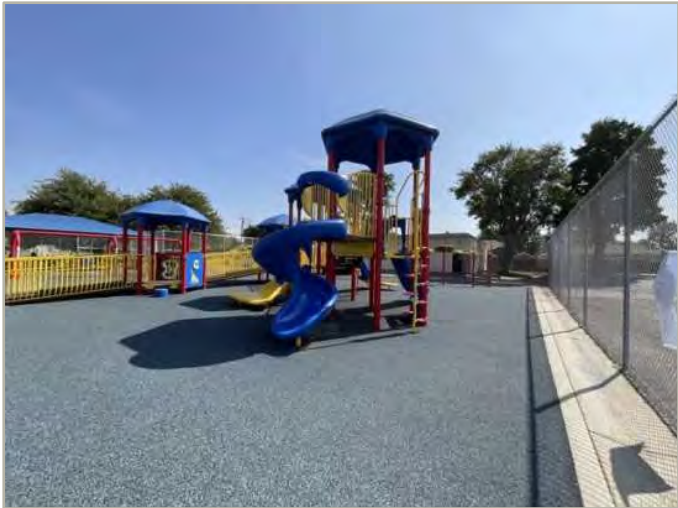
10. Site Summary

Site Information		
System	Description	Condition
Pavement/Flatwork	Concrete lots with adjacent concrete sidewalks, curbs, ramps, and stairs	Fair
Site Development	Building-mounted wood board Playgrounds and sports fields and courts with fencing, and site lights Limited park benches and picnic tables	Fair
Landscaping and Topography	Significant landscaping features including lawns, trees, bushes, and planters Irrigation present Relatively flat	Fair
Utilities	Municipal water and sewer Local utility-provided electric and natural gas	Fair
Site Lighting	Building-mounted: LED	Fair
Ancillary Structures	Storage sheds and Prefabricated modular buildings	Fair
Accessibility	Potential moderate/major issues have been identified associated with the site areas and a detailed accessibility study is recommended. See Appendix D.	
Key Issues and Findings	No key findings at this time

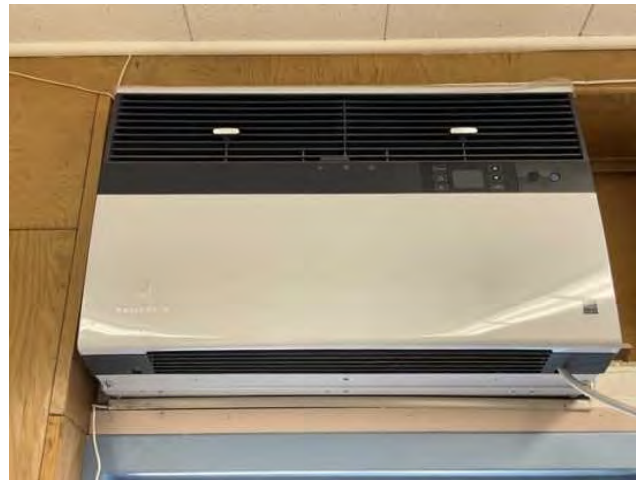
10 - AIR CONDITIONER, WINDOW/THRU-WALL, 1  
TO

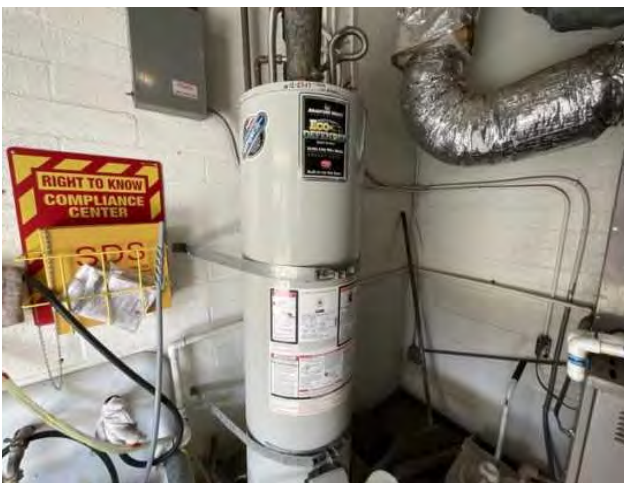
17 - WATER HEATER

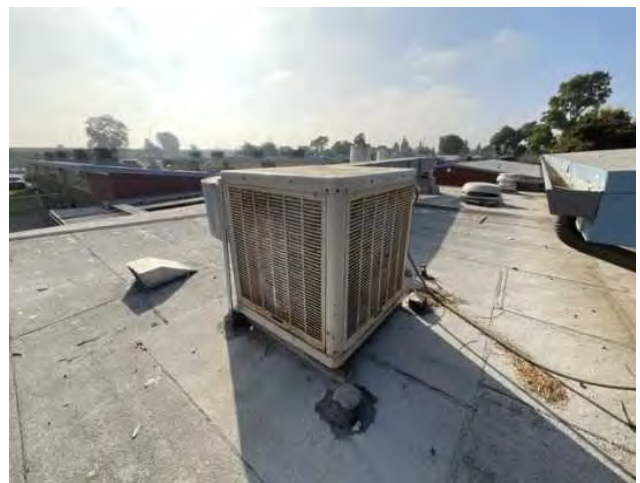
18 - EVAPORATIVE COOLER

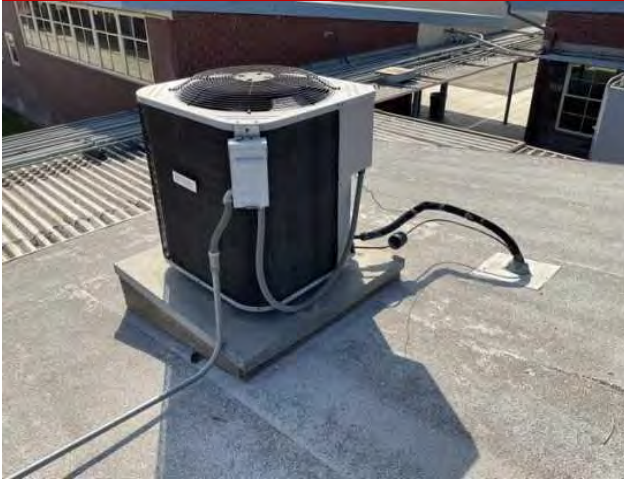
19 - SPLIT SYSTEM

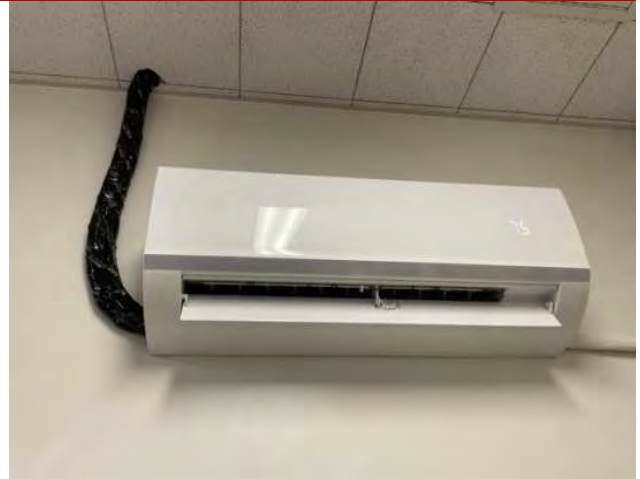
20 - AIR CONDITIONER

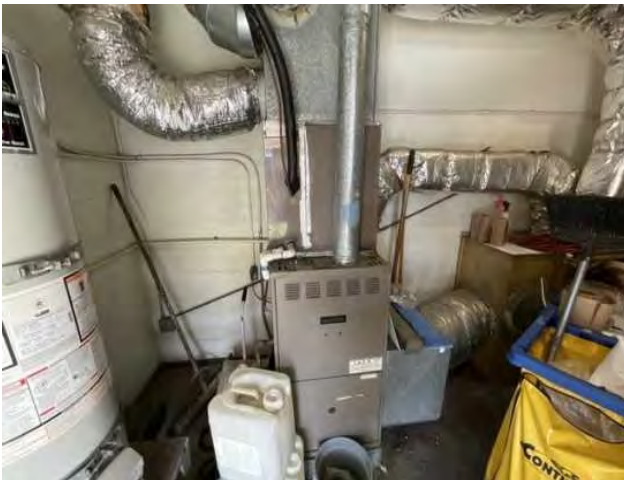
21 - FAN COIL UNIT: SPLIT SYSTEM

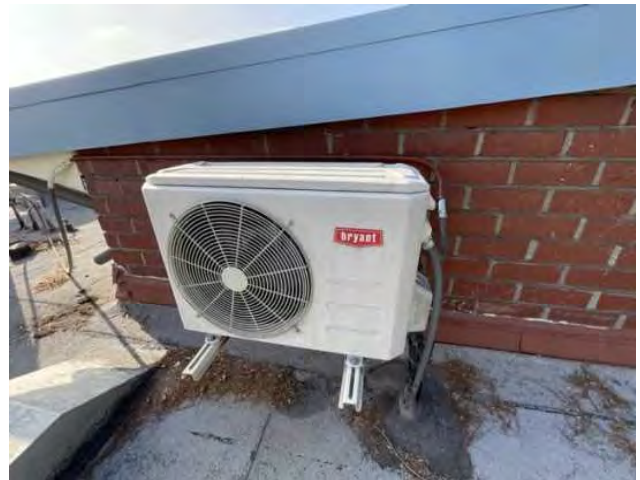
22 - DUCTLESS SPLIT SYSTEM

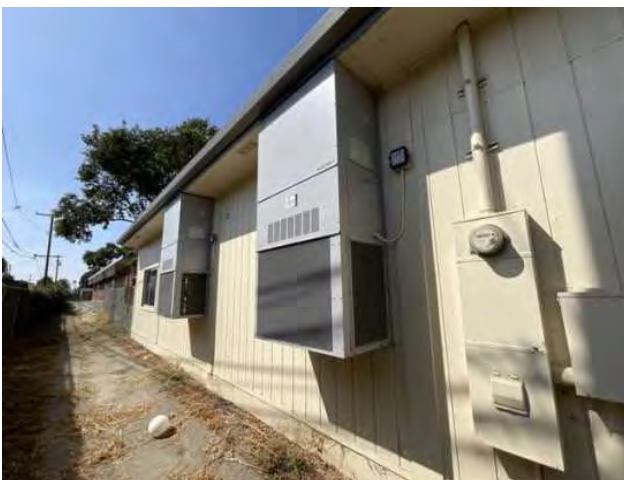
23 - WALL-MOUNTED HEAT PUMP

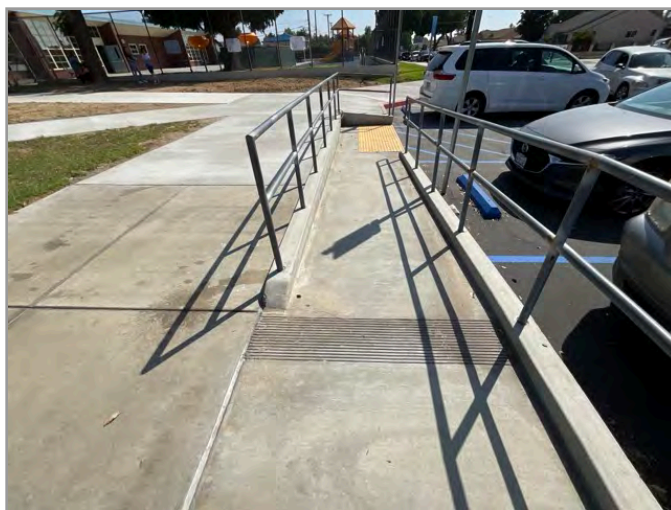
ACCESSIBLE RAMP

Question		Yes	No	NA	Comments
1	Is an accessible route present from public transportation stops and municipal sidewalks on or immediately adjacent to the property ?	✗			
2	Does a minimum of one accessible route appear to connect all public areas on the exterior, such as parking and other outdoor amenities, to accessible building entrances ?	✗			
3	Are curb ramps present at transitions through raised curbs on all accessible routes?	✗			
4	Do curb ramps appear to have compliant slopes for all components ?	✗			
5	Do ramp runs on an accessible route appear to have compliant slopes ?	✗			
6	Do ramp runs on an accessible route appear to have a compliant rise and width ?	✗

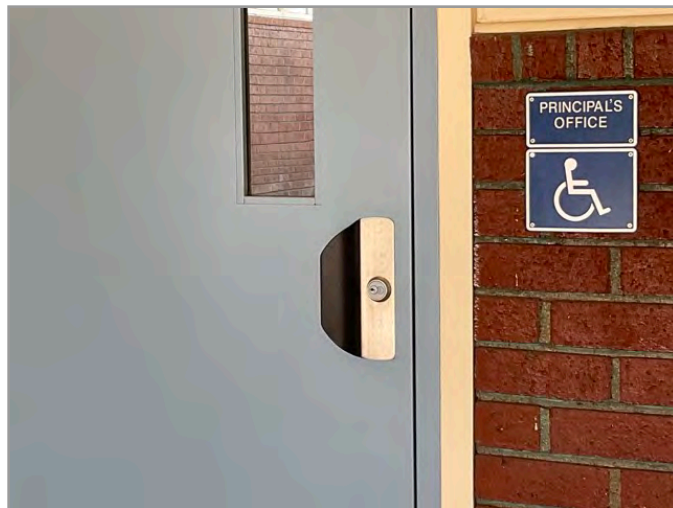
DOOR HARDWARE

Question		Yes	No	NA	Comments
1	Do a sufficient number of accessible entrances appear to be provided ?	✗			
2	If the main entrance is not accessible, is an alternate accessible entrance provided?	✗			
3	Is signage provided indicating the location of alternate accessible entrances ?	✗			
4	Do doors at accessible entrances appear to have compliant maneuvering clearance area on each side ?	✗			
5	Do doors at accessible entrances appear to have compliant hardware ?	✗			
6	Do doors at accessible entrances appear to have a compliant clear opening width ?	✗

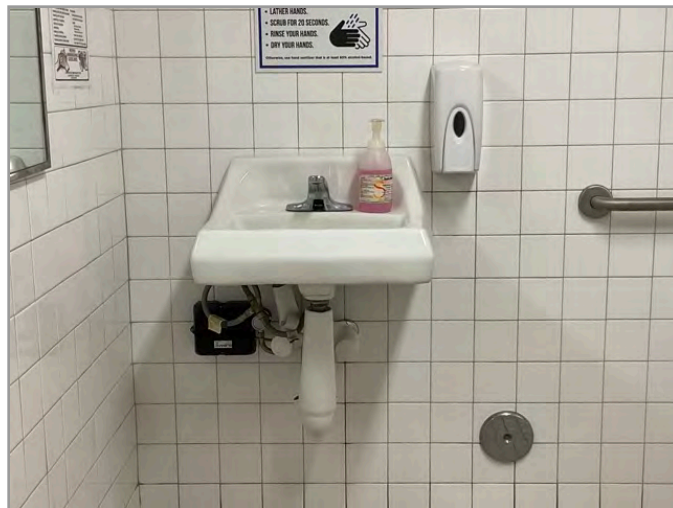
SINK, FAUCET HANDLES AND ACCESSORIES

Question		Yes	No	NA	Comments
1	Do publicly accessible toilet rooms appear to have a minimum compliant floor area ?	✗			
2	Does the lavatory appear to be mounted at a compliant height and with compliant knee area ?	✗			
3	Does the lavatory faucet have compliant handles ?	✗			
4	Is the plumbing piping under lavatories configured to protect against contact ?	✗			
5	Are grab bars provided at compliant locations around the toilet ?	✗			
6	Do toilet stall doors appear to provide the minimum compliant clear width ?	✗
