FACILITY CONDITION ASSESSMENT

Manhattan Beach USD 325 South Peck Avenue Manhattan Beach, CA 90266

Pacific Elementary School 1200 Pacific Avenue Manhattan Beach, CA 90266

Bureau Veritas 6021 University Boulevard, Suite 200 Ellicott City, MD 21043 800.733.0660 www.us.bureauveritas.com

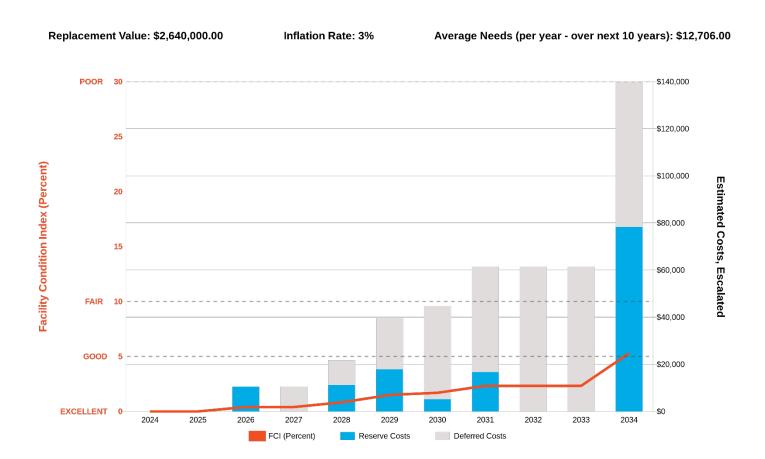
Needs by Year with Unaddressed FCI Over Time

NEEDS OVER TIME: The vertical blue bars in the graphic below represent the year-by-year needs identified for the facility. The orange line forecasts what would happen to the FCI (left Y axis) over time, assuming zero capital expenditures over the next ten years. The dollar amounts allocated for each year are associated with the values along the right Y axis.

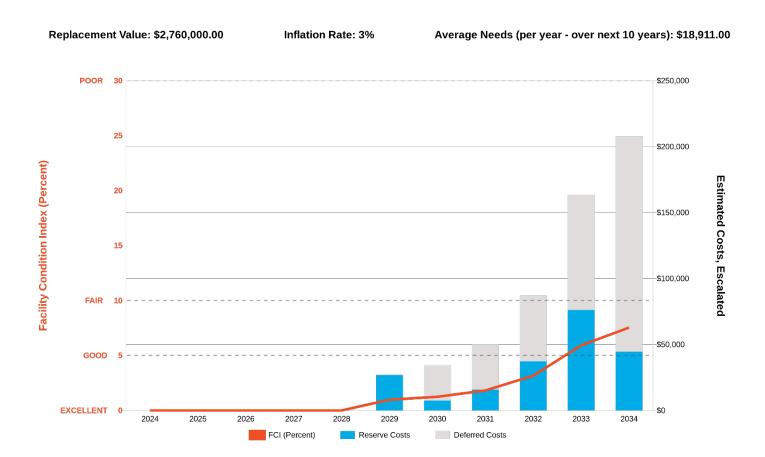
Needs by Year with Unaddressed FCI Over Time

NEEDS OVER TIME: The vertical blue bars in the graphic below represent the year-by-year needs identified for the facility. The orange line forecasts what would happen to the FCI (left Y axis) over time, assuming zero capital expenditures over the next ten years. The dollar amounts allocated for each year are associated with the values along the right Y axis.

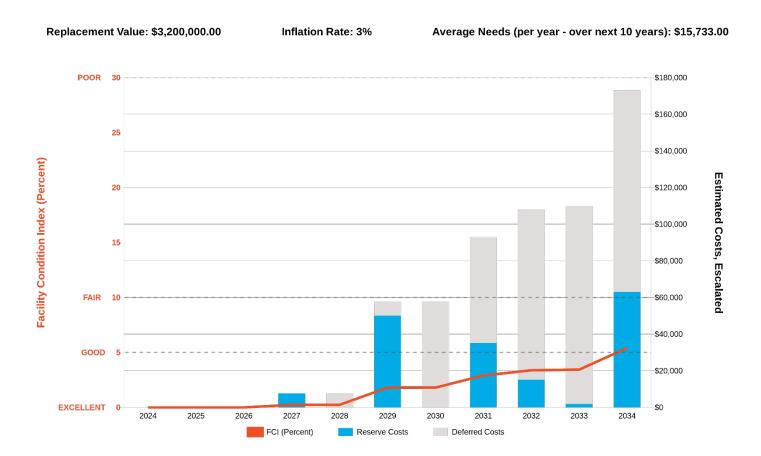
Needs by Year with Unaddressed FCI Over Time

NEEDS OVER TIME: The vertical blue bars in the graphic below represent the year-by-year needs identified for the facility. The orange line forecasts what would happen to the FCI (left Y axis) over time, assuming zero capital expenditures over the next ten years. The dollar amounts allocated for each year are associated with the values along the right Y axis.

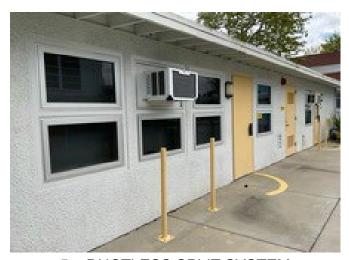
5 - DUCTLESS SPLIT SYSTEM

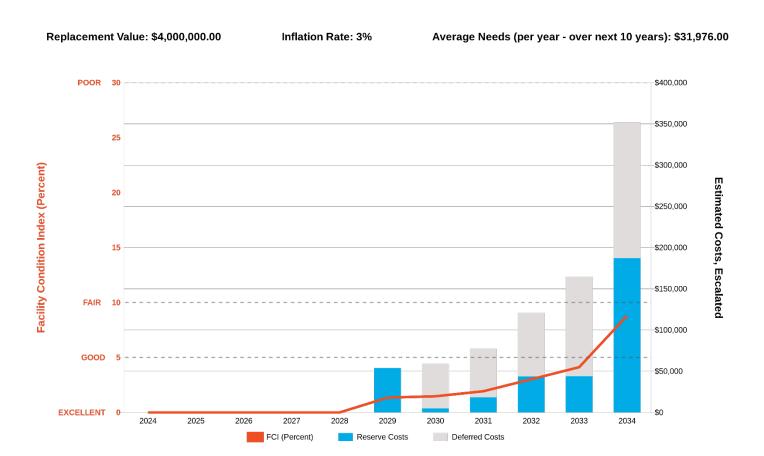
Needs by Year with Unaddressed FCI Over Time

NEEDS OVER TIME: The vertical blue bars in the graphic below represent the year-by-year needs identified for the facility. The orange line forecasts what would happen to the FCI (left Y axis) over time, assuming zero capital expenditures over the next ten years. The dollar amounts allocated for each year are associated with the values along the right Y axis.

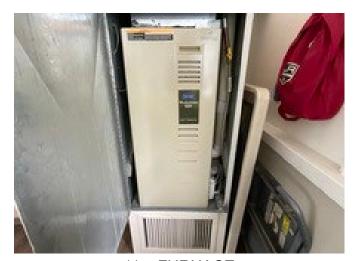
11 - FURNACE

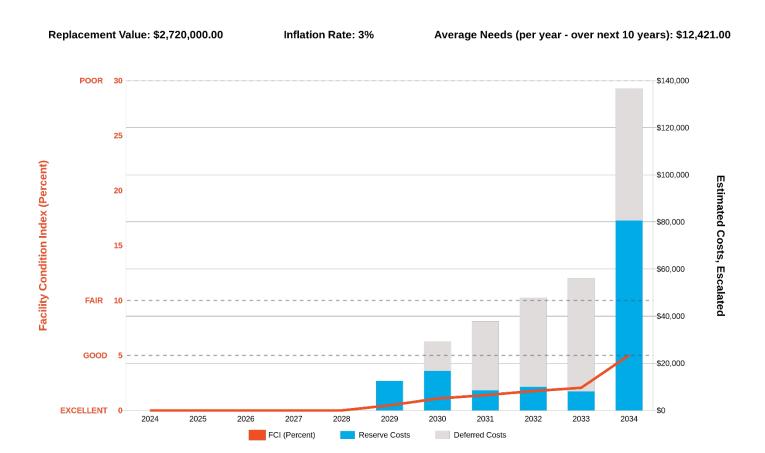
Needs by Year with Unaddressed FCI Over Time

NEEDS OVER TIME: The vertical blue bars in the graphic below represent the year-by-year needs identified for the facility. The orange line forecasts what would happen to the FCI (left Y axis) over time, assuming zero capital expenditures over the next ten years. The dollar amounts allocated for each year are associated with the values along the right Y axis.

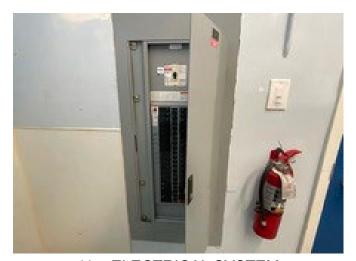
11 - ELECTRICAL SYSTEM

Electrical service is provided through main switchboards located between buildings E and F, and although they show some external oxidation, they are still in fair condition. Most lighting fixtures have been upgraded to LED, with only a few exceptions. Additionally, there are no electric generators on the premises.

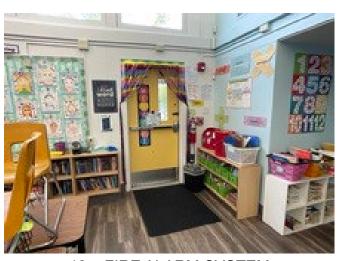
12 - FIRE ALARM SYSTEM

The renovation of the fire alarm system was a significant part of the 2019 modernization. It's worth noting that no buildings were found to have a fire suppression system, which is a significant recommendation for this school to address.

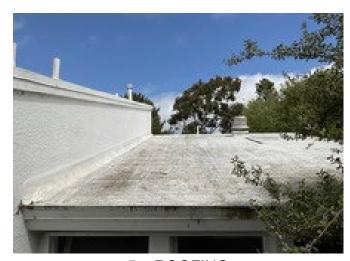
5 - ROOFING

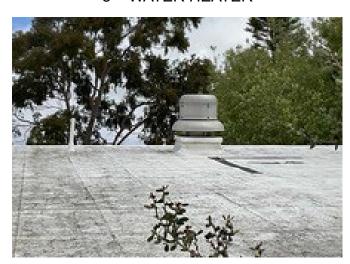
10 - EXHAUST FAN

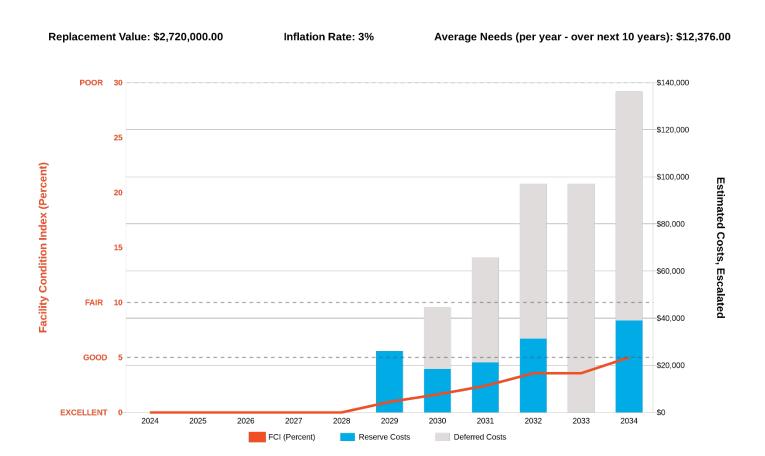
Needs by Year with Unaddressed FCI Over Time

NEEDS OVER TIME: The vertical blue bars in the graphic below represent the year-by-year needs identified for the facility. The orange line forecasts what would happen to the FCI (left Y axis) over time, assuming zero capital expenditures over the next ten years. The dollar amounts allocated for each year are associated with the values along the right Y axis.

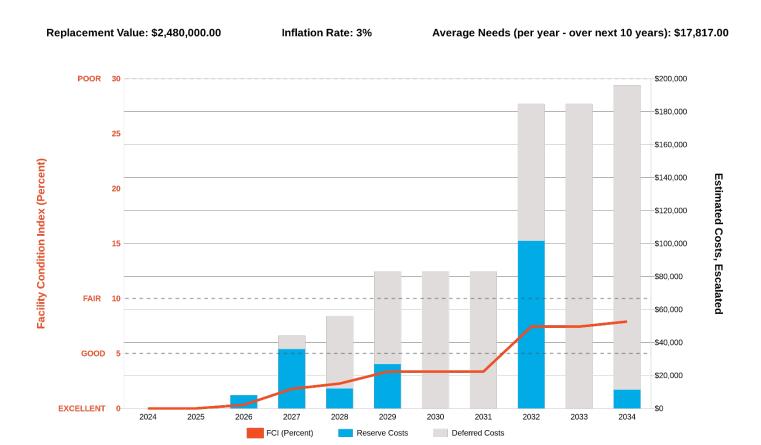
Needs by Year with Unaddressed FCI Over Time

NEEDS OVER TIME: The vertical blue bars in the graphic below represent the year-by-year needs identified for the facility. The orange line forecasts what would happen to the FCI (left Y axis) over time, assuming zero capital expenditures over the next ten years. The dollar amounts allocated for each year are associated with the values along the right Y axis.

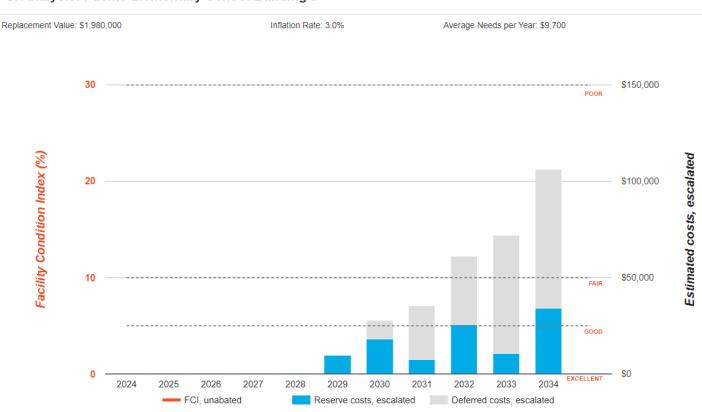
FCI Analysis: Pacific Elementary School Building J

Needs by Year with Unaddressed FCI Over Time

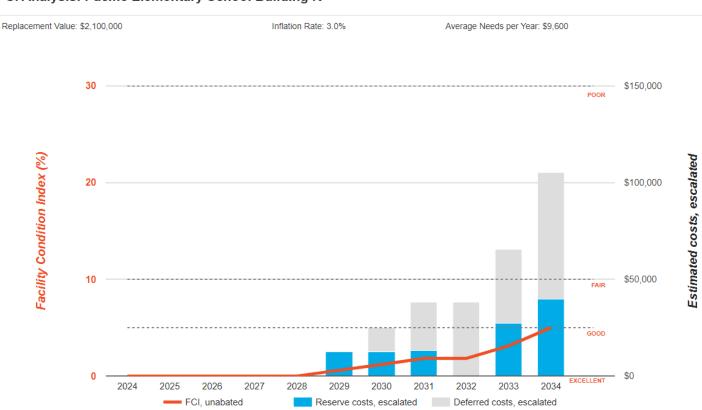
FCI Analysis: Pacific Elementary School Building K

Needs by Year with Unaddressed FCI Over Time

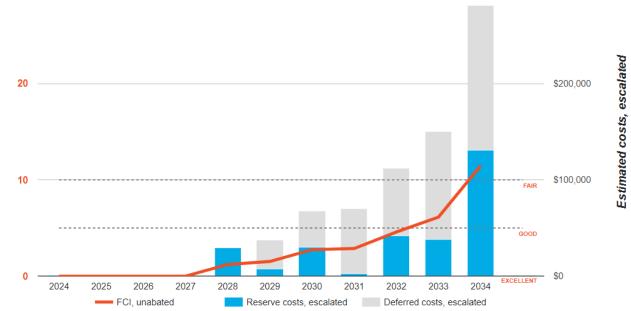
Replacement Value: \$2,450,000

\$300,000 POOR Facility Condition Index (%) 20 \$200,000

Inflation Rate: 3.0%

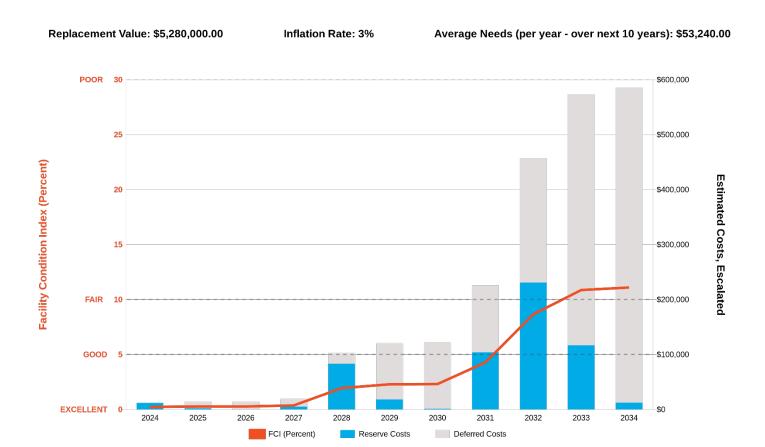
Needs by Year with Unaddressed FCI Over Time

NEEDS OVER TIME: The vertical blue bars in the graphic below represent the year-by-year needs identified for the facility. The orange line forecasts what would happen to the FCI (left Y axis) over time, assuming zero capital expenditures over the next ten years. The dollar amounts allocated for each year are associated with the values along the right Y axis.

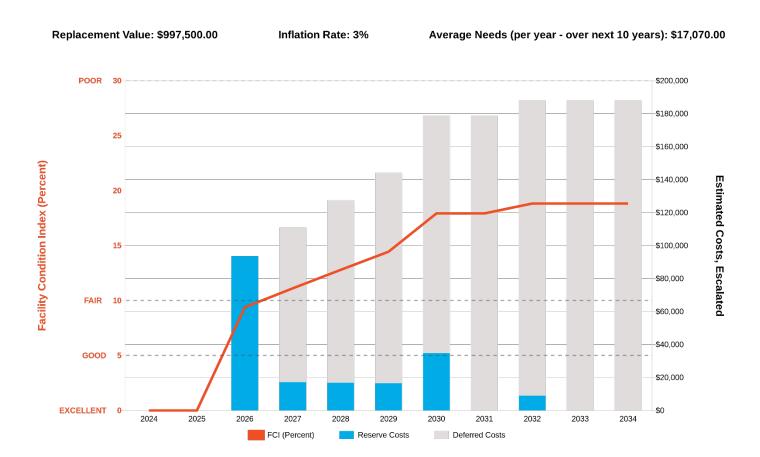
Needs by Year with Unaddressed FCI Over Time

NEEDS OVER TIME: The vertical blue bars in the graphic below represent the year-by-year needs identified for the facility. The orange line forecasts what would happen to the FCI (left Y axis) over time, assuming zero capital expenditures over the next ten years. The dollar amounts allocated for each year are associated with the values along the right Y axis.

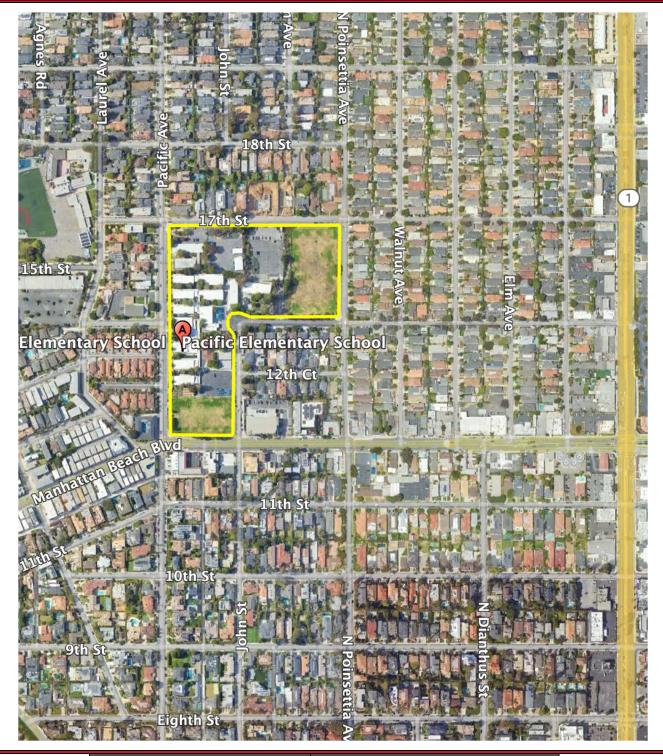
Site Plan

Project Number	Project Name
166615.24R000-002.017	Pacific Elementary School
Source	On-Site Date
Google Earth Pro	April 5, 2024

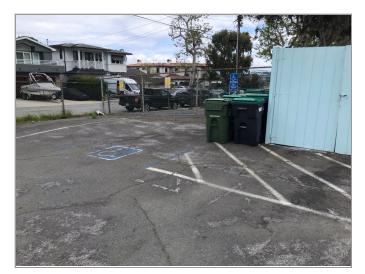
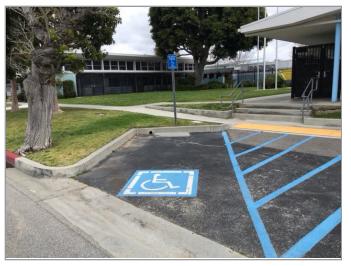
2ND AREA OF ACCESSIBLE PARKING

Question		Yes	No	NA	Comments
1	Does the required number of standard ADA designated spaces appear to be provided?	×			
2	Does the required number of van-accessible designated spaces appear to be provided?	×			
3	Are accessible spaces on the shortest accessible route to an accessible building entrance ?	×			
4	Does parking signage include the International Symbol of Accessibility?	×			
5	Does each accessible space have an adjacent access aisle ?	×			
6	Do parking spaces and access aisles appear to be relatively level and without obstruction?	×

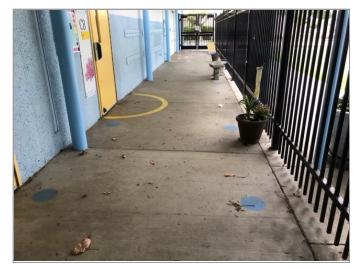
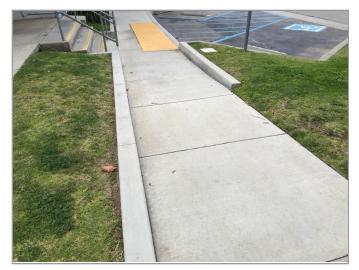
ACCESSIBLE PATH

CURB CUT

7	Do ramps on an accessible route appear to have compliant end and intermediate landings?	×		
8	Do ramps and stairs on an accessible route appear to have compliant handrails?	×		
9	For stairways that are open underneath, are permanent barriers present that prevent or discourage access?		×

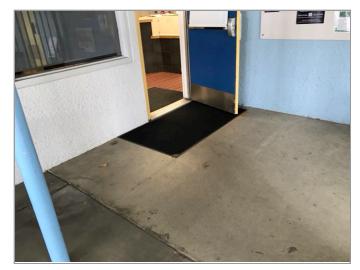
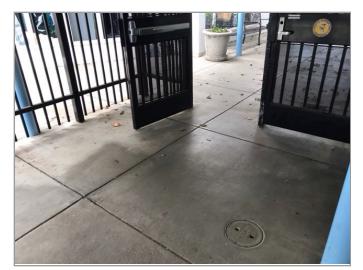
MAIN ENTRANCE

ADDITIONAL ENTRANCE

7	Do pairs of accessible entrance doors in series appear to have the minimum clear space between them ?	×		
8	Do thresholds at accessible entrances appear to have a compliant height?	×

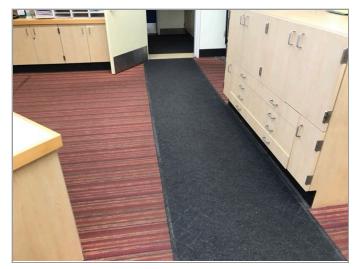
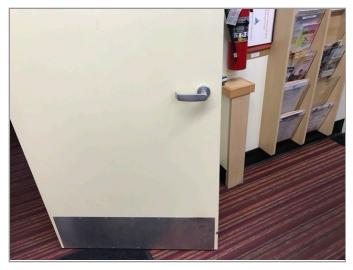
DOOR HARDWARE

Question	Yes	No	NA	Comments
1	Does an accessible route appear to connect all public areas inside the building ?	×			
2	Do accessible routes appear free of obstructions and/or protruding objects?	×			
3	Do ramps on accessible routes appear to have compliant slopes ?			×	
4	Do ramp runs on an accessible route appear to have a compliant rise and width ?			×	
5	Do ramps on accessible routes appear to have compliant end and intermediate landings?			×	
6	Do ramps on accessible routes appear to have compliant handrails ?			×

7	Are accessible areas of refuge and the accessible means of egress to those areas identified with accessible signage?	×		
8	Do public transaction areas have an accessible, lowered service counter section ?	×		
9	Do public telephones appear mounted with an accessible height and location ?		×	
10	Do doors at interior accessible routes appear to have compliant maneuvering clearance area on each side ?	×		
11	Do doors at interior accessible routes appear to have compliant hardware ?	×		
12	Do non-fire hinged, sliding, or folding doors on interior accessible routes appear to have compliant opening force ?	×		
13	Do doors on interior accessible routes appear to have a compliant clear opening width ?	×

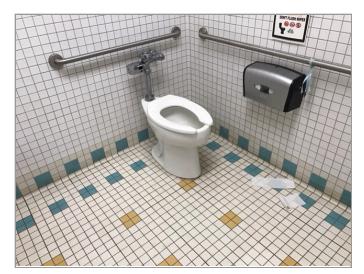
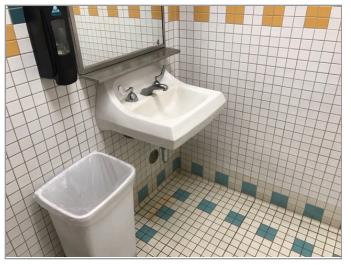
SINK, FAUCET HANDLES AND ACCESSORIES

Question	Yes	No	NA	Comments
1	Do publicly accessible toilet rooms appear to have a minimum compliant floor area ?	×			
2	Does the lavatory appear to be mounted at a compliant height and with compliant knee area ?	×			
3	Does the lavatory faucet have compliant handles ?	×			
4	Is the plumbing piping under lavatories configured to protect against contact?		×		
5	Are grab bars provided at compliant locations around the toilet ?	×			
6	Do toilet stall doors appear to provide the minimum compliant clear width ?	×

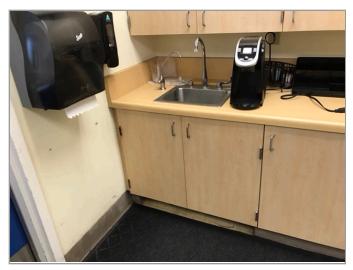
SINK CLEARANCE

Question	Yes	No	NA	Comments
1	Do kitchens/kitchenettes appear to have a minimum compliant path of travel or area of maneuverability ?	×			
2	Are the appliances centered for a parallel or forward approach with adequate clear floor space ?			×	
3	Is there an accessible countertop/preparation space of proper width and height?	×			
4	Is there an accessible sink space of proper width and height?	×			
5	Does the sink faucet have compliant handles ?	×			
6	Is the plumbing piping under the sink configured to protect against contact?			×

7	Are the cooktop/range controls front-mounted (or in a location that does not require reaching across the burners) ?			×	
---	---	--	--	---	--

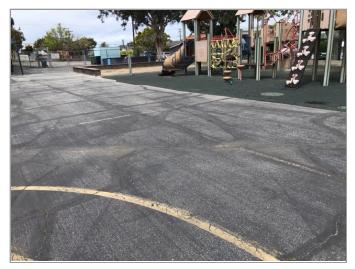
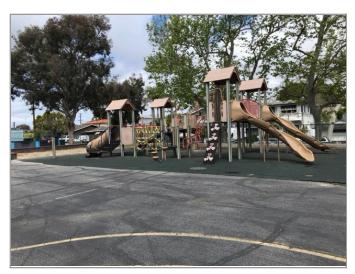
ACCESSIBLE ROUTE TO PLAYGROUND

OVERVIEW OF PLAYGROUND

Question	Yes	No	NA	Comments
1	Is there an accessible route to the play area / s?	×			
2	Has the play area been reviewed for accessibility ?	×			2000
3	Are publicly accessible swimming pools equipped with an entrance lift ?			×
