Northern Pacific Railway Company. Engineering Department Records.

Wood Preservatives

Osmoseplastic treatment timbers Bridge 27.2, Snoqualmie Branch

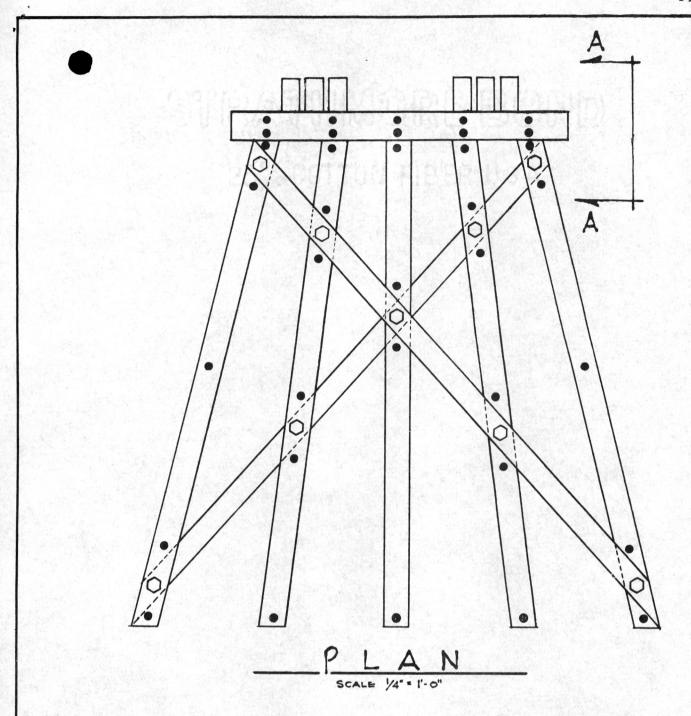
SECTION "A-A"

\* A 5% by weight solution of OsmoBor preservative (sodium borate equivalent to 5.2% anhydrous Borax) may be used internally in lieu of 24-12 on that portion of the structure over or adjacent to water.

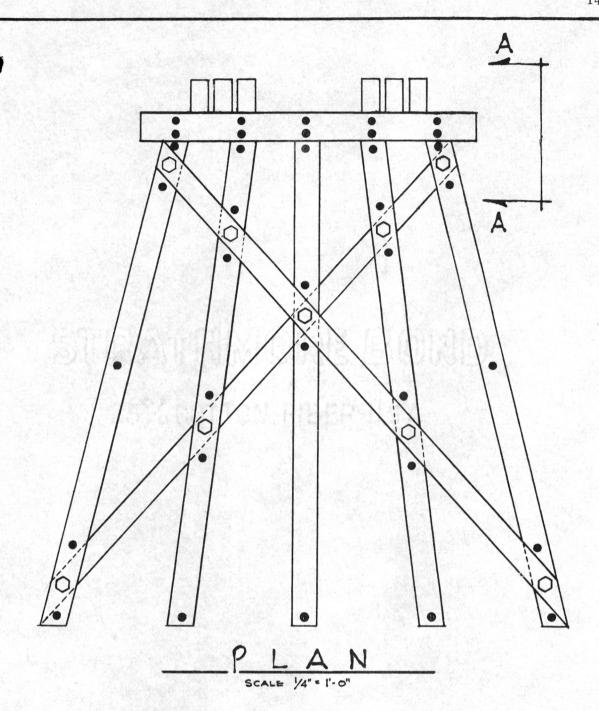
SECTION "A-A"

<sup>\*</sup> A 5% by weight solution of OsmoBor preservative (sodium borate equivalent to 5.2% anhydrous Borax) may be used internally in lieu of 24-12 on that portion of the structure over or adjacent to water.

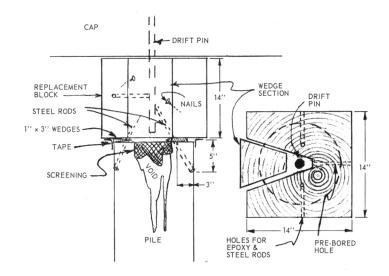
- (a) Pre-cut 14" wood replacement section (pressure treated).
- (b) Plastic screening or equivalent.
- (c) OsmoWeld (epoxy resin).
- (d) Large nails to secure replacement section.
- (e) Three 1" x 3" treated wood wedges.
- (f) Treated wooden dowels 7/8" x 3".
- (g) 3" pressure sensitive tape.
- (h) Deformed reinforcing rod 3/8" x 14".

- (1) Limits of decay are determined by borings and shell thickness indicator. Piling having little or no decay below the drift pin area should be noted for this special process of rehabilitation.

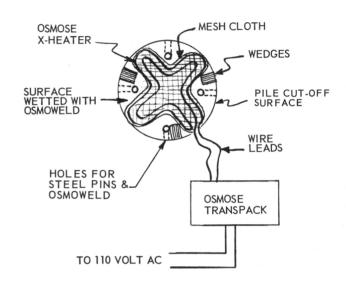
- 1. **PURPOSE** To speed up the curing time of an OsmoWeld joint when posting piling in accordance with Specification 141.3 or Specification 141.2, when the air temperature is below 45° F.
- 2. DIAGRAM (at right)

- (a) Usual posting materials as outlined in Specification 141.3.
- (b) 110-120V AC power source.
- (c) Osmose Transpack. (Available from Osmose at \$118.00 F.O.B. Buffalo.)
- (d) One Osmose X-Heater wire grid for each joint to be heated. (Available from Osmose at \$1.90 each F.O.B. Buffalo and packaged in cartons of 12 each.)

- (1) The method contained in the Specifications referred to above is followed until the cut surfaces are wetted with OsmoWeld.
- (2) The wire grid is patted onto the cut surfaces as shown in the diagram and pile is marked so that the holes for the pins may be drilled without cutting the grid. The OsmoWeld allows the grid to adhere to the surface without fastenings.

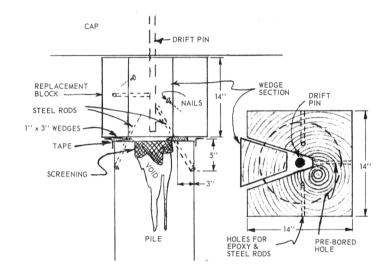
- (a) Pre-cut 14" wood replacement section (pressure treated).
- (b) Plastic screening or equivalent.
- (c) OsmoWeld (epoxy resin).
- (d) Large nails to secure replacement section.
- (e) Three 1"x 3" treated wood wedges.
- (f) Treated wooden dowels 7/8"x 3".
- (g) 3" pressure sensitive tape.
- (h) Deformed reinforcing rod 3/8" x 14".

- (1) Limits of decay are determined by borings and shell thickness indicator. Piling having little or no decay below the drift pin area should be noted for this special process of rehabilitation.

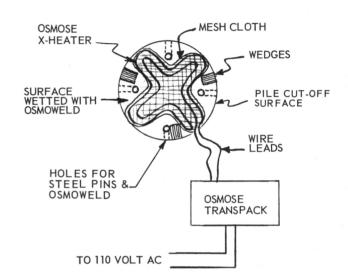
- (a) Usual posting materials as outlined in Specification 141.3.
- (b) 110-120V AC power source.
- (c) Osmose Transpack. (Available from Osmose at \$118.00 F.O.B. Buffalo.)
- (d) One Osmose X-Heater wire grid for each joint to be heated. (Available from Osmose at \$1.90 each F.O.B. Buffalo and packaged in cartons of 12 each.)

- (1) The method contained in the Specifications referred to above is followed until the cut surfaces are wetted with OsmoWeld
- (2) The wire grid is patted onto the cut surfaces as shown in the diagram and pile is marked so that the holes for the pins may be drilled without cutting the grid. The OsmoWeld allows the grid to adhere to the surface without fastenings.

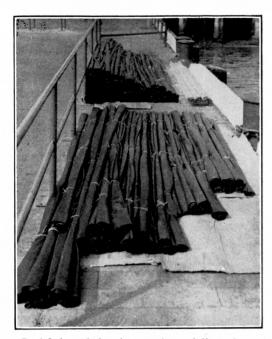
Prefabricated barrier sections delivered to wharf location.

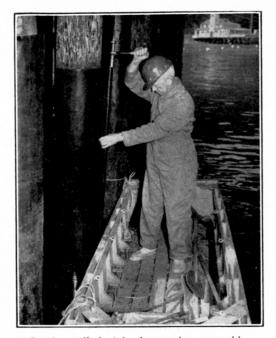
Barrier rolled tight by ratchet assembly.

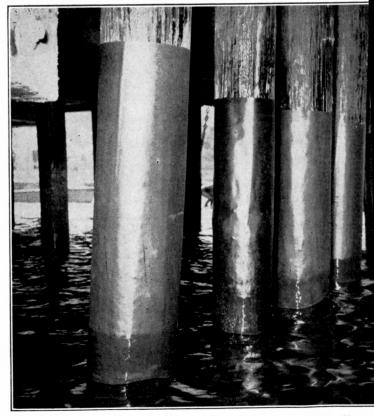
Completed protection of wood piling.
