RCWD BOARD OF MANAGERS WORKSHOP

Subject: Anoka County Ditch 55 Re-Route Easement and Repair

Subject: Anoka County Ditch 55
Repair Memorandum

**ANOKA COUNTY DITCH (ACD) 53/62
RARE PLANT AVOIDANCE STRATEGY
Repair of Branch 1 & Lateral 1-Anoka County Ditch 53/62**

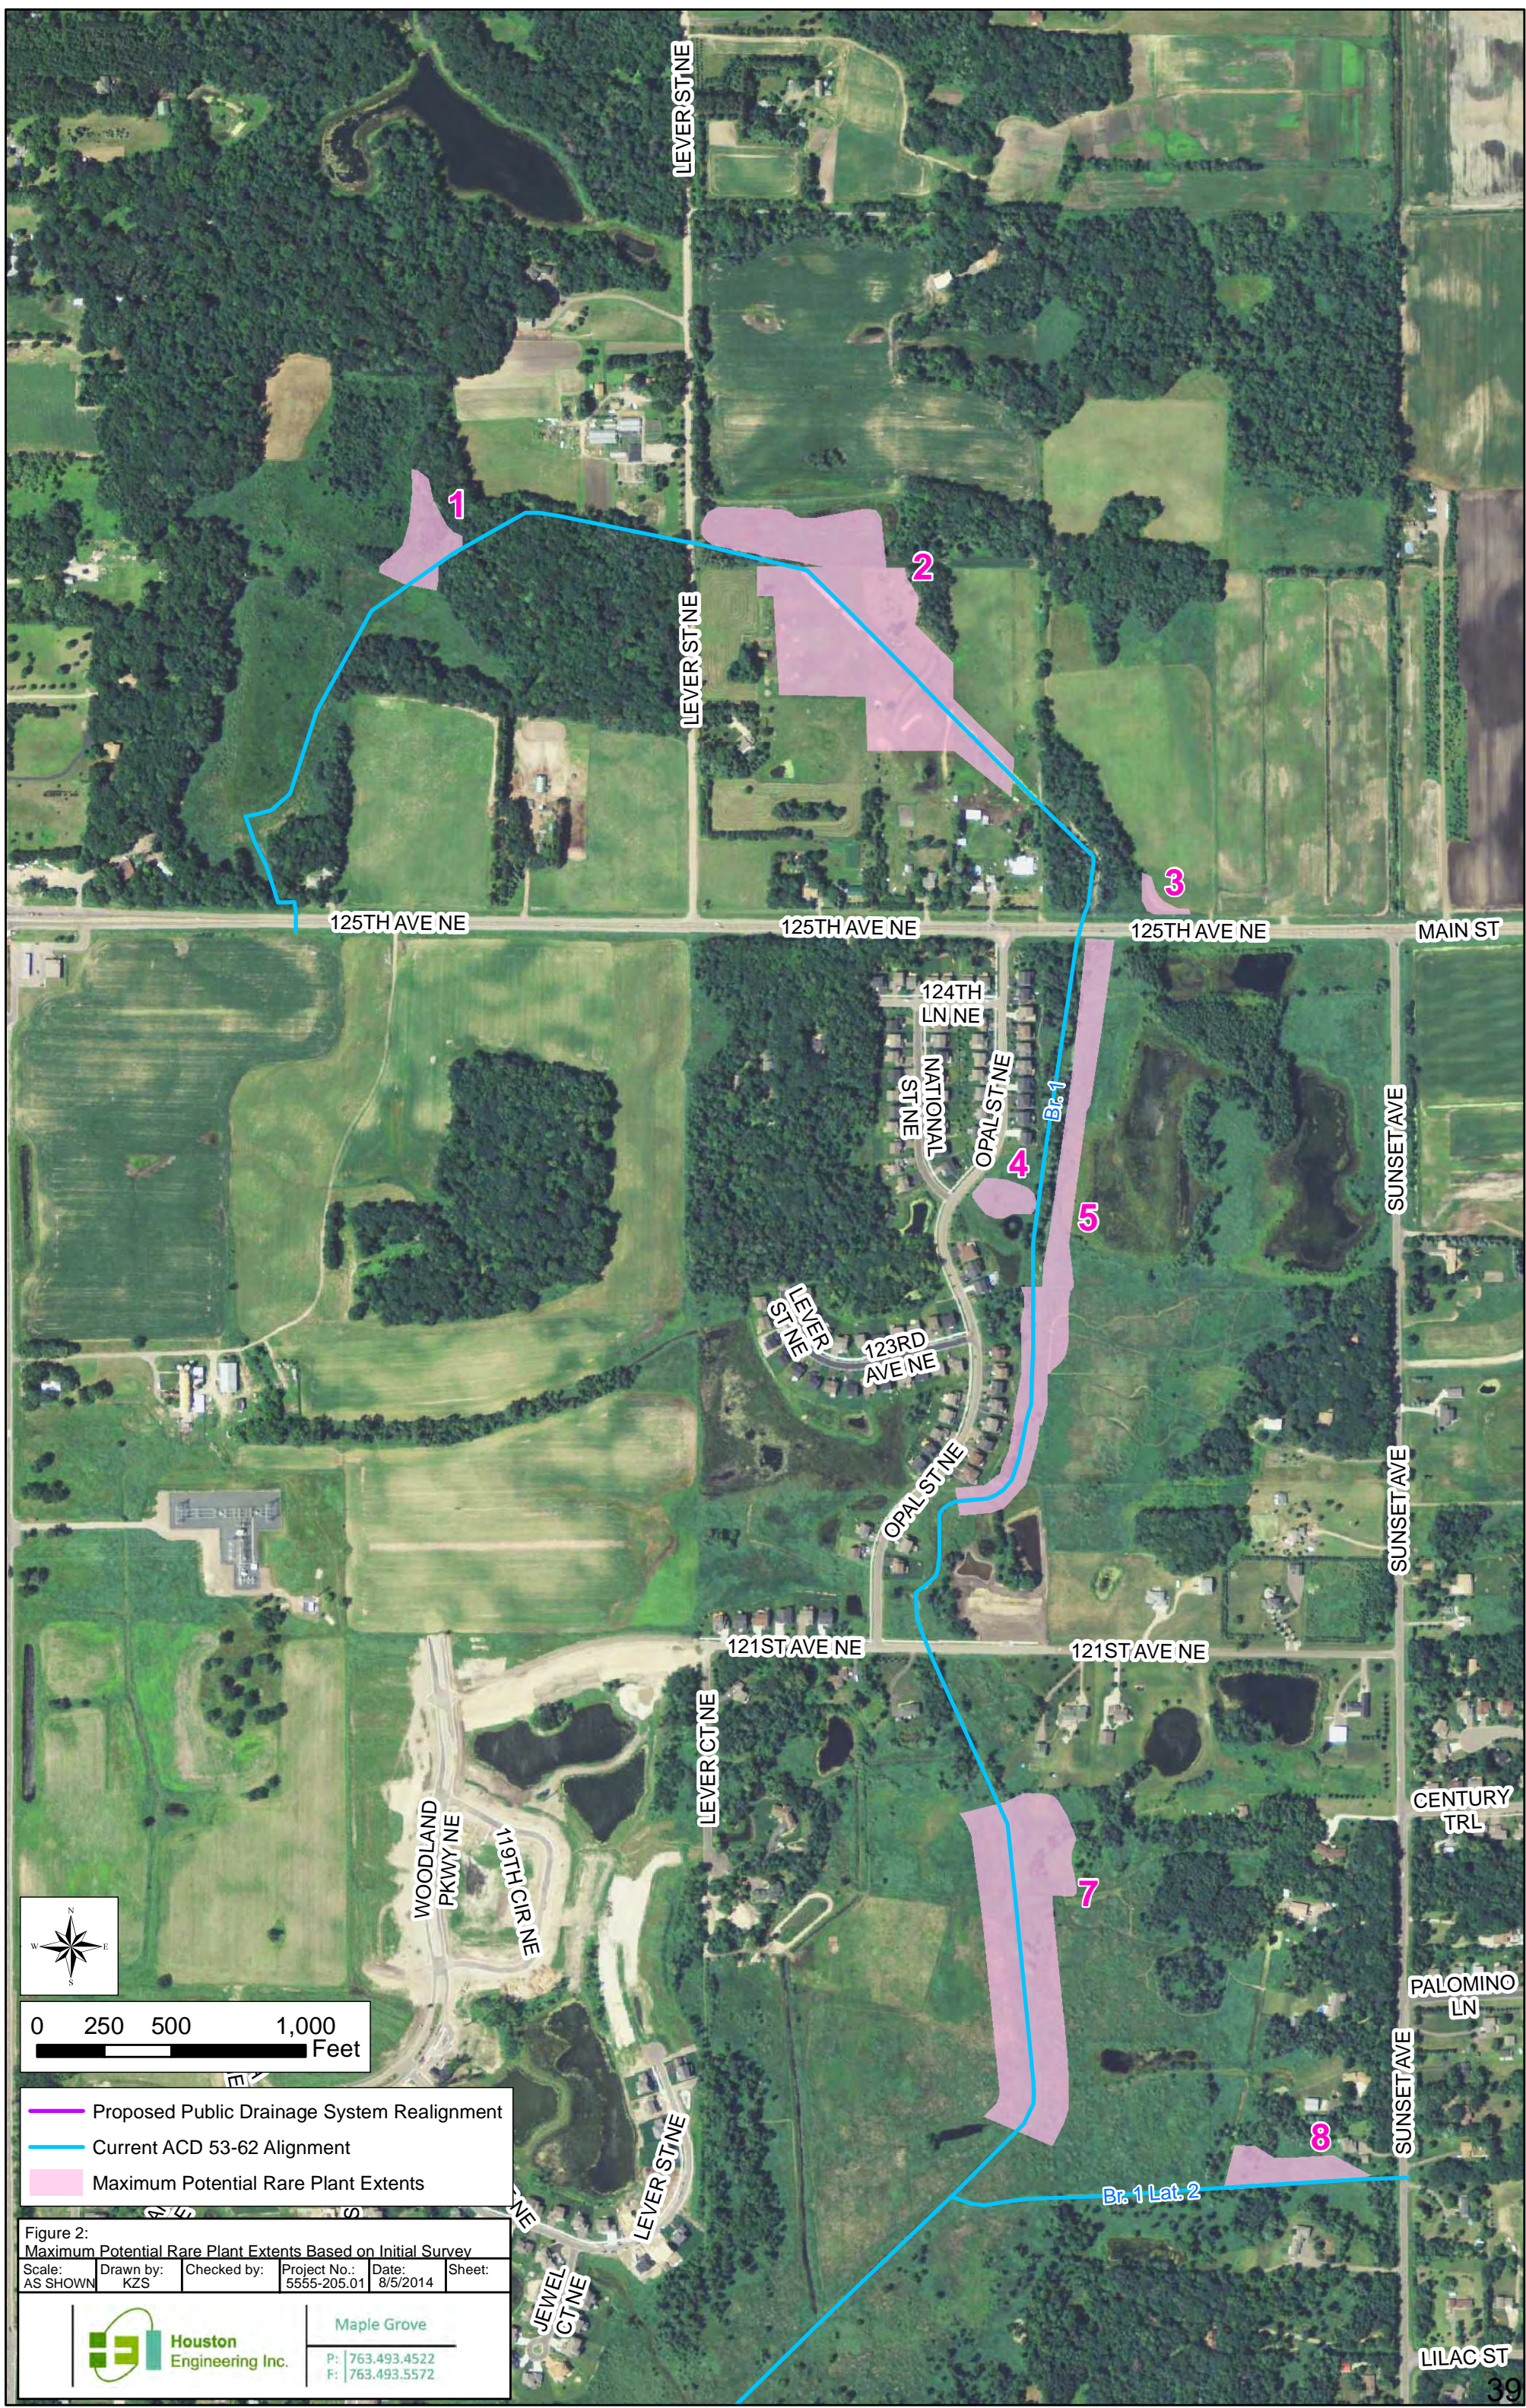
Figure 2:
Maximum Potential Rare Plant Extents Based on Initial Survey

- Proposed Public Drainage System Realignment
- Current ACD 53-62 Alignment
- Maximum Potential Rare Plant Extents

Since the degree of disrepair¹ varies throughout Branch 1 of the public drainage system (maintenance at select limited problem areas has occurred in some areas during recent years), the planned construction activities vary throughout the Project. The following is a brief description of the type of work planned for each of the potential rare species habitat polygon areas shown in **Figures 2 and 3**:

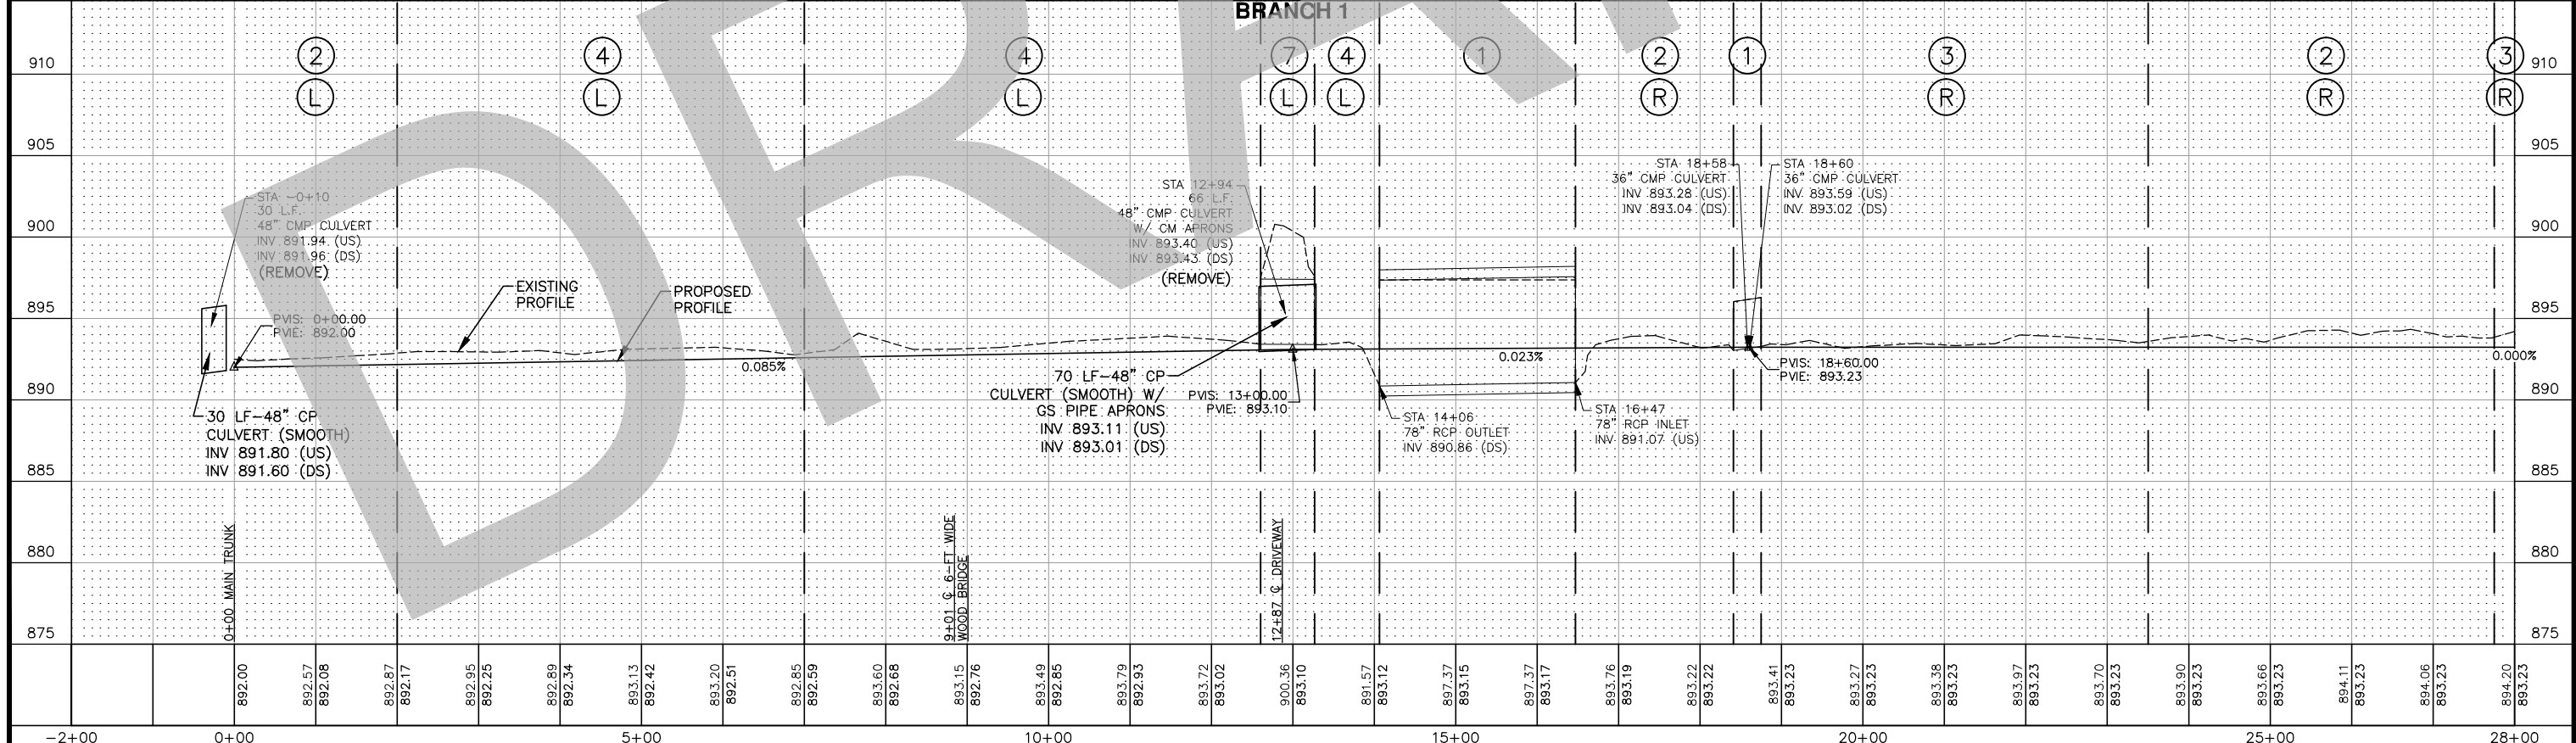
WORK TYPE KEY

- ① NO WORK REQUIRED.
- ② EXCAVATE CHANNEL, PLACE SPOIL AT TOP OF BANK. NO TREE REMOVAL REQUIRED.
- ③ EXCAVATE CHANNEL. CLEAR TREES & BRUSH. PLACE SPOIL AND TREES AND BRUSH AT TOP OF BANK.
- ④ EXCAVATE CHANNEL. CLEAR TREES & BRUSH. CHIP TREES & BRUSH AND PLACE AT TOP OF BANK.
- ⑤ NO EXCAVATION. CLEAR TREES & BRUSH AND PLACE AT TOP OF BANK.
- ⑥ NO EXCAVATION. CLEAR TREES & BRUSH. CHIP TREES AND BRUSH AND PLACE AT TOP OF BANK.
- ⑦ REPLACE EXISTING CULVERT.
- ⑧ EXCAVATE NEW CHANNEL. CLEAR TREES & BRUSH. PLACE SPOIL AND DEBRIS AT TOP OF BANK.
- Ⓜ DITCH ACCESS AND SPOIL PLACEMENT—RIGHT LOOKING UPSTREAM
- Ⓛ DITCH ACCESS AND SPOIL PLACEMENT—LEFT LOOKING UPSTREAM

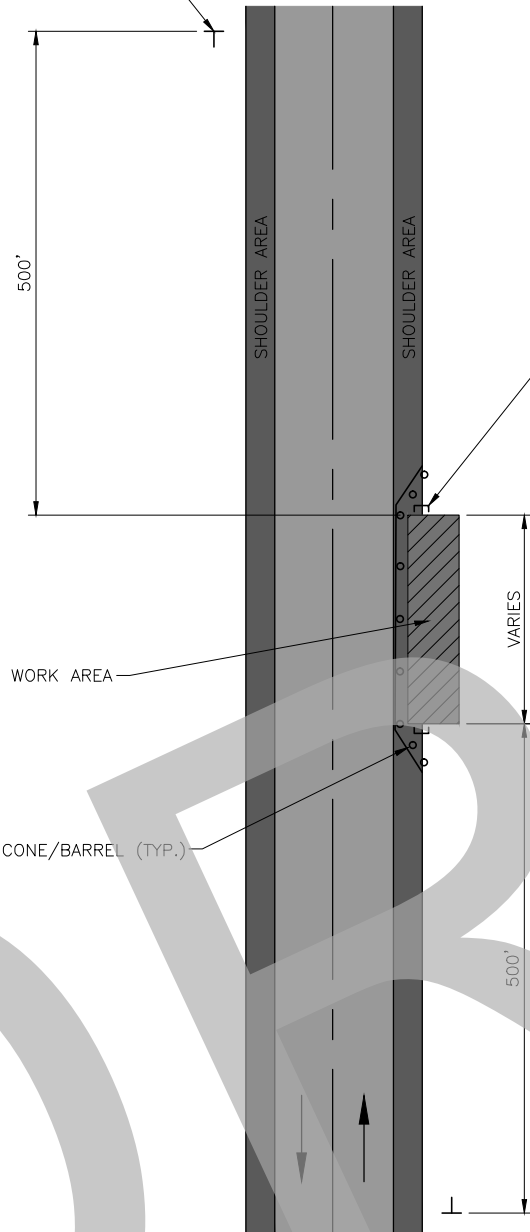
ROAD WORK AHEAD SIGN (TYP.)

TYPE C CHANNELIZING DEVICE (TYP.)

WORK AREA

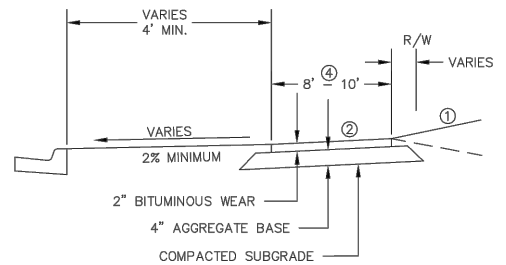
OFF ROAD TRAIL
TYPICAL SECTION Plate No. ST-16

- NOTES:
- ① - SLOPE VARIES 1:2 TO 1:4
 - ② - CROSS SLOPE 2%
 - ③ - RESTORE ALL DISTURBED AREAS WITH 4" TOPSOIL AND SOD.
 - ④ - CHECK WITH CITY ENGINEERING DEPARTMENT FOR REQUIRED WIDTH.
