# The Minneapolis Lumber Exchange Fire of 1891 and Fire-Resisting Construction

SARA E. WERMIEL

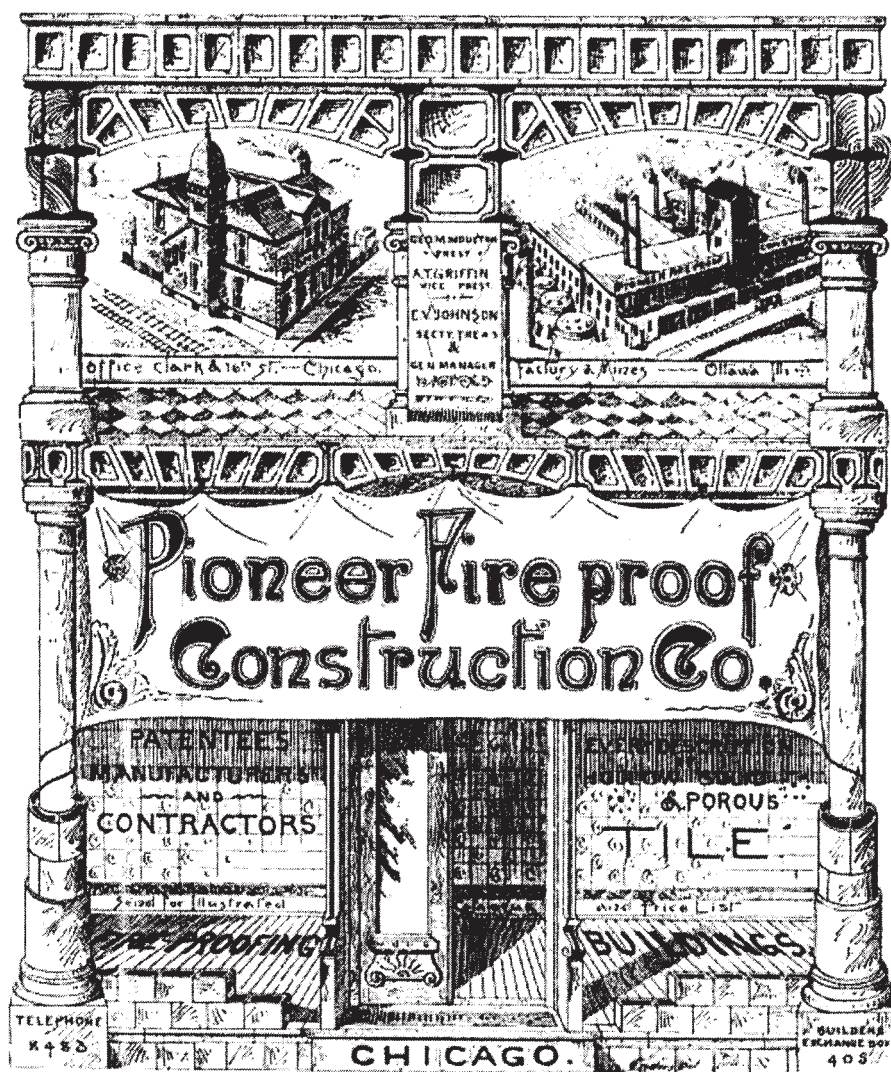
Advertisement, *Inland Architect*, May 1885, for the Midwest's first and leading manufacturer of hollow structural blocks. The illustrations show hollow-block floors (flat and curved arches), column protection, and partitions.

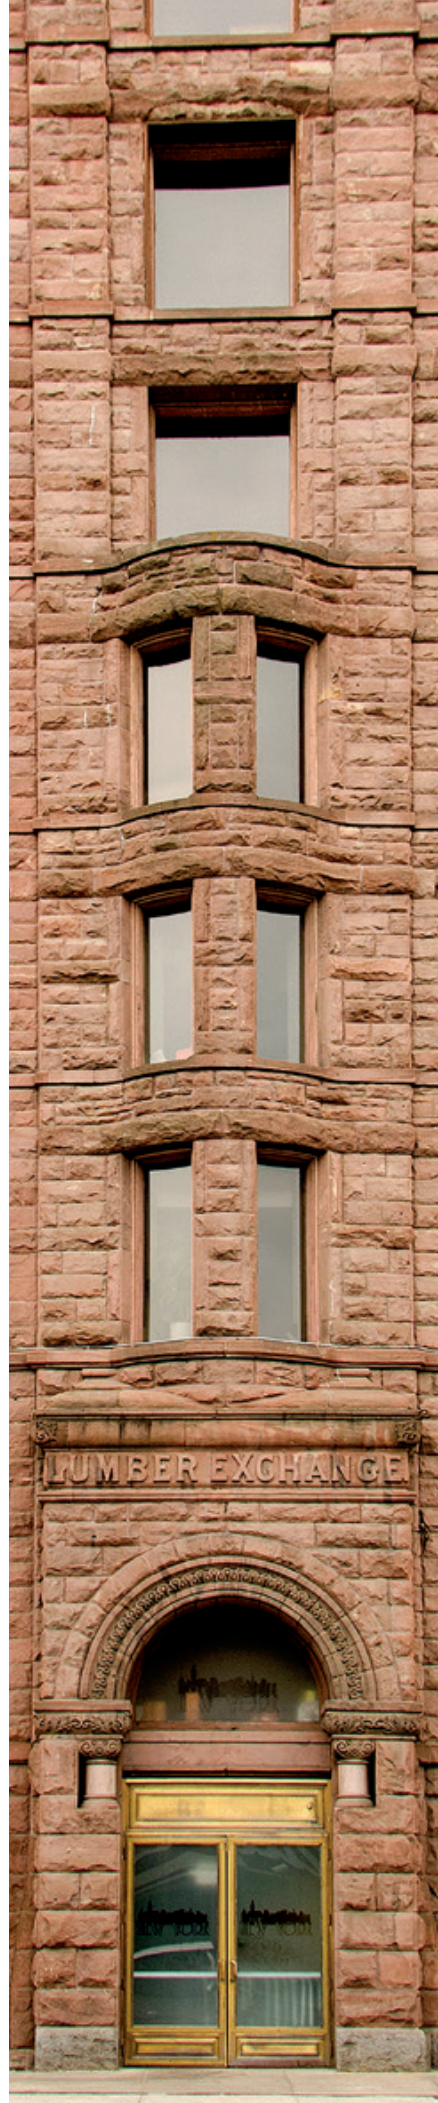
*Detail of the Lumber Exchange’s rock-faced façade, 2014. This section was the terminus of the original building’s Hennepin Avenue side.*

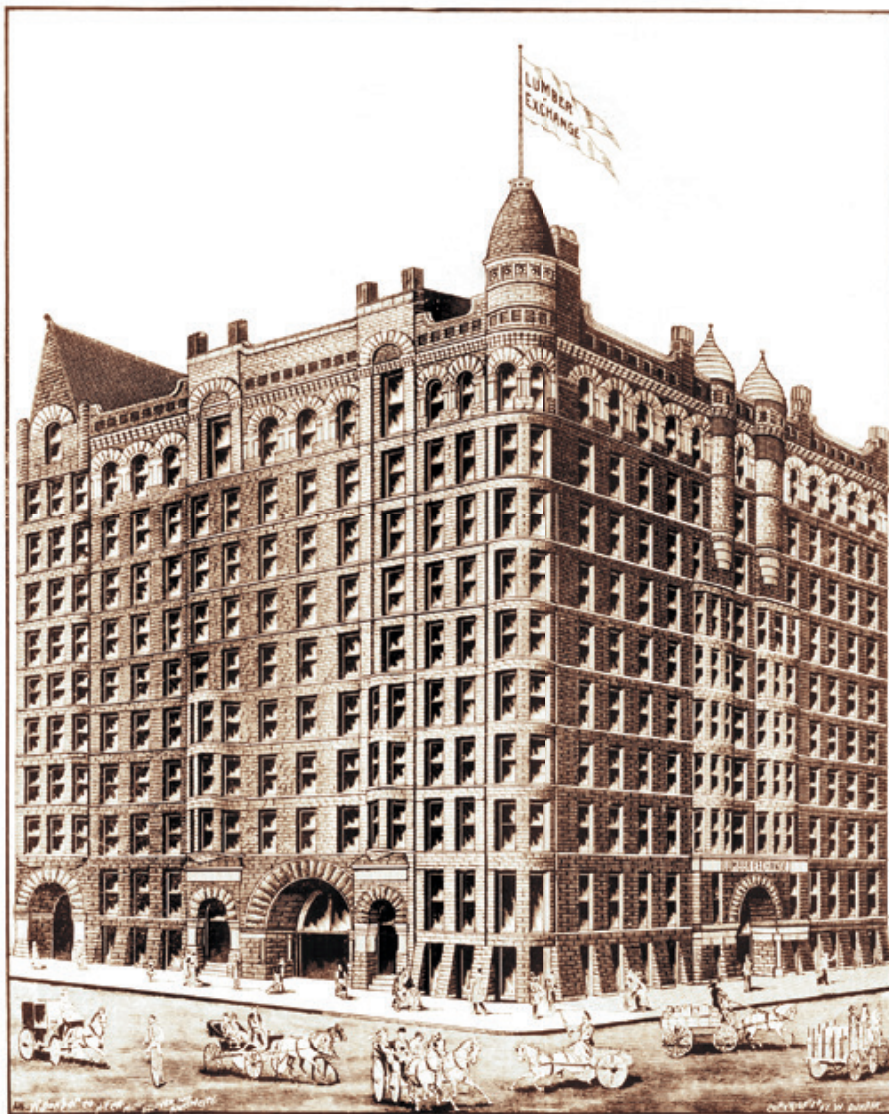
Early design for enlarging the Lumber Exchange. The addition (left side) along Hennepin Avenue is ten stories, like the original section, and preserves the original roofline.

**I**N ABOUT 1889 the owners of the Lumber Exchange decided to expand the two-year-old building and commissioned Long and Kees to design the addition. An early drawing of the enlarged skyscraper shows the new section, which would front Hennepin Avenue, to be ten stories, the same height as the original section. But as built, the addition was 12 stories, and two stories were added to

the original Lumber Exchange, creating an overall 12-story block.

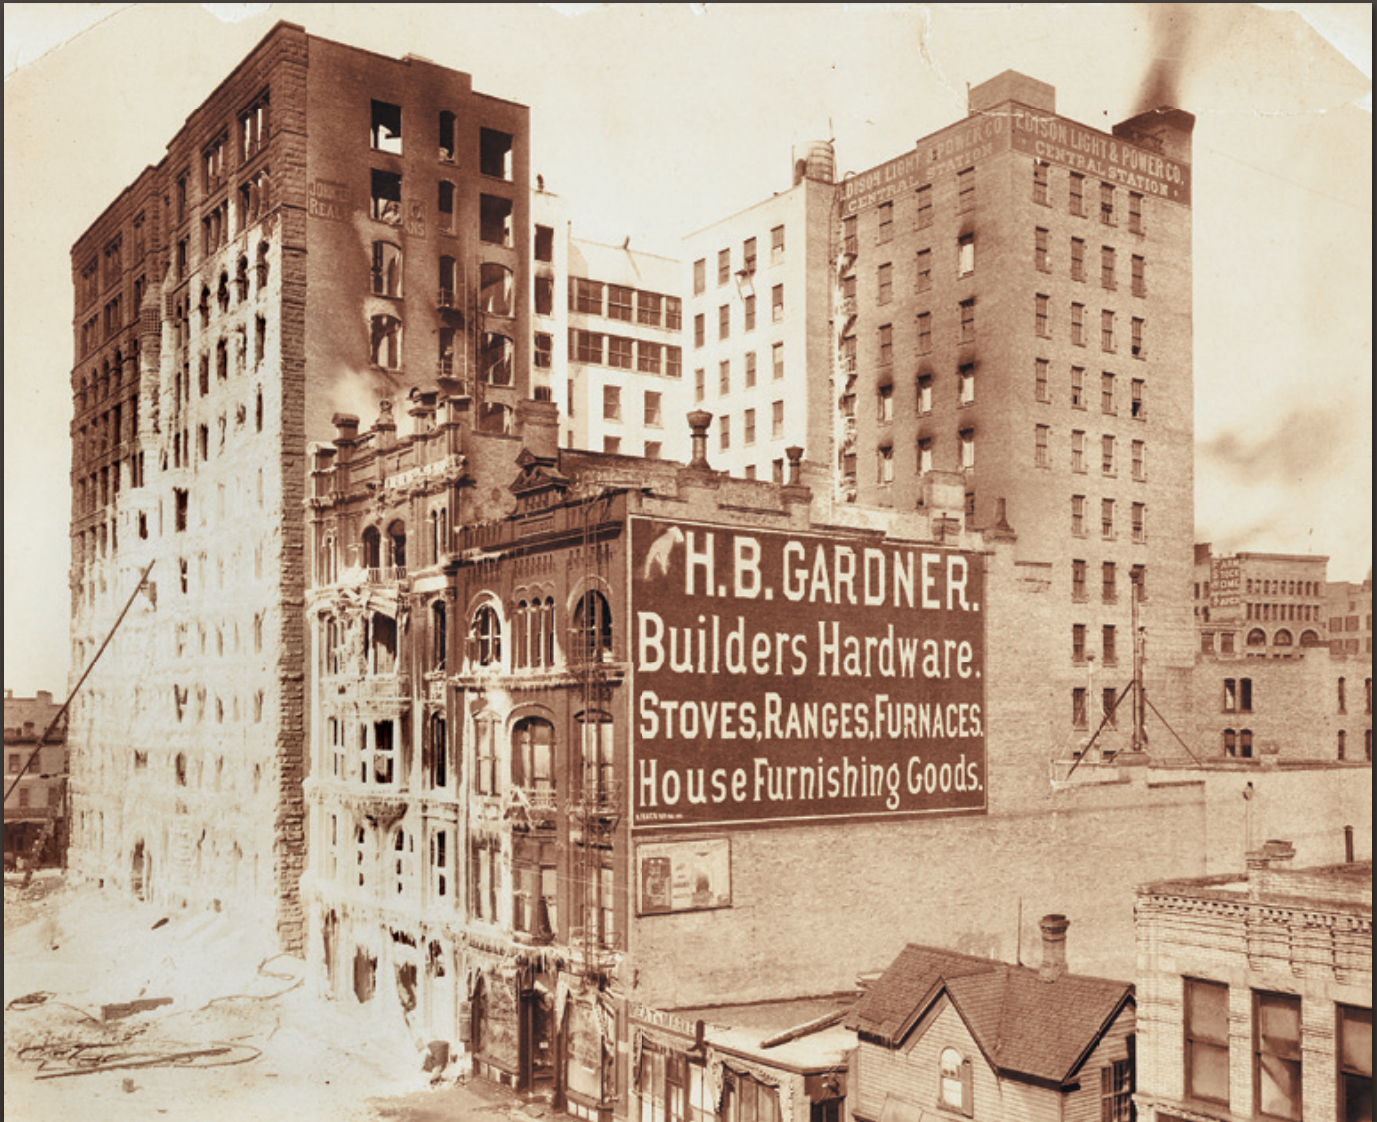
Aftermath: The Lumber Exchange, Russell Block, and Robinson Building, after fire and ice.

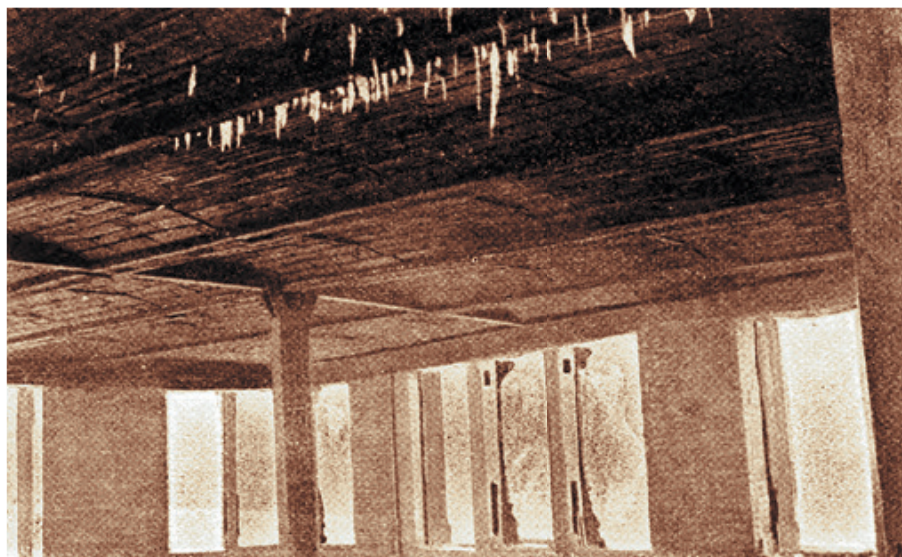
*Tenth-floor ceiling in the original section after the fire, showing uninjured fireproof arches; Inland Architect, August 1891, page 9.*

Although the new part was exposed to the heat of the fire burning in the old part through large openings in the walls between the two sections, it suffered little damage. Since it was unoccupied and had little to burn, this is not surprising. What was surprising was that the two-story addition on the original building survived. Despite the prolonged fire beneath it, which burned out the floors below,

the iron frame of the building remained intact and supported the top two floors, which likewise remained intact. And despite the interior damage, the exterior walls of the original section survived. They were repaired, and the old section was completely rebuilt inside. This time, only fireproof materials were used.
