Preliminary Storm Drainage Report City of Carnation

**Boyd Short Plat
31964 E Blanche St
Carnation WA, 98014**

Encompass Engineering Job No. 23608

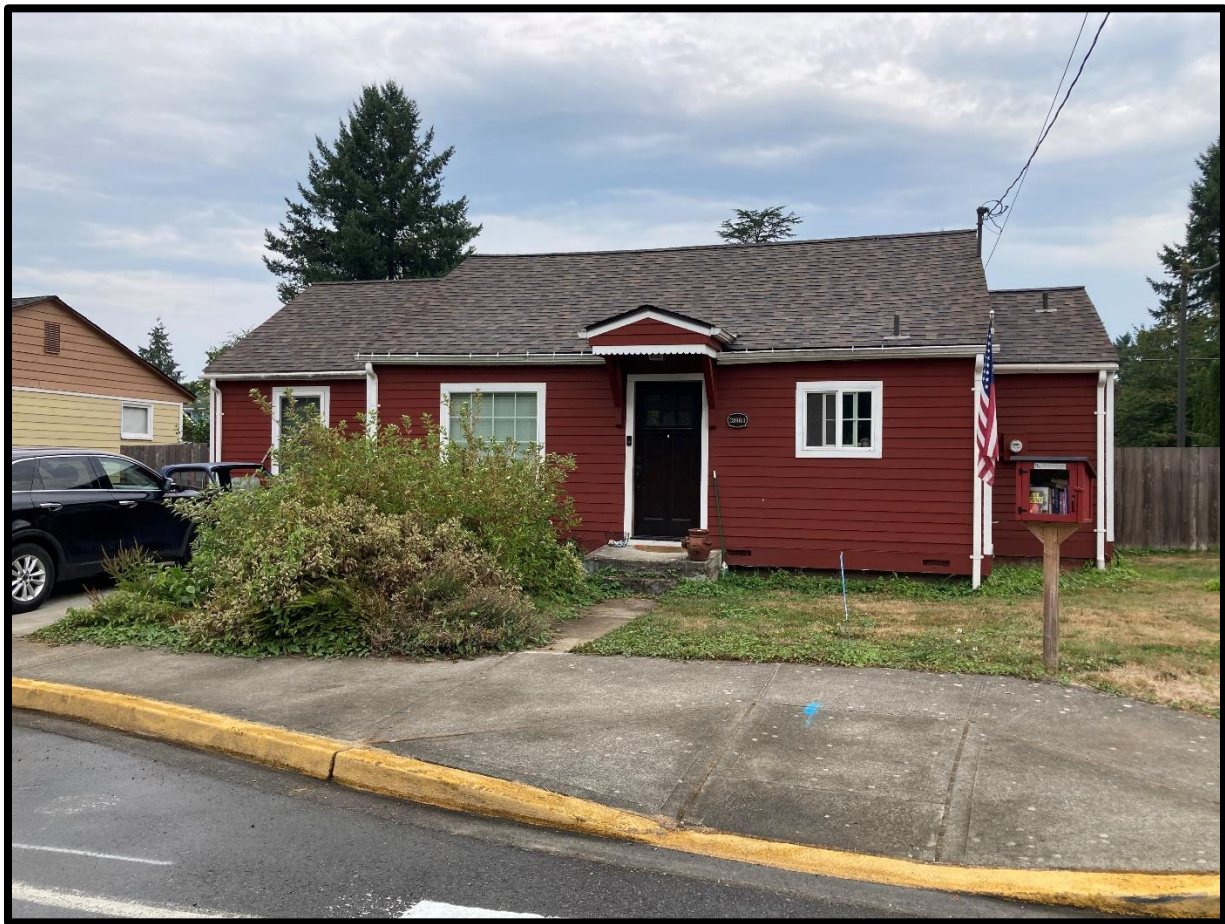
Figure 2: Existing Site Photo

The southern half of the 0.24-acre parcel is currently developed with a single-family residence with access from Blanche Street via a concrete driveway. Several small sheds are located in the northern portion of the property. The vegetation on the site consists of some shrubs and lawn. Runoff from the existing residence is routed underground via roof drains and is assumed to connect to the City of Carantion's public stormwater system in Blanche Street. Runoff from the existing driveway/walkway surfaces sheet flows into the right-of-way (ROW) for Blanche Street where it enters the public stormwater system. Please refer to the Existing Conditions Map (Figure 3) on the following page.

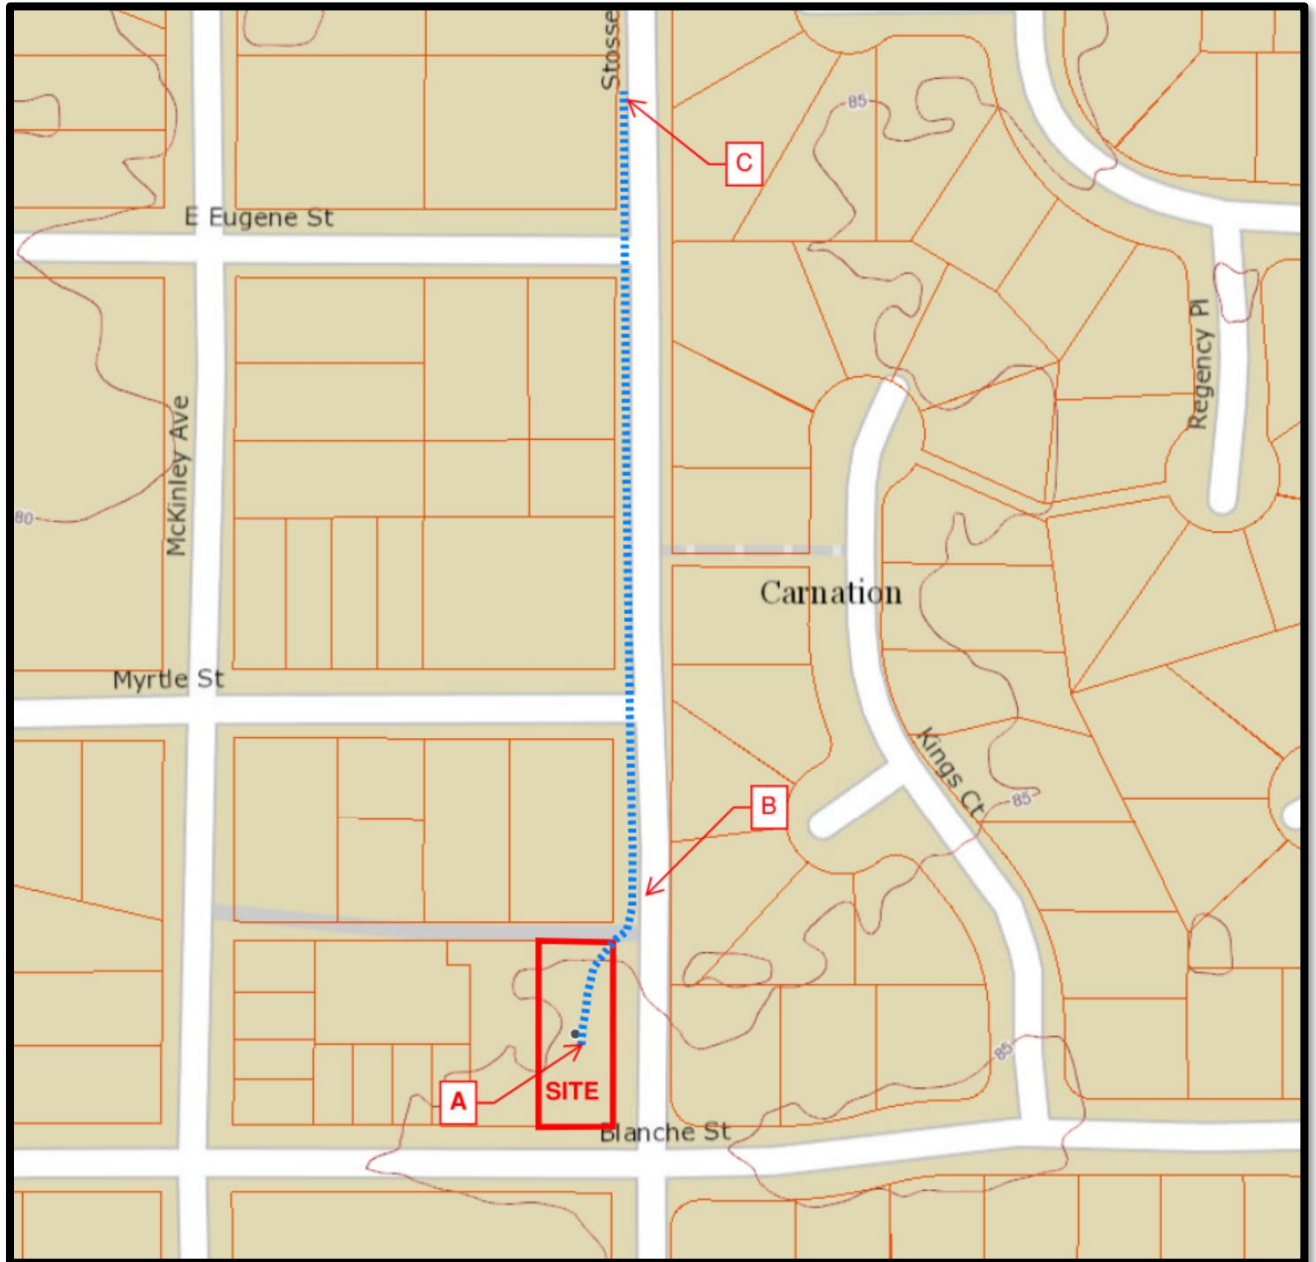
Figure 6: Downstream Drainage Map

Stormwater runoff from the site typically infiltrates into the native soils found on-site; however, in the event of an extreme rain event, runoff would sheet flow to the northeast across lawn surfaces at mild grades of 1 to 2 percent (A). The only natural discharge area (NDA) for the site is located in the northeastern portion of the property, which results in a total of one threshold discharge area (TDA) for the site. Once the stormwater sheet flows off the northeastern portion of the site, it enters a catch basin located in Stossel Avenue just north of the site (B). After entering the public stormwater system, stormwater continues flowing north within the public stormwater system within Stossel Avenue at the ¼ mile downstream limit (C). No signs of erosion or drainage concerns were observed during the site visit. Please refer to the Downstream Drainage Map below for the referenced points of interest in the above. The site proposed to fully infiltrate all runoff

generated from the proposed development; therefore, we do not anticipate any impact to the downstream public stormwater system.

An Offsite Analysis was performed based on the requirements in the 2019 DOE SWMMWW. A Downstream Drainage Map (Figure 6), which summarizes the downstream drainage components for one-quarter mile, has been included at the end of this section to aid in this discussion.

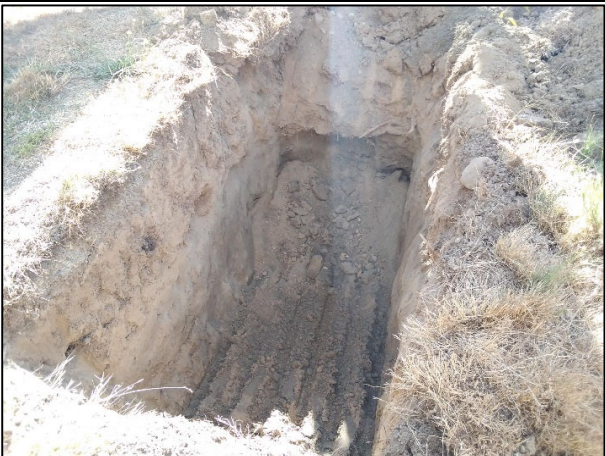
Depth (ft.)	Soil Description	USC	View of PIT-1
0.0 - 0.5	Light brown silty fine sand with gravel and organics (loose, dry to moist) (Topsoil)	SM

0.5 - 3.5	Brown silty sand with some gravel and trace organics (medium dense, dry to moist)	SM	
3.5 - 4.5	Brown silty fine to medium sand (medium dense, moist)	SM

general accordance with the Unified Soil Classification System, a copy of which is presented as Figure 3. The logs of the explorations are presented in Figures 4 and 5.

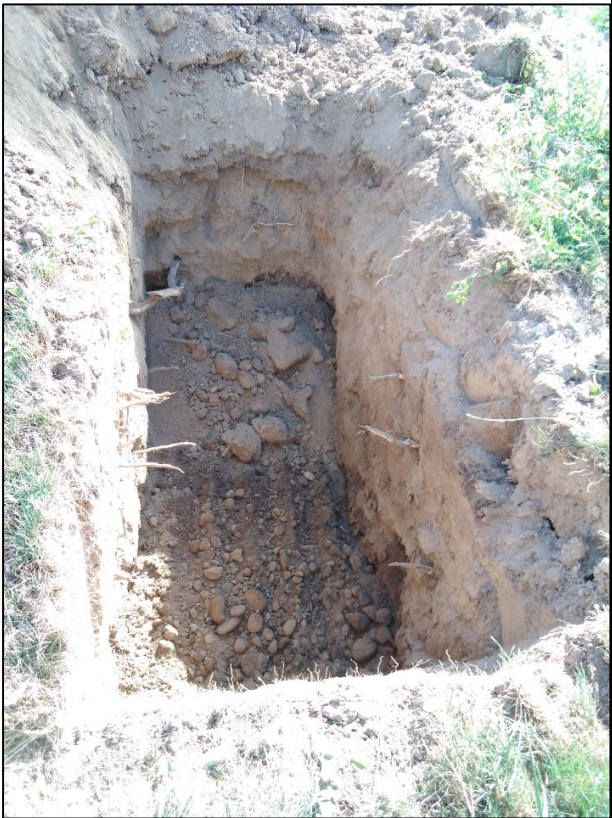
Depth (ft.)	Soil Description	USC	View of PIT-2
0.0 - 0.5	Light brown silty fine sand with gravel and organics (loose, dry to moist) (Topsoil)	SM

0.5 - 3.5	Brown silty sand with some gravel and trace organics (medium dense, dry to moist)	SM	
3.5 - 4.5	Brown silty fine to medium sand with gravel (medium dense, dry to moist)	GP-GM
