SAFETY ELEMENT

5.07.000 INTRODUCTION

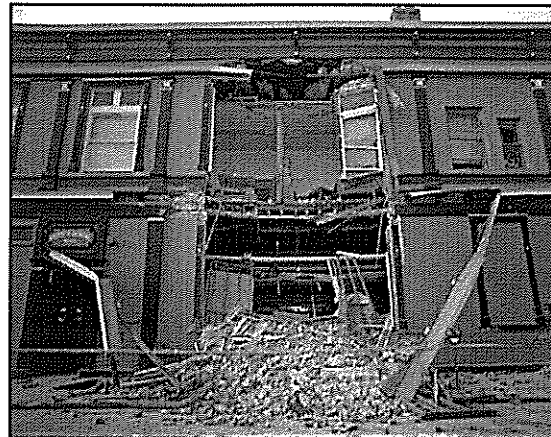
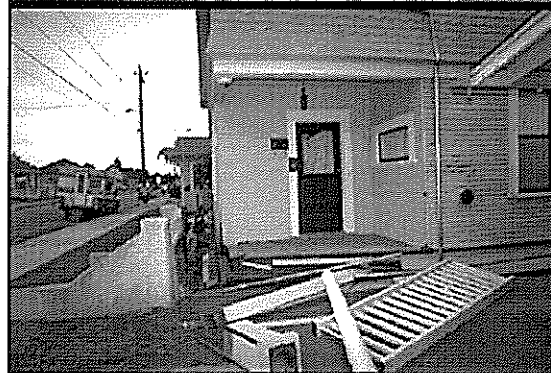
In earthquakes, unreinforced masonry buildings (top) are particularly vulnerable. Wood-frame buildings generally perform well, although an earthquake's lateral force may cause structures to separate from their foundations (the house in the bottom photo was originally positioned next to the stairway).

Buildings which can be considered dangerous have exterior parapets and ornamentation

subject to shaking loose in an earthquake, unanchored exterior walls or sheathing on roof or floors incapable of withstanding lateral loads. Structures exhibiting these characteristics have not been individually identified; however, owners of unreinforced masonry buildings constructed prior to 1933 should have the structures examined by a licensed engineer or architect and should undertake improvement of structures to ensure seismic safety. The Town's Municipal Code (Section 5.407) calls for the abatement of dangerous buildings as specified by the National Construction Codes. These buildings are a public nuisance which require either repair, rehabilitation, or demolition. When a property owner requests any kind of permit from the Town, his or her building will be evaluated for its safety. If the Town Building Official suspects the building to be unsafe, the Town will require the owner to have the building

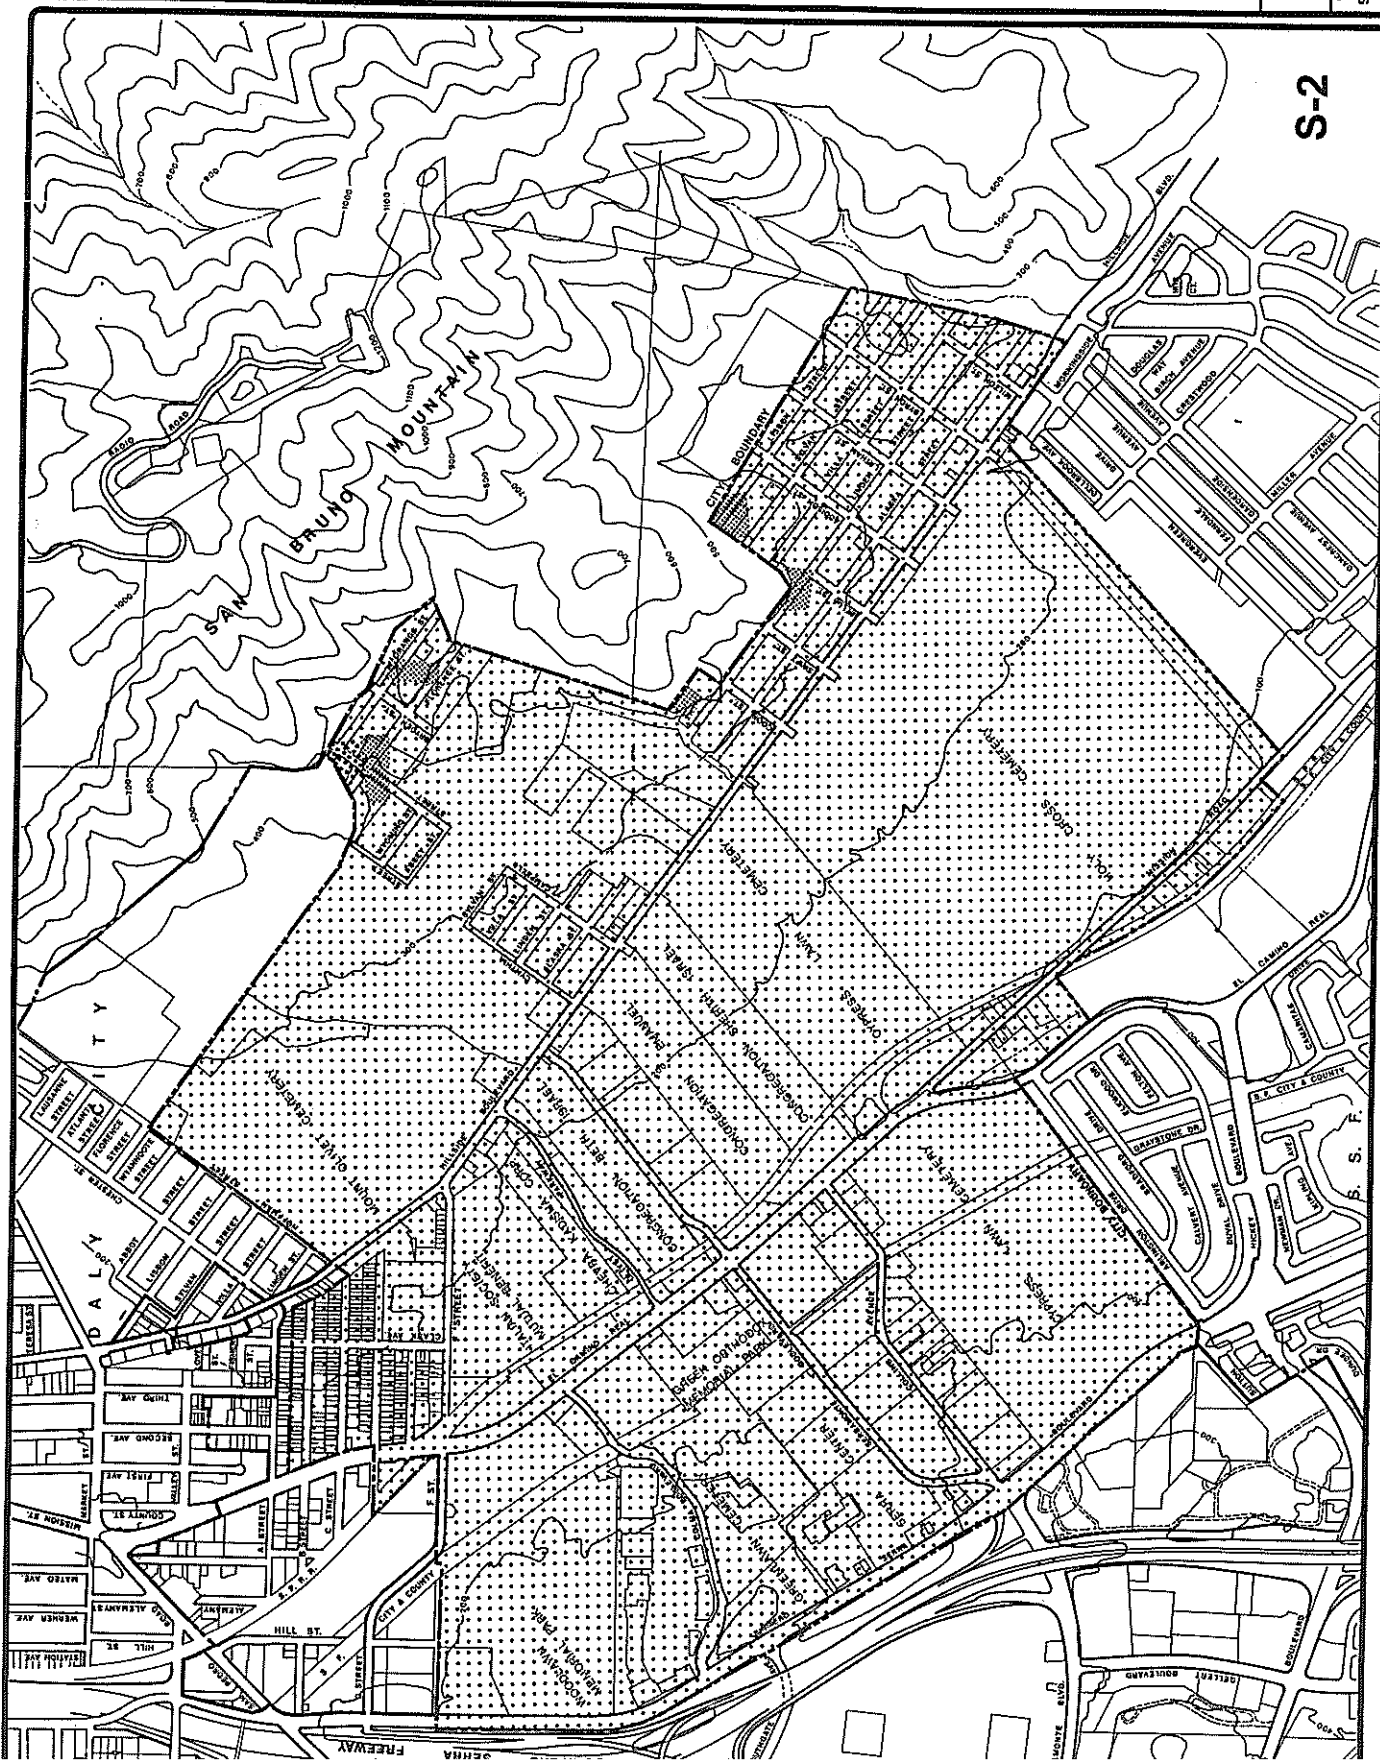
MALCOLM CARPENTER ASSOCIATES
CITY AND REGIONAL PLANNERS
SOURCE: U.S.G.S. Map 1-1257-H
6/99

depends upon a specific site's geology, topography, soil type, weather and intensity of development. The Geologic, Seismic-Shaking, and Hazards Maps (Exhibits S-1, S-2 and S-3) provide a basis for evaluating potential hazards in Colma and for requiring a geotechnical study or special engineering, architectural, or site design consideration. The seismic hazards are described below.

The primary effect of an earthquake which may be experienced in Colma is ground shaking that could last for up to one minute. The intensity of shaking is measured by the logarithmic Richter scale or rated using the modified Mercalli index. The shaking may cause sliding and tipping over of furniture, falling of objects from shelves, and collapse or partial collapse of weak masonry structures such as water tanks and chimneys. Table S-1 shows the amount of shaking that would occur in Colma from an earthquake, depending on the fault, and the probability of an earthquake occurring on a particular fault in the next 30 years. (When reviewing Table S-1, note that the 1989 Loma Prieta earthquake had a Richter Magnitude of 7.1).
