# Geotechnical Evaluation

## Mission Road Bicycle and Pedestrian Improvement Project Colma, California

Town of Colma  
1198 El Camino Real | Colma, California 94014

August 30, 2019 | Project No. 403573001

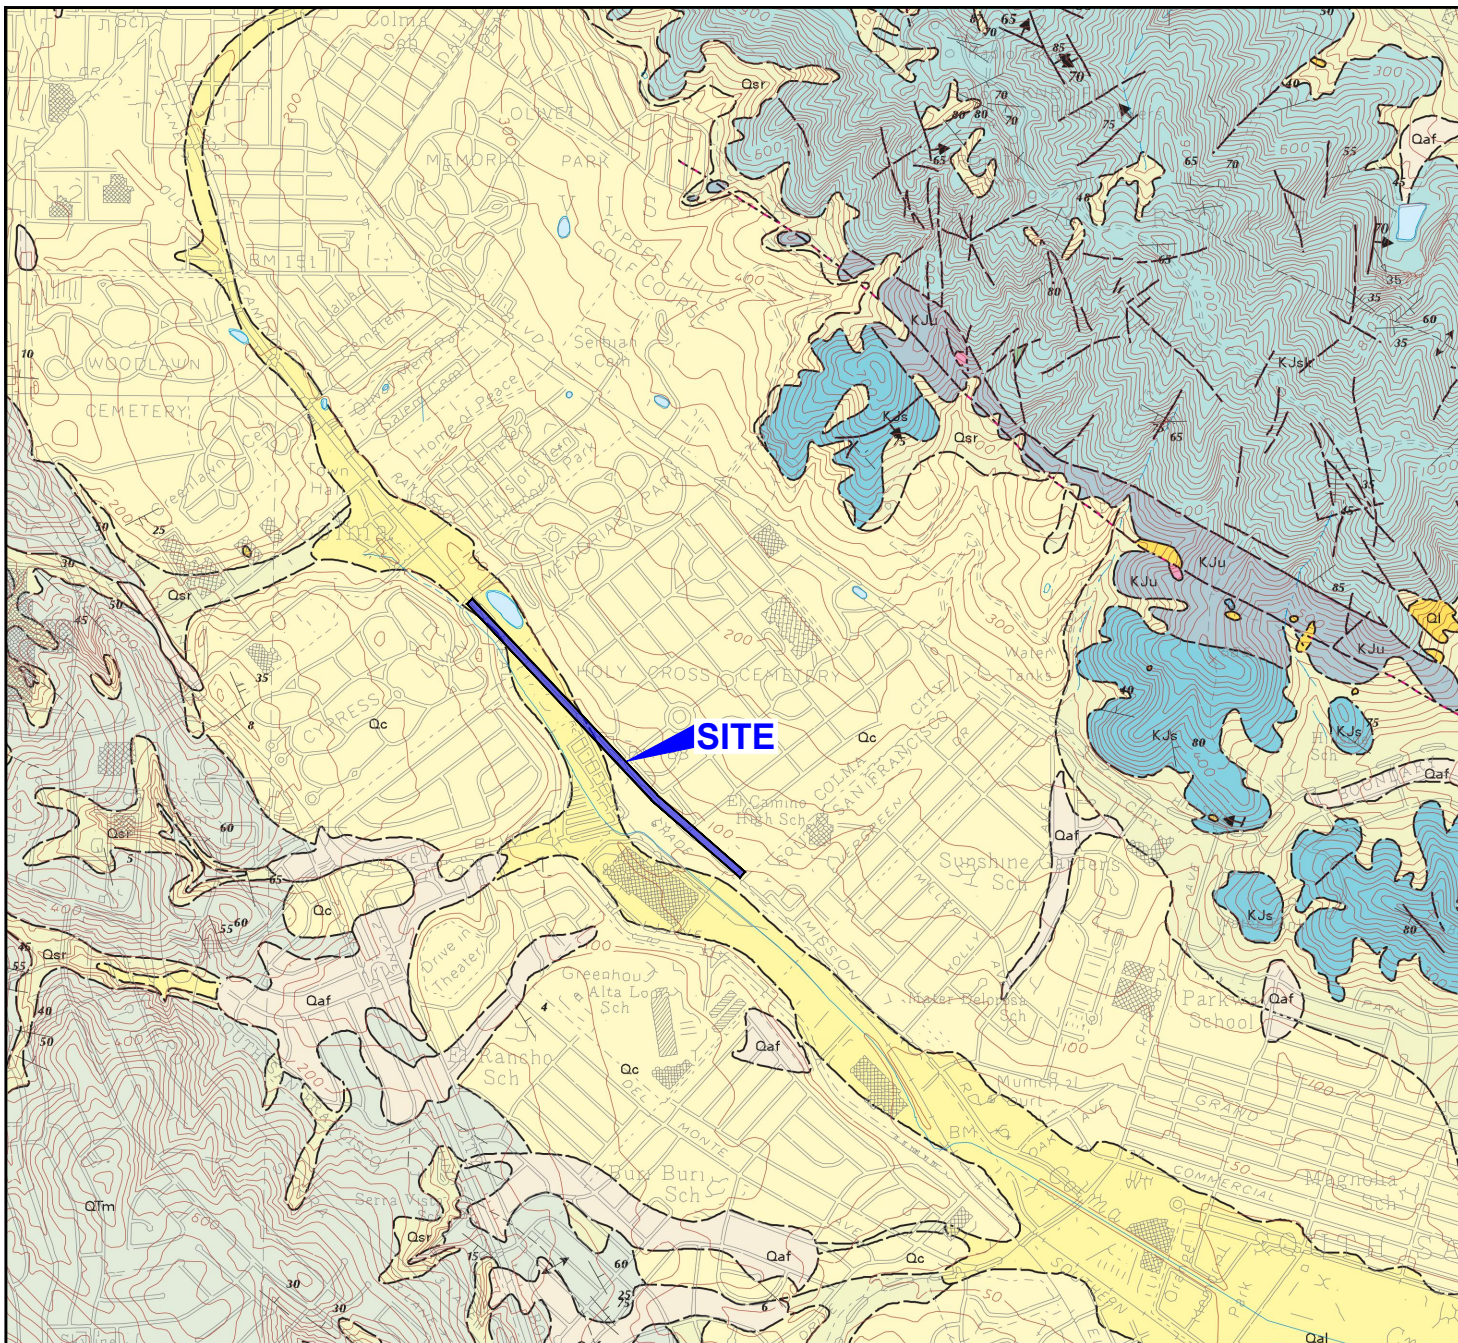
<b>Qaf</b> ARTIFICIAL FILL (HOLOCENE)	<b>Qc</b> COLMA FORMATION (PLEISTOCENE)	<b>KJg</b> GREENSTONE (CRETACEOUS & JURASSIC)	▲▲▲▲ THRUST FAULT
<b>Ql</b> LANDSLIDE DEPOSITS (HOLOCENE)	<b>Qtm</b> MERCED FORMATION (PLEISTOCENE & PIOCENE)	<b>sp</b> SERPENTINE (CRETACEOUS & JURASSIC)	—— FAULT
<b>Qal</b> ALLUVIUM (HOLOCENE)	<b>KJs</b> SANDSTONE & SHALE (CRETACEOUS & JURASSIC)	<b>KJu</b> SHEARED ROCKS (CRETACEOUS & JURASSIC)	- - - - GEOLOGIC CONTACT
<b>Qsr</b> SLOPE DEBRIS & RAVINE FILL (HOLOCENE)	<b>KJsk</b> SANDSTONE & SHALE WITH FELDSPAR (CRETACEOUS & JURASSIC)		—   — STRIKE AND DIP OF BEDDING

The campus is located west of San Francisco Bay in the Coast Ranges geomorphic province of California. The Coast Ranges are comprised of several mountain ranges and structural valleys formed by tectonic processes commonly found around the Circum-Pacific belt. Basement rocks have been sheared, faulted, metamorphosed, and uplifted, and are separated by thick blankets of Cretaceous and Cenozoic sediments that fill structural valleys and line continental margins. The San Francisco Bay Area has several ranges that trend northwest, parallel to major strike-slip faults such as the San Andreas, Hayward, and Calaveras. Major tectonic activity associated with these and other faults within this regional tectonic framework consists primarily of right-lateral, strike-slip movement.

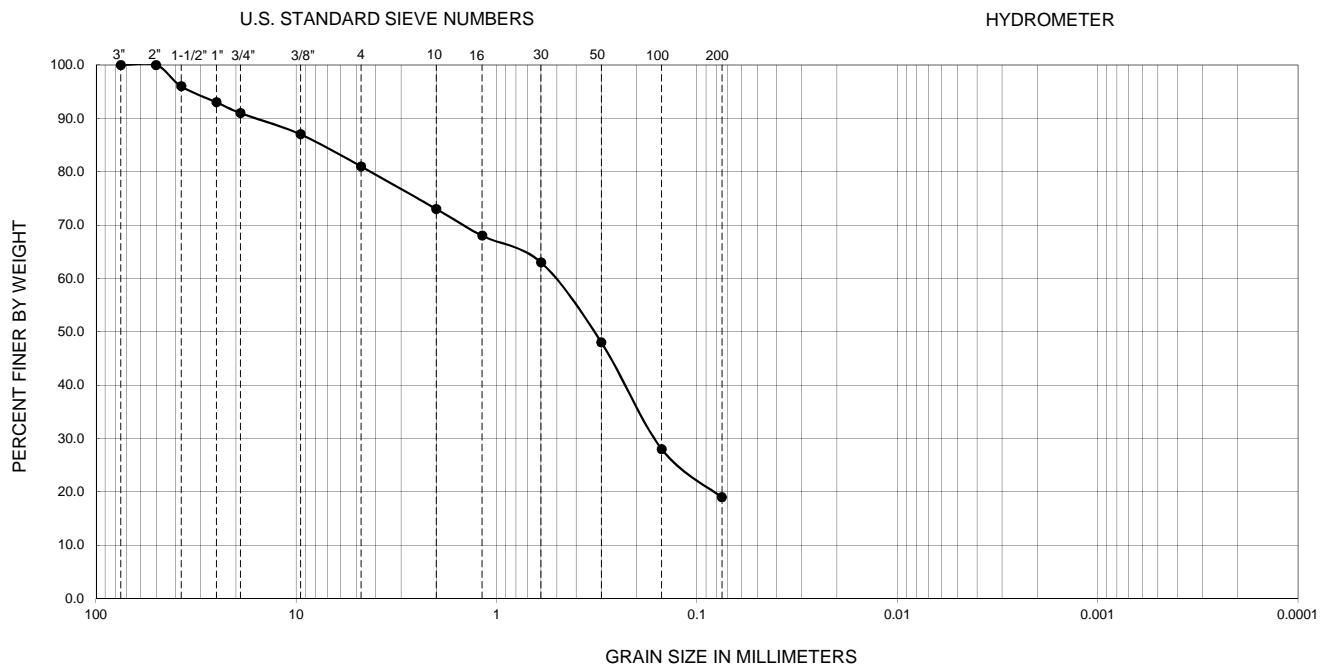
GRAVEL		SAND			FINES	
Coarse	Fine	Coarse	Medium	Fine	SILT	CLAY

Symbol	Sample Location	Depth (ft)	Liquid Limit	Plastic Limit	Plasticity Index	D <sub>10</sub>	D <sub>30</sub>	D <sub>60</sub>	C <sub>u</sub>	C <sub>c</sub>	Passing No. 200 (percent)	USCS
●	B-1	0.0-3.0	--	--	--	--	0.17	0.54	--	--	19	SM

PERFORMED IN ACCORDANCE WITH ASTM D 422 / D6913

Laboratory testing was performed on soil samples recovered from the borings to evaluate in-place moisture content, soil gradation, Atterberg limits, and soil corrosivity. The results of the in-place moisture content tests are shown at the corresponding sample depth on the boring logs in Appendix A. The results of the other laboratory tests performed are presented in Appendix B.

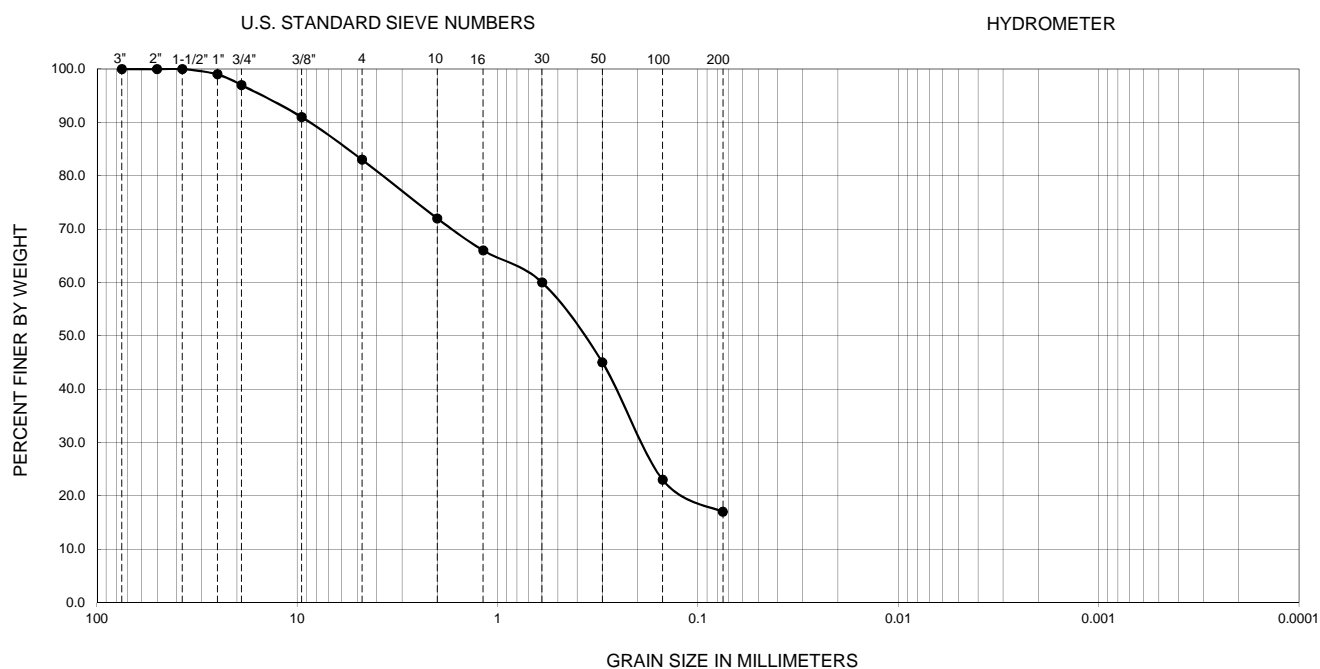
GRAVEL		SAND			FINES	
Coarse	Fine	Coarse	Medium	Fine	SILT	CLAY

Symbol	Sample Location	Depth (ft)	Liquid Limit	Plastic Limit	Plasticity Index	D <sub>10</sub>	D <sub>30</sub>	D <sub>60</sub>	C <sub>u</sub>	C <sub>c</sub>	Passing No. 200 (percent)	USCS
●	B-1	3.0-5.0	--	--	--	--	0.20	0.60	--	--	17	SM

PERFORMED IN ACCORDANCE WITH ASTM D 422 / D6913

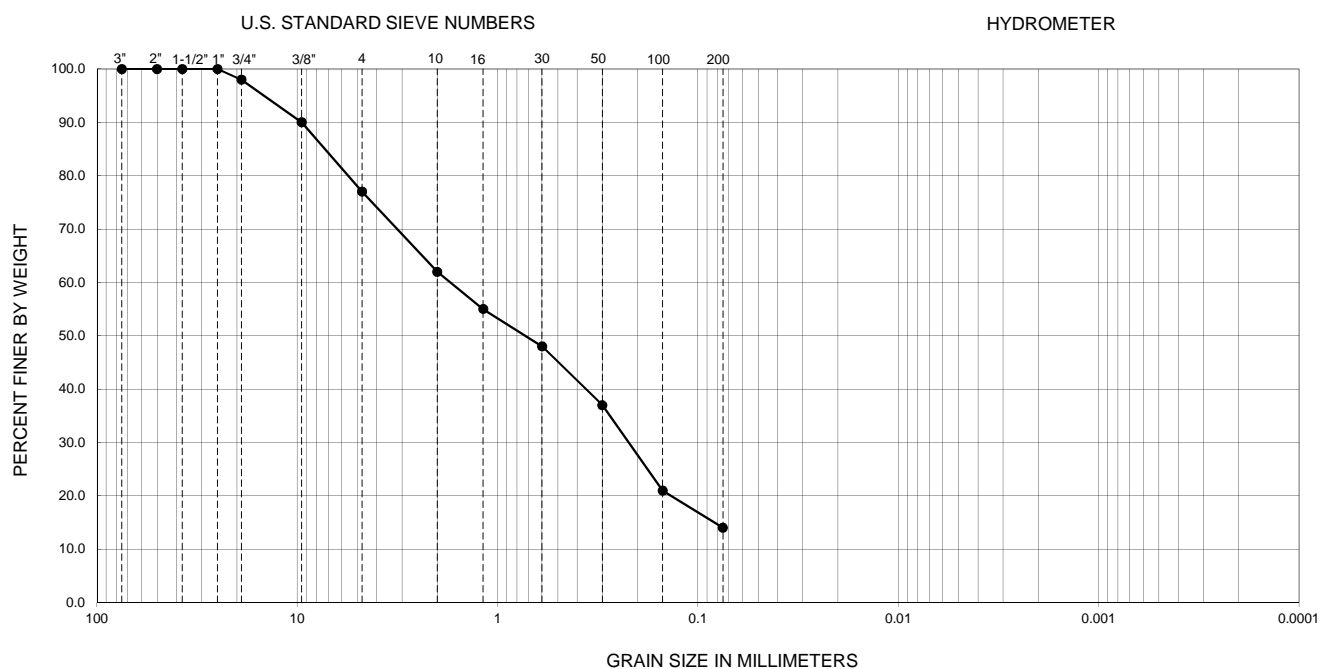
GRAVEL		SAND			FINES	
Coarse	Fine	Coarse	Medium	Fine	SILT	CLAY

Symbol	Sample Location	Depth (ft)	Liquid Limit	Plastic Limit	Plasticity Index	D <sub>10</sub>	D <sub>30</sub>	D <sub>60</sub>	C <sub>u</sub>	C <sub>c</sub>	Passing No. 200 (percent)	USCS
●	B-2	1.5-3.0	--	--	--	--	0.23	1.77	--	--	14	SM

PERFORMED IN ACCORDANCE WITH ASTM D 422 / D6913

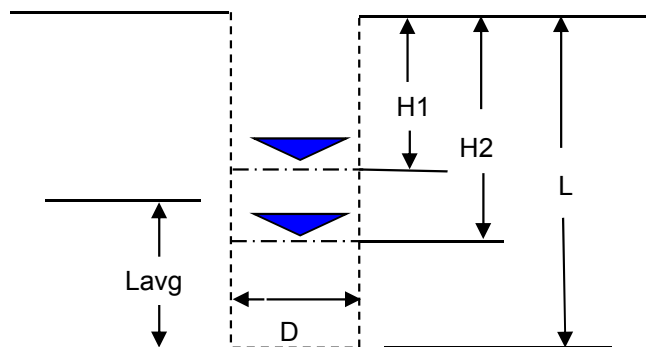
## FIGURE C-2: Percolation Test Data Sheet

Project =	MISSION ROAD IMPROVEMENT PROJECT		
Project No. =	403573001		
Depth of Test Hole, L (ft) =	2.5		
Diameter, D (in) =	7.0		
Initial Water Depth, d1 (in) =	24.0		
Average/Final Water Level Drop, $\Delta d$ (in) =	6.8		
Reduction factor, Rf =	6.9

Test Hole No.	Time (hr:min)	Elapsed Time (min)	Water Level (in)	Change in Water Level (in)	Time Interval (hour)	Pre-Adjusted Percolation Rate (inch/hour)	Adjusted Percolation Rate (inch/hour)
P-1	7:20		30.00				
	8:03	43.00	6.00	-24.00	0.72	33.5	4.86
	8:03		24.00				
	8:18	15.00	15.00	-9.00	0.25	36.0	5.22
	8:19		24.00				
	8:34	15.00	16.50	-7.50	0.25	30.0	4.35
	8:37		24.00				
	8:52	15.00	17.25	-6.75	0.25	27.0	3.92
	8:54		24.00				
	9:09	15.00	17.25	-6.75	0.25	27.0	3.92
	9:10		24.00				
	9:25	15.00	17.25	-6.75	0.25	27.0	3.92
	9:26		24.00				
	9:41	15.00	17.25	-6.75	0.25	27.0	3.92
	9:42		24.00				
	9:57	15.00	17.25	-6.75	0.25	27.0	3.92
	10:00		24.00				
	10:15	15.00	17.25	-6.75	0.25	27.0	3.92
	10:16		24.00				
	10:31	15.00	17.25	-6.75	0.25	27.0	3.92

$d1 = L - H1$  (in inches)

Ninyo & Moore performed percolation testing to evaluate the rate of infiltration on site for design of bioretention systems. The percolation test procedures utilized are presented in Appendix C. The test results, presented in Appendix C and summarized in Table 1, indicate that the infiltration rate of the near surface soil on site is relatively fast and consistent with Hydrologic Soil Group A. Due to the variability of subsurface materials encountered during our exploration, variability in subsurface infiltration should be anticipated.

Test	Test Depth (inches)	Subsurface Conditions	Percolation Rate (inches/hour)	Infiltration Rate <sup>1</sup> (inches/hour)
P-1	30	Silty SAND	27.0	3.92
P-2	30	Silty SAND	32.0	4.00
