**TOWN OF FAIRFAX
STAFF REPORT**
Department of Planning and Building Services

TO: Fairfax Planning Commission
DATE: April 26, 2017
FROM: Michelle Levenson, Zoning Technician
LOCATION: 145 Forrest Avenue; Assessor' Parcel No. 002-192-38
ZONING: Residential RS 6 Zone
PROJECT: Renovate a Single-Family Residence and Remove an Unauthorized Retaining Wall and Vehicle Pull-Out
ACTION: Application No. 16-35; Conditional Use Permit
APPLICANT: Erick Mikiten, Mikiten Architecture
OWNER: Vakil Kuner
CEQA STATUS: Categorically Exempt, §15301(a)

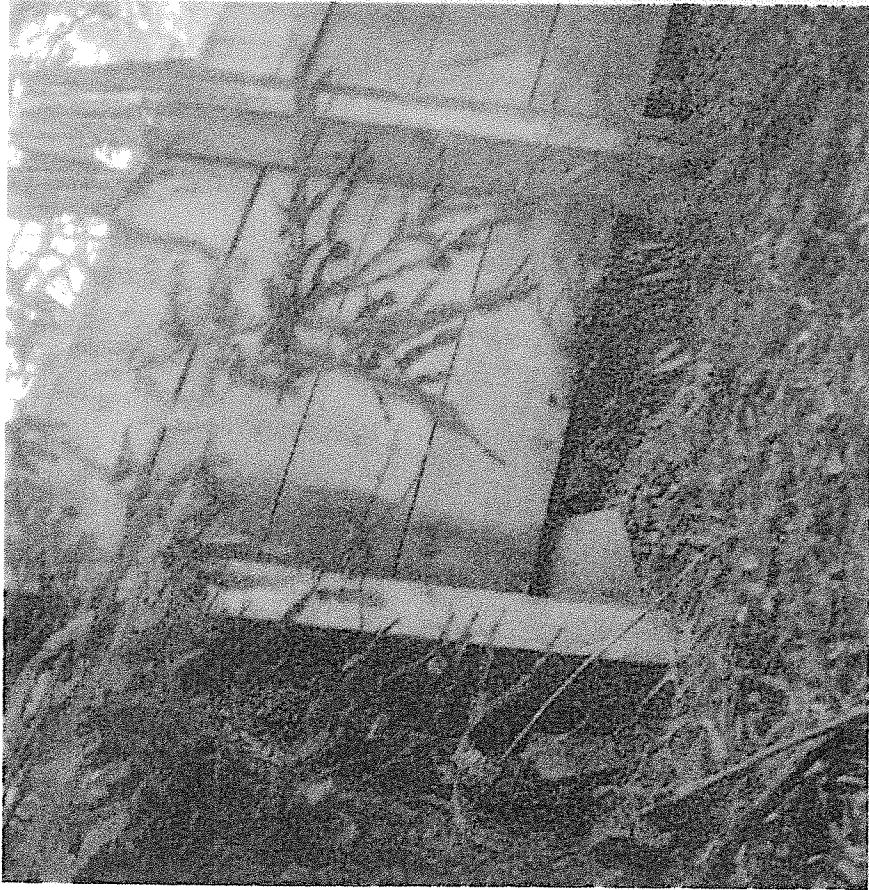
Photo 1: Retaining wall tilting to the west (driveway above)

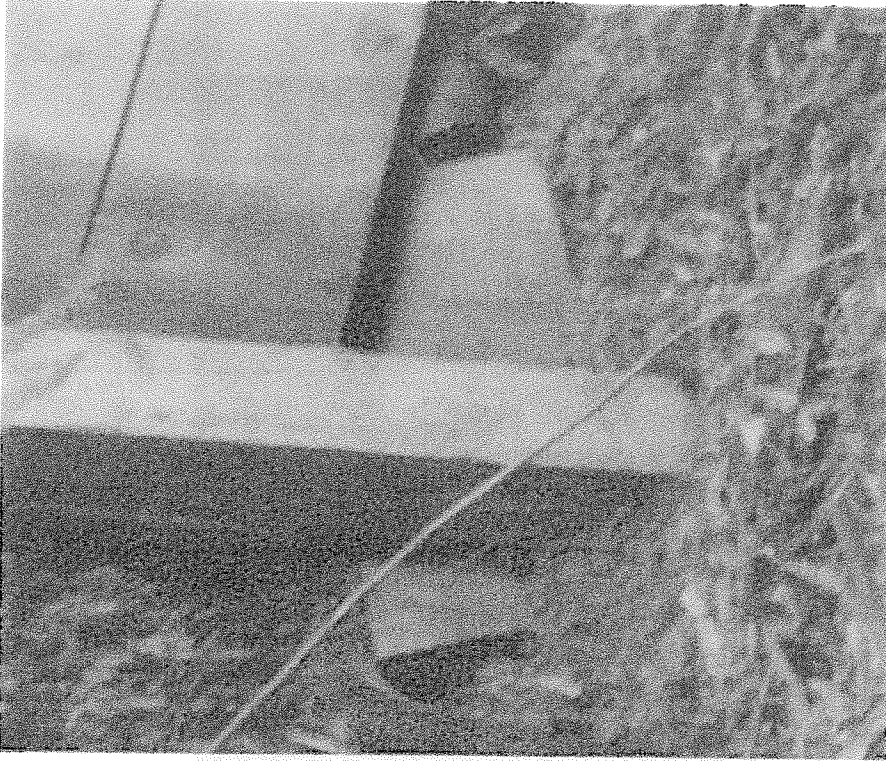
Photo 2: Compromised base of wall. Note exposed open-ended drainage pipe.

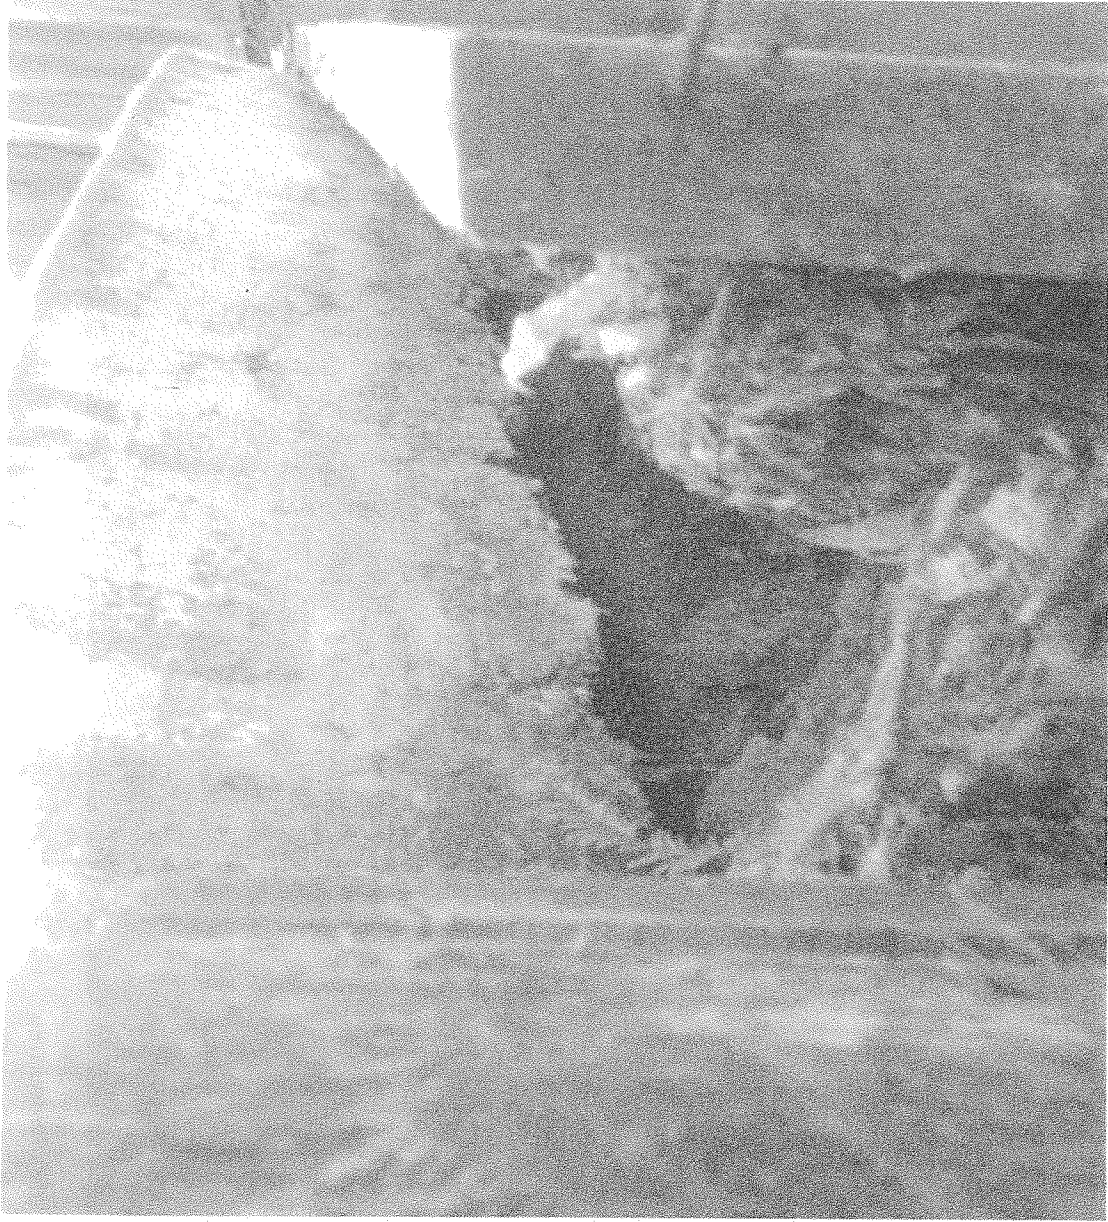
Photo 5: Deteriorated wall.

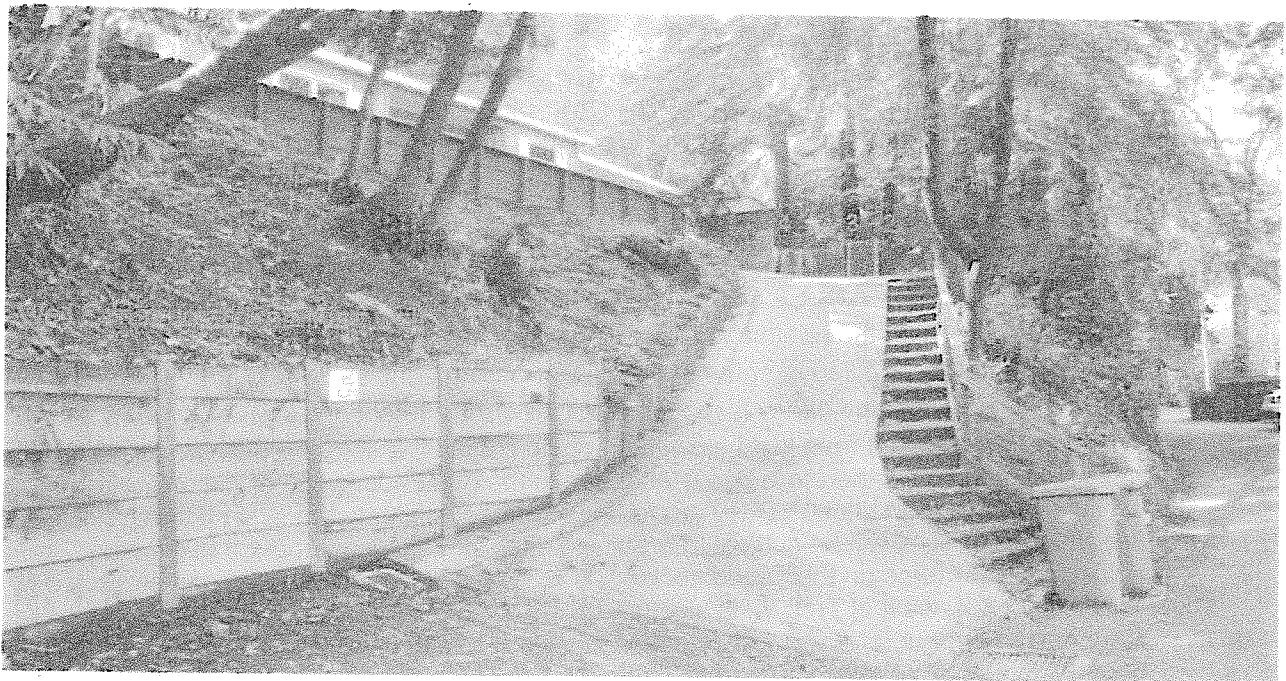
The subject trees support the cut bank of the road between the 145 driveway and Forrest Ave.

Trees 1, 2, 3 & 4 have been employed as retaining wall supports which threatens both the trees and the walls.

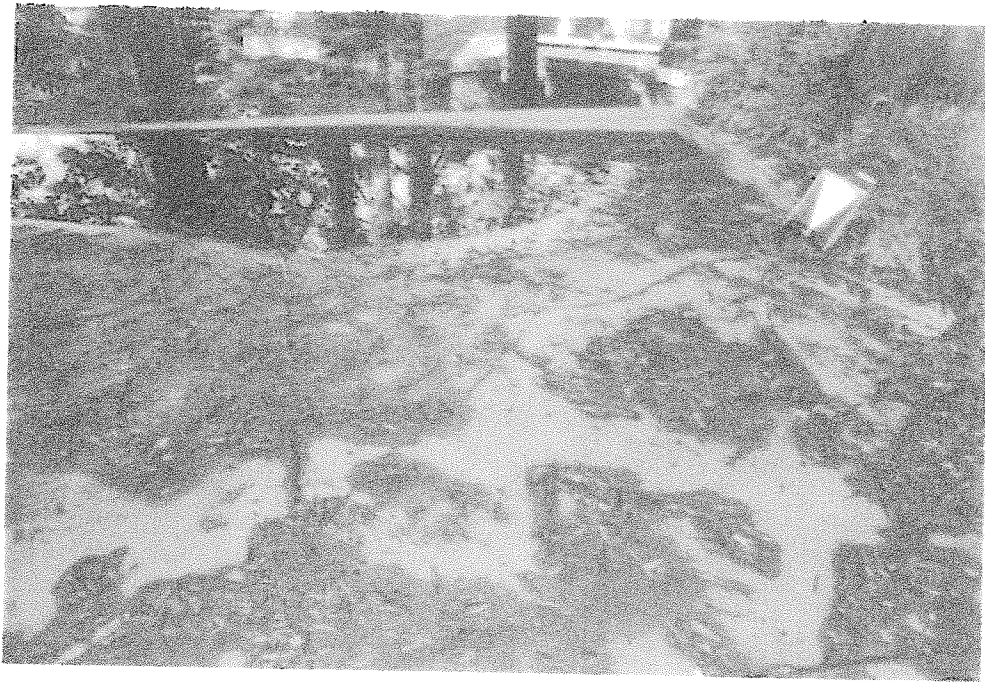
The failing parking turnout. Tree #1 is shown in the upper right hand corner just 5" from the slab.
Tree #1

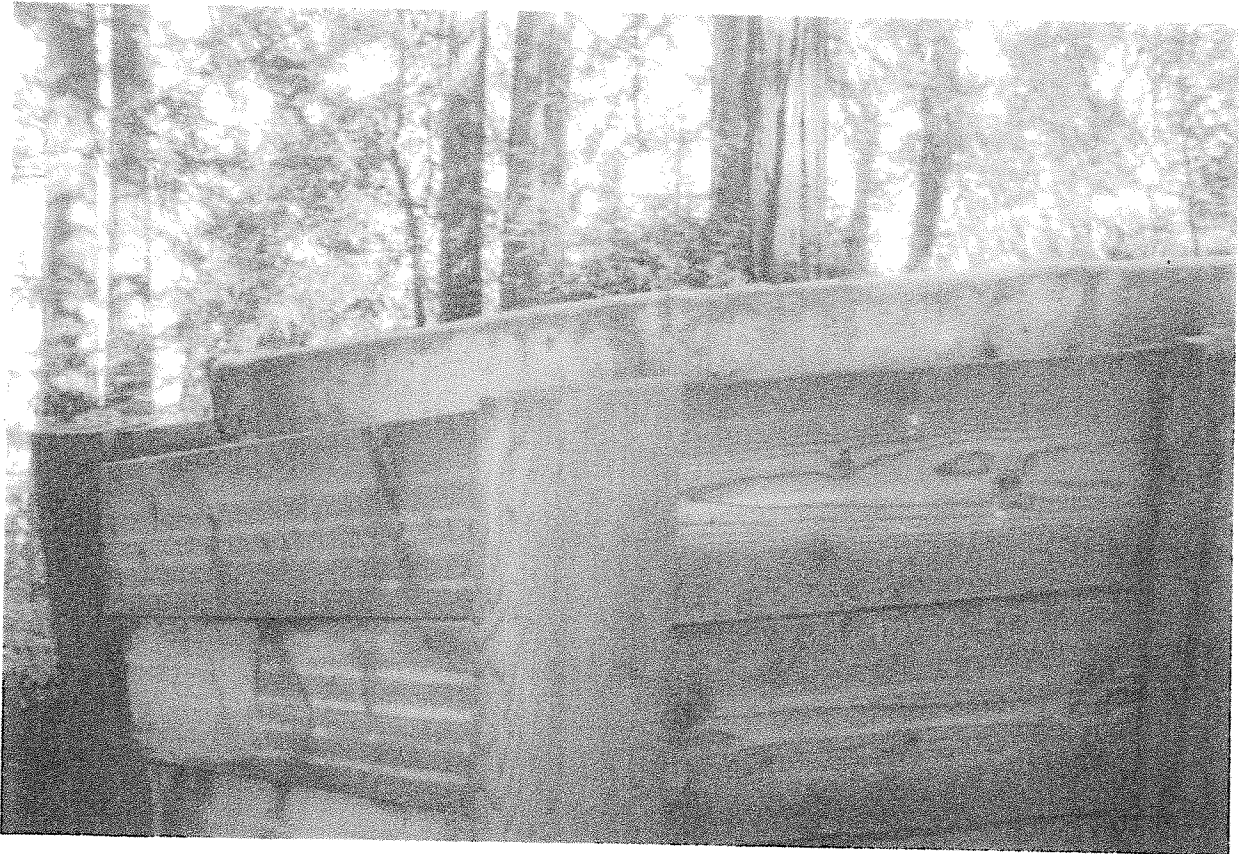
The failing retaining wall above Trees #5 and 6. Failure of the wall and fill soil will impact Trees #5 and 6.

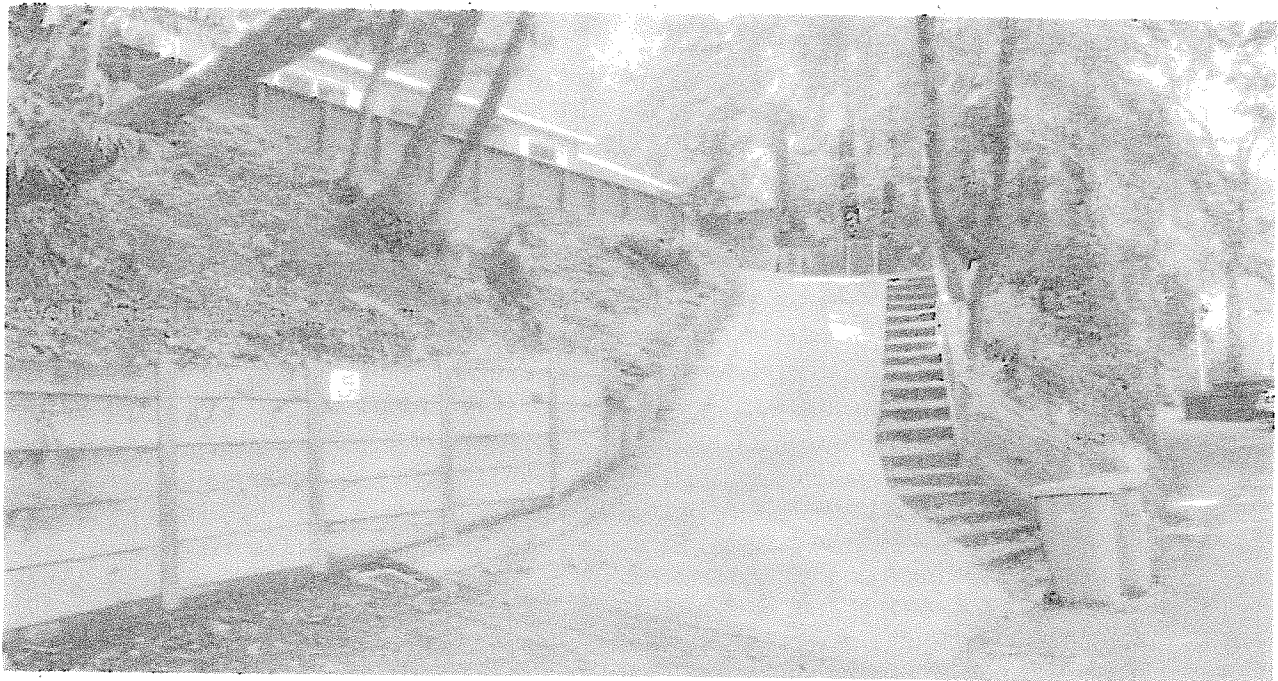
The subject trees support the cut bank of the road between the 145 driveway and Forrest Ave.

Trees 1, 2, 3 & 4 have been employed as retaining wall supports which threatens both the trees and the walls.

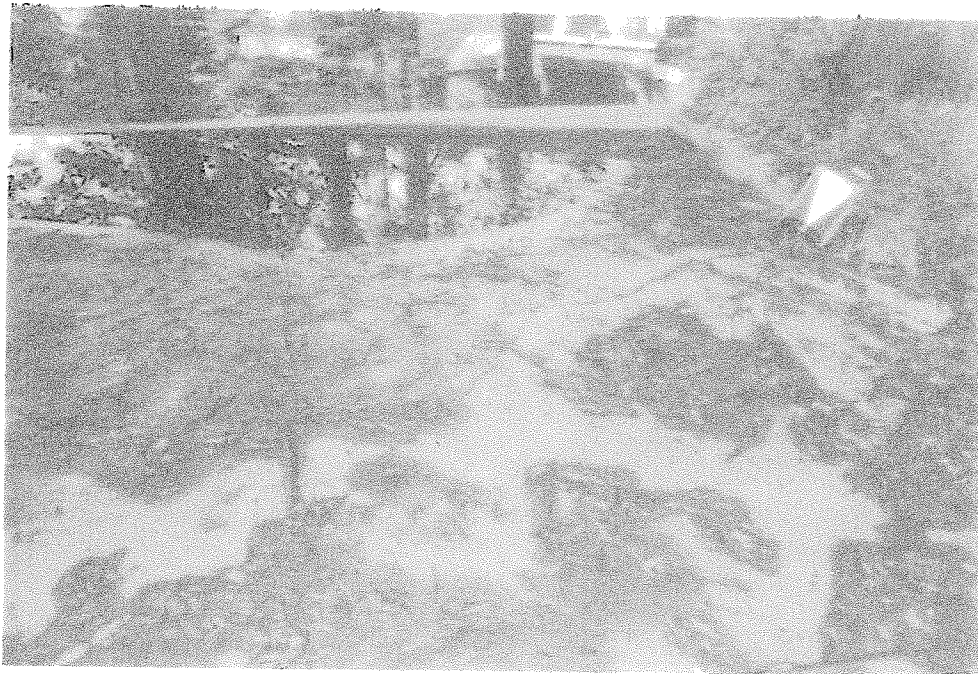
The failing parking turnout. Tree #1 is shown in the upper right hand corner just 5" from the slab.
Tree #1

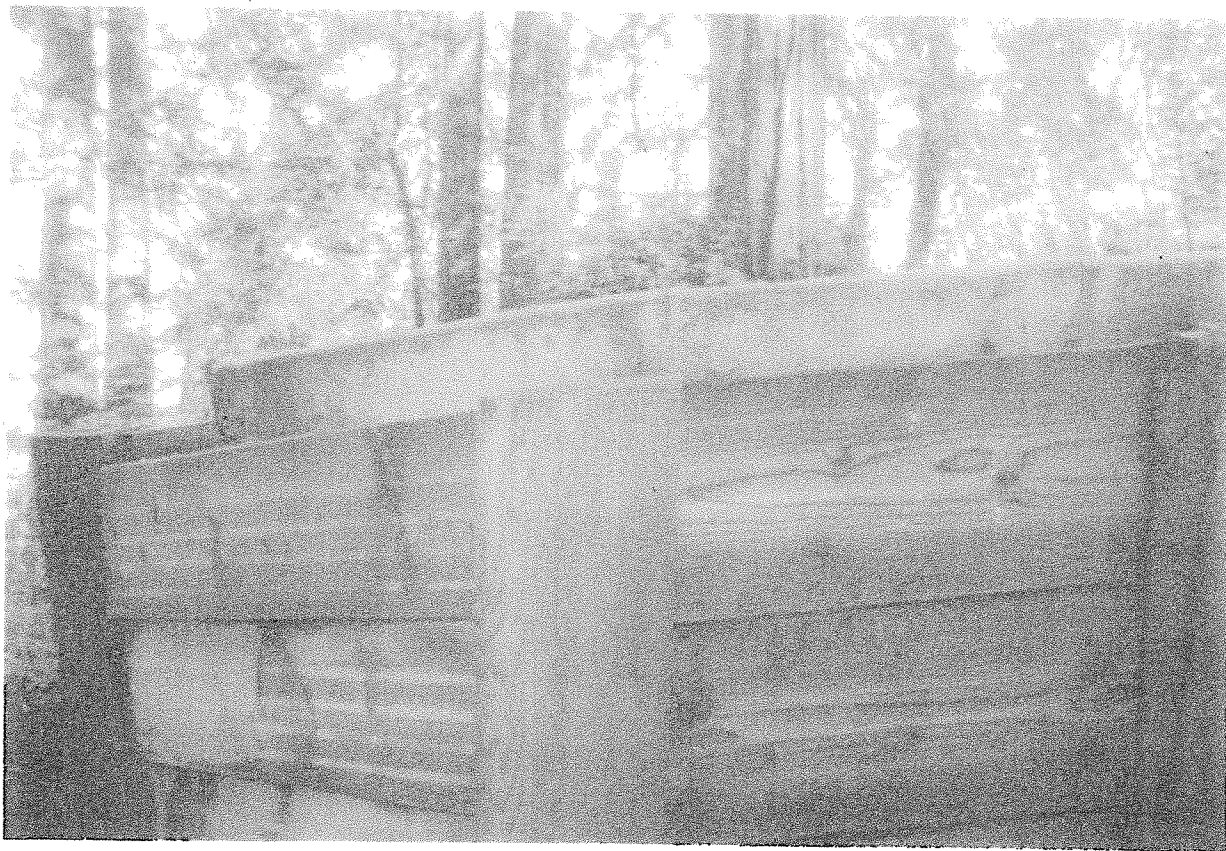
The failing retaining wall above Trees #5 and 6. Failure of the wall and fill soil will impact Trees #5 and 6.
