**TOWN OF FAIRFAX
STAFF REPORT
Department of Planning and Building Services**

TO: Fairfax Planning Commission
DATE: May 19, 2016
FROM: Jim Moore, Director of Planning and Building Services
Linda Neal, Principal Planner
LOCATION: 118 Tamalpais Road; Assessor's Parcel No. 001-121-61
ZONING: Residential RS-6 Zone
PROJECT: Construction of front access stairway to residence
ACTION: Side-yard Setback Variance and Encroachment Permit;
Application # 16-20
APPLICANT: Nick Rasic
OWNER: Federal National Mortgage Association
CEQA STATUS: Categorically Exempt, § 15302 and 15305(a)

GENERAL PLAN
PROPOSED DRILLED I-BEAM
RETAINING WALL
STAIRWAY ACCESS CUT
118 TAMALPAIS RD
FAIRFAX, CA
FOR AMERICAN LAND SURVEYING

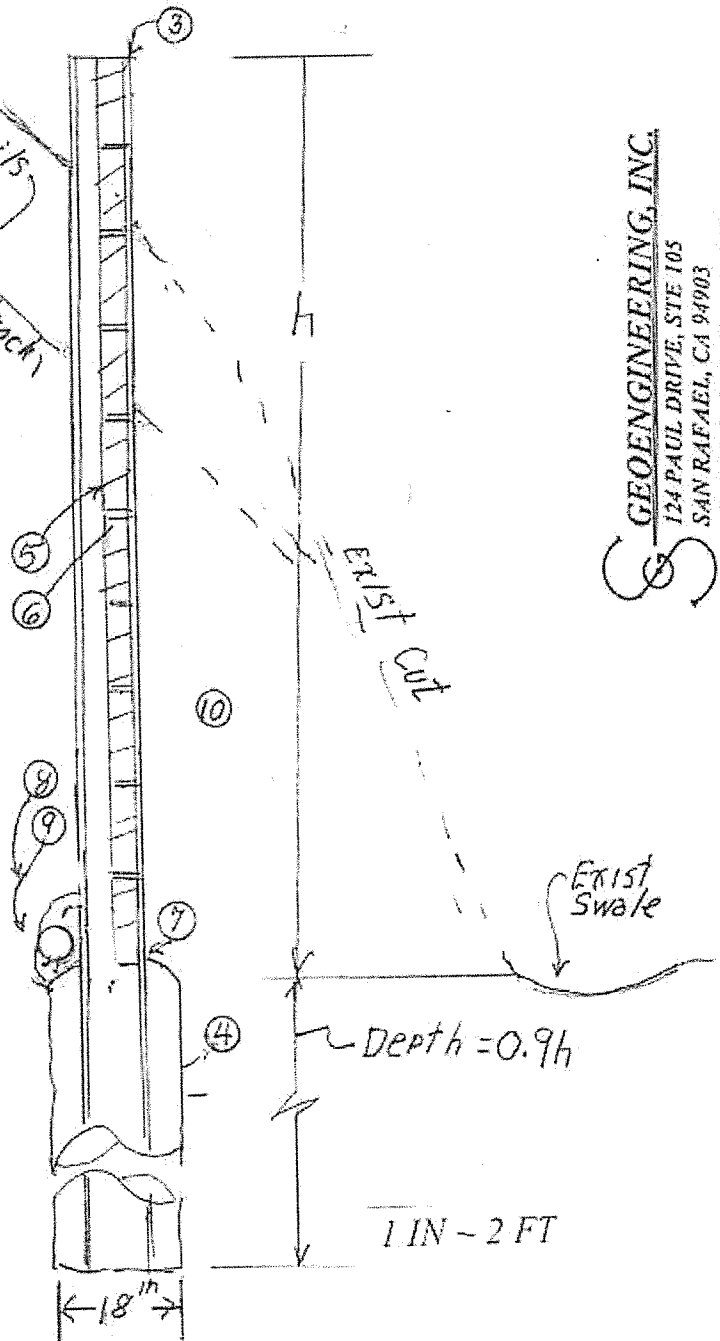
colluvial Soils
(weathered Bedrock)

TYPICAL SECTION
 PROPOSED DRILLED I-BEAM
 RETAINING WALL
 STAIRWAY ACCESS CUT
 118 TAMALPAIS RD
 FAIRFAX, CA
 FOR AMERICAN LAND SURVEYING

The applicant has submitted a geotechnical report prepared by Geoengineering, Inc., that indicates that a retaining wall engineered and designed to support the cut hillside and accommodate the new stairway requires piers drilled to a depth of 9 feet. (Attachment C). The retaining wall has been designed with piers that would be 12 ½ feet deep exceeding the depth recommended by the geotechnical engineer (Page 5 of the Plans, Section A).
