**TOWN OF FAIRFAX  
STAFF REPORT**  
Department of Planning and Building Services

**TO:** Fairfax Planning Commission  
**DATE:** December 19, 2019  
**FROM:** Linda Neal, Principal Planner  
**LOCATION:** 78 Bay Road; Assessor's Parcel No. 001-093-21  
**PROJECT:** New single-family residence and existing driveway improvements  
**ACTION:** Hill Area Residential Development, Excavation and Design Review permits; Application # 19-16  
**APPLICANT:** Leyla Hilmi, Designer  
**OWNER:** Ann Lockhart and Ted Bender  
**CEQA STATUS:** Categorically exempt, §15303(a)

**78 BAY ROAD**

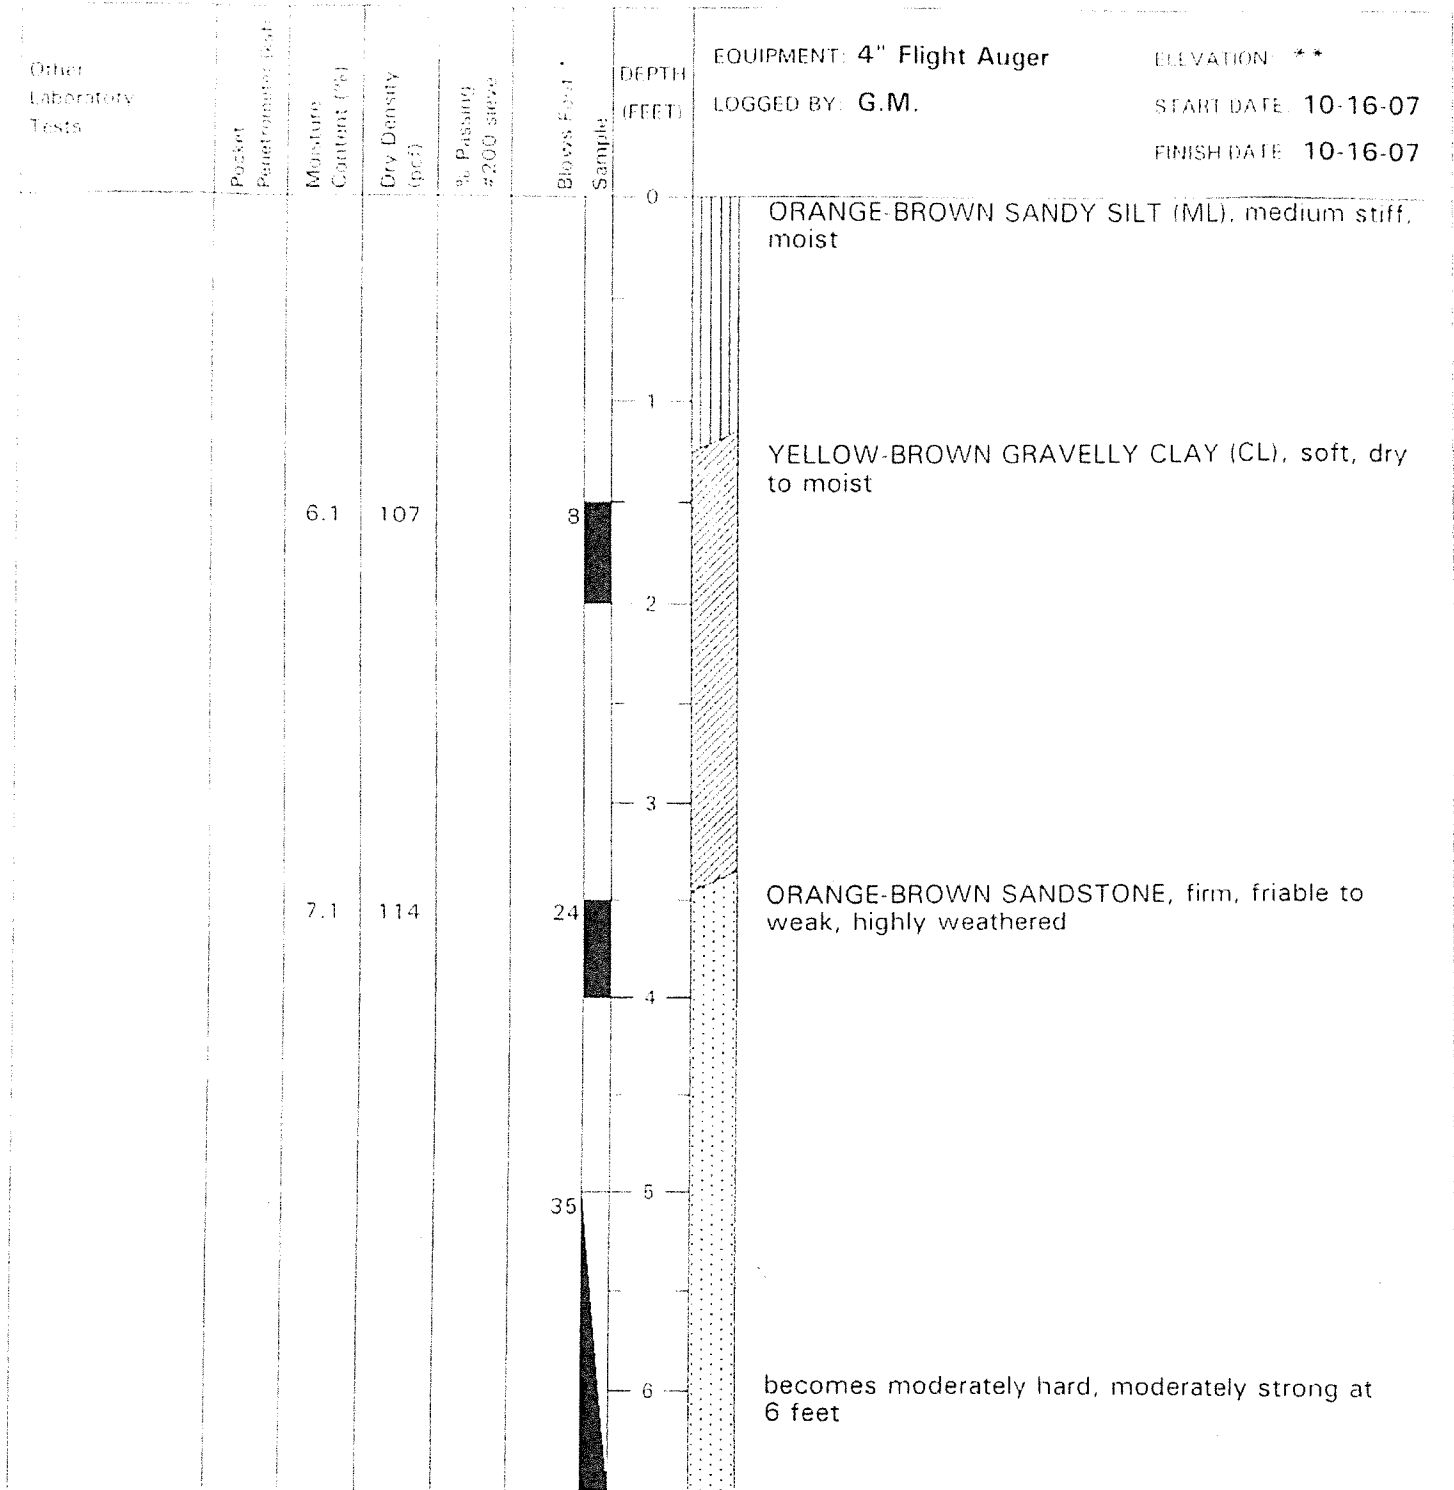
BOTTOM OF BORING 1 @ 6.5 FEET  
No Free Water Encountered

\* Converted to equivalent standard penetration blow counts.  
 \*\* Existing ground surface at time of drilling.
