**TOWN OF FAIRFAX
STAFF REPORT**
Department of Planning and Building Services

TO: Planning Commission
DATE: May 20, 2021
FROM: Linda Neal, Principal Planner
LOCATION: 500 Bolinas Road; APN # 002-051-03
PROJECT: Reconstruction/expansion of existing wrap around deck
ACTION: Use Permit and Tree Removal Application; Application # 21-08
APPLICANT: Brian Farnsworth, Architect
OWNER: Linda Anderson/Jamie Taylor
CEQA STATUS: Categorical exemption, § 15301(e)(1)

500 BOLINAS ROAD

**Arborist Report
500 Bolinas Rd
Fairfax, CA**

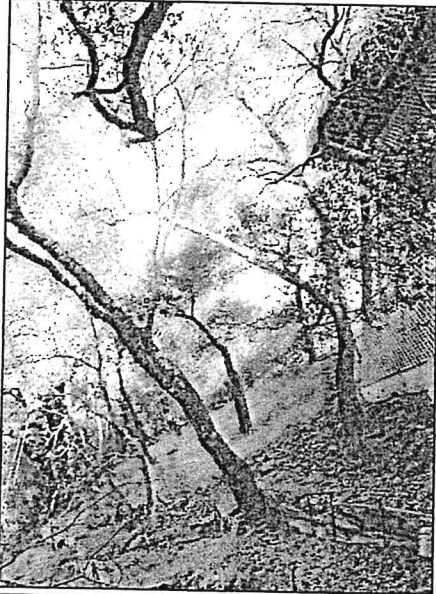
Photo 1 (left top). Coast live oak #4 (right) had lost the central leader and tree #5 (left) was leaning northwest.

or leaders, cavities at the base and stems that bowed or grew horizontally (Photo 1). In addition, live oak #19 had failed at the base? into the other trees in the vicinity (Photo 2).

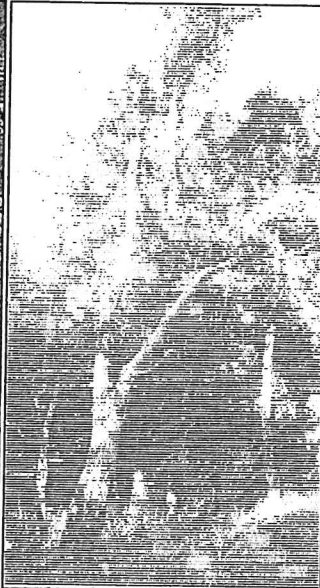
Photo 2 (right top). Live oak #19 had failed into adjacent trees.

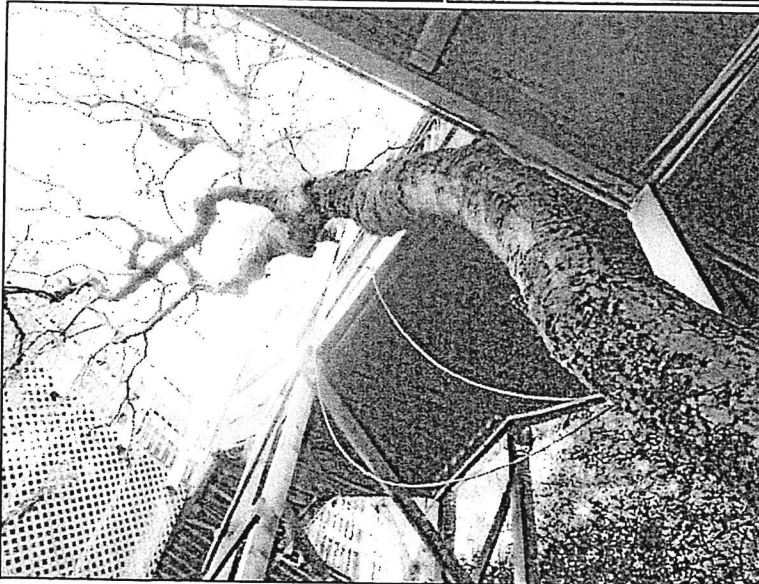
Photo 3 (bottom). California buckeye #2 was growing out of a retaining wall and out from under the stairs connecting the house to the parking area. Additionally, the tree had a large basal cavity with decay.

tree #35 (6-inches) was in poor condition. Tree #2 was growing out from under the deck through a crack in a retaining wall (Photo 4). It had a large cavity with decay at the base. Tree #35 had a sweeping trunk and a cavity over the main branch attachment.

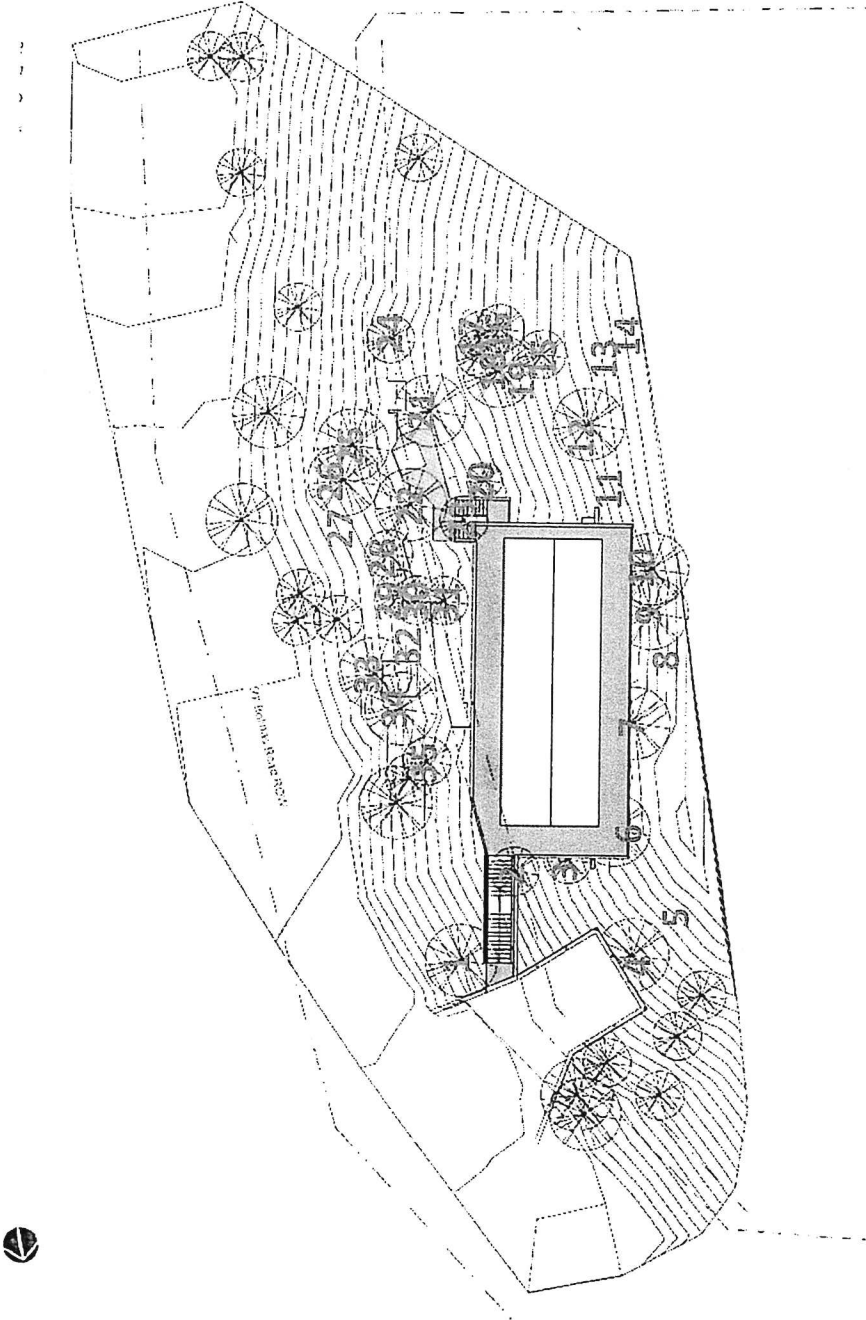
Tree Assessment

Base map provided by:
Brian Farnsworth, Architect

Numbered tree locations are approximate

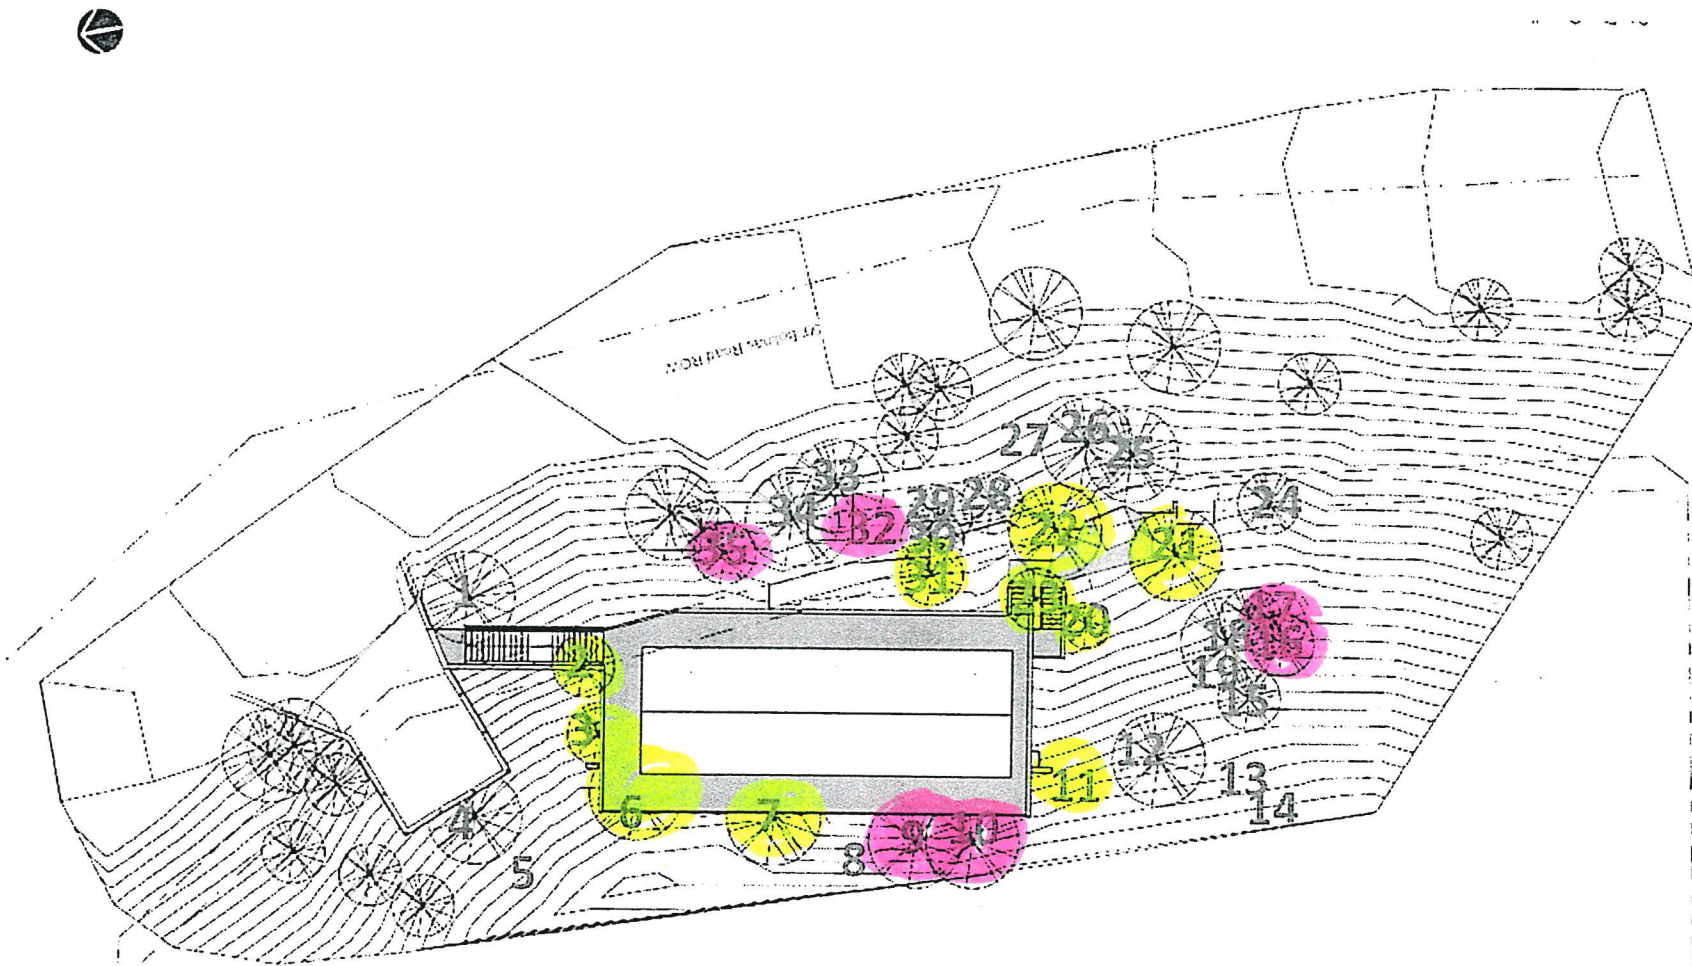
= TREES COMING OUT FOR PROJECT

Construction of the deck will require the removal of 16 trees – ten oaks, four bays and two buckeyes. Ten of the trees are being removed because they will interfere with the deck construction and the other six are being removed because their removal was recommended by the project arborist due to their poor health or due to their being non-fire-resistant species. The Fairfax Tree Committee reviewed the tree removal permit and voted unanimously to recommend that the Planning Commission approve the requested tree removal permit subject to the ten oak trees being replaced somewhere on the site with fire resistant trees.
