Project Number: 4999.01.04.1

Geotechnical Review
Grading Plans
Quirie Residence
12 Barker Avenue
Fairfax, California

This report presents the results of our geotechnical study for the residence and other improvements to be constructed at 12 Barker Avenue in Fairfax, California. The undeveloped property extends over gently to steeply sloping terrain and contains a dirt access road. The site location is shown on Plate 1, Appendix A.

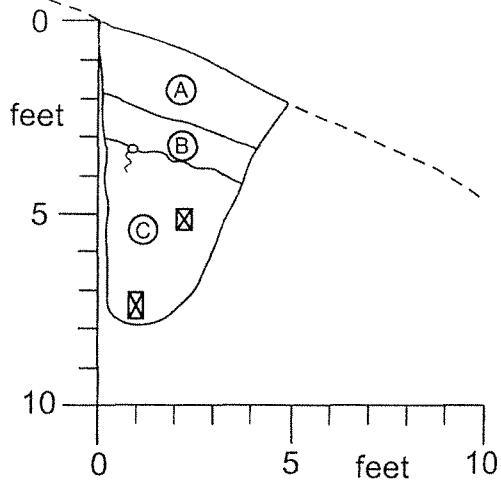
ADU, Driveway, Wall

- (A) BROWN CLAY (CL), soft, wet; porous, abundant large roots
- (B) ORANGE-BROWN SHALE, soft, plastic, completely weathered to clay (CH)
- (C) DARK BROWN SHALE, pervasively sheared, soft, plastic to friable, highly weathered

Minor seepage at 3', no caving

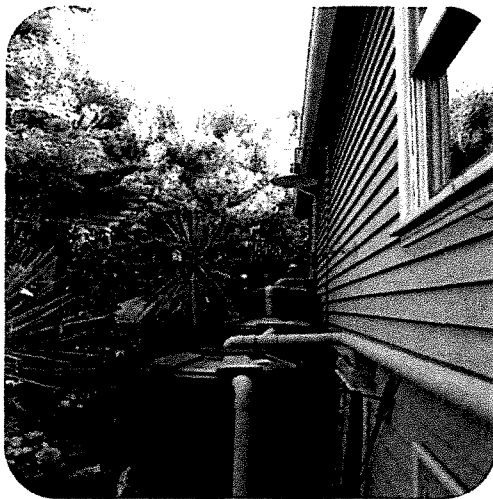
Daisy chained system of 205-gallon rain barrels
 Courtesy of The City of Oakland

Rain barrels and cisterns can be installed to capture stormwater runoff from rooftops and store it for later use. They are low-cost systems that will allow you to supplement your water supply with a sustainable source and help preserve local watersheds by detaining rainfall.

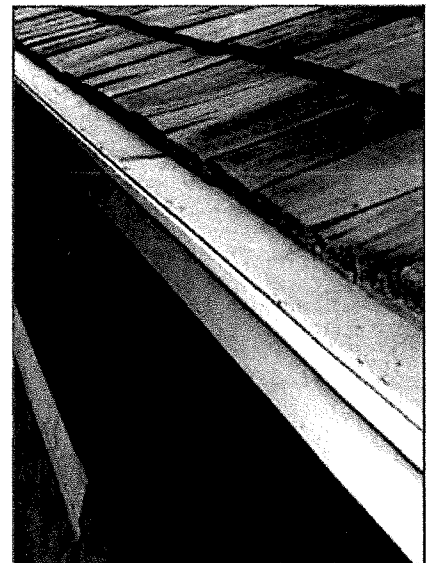
This gutter is covered by a fine mesh gutter guard to keep debris out.
Courtesy of Gutter Glove

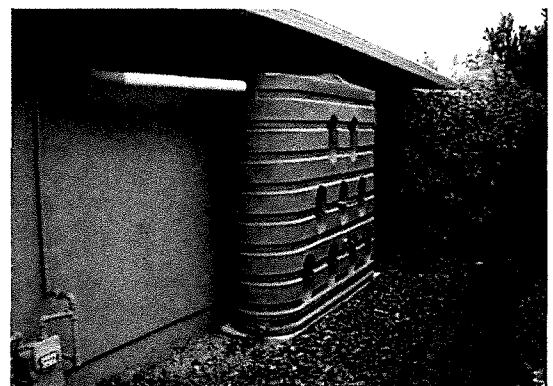
Large unit installed at a single family residence.

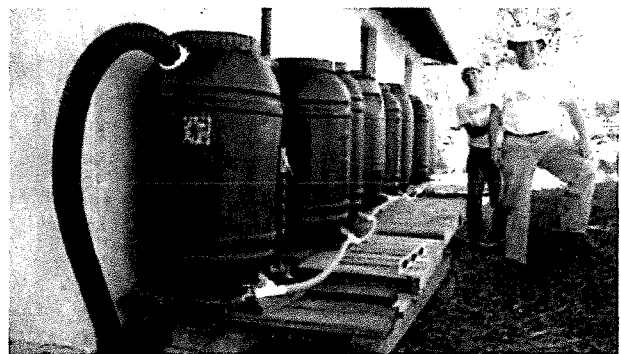
Daisy-chained system
Courtesy of Acterra
