# Appendix G Geotechnical Report

**DRAFT** GEOTECHNICAL STUDY  
PROPOSED COSTCO WHOLESALE WAREHOUSE  
SIERRA COLLEGE BOULEVARD AND  
BRACE ROAD  
LOOMIS, CALIFORNIA  
CW# 16-0132  
KLEINFELDER PROJECT NO. 20173273.001A

This report presents the results of our geotechnical study for the proposed Costco Wholesale Warehouse (CW# 16-0132) located southeast of the intersection of Sierra College Boulevard and Brace Road in Loomis, California. The purpose of our study was to evaluate soil and groundwater conditions beneath the site and provide geotechnical recommendations for design and construction. We based our study on the Costco Wholesale Development Requirements (CWDRs), Version 2016, dated September 19, 2016. The site is currently very wet with perched groundwater near the ground surface and the planned infiltration tests could not be performed. However, based upon subsurface soil conditions, these tests are no longer considered necessary and, therefore, will not be performed.

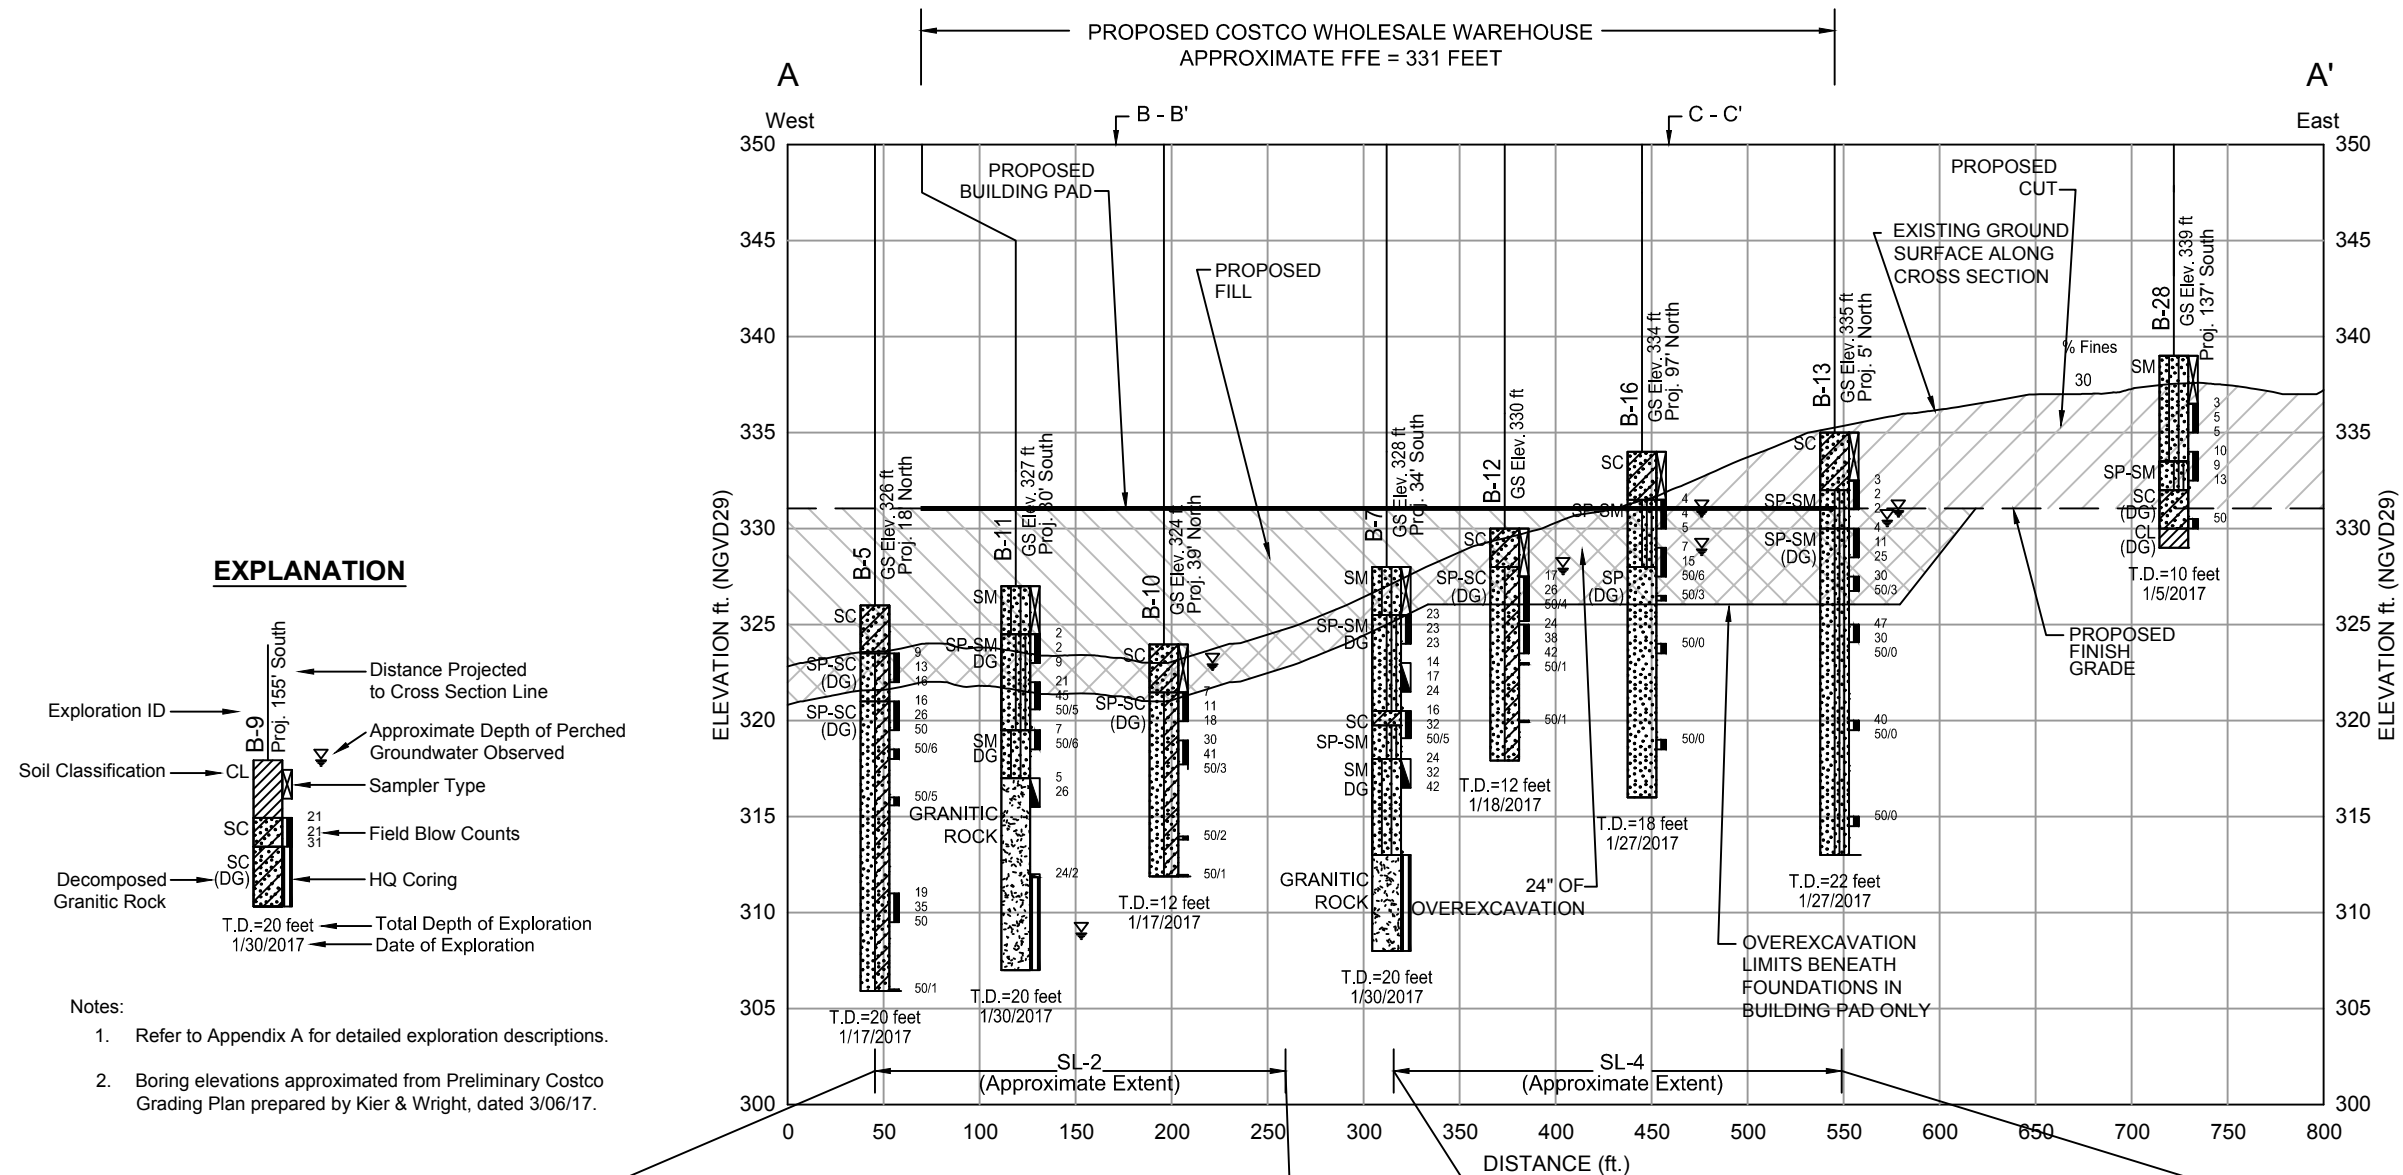
**2**

Perched water was encountered in a majority of our borings and test pits as shallow as 1 foot. Portions of the site had ponded surface water with small stream flowing through the low area in the middle of the site to a culvert beneath Sierra College Boulevard. This surface water infiltrated the near surface soils, collected on less permeable soil and rock at shallow depth, was observed seeping into the test pit excavations, and was encountered in the soil borings at various depths. The approximate locations of the borings and test pits are presented on Figure 2, Exploration Location Plan.

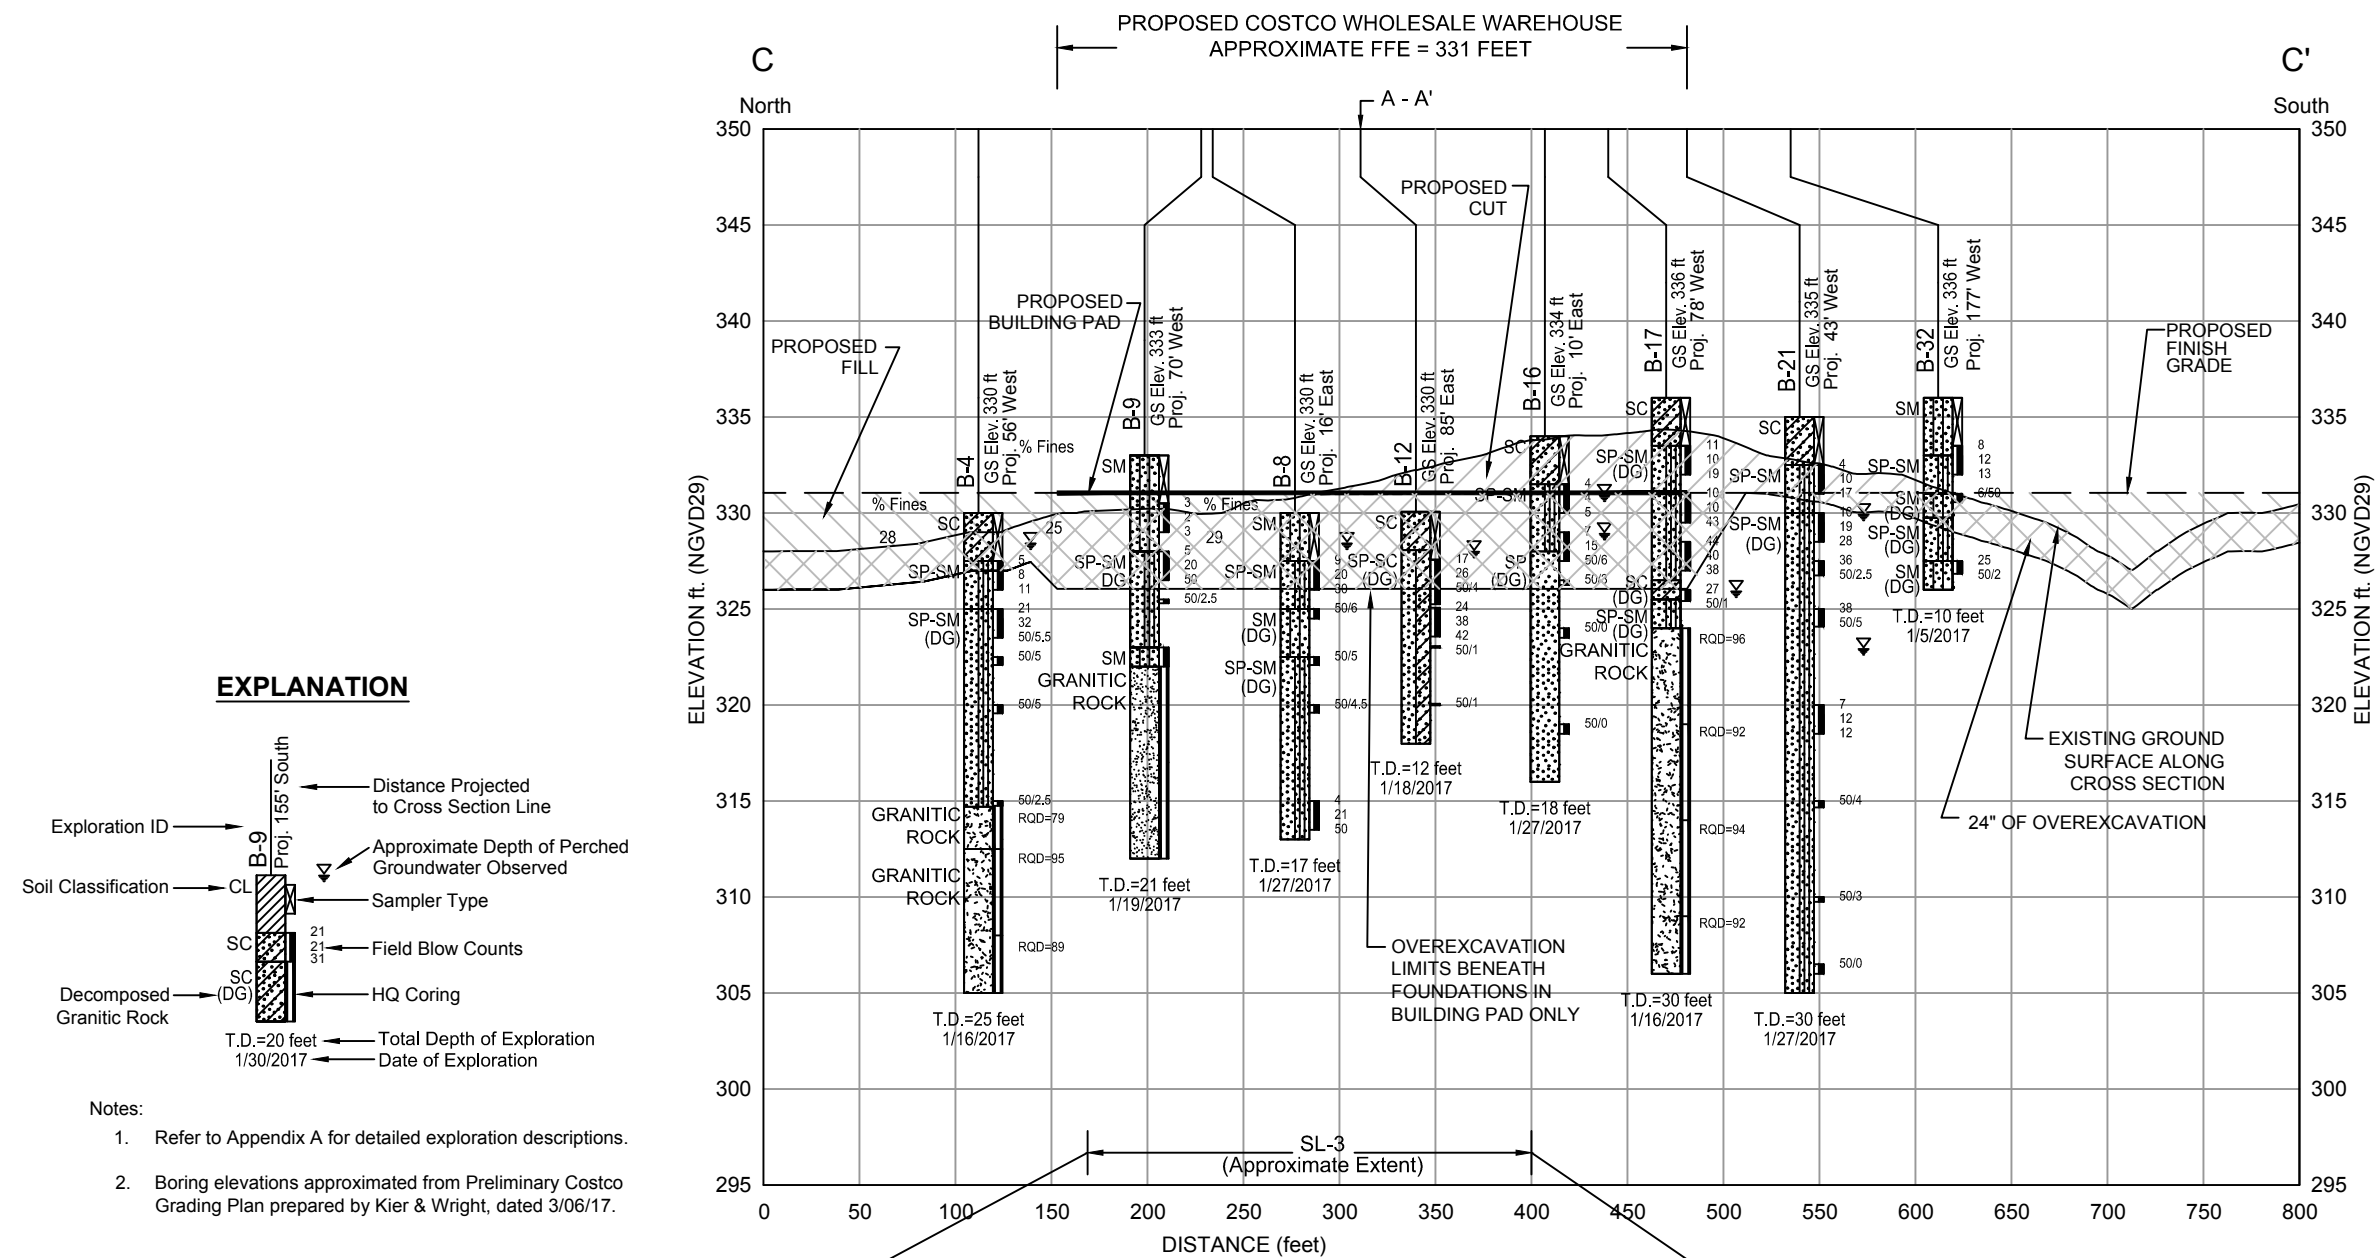
- Notes:
1. Spread footings shall be overexcavated to a depth of at least 2 feet below existing grade, 3 feet below the bottom of the footings, or 3 feet below the bottom of the floor slabs, whichever is deeper.
  2. Warehouse building slab shall be underlain by at least 6 inches of aggregate base materials supported on at least 6 inches of engineered fill.

- Proposed Fill
- Proposed Cut
- 24" of over-excavation

- The proposed Costco warehouse building and fuel facility may be supported on a conventional shallow foundation system. Based on the preliminary grading plan, the warehouse building footprint is situated on a cut/fill transition with fills up to approximately 10 feet in the south-western corner of the building and cuts up to about 5 feet in the south-eastern corner. Overexcavation and recompaction of on-site soils/weathered bedrock is recommended to reduce the potential for differential settlement and provide relatively uniform support for the proposed warehouse and other improvements.

- Soils within 10 feet laterally of the warehouse pad (including the entrance canopy, building aprons, utility pads, stairs, ramps, stoops, and the loading dock) should be overexcavated to a depth of at least 2 feet below existing grade, 3 feet below the bottom of the footings, or 3 feet below the bottom of the floor slabs, whichever is deeper. If existing fill soils are encountered at the base of the overexcavation, the overexcavation should continue until the fill is removed. The overexcavated soils can be moisture conditioned and recompacted as structural fill.

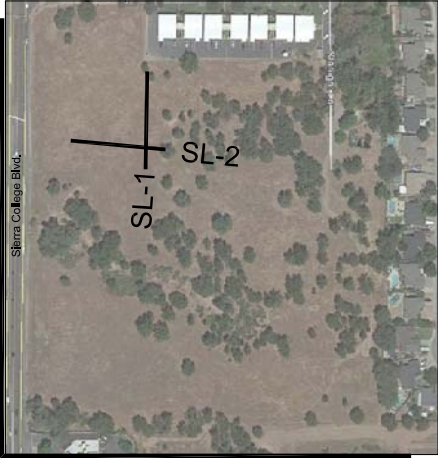
Seismic Refraction Survey Results-  
P-wave Velocity Layer Models for  
Lines SL-1 and SL-2

SEISMIC LINE LOCATIONS

The results of the seismic refraction survey are presented on Figures 2 through 6, which show the seismic line locations and profiles of subsurface velocity layering. In general, the refraction data indicate the presence of three velocity layers within the upper 40 feet of subsurface— Layer  $V_1$  is the uppermost 2- to 10-foot thick low-velocity layer representing surficial soil and deeply-weathered bedrock. Layer  $V_2$  is the middle, medium-velocity layer ranging from 5 to 27 feet in thickness that represents more compacted soil and weathered bedrock. Layer  $V_3$  is the high-velocity basement layer ranging from 12 to 30 feet in depth that represents little-weathered bedrock.

The results of the seismic refraction survey are summarized on Table 1, below, and presented on Figures 2 through 5, which show the seismic line locations and models (profiles) of subsurface velocity layering that were calculated from the seismic refraction data. Figure 6 presents the tomographic models, which were prepared to assess localized velocity variations along the seismic lines.

Layer  $V_2$  exhibits P-wave velocities ranging from 2,400 to 3,400 feet per second (fps), which indicates that the subsurface should be readily rippable through this layer to depths ranging from 12 to 30 feet; although, except for a small area (see Figure 2), the entire site appears to be rippable to a depth of at least 20 feet. Layer  $V_3$  occurs at depths ranging from 12 to 30 feet below ground surface (bgs) and, exhibiting P-wave velocities in excess of 10,000 fps, is considered to be "non-rippable." It is worth noting that layer  $V_3$  exhibits lower velocity along

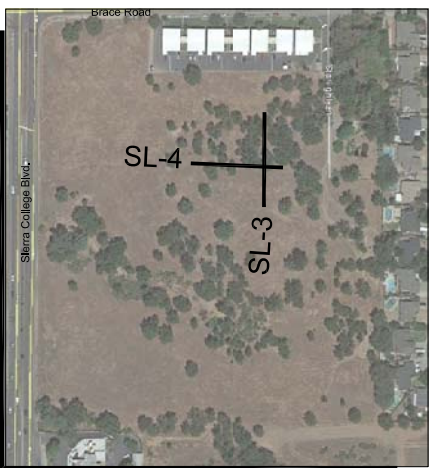
<b>ADVANCED GEOLOGICAL SERVICES</b>	Seismic Refraction Survey Results- P-wave Velocity Layer Models for Lines SL-3 and SL-4		
	LOCATION: Loomis, California		
	CLIENT: Kleinfelder, Inc.		FIGURE  <b>4</b>
	PROJECT #: 16-139-1CA		
DATE: Feb 9, 2017	DRAWN BY: R. SMITH		
1605 School Street Suite 4 Moraga, CA 94556 (925) 808-8965

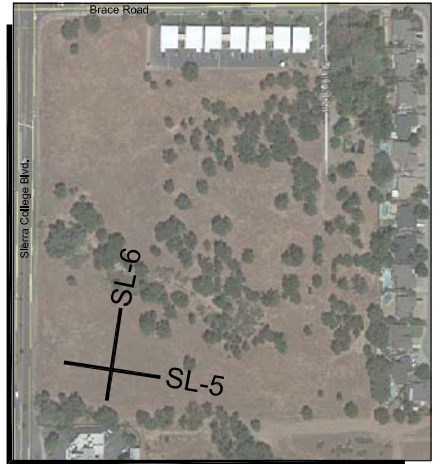
Seismic Refraction Survey Results-  
P-wave Velocity Layer Models for  
Lines SL-5 and SL-6

LOCATION: Loomis, California		FIGURE  <b>5</b>
CLIENT: Kleinfelder, Inc.		
PROJECT #: 16-139-1CA		
DATE: Feb 9, 2017	DRAWN BY: R. SMITH
