Appendix A

Representative Cross-Sections for Geomorphic Analysis

Representative Cross-Sections

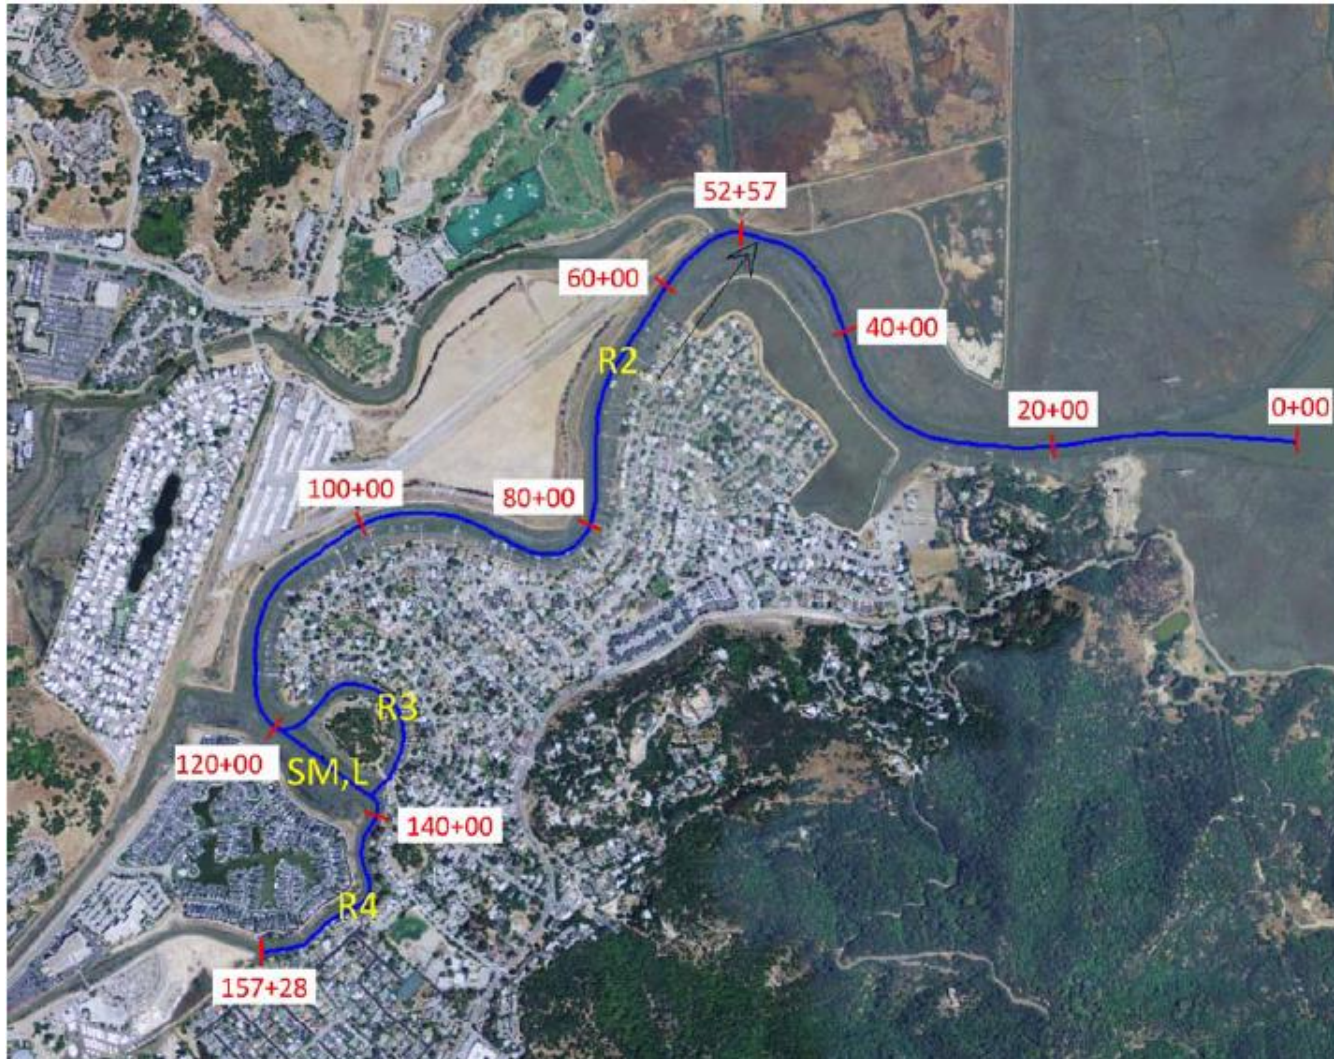
- 25+07 (above Bucks)
- 28+94
- 40+00
- 49+27
- **52+50**
- **60+41** (SV marsh)
- **70+93**
- **80+00** (La Pasada)
- **91+27**
- 100+00 (Mabry Way)
- 110+00
- 120+00 (SM island)
- 125+00
- **130+00**
- 135+00
- **140+00** (Meadow)
- 145+12
- **150+00** (Mark Twain)

Bolded Sections are
in Appendix A

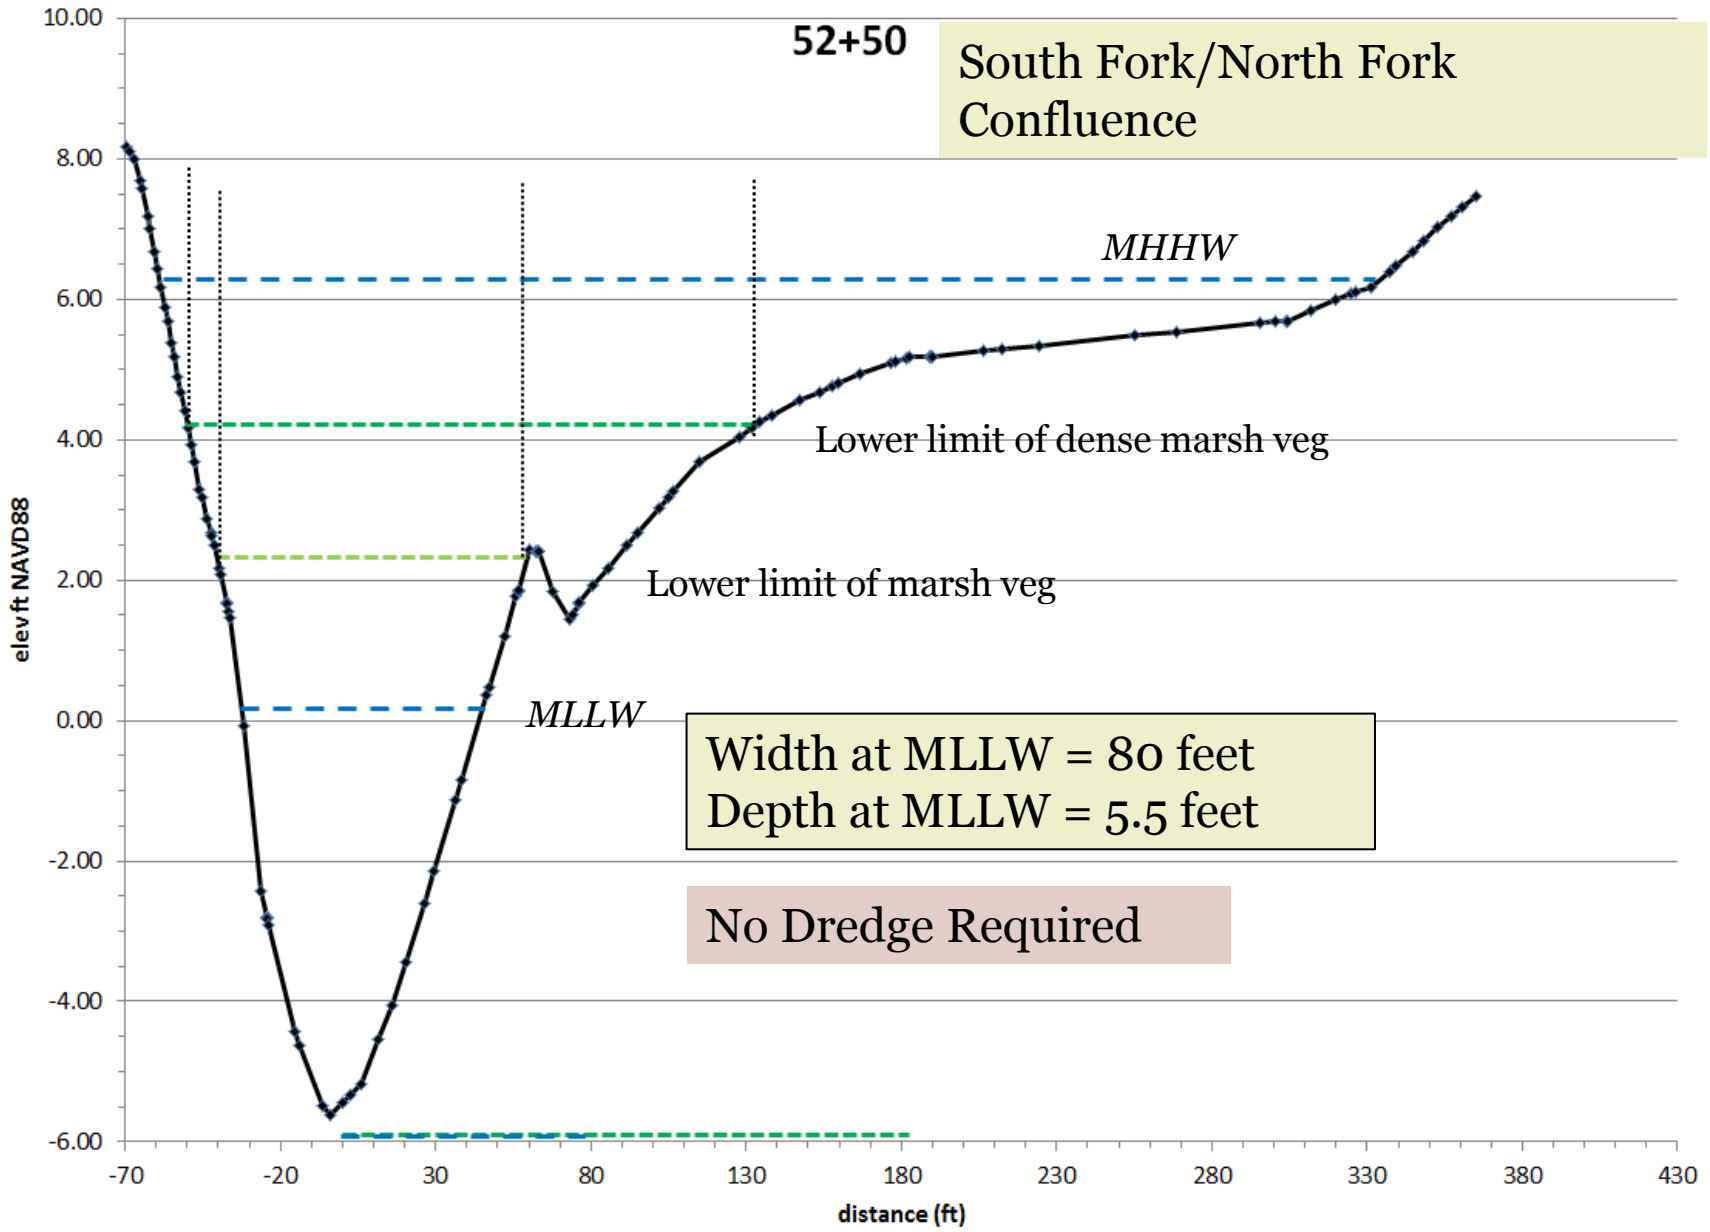
52+50

South Fork/North Fork Confluence

Width at MLLW = 80 feet
Depth at MLLW = 5.5 feet

No Dredge Required

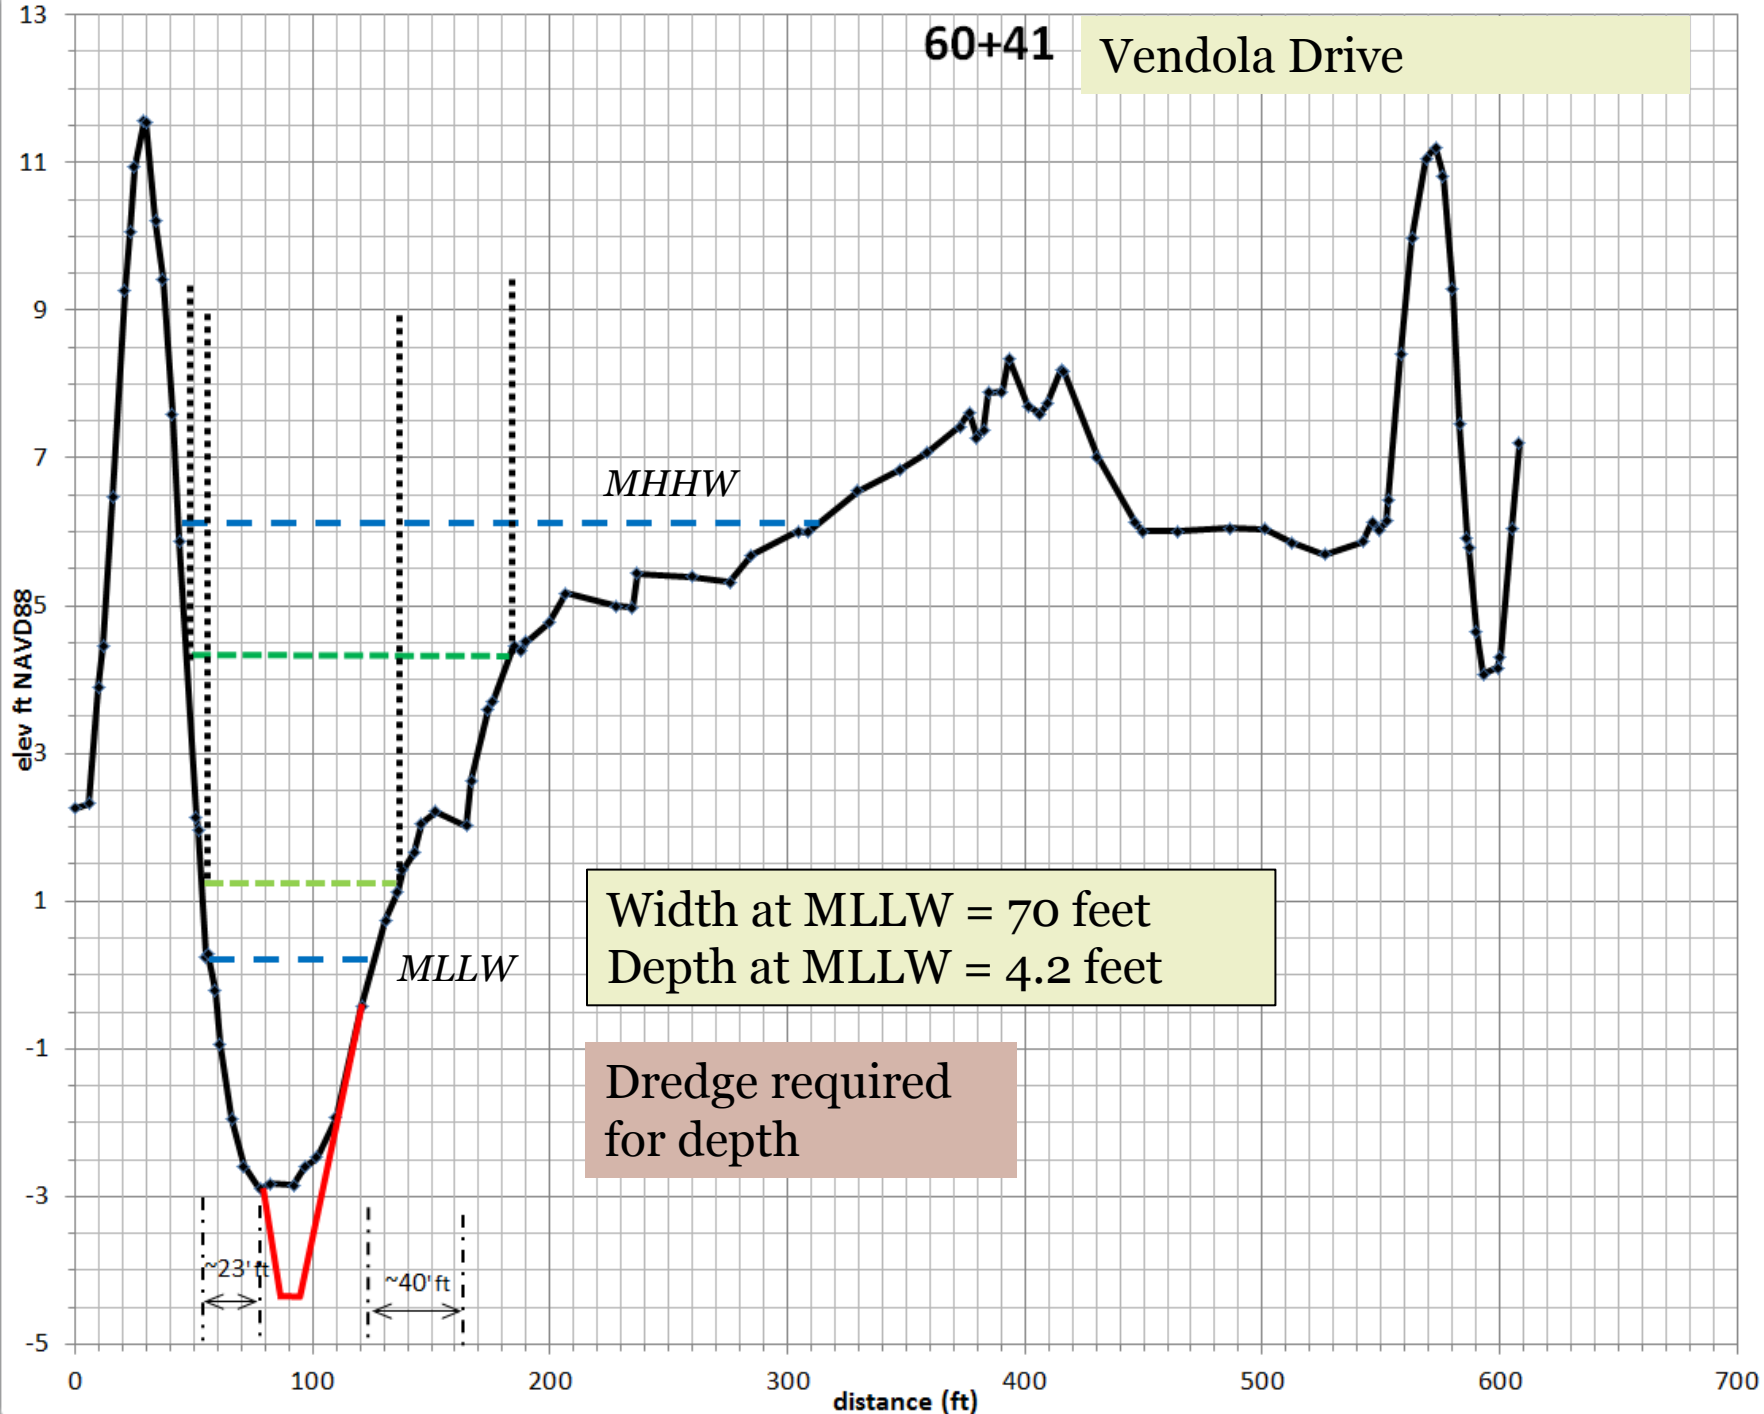
60+41

Vendola Drive

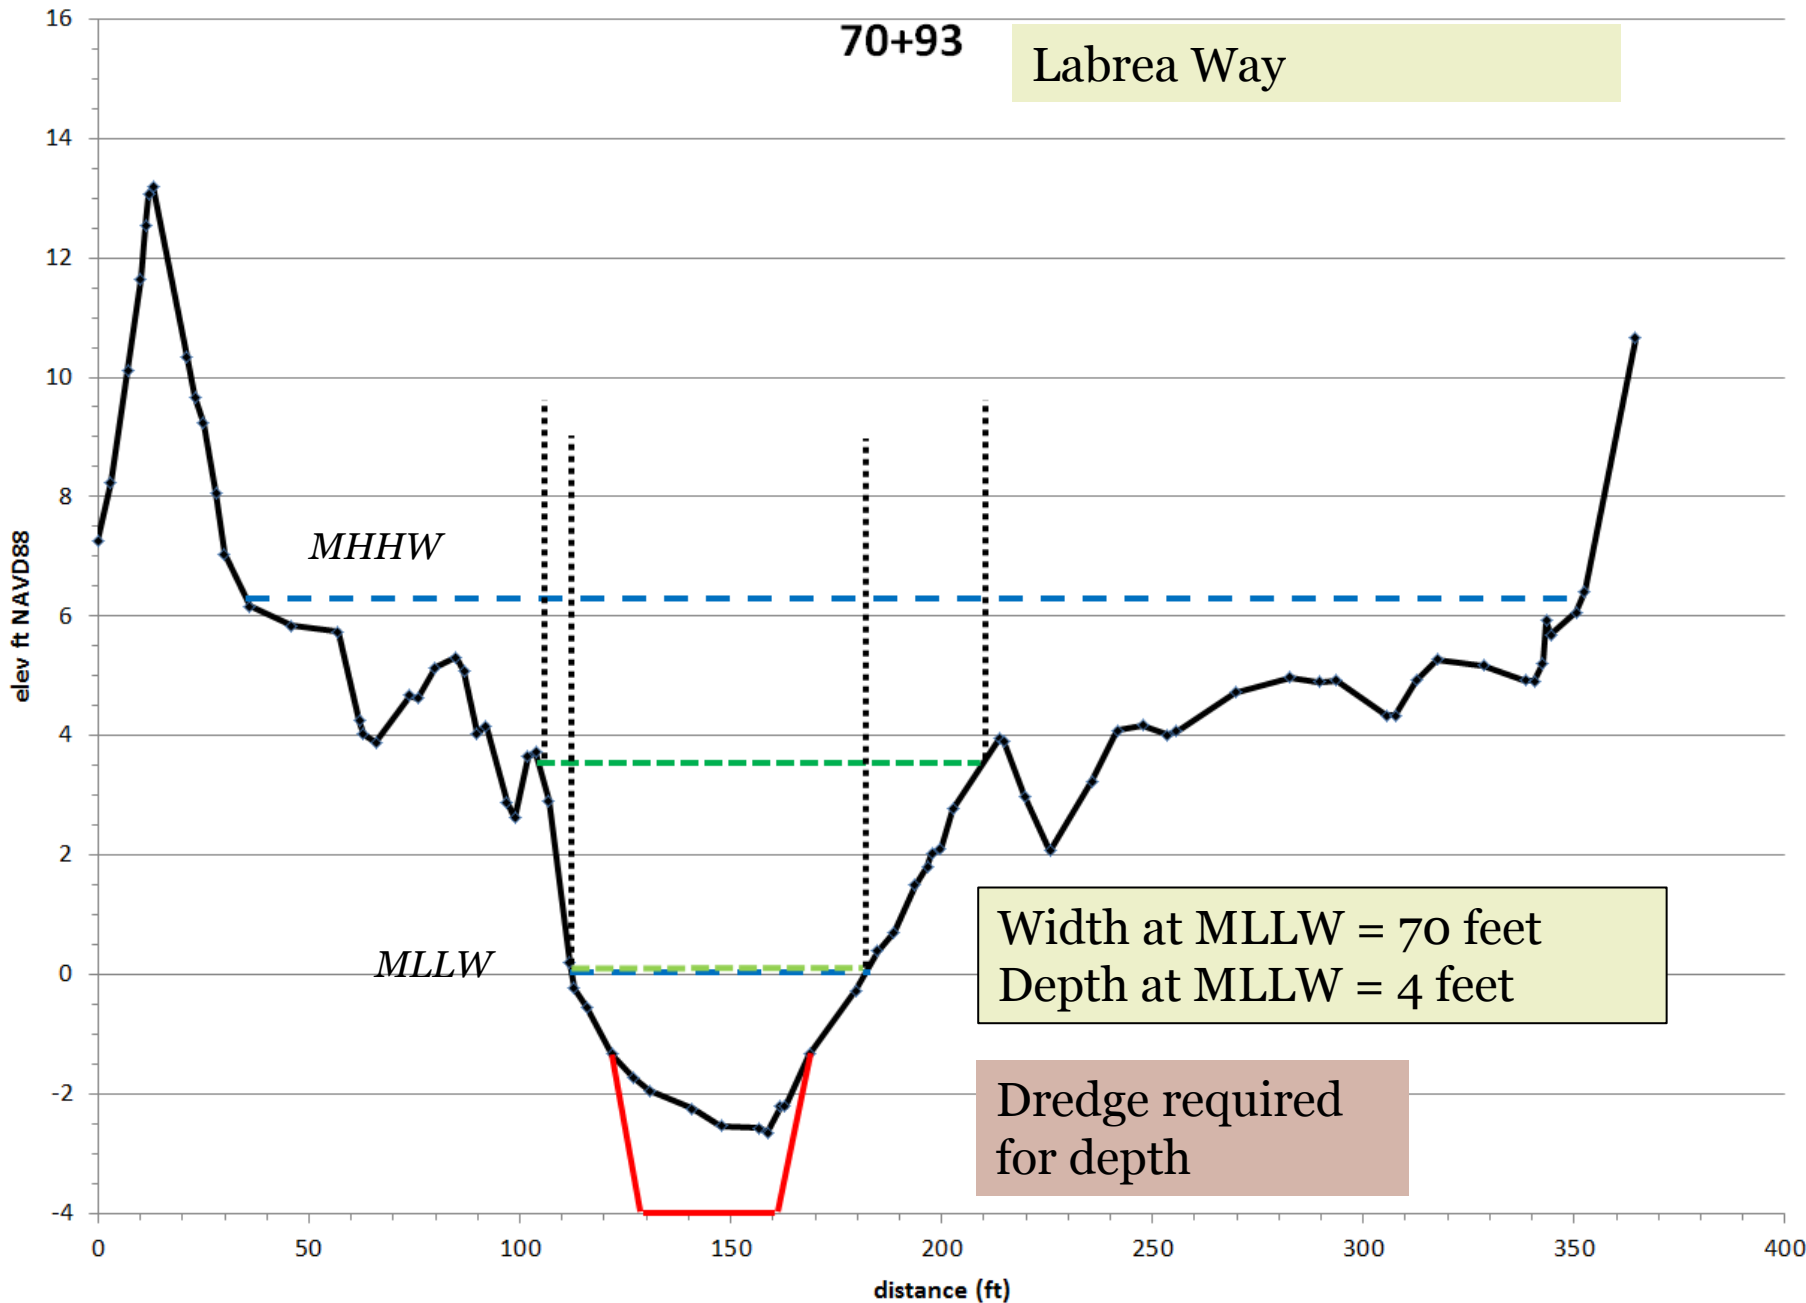
70+93

Labrea Way

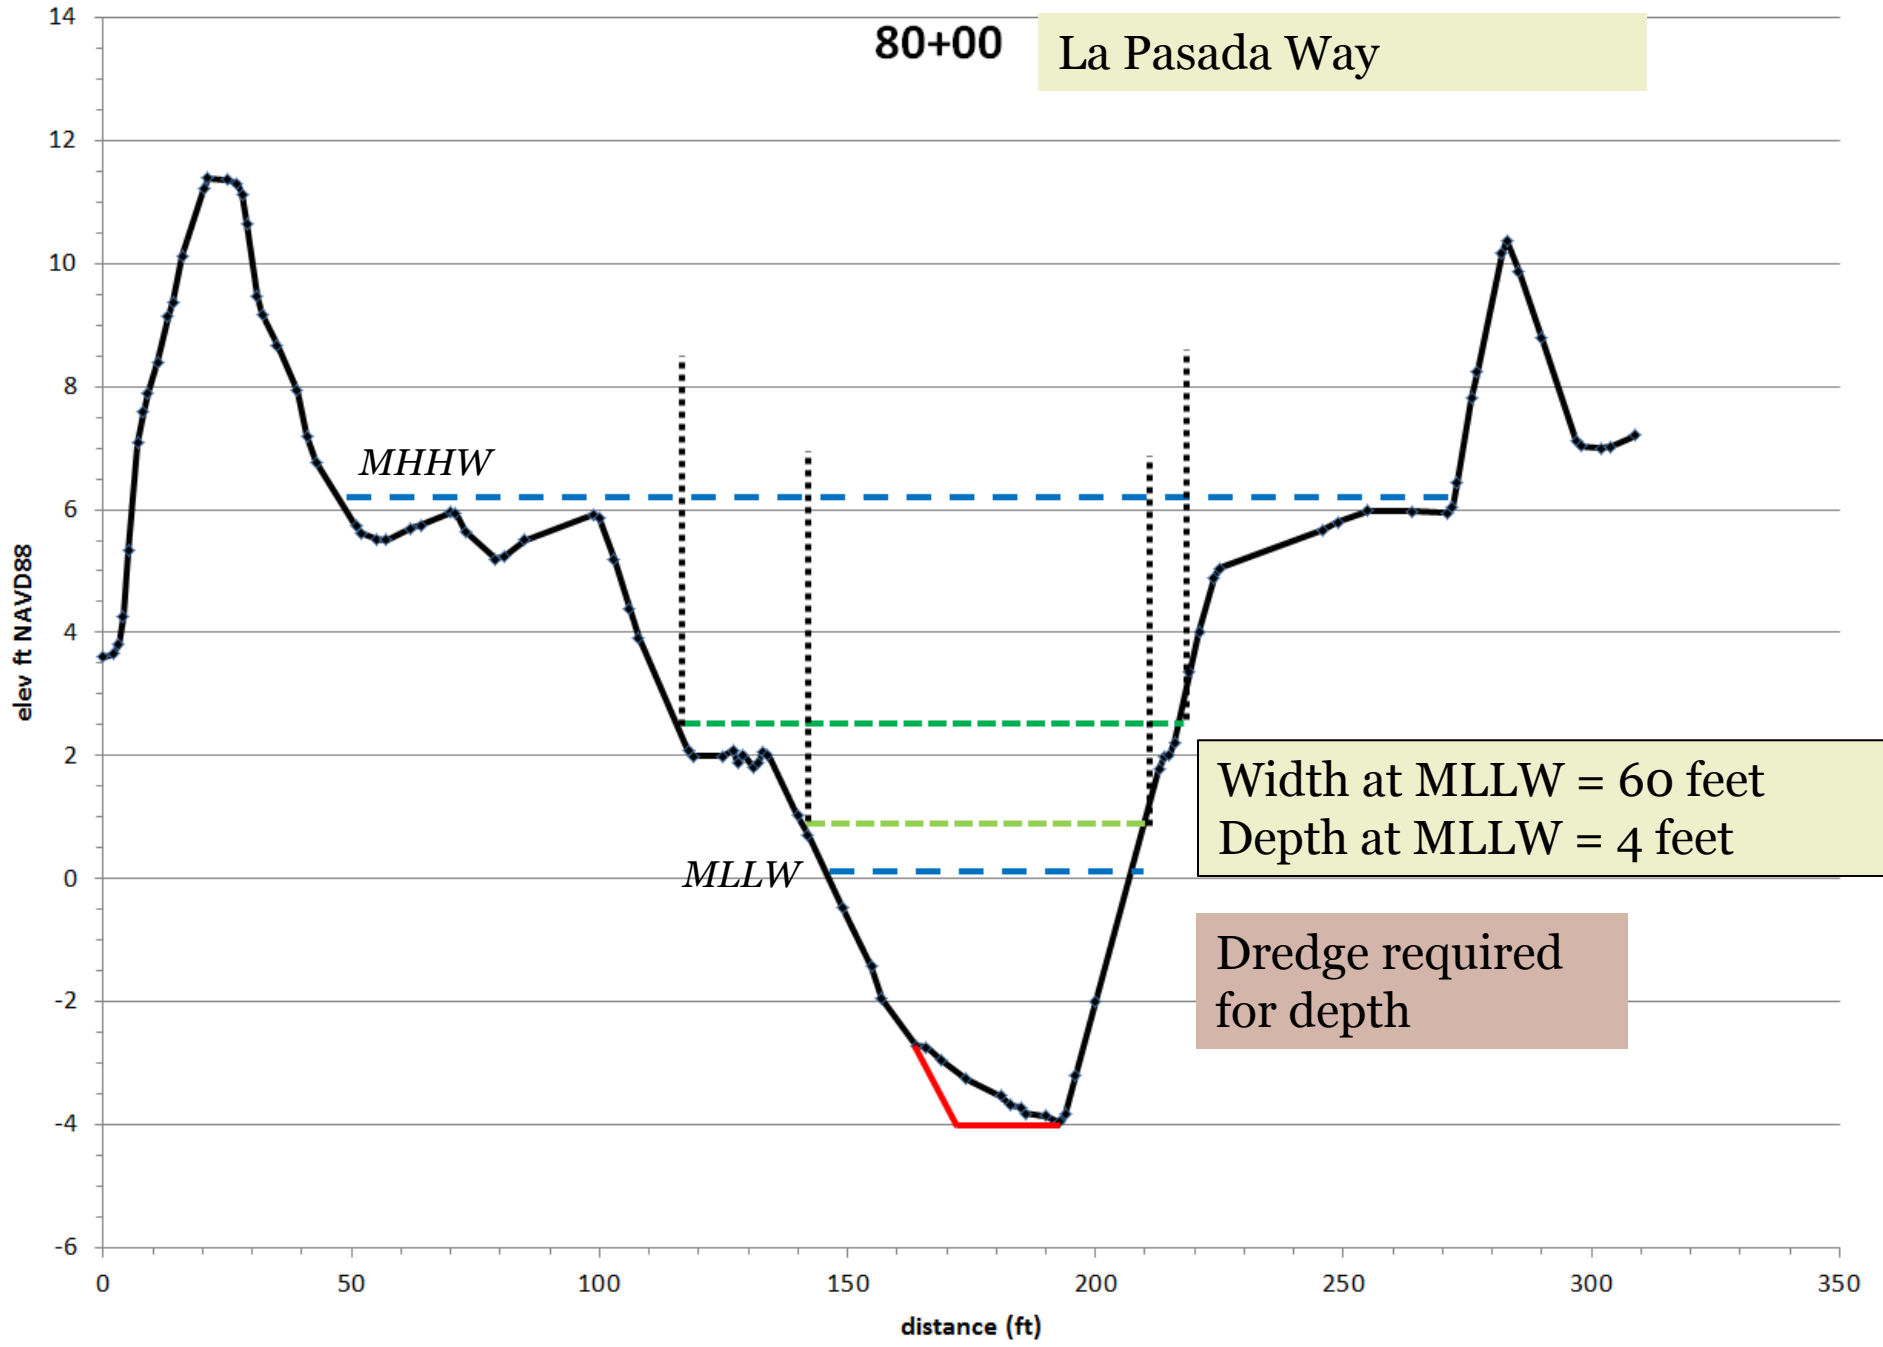
80+00

La Pasada Way

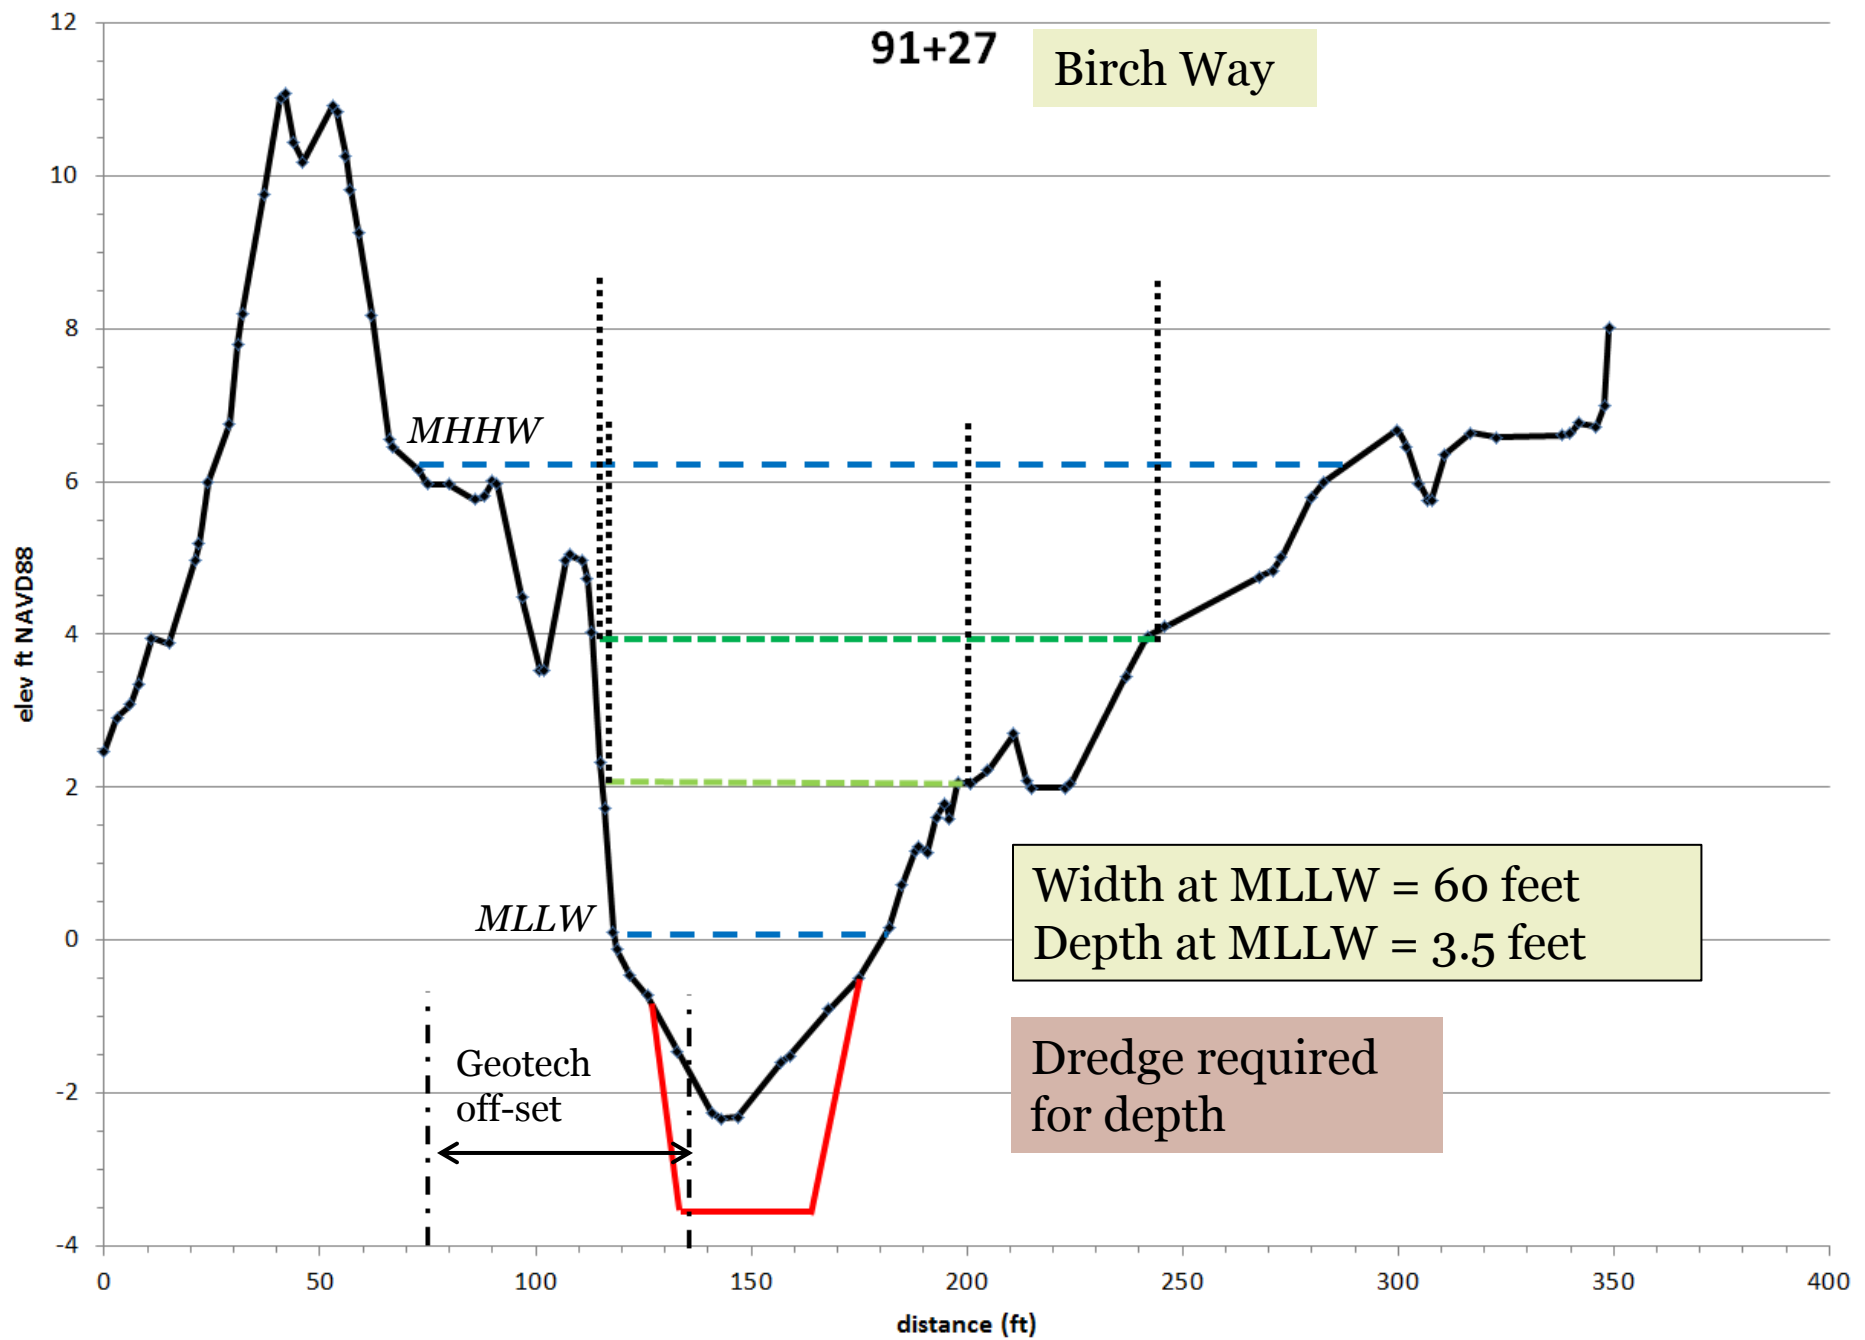
91+27

Birch Way

Width at MLLW = 60 feet
Depth at MLLW = 3.5 feet

Dredge required
for depth

Geotech
off-set

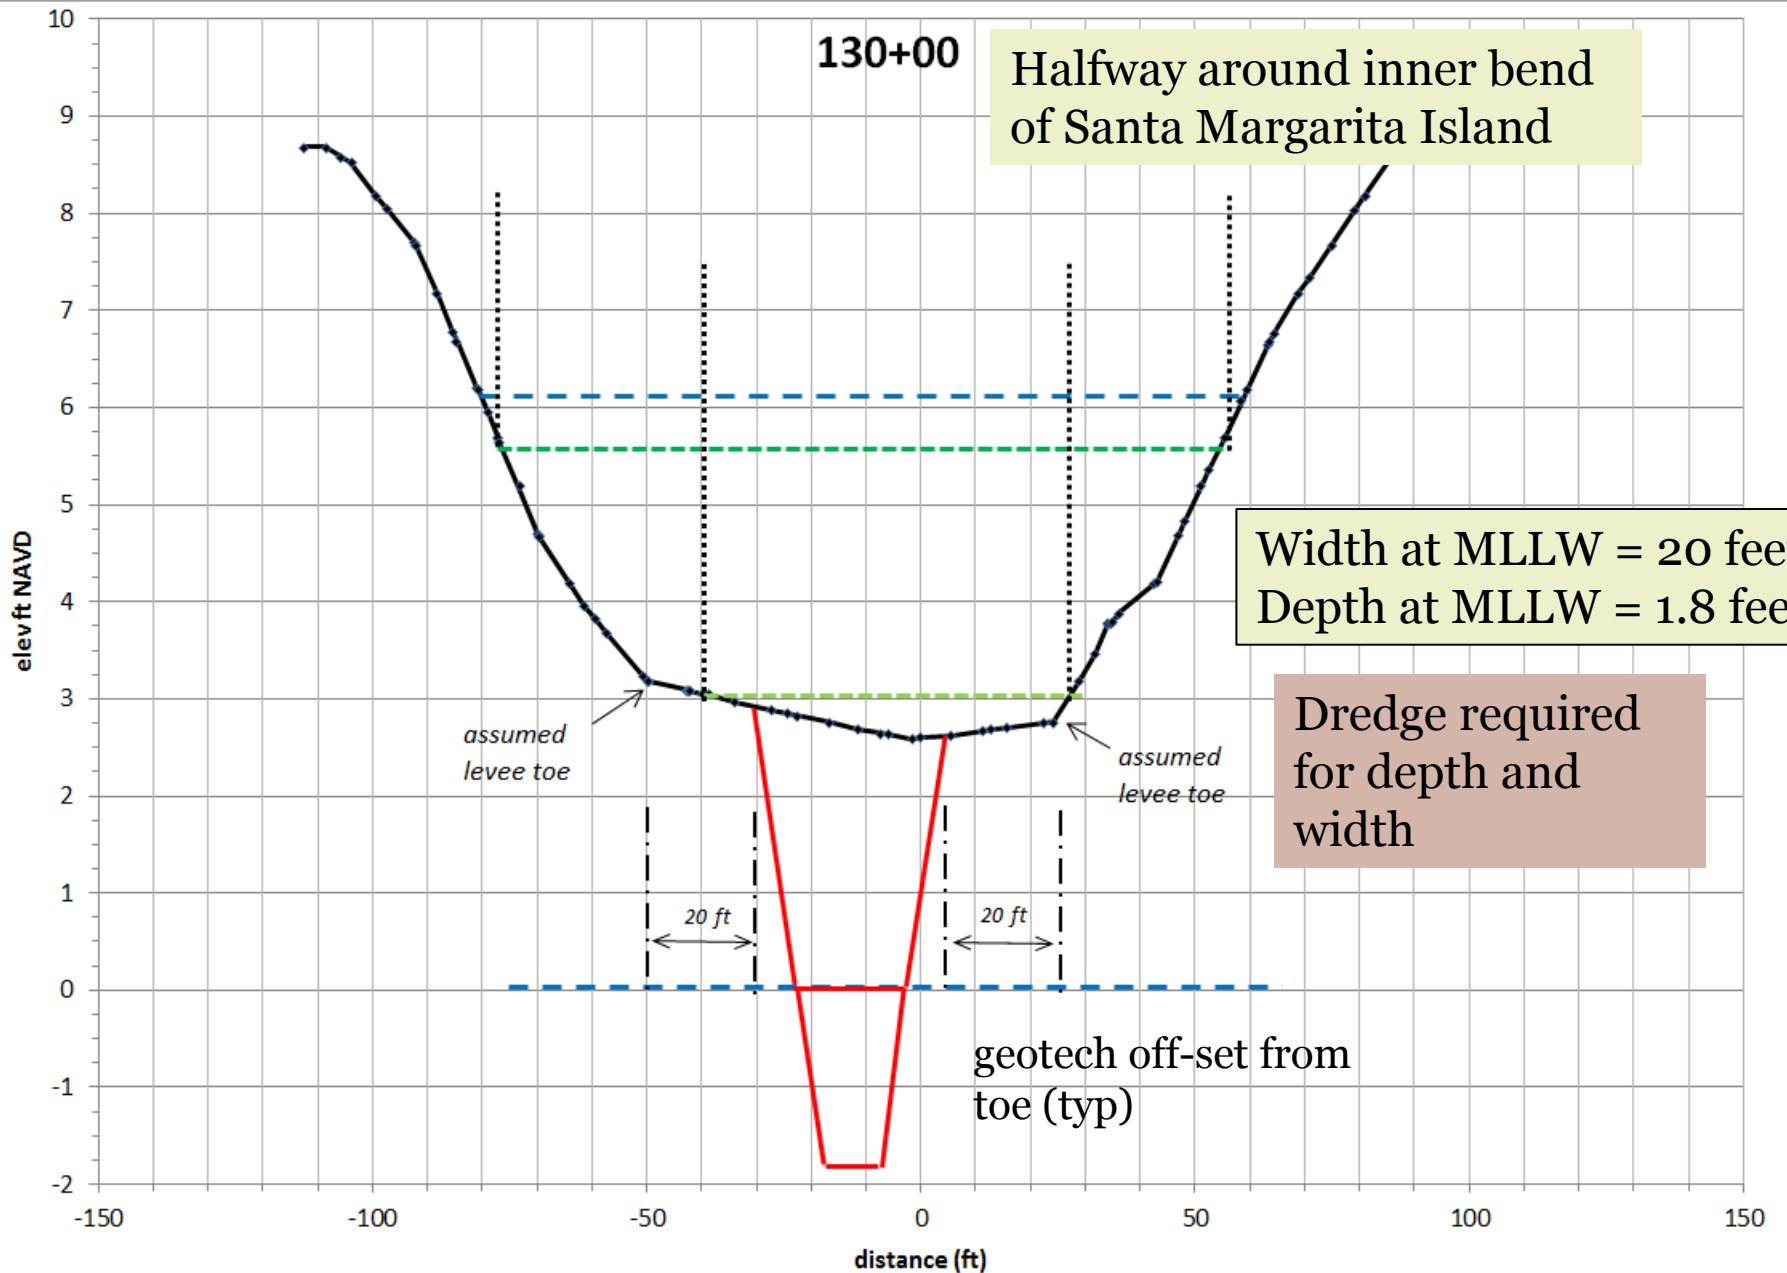
130+00

Halfway around inner bend
of Santa Margarita Island

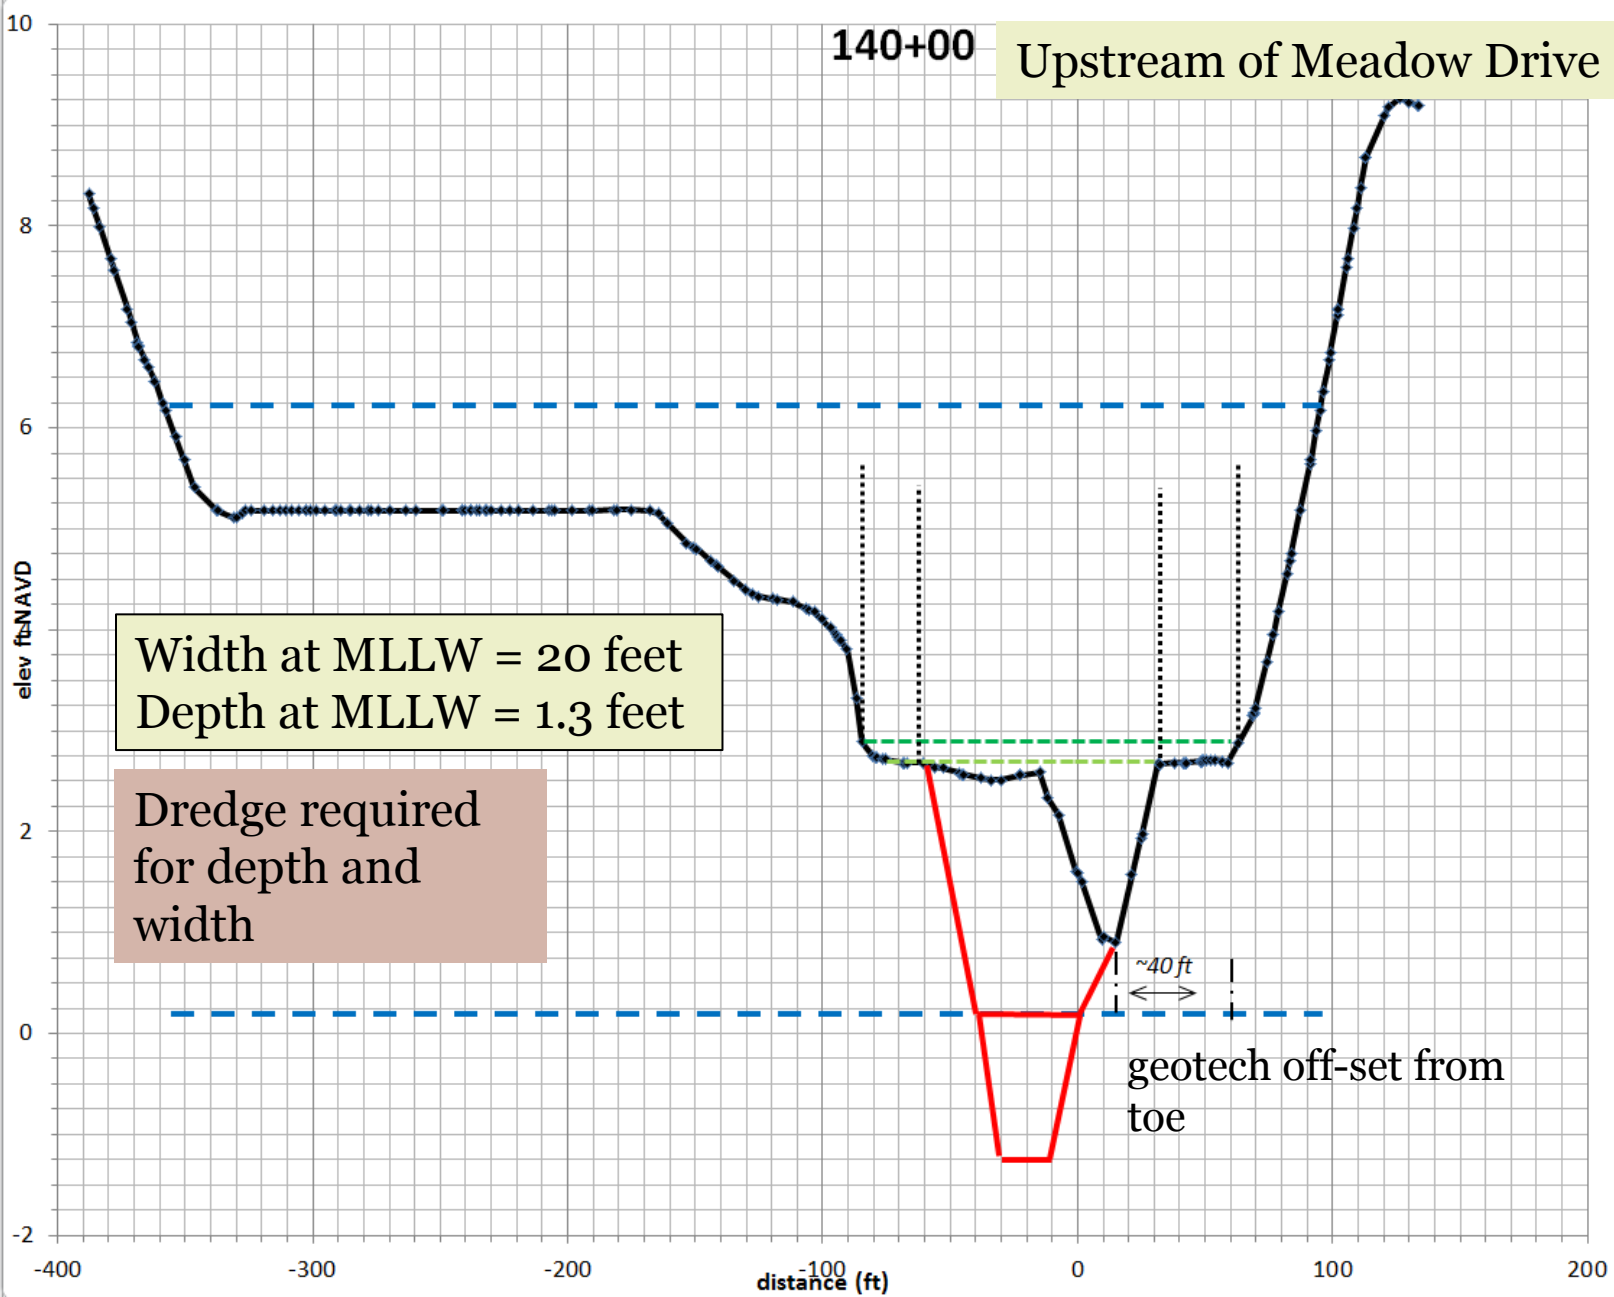
140+00 Upstream of Meadow Drive

Width at MLLW = 20 feet
Depth at MLLW = 1.3 feet

Dredge required
for depth and
width

~40 ft
geotech off-set from
toe

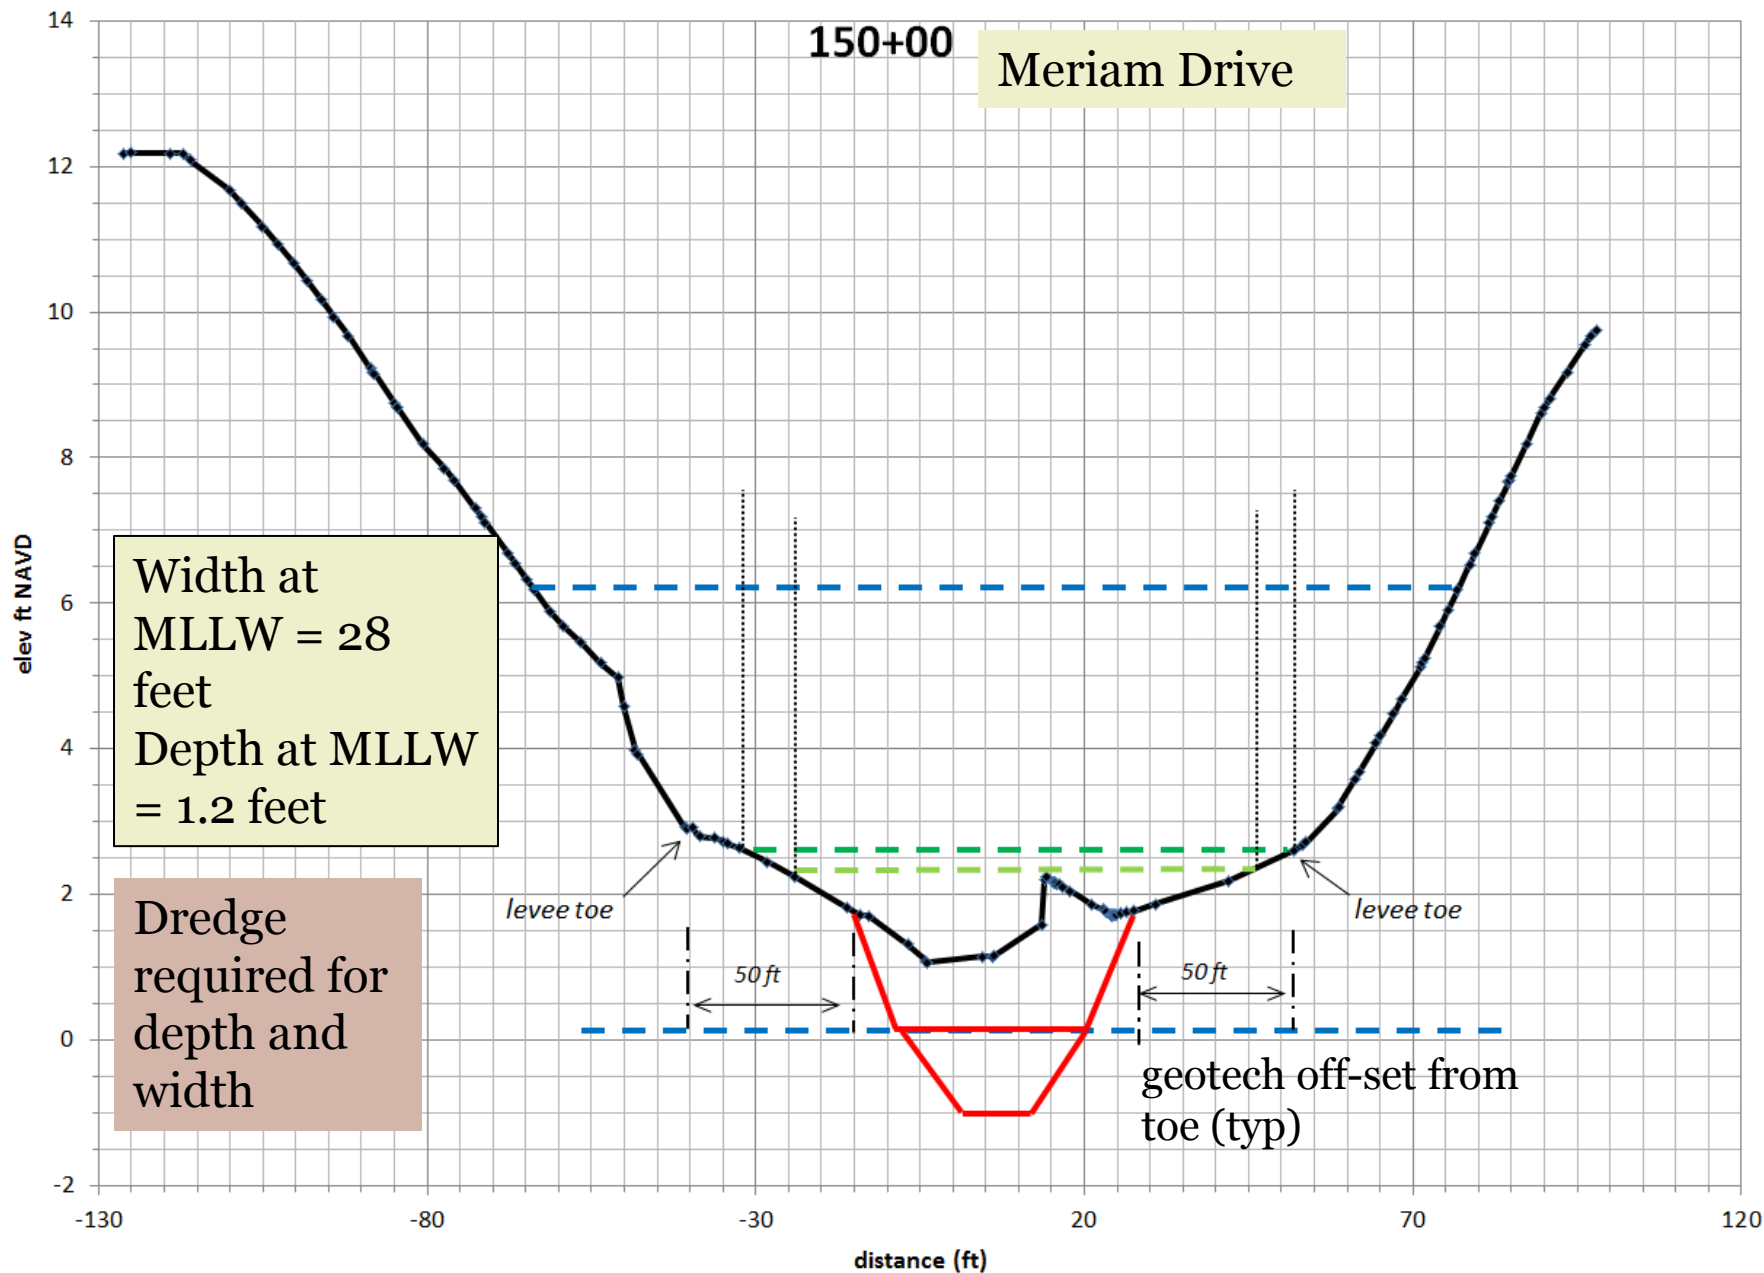
150+00

Meriam Drive

Width at
MLLW = 28
feet
Depth at MLLW
= 1.2 feet

Dredge
required for
depth and
width

geotech off-set from
toe (typ)

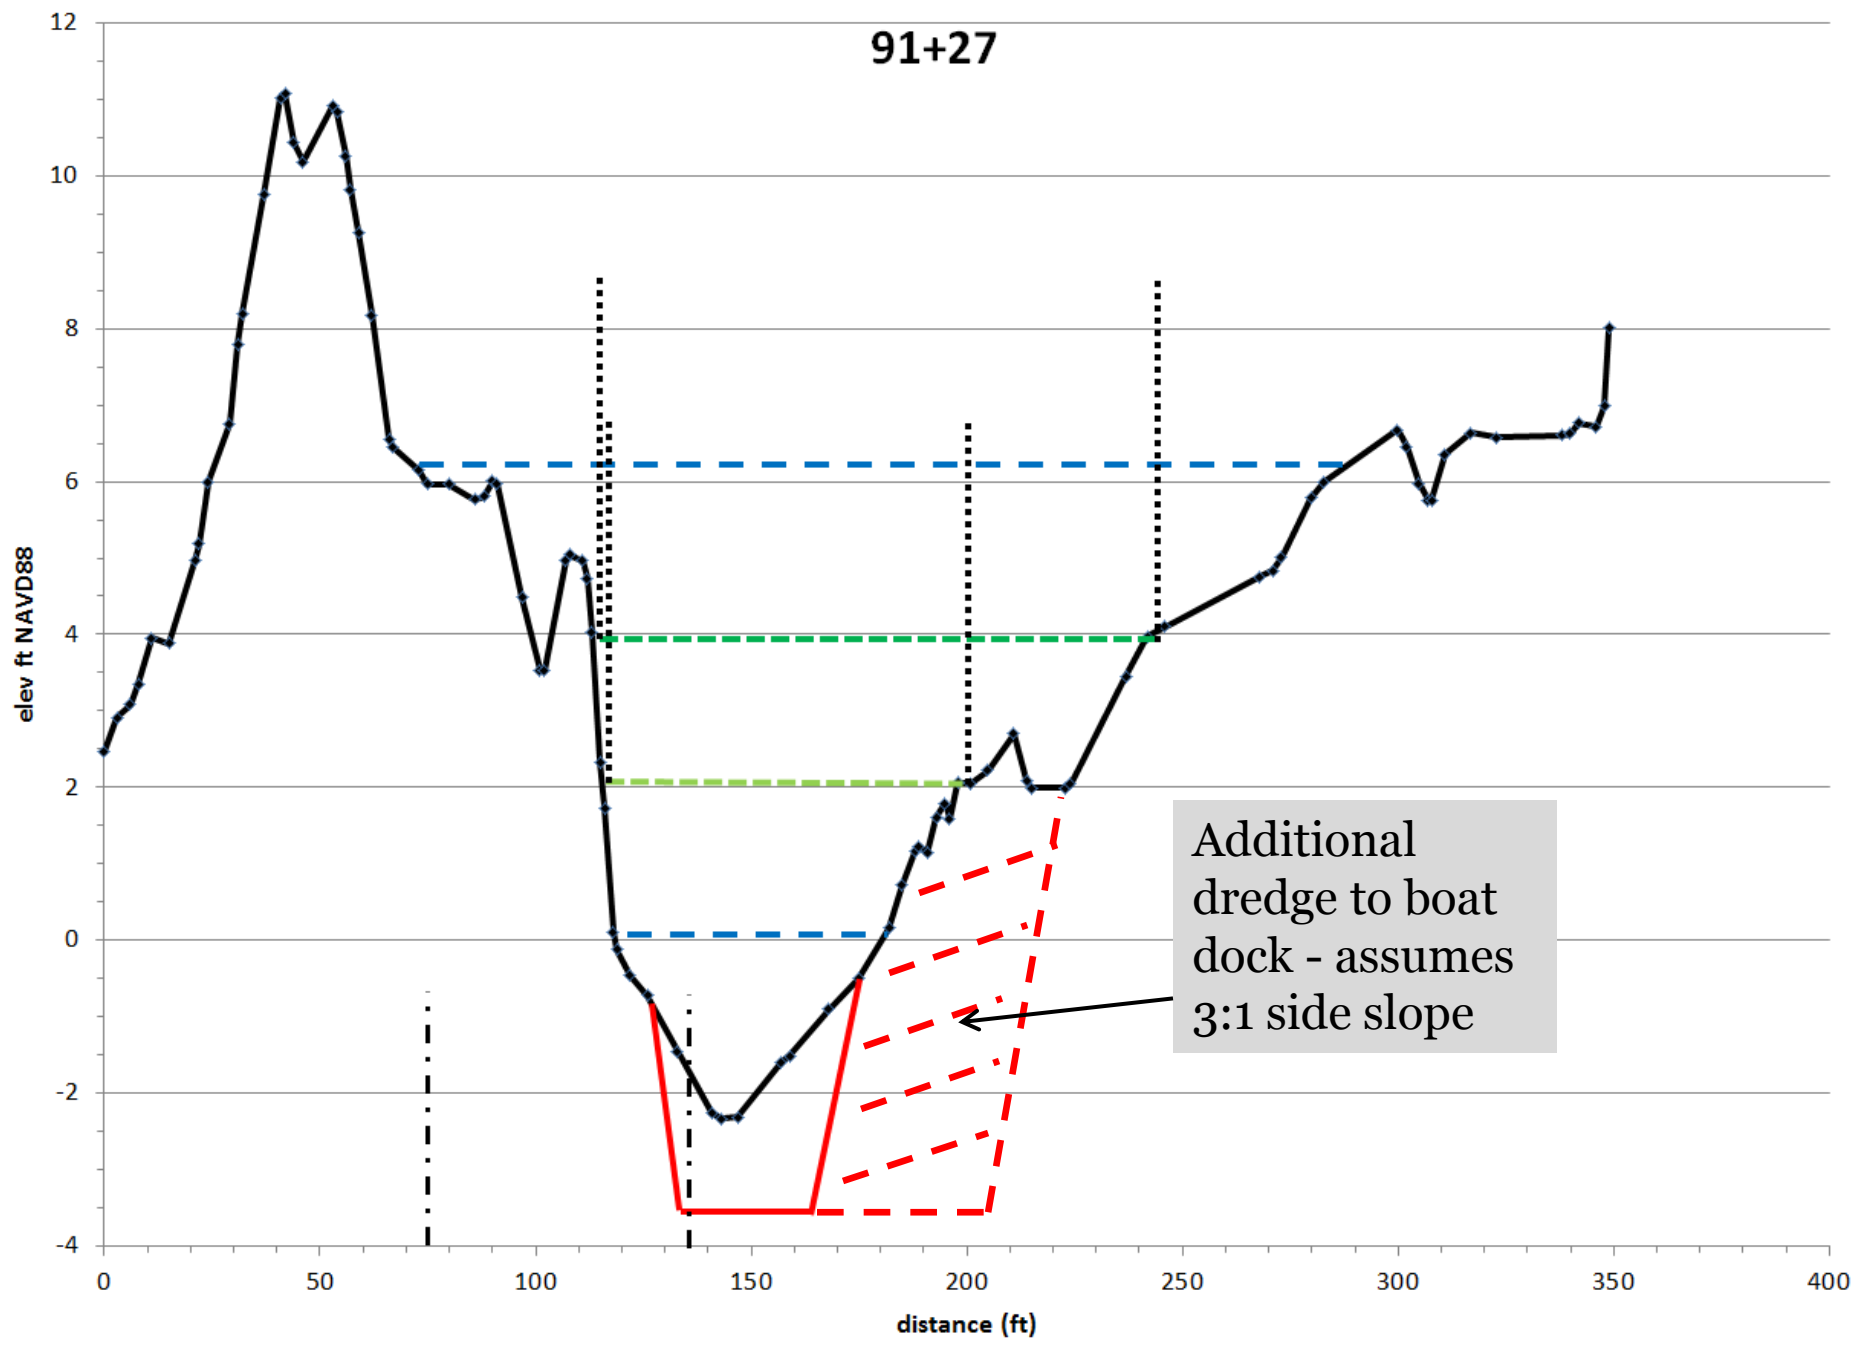
91+27

Add-On Project 1 – Close-Up Boat Dock Dredge Example

Expanded dredging to docks (side slopes cut at 3:1 and impacts to habitat not shown)
