Appendix A

Representative Cross-Sections for Geomorphic Analysis

Representative Cross-Sections

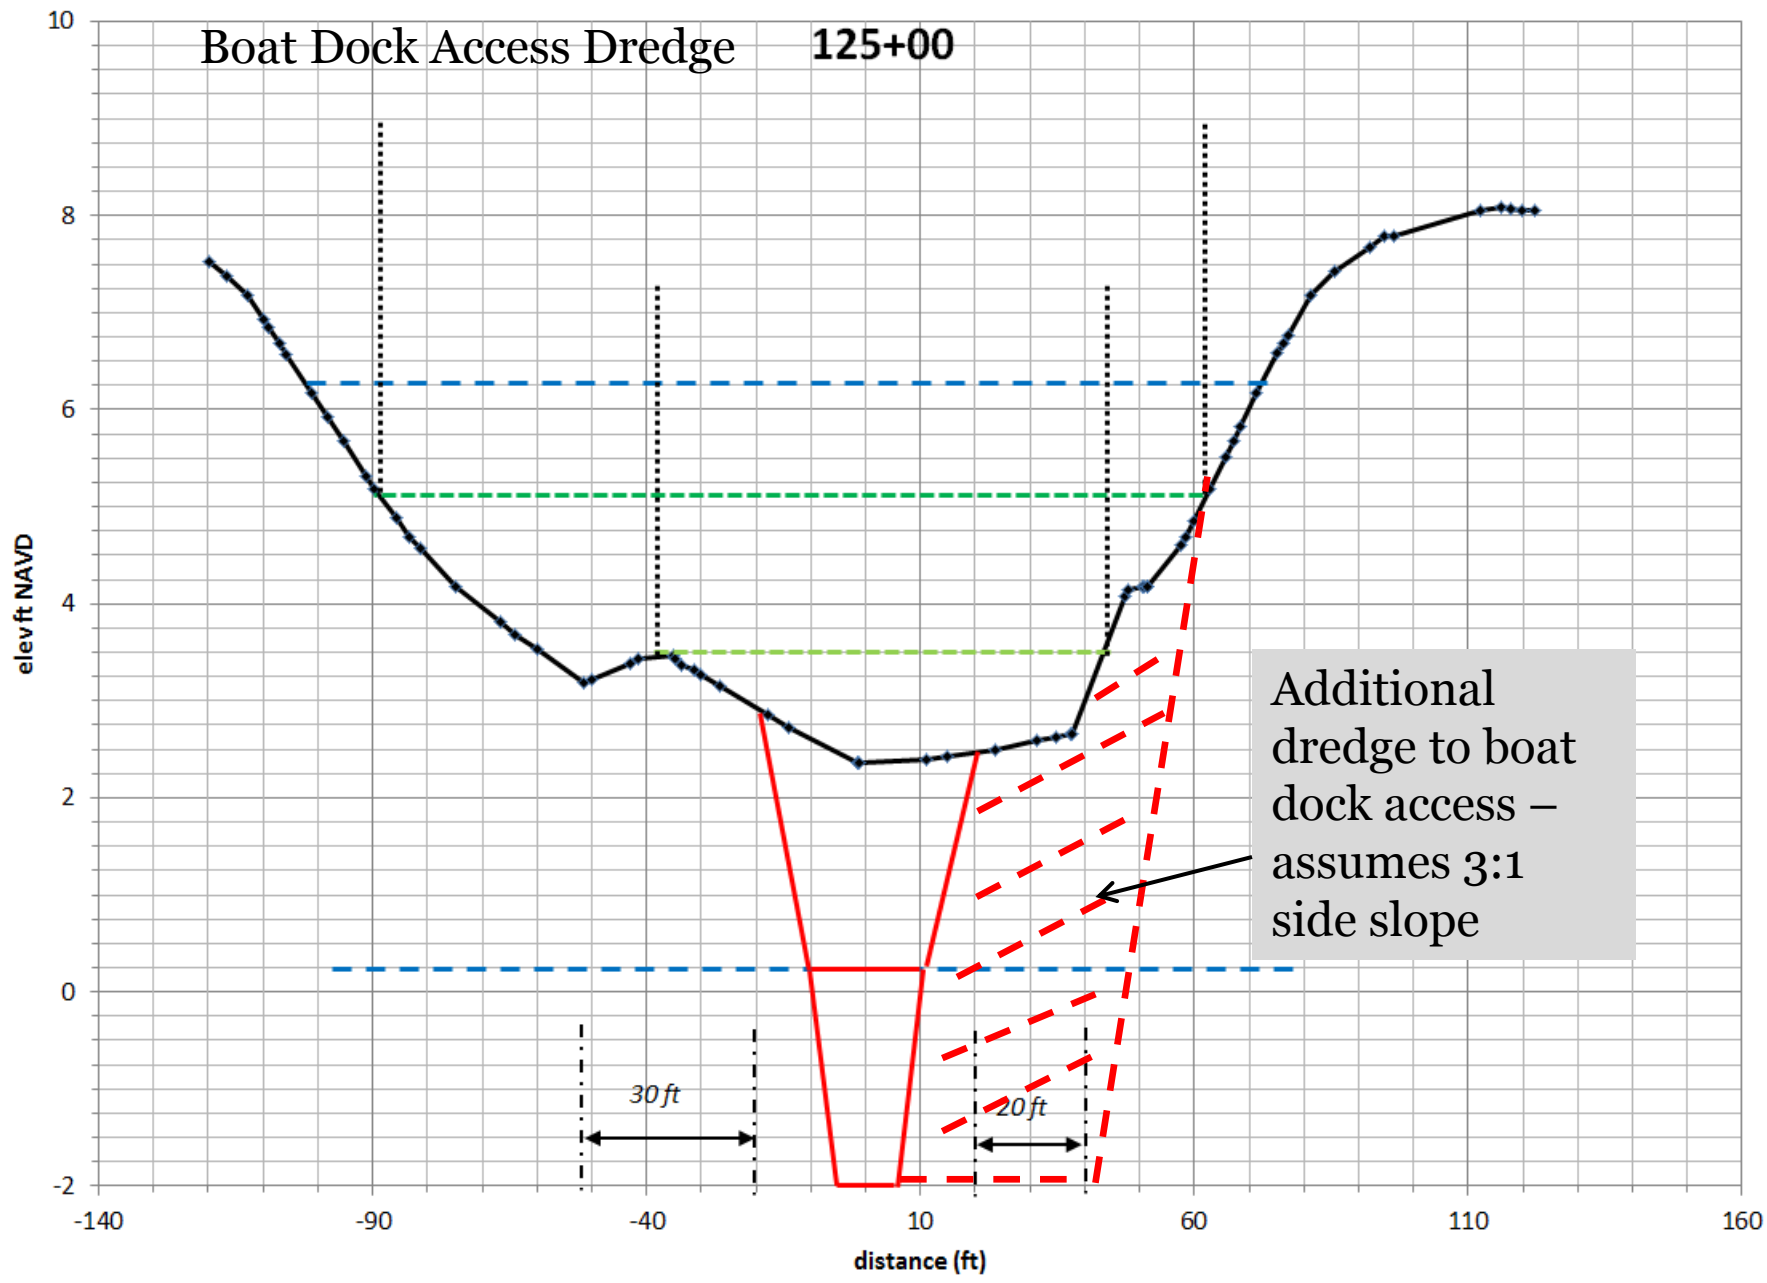
Boat Dock Access Dredge 125+00
