**GEOTECHNICAL ALTERNATIVES ANALYSIS
LAS GALLINAS LEVEE SYSTEM
SAN RAFAEL, CALIFORNIA**

**Subject: Geotechnical Alternatives Analysis Report
Las Gallinas Levee System
San Rafael, California**

The purpose of this report is to provide a preliminary assessment of potential improvement alternatives for the LGLS.

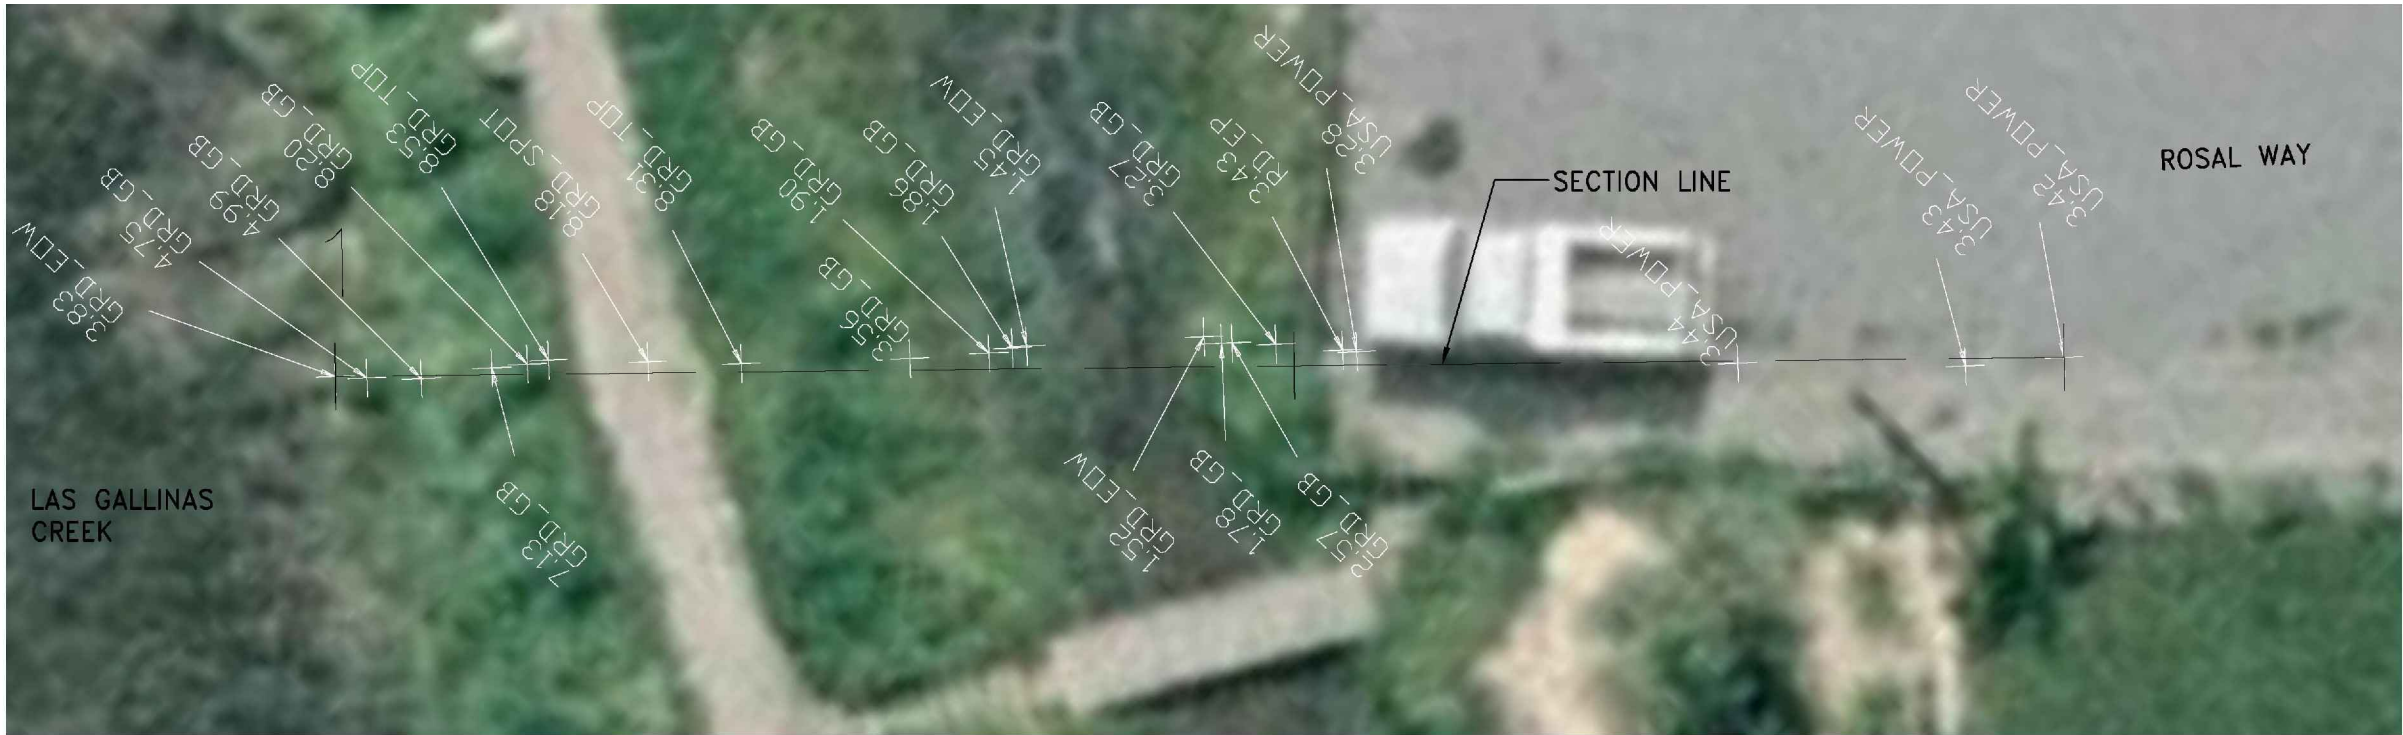
PROJECT NO.	96670	CROSS SECTION B-B' 851 ROSAL WAY	PLATE 2-2
DRAWN:	JAN 2014		
DRAWN BY:	JDS/AG		
CHECKED BY:	EMJ	ALTERNATIVES ANALYSIS LAS GALLINAS LEVEE SYSTEM SAN RAFAEL, CALIFORNIA	
FILE NAME:	X-Section 117-851_R1.dwg

REFERENCE: Wood Rodgers, Levee Evaluation drawing, dated December 2008

Based on the soils encountered in Kleinfelder's subsurface exploration programs, the levee fill in Reach 2 is between about 5 and 17 feet thick and generally consists of layers of soft to stiff lean clay and silt with up to about 30 percent sand and layers of very loose to medium dense sands and gravels with clay. Underlying the levee embankment fill is between 45 and 50 feet of Young Bay Mud. Underlying the Young Bay Mud is stiff clay and dense sand to the depths explored. Groundwater was observed at depths ranging from 2.0 to 5.5 feet below existing ground surface (bgs) at the time of drilling.

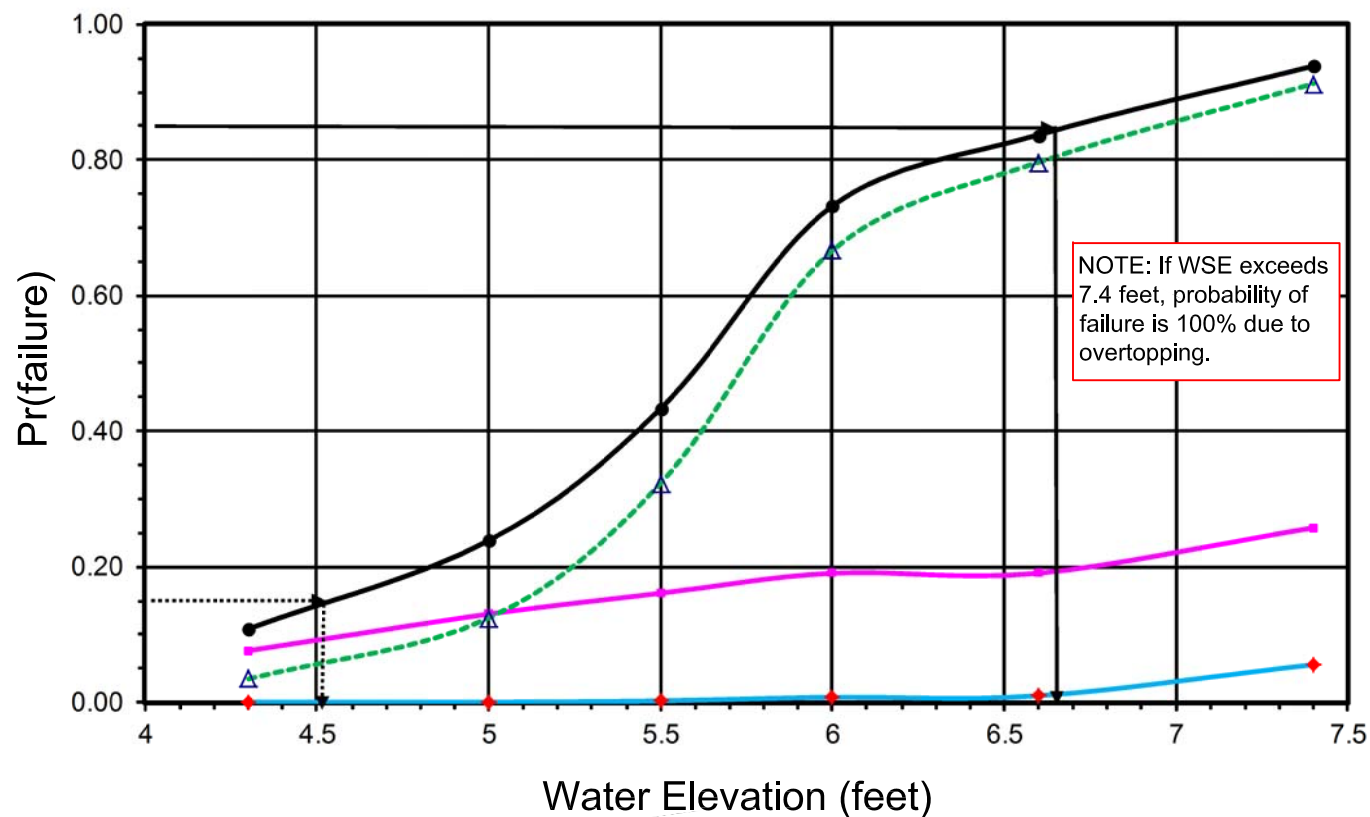
Combined Probability of Failure Existing Conditions

Underseepage

Stability

Combined

Seepage, stability, and fragility analyses were performed for an index point along Reach 2 based on available geotechnical and survey data, discussions with USACE, and indications of prior ponding during field reconnaissance. Because the Reach 2 levees present a more considerable potential for failure due to their height, construction, and variable engineering quality, and because overtopping of the Reach 1 or Reach 2 levees would result in inundation of the same areas, fragility analyses were performed only for an index point in Reach 2. Fragility analyses were not performed for Reach 1 levees.

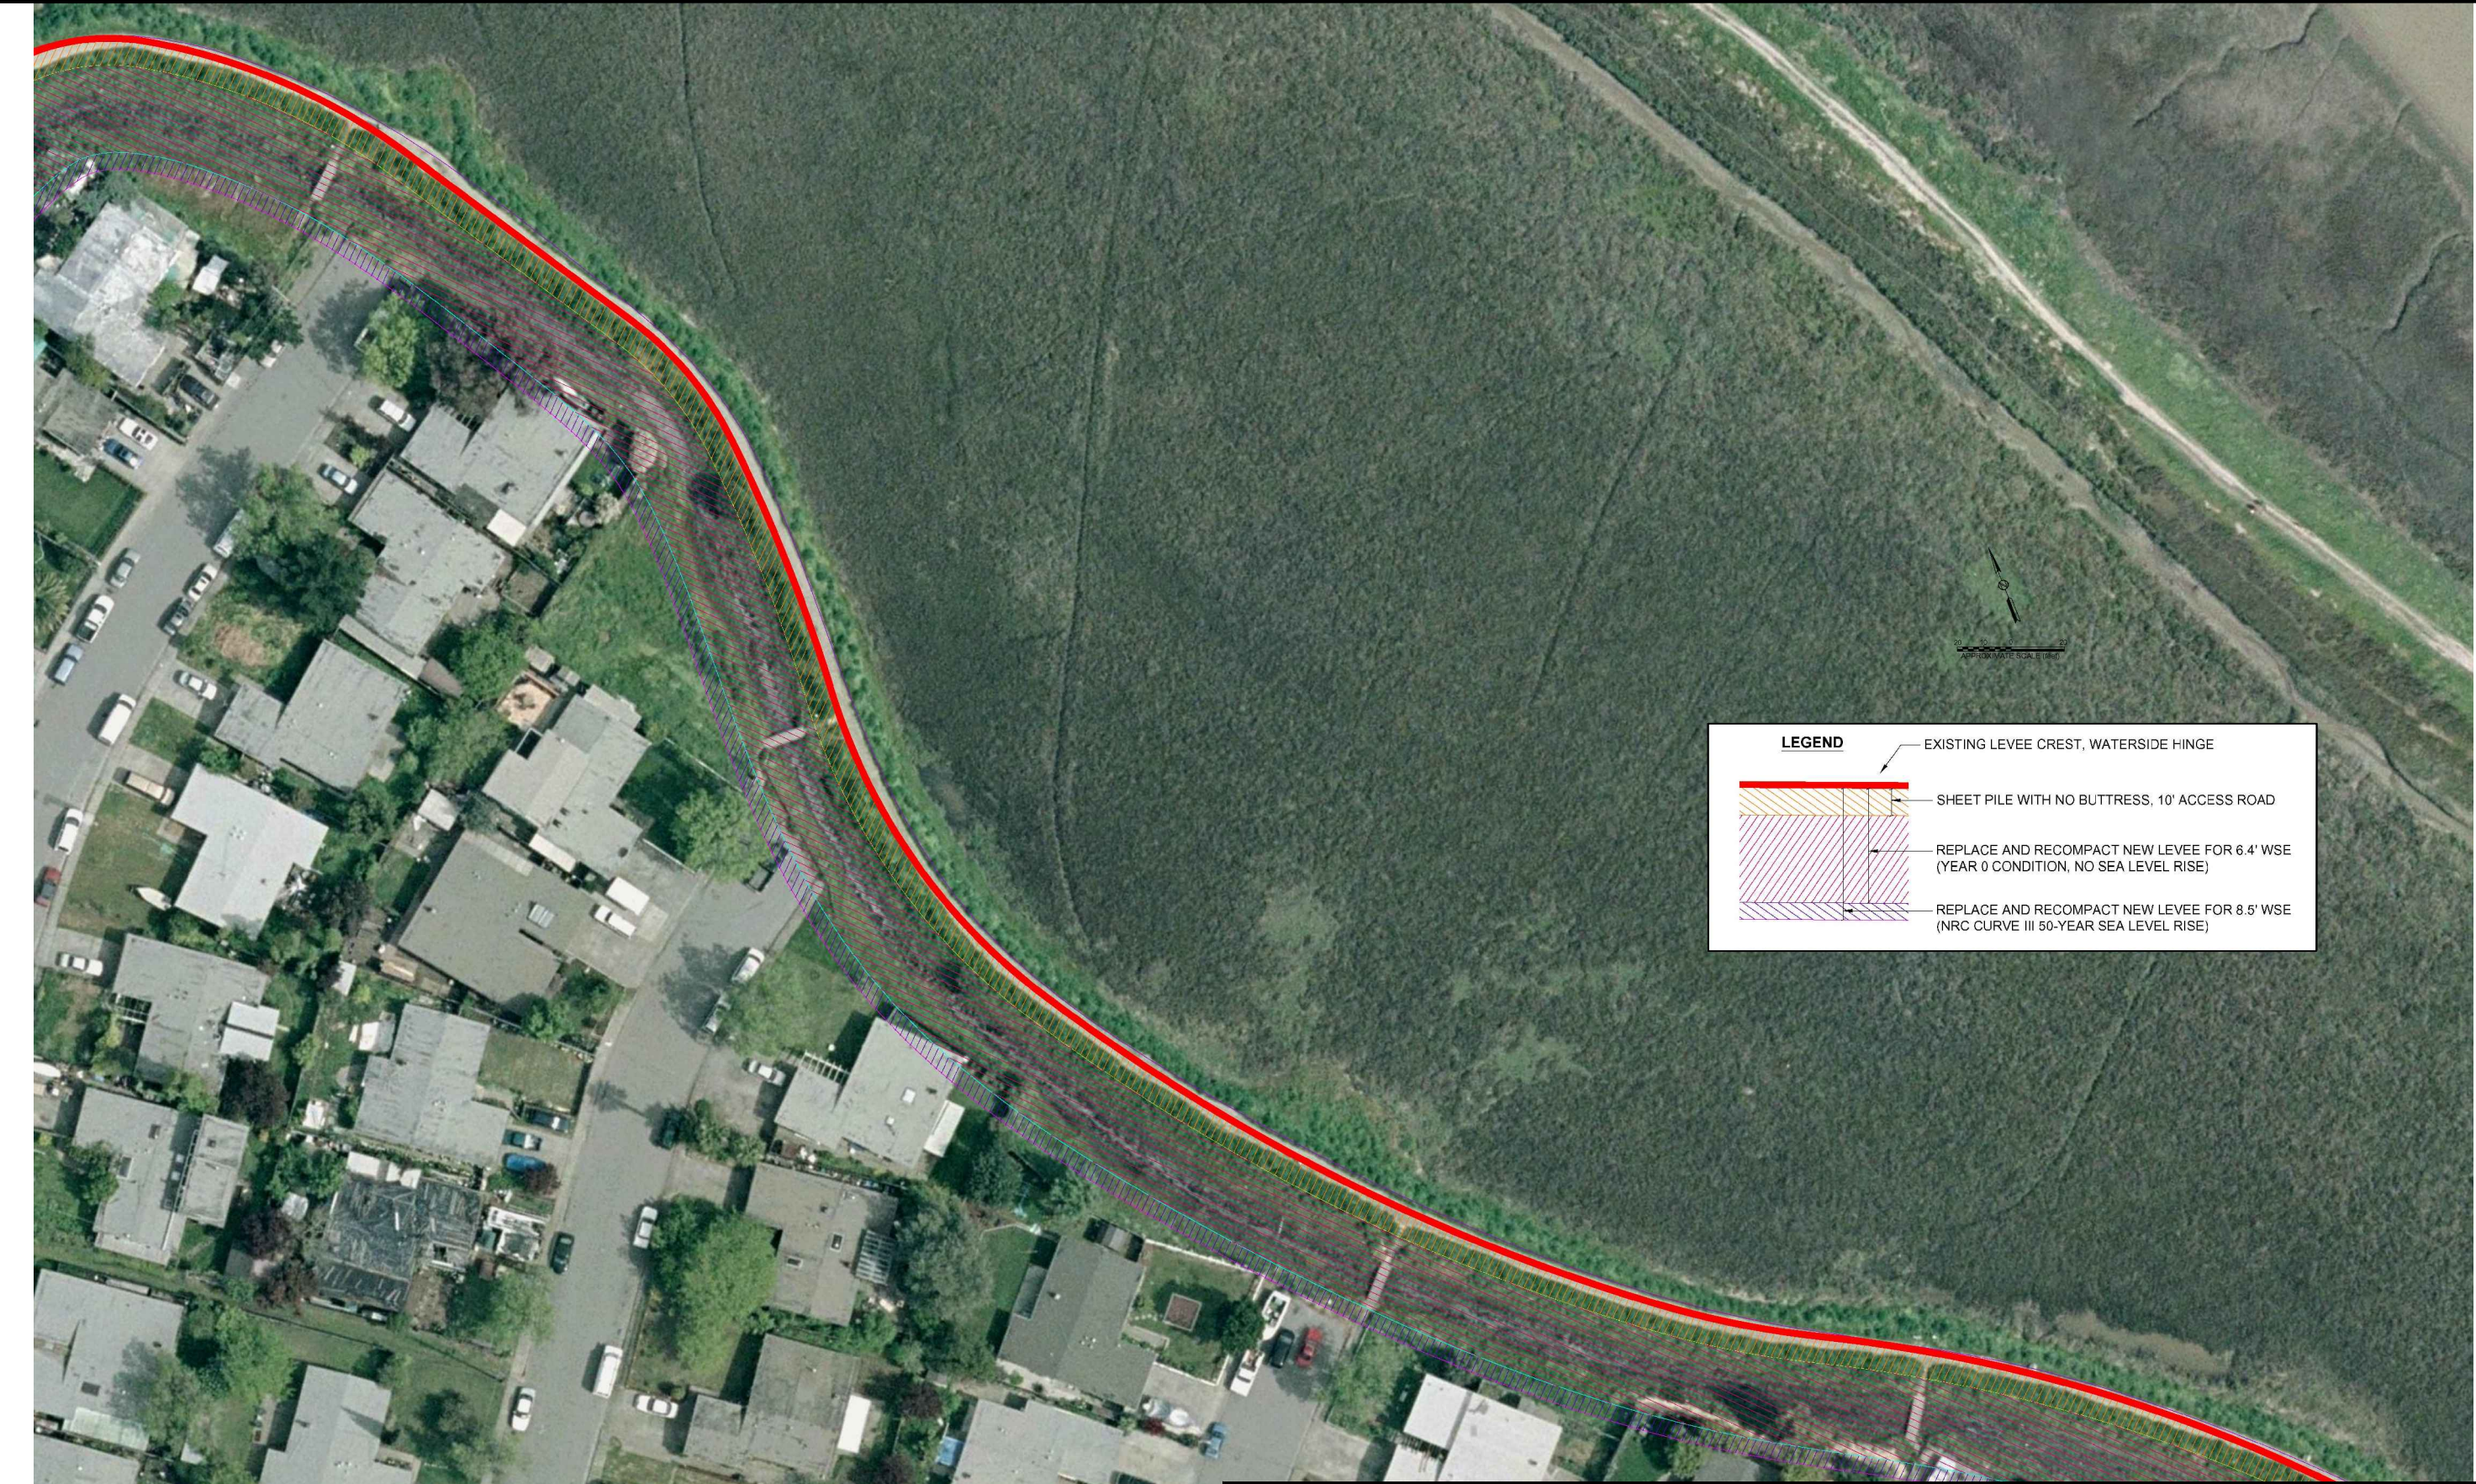
PROJECT NO. 96670	REACH 1 - VIEW 5	PLATE 5-6
DRAWN: JAN 2014		
DRAWN BY: AG	ALTERNATIVES ANALYSIS LAS GALLINAS LEVEE SYSTEM SAN RAFAEL, CALIFORNIA	
CHECKED BY: EMJ		
FILE NAME: SiteViews_1-6_R1.dwg

EXISTING LEVEE CREST, WATERSIDE HINGE
