# Project Conditions Hydraulic Evaluation of the Corte Madera Creek Levees

Stetson Engineers Inc.

October 11, 2019

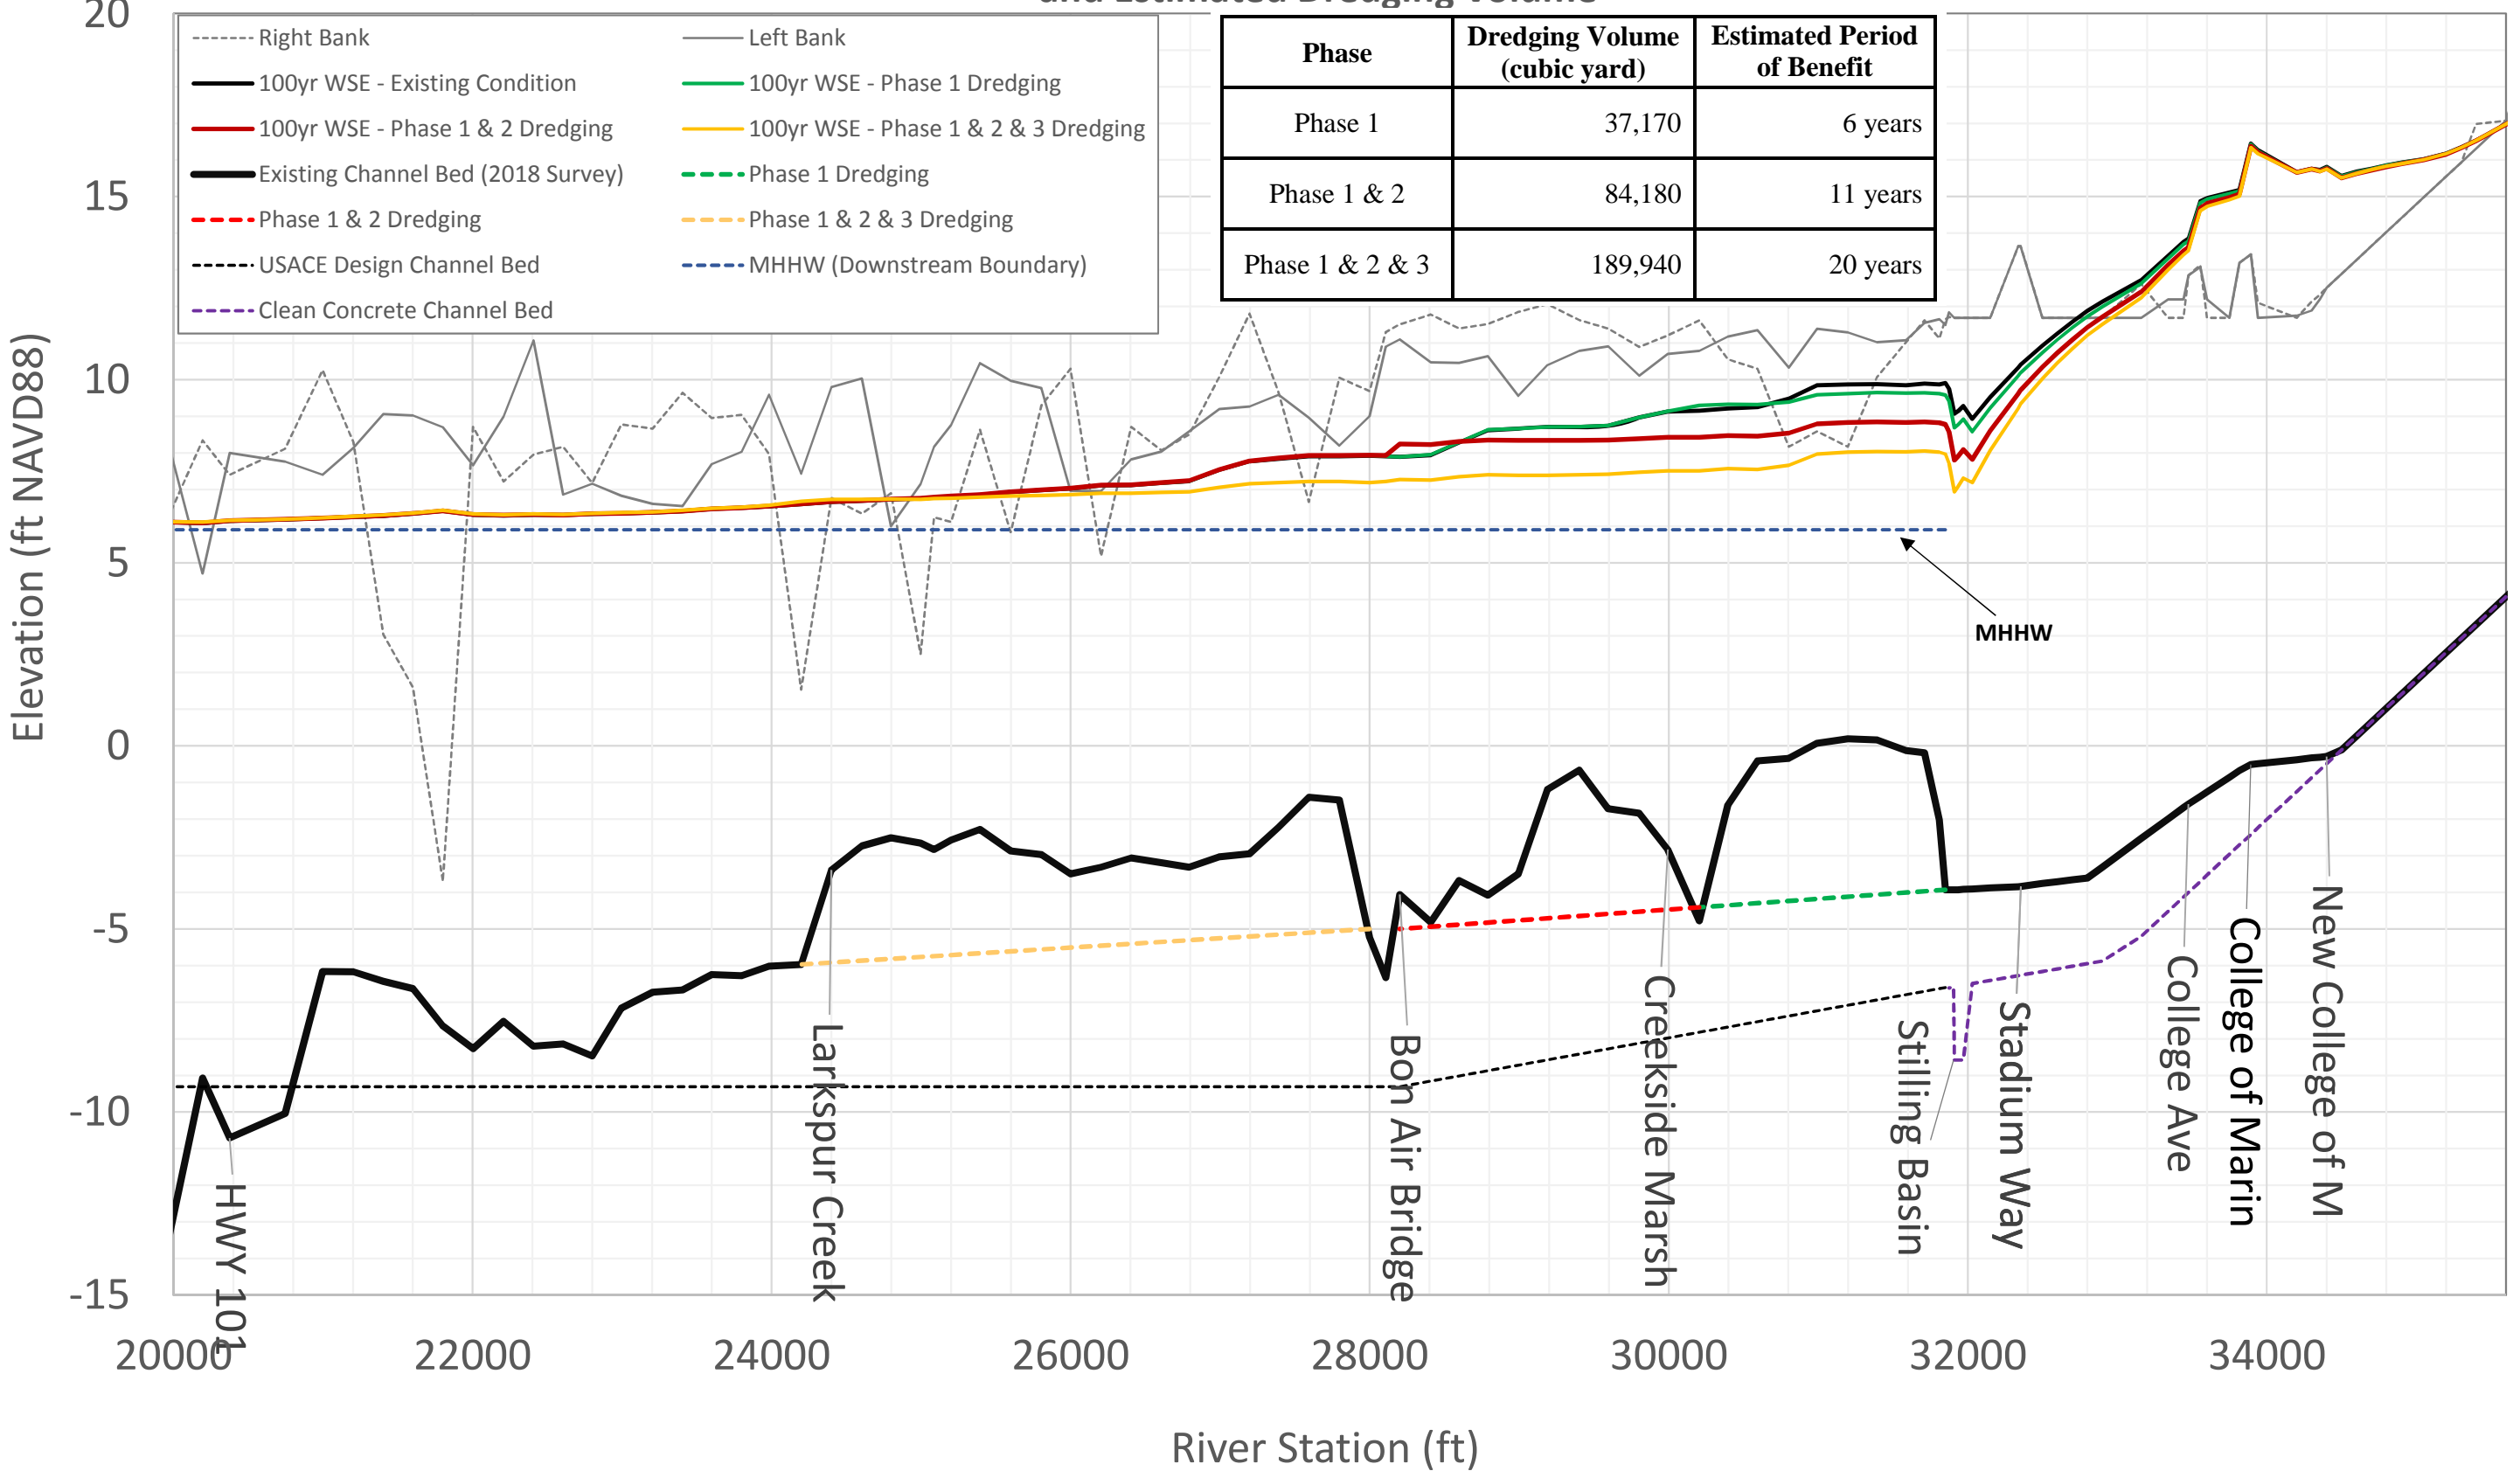
### HEC-RAS Simulated 100-Year WSE of Localized Dredging of Corte Madera Creek Earthen Channel and Estimated Dredging Volume

Figure 3 shows the dredging extent scenarios from the Stilling Basin down to the Larkspur Creek confluence (green + blue + yellow dashed lines; Phase 1 + 2 + 3). Laterally the dredged channel cross sections in the earthen channel followed the typical cross section shown in Figure 4, with the same width and same side slope (1V: 6H) as the USACE original design channel (but to varying depths along the reach). The simulated water surface elevation (WSE) profiles under

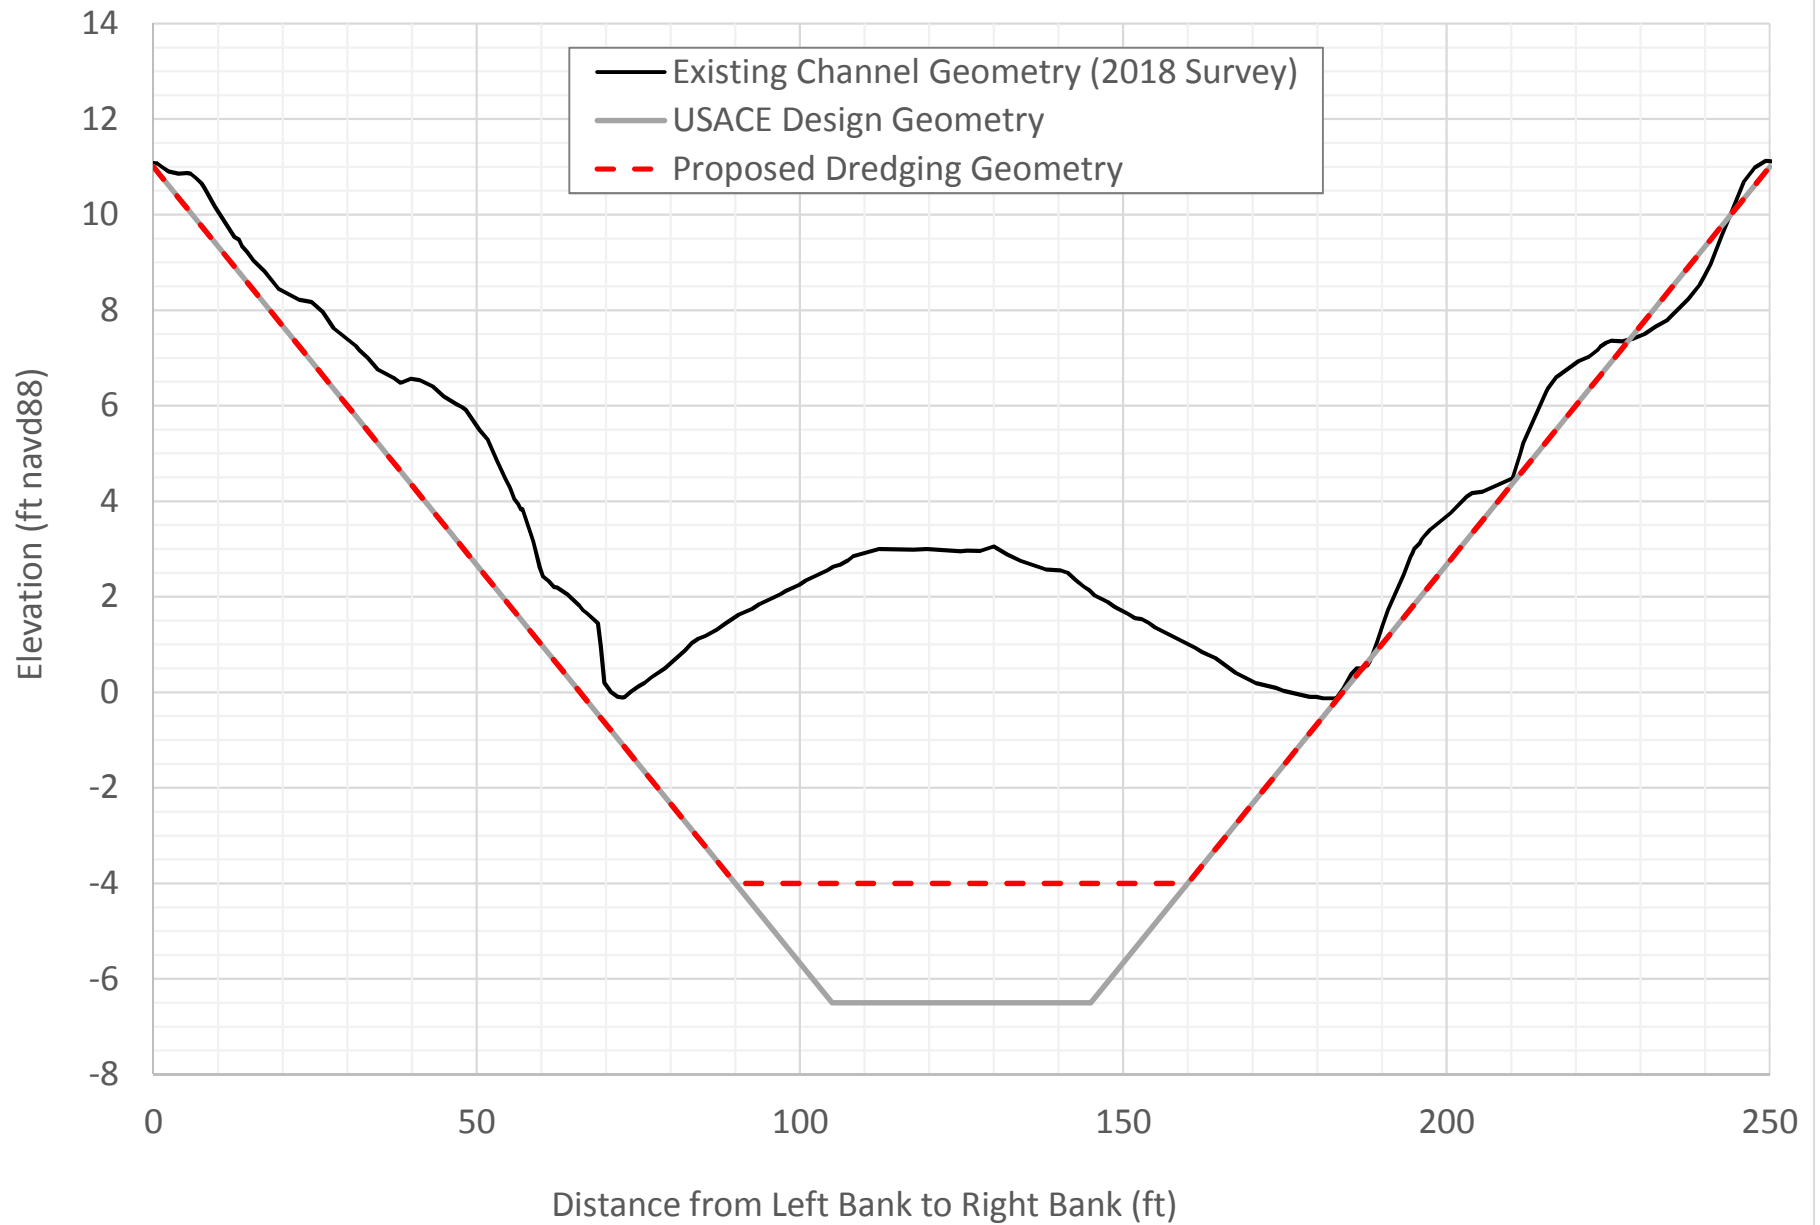
Figure 4 Proposed Earthen Channel Dredging at Typical Cross-Section (XS 31587)

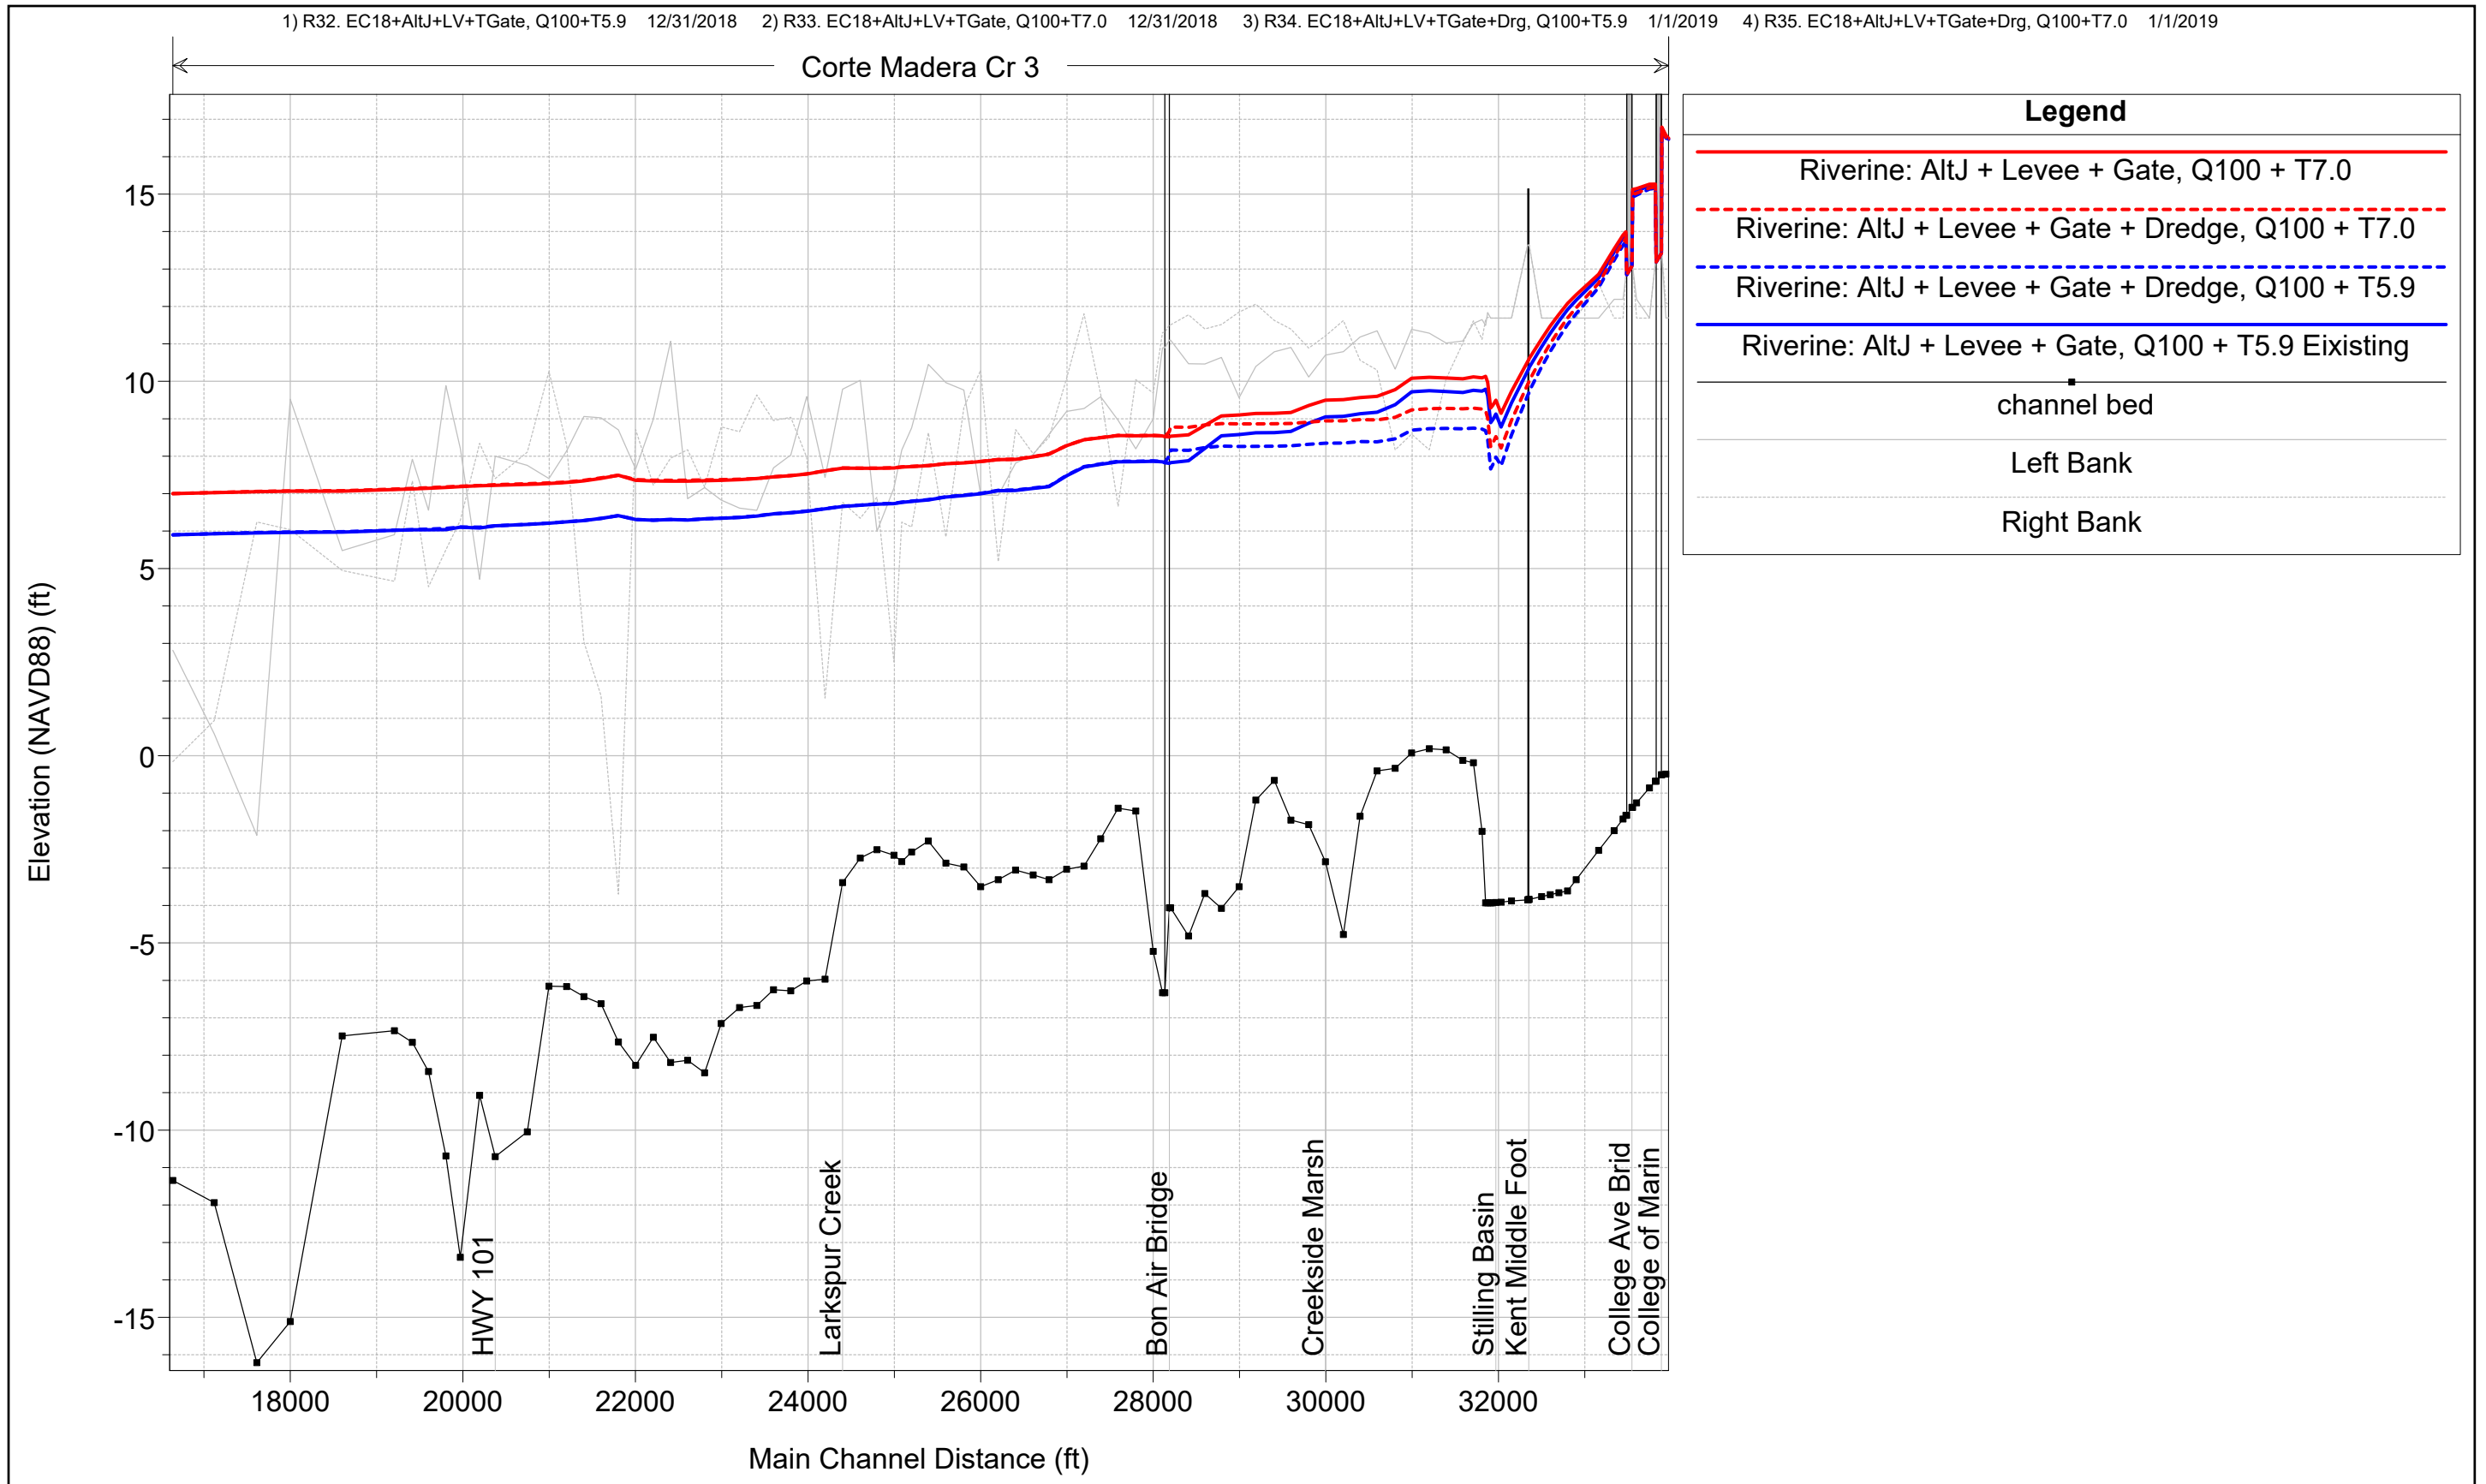
**Figure 15 Riverine 100-Year WSE Profiles; Scenarios #1, #2, #3, and #4 (solid blue, dashed blue, solid red, dashed red respectively)**

Figure 15 shows the simulated riverine 100-year WSE profiles for Scenarios #1 to #4 and Figure 16 shows the simulated coastal 100-year WSE profiles for Scenarios #5 to #8.

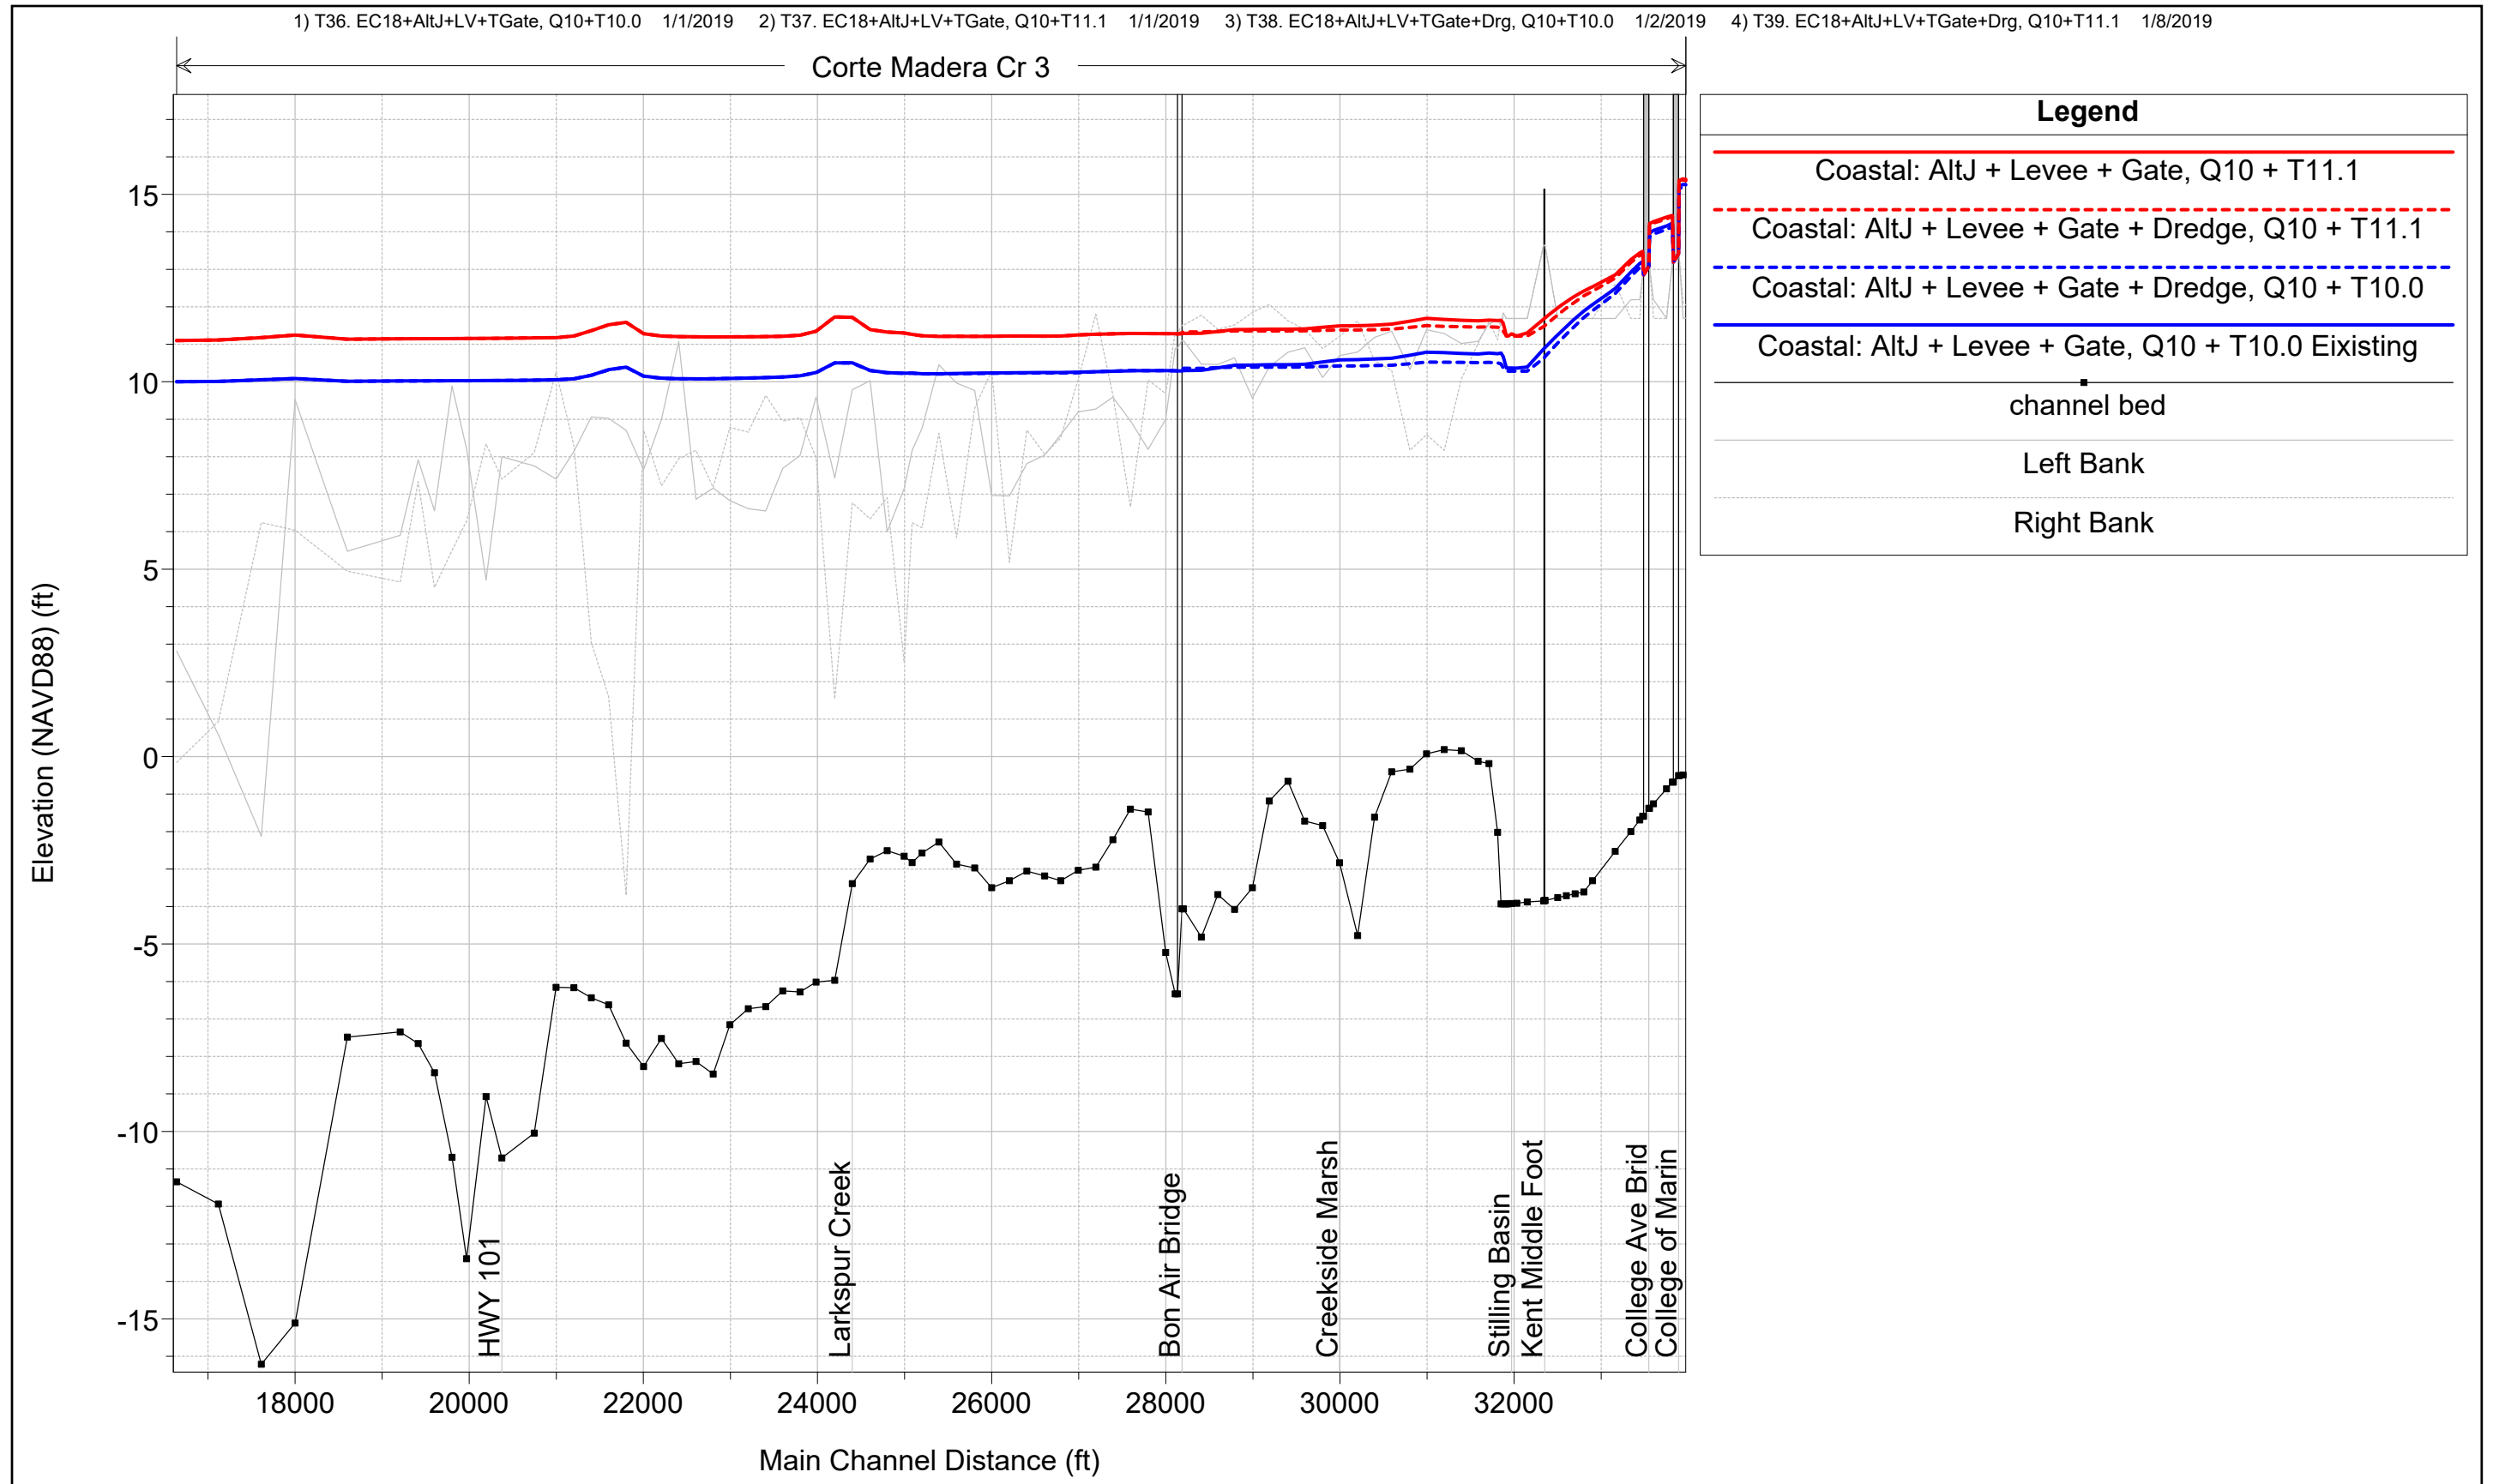
**Figure 16 Coastal 100-Year WSE Profiles; Scenarios #5, #6, #7, and #8 (solid blue, dashed blue, solid red, dashed red respectively)**

- The benefit of dredging during a 100-year coastal flood would be minimal (see Figure 16).

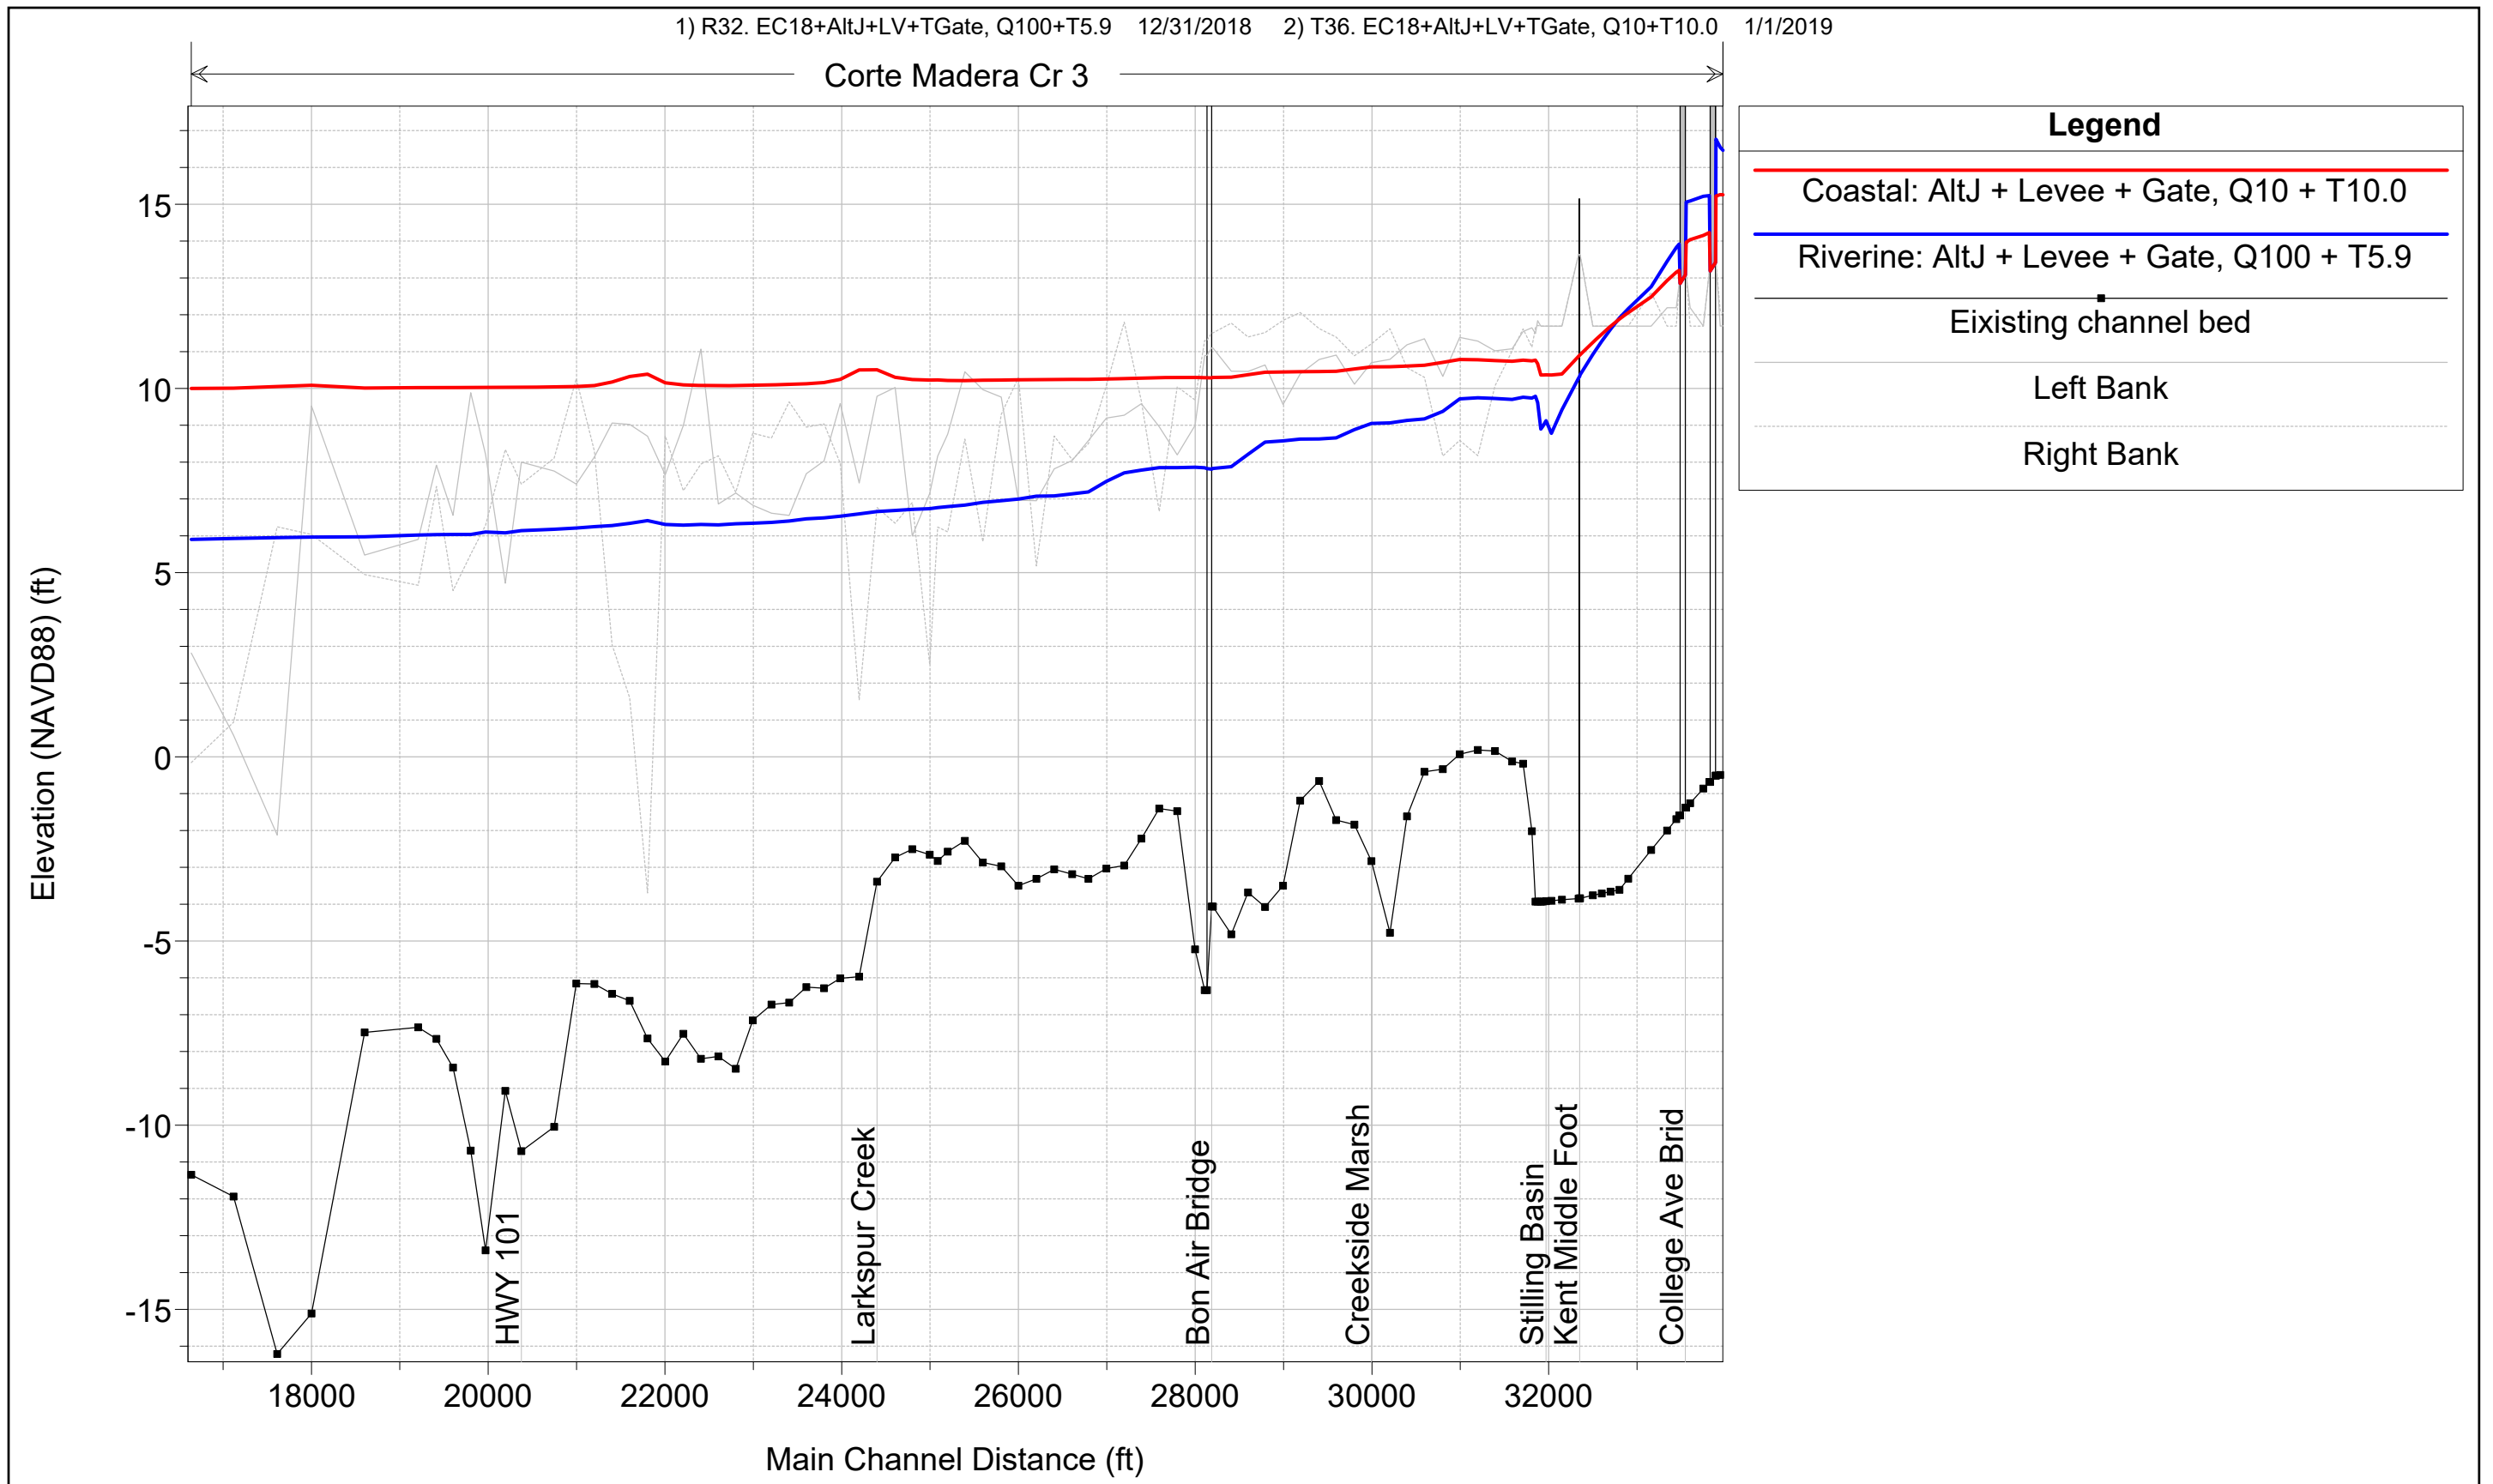
Figure 17 Riverine and Coastal 100-Year WSE Profiles; (no dredge, no SLR); Scenarios #1 and #5

Figure 17 compares the simulated WSE profiles between the riverine 100-year flood and the coastal 100-year flood under the without dredge and without SLR conditions (Scenario #1 vs. Scenario #5).

- The flood WSE along the Corte Madera Creek earthen channel is dominated by the 100-year coastal flood (see Figures 17 – 20).
- With the levees/flood barriers in place, the benefit of dredging during a 100-year riverine flood would be insignificant in terms of reduction in flood inundation (see Figures 13 and 14).

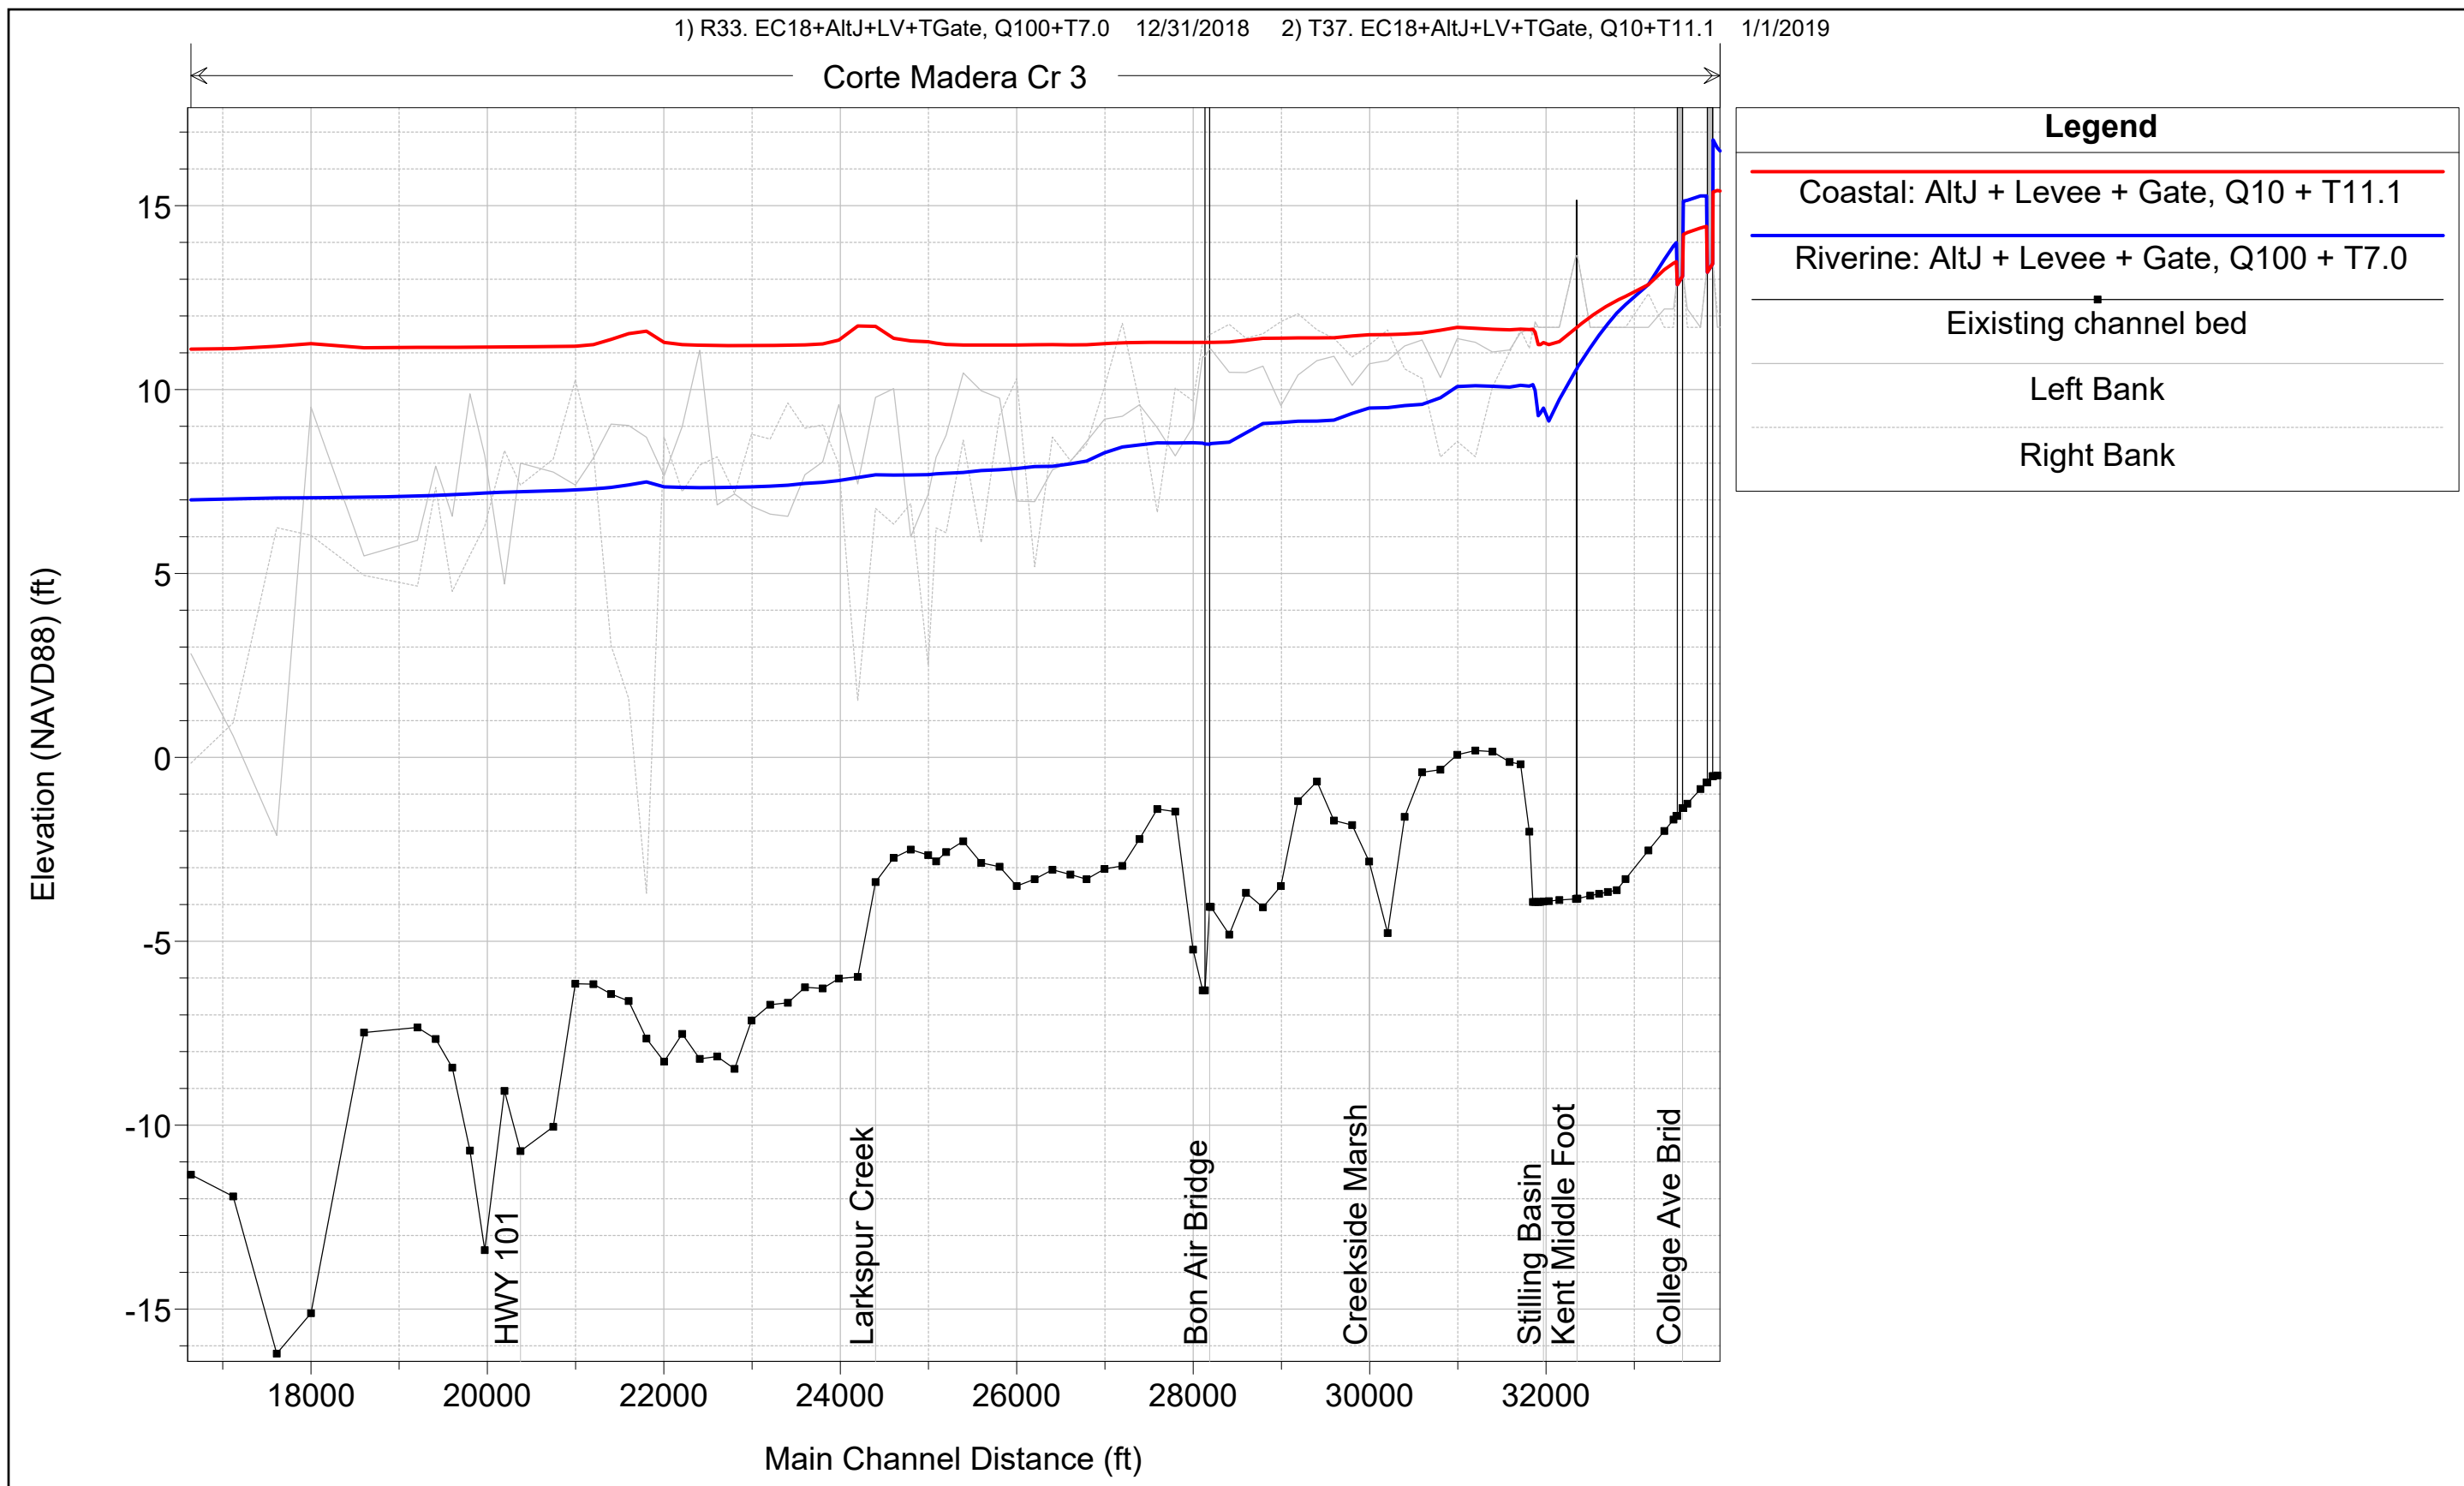
Figure 18 Riverine and Coastal 100-Year WSE Profiles; (no dredge, with SLR); Scenarios #2 and #6

Figure 18 compares the simulated WSE profiles between the riverine 100-year flood and the coastal 100-year flood under the without dredge and with SLR conditions (Scenario #2 vs. Scenario #6).
