# Project Conditions Hydraulic Evaluation of the Corte Madera Creek Levees

Stetson Engineers Inc.

October 11, 2019

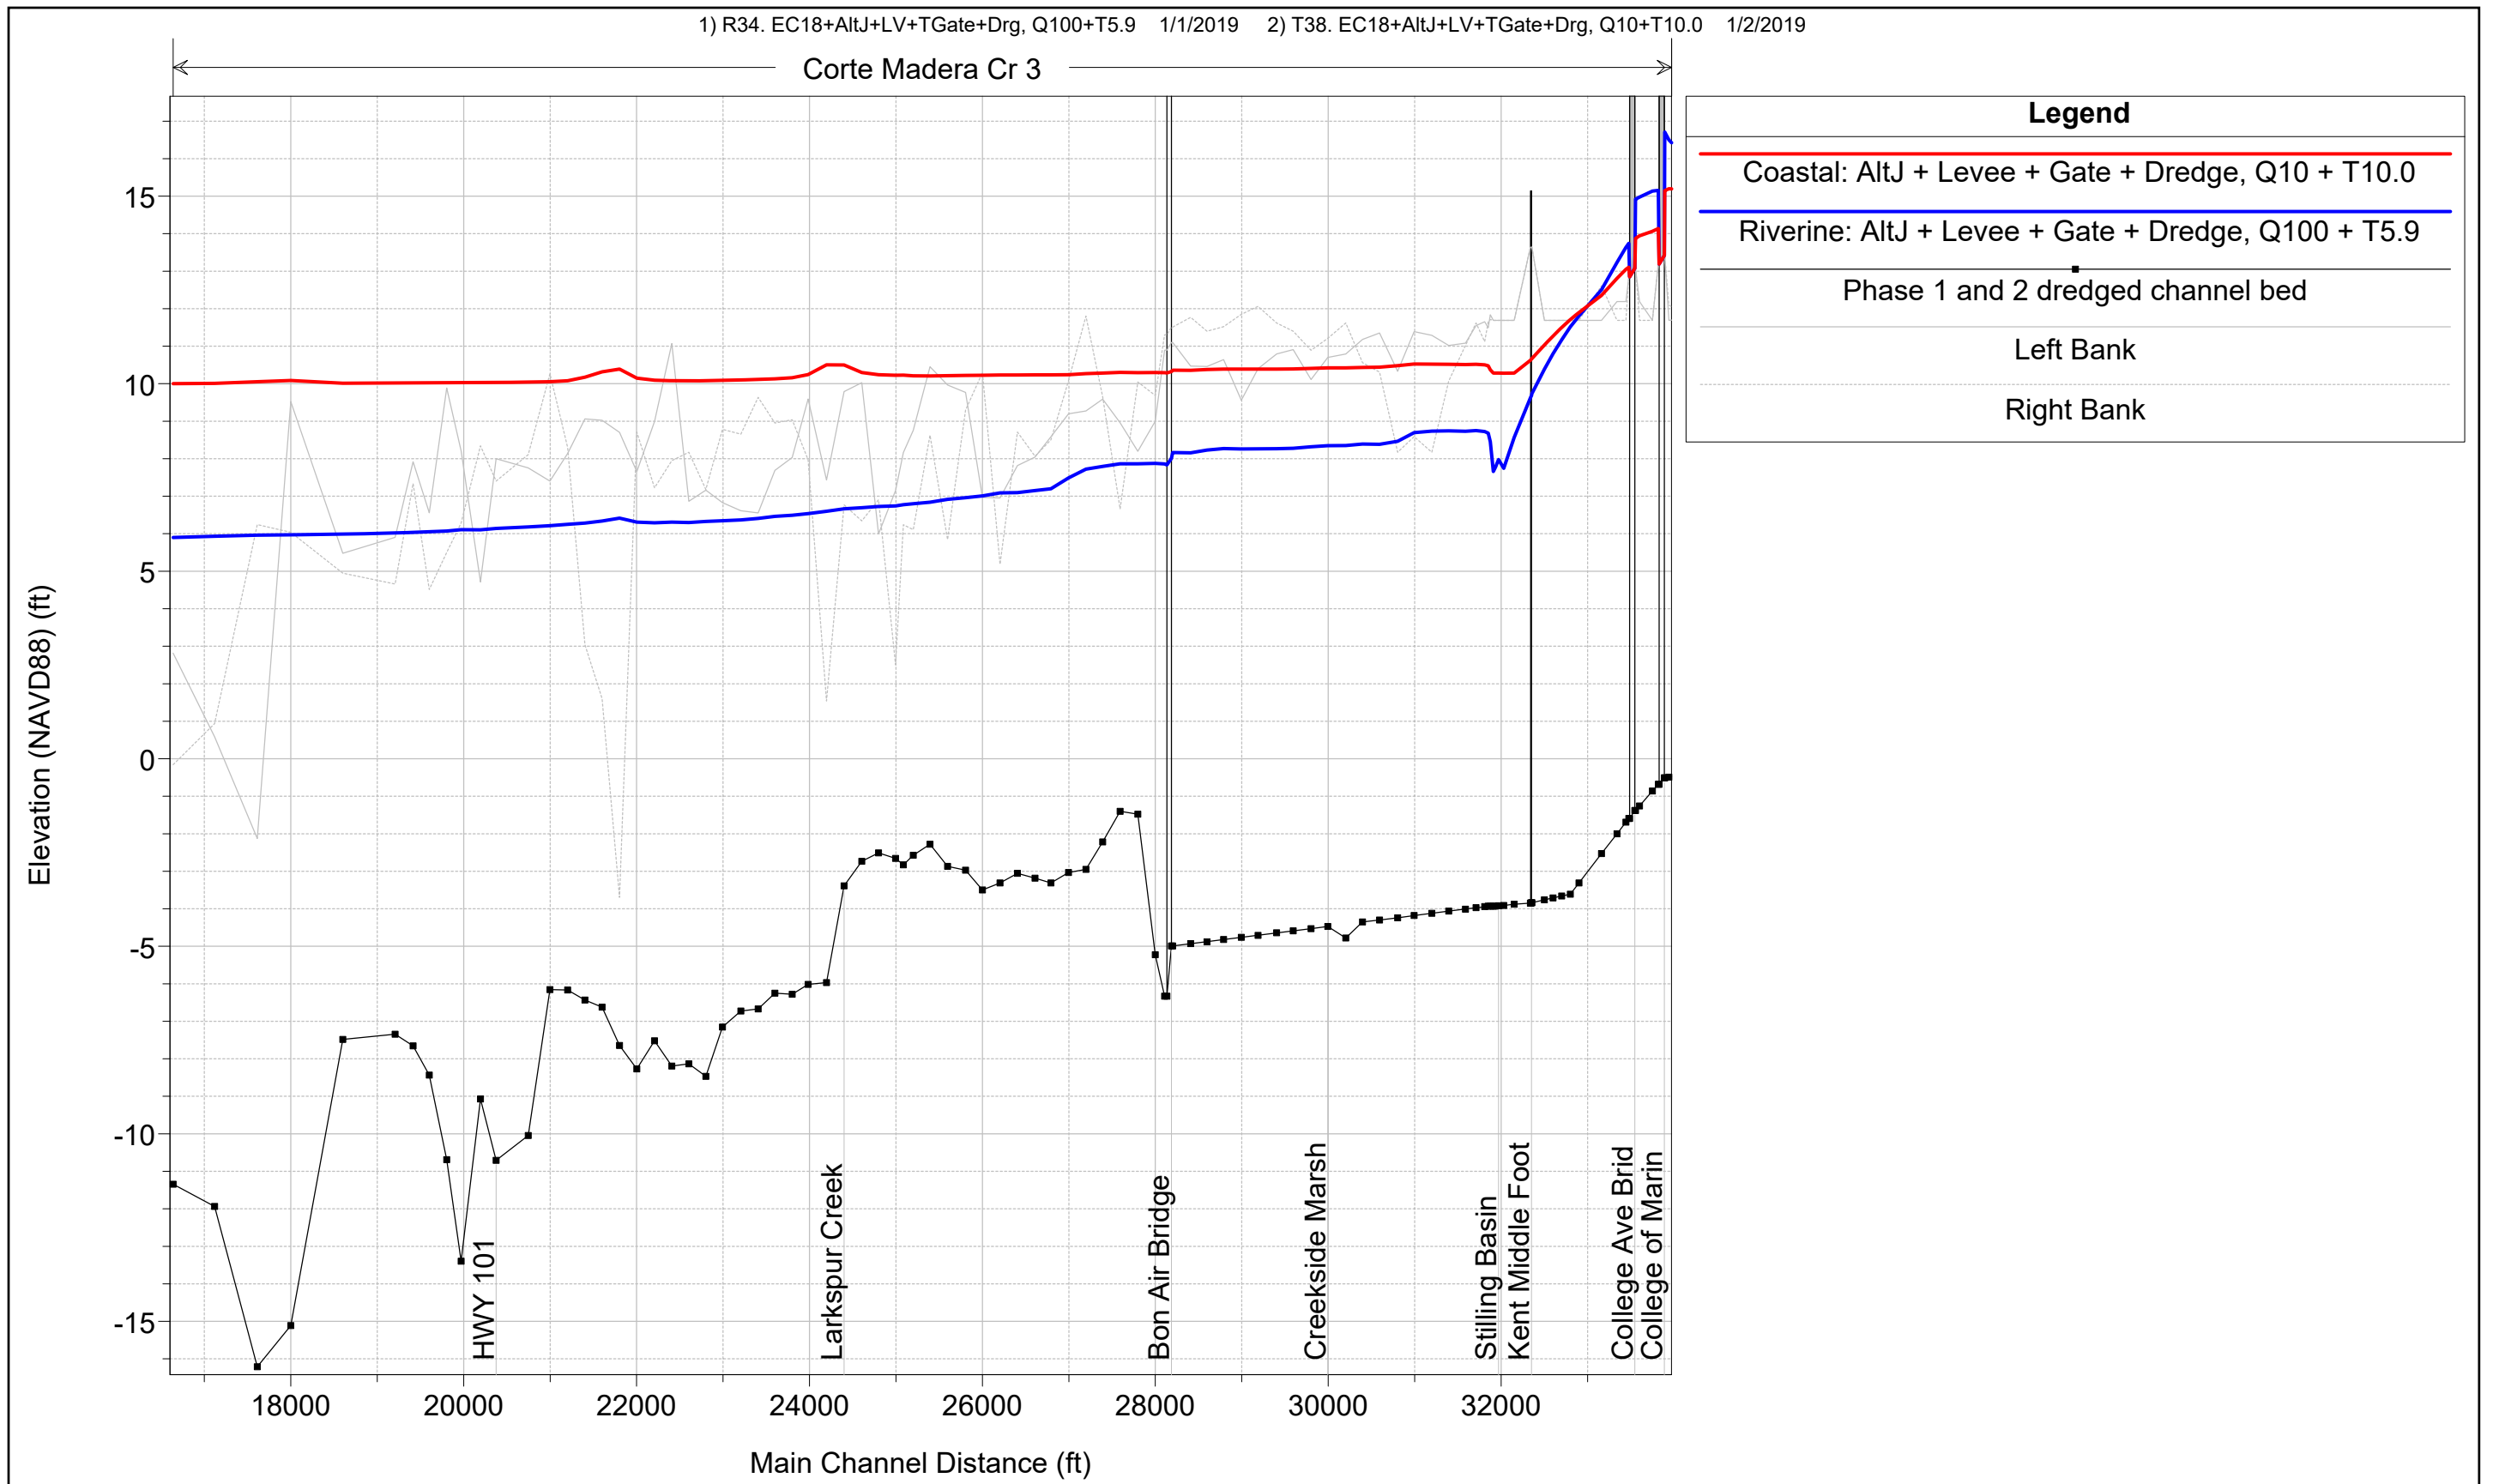
Figure 19 Riverine and Coastal 100-Year WSE Profiles; (with dredge, no SLR); Scenarios #3 and #7

Figure 19 compares the simulated WSE profiles between the riverine 100-year flood and the coastal 100-year flood under the with dredge and without SLR conditions (Scenario #3 vs. Scenario #7).

- The flood WSE along the Corte Madera Creek earthen channel is dominated by the 100-year coastal flood (see Figures 17 – 20).
- With the levees/flood barriers in place, the benefit of dredging during a 100-year riverine flood would be insignificant in terms of reduction in flood inundation (see Figures 13 and 14).

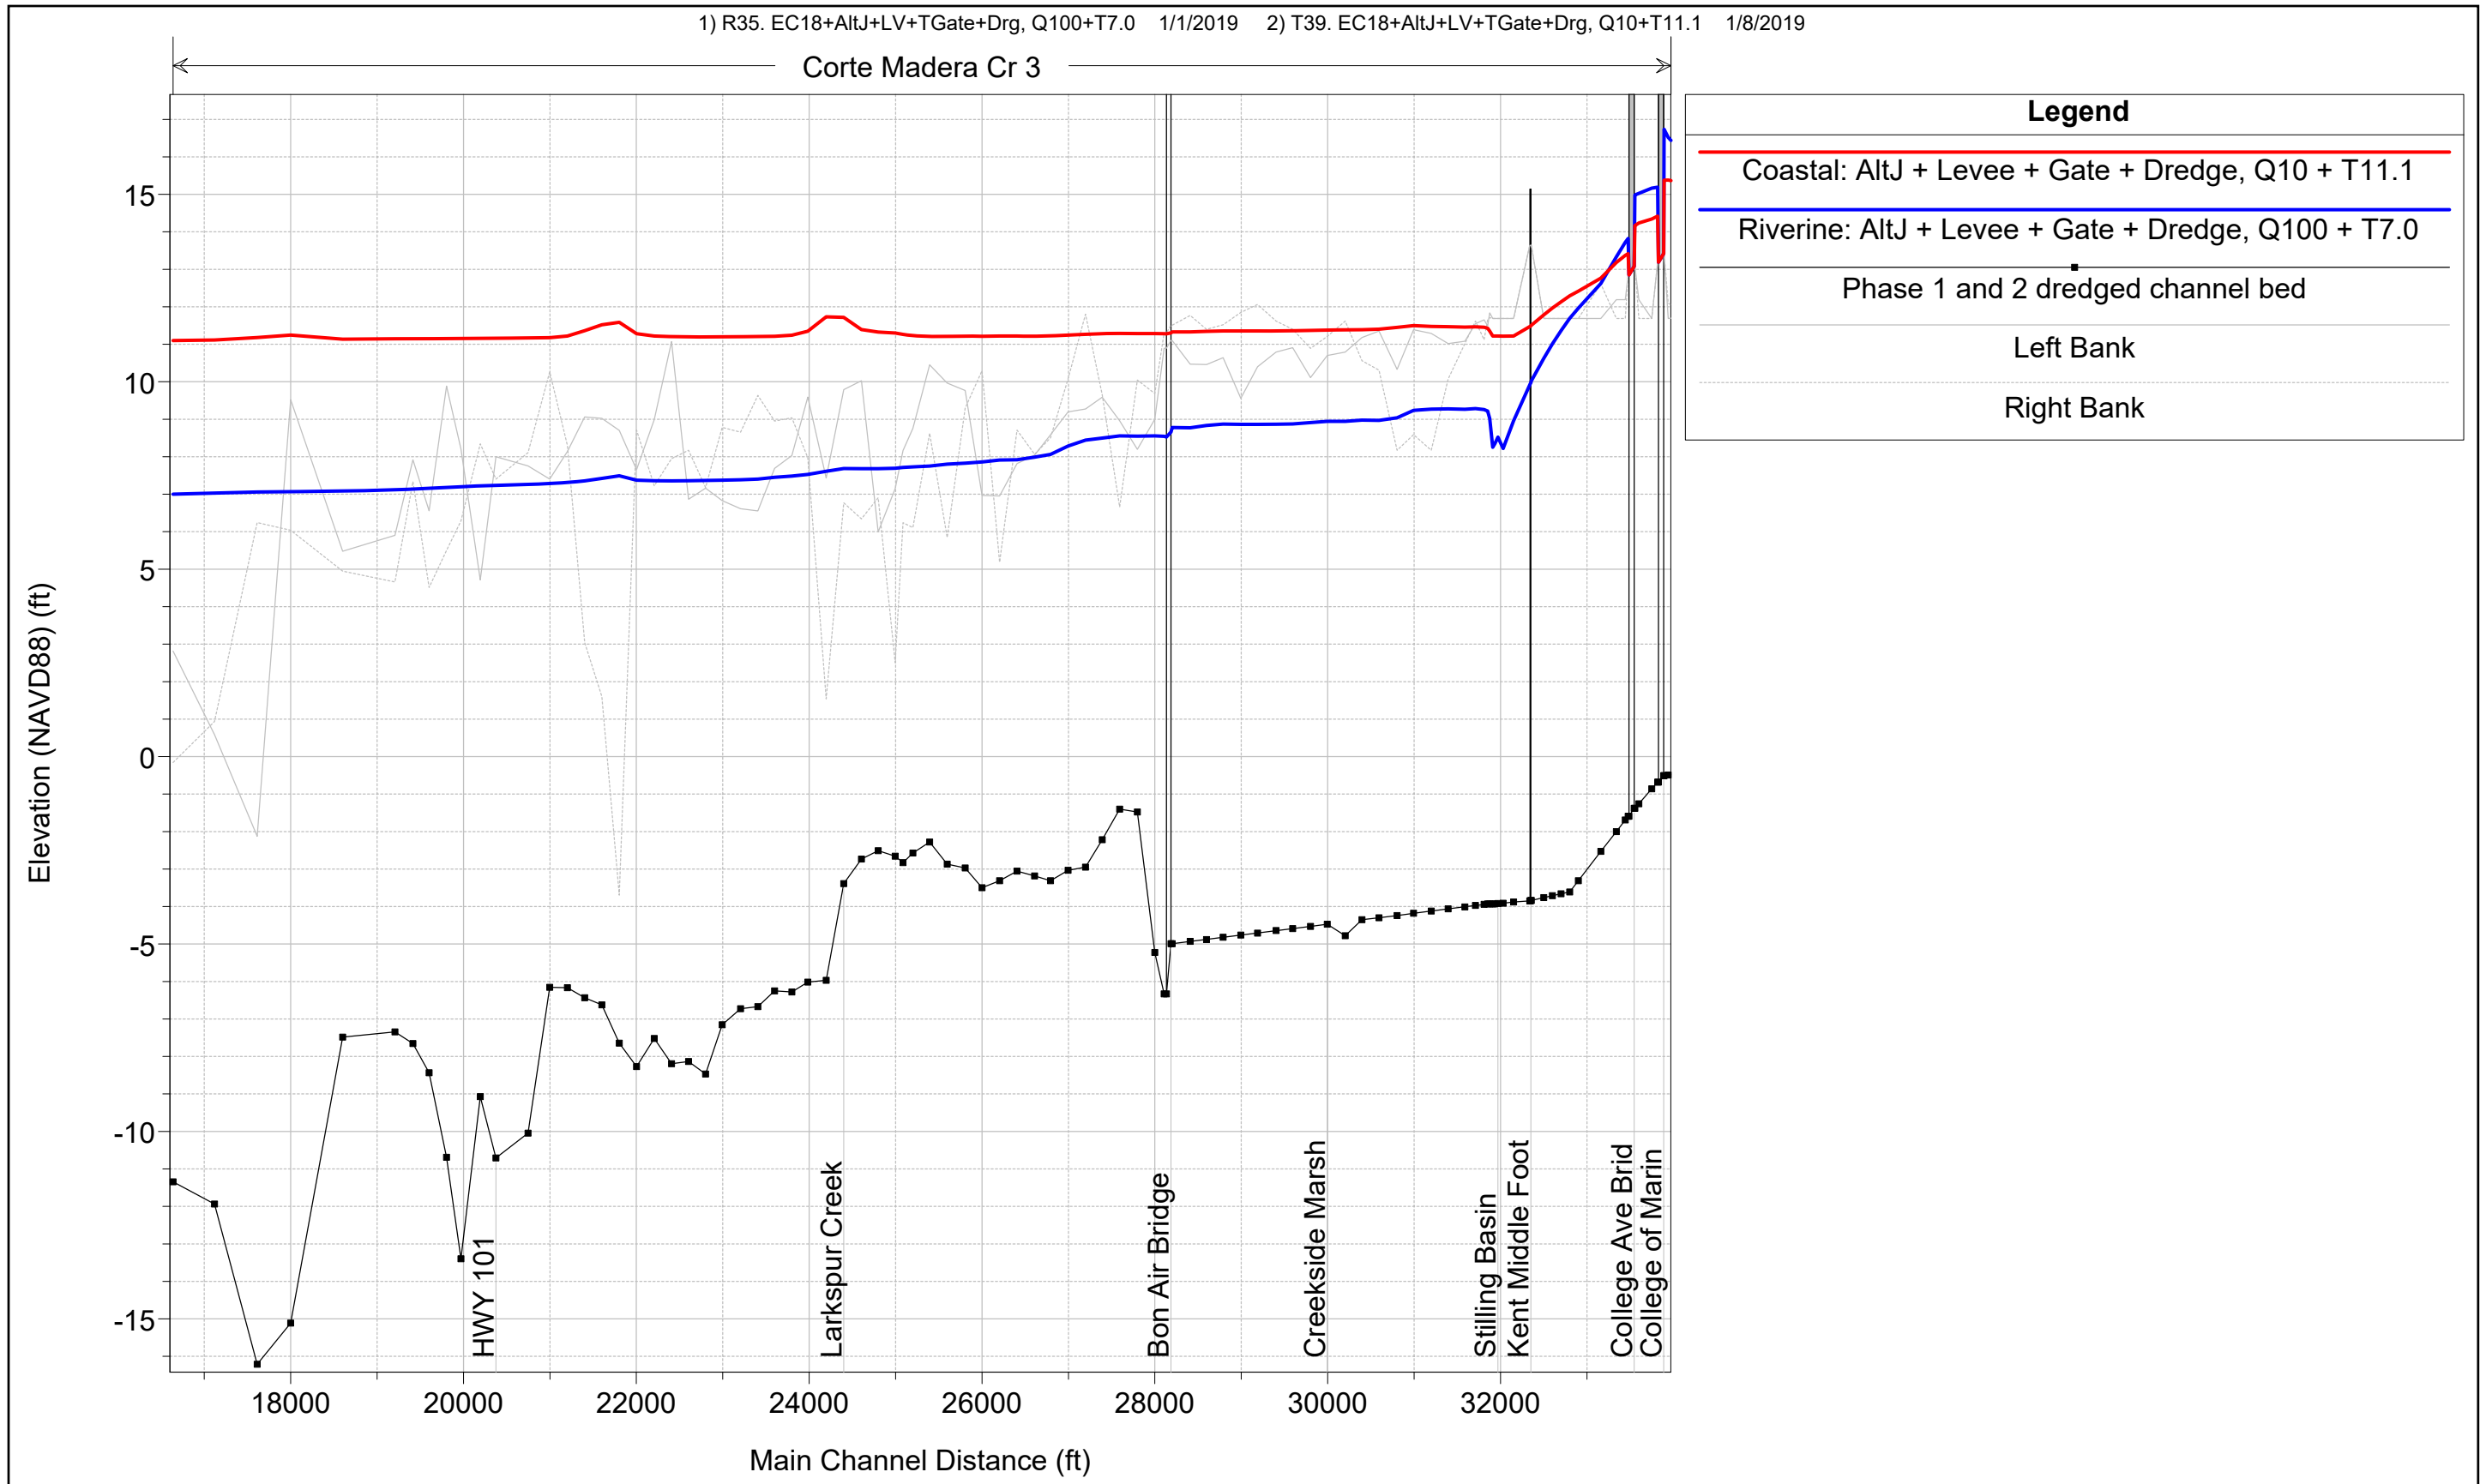
Figure 20 Riverine and Coastal 100-Year WSE Profiles; (with dredge, with SLR); Scenarios #4 and #8

Figure 20 compares the simulated WSE profiles between the riverine 100-year flood and the coastal 100-year flood under the with dredge and with SLR conditions (Scenario #4 vs. Scenario #8).

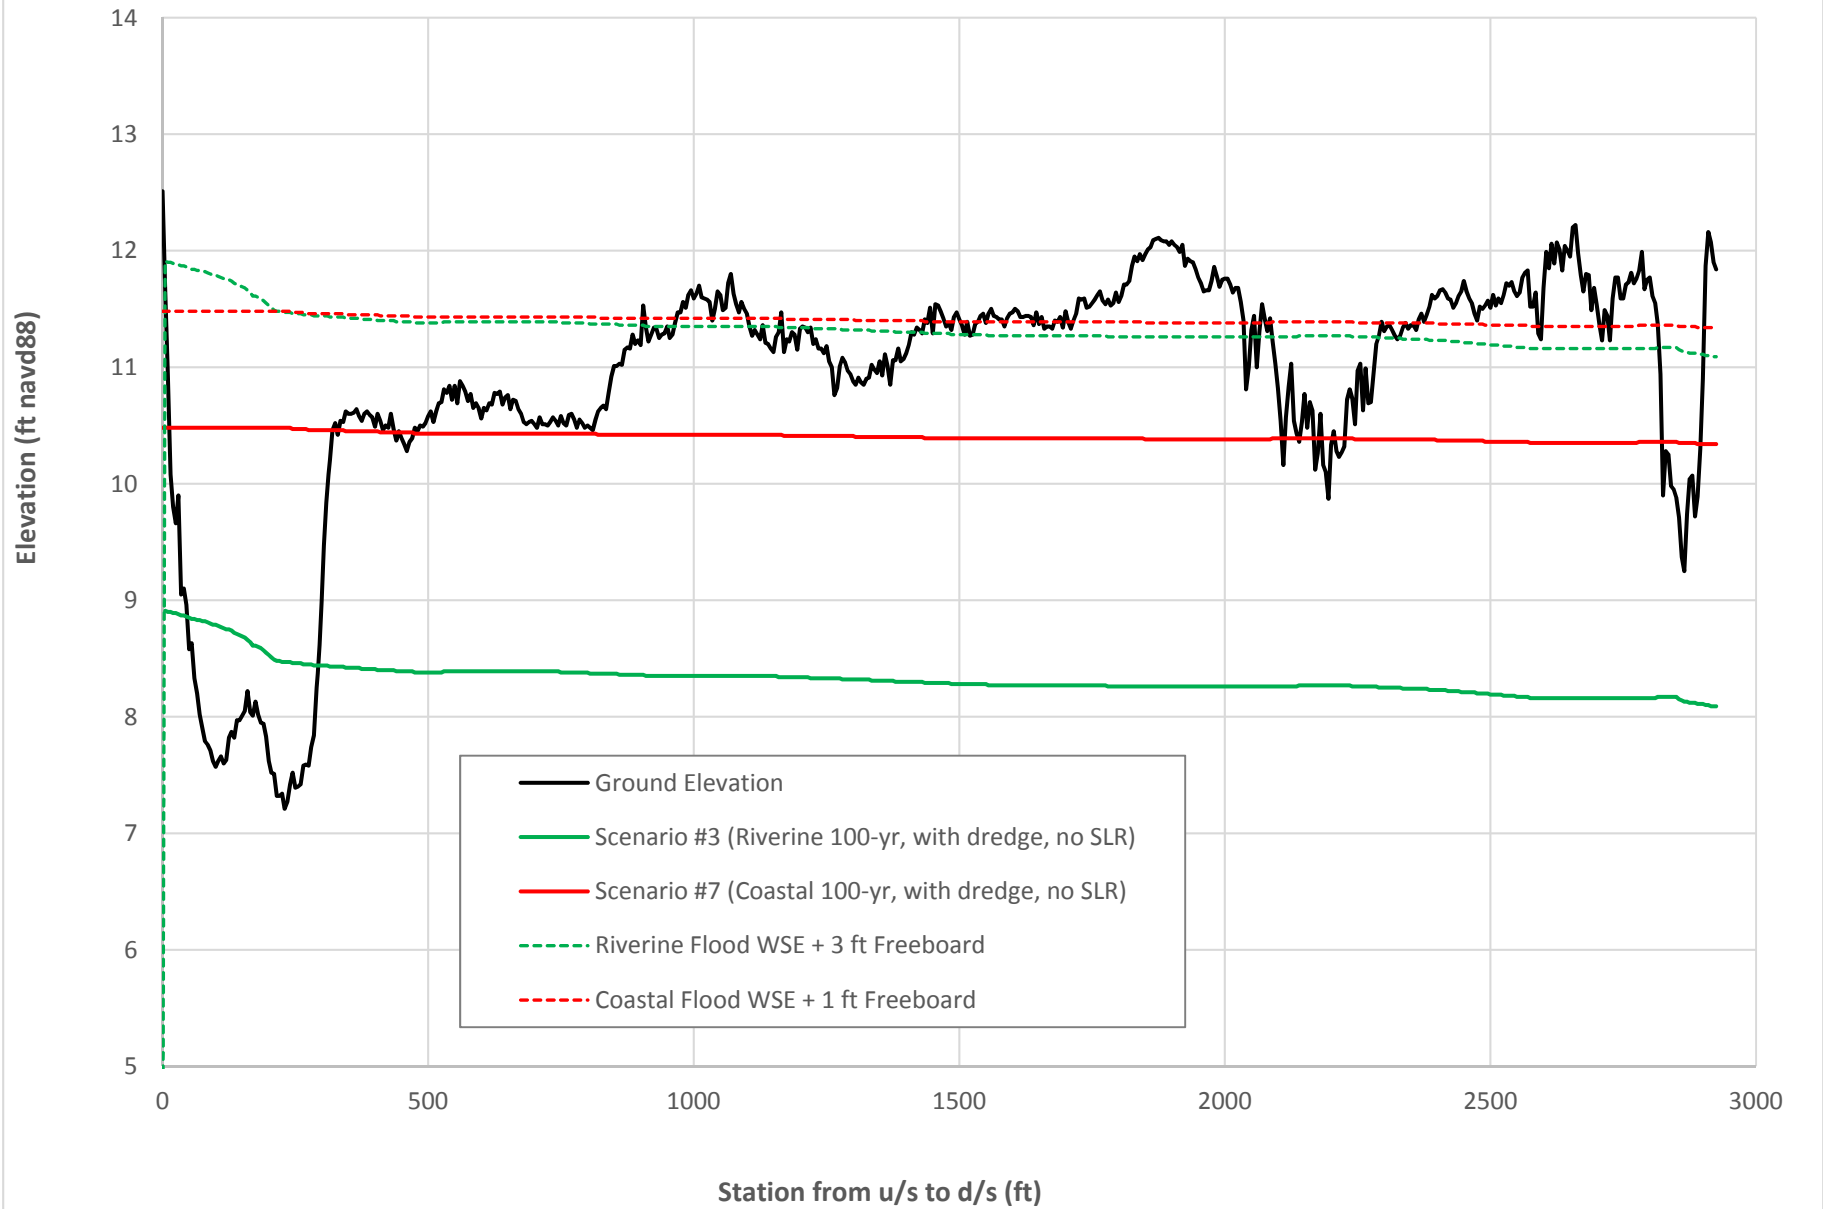
Figure 21c

WSE and Ground Elevations along Hillview Gardens Levee and Freeboard Assessment  
- Scenario 3 vs. 7; with Dredge; No SLR

Figures 21a, 21b, 21c, and 21d graphically present the freeboard assessment for the existing Hillview Gardens levee (Scenarios #1 vs. #5, #2 vs. #6, #3 vs. #7, and #4 vs. #8, respectively).

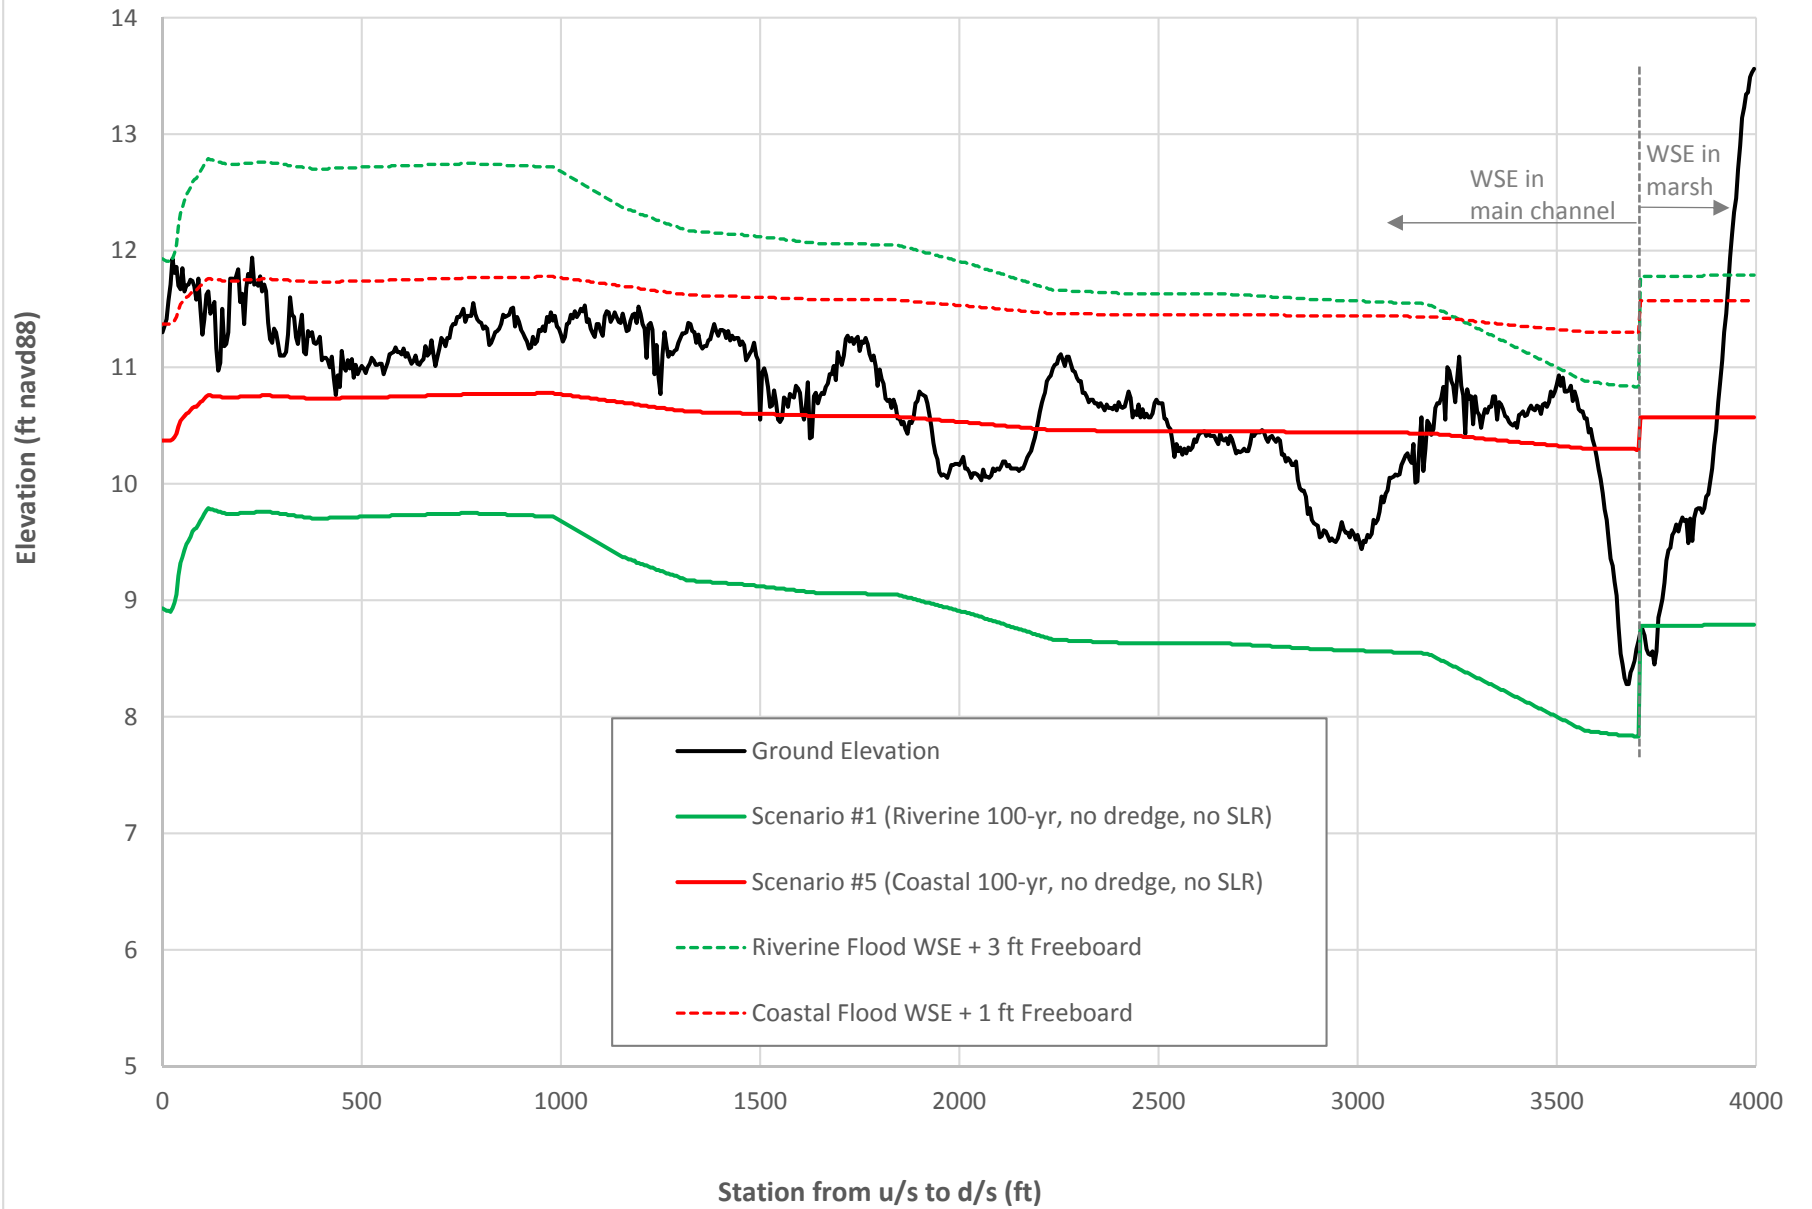
Figure 22a

WSE and Ground Elevations along Kentfield Gardens Levee and Freeboard Assessment  
- Scenario 1 vs. 5; No Dredge; No SLR

Figures 22a, 22b, 22c, and 22d graphically present the freeboard assessment for the existing Kentfield Gardens levee.

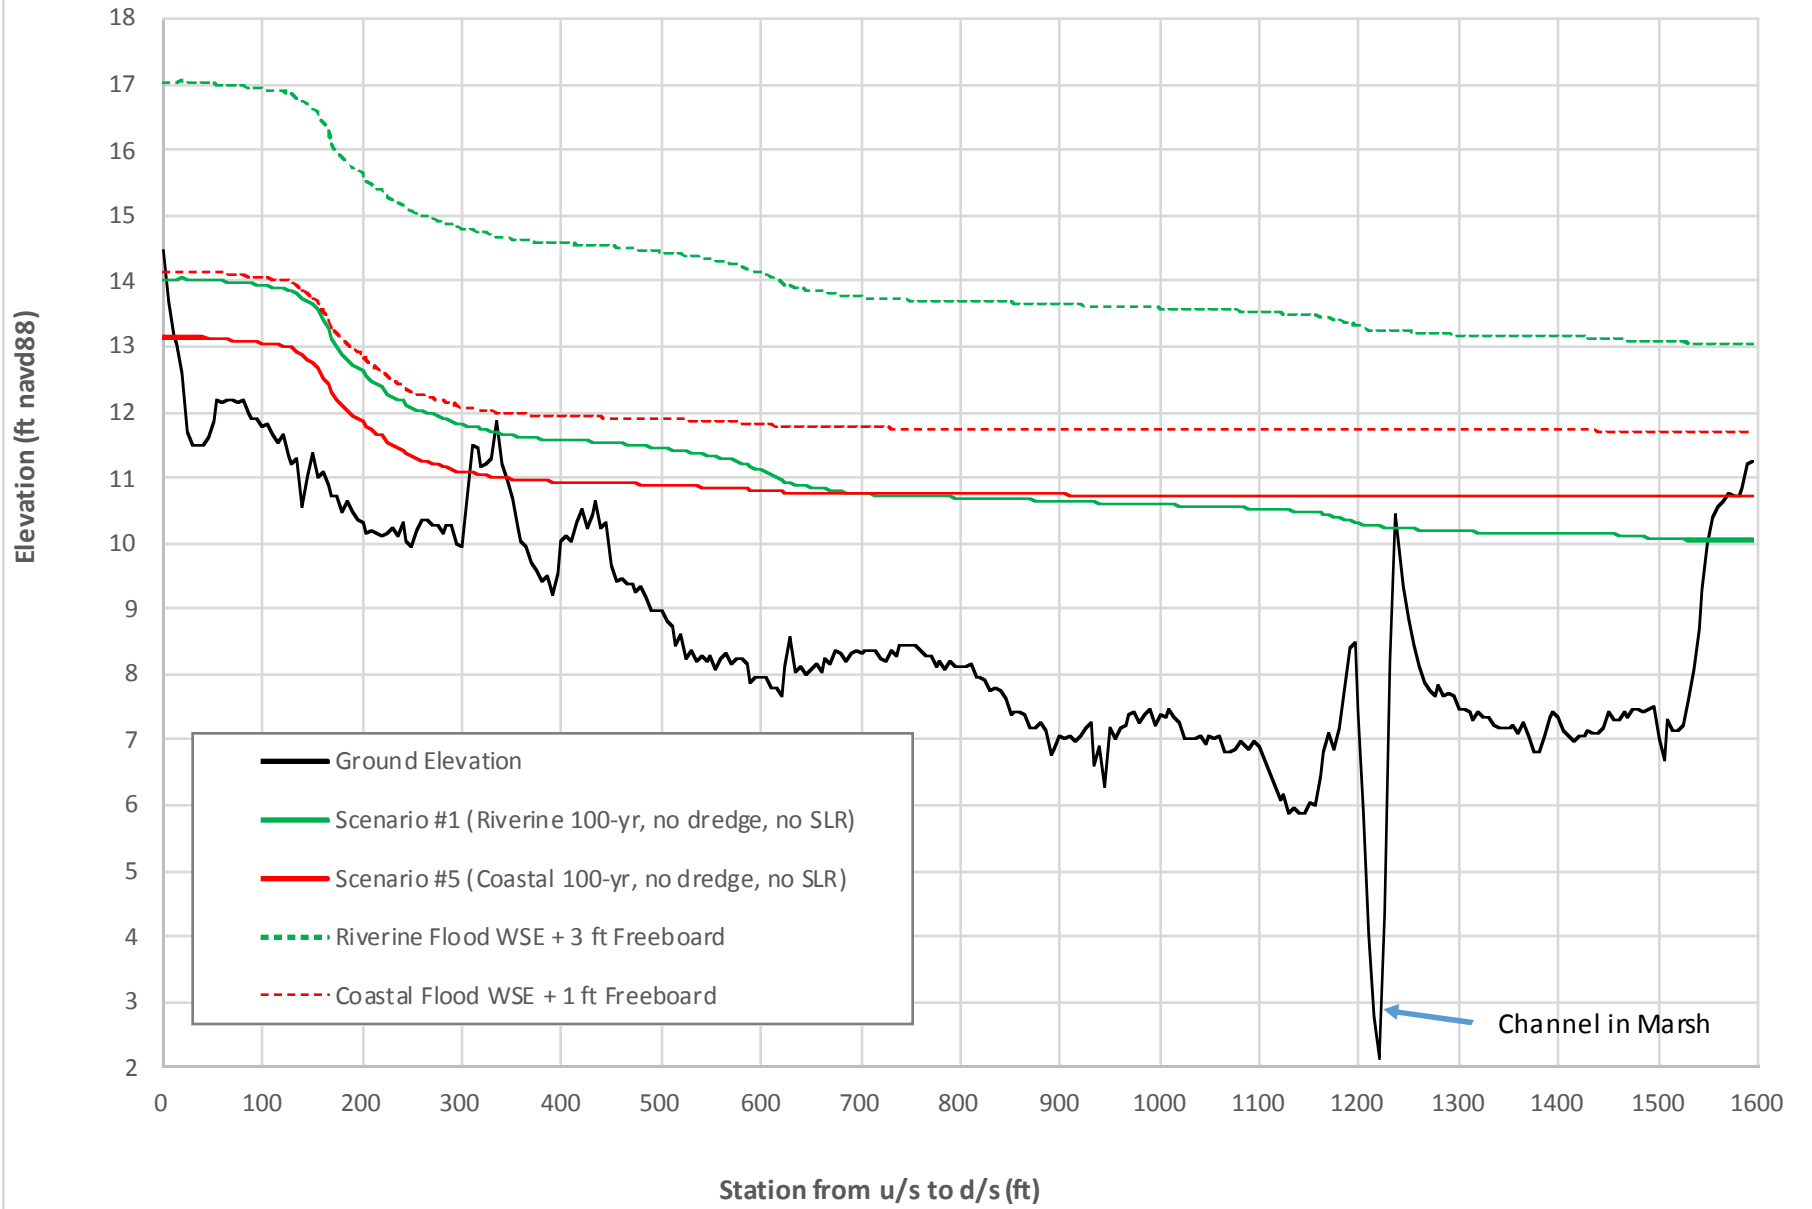
Figure 23a

WSE and Ground Elevations along College Ct Flood Barrier and Freeboard Assessment  
- Scenario 1 vs. 5; No Dredge; No SLR

Figures 23a, 23b, 23c, and 23d graphically present the freeboard assessment for the proposed College Ct flood barrier.

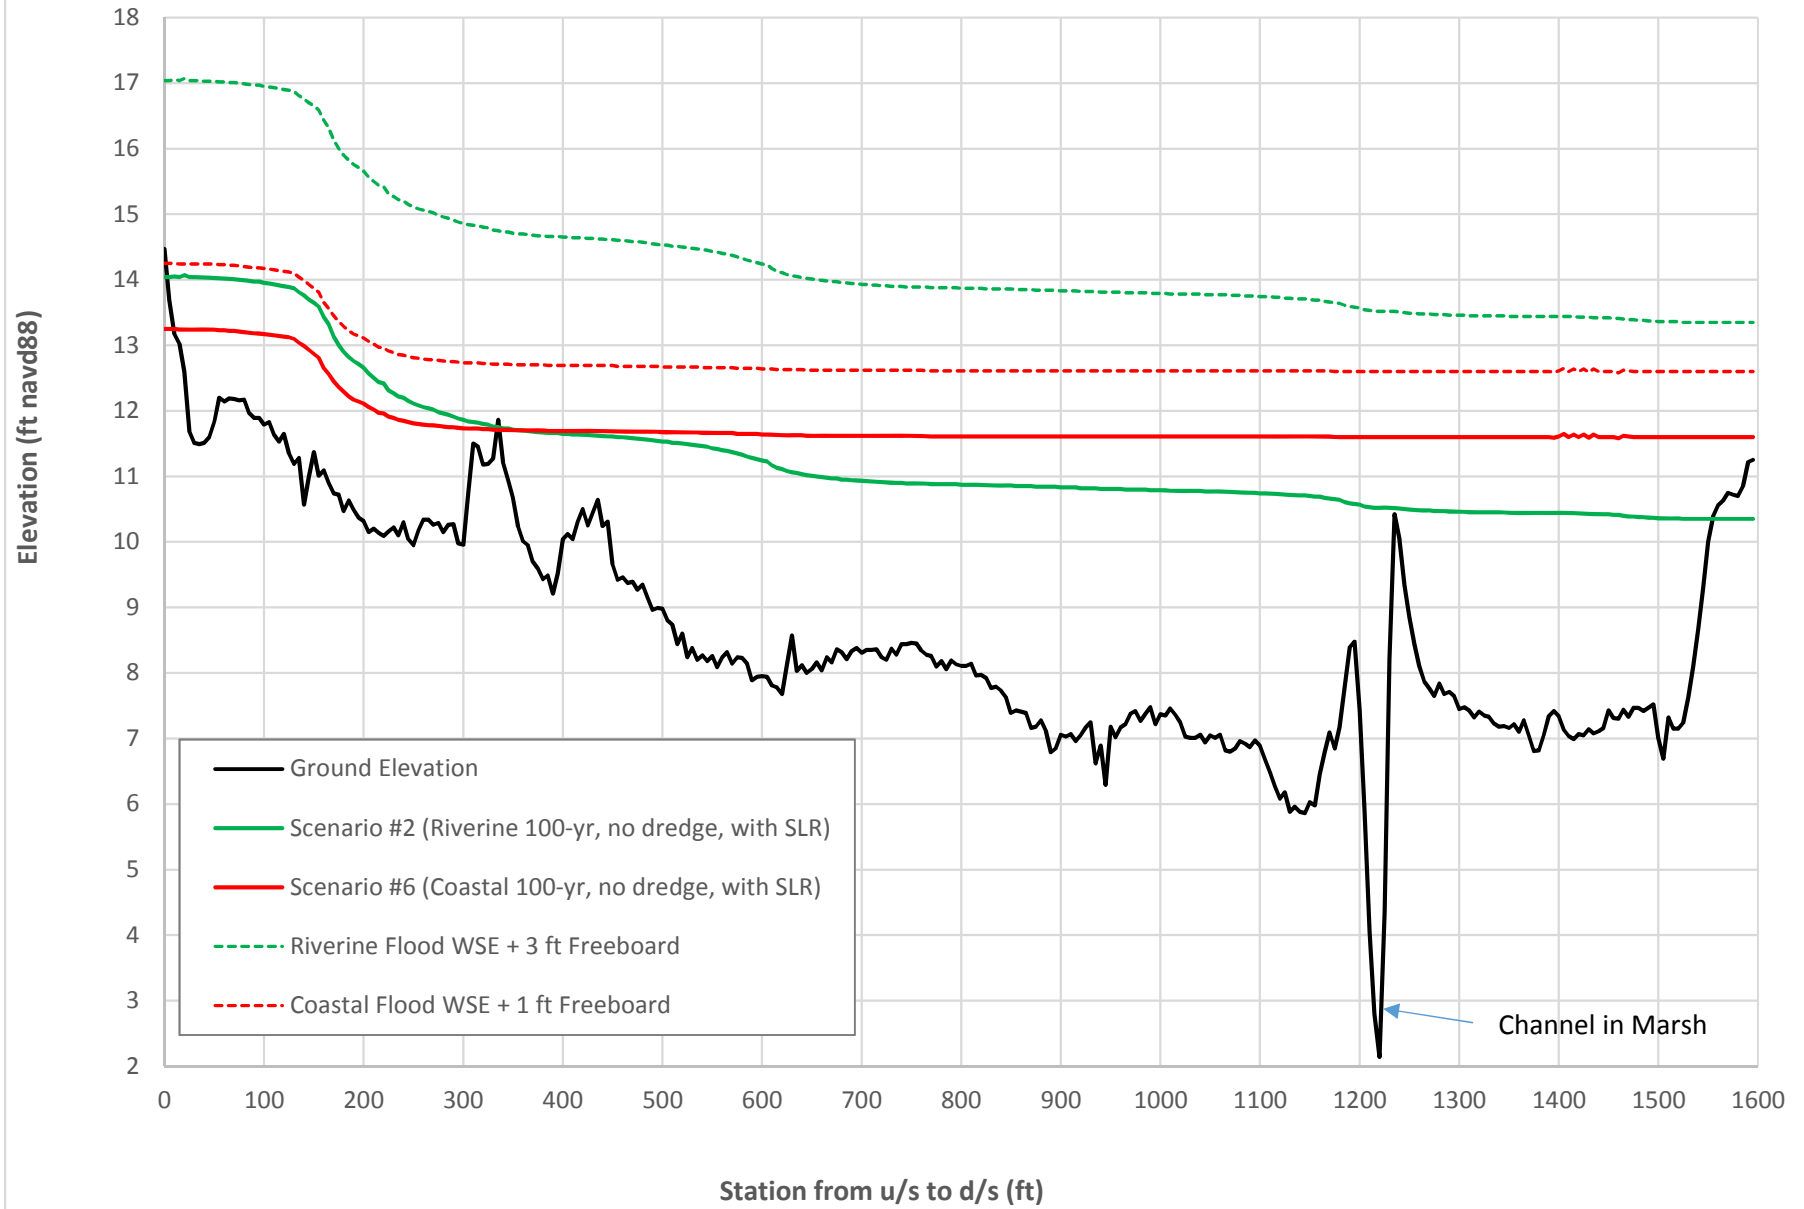
Figure 23b

WSE and Ground Elevations along College Ct Flood Barrier and Freeboard Assessment  
- Scenario 2 vs. 6; No Dredge; with SLR

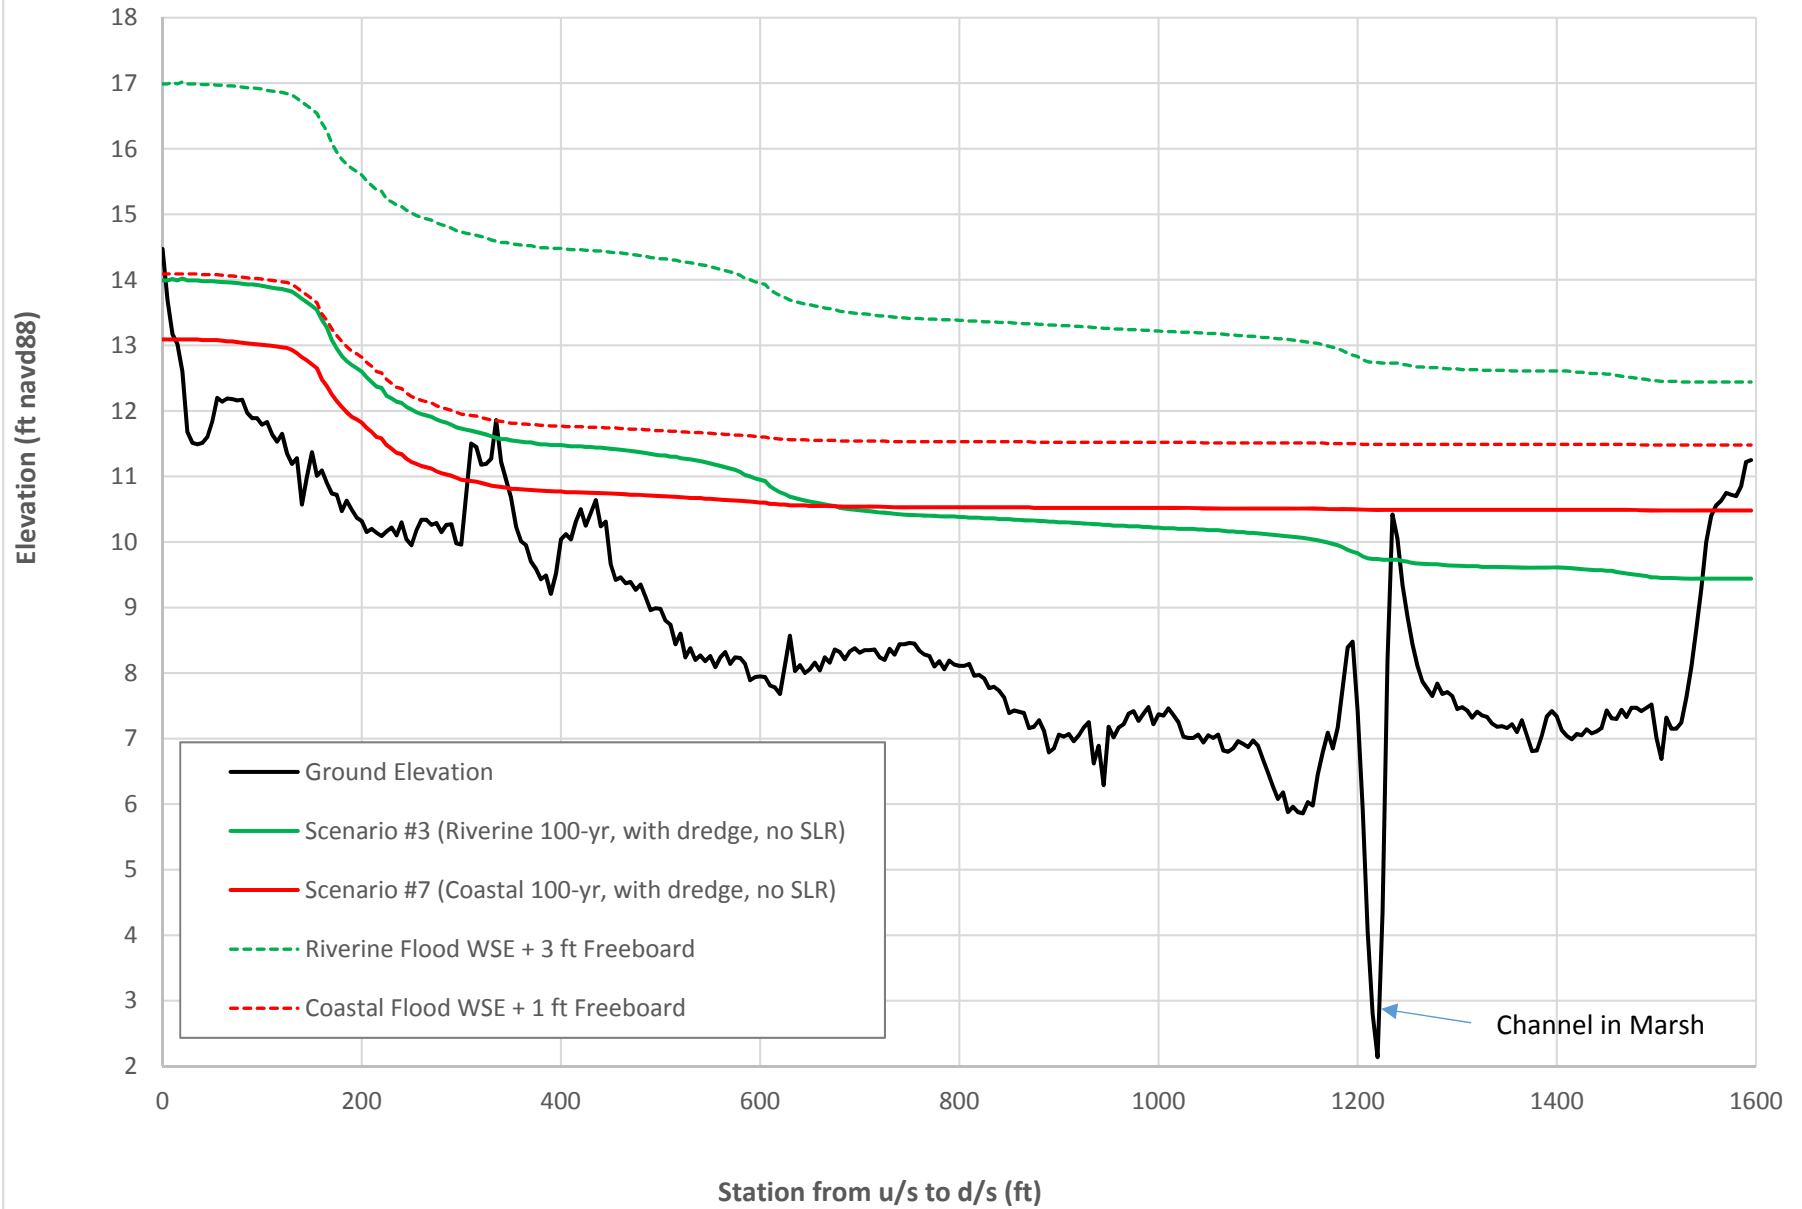
Figure 23c

WSE and Ground Elevations along College Ct Flood Barrier and Freeboard Assessment  
- Scenario 3 vs. 7; with Dredge; No SLR

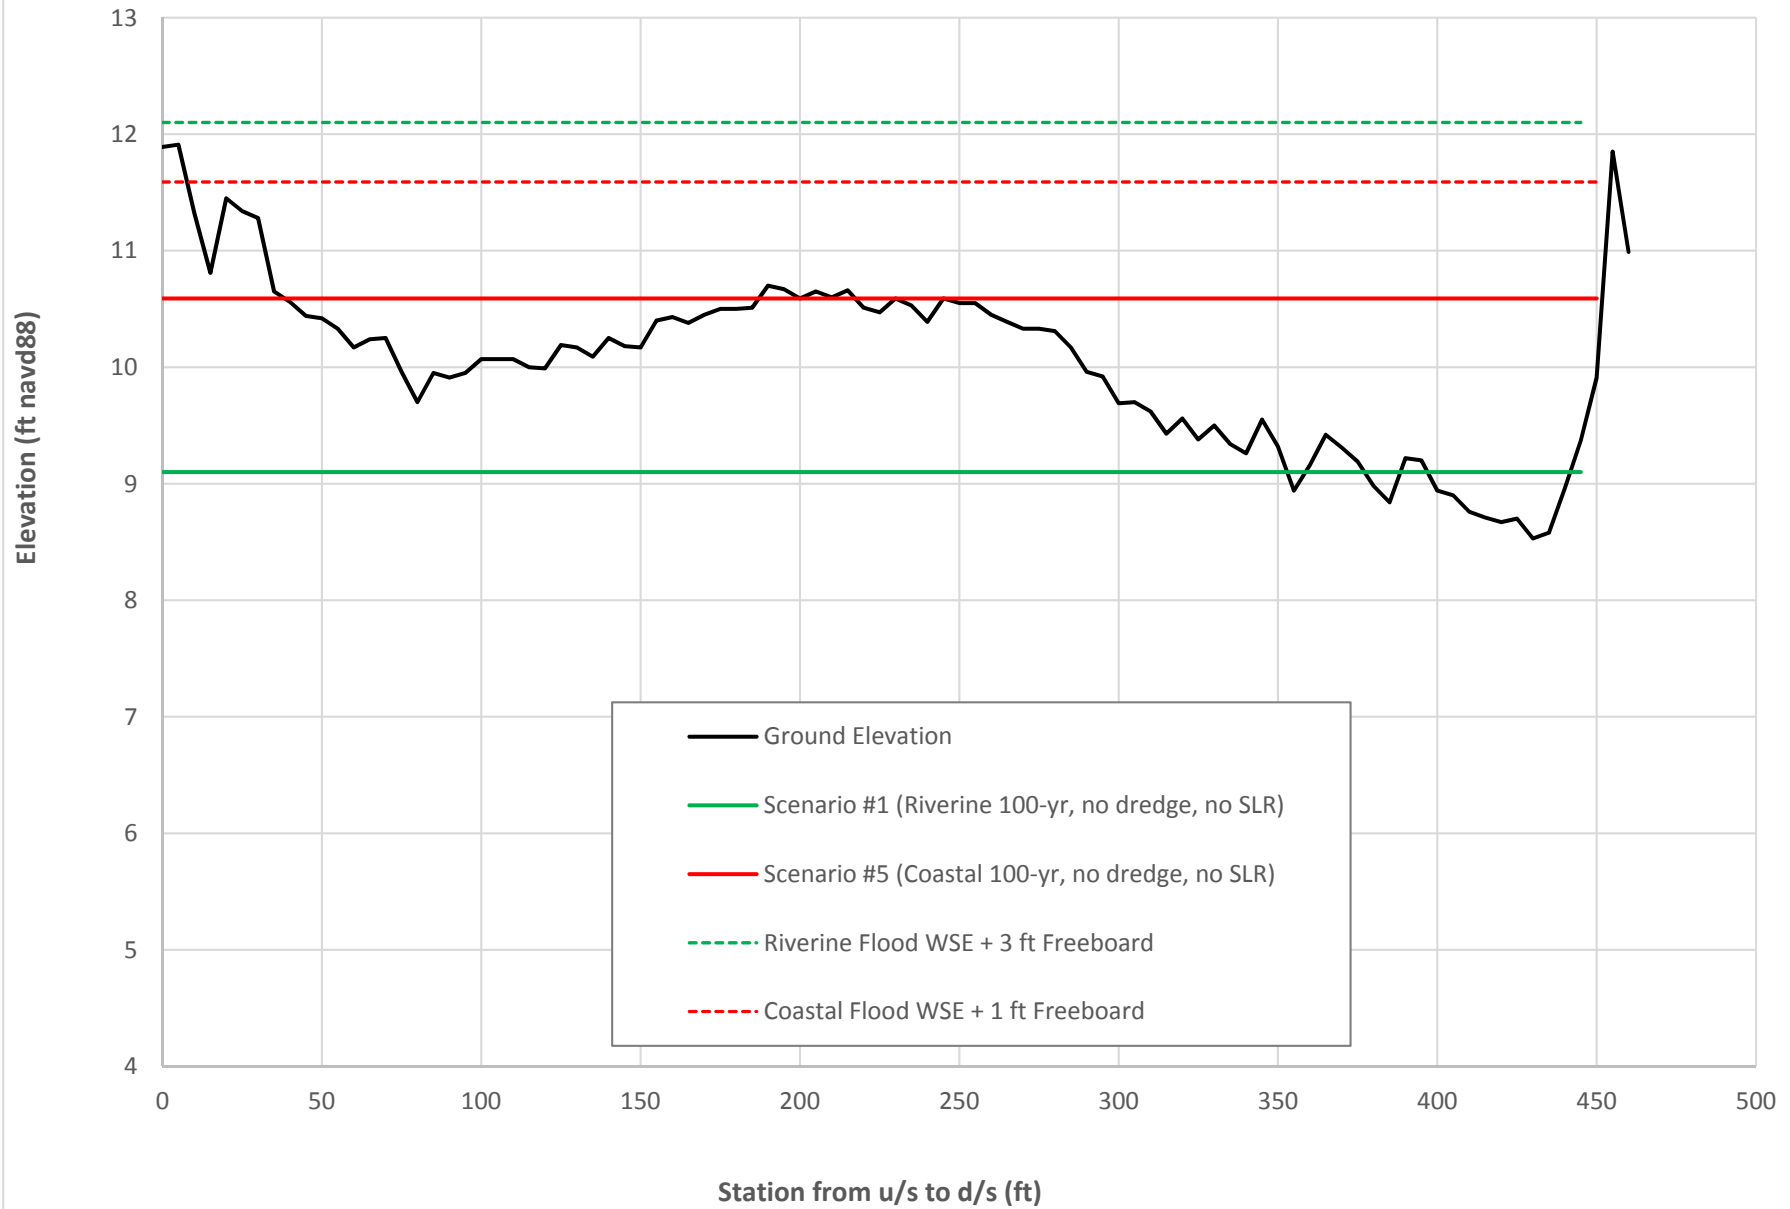
Figure 26a

WSE and Ground Elevations along Wolfe Grade Flood Barrier (#1) and Freeboard Assessment  
- Scenario 1 vs. 5; No Dredge; No SLR

Figures 26a, 26b, 26c, and 26d graphically present the freeboard assessment for the proposed Wolfe Grade flood barrier #1.
