# Project Conditions Hydraulic Evaluation of the Corte Madera Creek Levees

Stetson Engineers Inc.

October 11, 2019

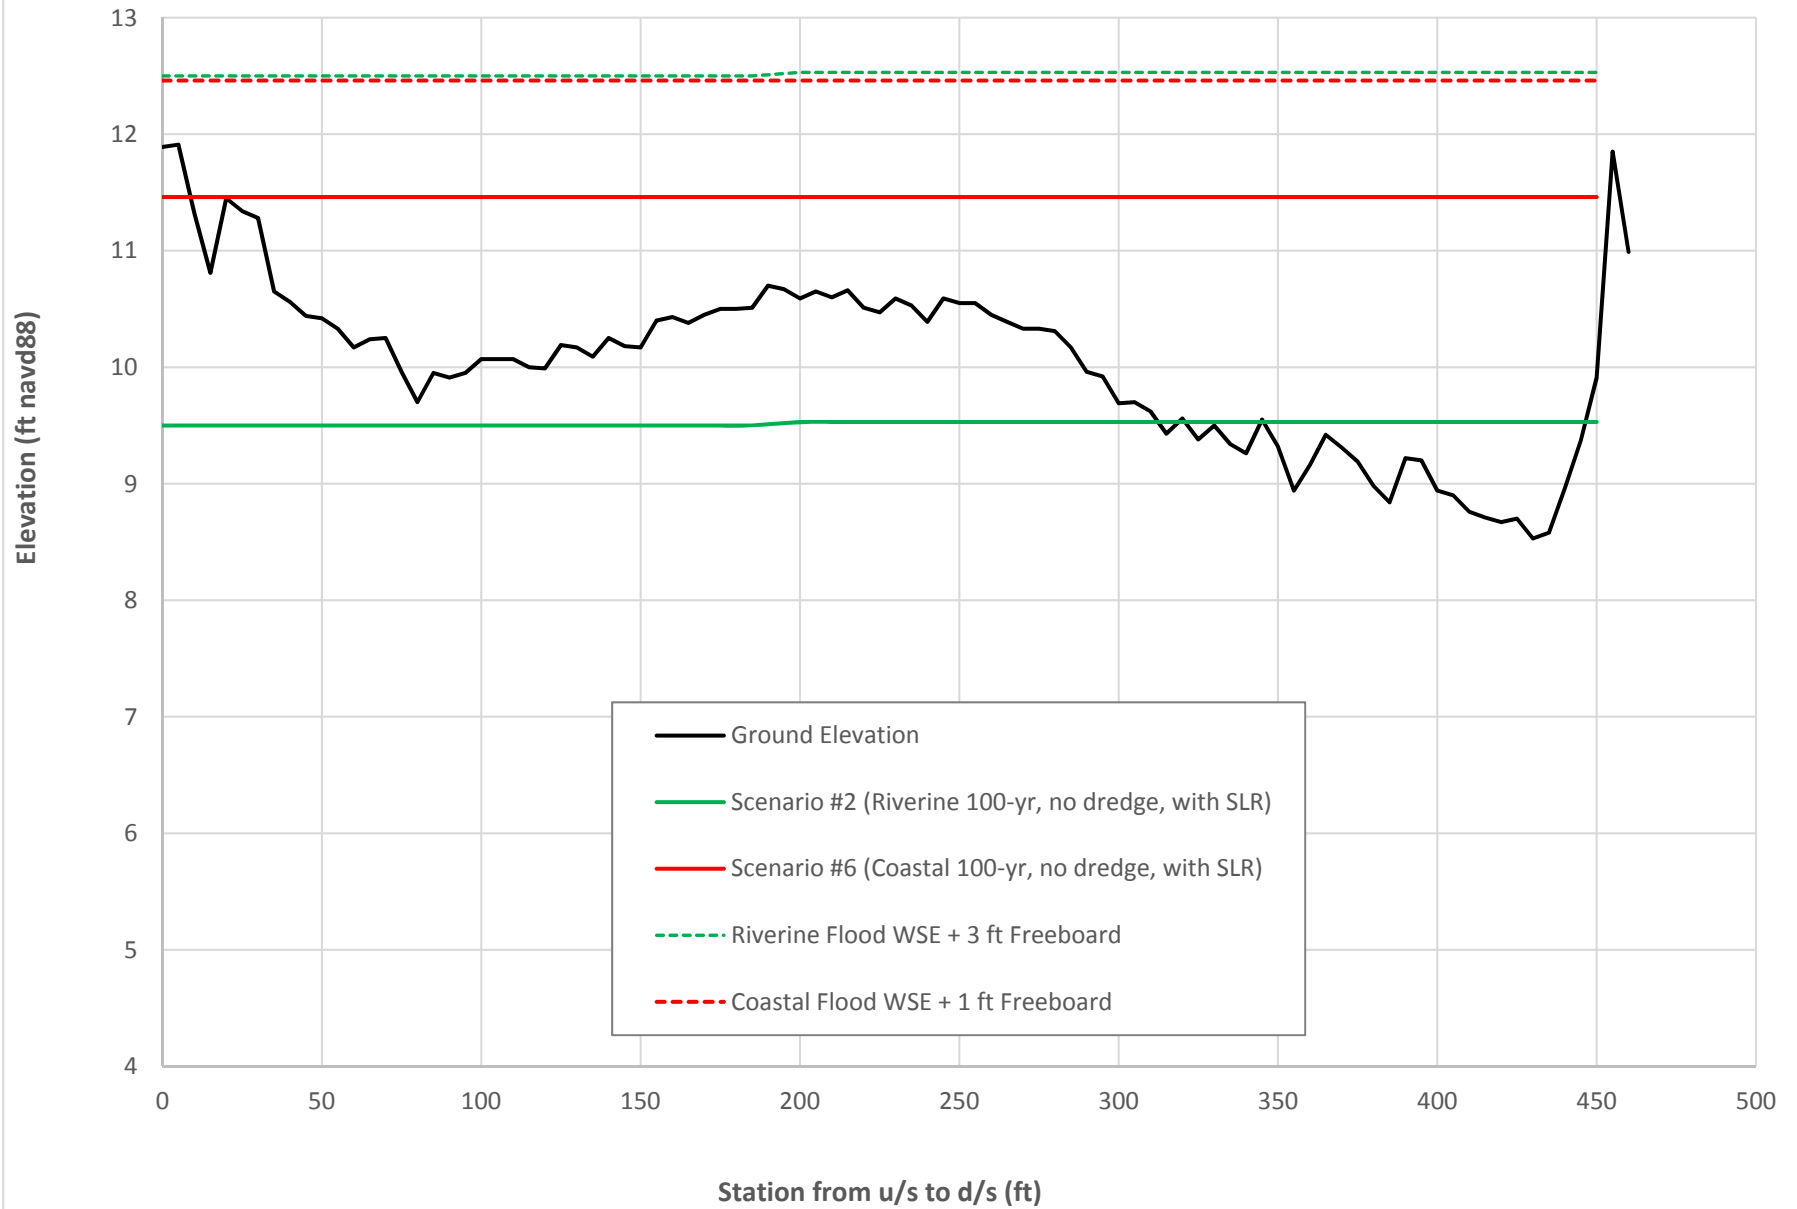
Figure 26b

WSE and Ground Elevations along Wolfe Grade Flood Barrier (#1) and Freeboard Assessment  
- Scenario 2 vs. 6; No Dredge; with SLR

Figures 26a, 26b, 26c, and 26d graphically present the freeboard assessment for the proposed Wolfe Grade flood barrier #1.

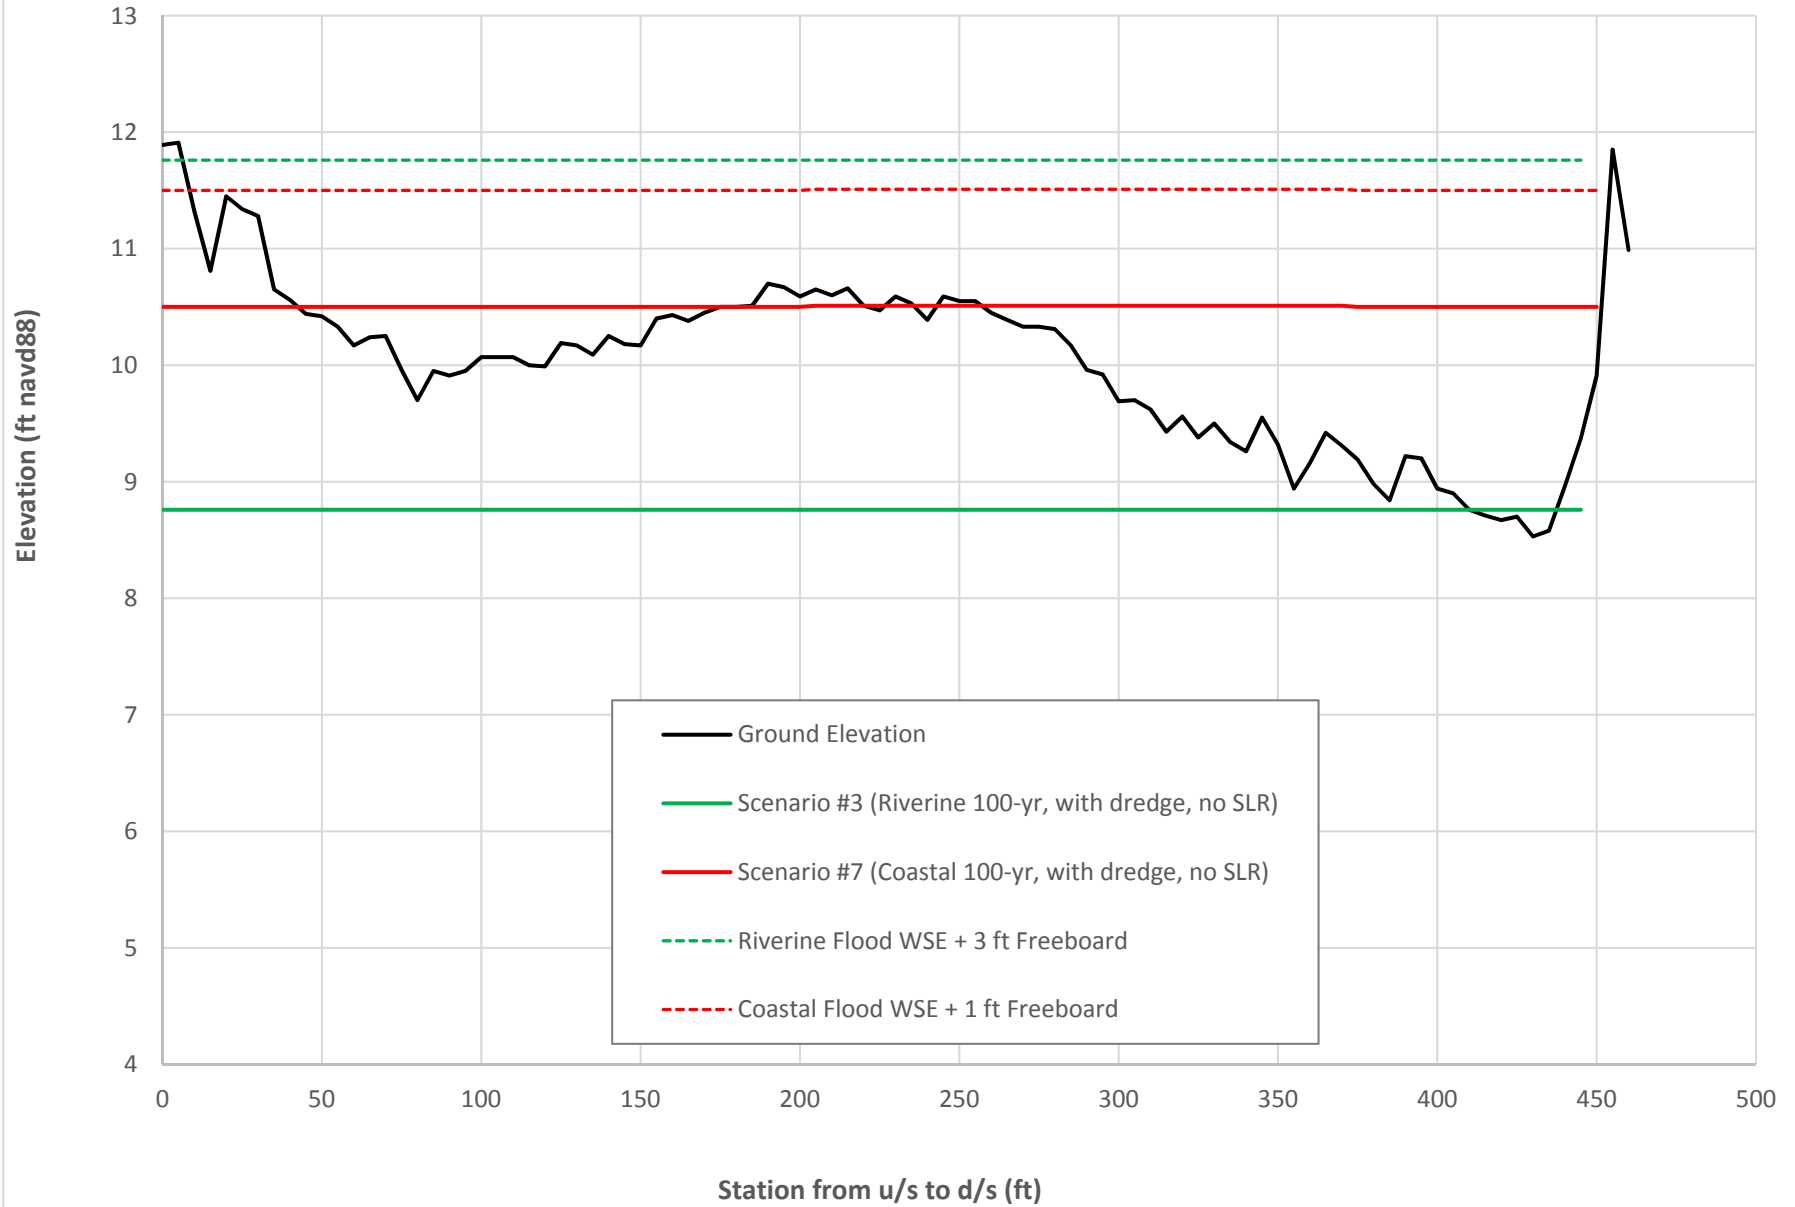
Figure 26c

WSE and Ground Elevations along Wolfe Grade Flood Barrier (#1) and Freeboard Assessment  
- Scenario 3 vs. 7; with Dredge; No SLR

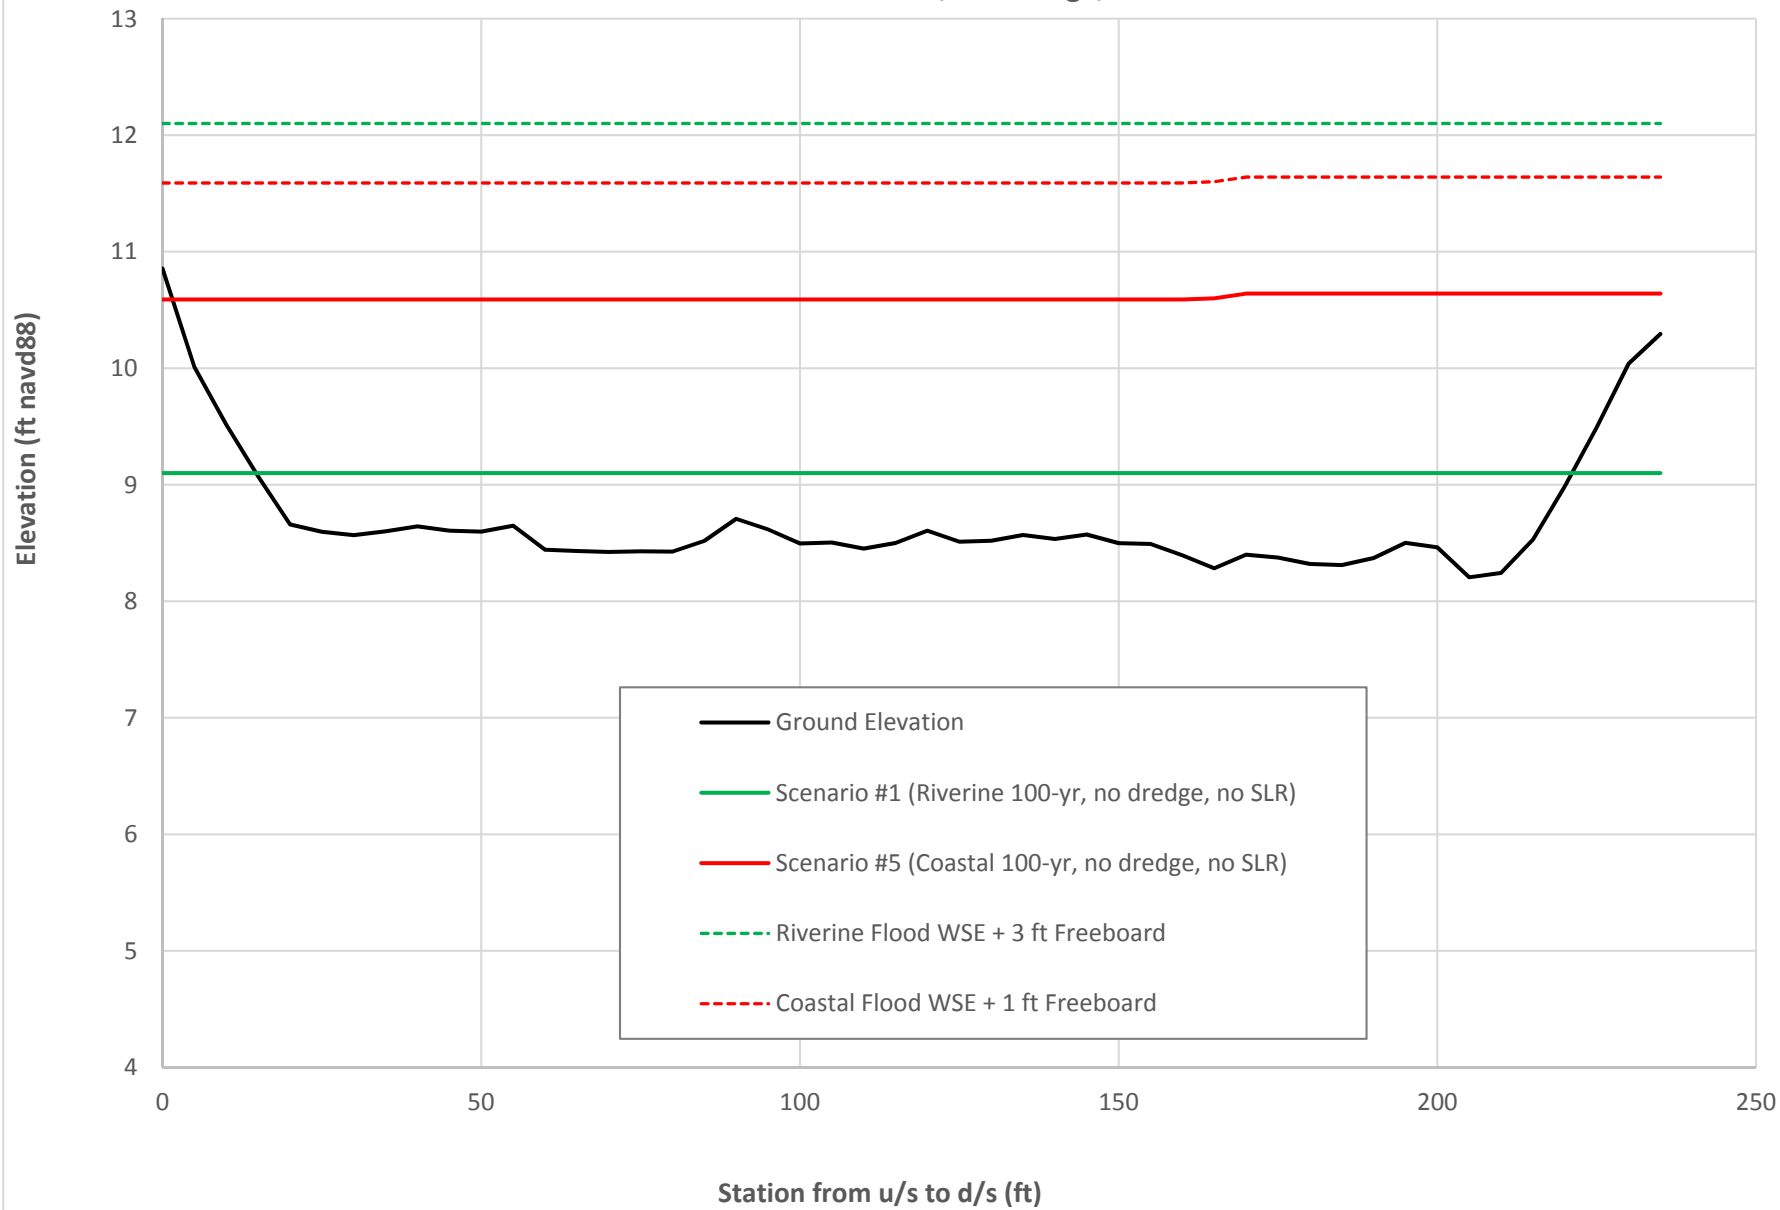
Figure 27a

WSE and Ground Elevations along Wolfe Grade Flood Barrier (#2) and Freeboard Assessment  
- Scenario 1 vs. 5; No Dredge; No SLR

Figures 27a, 27b, 27c, and 27d graphically present the freeboard assessment for the proposed Wolfe Grade flood barrier #2.

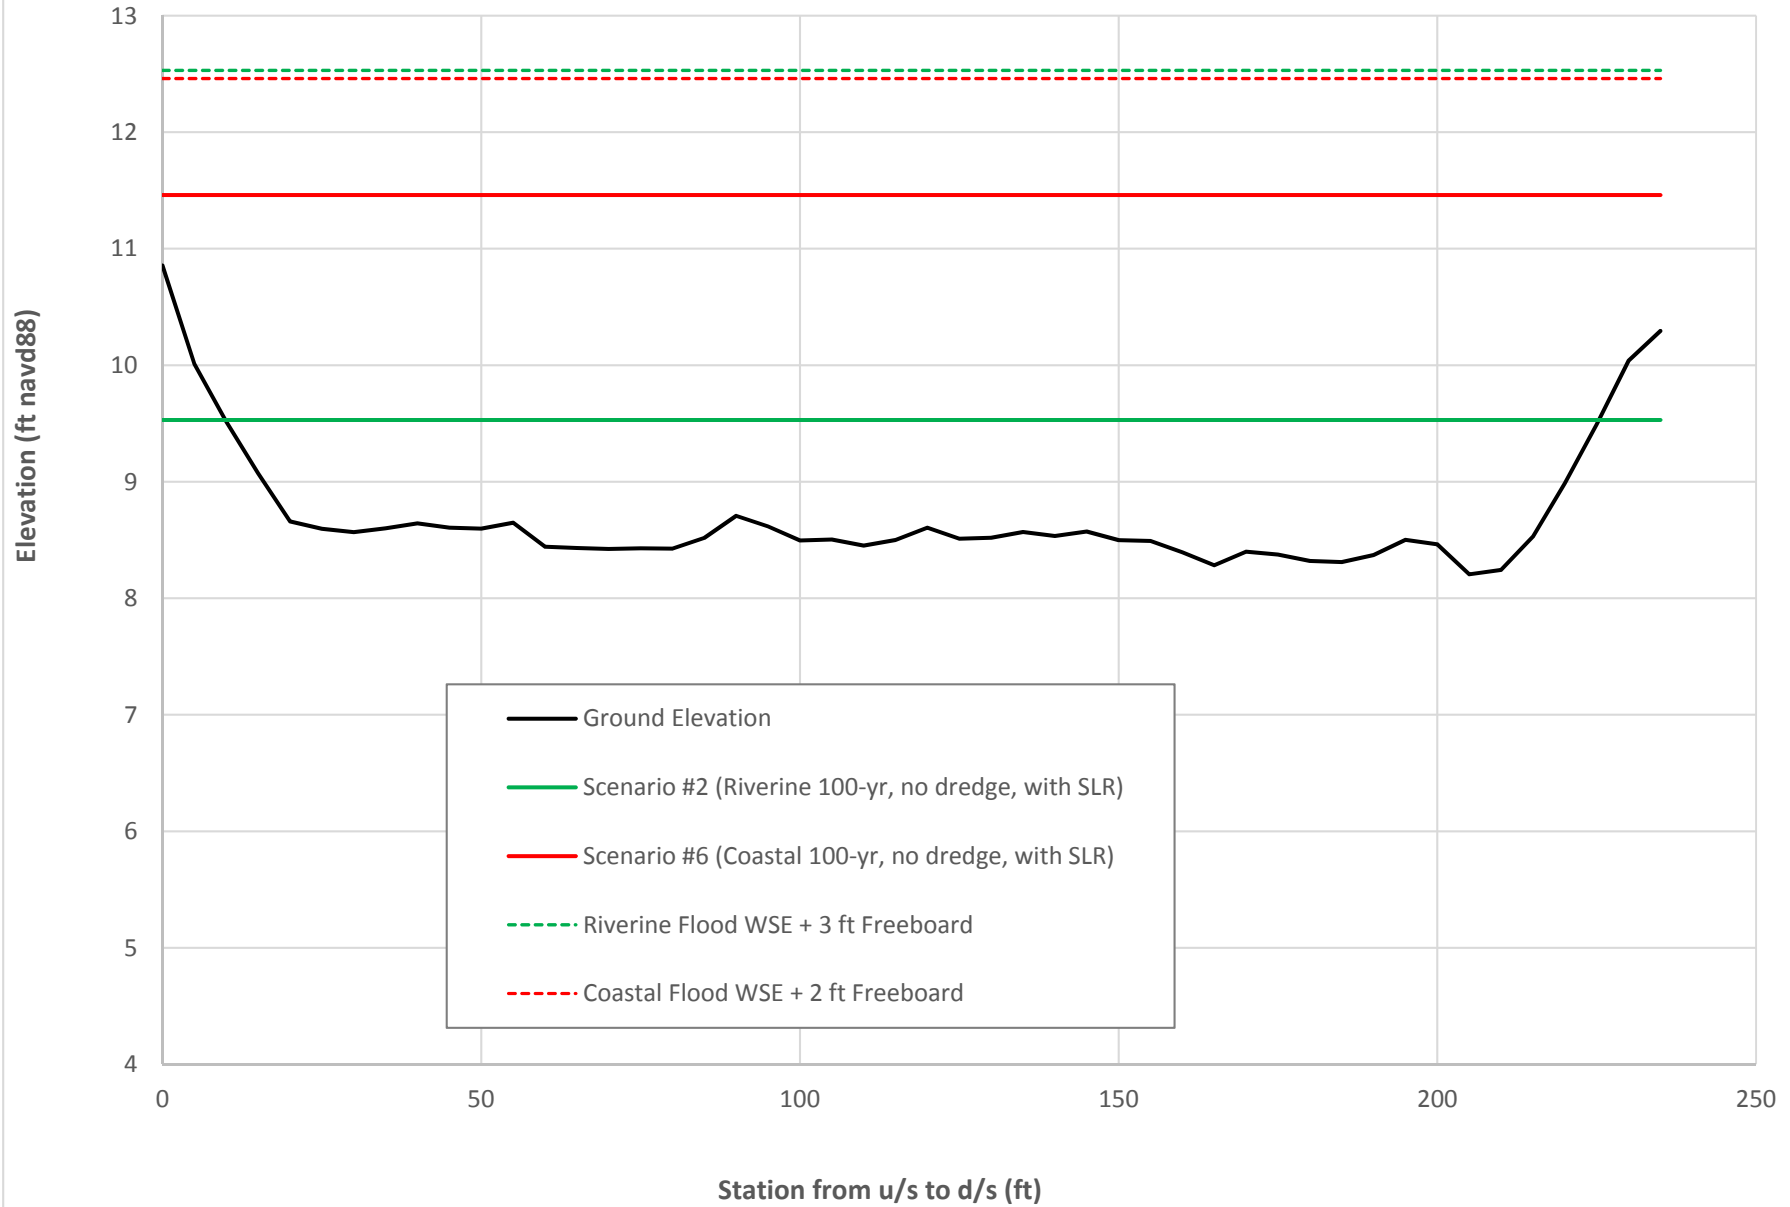
Figure 27b

WSE and Ground Elevations along Wolfe Grade Flood Barrier (#2) and Freeboard Assessment  
- Scenario 2 vs. 6; No Dredge; with SLR

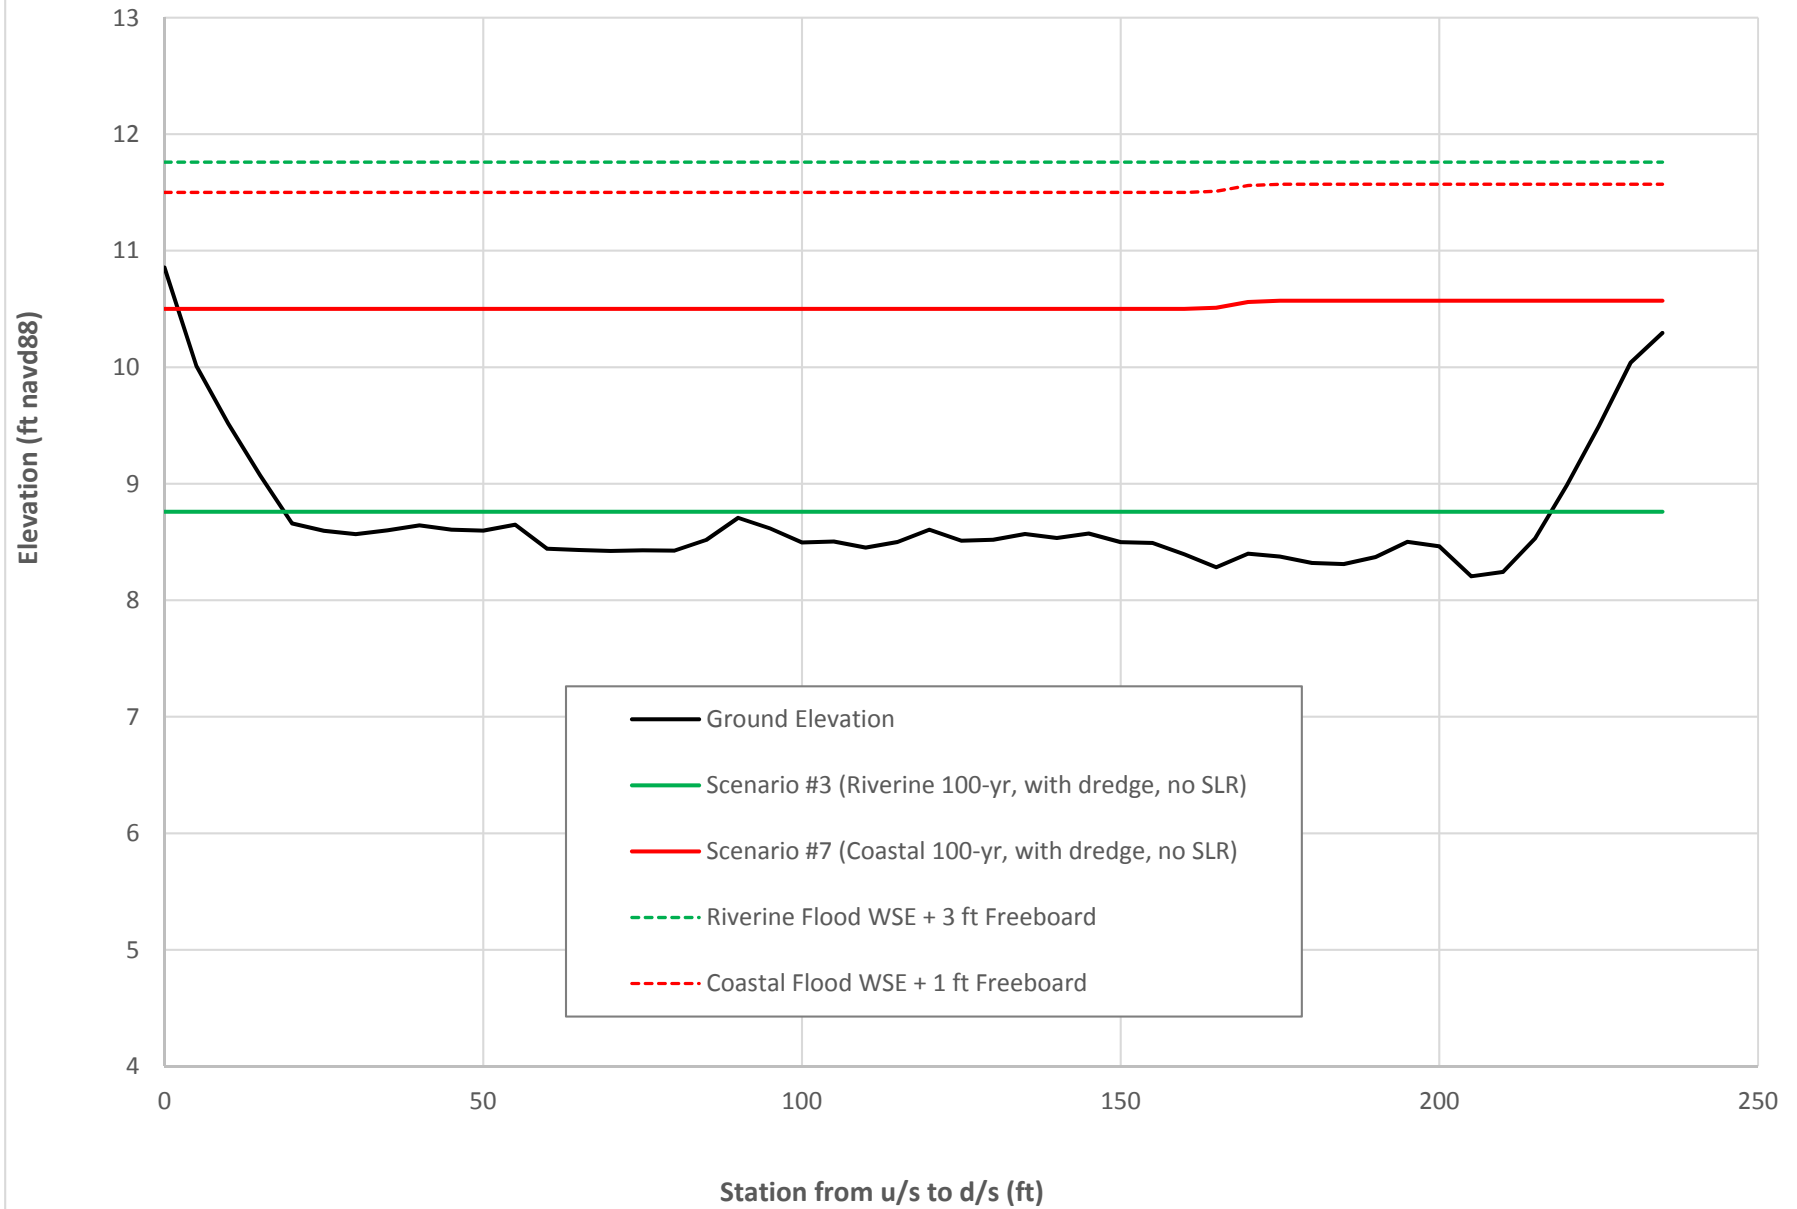
Figure 27c

WSE and Ground Elevations along Wolfe Grade Flood Barrier (#2) and Freeboard Assessment  
- Scenario 3 vs. 7; with Dredge; No SLR

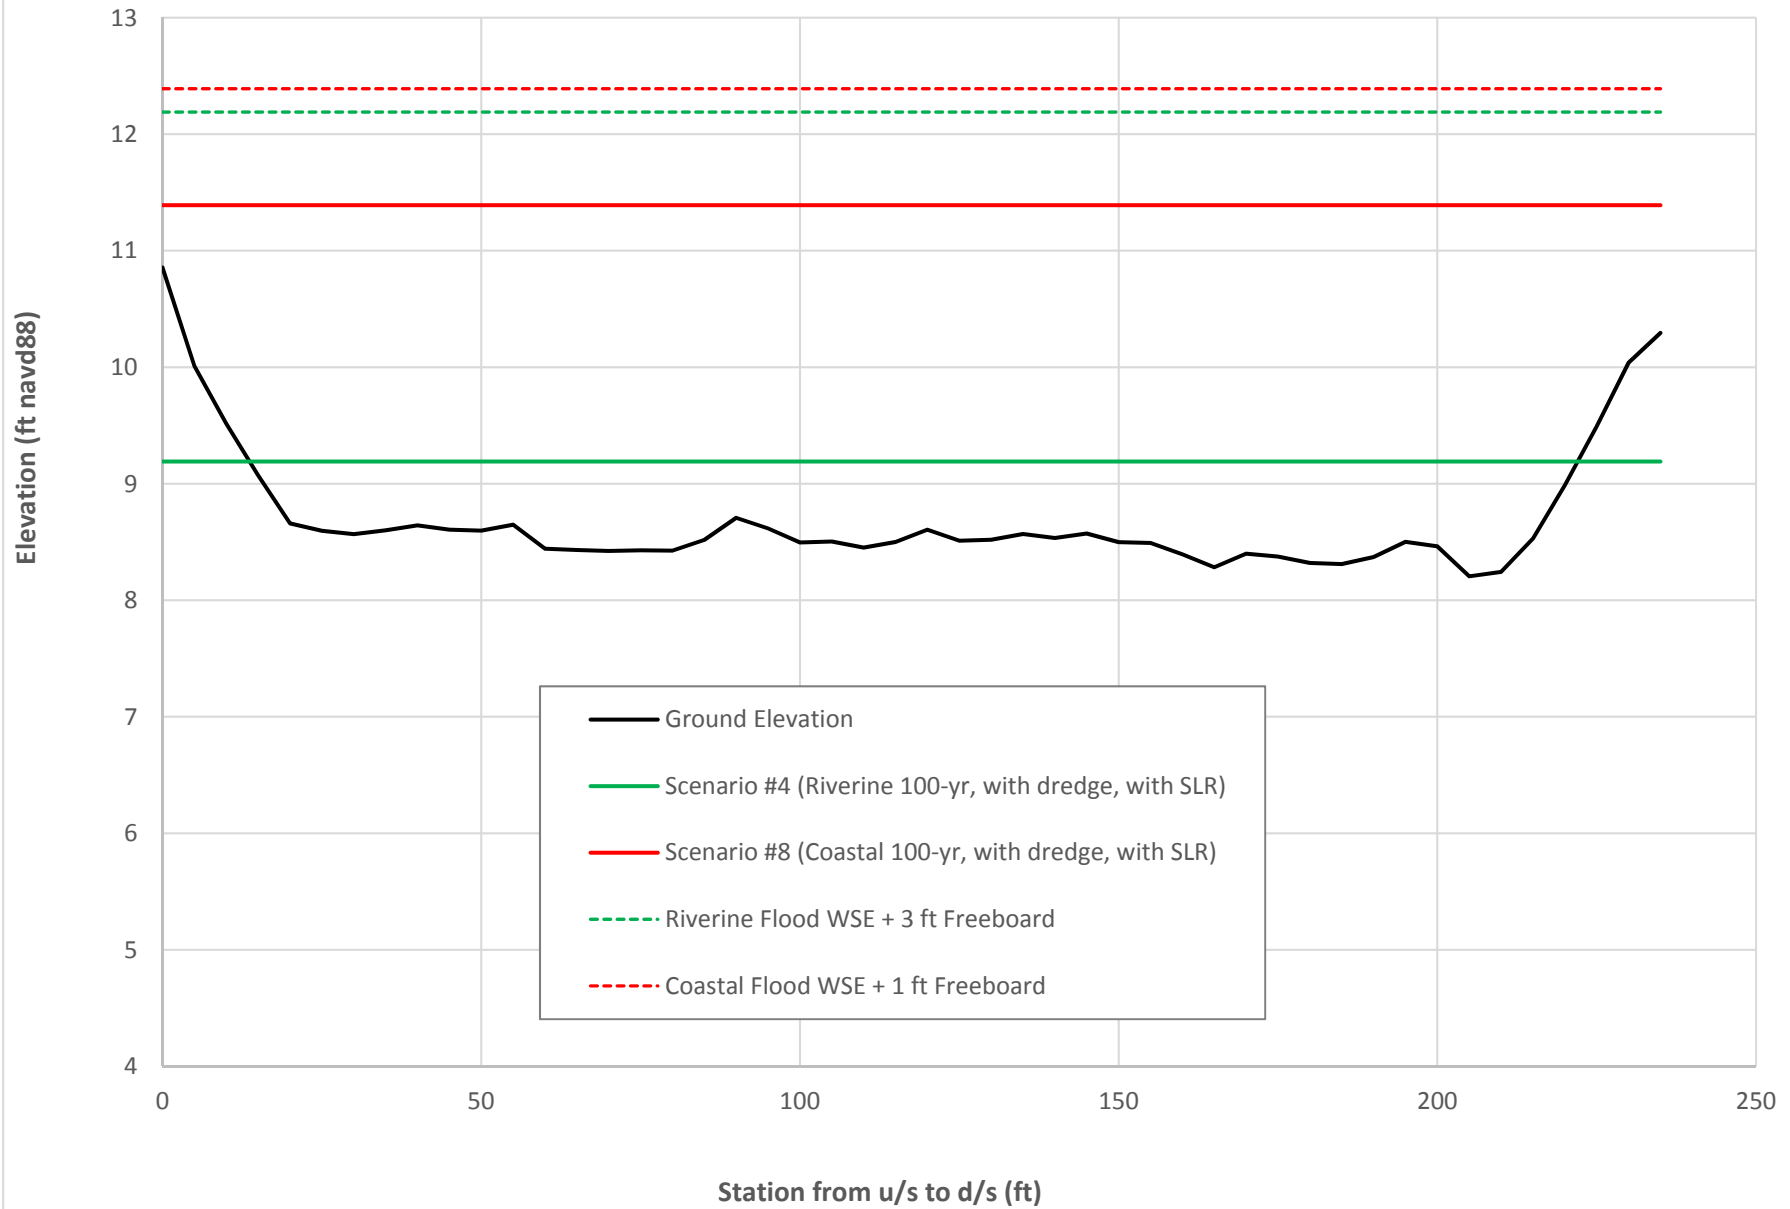
Figure 27d

WSE and Ground Elevations along Wolfe Grade Flood Barrier (#2) and Freeboard Assessment  
- Scenario 4 vs. 8; with Dredge; with SLR
