COYOTE CREEK LEVEE EVALUATION PROJECT

Geotechnical Data Report

May 21, 2015, Revision 1

Project 140457-0

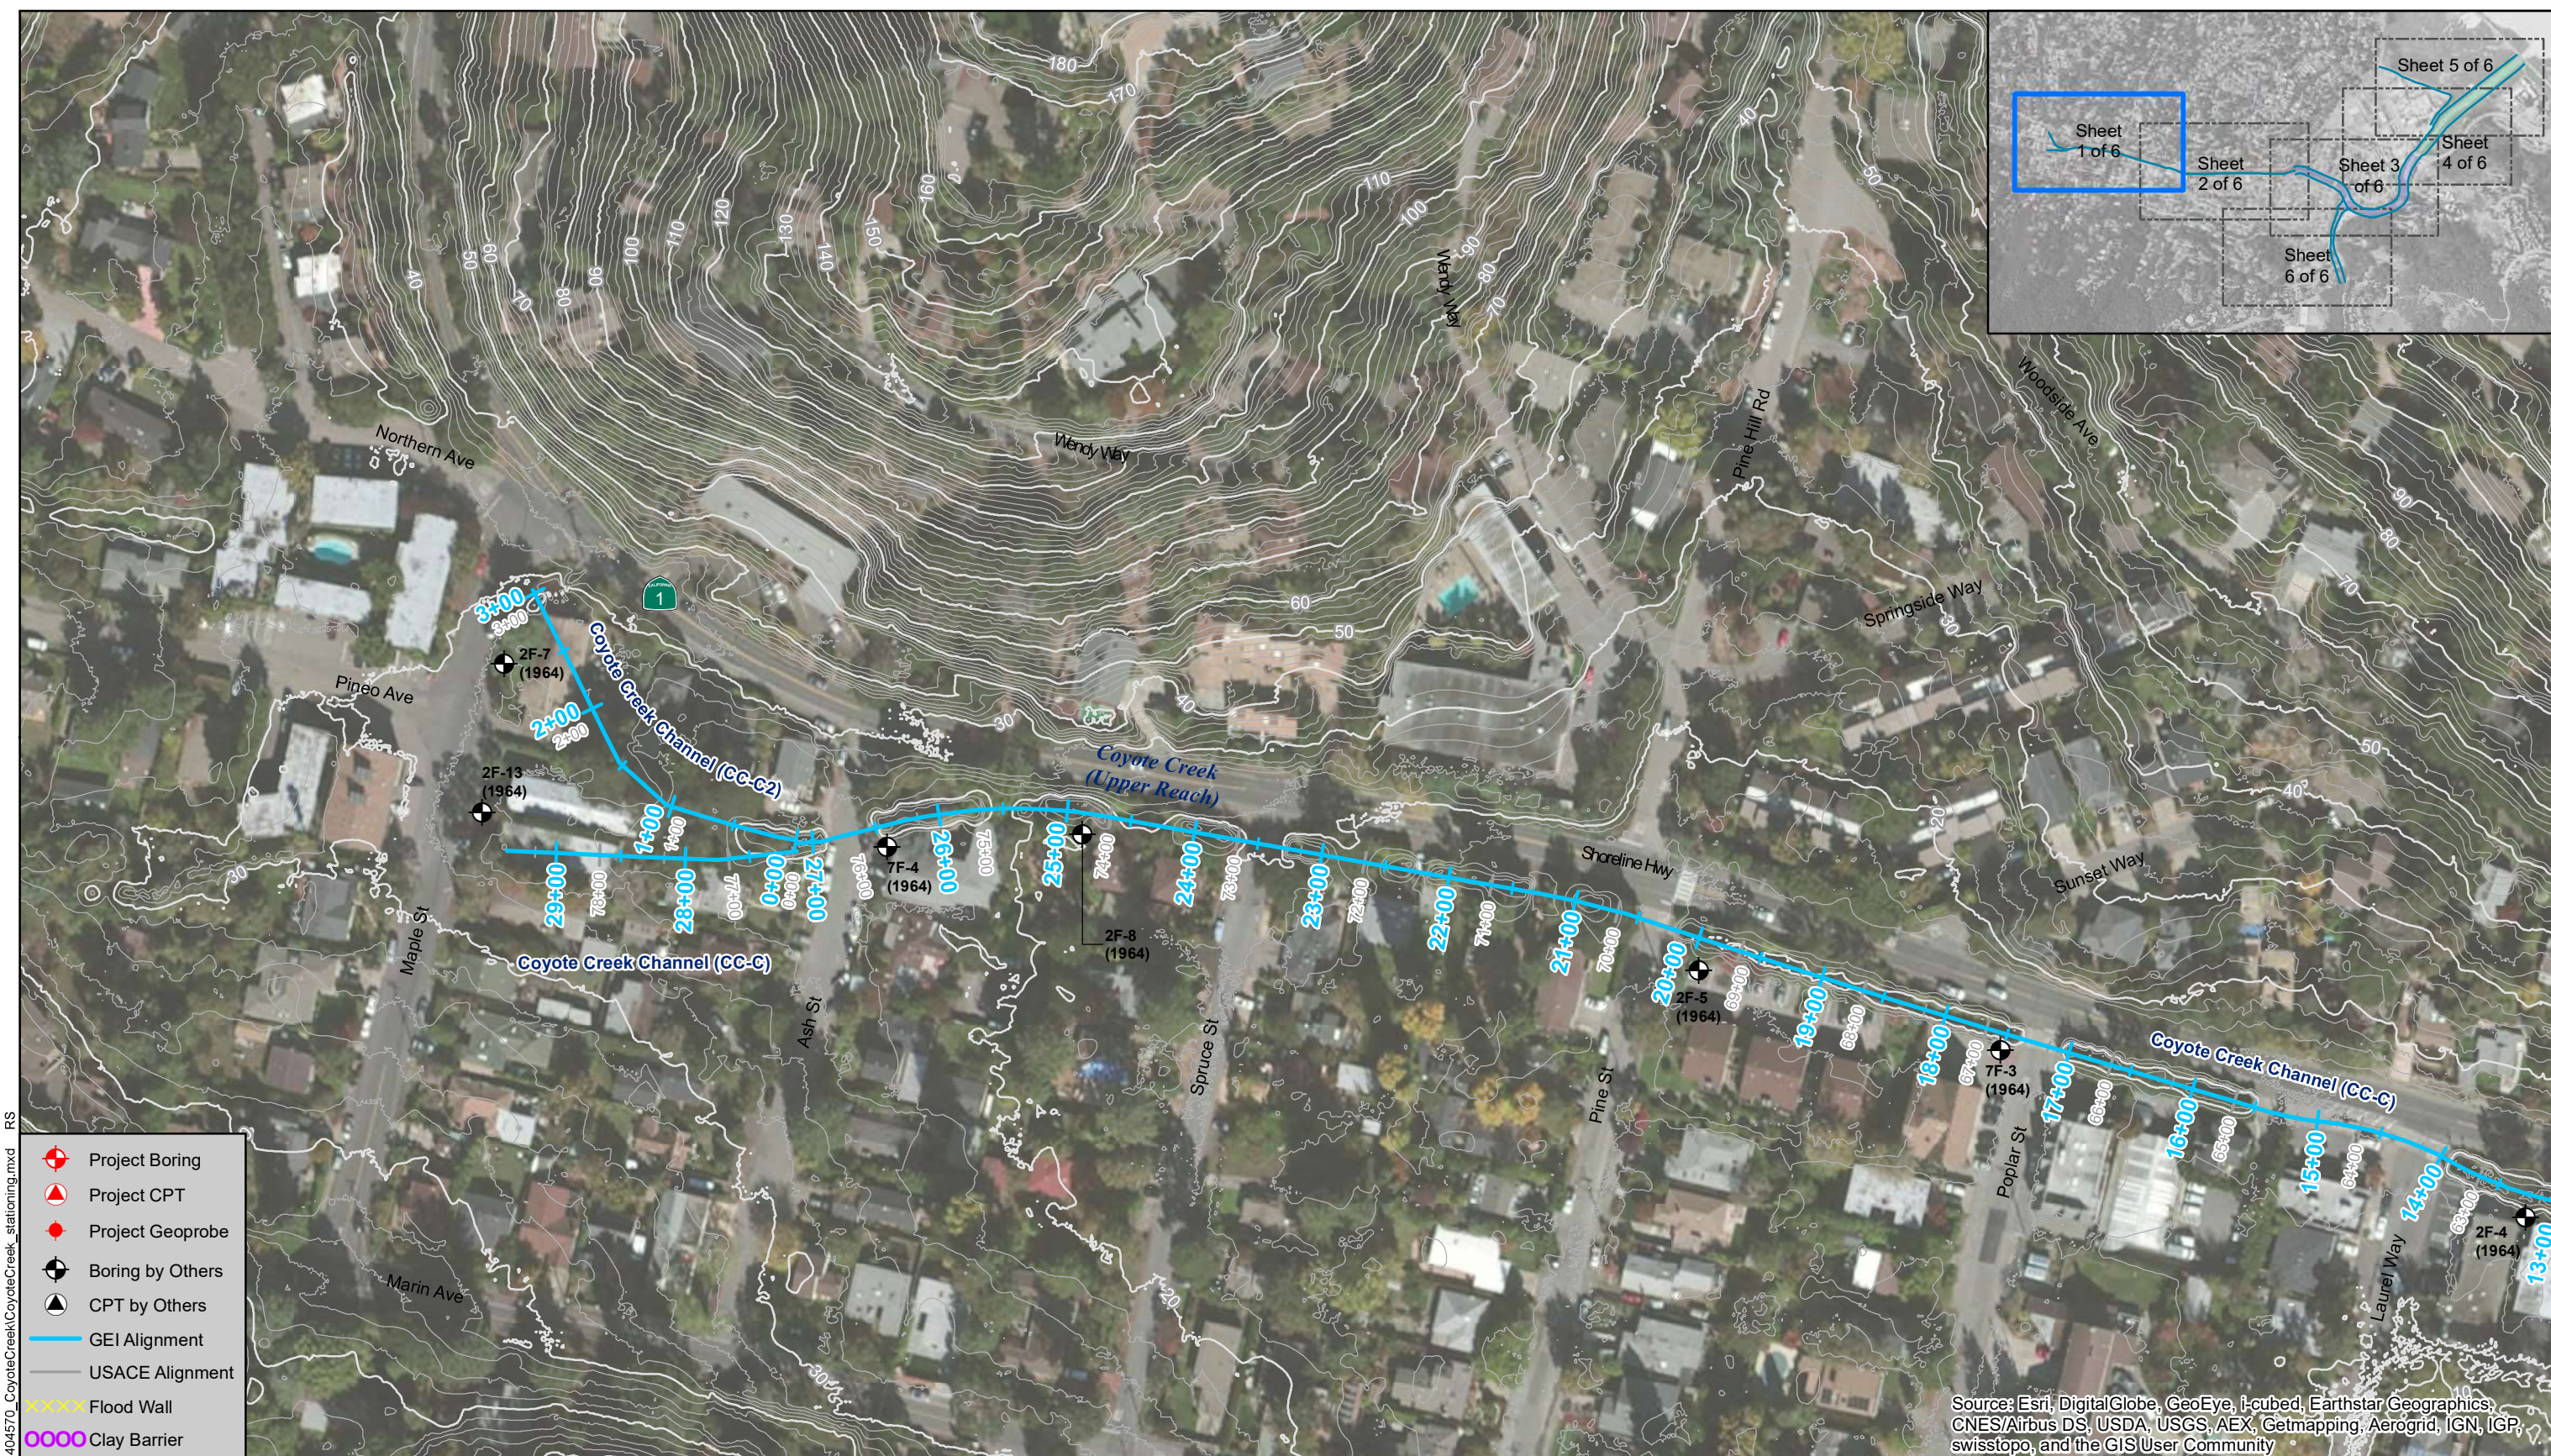
FIGURE 1

The locations of the new explorations and identified historic explorations by others are shown for reference in plan-view on Figures 1 through 6 and in profile-view on Figures 7 through 14. It should be noted that the stationing alignments included on these figures refer to GEI stationing developed for this evaluation project and not the original USACE channel centerline station alignment; however, USACE stationing is included in the plan-view Figures 1 through 6 for reference. GEI stationing was developed to provide unique station alignments along both sides of channel to aid in developing this report and future analyses of potential levee remediations. The GEI stationing convention begins with 0+00 feet at the downstream limit of a channel and increases in the upstream direction. Separate stationing alignments were created for the left and right banks of Coyote Creek (CC-L, CC-R), the left and right banks of Nyhan Creek (NC-L, NC-R), the high-ground area adjacent to Bothin Marsh (BM-L), and the centerline of the concrete-lined channel portion of Coyote Creek (CC-C, and CC-C2).

and three direct push geoprobes. The exploration strategy was to advance the CPTs and direct push geoprobes first, in order to define the nature of subsurface materials. Auger/mud rotary drilling followed, with the intent of focused sampling based on information from the CPT and geoprobe explorations. Exploration types, locations, and exploration depths are summarized in Table 1, and are shown in Figures 1 through 6.

A series of pump stations were constructed between 1978 and 1985. These include the Crest Marin (1978), Cardinal, (1983), and Shoreline (1985) storm water pump stations and are shown on Figures 3 and 4. Both the Cardinal and Shoreline pump stations discharge directly into Coyote Creek while the Crest Marin pump station discharges into Nyhan Creek.

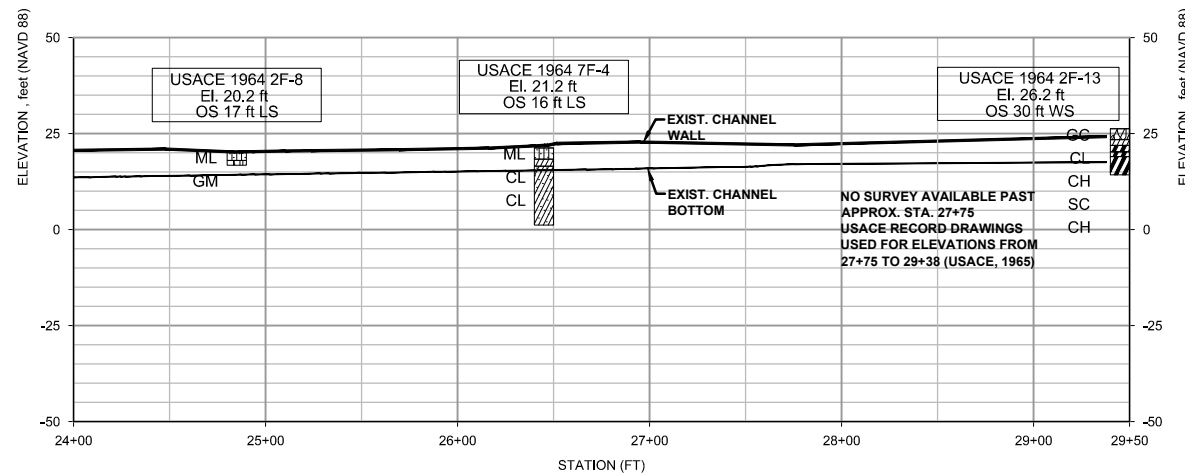
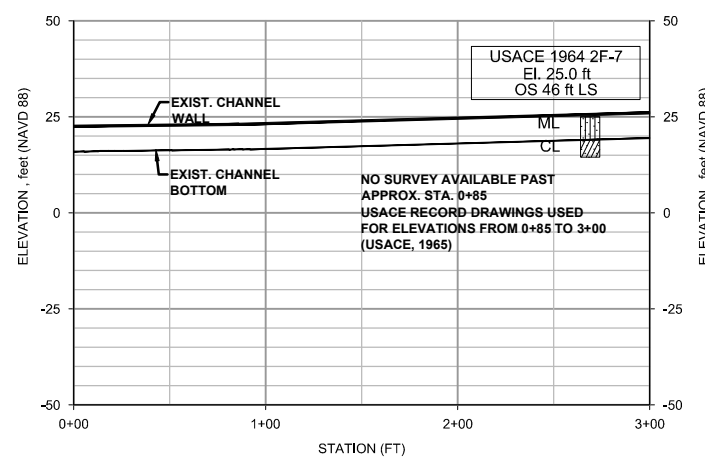
<p>COYOTE CREEK CHANNEL PROFILES (SHEET 2 OF 2)</p>
<p>Marin County Flood Control and Water Conservation District</p>	<p>Project 140457-0</p>	<p>April 2015 Figure 12</p>

Coyote Creek Channel (CC-C)
STA. 24+00 - STA. 29+50

Coyote Creek Channel (CC-C2)
STA. 0+00 - STA. 3+00

NOTE - EXISTING LEVEE CREST AND TOE PROFILES BASED ON 2013 MERIDIAN CHANNEL SURVEY, USGS 2011 GEOTIFF, AND USACE RECORD DRAWING (1965)

The topographic data utilized for Project evaluations, including the elevation contours presented on Figures 1-6 and the elevation profiles presented on Figures 7-14, was provided by the District. Two separate data sets were provided, which include 1) County of Marin digital topographic-bathymetric surface model, Revision 2013.12.18 (County of Marin, 2013), and 2) topographic and bathymetric data derived from field survey of the Coyote Creek channel and levees, performed by Meridian Surveying Engineering (Meridian, 2013). Brief descriptions of these datasets are provided in the following sections.

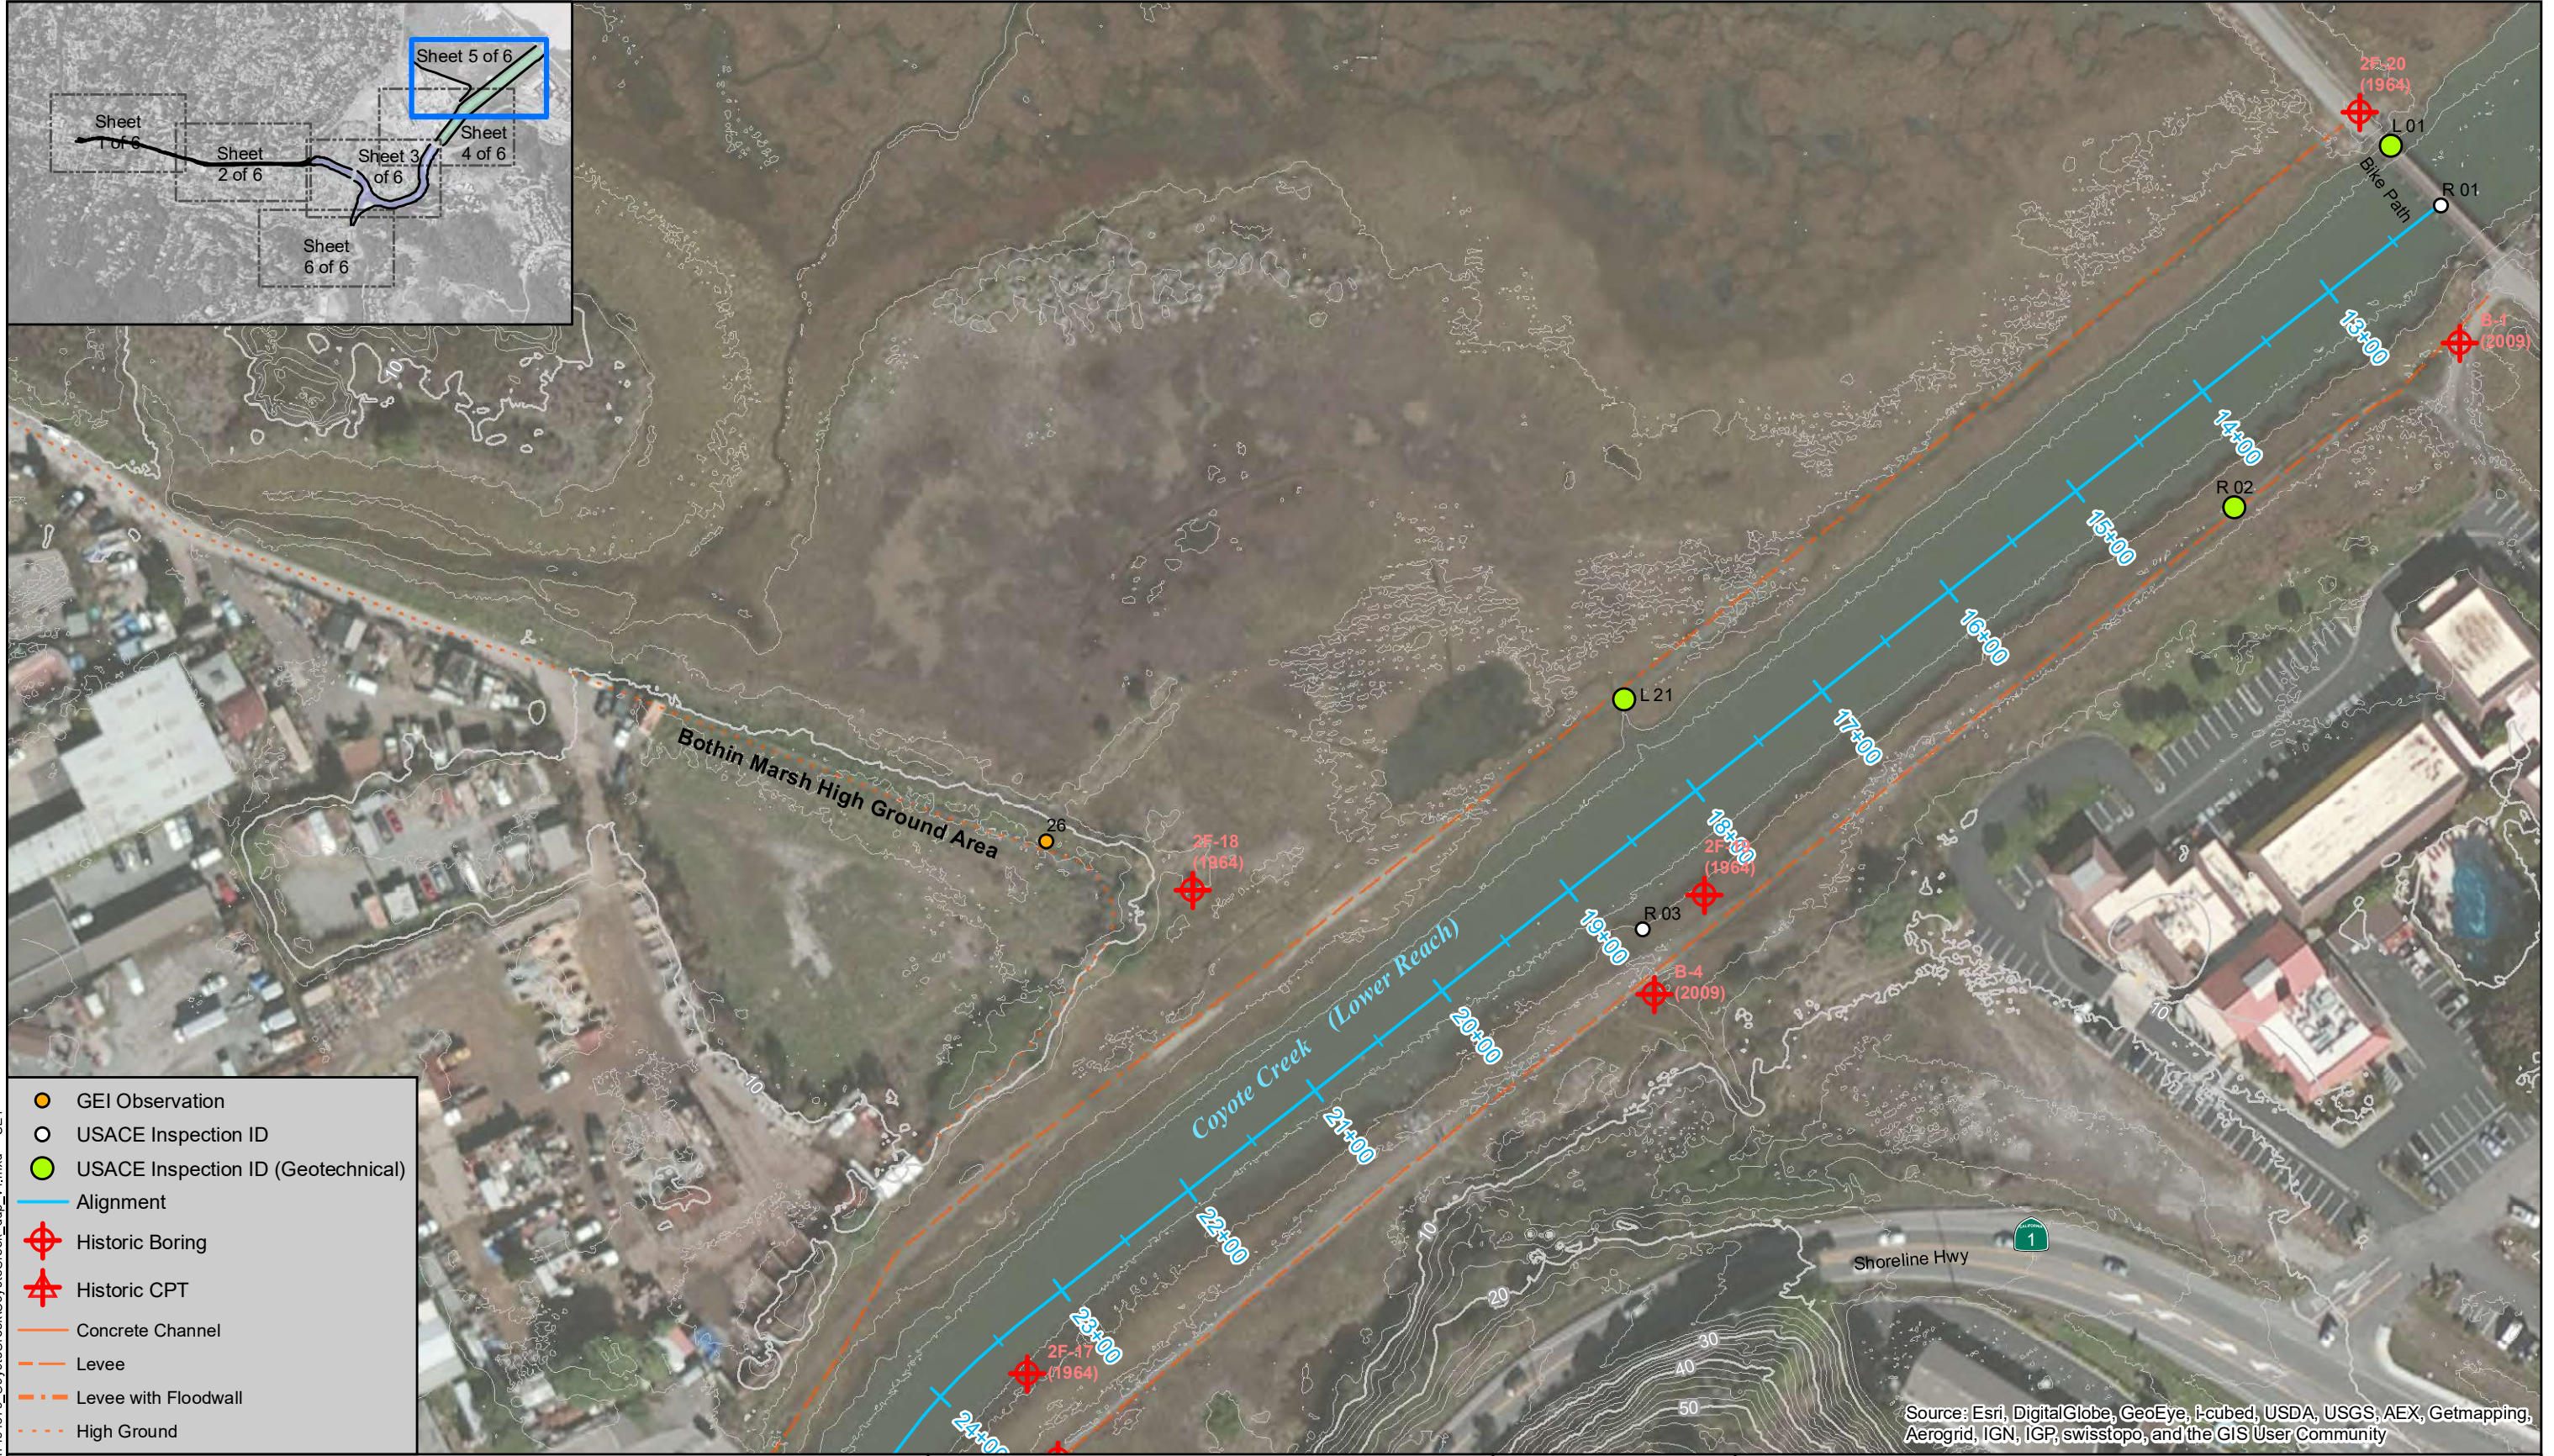
FIGURE 4

- GEI Observation
- USACE Inspection ID
- USACE Inspection ID (Geotechnical)
- Alignment
- ⊕ Historic Boring
- ⊕ Historic CPT
- Concrete Channel
- - - Levee
- · - · - Levee with Floodwall
- · - · - High Ground
