FLOOD CONTROL ZONE 4

Preliminary Flood Risk Reduction Alternatives

MARIN COUNTY WATER CONSERVATION
AND FLOOD CONTROL DISTRICT ZONE 4
TIBURON, CALIFORNIA 94920

TASK 3 FLOOD RISK REDUCTION ALTERNATIVES
EAST & WEST CREEKS
HYDRAULIC MODEL ANALYSIS FOR FLOOD RISK REDUCTION

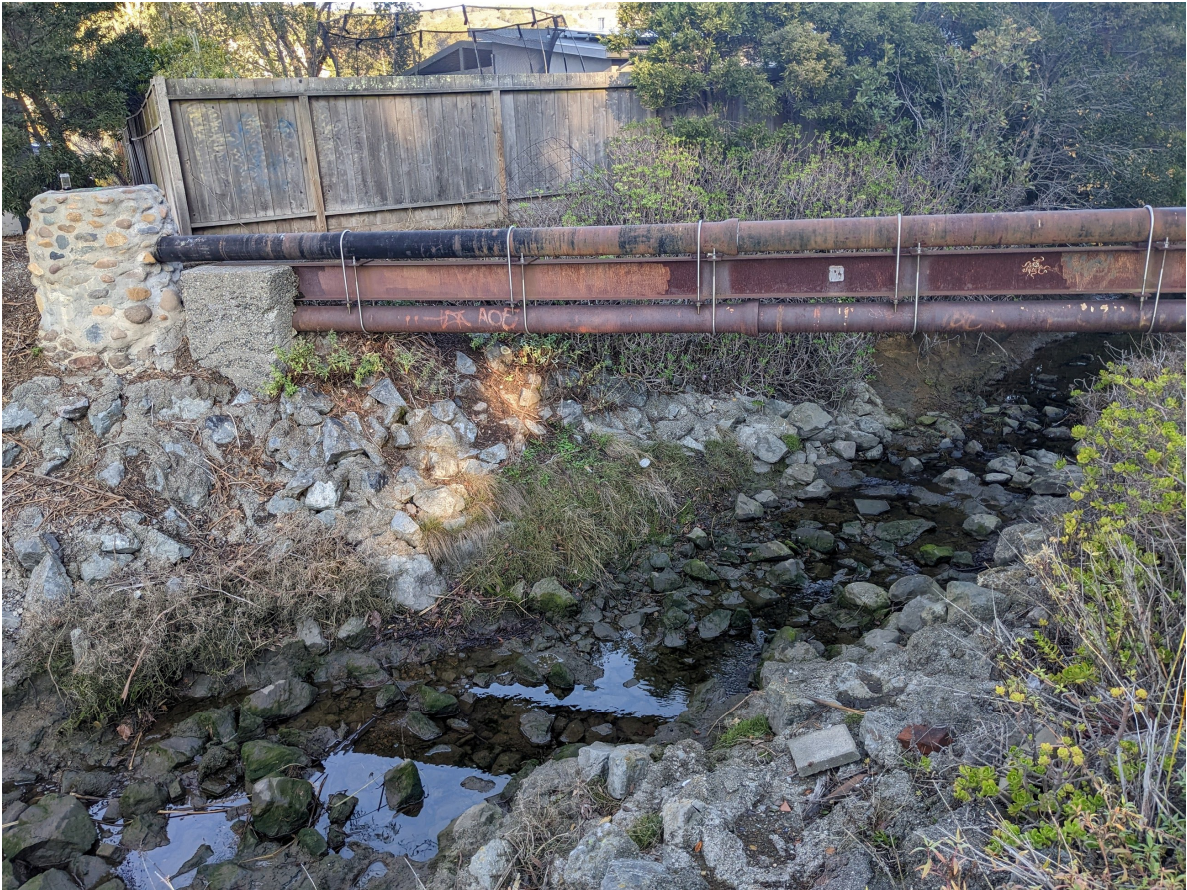
Looking upstream to East Creek from near STA 1+50' to RBSD sanitary sewer pipe crossing (December 16, 2022).

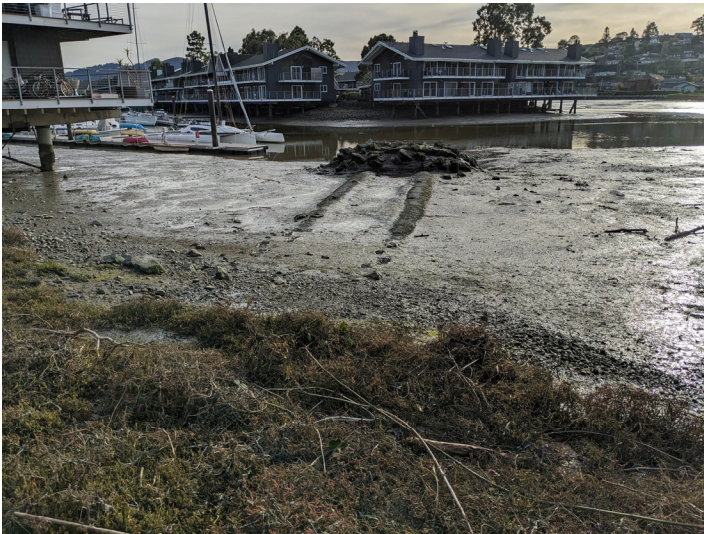
Photo 1. East Creek. Looking downstream to the original double-barrel 60" CMPs outfalling in Richardson Bay near Station -3+95' (January 19, 2023).

Crossing	Stakeholder	Description
Greenwood Cove Dr	County of Marin	Two 60" CMP culverts slip-lined with 52" HDPE plastic pipes all or part of the approx. 280-ft-long distance from the north edge of Greenwood Cove Drive to outfall in Richardson Bay (Photo 1)
SR 131 (Tiburon Blvd)	CalTrans	Two approx. 120-ft-long 66" RCP culverts extending from the vertical concrete headwall at north edge of Tiburon Blvd to two 36" RCP risers between Tiburon Blvd and Greenwood Cove Drive (Photo 2)
Grouted Rock Channel	RBSD	Approx. 180-ft-long grouted rock rip-rap lined channel transitioning from the grouted section at the overhead sewer crossing downstream to the Tiburon Blvd culvert headwall (Photo 3)
Sanitary Sewer Crossing	RBSD	Overhead sewer pipeline crossing with narrow, elevated grouted rock channel section (4.7' invert) (Cover Photo, Photo 4)
Cecilia Way	Town of Tiburon	Approx. 30-ft-long 5'x10' concrete box culvert (6.9' culvert invert) with approx. 25-ft-long 10-ft-wide open concrete rectangular channel transition upstream and overhead sanitary sewer pipe crossing (Photo 5) (Photo 9)

On January 19, 2023, during a low, low tide, GDG surveyed the East Creek culvert outfalls in Richardson Bay (Photo 1) (near Station minus 3+95') about 400 feet downstream from the culvert inlets at Station 0+00'. According to Cal-Trans as-built design plans furnished by the District, the State Route 131 "double-barrel" culverts were originally 60"-diameter corrugated metal pipes (CMPs) that were later upgraded to the current existing 66"-diameter reinforced concrete pipes (RCPs). Near Station -1+20' the 66" RCPs join with separate culverts run the approximately 275-foot remainder of the distance under Greenwood Cove Drive right-of-way and the easement to the Richardson Bay outfalls (Photo 2).

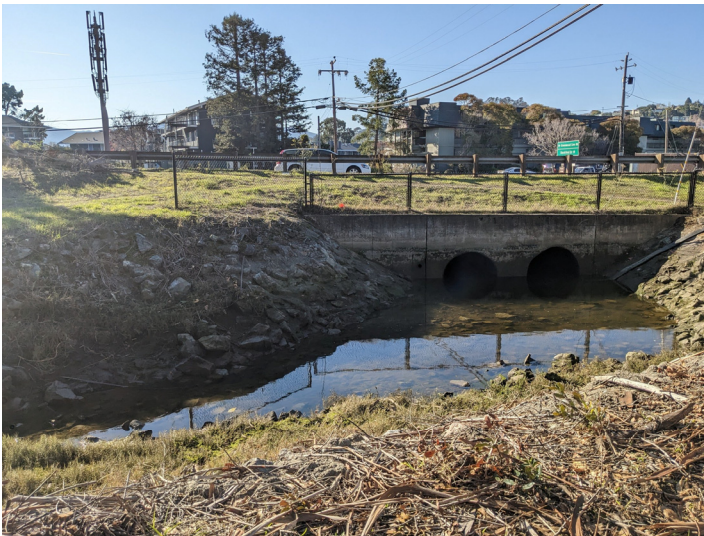
Photo 2. East Creek. Looking downstream from right bank of the grouted rock channel to the vertical concrete headwall inlet to the State Route 131 66" RCP "double-barrel" at Station 0+00' (December 16, 2022).

On December 16, 2022, GDG surveyed East Creek crossing infrastructure from the State Route 131 culvert headwall (at Station 0+00') (Photo 2) to the upstream end of Upper East Creek at the culvert outfalls downstream from Karen Way (near Station 15+00') (Photo 8).

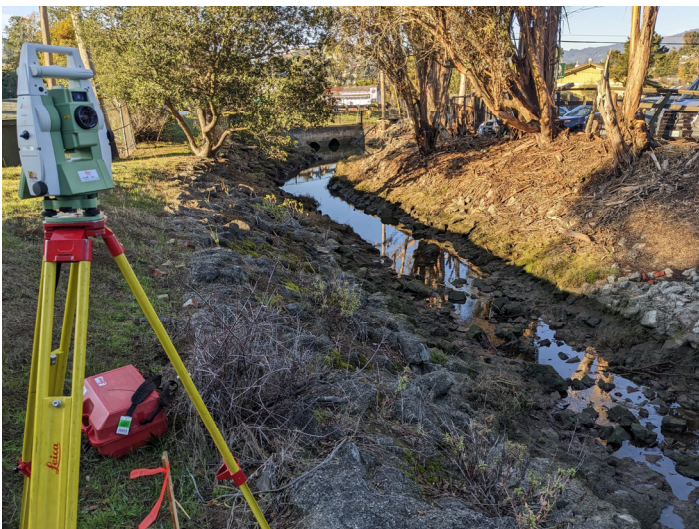
Photo 3. East Creek. Looking downstream from Control Point 1 near Station 1+55' to Lower East Creek. The grouted rock-lined channel extends from the sanitary sewer crossing near Station 1+80' to the State Route 131 "double-barrel" culverts headwall seen in background of view at Station 0+00' (December 16, 2022).

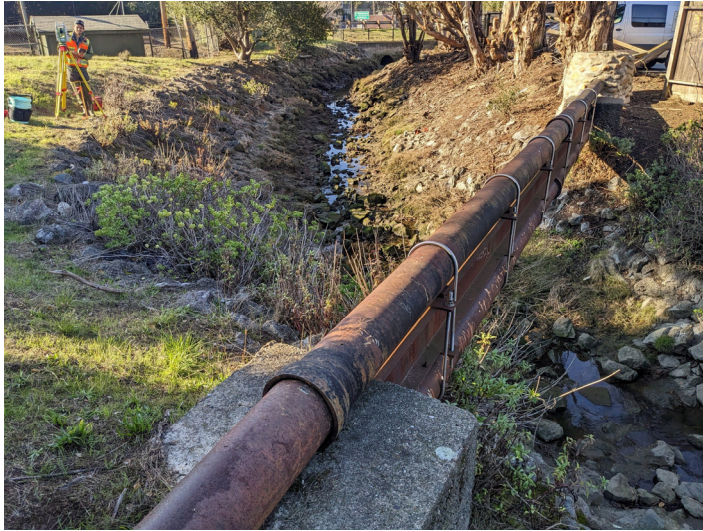
Photo 4. East Creek. Looking from left bank to right bank along the sanitary sewer crossing near Station 1+80' and narrow grouted rock channel with 4.7' invert on the pipeline section (December 16, 2022). See also cover photo.

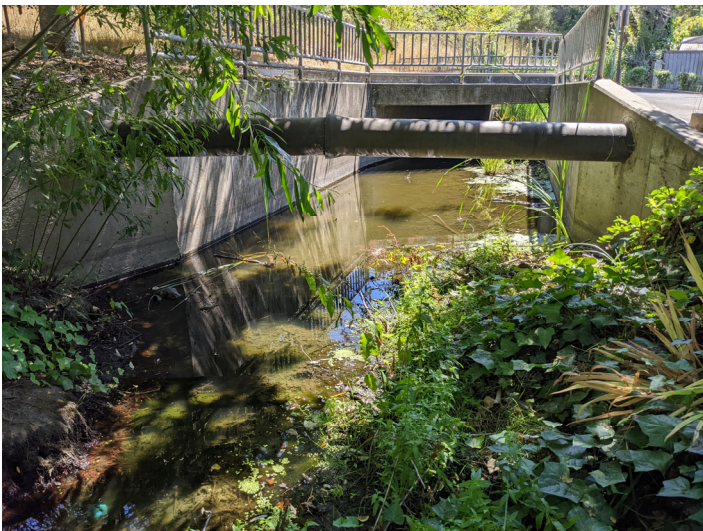
Photo 5. East Creek. Looking downstream from inlet to the 10-ft-wide open concrete box culvert and overhead sanitary sewer pipe crossing to 5'x10' Cecilia Way concrete box culvert downstream in background of view (August 3, 2022).

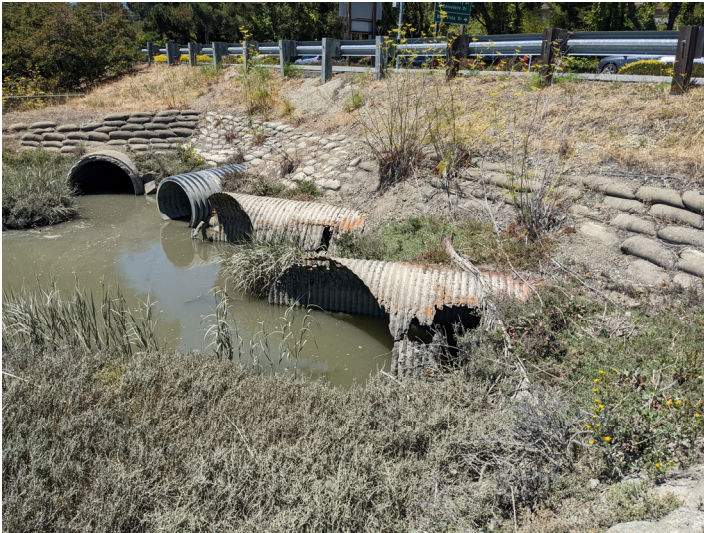
Photo 6. West Creek. Looking from left bank to outlet of two 60" CMP culverts (in foreground) outfalling to open natural channel downstream from Tiburon Boulevard (August 3, 2022).

Crossing	Stakeholder	Description
SR 131 (Tiburon Blvd)	Cal-Trans	Two approx. 180-ft-long 60" CMP culverts extending from the vertical concrete headwall at north edge of Tiburon Blvd to constructed natural open channel downstream from Tiburon Blvd (Photo 6)
Cecilia Way	Town of Tiburon	Approx. 50-ft-long 5.3'x11.4' concrete box culvert (5.4' culvert invert) with narrow natural channel transitioning into culvert inlet (Photo 7)

On January 19, 2023, GDG GPS-surveyed Lower West Creek culvert inlet and outlet invert elevations of the approx. 180-ft-long double-barrel 60"-diameter CMP State Route 131 culverts (Photo 6), including the inverts and limits of the sackrete-lined 90-degree bending transition structure upstream from the culvert inlets.

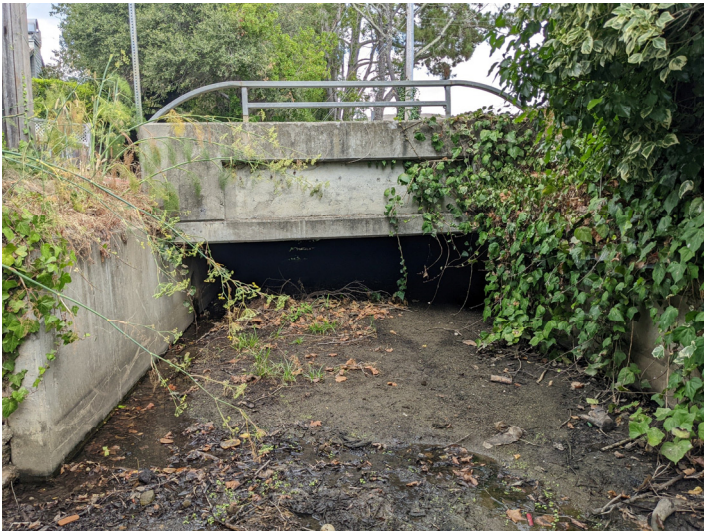
Photo 7. West Creek. Looking upstream to outlet of the Cecilia Way 5.3'x11.4' concrete box culvert (August 17, 2022). Note there is about 2-3 ft of fine sediment deposited within the downstream part of the culvert but much less sediment deposited in the upstream part of the culvert. This is the natural, unmaintained condition.

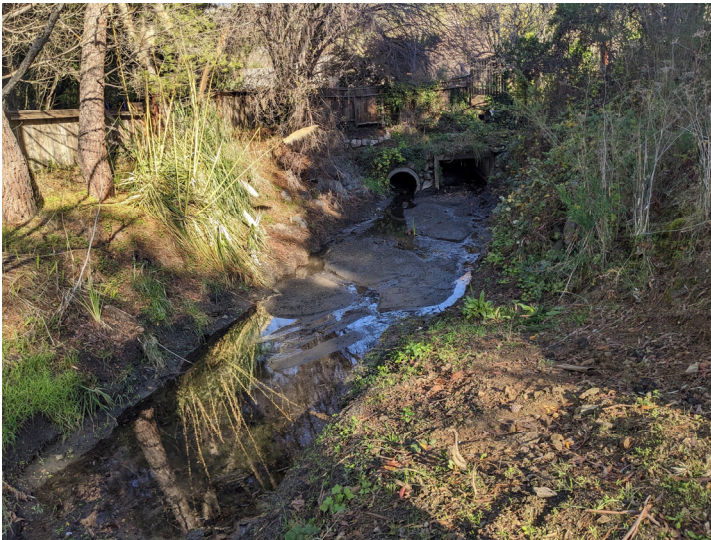
Photo 8. East Creek. Looking upstream to the outlet of culverts originating at or upstream from Karen Way (December 16, 2022). This is the maintained condition following channel maintenance dredging completed in October 2022. Note sedimentation near the culvert outfalls that occurred during November and December rainstorms.

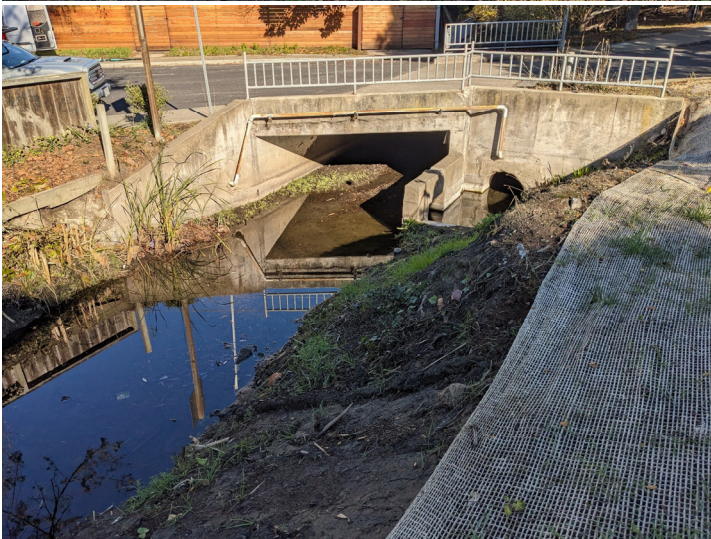
Photo 9. East Creek. Looking upstream to the outlet of Cecilia Way culvert (December 16, 2022). This is the maintained condition following channel maintenance dredging completed in October 2022. None or negligible sedimentation occurred downstream from Cecilia Way culvert during November and December rainstorms.

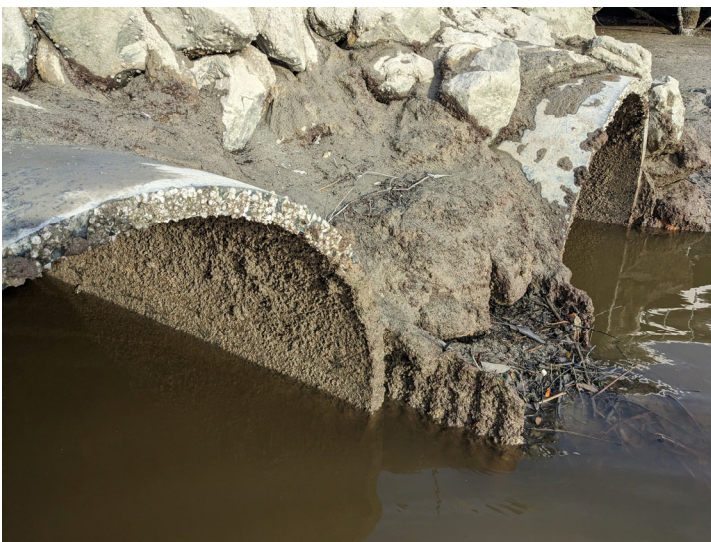
Photo 10. East Creek. View of the East Creek culvert outfalls in Richardson Bay near Station -3+95' (see also Photo 1). The original double-barrel 60" CMPs appear to have been slip-lined with 52" HDPE plastic pipe culverts (January 19, 2023).

These downstream culverts were also originally 60"-diameter CMPs. At the outfall they were measured to be 52" thick-smooth-walled HDPE plastic pipes (PPs) (Photo 10). It has not been confirmed if the 60" CMPs were slip-lined with the 52" PPs all the way upstream to the junction with the 66" RCPs, or if there are remainder segments of the original 60" CMPs downstream from the Cal-Trans Right-of-Way.

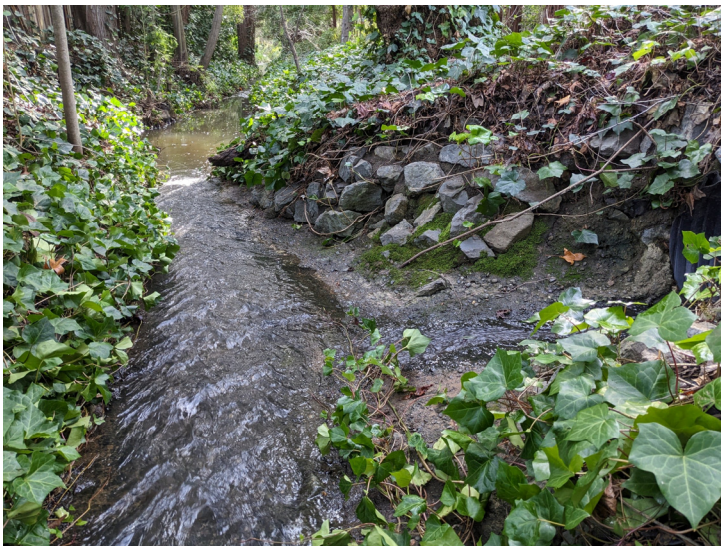
Photo 11. Looking downstream to the grade-controlling channel-spanning concrete stormwater outfall forming a headcut-step on Upper West Creek near Station 11+60' (January 19, 2023).

GDG GPS-surveyed the bed elevations from the downstream end of the Tiburon Boulevard culverts (near Station minus 1+80') to the upstream end of Lower West Creek (near Station 5+80'), and Total Station-surveyed new channel cross-sections and channel bed and bank features in Upper West Creek including multiple flow-blocking in-channel trees, and the channel-spanning concrete stormwater outfall apron forming a headcut-step near Station 11+60' (Photo 11).

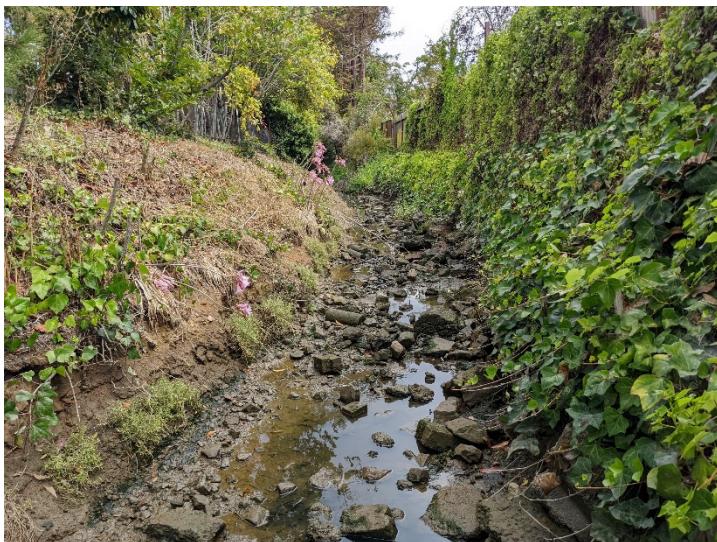
Photo 12. Lower West Creek. Looking upstream from Lower West Creek channel bed near Station 3+00' to the broken concrete rubble covered channel bed (August 17, 2022).

Theoretically, the 6-ft self-setting channel bed elevation downstream from Cecilia Way culvert is artificially high due to the prevalence of loose broken concrete rubble and foreign rock rip-rap pieces covering the width of the channel bed downstream from Cecilia Way culvert (Photo 12). Rubble and rock pieces issued out of failed bank erosion protection structures over decades has been transported by high peak flows (such as the December 31, 2005 flood)

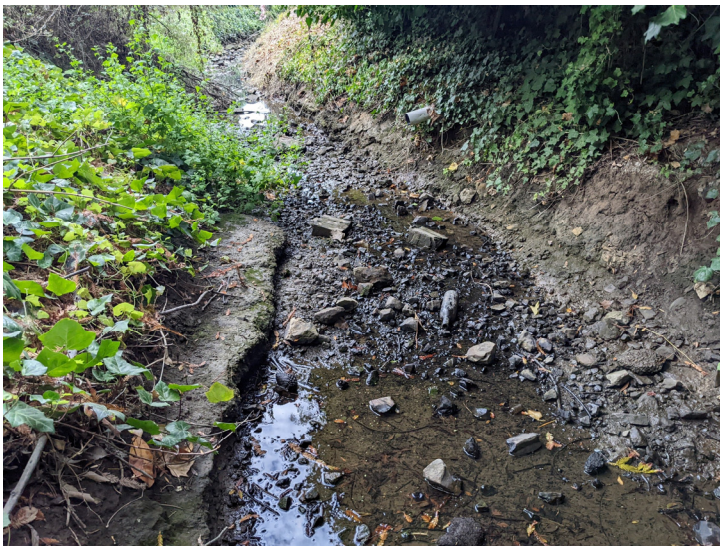
Photo 13. Lower West Creek. Looking downstream from the Lower West Creek channel bed near Station 4+10' to the lightweight foreign rubble deposited upstream from the rubble covered channel bed downstream, and evidence of recent natural tendency channel bed downcutting limited by coarse foreign material on the bed (August 17, 2022).

self-setting bed elevation upstream from the rubble covered reach between Station 4+00' (Photo 13) and the downstream face of Cecilia Way culvert is reduced from about 6 ft to about 5.5 ft, and the culvert depth-block is reduced from 2 ft to 1.5 ft.

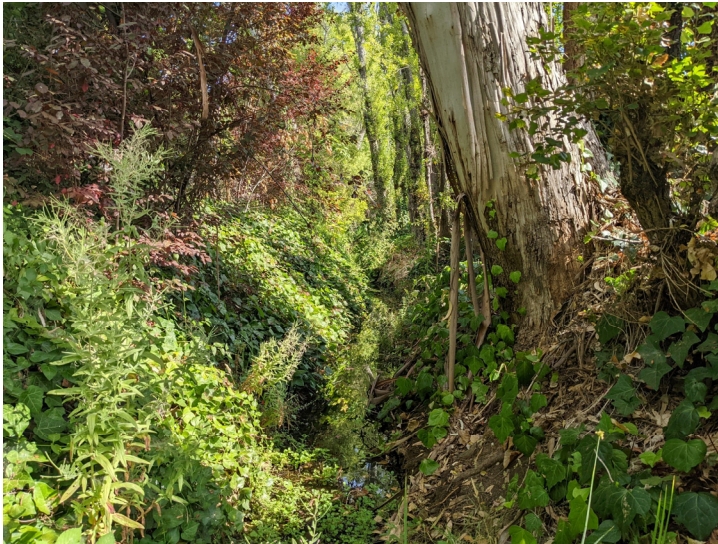
Photo 14. West Creek. Looking upstream from the channel bed near Station 7+60' to the left bank in-channel tree, Tree #4 (46"-diameter eucalyptus), surveyed on Cross-Section 58 at Station 7+77'. Tree #4 was topped approximately 10 years ago. Model simulations show that removal of Tree #4 reduces the computed 50-year flood water surface elevation by 0.4' upstream near Station 8+19' (August 17, 2022).

- Medium Plan 2-4 (Plan 56). Simulates removal of Tree #2, Tree #3, and Tree #4 (Photo 14) (3 trees, all non-native). Plan 56 produces a total 50-year WSE reduction of 0.4' near Station 8+19', reducing the computed 50-year WSE to less than the overbank flow threshold. Removal of Tree #4 was retained in remaining simulations.

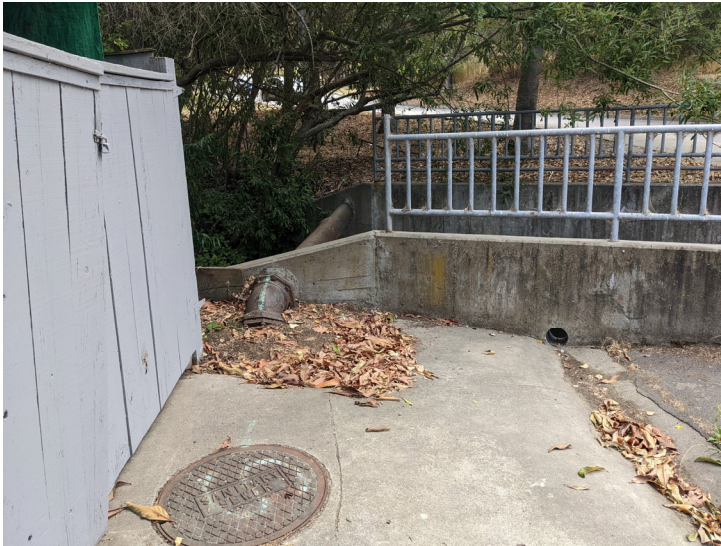
Photo 14. Upper East Creek. Looking from Cecilia Way to the upstream end of the right bank concrete transition channel wall about 30 feet upstream from the Cecilia Way culvert road crossing (August 17, 2022). The stormwater drain hole in the wall discharges creek flow onto the street during routine or average annual high creek flows. Blocking the drain hole combined with surface drainage improvements for directing the concrete swale flows to existing storm drain inlets near the Cecilia-Leland Way intersection should be considered.

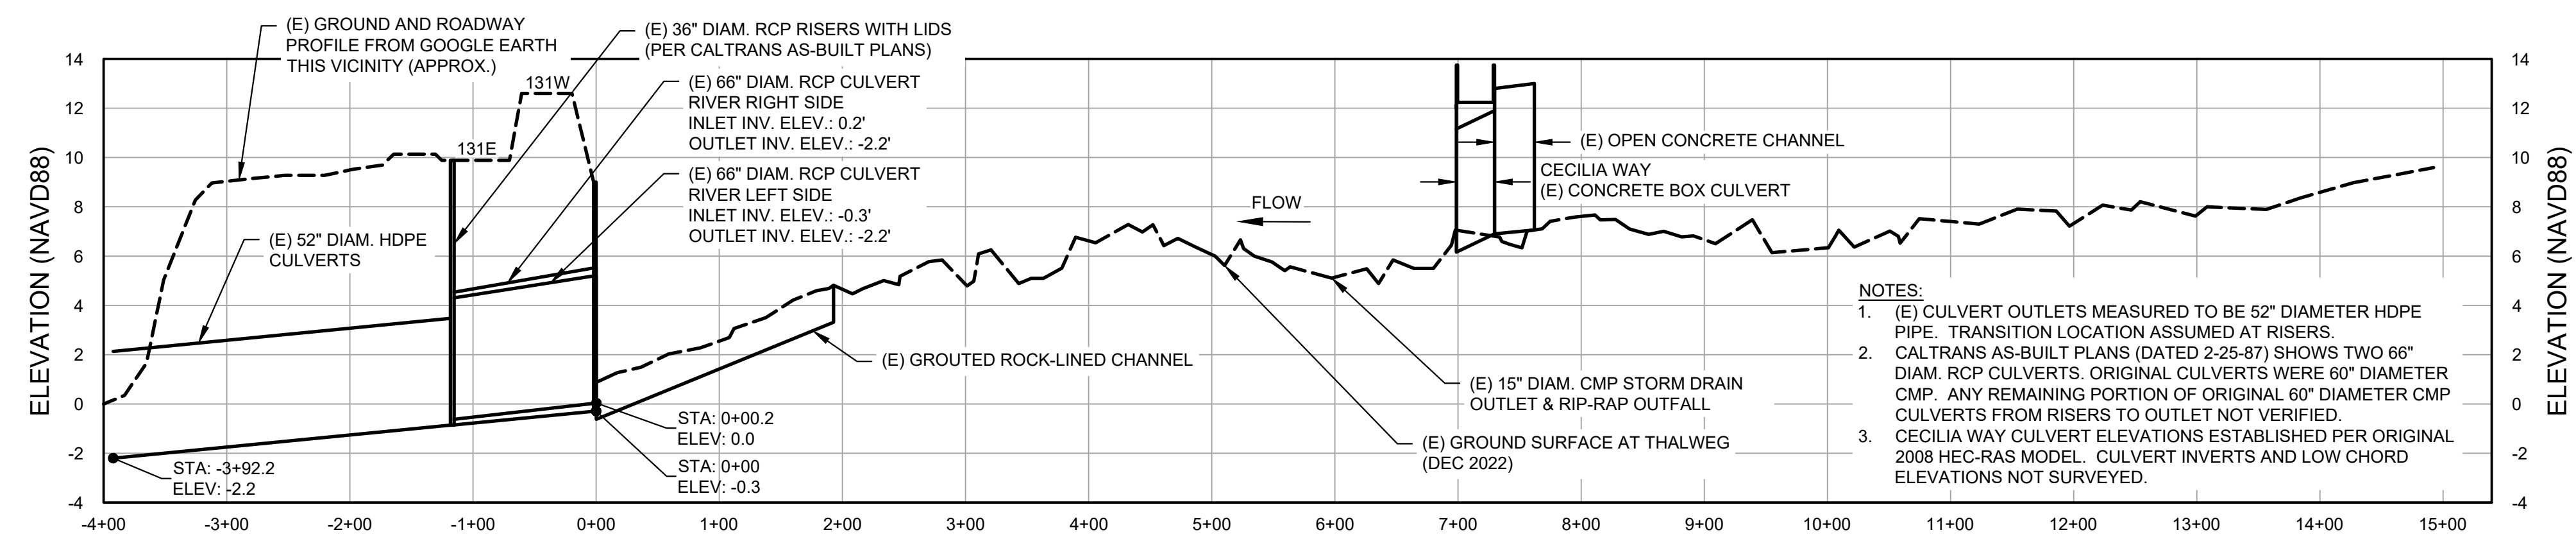
FIG.1

EAST CREEK MINIMUM PLAN "MINIMUM PLAN" (PLAN 28)
SCALE: 1" = 60'

POTENTIAL EAST CREEK FLOOD RISK REDUCTION MEASURES - PROFILE
SCALE: H:1" = 100', V:1" = 5' (20X EXAGGERATION)

Minimum Plan	Medium Plan	Maximum Plan
“Minimum Plan” (Plan 28) Figure 1	“Medium Plan” (Plan 32) Figure 2	“Medium Plan +1+2+3” (Plan 40) Figure 3
<i>Status Quo.</i> District continues current program of periodic as needed vegetation and sediment removal from accessible reaches and according to the current permitted extents downstream and upstream from Cecilia Way culvert.	District obtains new permits to one-time extend channel maintenance 220-250 feet downstream from its current permitted limit. The one-time project would “restore” an adequate width and depth channel sloped 0.3% from the Cecilia Way culvert concrete floor to the grouted channel bed invert at the RBSD sanitary sewer crossing.	Same as Medium Plan.
	One-time sediment removal from within Cecilia Way concrete box culvert, open concrete box culvert transition upstream and from within the tree-covered natural channel reach bordering 100, 106, and 112 Leland Way.	Same as Medium Plan.

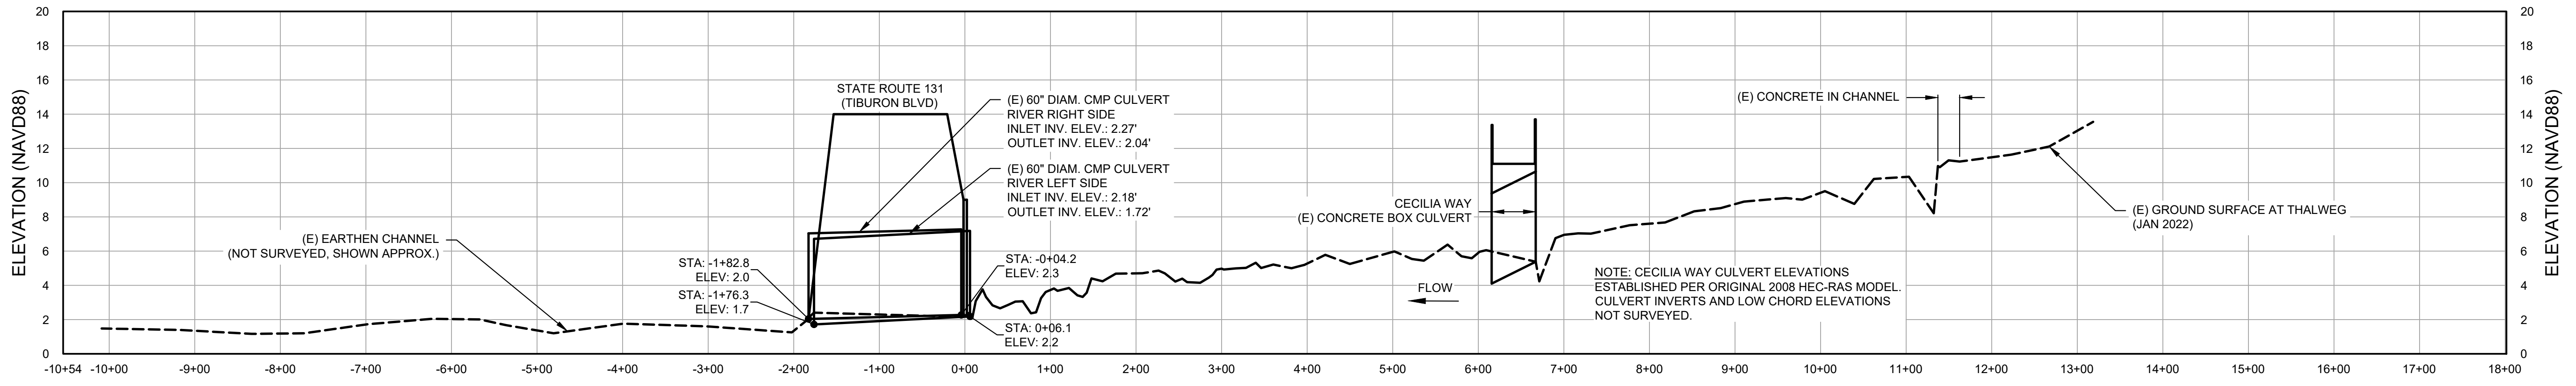
WEST CREEK MINIMUM PLAN "MINIMUM PLAN 2" (PLAN 47)
SCALE: 1" = 100'

POTENTIAL WEST CREEK FLOOD RISK REDUCTION MEASURES - PROFILE
SCALE: H:1" = 100', V:1" = 5' (20X EXAGGERATION)

Minimum Plan	Medium Plan	Maximum Plan
“Minimum Plan 2” (Plan 47) Figure 4	“Medium Plan 3-2” (Plan 63) Figure 5	“Maximum Plan Med-3” (Plan 66) Figure 6
District would obtain new permits and implement one-time hand-work to remove about 100 CY of foreign rock and concrete materials accumulated in places along the length of the channel bed in an approximately 300-ft long of Lower West Creek and an approximately 400-ft-long reach of Upper West Creek, including minor bank shaping and biotechnical erosion protection in Upper West Creek.	Same as Minimum Plan 2.	Same as Medium Plan 3-2.
No tree removals.	Remove 4 Trees (#1, 2, 3, 4)	Same as Medium Plan 3-2.
	District would also remove the existing channel-spanning concrete storm drain outfall and restore adequate width-and-depth channel upstream and downstream from the replaced outfall with minimized rock lining and biotechnical bank erosion protection measures.	Same as Medium Plan 3-2.

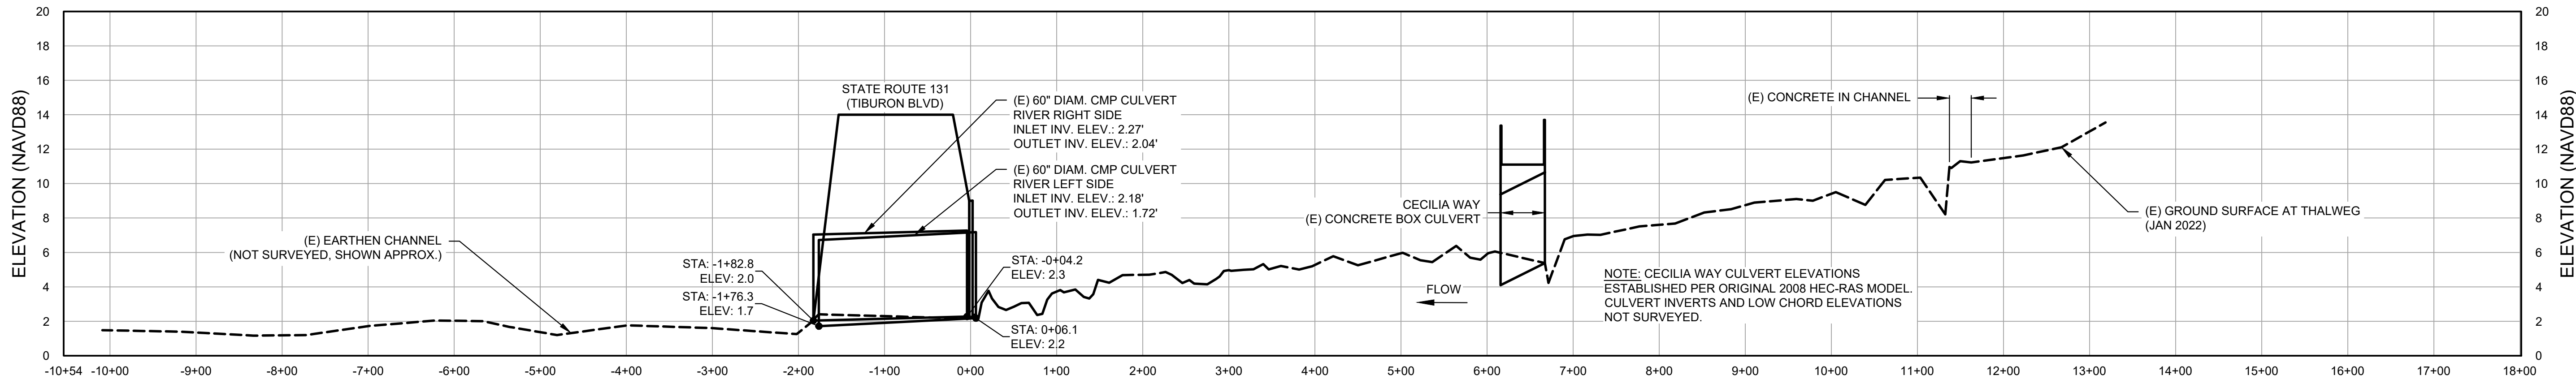
FIG.5

WEST CREEK MEDIUM PLAN "MEDIUM PLAN 2" (PLAN 63)
SCALE: 1" = 100'

POTENTIAL WEST CREEK FLOOD RISK REDUCTION MEASURES - PROFILE
SCALE: H:1" = 100', V:1" = 5' (20X EXAGGERATION)

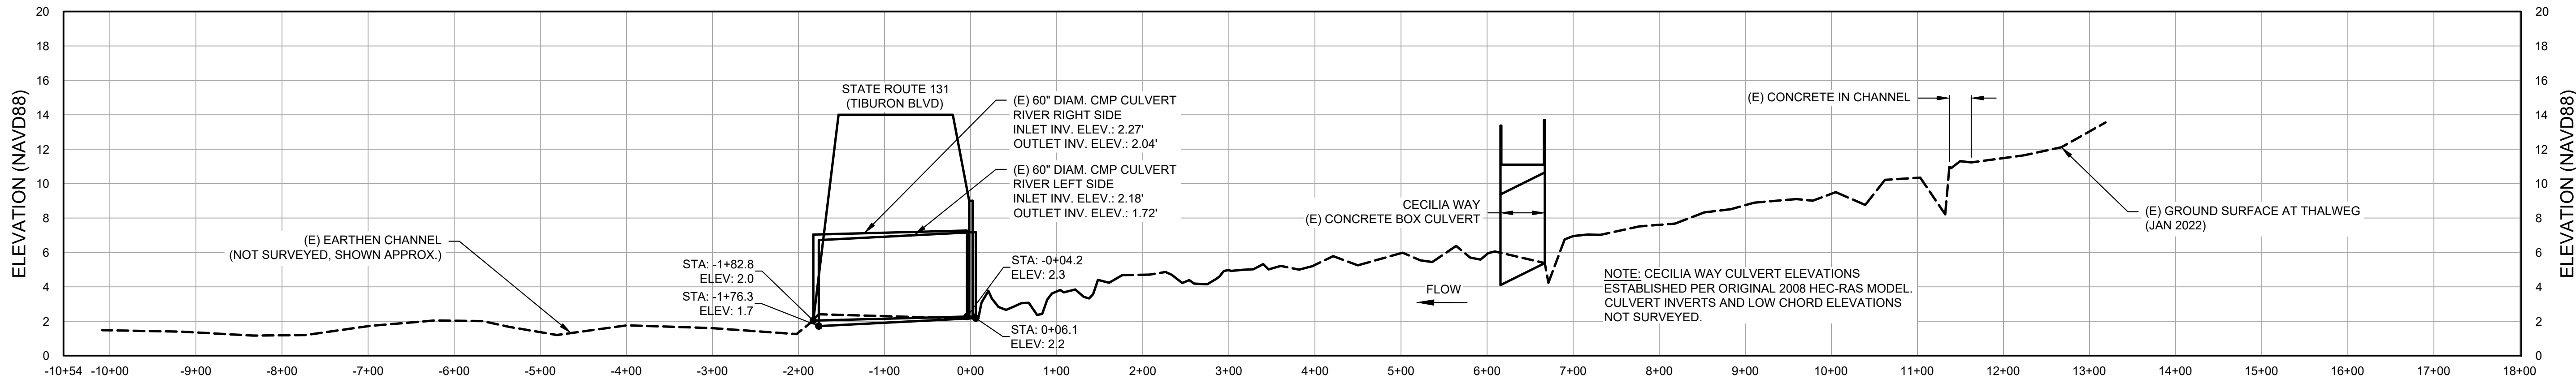
FIG.6

WEST CREEK MAXIMUM PLAN "MAXIMUM PLAN MED-3" (PLAN 66)
SCALE: 1" = 100'

POTENTIAL WEST CREEK FLOOD RISK REDUCTION MEASURES - PROFILE
SCALE: H:1" = 100', V:1" = 5' (20X EXAGGERATION)
