Report
Soil Investigation
Lands of Baywood
Petaluma, California

GIBLIN ASSOCIATES
Consulting Geotechnical Engineers

Job No. 321.59.1
May 16, 2008

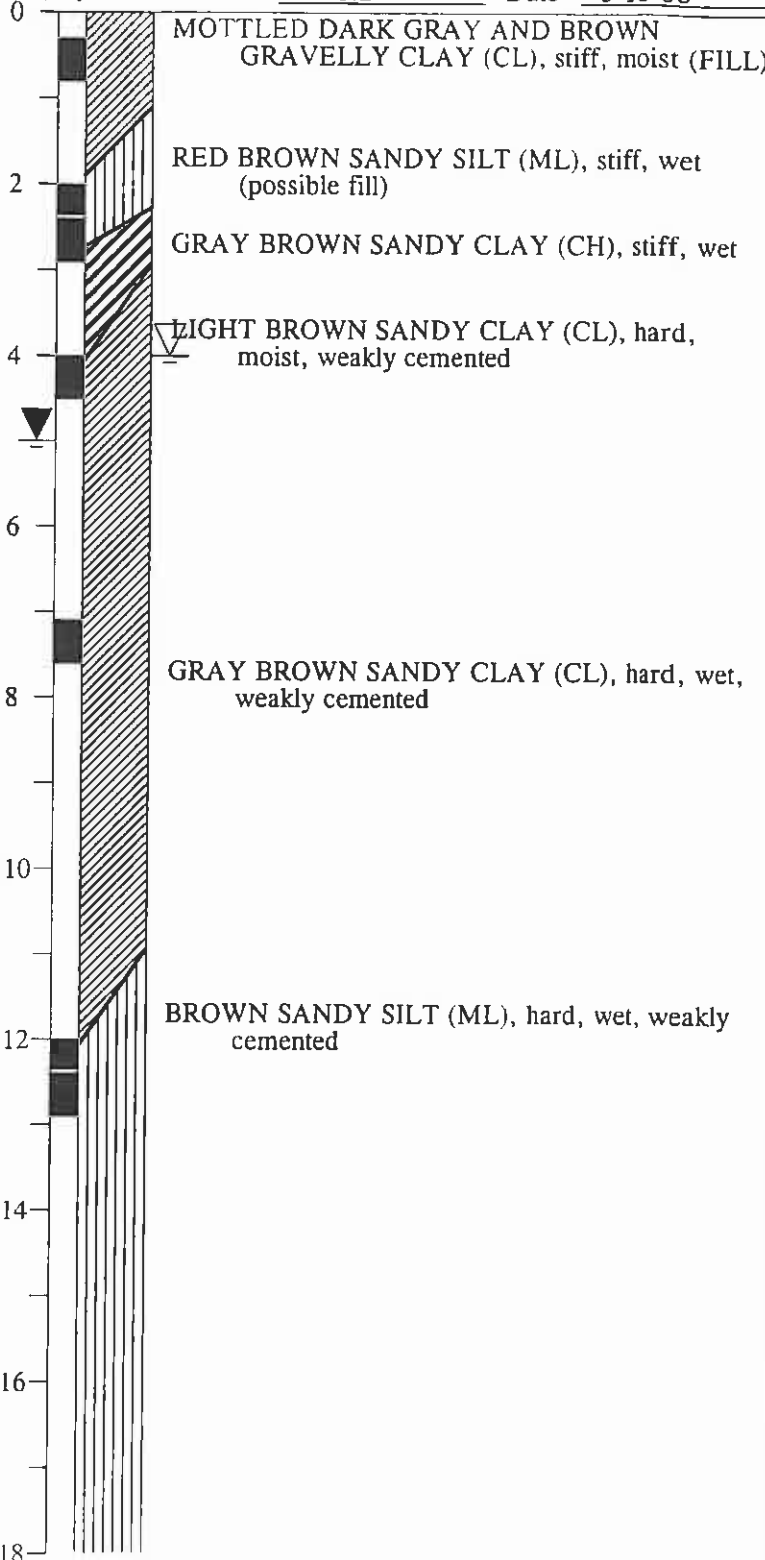
Equipment 6" FLIGHT AUGER
Elevation 8.2 Date 3-18-08

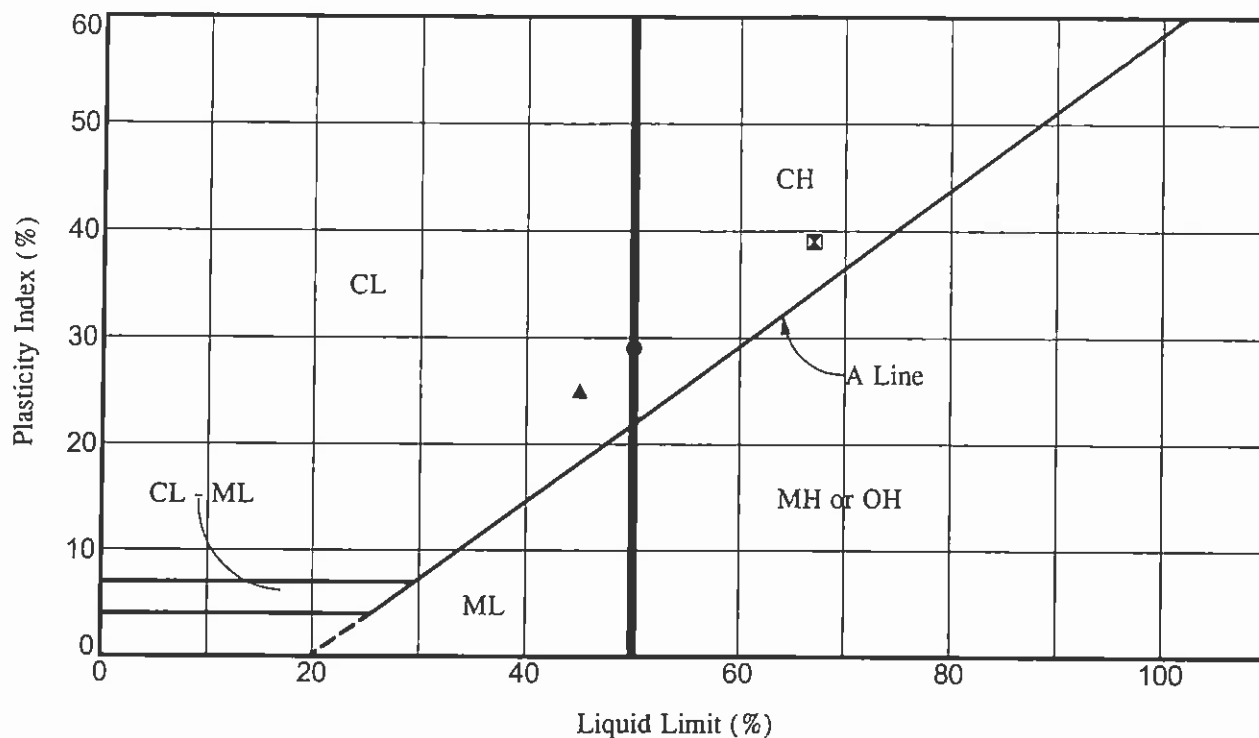
18

ASTM D 4318-98

Symbol	Classification and Source	Liquid Limit (%)	Plastic Limit (%)	Plasticity Index (%)	Free Swell (%)
●	BLACK SANDY CLAY (CH) Test Boring 1 at 1.4 feet	50	21	29	100
▣	BLACK SANDY CLAY (CH) Test Boring 14 at 1.5 feet	67	28	39	90
▲	DARK BROWN GRAVELLY CLAY (CL) Test Boring 15 at 0.3 feet	45	20	25	60

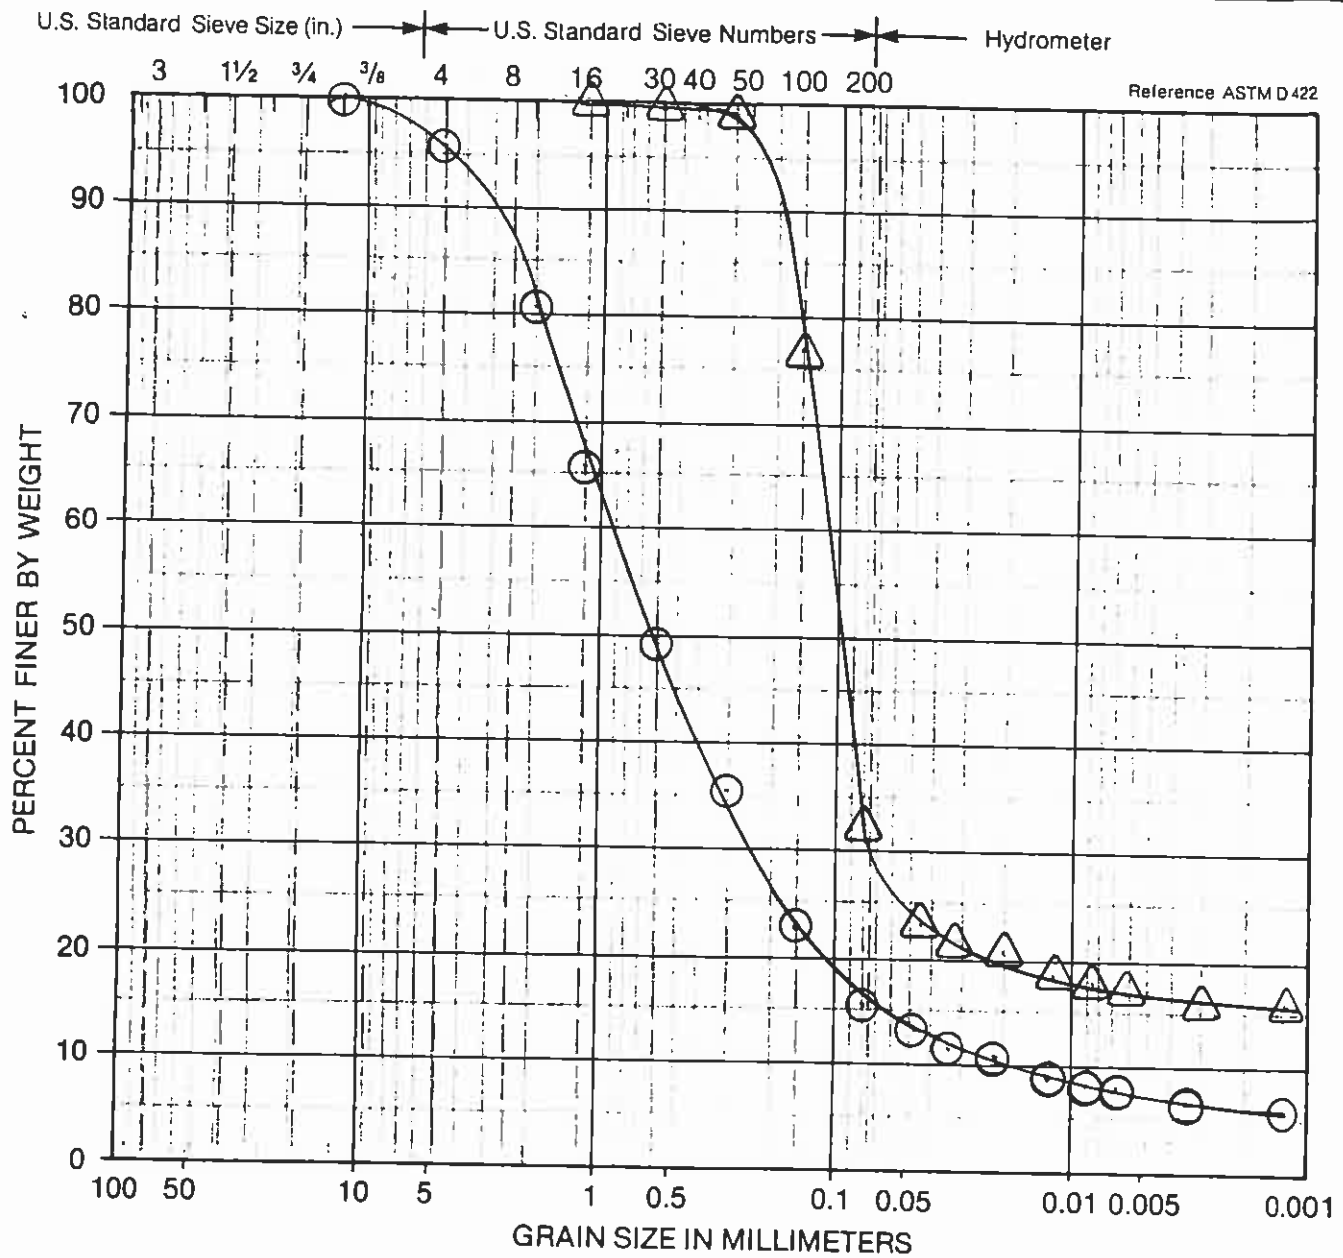
19

COBBLES	COARSE	FINE	COARSE	MEDIUM	FINE	SILT OR CLAY
	GRAVEL		SAND

Symbol	Sample Source	Classification
○	Boring 5 at 10 feet	BROWN SILTY SAND (SM)
△	Boring 8 at 4.9 feet	GRAY CLAYEY VERY FINE SAND (SC)
