Stormwater Control Plan
For a Regulated Project
Creekwood Condominiums

March 23, 2021

Prepared by:
Steven J. Lafranchi & Associates, Inc.
140 Second Street, Suite 312
Petaluma, CA 94952
Business: 707-762-3122
Fax: 707-762-3239

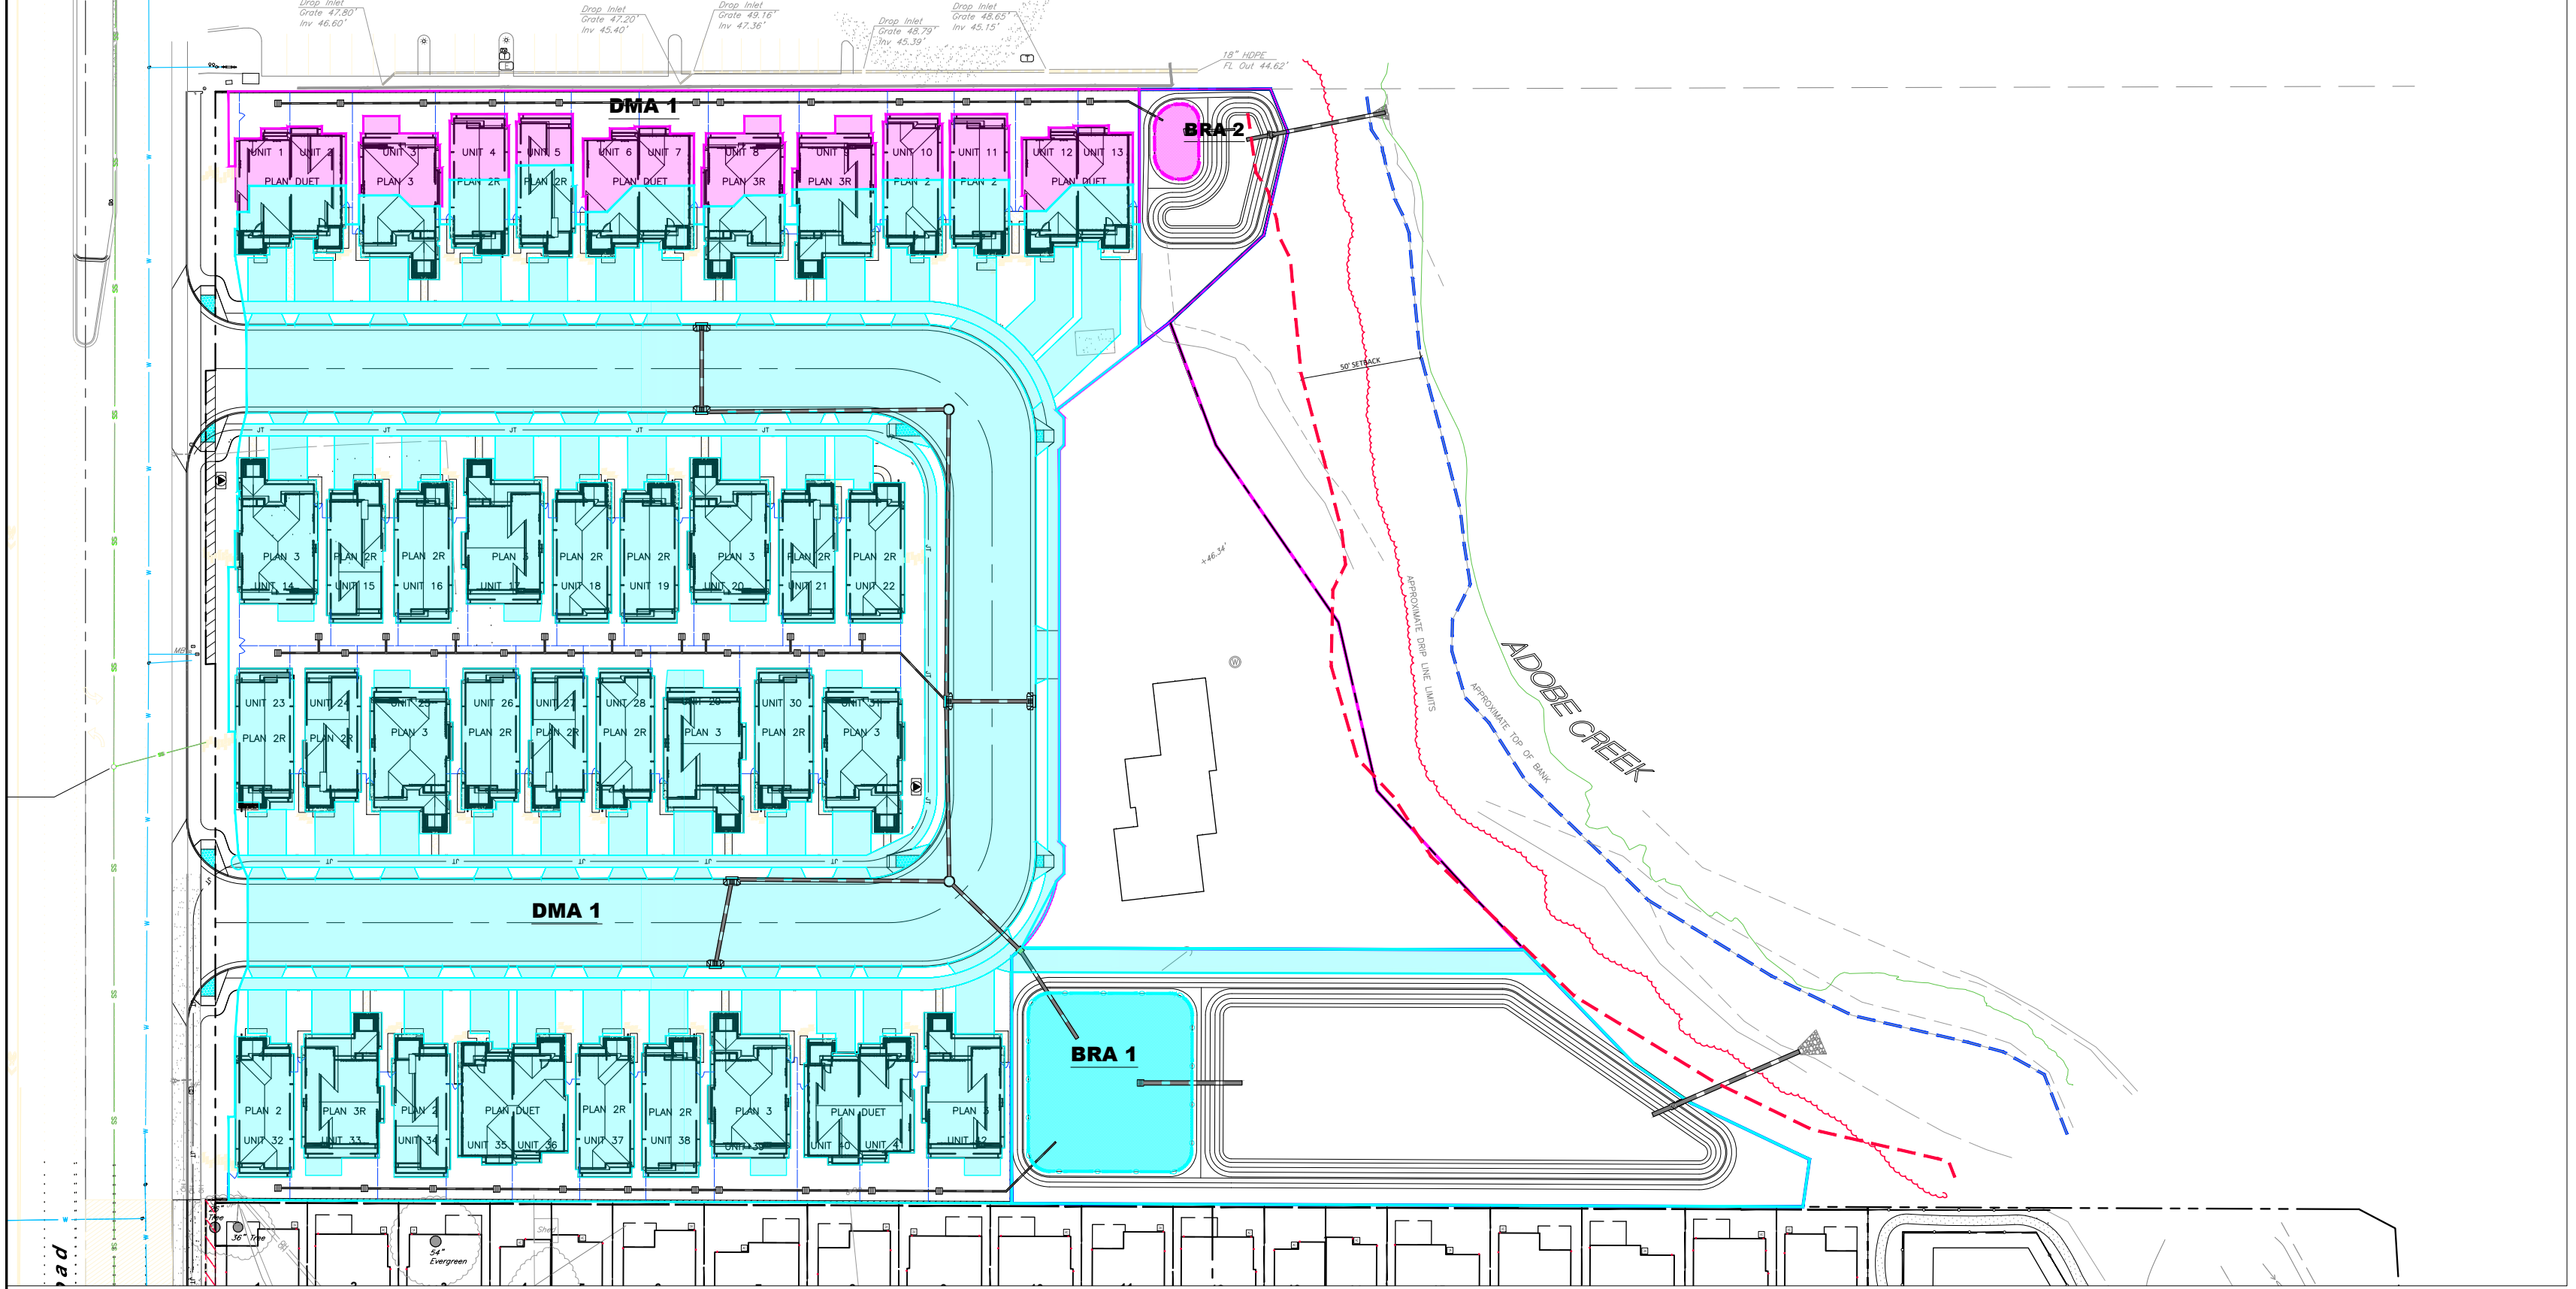
- PROPERTY LINE
- STORM DRAIN LINE
- BRA BASIN RETENTION AREA. SEE DETAIL SHEET C-15.
- DMA DRAINAGE MANAGEMENT AREA (IMPERVIOUS SURFACES) ROOFS, AC PAVEMENT, SIDEWALK, DRIVEWAYS.
- DMA DRAINAGE MANAGEMENT AREA (PERVIOUS SURFACES) LANDSCAPE AREAS, TURFBLOCK OR GRAVEL, OPEN OR POROUS PAVERS, GRANULAR PAVEMENT, GROUND COVER)

DMA 1	DMA Area (s.f.)	Post-Project Surface Type	DMA Runoff Factor	DMA Area x Runoff Factor	Basin Area A		
Roof	53,614.00	Roof	1.0	53,614.0	BRA 1		
Landscape	62,060	Landscape	0.1	6,206.0	Sizing Factor	Minimum Facility Area	Proposed Facility Area
Pavement	61,592	Hardscape	1.0	61,592.2			
Total				121,412.2	0.04	4856.5	4977

DMA 2	DMA Area (s.f.)	Post-Project Surface Type	DMA Runoff Factor	DMA Area x Runoff Factor	Basin Area B		
Roof	9,013	Roof	1.0	9,013.0	BRA 2		
Landscape	11,794	Landscape	0.1	1,179.4	Sizing Factor	Minimum Facility Area	Proposed Facility Area
Pavement	0	Hardscape	1.0	0.0			
Total				10,192.4	0.04	407.7	510
