Silk Mill, Petaluma
Historical Summary and Project Evaluation

Introduction

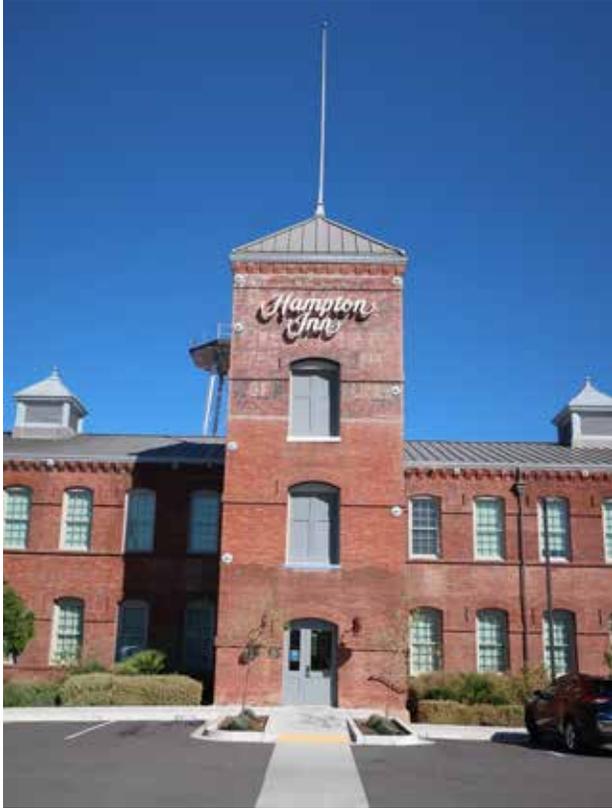
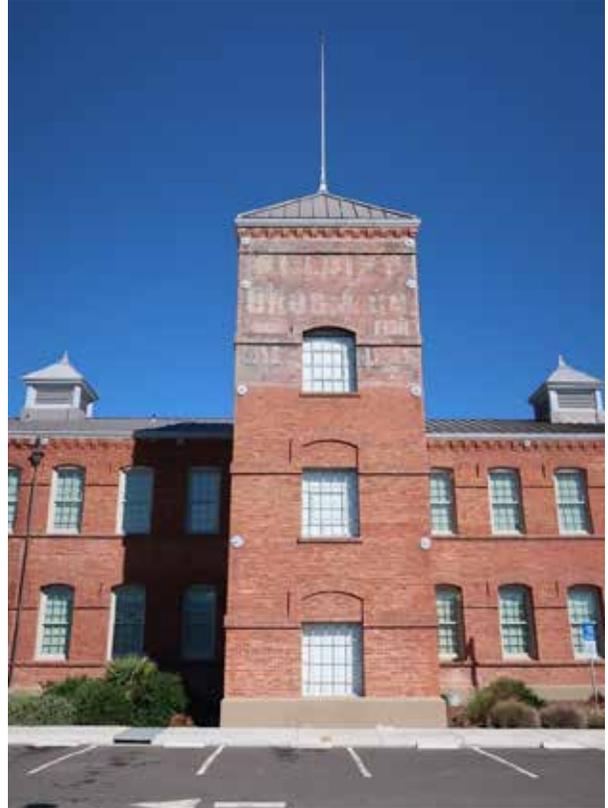
Figs.13-14: Petaluma Silk Mill – Front west tower, at left; east tower, at right (figs.13-23, MH 2021)

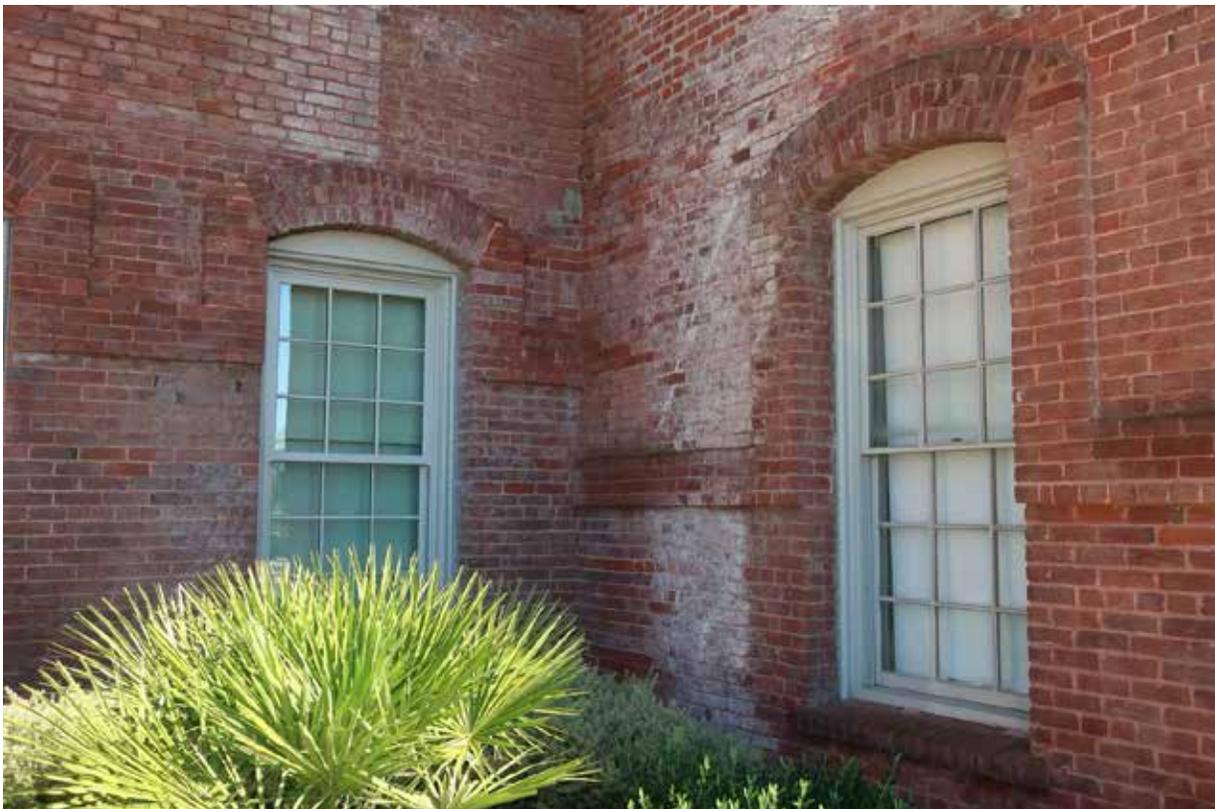
Fig.15: Petaluma Silk Mill – 2018 window at Main Building, at left; 1892 window at west tower, at right

The Silk Mill was recently adapted from an industrial use to its current hotel use. That adaptation and rehabilitation was successful as there were minor losses of historic elements, extensive rehabilitation work along with in-kind replacement and, overall, no loss of historic integrity. This conclusion is best exemplified by one topic that raised concern in the process of the recent project – the replacement of the majority of windows. As the window openings and their distinctive wood frames were retained and the original window design replicated, the replacement windows are, from an historic architectural perspective, highly effective (fig.15).

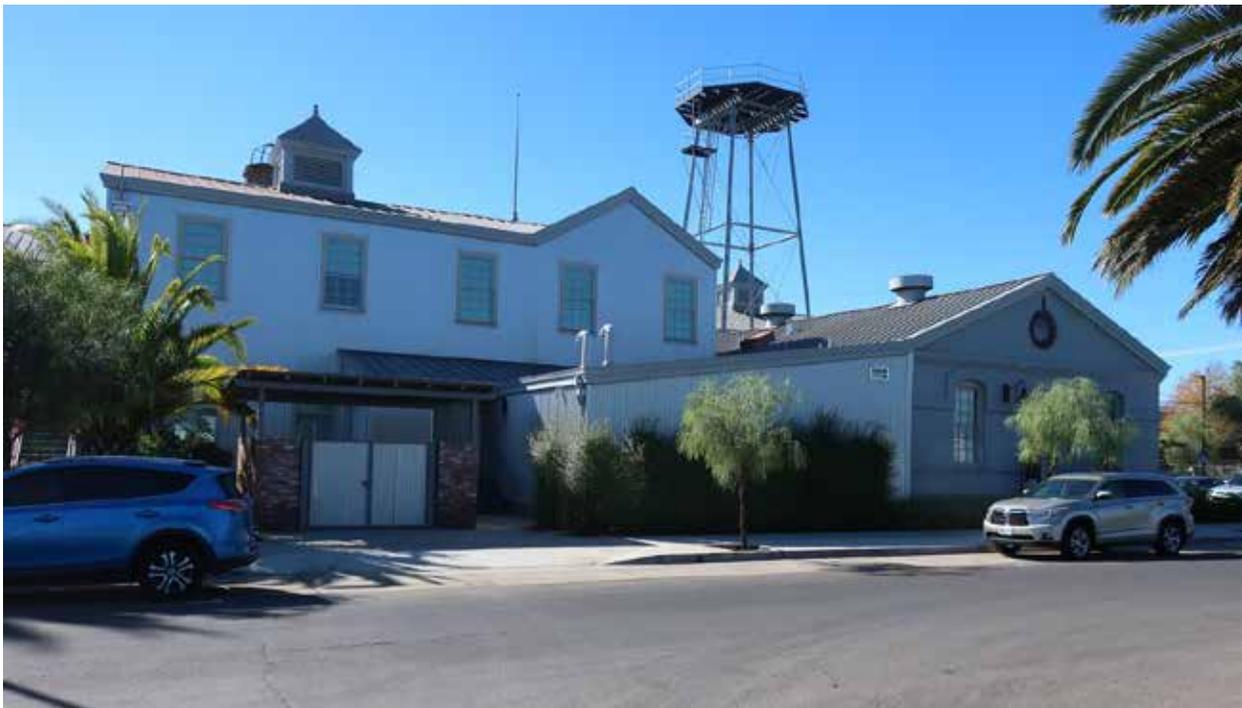
Fig.18: Petaluma Silk Mill – Rear (north), Machine Rm. Building, at left/center; Dye House, at right; water tank structure beyond

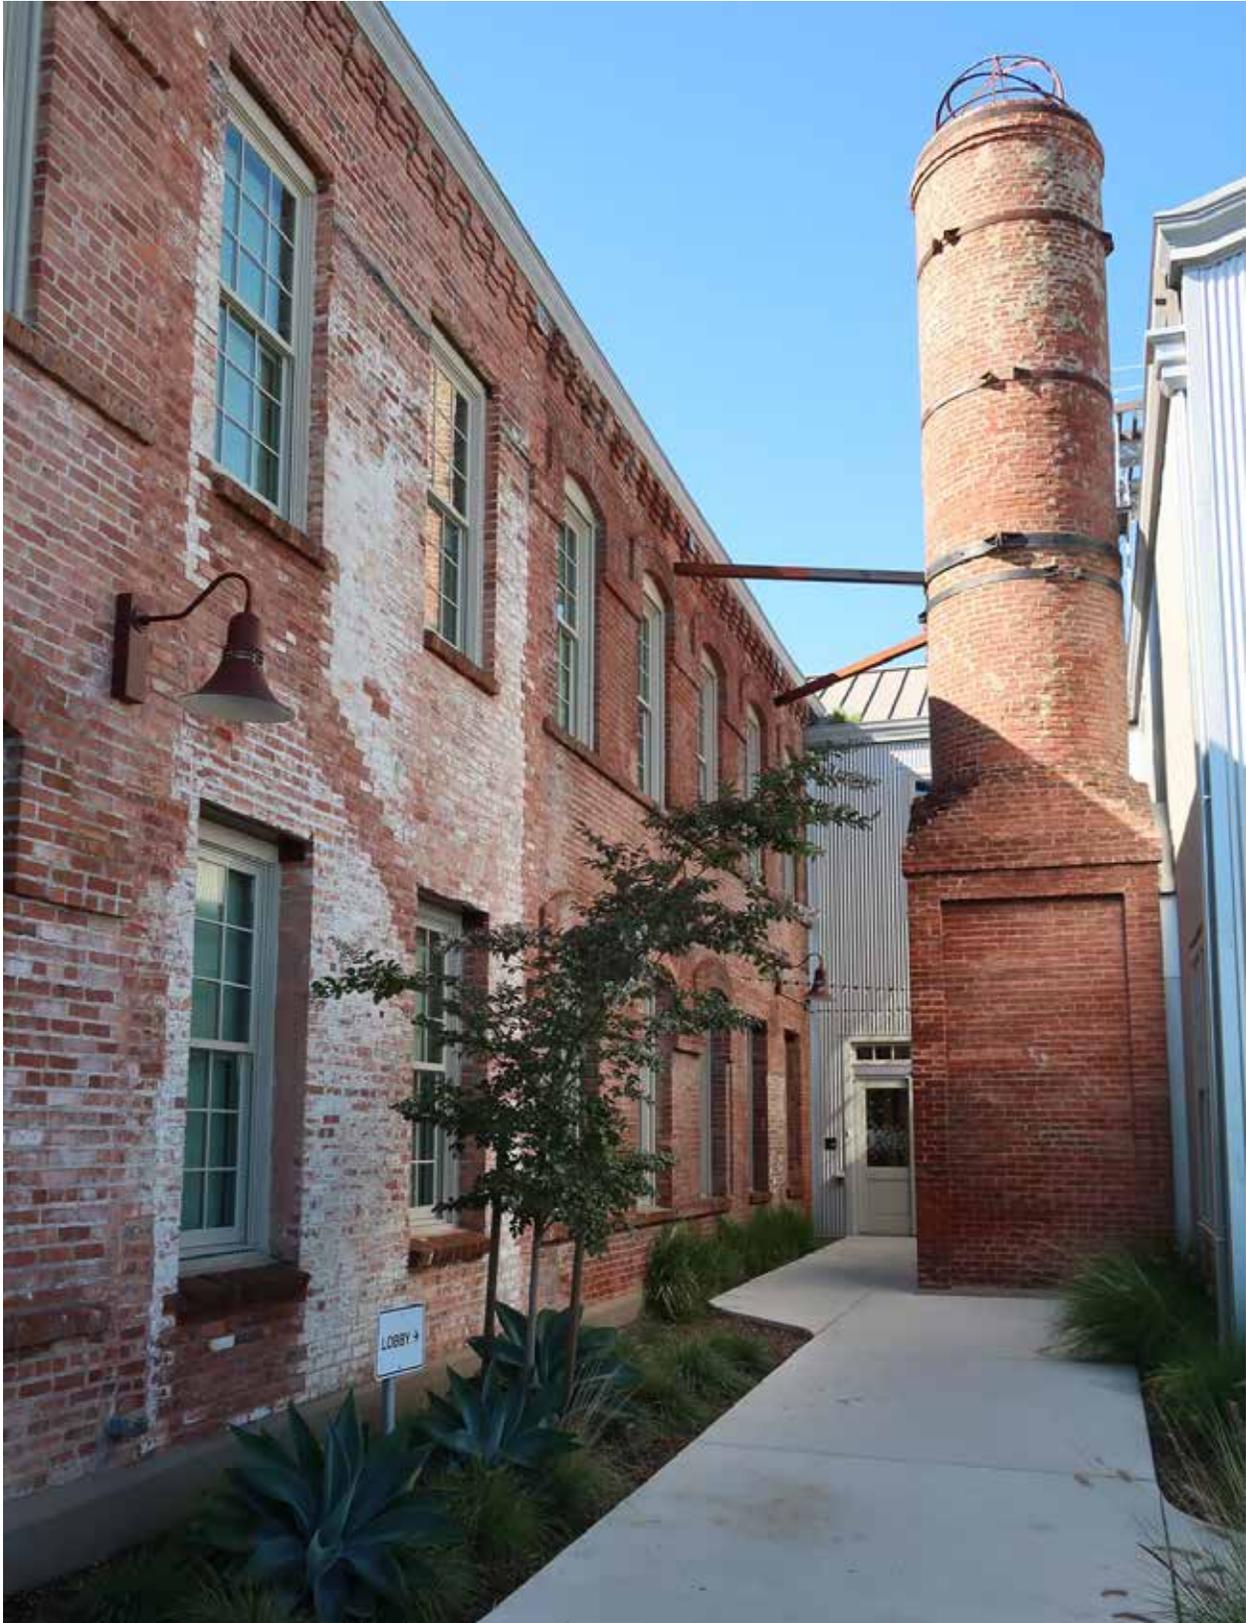
Fig.19: Petaluma Silk Mill – Brick chimney at northeast entry way

- Removed and replaced all doors
- Added new entries at Engine Rm. Building
- Retained, altered and strengthened brick chimney at Engine Rm. Building
- Retained interior elevator and stair at Main Building west tower

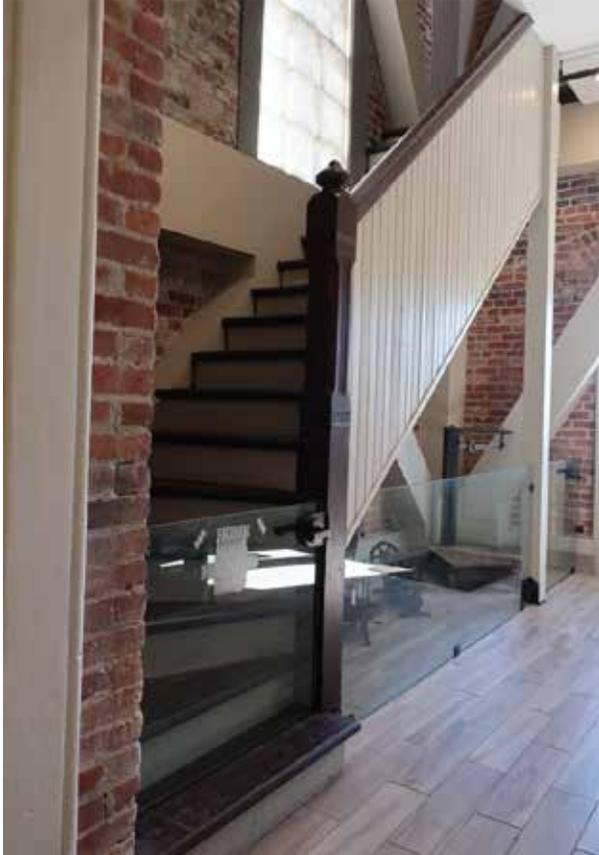
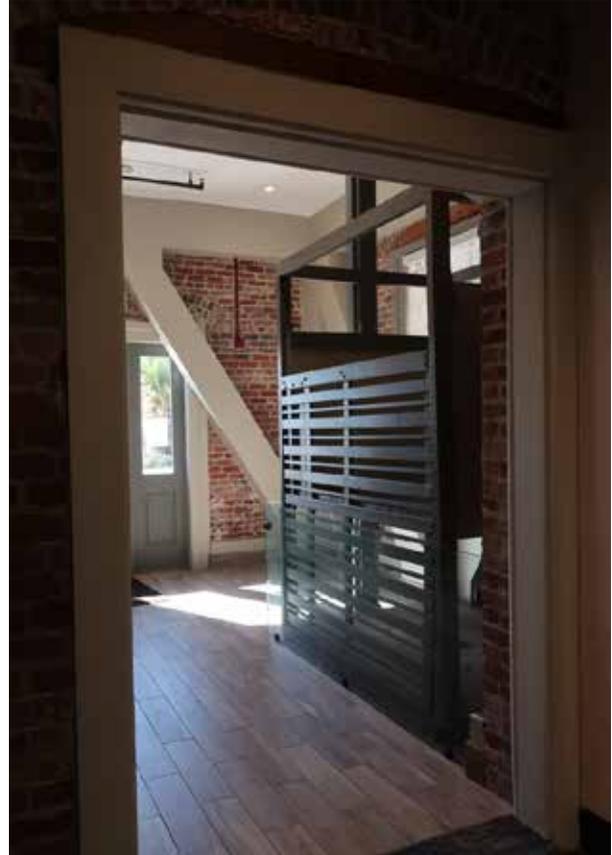
Figs.20-21: At Main Building west tower, historic stair (at left) and elevator (at right)

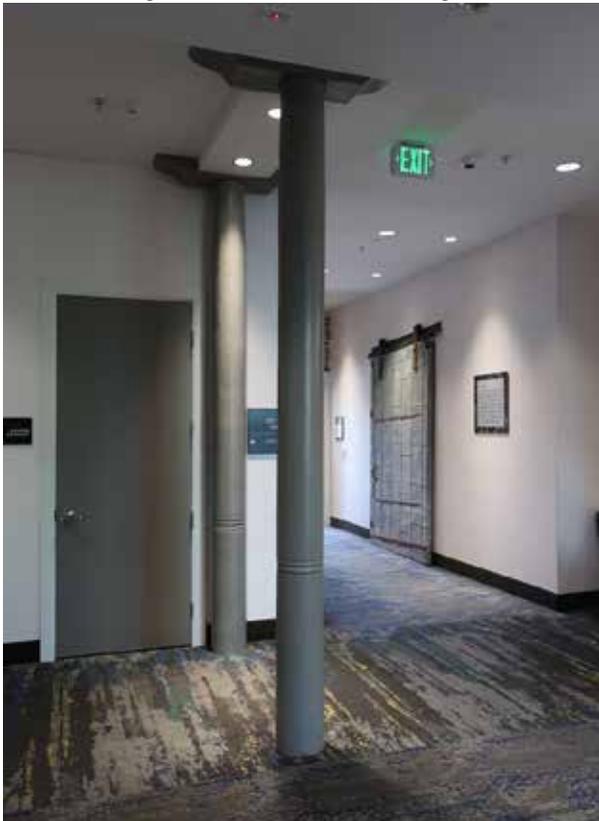
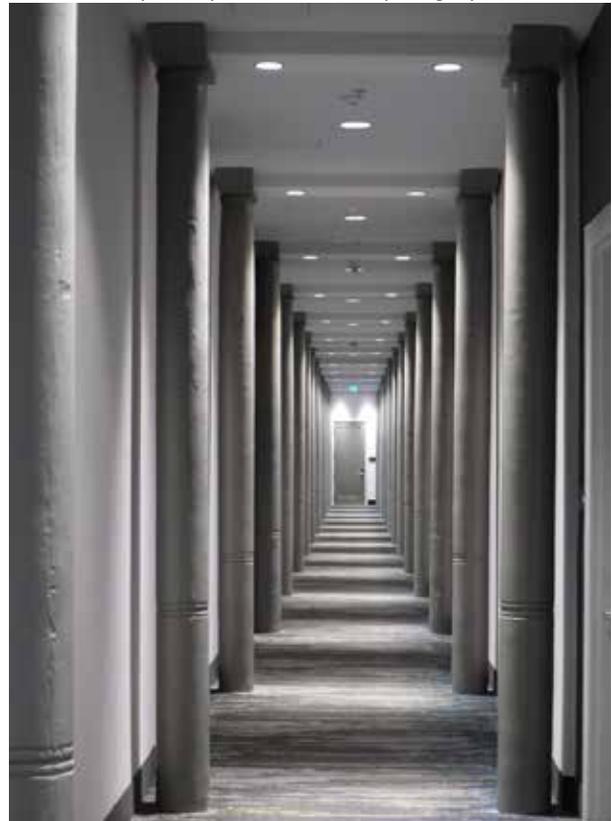
Figs.22-23: At Main Building first floor, retention of historic doors and columns

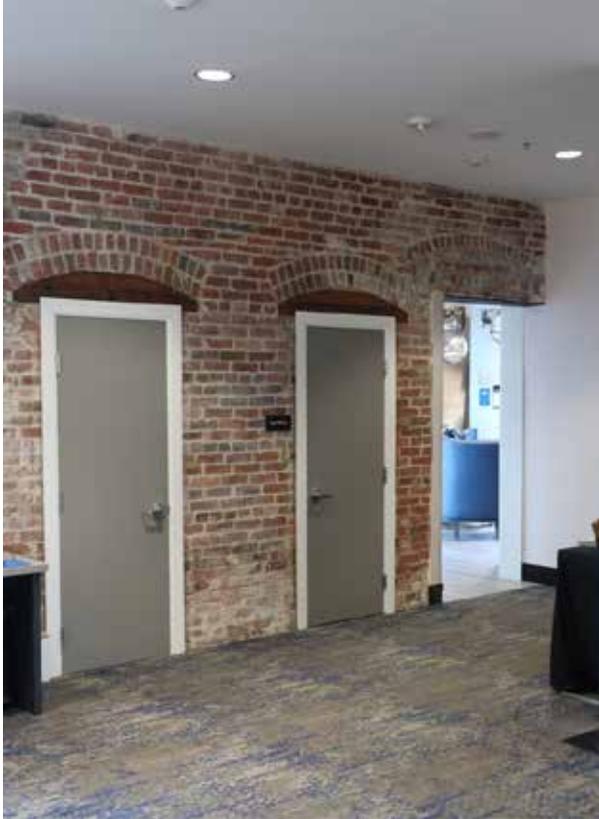
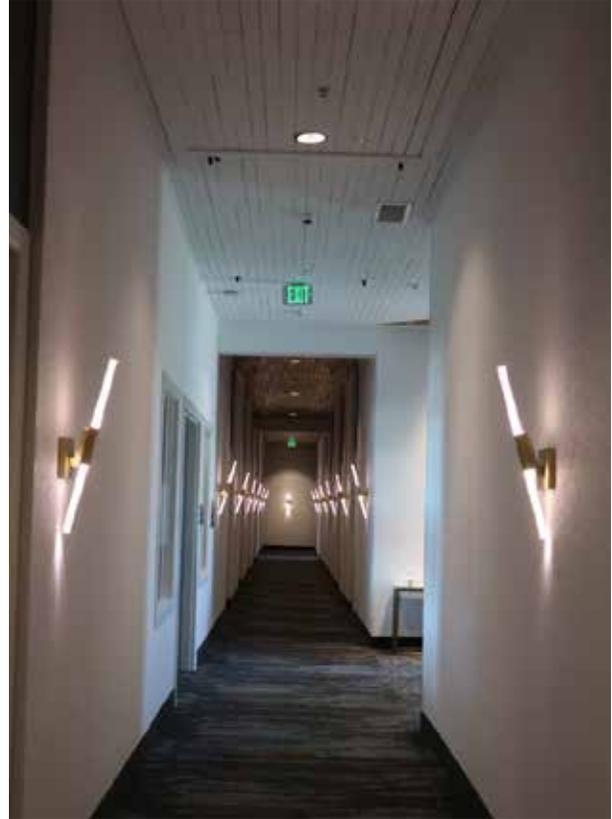
Figs.24-25: At Main Building second floor, retention of historic openings and ceilings
