**PRELIMINARY GEOTECHNICAL INVESTIGATION  
THE NEIGHBORHOOD DEVELOPMENT  
LOS GAMOS AVENUE  
SAN RAFAEL, CALIFORNIA**

December 7, 2020

Job No. 3013.001

**MILLER PACIFIC ENGINEERING GROUP**  
(a California corporation)

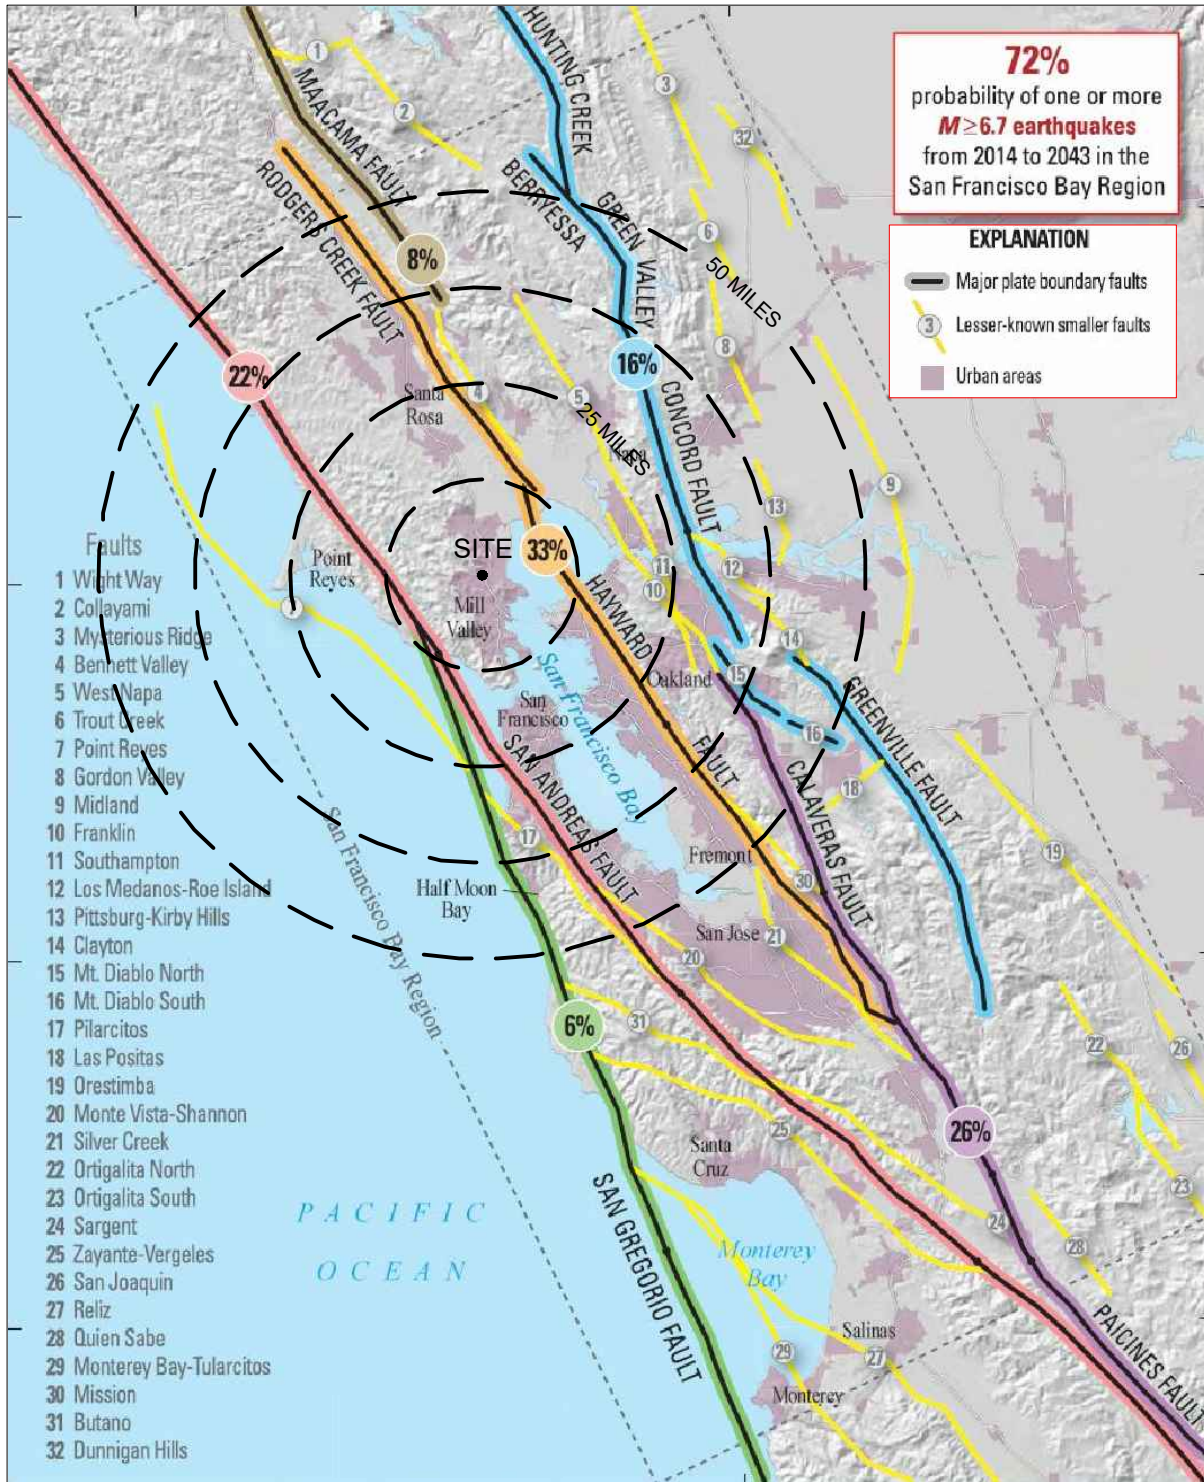
**4**  
FIGURE

**72%**  
probability of one or more  
**M ≥ 6.7 earthquakes**  
from 2014 to 2043 in the  
San Francisco Bay Region
