GEOTECHNICAL INVESTIGATION

RESTORE ERODED AND DIKED MARSH TISCORNIA MARSH HABITAT RESTORATION SAN RAFAEL, CALIFORNIA

Project No. 923.01
January 14, 2021

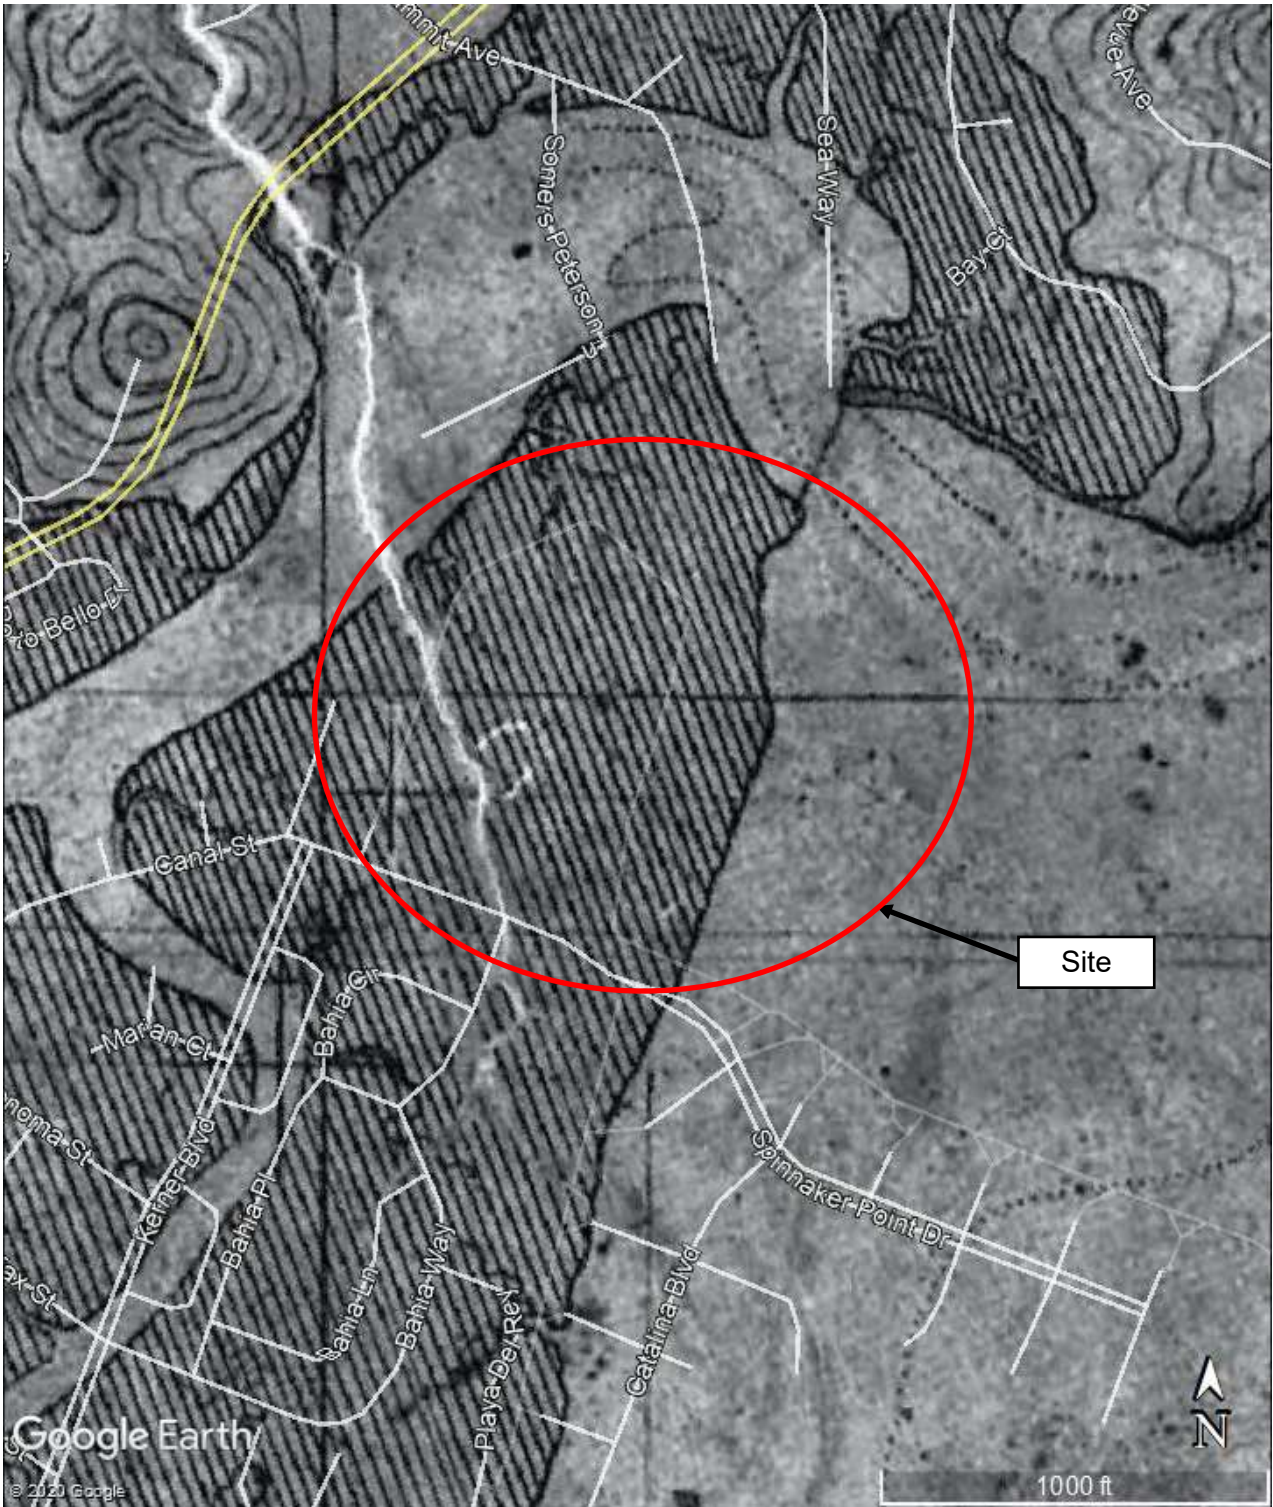
Plate No. 5

Source: U.S. Coast Survey, San Francisco, California, Plane Table Sheet No. IV, 1853.

We reviewed available historic shoreline surveys (t-sheets) by NOAA published in 1853, 1943, and 1979. The historic shoreline surveys are presented on Plates 5 through 7. We also reviewed available historic topographic maps published by USGS. The existing perimeter levees around the diked marsh and soccer field were likely built in the early- to mid-1900s. The perimeter levee was then extended along the shoreline of San Rafael Creek to San Pablo Bay in the 1960s to accommodate further development. The levees were likely constructed by excavating Bay Mud from the adjacent land, waterways or ditches. The tidal marshplain located east of the soccer field has been eroding at a rate up to 4 to 5 feet per year for the last several decades.

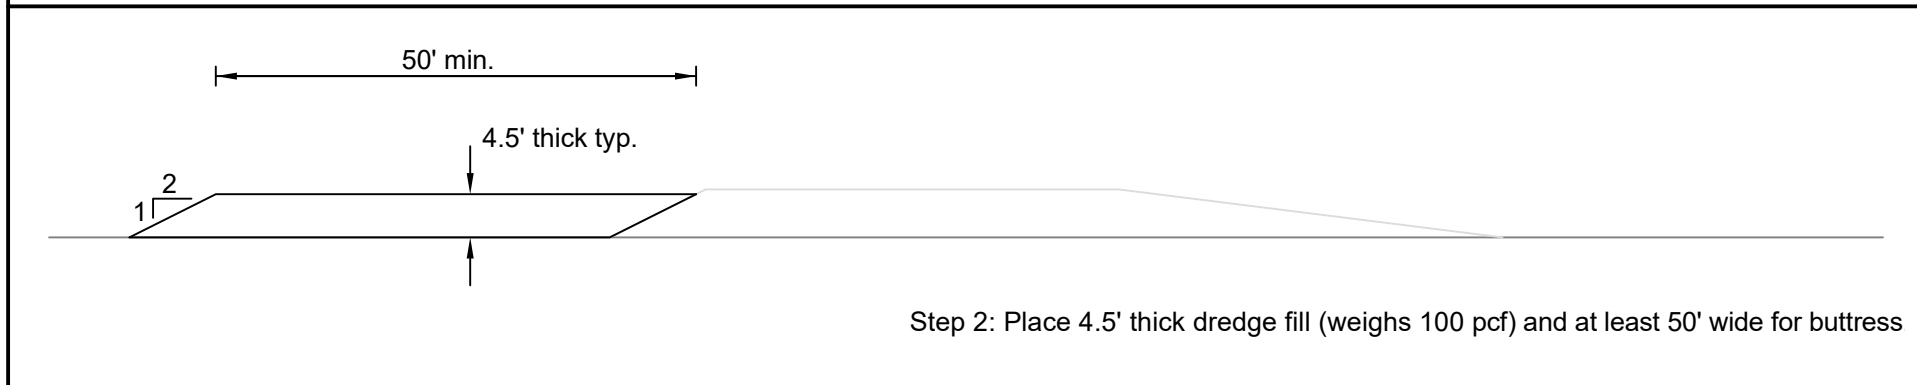
NOT TO SCALE	Restore Eroded and Diked Marsh Tiscornia Marsh Habitat Restoration San Rafael, California		Preliminary Typical Configuration Details Tidal Marsh Area Coarse Beach Section on Eroded Marsh Areas	
	Hultgren - Tillis Engineers		Project No. 923.01	Plate No. 11

We conclude that the restored marsh fills need to be placed in stages to limit stress on the Bay Mud. We have developed preliminary construction sequences for the coarse beach and rock jetty. The construction sequence for the coarse beach on the eroded marsh areas is presented on Plate 11. The construction sequence for the coarse beach on the virgin marsh areas is presented on Plate 12. The construction sequence for the rock jetty on eroded marsh areas is presented on Plate 13. The sequences are also described below.

We have developed preliminary construction sequences for the dredged containment including for the coarse beach on eroded marsh areas, the coarse beach on virgin marsh areas, and the rock jetty on eroded marsh areas. The preliminary construction sequence for the coarse beach on eroded marsh areas is presented on Plate 11, the coarse beach on virgin marsh areas is presented on Plate 12, and the rock jetty on eroded marsh areas is presented on Plate 13. The construction sequences are based on limited geotechnical data

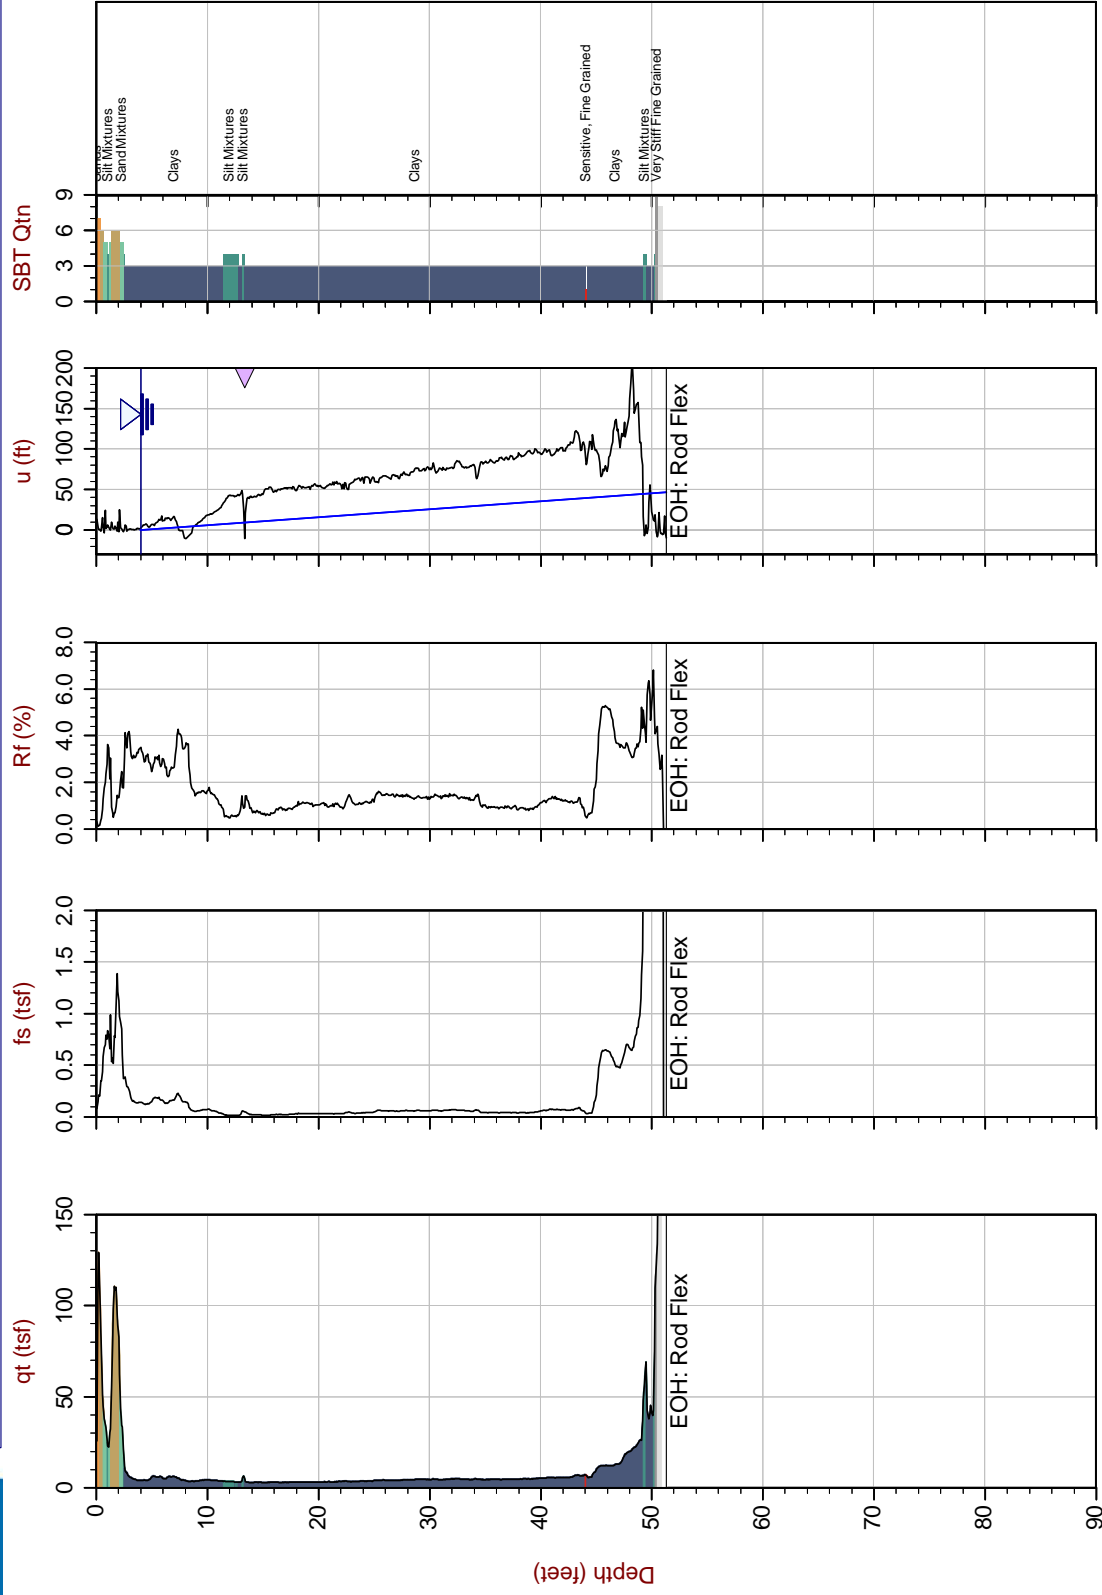
Job No: 19-56169 Sounding: CPT-01
 Date: 2019-11-01 08:07 Cone: 443:T1500F15U500
 Site: Tiscornia Marsh

Max Depth: 15.650 m / 51.34 ft
 Depth Inc: 0.025 m / 0.082 ft
 Avg Int: Every Point

● Equilibrium Pore Pressure (Ueq)
● Assumed Ueq
▼ Dissipation, Ueq not achieved
— Hydrostatic Line

We explored subsurface conditions on November 1 and 4, 2019 by pushing five CPTs to depths of about 51.5 to 87.5 feet below existing grade. The CPTs were performed by our subcontractor with a 25-ton truck-mounted CPT rig. After pushing each CPT, the holes were backfilled with grout. The CPT logs are presented in Appendix A, Plates A-1 through A-5. Soil descriptions on the CPT logs are in general accordance with the CPT Soil Behavior Type Legend presented on Plate A-6. Pore pressure dissipation test results are presented in Plates A-7 and A-8.

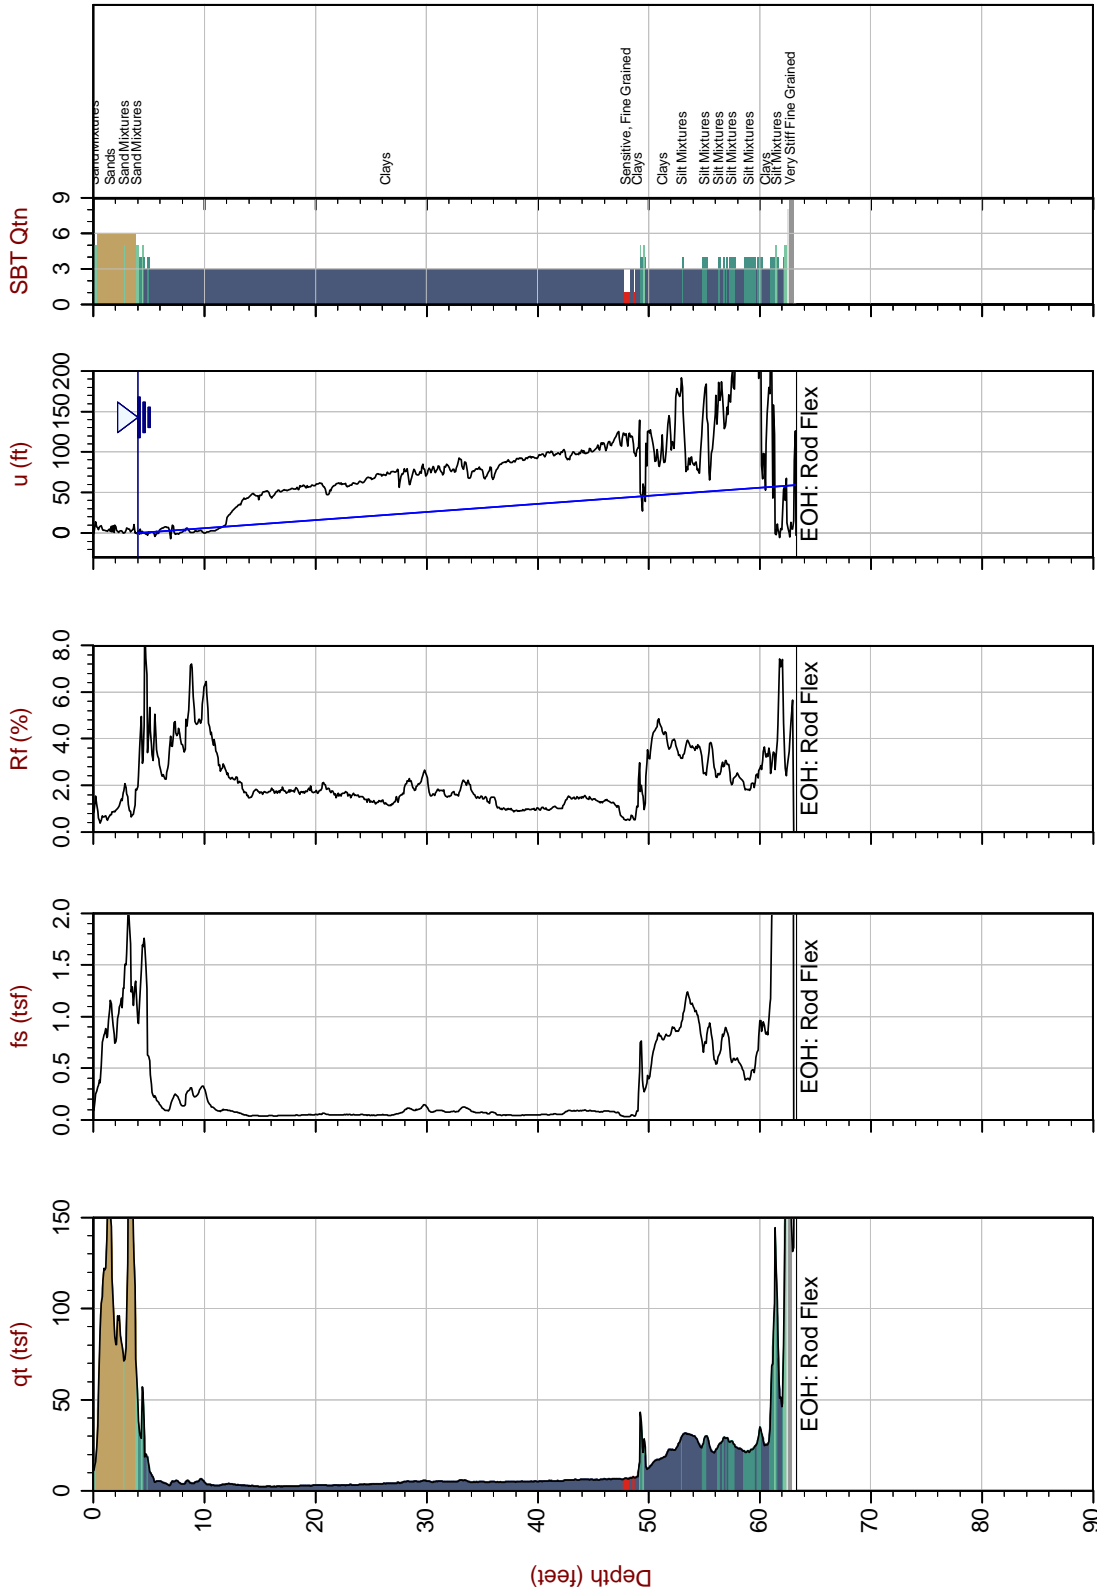
Sounding: CPT-03
Cone: 443:T1500F15U500

Latitude: 37.96901 Longitude: -122.49709 Elevation: 10 feet

Max Depth: 19.300 m / 63.32 ft
Depth Inc: 0.025 m / 0.082 ft
Avg Int: Every Point
● Equilibrium Pore Pressure (Ueq)
The reported coordinates were acquired from consumer grade GPS equipment and are only approximate locations.

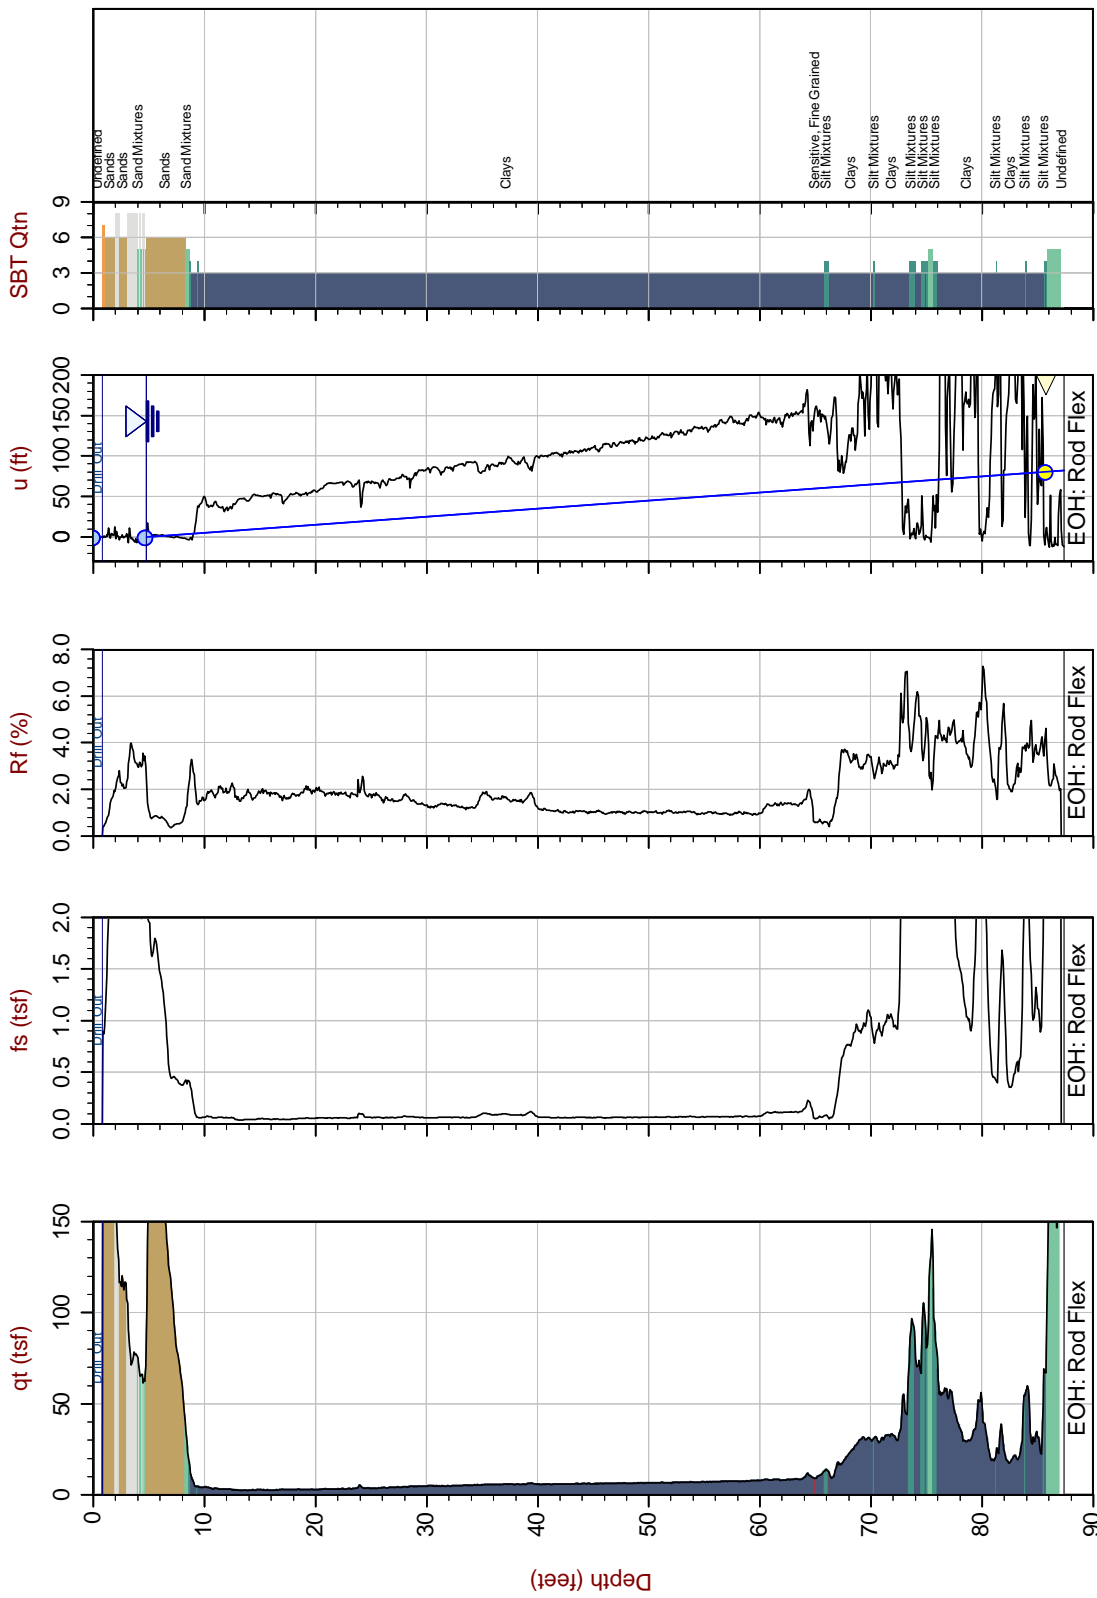
Sounding: CPT-05

SBT: Robertson, 2009 and 2010
Coords: UTM 10N N: 4202292m E: 544247m

Max Depth: 26.650 m / 87.43 ft
Depth Inc: 0.025 m / 0.082 ft
Avg Int: Every Point

- Equilibrium Pore Pressure (Ueq)
 - Assumed Ueq
 - △ Dissipation, Ueq achieved
 - Dissipation, Ueq not achieved
 - Hydrostatic Line
- The reported coordinates were acquired from consumer grade GPS equipment and are only approximate locations. The coordinates should not be used for design purposes.

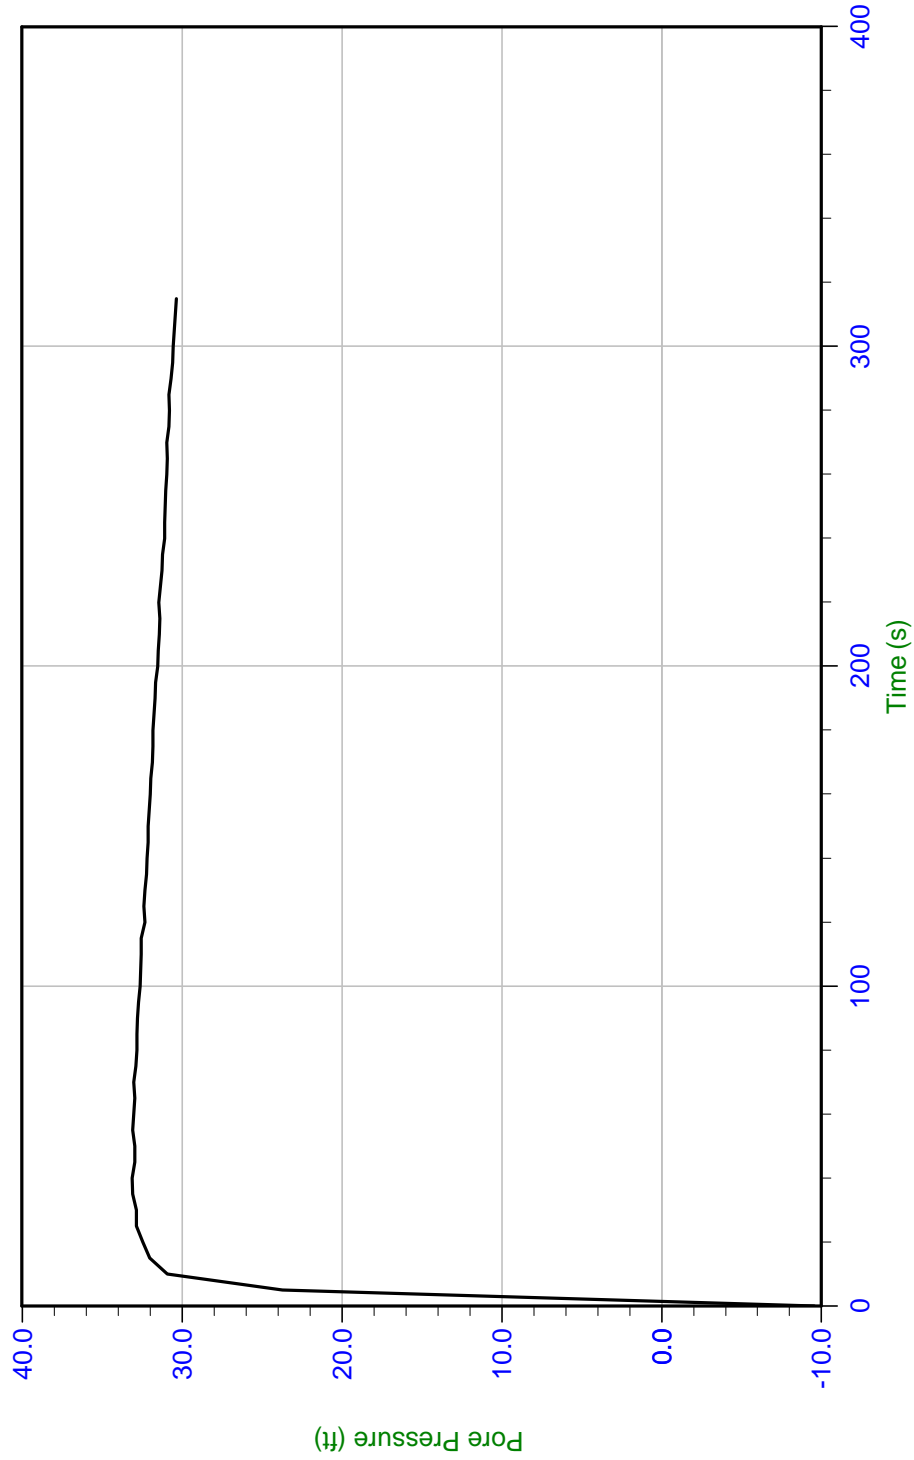
Sounding: CPT-01

u Min: -9.5 ft
u Max: 33.1 ft
u Final: 30.3 ft

Filename: 19-56169_CP01.PPF
Depth: 4.075 m / 13.369 ft
Duration: 315.0 s

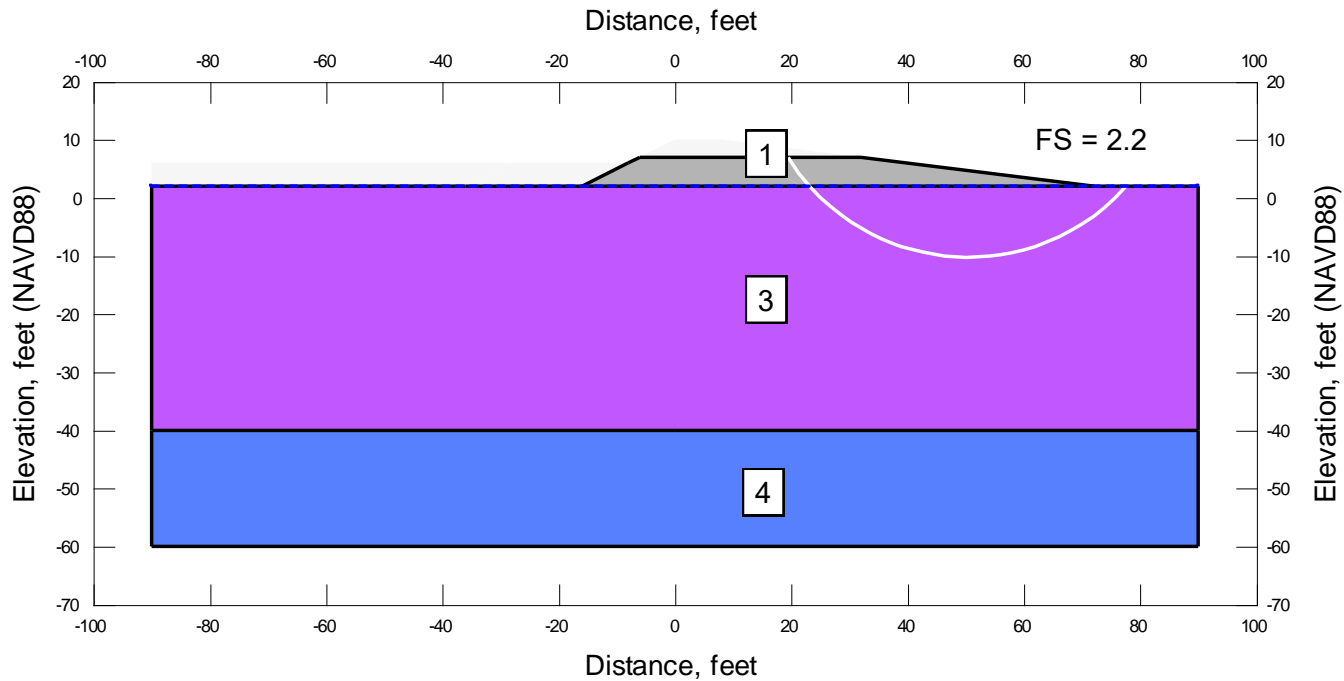
STABILITY MODEL MATERIAL PROPERTIES

UNIT NO.	LAYER COLOR	MATERIAL TYPE	UNIT WEIGHT (pcf)	UNDRAINED STRENGTH		EFFECTIVE STRENGTH	
				COHESION (psf)	FRICTION ANGLE (degrees)	COHESION (psf)	FRICTION ANGLE (degrees)
1		New Rock Fill	135	-	-	50	38
2		New Dredged Fill	100	-	-	50	30
3		Eroded Bay Mud	97	140 + 10H	-	-	-
4		Stiff Clay	120	1,000	-	-	-

We performed slope stability analyses to determine the factors of safety for the end of construction condition to evaluate the safe rate of fill placement. We used the computer program SLOPE/W and Spencer's method of analysis. We used presumptive undrained shear strengths for the underlying Bay Mud. In eroded marsh areas, we used an undrained strength of 140 psf at the ground surface and increasing 10 psf for each additional foot of depth. In virgin marsh areas, we used an undrained strength of 100 psf at the ground surface and increasing 10 psf for each additional foot of depth. The soil parameters used in our analysis are presented on Table E-4 below.

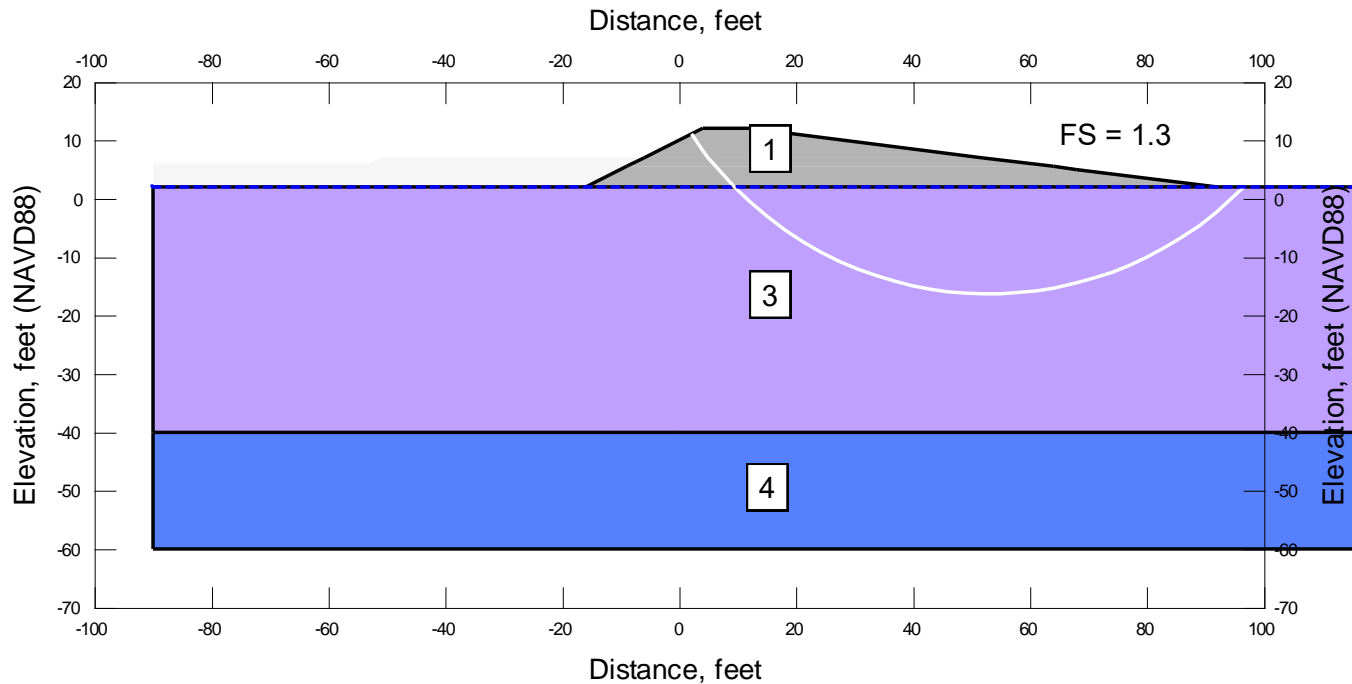
STABILITY MODEL MATERIAL PROPERTIES

UNIT NO.	LAYER COLOR	MATERIAL TYPE	UNIT WEIGHT (pcf)	UNDRAINED STRENGTH		EFFECTIVE STRENGTH	
				COHESION (psf)	FRICTION ANGLE (degrees)	COHESION (psf)	FRICTION ANGLE (degrees)
1		New Rock Fill	135	-	-	50	38
2		New Dredged Fill	100	-	-	50	30
3		Virgin Bay Mud	97	100 + 10H	-	-	-
4		Stiff Clay	120	1,000	-	-	-
